SYDENHAM TO BANKSTOWN

ENVIRONMENTAL IMPACT STATEMENT

Technical Paper 3

Non-Aboriginal Heritage Impact
Assessment

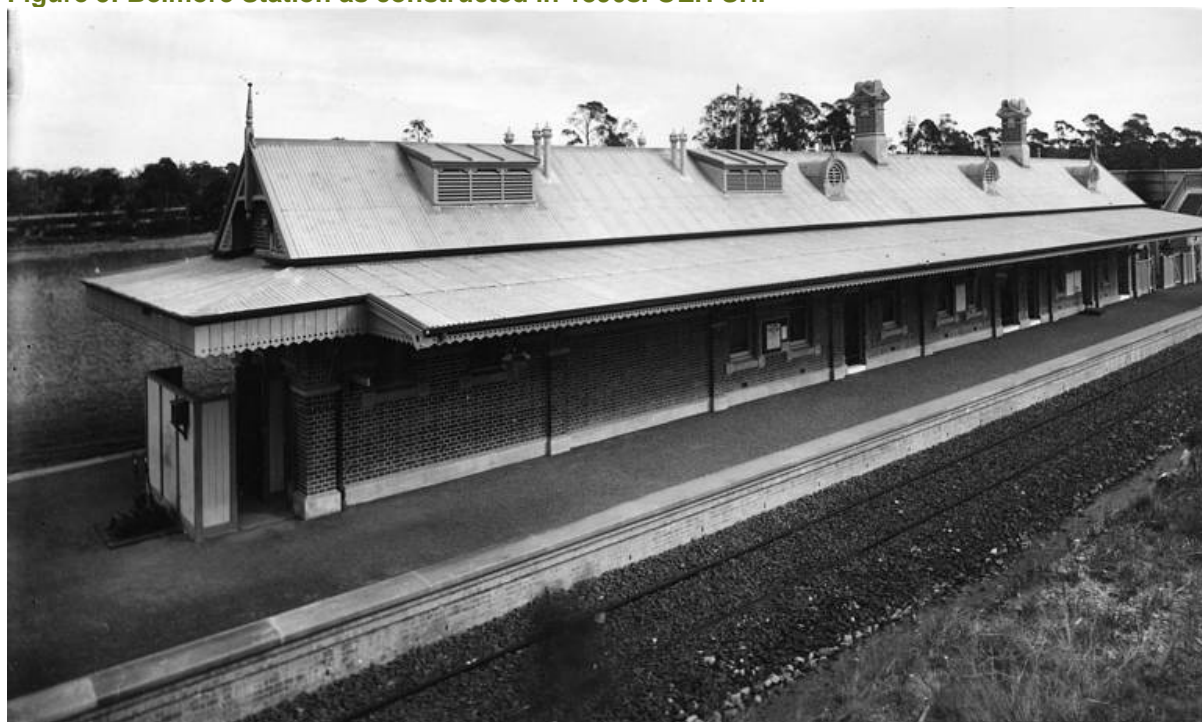
Figure 5: Belmore Station as constructed in 1890s. OEH SHI

The most important stations on the line, Belmore, Canterbury and Marrickville, were built with impressive near-identical brick buildings (Figure 5). The intermediate stations (Campsie, Dulwich Hill and Hurlstone Park) receiving more modest timber buildings, possibly due to the economic austerity required by the onset of the depression of the 1890s. These were later replaced with brick buildings. The depression also suppressed the profitability of the line and the extension to Liverpool did not proceed. However, suburban development followed in the early twentieth century, particularly during the interwar period when many War Service homes were built west of Canterbury.

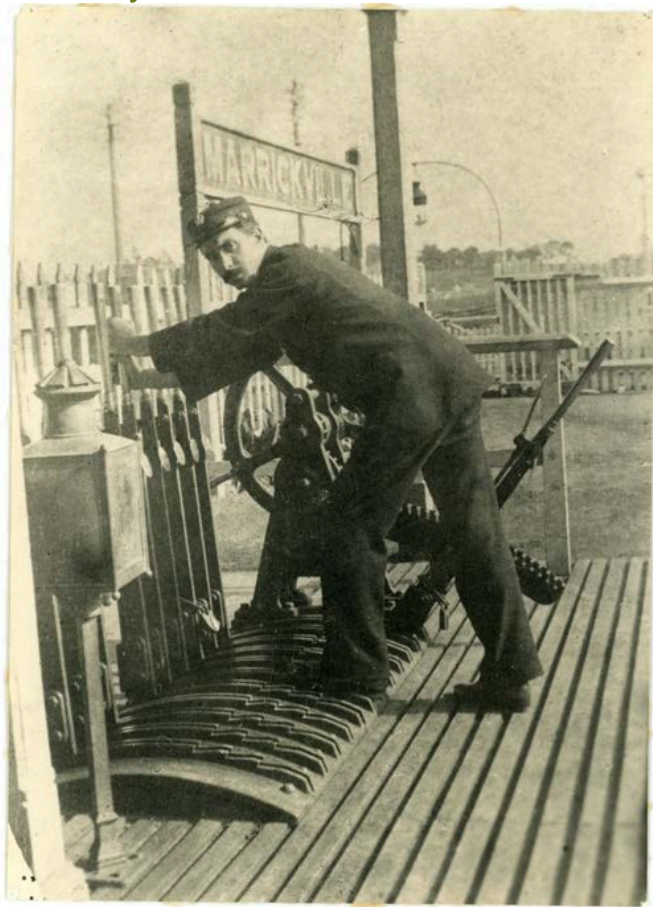
Figure 12: n.d. unidentified rail worker at signal box of Marrickville Station. Marrickville Library and History Services.

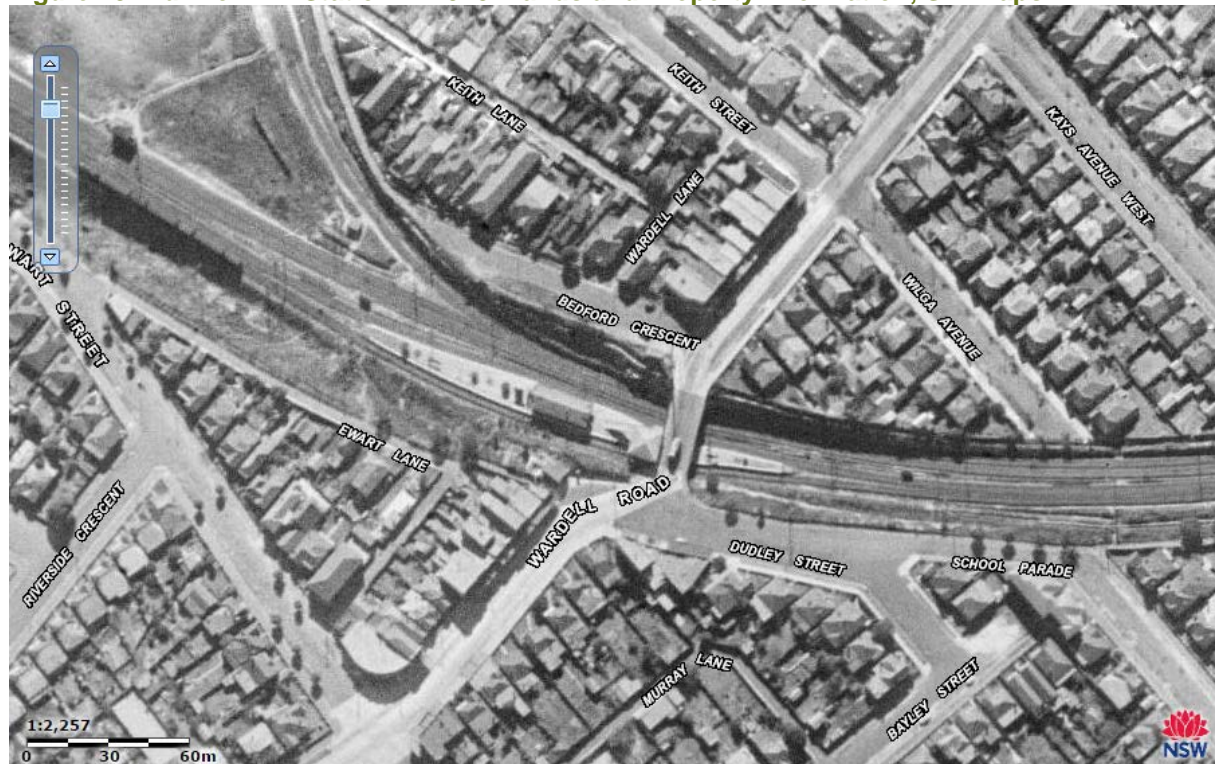
Figure 18: Dulwich Hill Station in 1943. Lands and Property Information, SIX Maps.

In 1935 the original 1895 timber station buildings were replaced. Historic plans dated 1935 show the demolition of the original platform building and the construction of a new brick platform building; a new overhead weatherboard booking and parcels office and bookstall; and the relocation of the stairs to the platform to accommodate modifications.³⁹ The layout of the station after these changes is evident in an aerial photograph dating to 1943 (Figure 18).

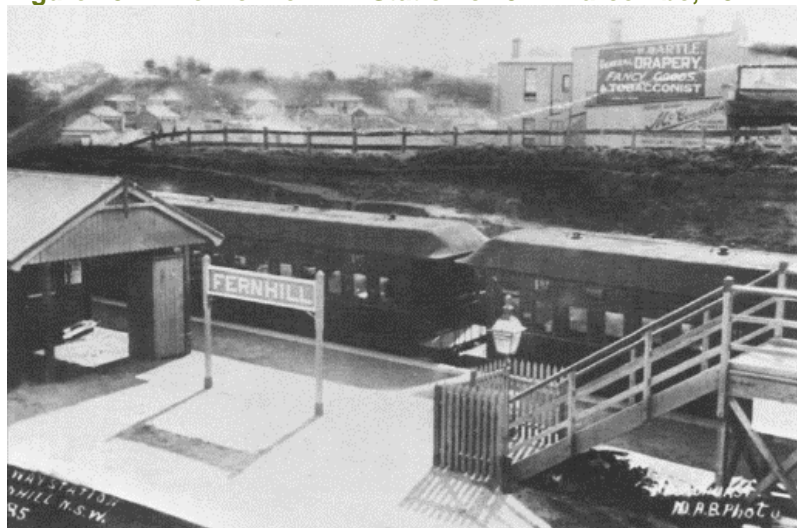
Figure 25: A view of Fernhill Station c.1911. Larcombe, 1971: 197.

Hurlstone Park Station was opened as Fern Hill on 27 November 1894 (Figure 25). It was renamed Hurlstone Park on 19 August 1911. In this year the Metropolitan Goods line was built past the station and a new Down platform was built. In 1915 the original timber station building was replaced by brick buildings on both platforms and an overhead booking office. The latter was replaced in the 1980s by a new booking office.⁴⁷

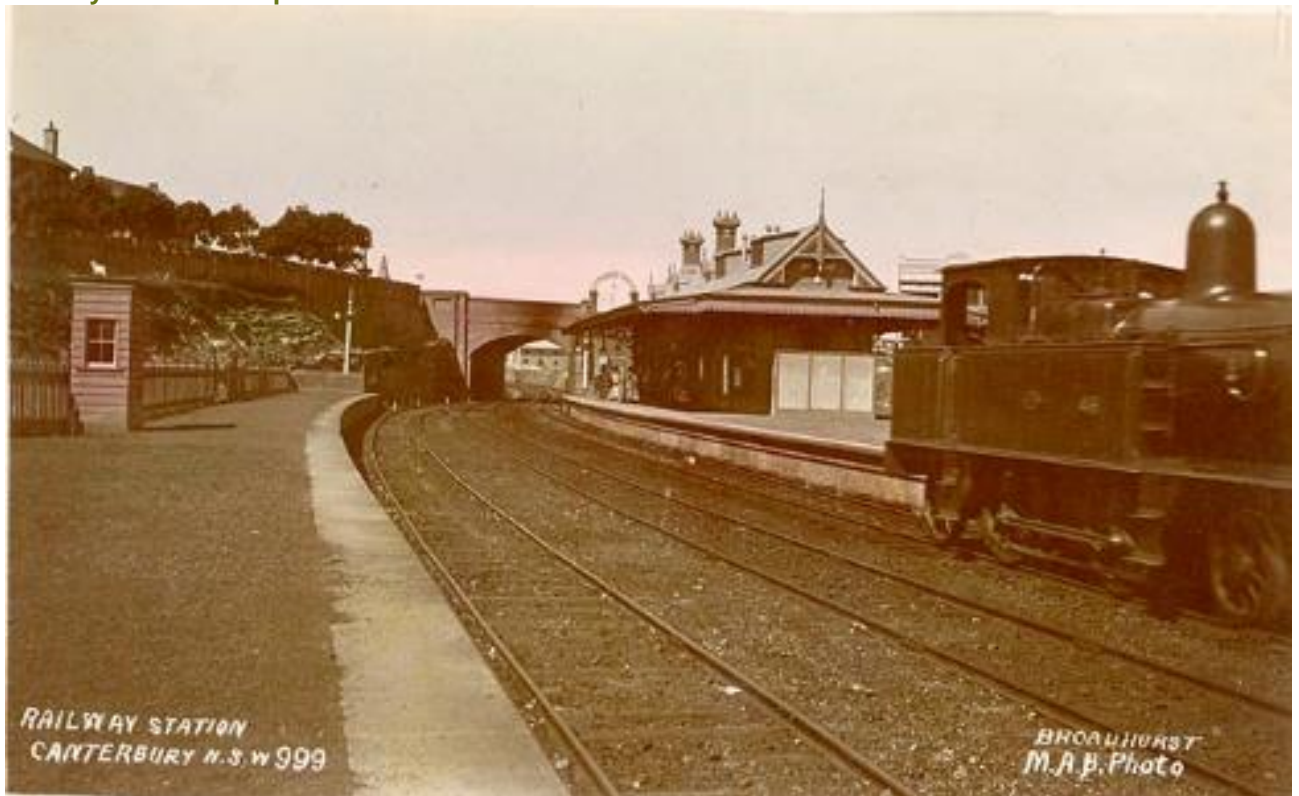
Figure 35: Canterbury Station between in 1916 and 1927. State Heritage Inventory 'Canterbury Railway Station Group'.

The opening of Canterbury Station on February 1, 1895, encouraged land sales throughout the area (Figure 33 and Figure 34). The subdivision catering to the new station was called the Silver Park Estate. The station consisted of two impressive polychromatic brick platform buildings (Figure 35). A branch line leading to sidings used on race days at the Canterbury Racecourse was also constructed (since demolished; Figure 36). Extensive cuttings within the existing bedrock took place at this time in

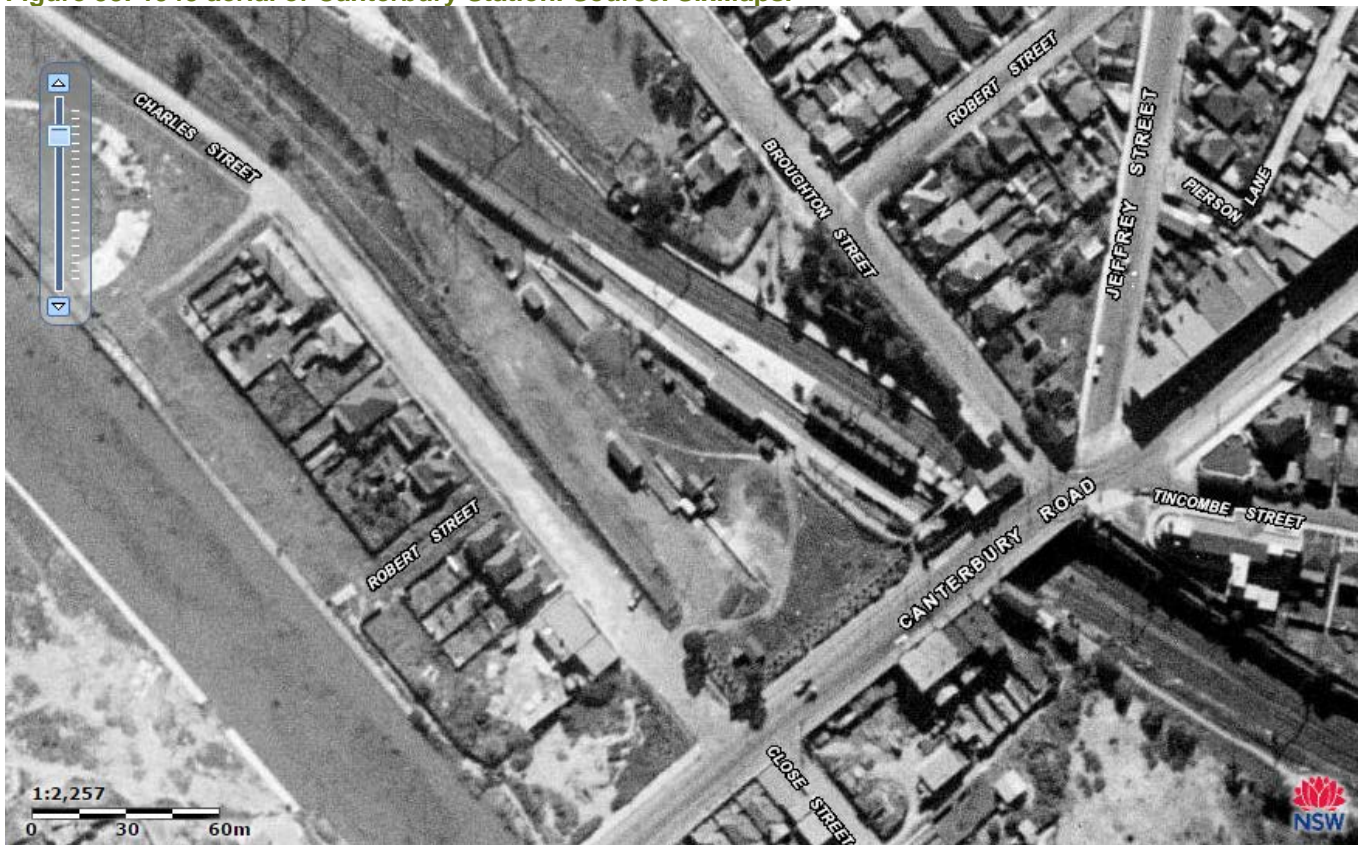
Figure 38: 1943 aerial of Canterbury Station. Source. SixMaps.

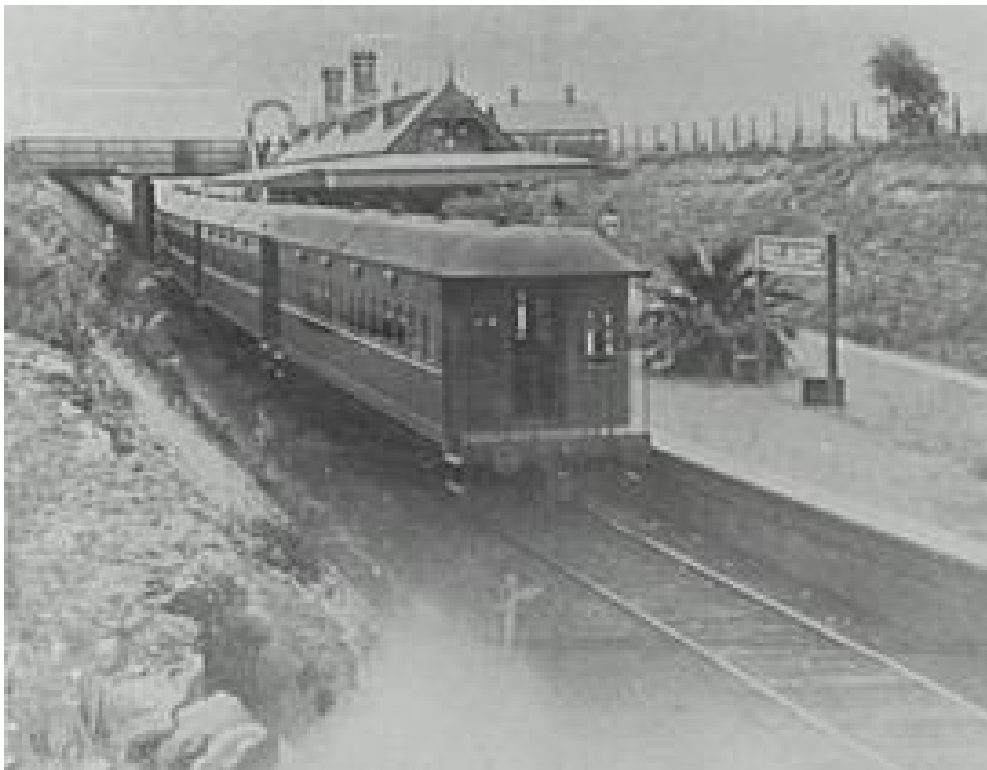
Figure 56: c.1900 photograph of Belmore Station. City of Canterbury Local History Photograph Collection.

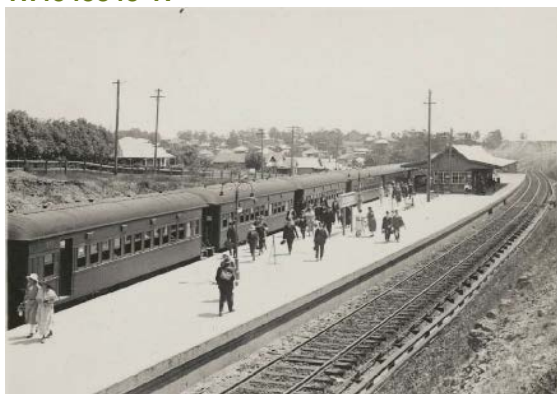
Figure 68: Lakemba Station c.1920. Source National Library of Australia nla.pic-vn4543845-v.

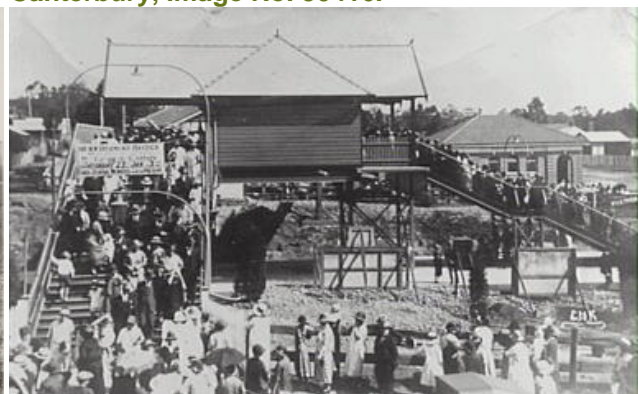
Figure 69: Opening of the overhead bridge. City of Canterbury Library Collection via Pictorial Canterbury, Image No. 30416.

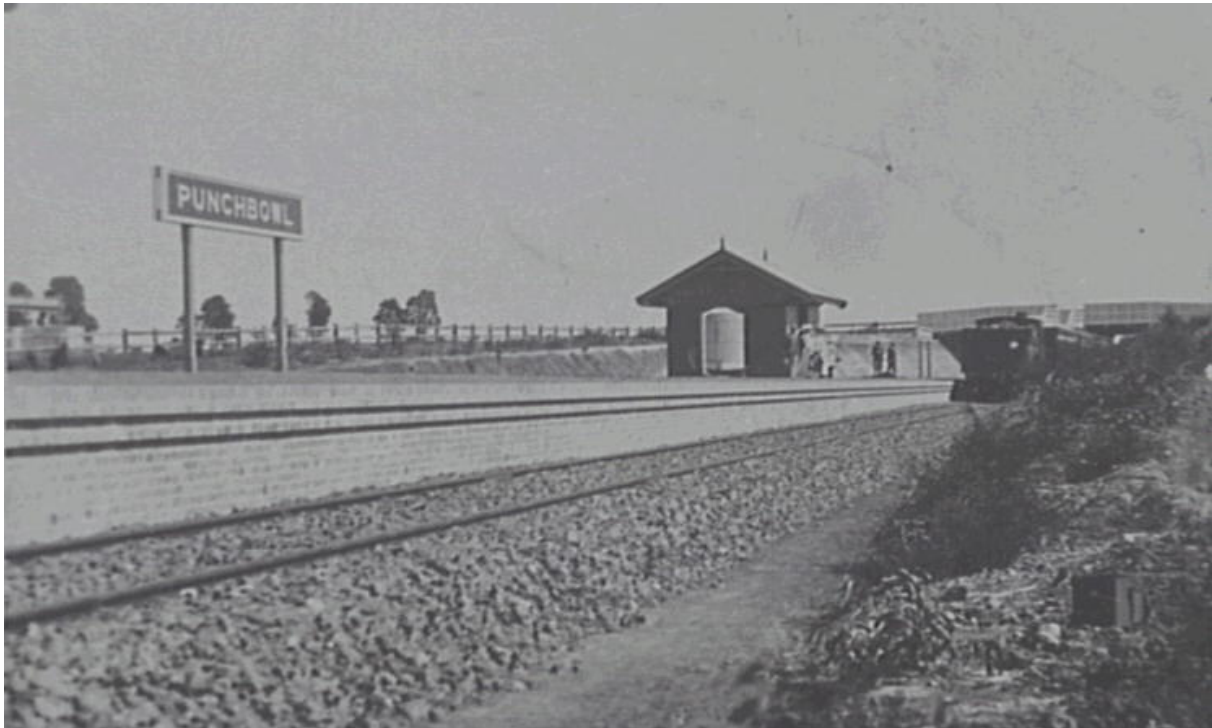
Figure 78: Punchbowl Station c.1909. City of Canterbury Library, Pictorial Canterbury, image no. 15073 ns.

Punchbowl Station was opened along with the line extension on 14 April 1909 (Figure 78), at the same time as Bankstown and Lakemba. The contract for construction of station buildings was awarded to G Leggo of Paddington.⁹⁰

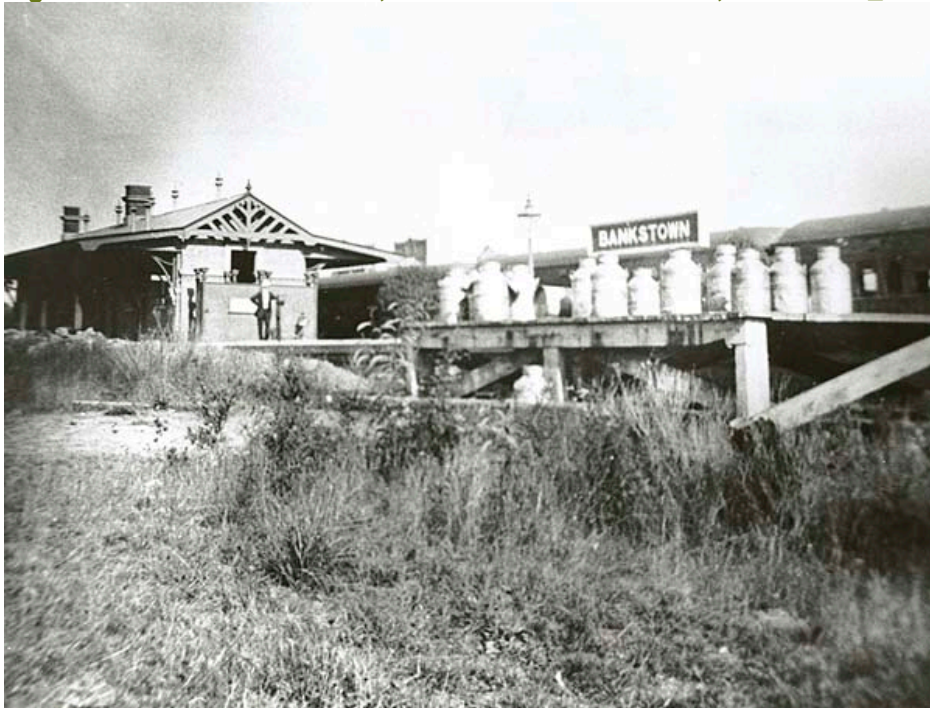
Figure 88: Bankstown Station, 1910. State Records NSW, item 17420_a014_a0140001090.

The original platform at Bankstown was 145 metres in length (Figure 87 and Figure 88). The tender for the construction of the brick platform buildings was awarded to George Albert Leggo in August 1908. A contract was also awarded around this time for the construction of a Station Master's Residence, which was located on the northern side of the tracks, near the goods yard and a goods shed built to the west of the old Chapel Road overbridge (Figure 89).⁹⁶

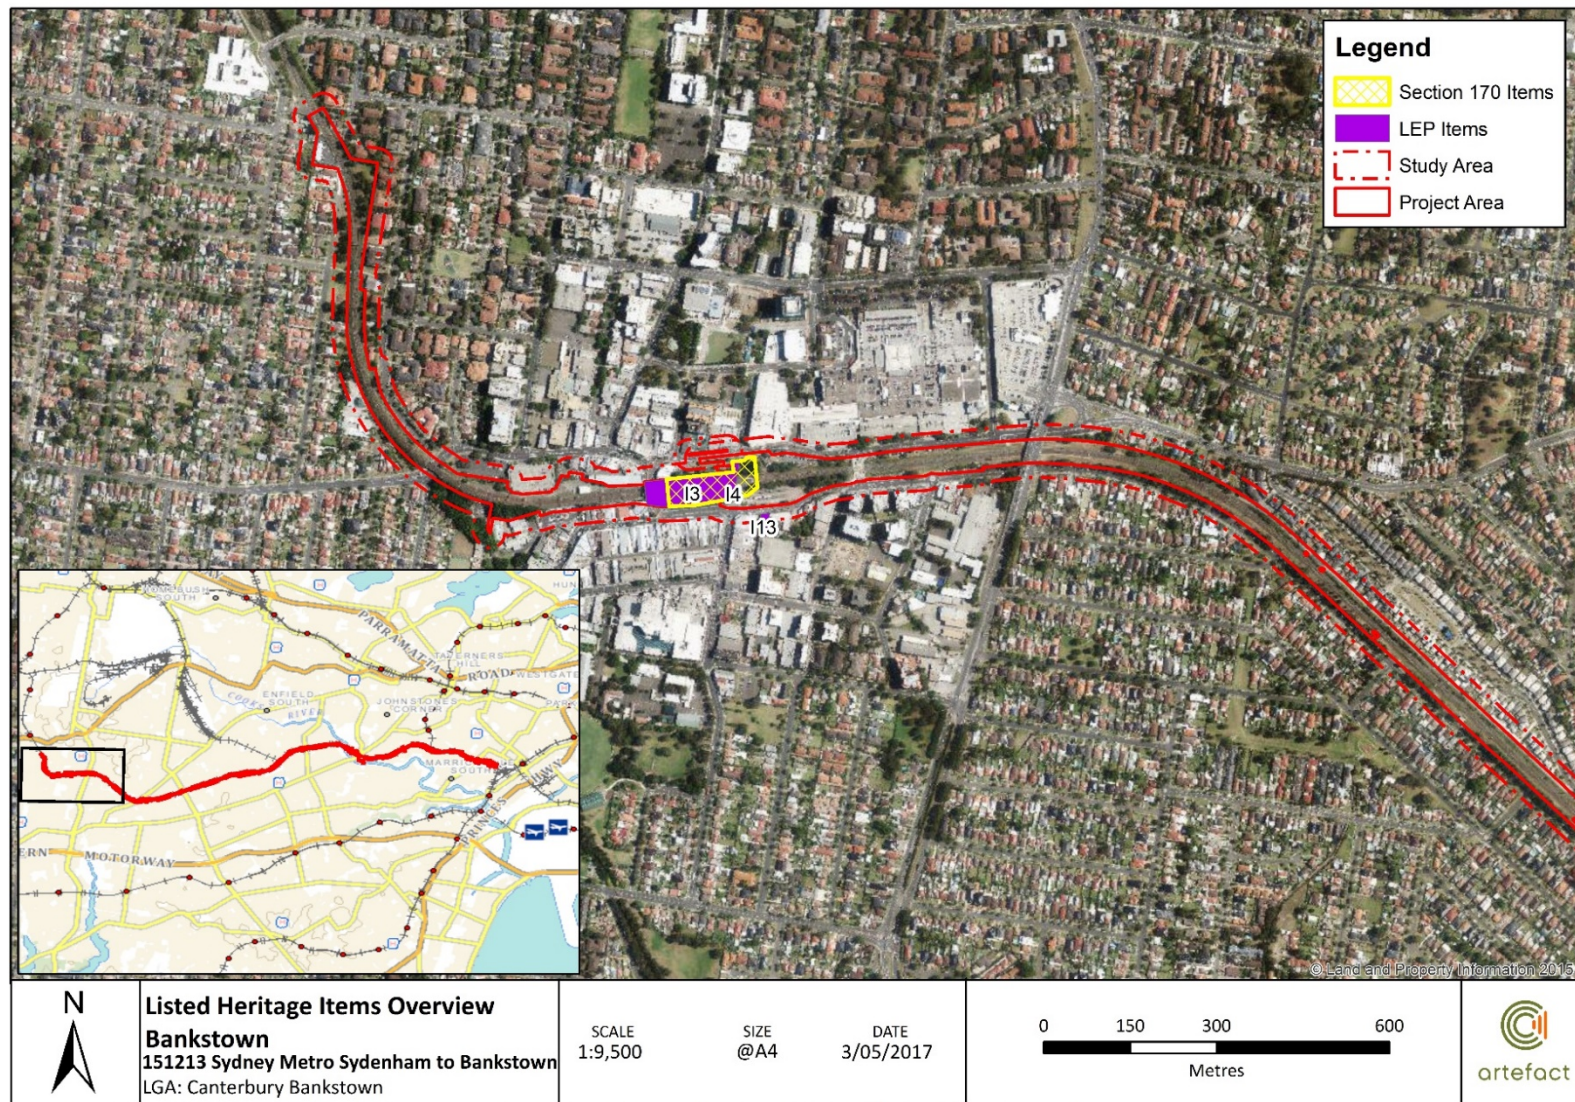
Figure 97: Aerial map showing heritage items within study area: Bankstown

A search of all relevant registers was undertaken on 22 June 2016. The results include both heritage items within the project area and a 25-metre visual buffer (the study area). The items are displayed below in Table 7, and maps of the heritage items are provided from Figure 92 to Figure 97 below.
