Environmental Impact Statement – Appendix N2: Geomorphology Technical Assessment

Warragamba Dam Raising

Reference No. 30012078
Prepared for WaterNSW
10 September 2021

Geomorphology Technical Assessment

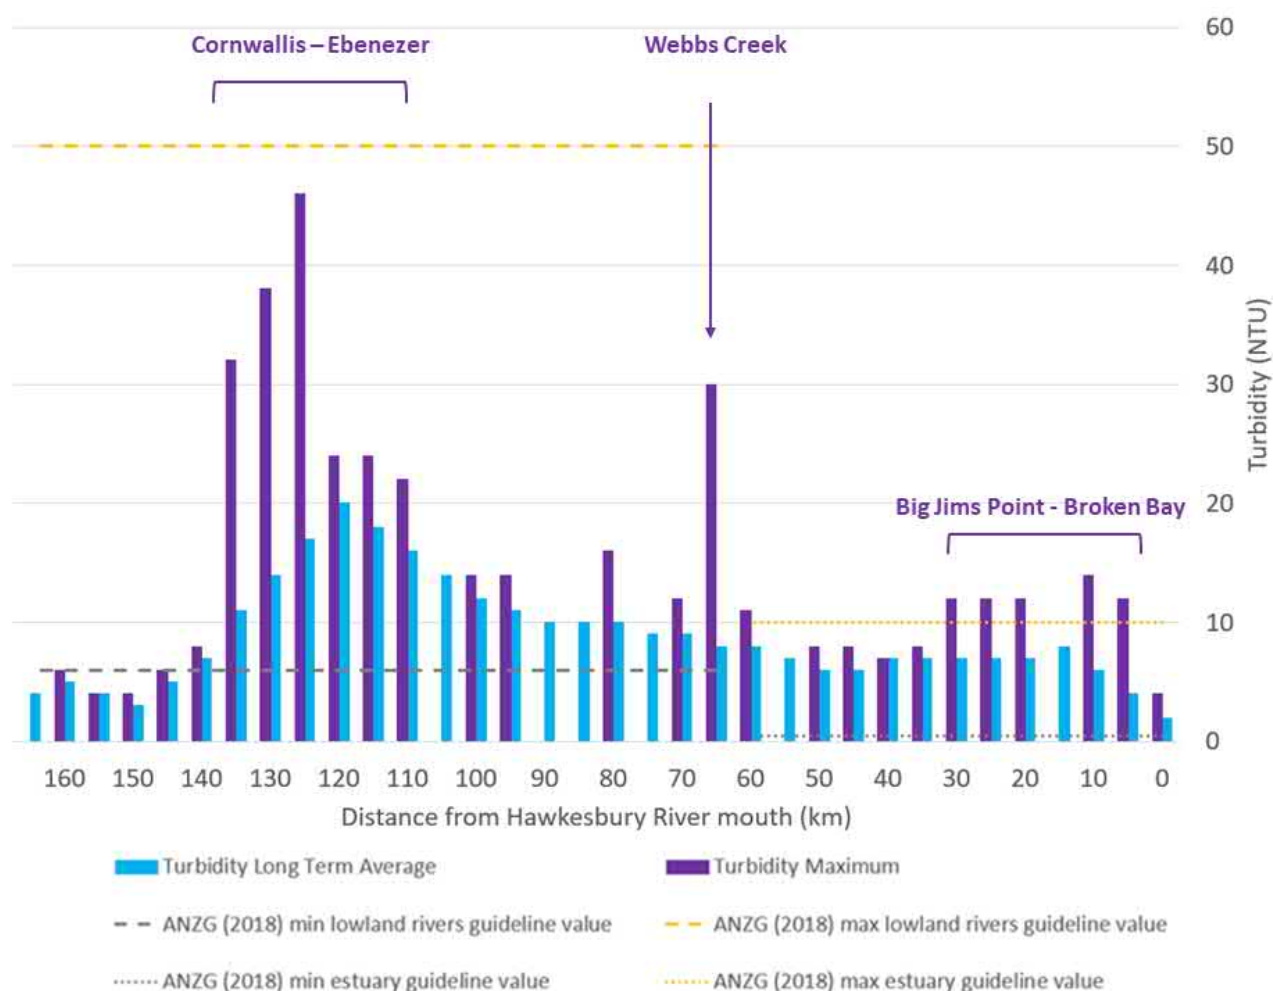
Figure 30 Hawkesbury-Nepean River turbidity profile

Figure 30 illustrates the changes in turbidity as you move from the mouth of the Hawkesbury River at Broken Bay upstream. These figures include historic turbidity data from a more extensive network of sites than is being monitored or identified for monitoring in the current DPI Water Program and values are based on long-term medians (DECC, 2009).

Long-term median turbidity levels generally remain relatively low in the freshwater section between Penrith and North Richmond. These levels are below the minimum ANZG 2018 guidance level for lowland rivers (South Australia, including NSW, aquatic ecosystem generic guideline) and could be due to lack of sediment

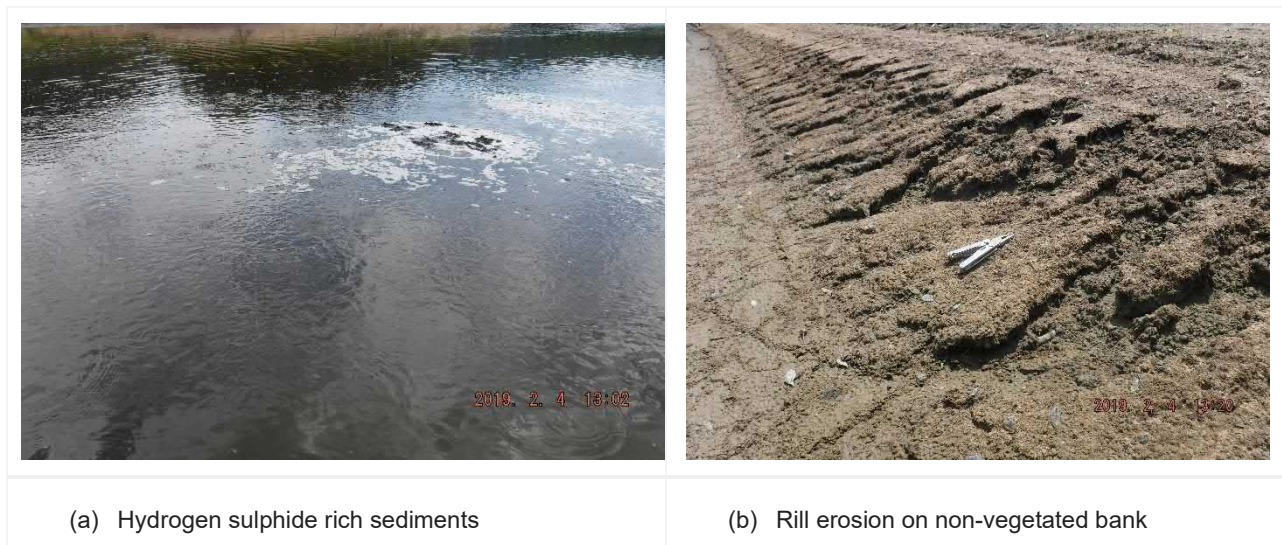
Figure 35 Cocks River downstream features

The Coxs River downstream extent has a lower gradient and a sand bed. The channel in this area has high organic loading, with hydrogen sulphide bubbling observed during disturbance (**Figure 35a**). Point bars form on the inside of meander bends and a small 2-4m strip of non-vegetated bank is exposed on the outside of meander bends before dense vegetation in the open u-shaped valley (**Figure 35b**). Rill erosion has been initiated in these deposits, presumably from runoff channels sourced on adjacent terracing.

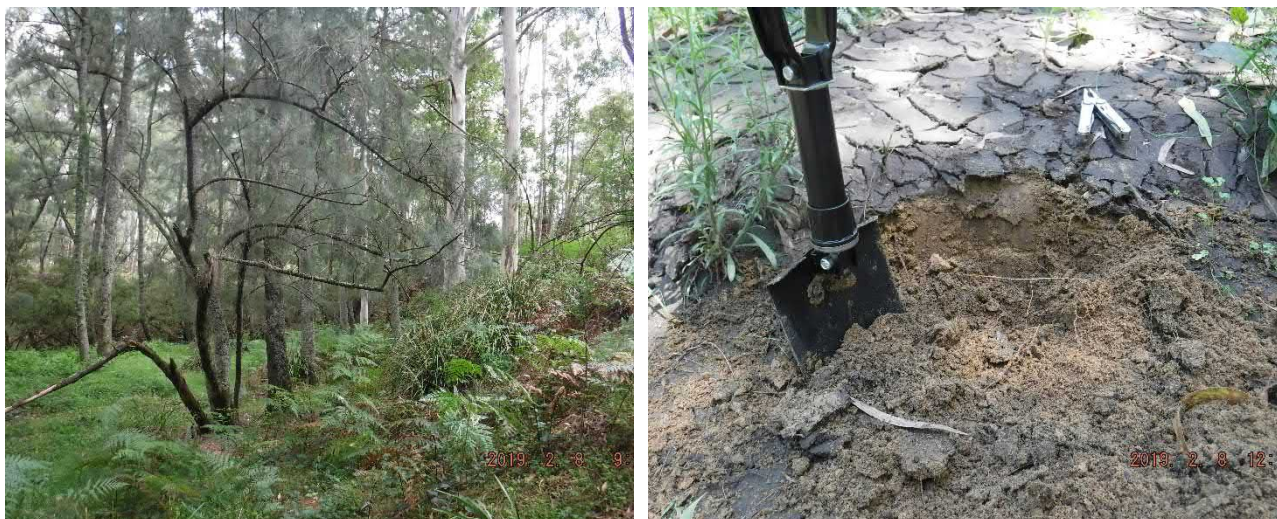
Figure 36 Kedumba Valley features

The Kedumba River is a valley-fill fine-grained channel with multiple well-developed levees. These raised elongated asymmetrical ridges border the Kedumba channel (i.e. along the proximal floodplain). The channel margin is steeper than the floodplain margin. Levee crests here are relatively shallow, laterally extensive features. They are composed almost entirely of suspended load sediments (dominantly silt, often sandy) deposited at high flood stage. Highly developed levees along extensive fine-grained floodplains such as these infer a laterally fixed channel zone and well-defined segregation of water and sediment transfer between the channel and flood basin. Overlying this material, a dark black thin layer of organic material was observed. It is postulated that this was sourced from recent wildfires in the catchment.

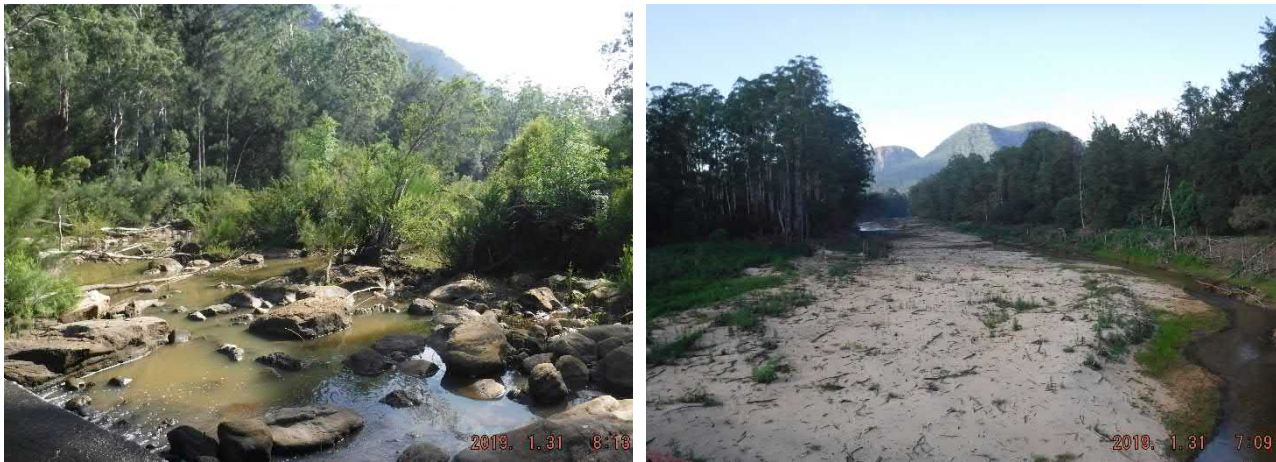
Figure 37 Nattai River channel features

The Nattai River is also set in valley fill floodplain with forested terracing. The upstream site contains elongated bedrock ridge over which finer sediments have been draped and colonised by vegetation (**Figure 37a**). These sediments were deposited on top of the instream bedrock ridge during the waning stages of flood events. As they have become colonised by vegetation, additional sediment has been trapped and accumulated on top of the bedrock core. Over time these bars have built both vertically and longitudinally as

sediments are trapped in the wake of vegetation. At the two downstream sites, relatively homogeneous, uniform, tabular ‘sand sheet’ deposits cover the entire bed (**Figure 37b**).

(a) In channel bedrock ridges

(b) Sand sheets

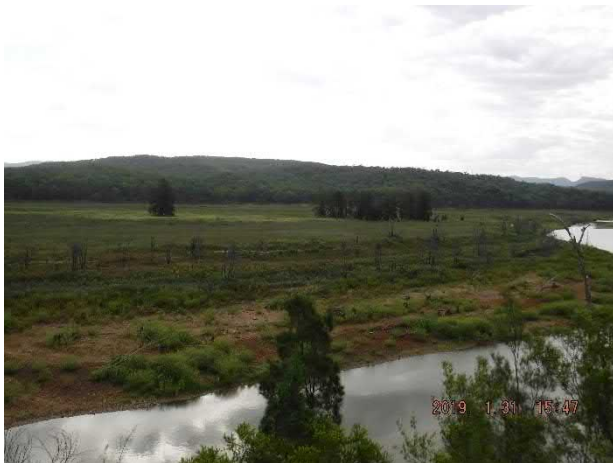
A roughly triangular (in map view) and wedge-shaped (in cross section) delta, approximately 5 km in length, has formed at the inlet point of the Wollondilly River into Lake Burragorang (**Figure 38a**). This is located at the point that velocities from the river have decreased below their conveyance capacity for the bedload and subsequently suspended load to the extent that a depositional environment predominates. This feature was not present at any other inlet points such as for the Coxs or Nattai Rivers. Bedding of materials (as is typical of deltas) was not observed with homogenous sediment composition generally comprising fine sands and silts. This was interspersed with gravels and cobble materials along the edge of the river channel (**Figure 38b**). The smoothed angle of the delta bank at the channel mouth and presence of lobate ‘fingers’ to the west suggests that delta morphology is influenced predominantly by the Wollondilly River current, and associated distributary channels, as opposed to wave action.

(a) Looking north west down onto the delta top

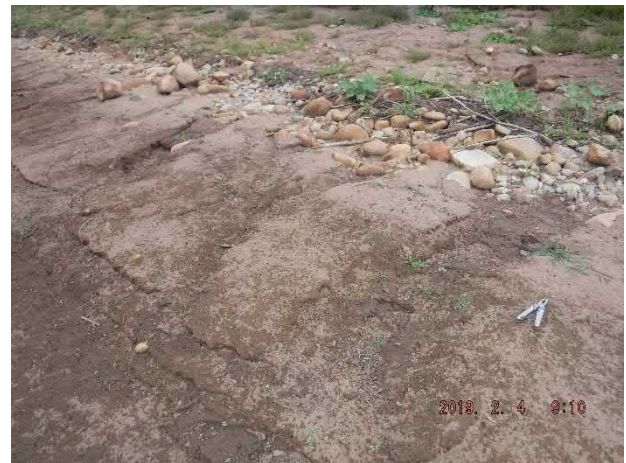
Figure 38 Wollondilly Delta

(b) Sediment composition along the delta edge

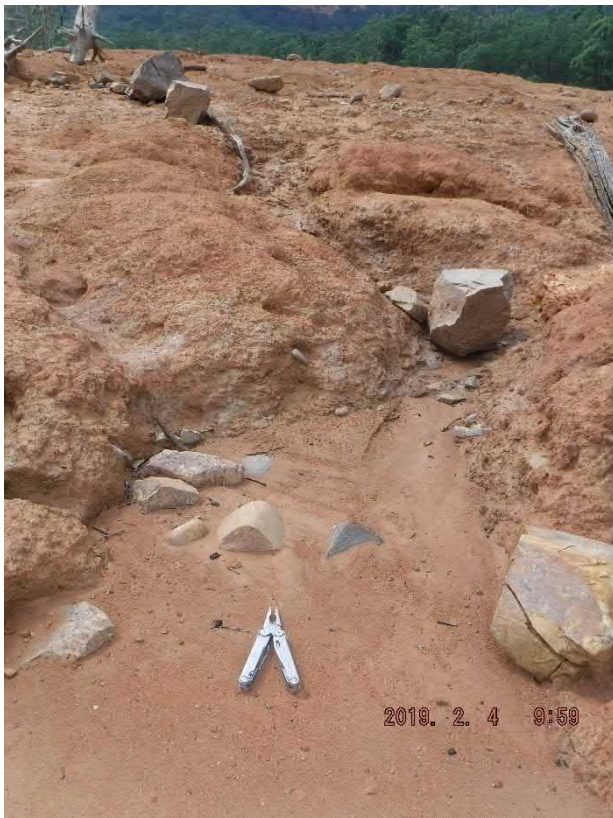
Lake Burragorang sites have larger exposed foreshores due to the current low water level conditions (site assessments undertaken 04/02/19 at a water level of 105.019 m). In the southern, central and both-west arms, well developed and extensive (circa 100m) partially vegetated shorelines with approximately 20 percent gradients are present. These contain incised rills with concentrated runoff lines developing into gullies (**Figure 39a**). Further up the shoreline above the mean water level, berms are often present protecting a backshore with more stable vegetation. These berms appear subject to infrequent wave action, causing bank erosion. In some instances, this wave undercutting has led to exposure of sheer cliff faces of unstable soil, revealing tree roots and causing vegetation mat collapse and cantilever failure of the bank (**Figure 39b**).

(a) Gully formation on the foreshore

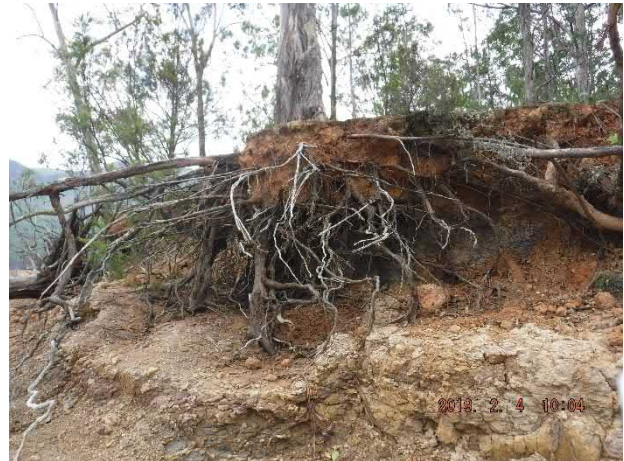
Figure 39 Lake Burragorang Foreshore

(b) Wave undercutting exposing tree roots

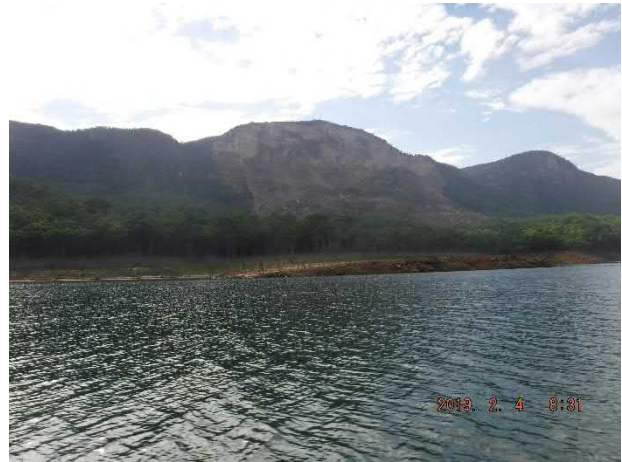
Figure 40 North Nattai Rock Avalanche

(b) View from the lake

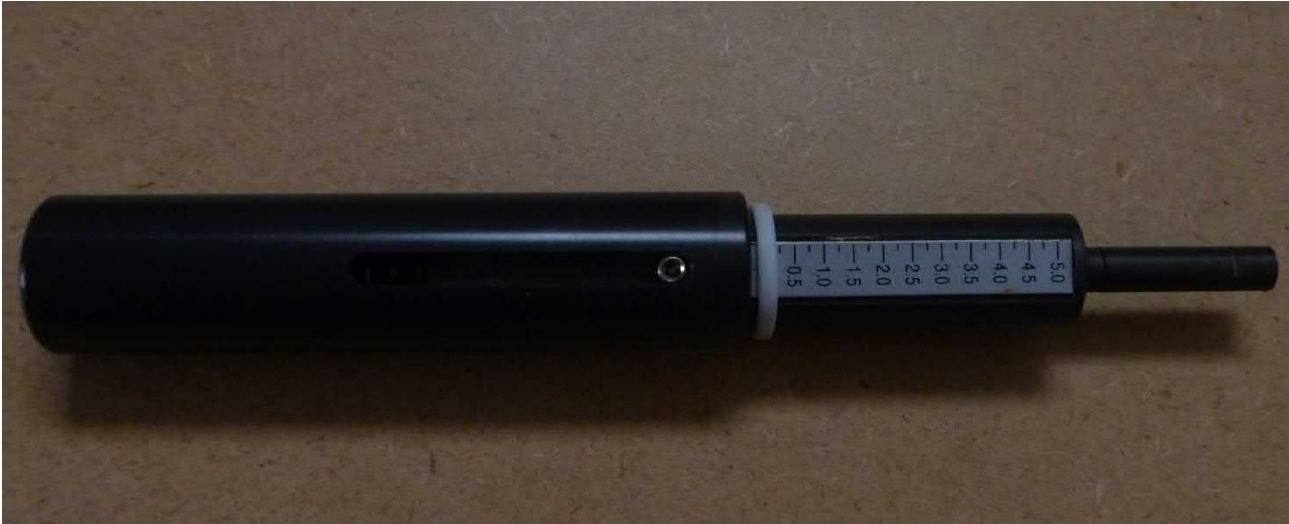
Figure 59 Pocket penetrometer for measuring bank strength

A Controls Model 16-T0171 pocket penetrometer (**Figure 59**) was used to measure river bank unconfined compressive strength (in kg cm^{-2}).

Logging was undertaken on dynamic samples (i.e. undisturbed and in-situ). Selection of measurements points were on a random basis but stones, tree roots and other obstructions were avoided. Eighteen readings were taken and recorded at each test site corresponding to different parts of the bank (i.e. toe, mid-wall and surface) and values were expressed to the nearest 0.1 kg cm^{-2} . Test refusals were reported as $> 4.5 \text{ kg cm}^{-2}$.

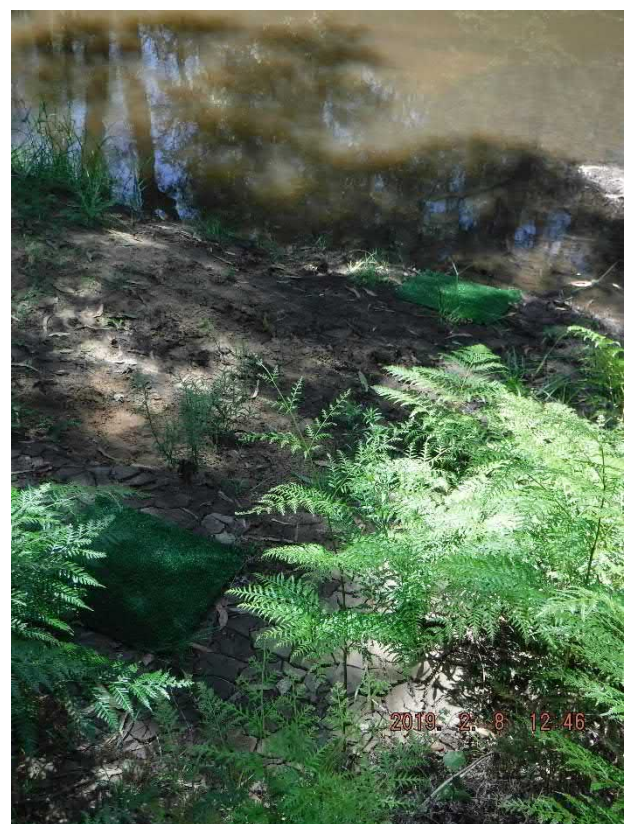
Figure 62 Deployment array for sedimentation AstroTurf mats

Typical arrangements are shown in **Figure 62**.

Kedumba River floodplain

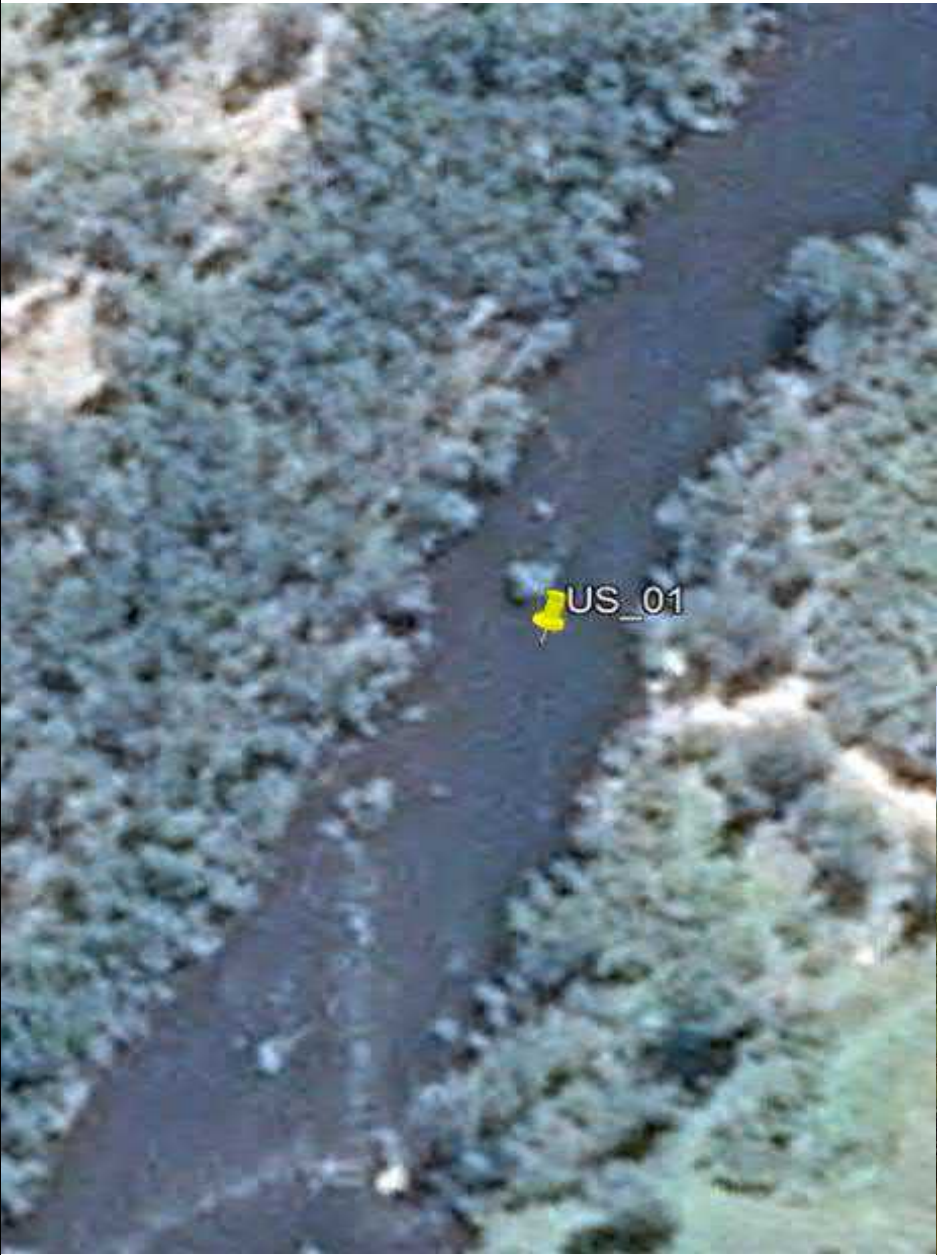
Historic Aerial US – 01 October 2016	Upstream US – 01	Downstream US - 01

Project	WDR EIS (Beca reference # 4512987)							Date		31/01/2019			
Surveyor	DE	Reach code: US-01							Time		12:41 hrs		
Drainage channel		Creek		River		Estuary	Pond		Wetland		Lake		
				X (Wollondilly)									
Weather conditions		Sunny, hot, wind				U-S elevation		157m	D-S elevation		149m		
Upstream grid reference		243026;6201566 (56H UTM)				Downstream grid reference		243020; 6201593					
Watercourse attributes													
Dimensions	Width	30.4 m			Max. depth	U-S = 0.22 m D-S = 0.36 m		Average velocity (ms ⁻¹)	U-S = 0.06 ms ⁻¹ D-S = 0.18 ms ⁻¹				
Shape description		Flat, open			Max. Roughness Height	0.3 m		Bank erosion	Attritional erosion to whole banks, no hotspots				
Instream vegetation <small>(% cover [emergent, floating, submerged, algae, moss])</small>	Benthic algae 60%		Bank vegetation None			Bench vegetation Grasses & herbs 30%; Casuarina and Mulga 70%			Organic matter Twigs / Leaves

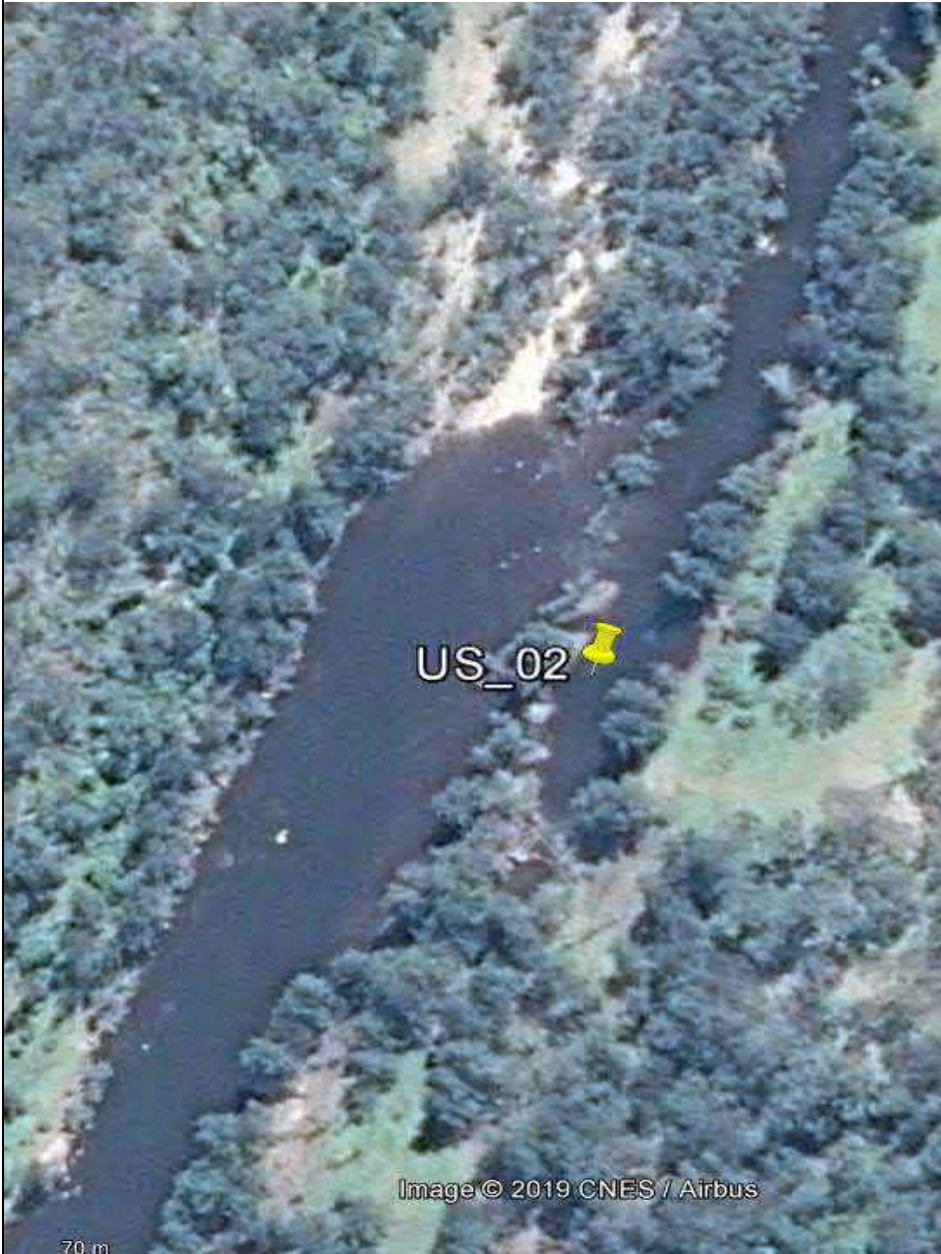
<p>US_02</p> <p>Image © 2019 CNES / Airbus</p> <p>70 m</p>		Cross-section US – 02

Project	WDR EIS (Beca reference # 4512987)							Date		31/01/2019							
Surveyor	DE	Reach code: US-02							Time		14:30 hrs						
Drainage channel		Creek		River		Estuary		Pond		Wetland		Lake					
				X (Wollondilly)													
Weather conditions		Sunny, hot, wind					U-S elevation		156m		D-S elevation		152m				
Upstream grid reference		244868 6206602 (56H UTM)					Downstream grid reference		244489; 6206888								
Watercourse attributes																	
Dimensions		Width		79.5 m		Max. depth		U-S = m D-S = m		Average velocity (ms ⁻¹)		U-S = 0.24 ms ⁻¹ D-S = 0.10 ms ⁻¹					
Shape description		Complex multi-terrace with mid-channel island				Max. Roughness Height		None		Bank erosion		No significant erosion observed					
Instream vegetation <small>(% cover [emergent, floating, submerged, algae, moss])</small>		Submerged Elodea 50% Emergent Cumbungi 10%		Bank vegetation None			Bench vegetation Grasses & herbs 80%; Casuarina 20%				Organic matter Twigs / Leaves & detritus

Flow type																	
Smooth surface flow <small>[H1]</small>		Broken standing waves <small>[H2]</small>		Unbroken standing waves <small>[H3]</small>		Chute <small>[H4]</small>		Rippled <small>[H5]</small>		Scarcely perceptible flow <small>[H6]</small>		Upwelling <small>[H7]</small>		Free fall <small>[H8]</small>		Standing water <small>[H9]</small>	
X						X		X		X							
Channel Planform																	
Sinuosity <small>(straight, low, intermediate, high)</small>		Intermediate			Form		Single		Forked		Braided X			Open			
Sand bars No			Gravel bars Yes			Rock outcrops No				Riparian strip No		Floodplain connectivity		Open			
Floodplain land use			LHB Cleared area with small farm holding & activity centre (disused) at end of Burnt Flat W4A fire trail RHB National Park & Sydney Water Protected Catchment				Bank Strength (kg/cm ²)			U-S 0.8, 0.6, 1.5 D-S 0.5, 0.4, 0.2		Bank structure & angle		LHB 45°, concave RHB 20°, straight

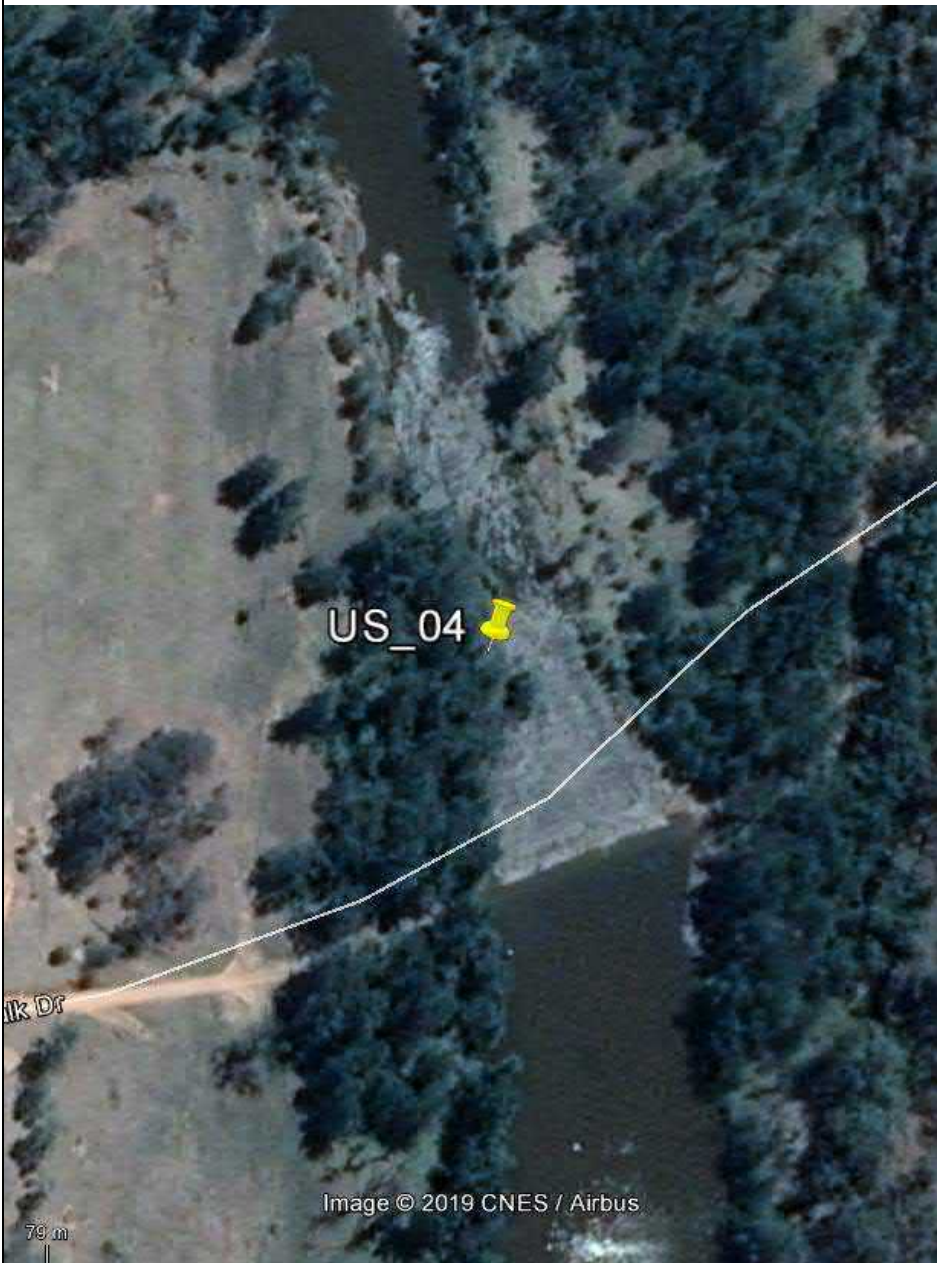
Historic Aerial US - 04 December 2018	Upstream US - 04	Downstream US - 04

Project	WDR EIS (Beca reference # 4512987)							Date		31/01/2019							
Surveyor	DE	Reach code: US-04							Time		16:15 hrs						
Drainage channel		Creek		River		Estuary		Pond		Wetland		Lake					
				X (Wollondilly)													
Weather conditions		Overcast, hot, breeze					U-S elevation		125m		D-S elevation		120m				
Upstream grid reference		251172 6013797 (56H UTM)					Downstream grid reference		251159 6215797								
Watercourse attributes																	
Dimensions		Width		65.9 m		Max. depth		U-S = 0.31 m D-S = 0.22 m		Average velocity (ms ⁻¹)		U-S = 0.15 ms ⁻¹ D-S = 0.69 ms ⁻¹					
Shape description		Open u-shape				Max. Roughness Height		0.2 m		Bank erosion		No erosion observed					
Instream vegetation <small>(% cover [emergent, floating, submerged, algae, moss])</small>		U-S benthic algae 10% D-S benthic algae 40%		Bank vegetation None			Bench vegetation Grasses & herbs 60%; Casuarina 20%				Organic matter Logs

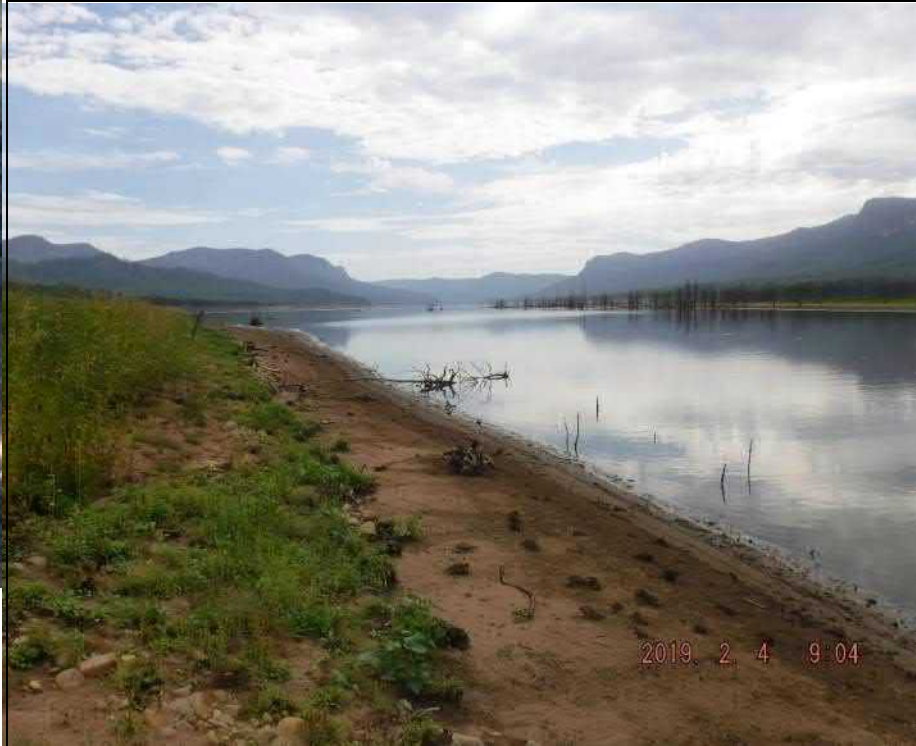
Historic Aerial US – 05 December 2018		Upstream US – 05	Downstream US - 05

Project	WDR EIS (Beca reference # 4512987)							Date		04/02/2019							
Surveyor	DE	Reach code: US-05							Time		10:00 hrs						
Drainage channel		Creek		River		Estuary	Pond		Wetland		Lake						
				X (Wollondilly)													
Weather conditions		Overcast, still				U-S elevation		111 m	D-S elevation		109 m						
Upstream grid reference		2544193; 6218438 (56H UTM)				Downstream grid reference		2544205; 6218458									
Watercourse attributes																	
Dimensions		Width		205 m		Max. depth		U-S = >5 m D-S = >5 m		Average velocity (ms⁻¹)		U-S = 0.0 ms ⁻¹ D-S = 0.0 ms ⁻¹					
Shape description		Flat, u-shaped channel				Max. Roughness Height		n/a		Bank erosion		Rill erosion forming on unconsolidated banks due to runoff water from island					
Instream vegetation <small>(% cover [emergent, floating, submerged, algae, moss])</small>		None		Bank vegetation None			Bench vegetation Grasses & herbs 100%			Organic matter Logs, Twigs / Leaves, Detritus

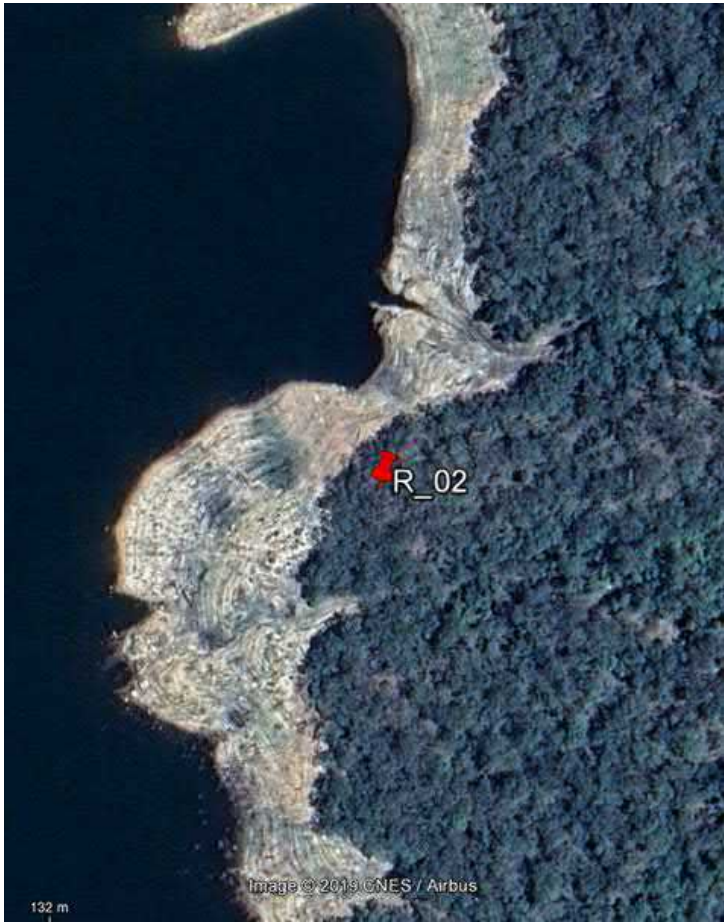
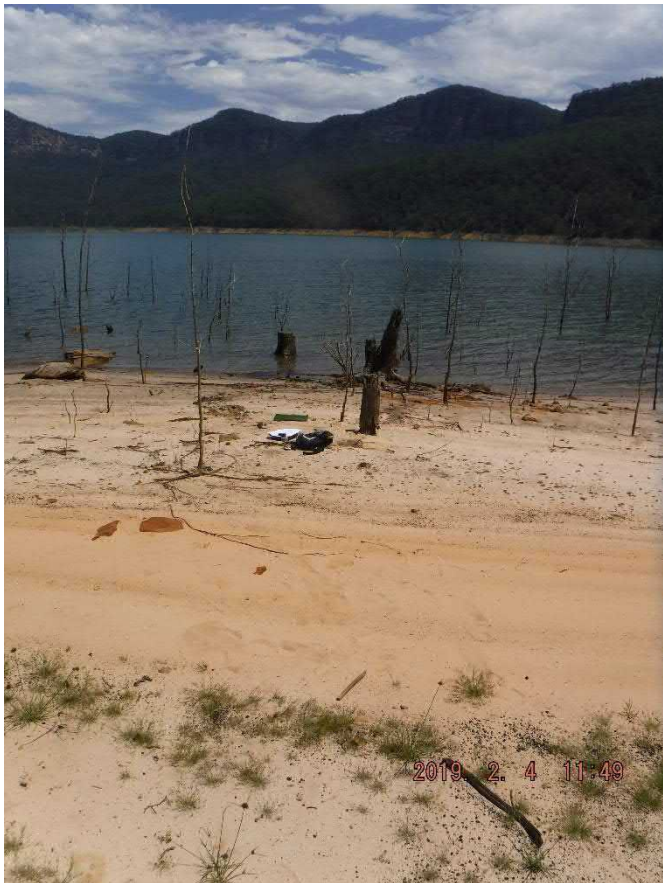
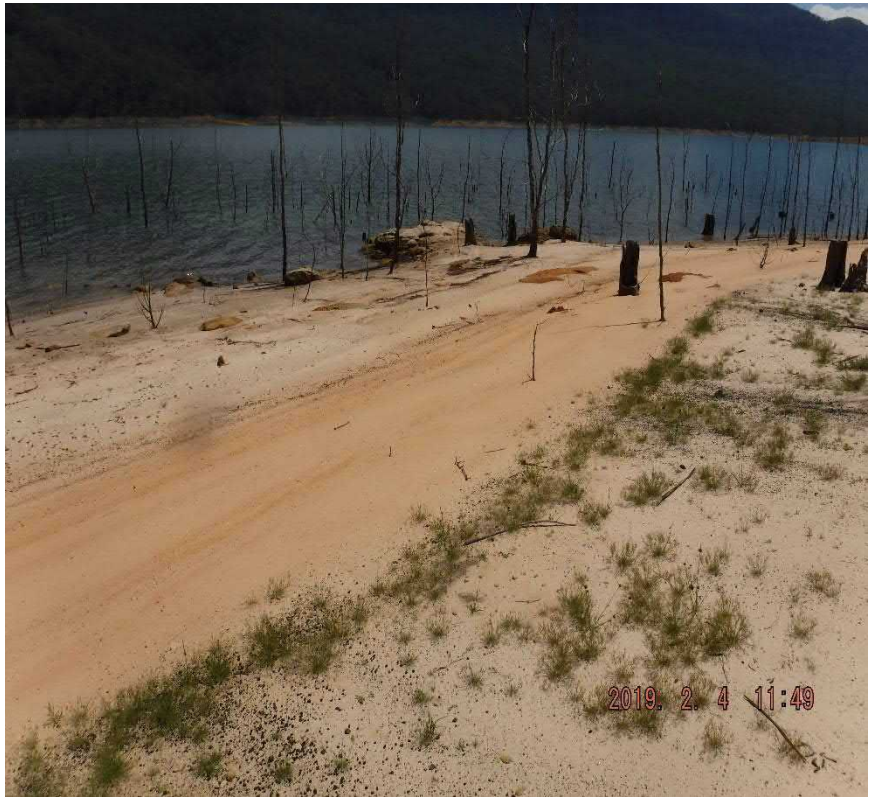
Project	WDR EIS (Beca reference # 4512987)					Date	04/02/2019
Surveyor	DE	Reach code: R-02				Time	11:30 hrs
Drainage channel	Creek	River	Estuary	Pond	Wetland	Lake	
						X	
Weather conditions	Bright, hot				Land use	National Park & Sydney Water Protected Catchment	
Grid reference	261129; 6229158 (56H UTM)				Elevation	96 m	
Bank attributes							
Wave height	15 cm		Bank structure and angle	10° straight			
Bank strength (kg/cm²)	SL 0.4, 0.6, 0.75, FSL 0.3, 0.2, 0.6		Bank erosion	Rill erosion parallel to the bank and approx. 1 m spacing			
Aquatic vegetation	None	Bank vegetation None		Bench vegetation Dead trees waters edge - 40 m, Grasses & herbs +40 m 75% cover		Organic matter Twigs & leaves, Detritus	
Bed character							
% composition	Boulder	Cobble	Gravel	Sand	Fine sand	Silt / clay	
	0	0	0	40	40	20

Aerial view of R02 site March 2019		Foreshore North View R02			Foreshore East View R02

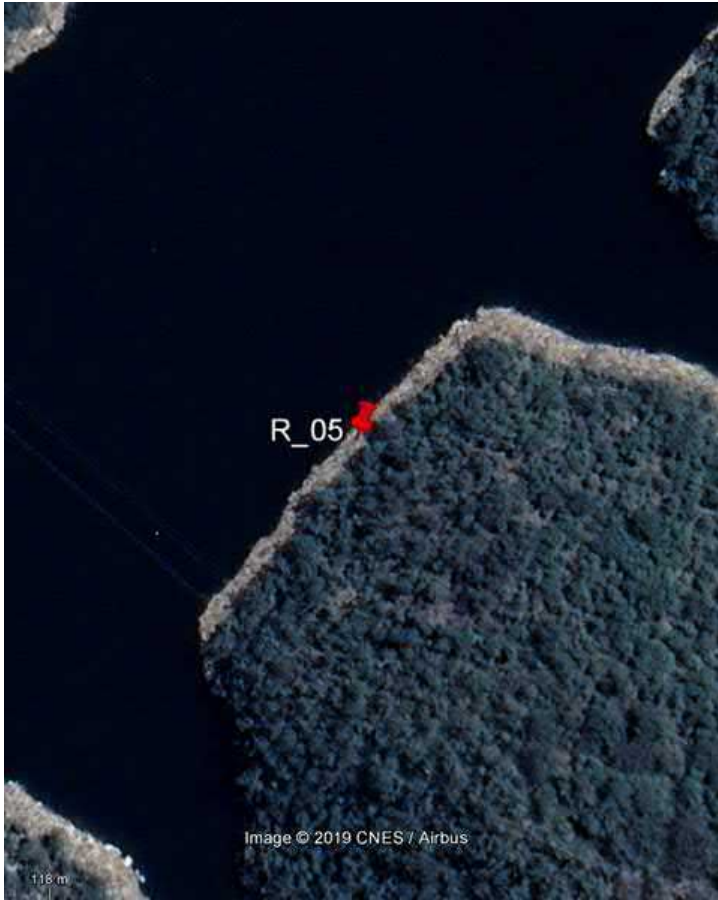
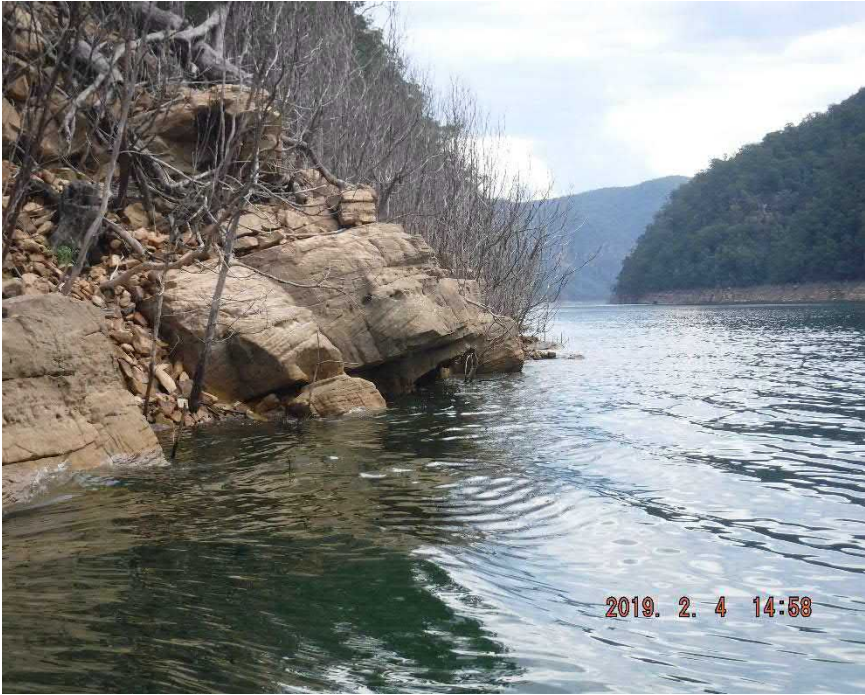
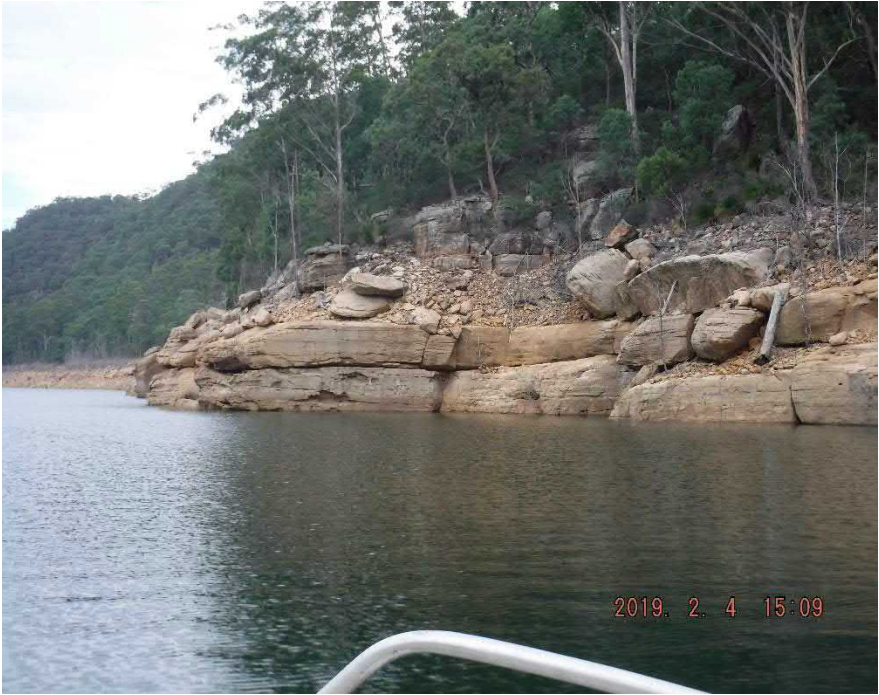
Aerial view of R05 site October 2018	Sandstone bedrock banks south west view R05	Sandstone bedrock banks north east view R05

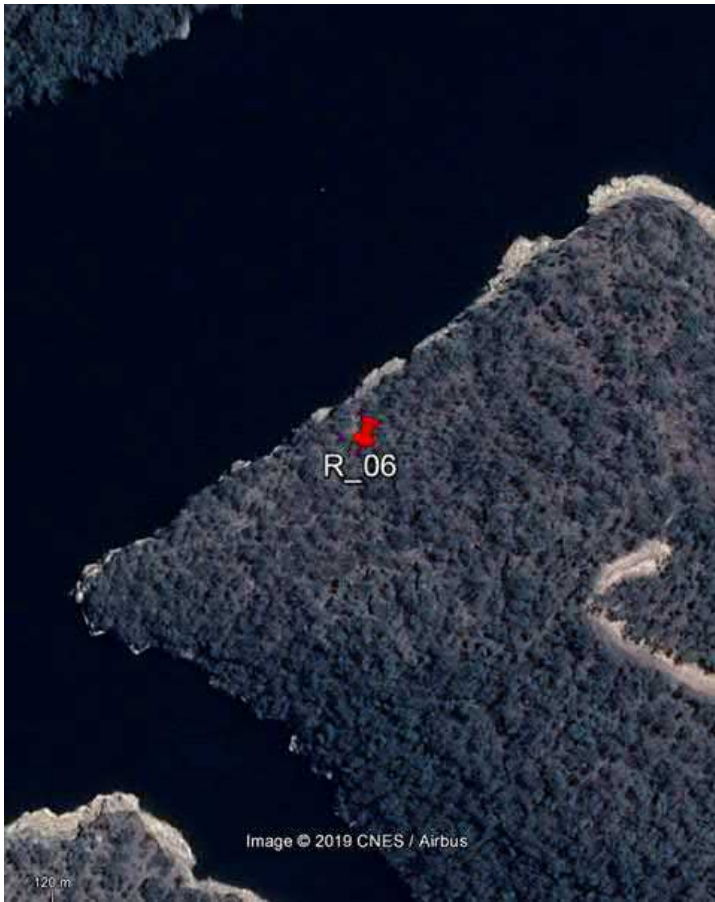
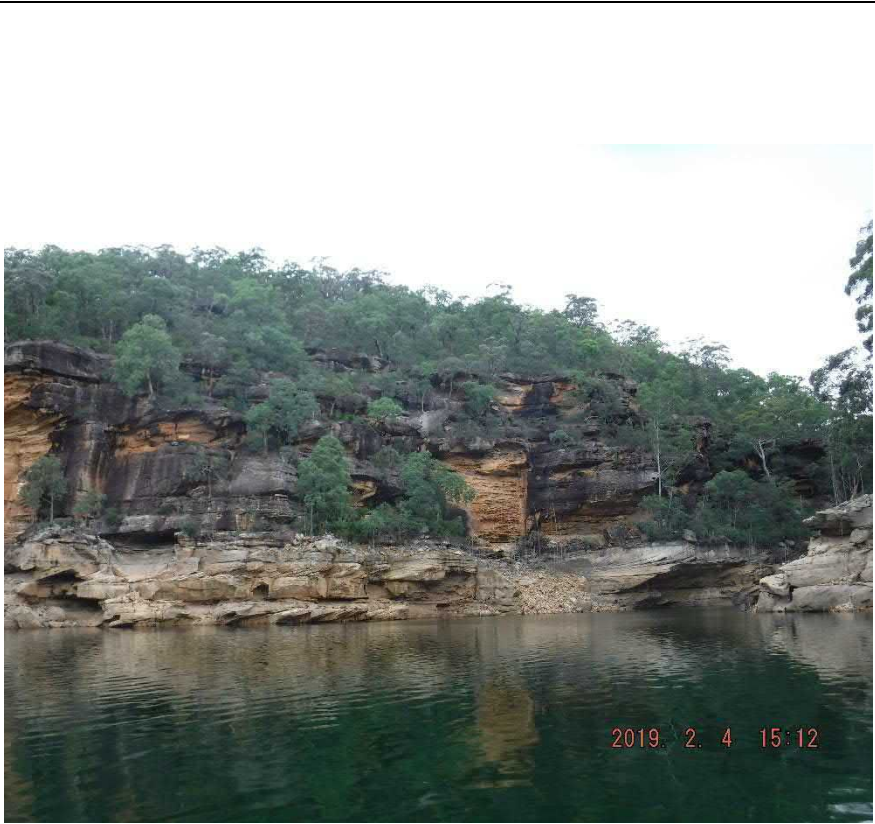
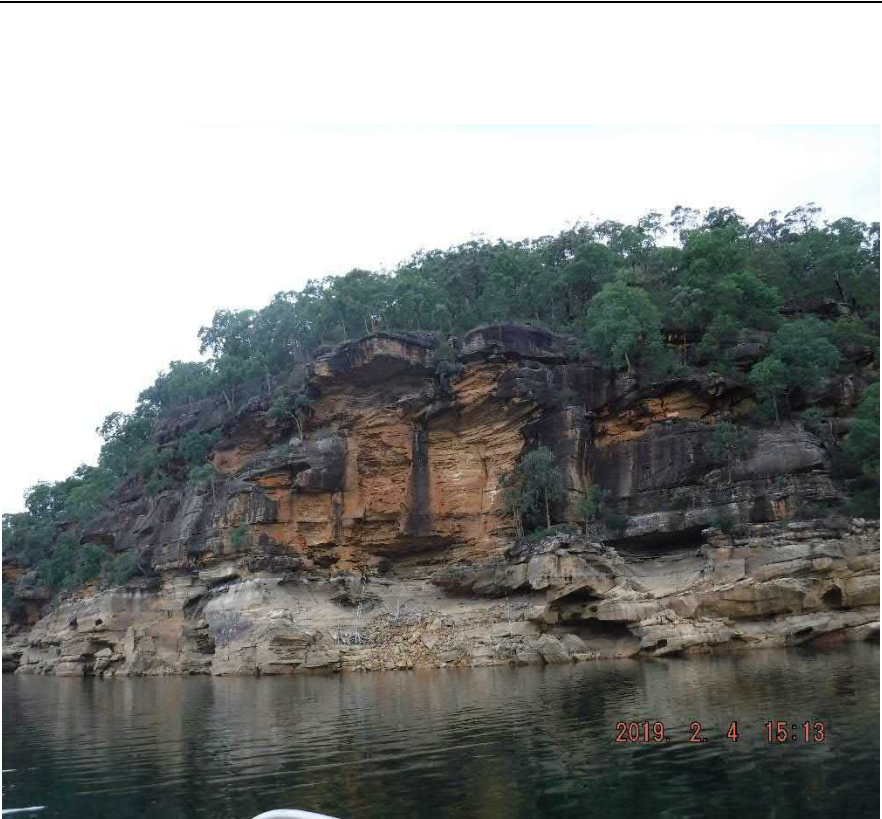
Aerial view of R06 site October 2018	Steep sandstone gorge east view R06	Steep sandstone gorge north east view R06
