# **M12 Motorway**

Non-Aboriginal heritage supplementary  
technical memorandum

October 2020

## M12 Motorway: Former Cecil Park Historical Complex

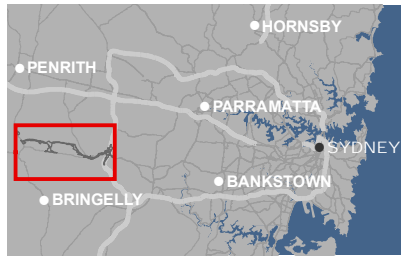
**Figure 2-1** Location of the amended study area

- Study area as per the EIS
- Amended project study area
- Western Sydney Parklands
- NPWS estate / reserves
- Waterways
- Motorway
- Main roads

The study area presented in the EIS has been increased to reflect the amended construction footprint shown in **Figure 1-2**. The amended study area is shown in **Figure 2-1**.

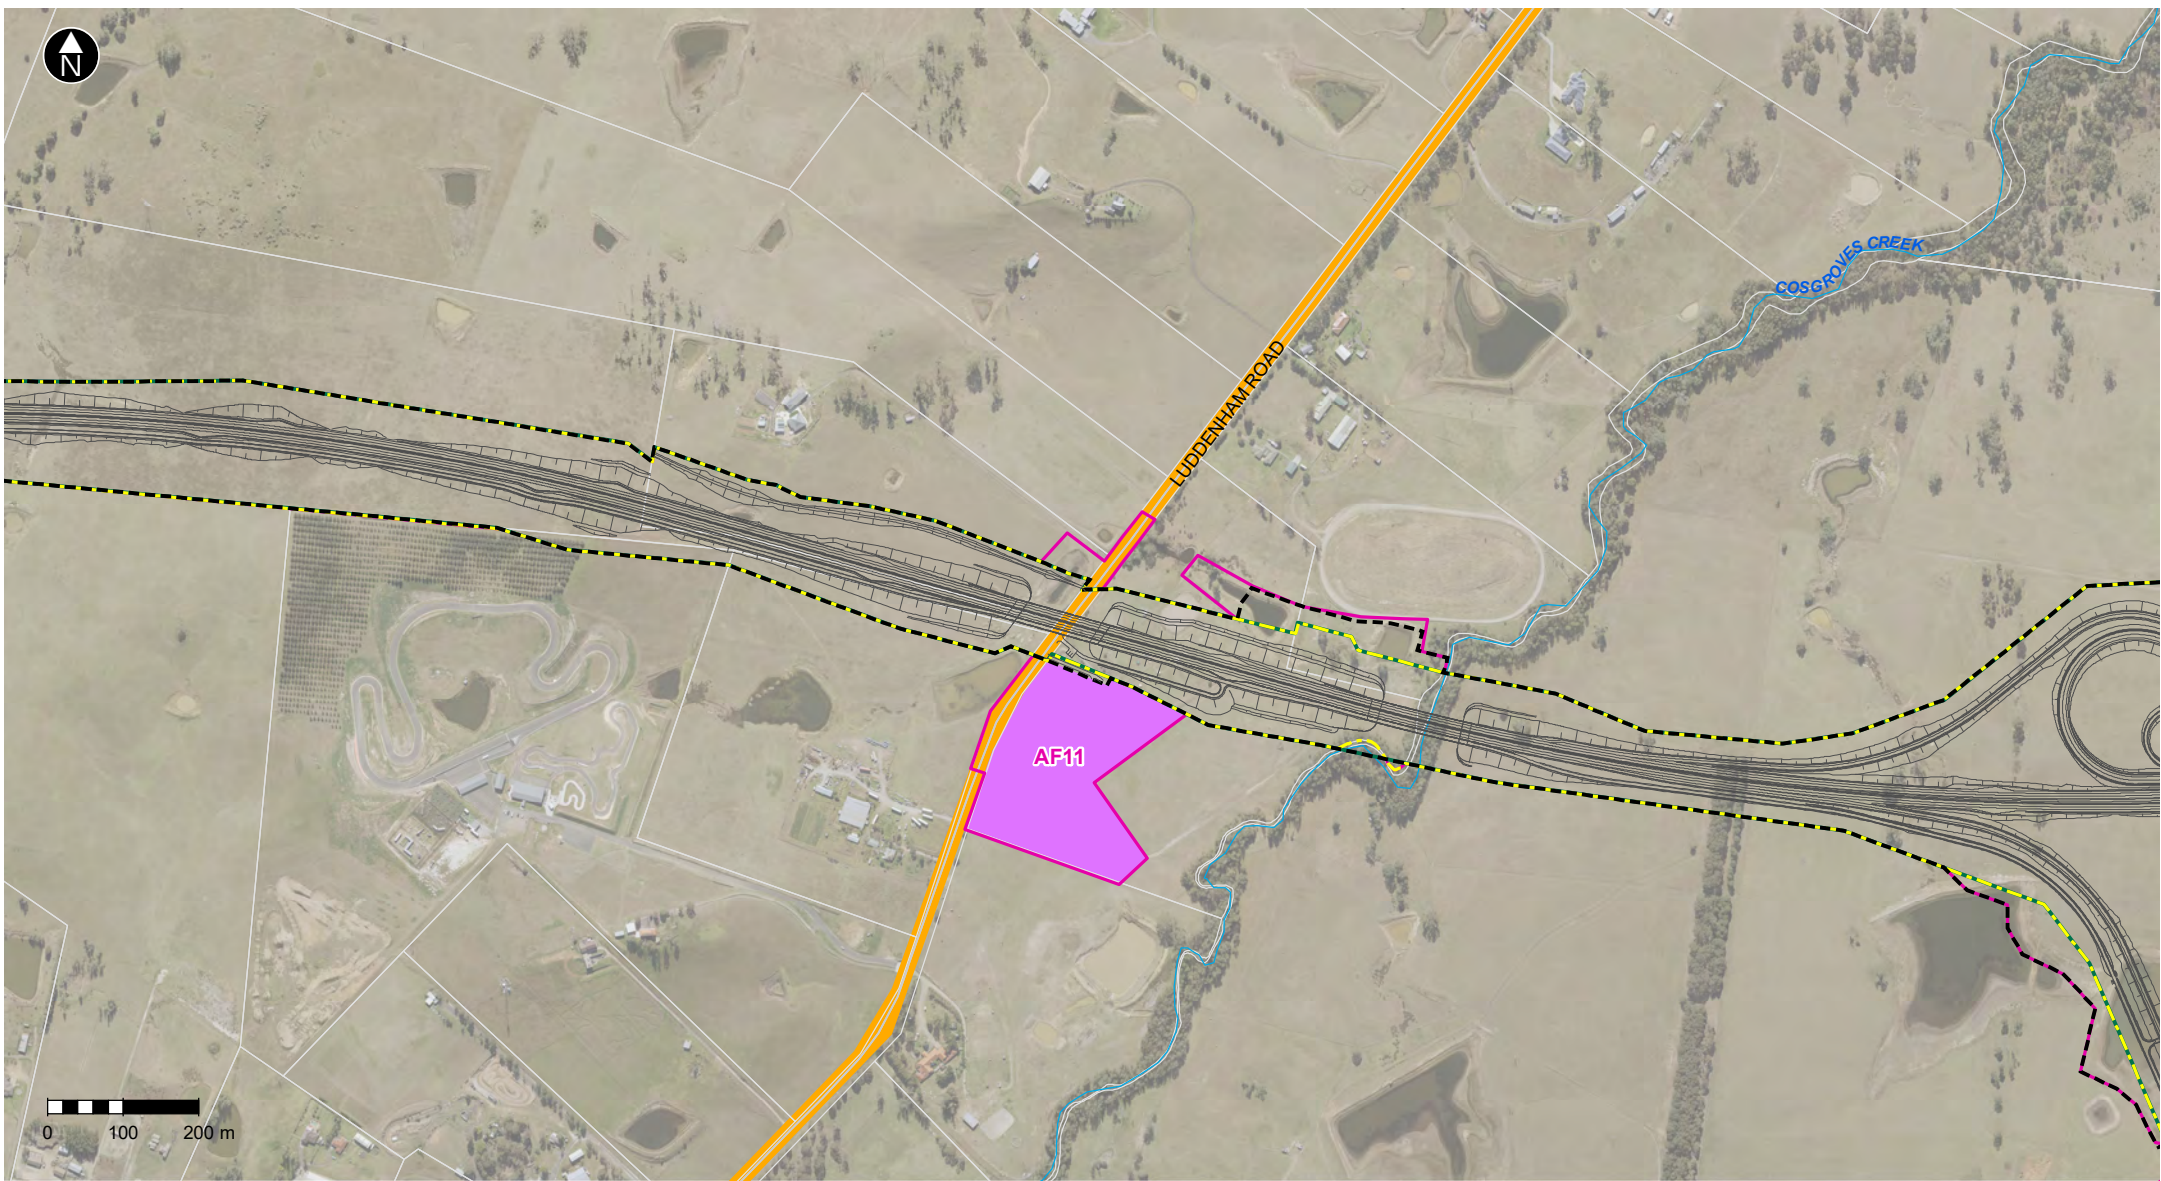
**Figure 4-1** Luddenham Road Alignment (Penrith LEP 843) (Item 3) in relation to the proposed works

Luddenham Road is registered on the Penrith LEP (843) and intersects the amended study area for about 65 metres to the south of the EIS construction footprint.

The Luddenham Road Alignment heritage item was previously surveyed for the EIS on 16 November 2017 including the section in the amended study area which was traversed while travelling to the EIS study area. The Luddenham Road Alignment heritage item within both the EIS and amended study areas comprises modern asphalt, and the original fabric associated with the early road no longer exists due to modifications and renewal of the road surface over time. The current Luddenham Road is located within the original cadastral location with road reserve either side.

The overlap of an additional 65 metres of Luddenham Road Alignment as a result of the amended study area would not impact on the significance of the heritage item which relates to the road's historical significance as a late nineteenth century road.

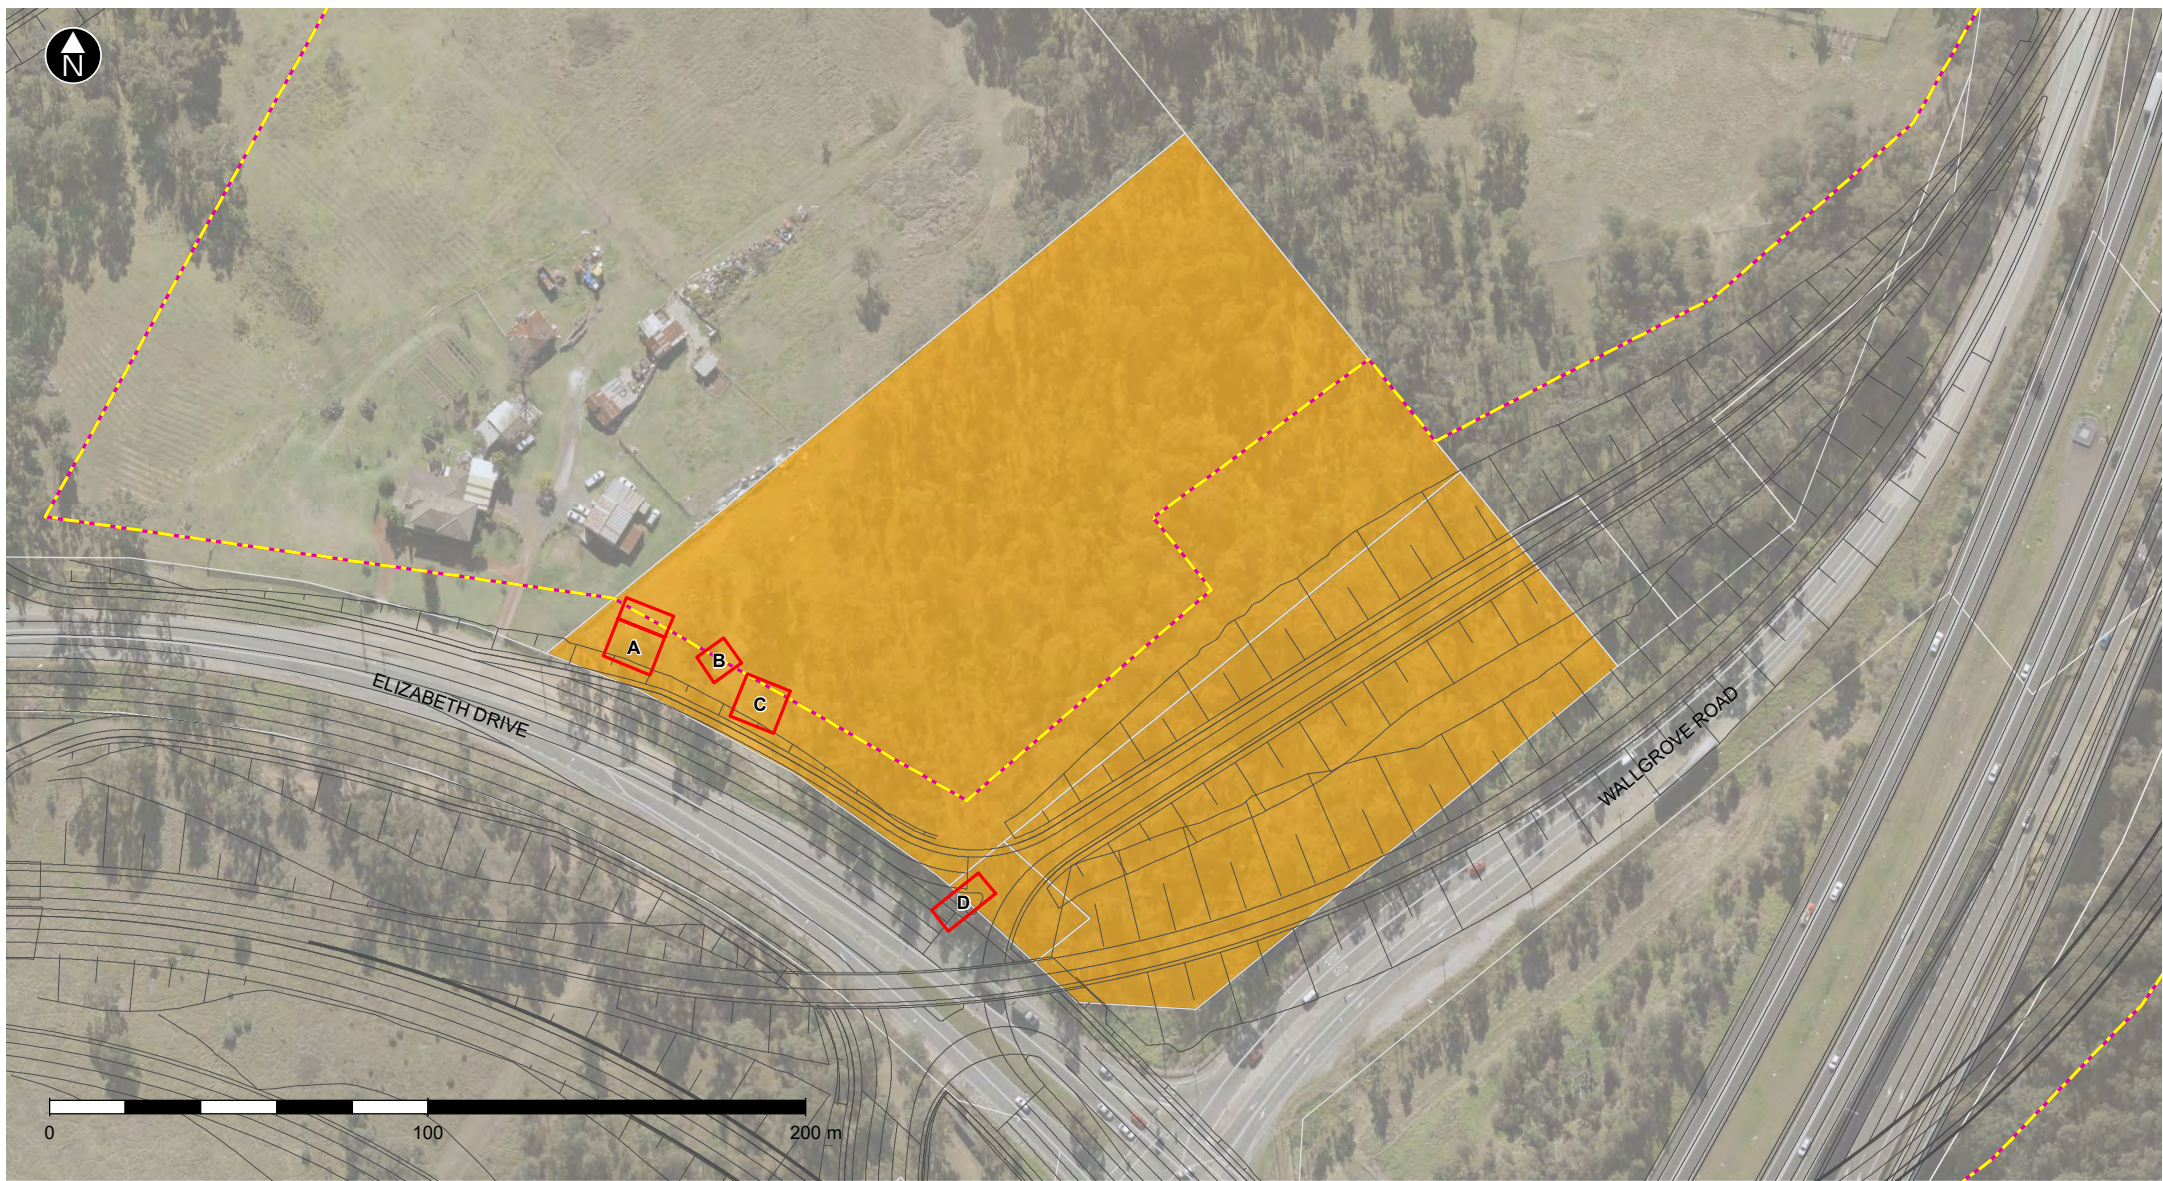
**Figure 4-2** Cecil Park School, Post Office and Church (Item 8) in relation to the proposed works

- The amended project
- The amended project construction footprint
- - - The amended project operational footprint
- Subject site boundary
- Cecil Park former building locations
  - A Cecil Park School
  - B Teacher's Residence
  - C Cecil Park Post Office
  - D School Church of St Paul

As identified in Section 7.6.4 of the EIS, construction impacts to Cecil Park School, Post Office and School Church historical complex would cause physical damage to the entire area of archaeological potential within the heritage item. Construction of the project as described in the EIS, would remove all of the archaeological values of the heritage item. This would be the same for the amended project and therefore there is no change in impact to that as described in the EIS.

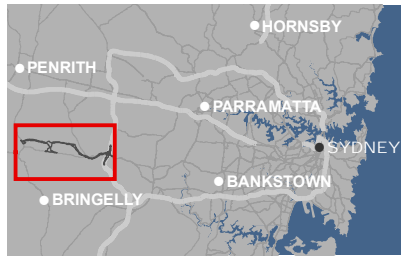
**Figure 1.1** Location of the EIS study area. The subject site is circled in yellow

- M12 study area
- Western Sydney Parklands
- ~~~~~ Waterways
- NPWS Reserves
- Motorway
- Main roads

The Former Cecil Park Historical Complex is located on Lot 1 DP724970 and Lot 2 DP922940 which is a vacant, heavily vegetated property located at 1097-1109 Elizabeth Drive and 33 Wallgrove Road, near the intersection of Elizabeth Drive and Wallgrove Road, Cecil Hills (**Figure 1.1**).

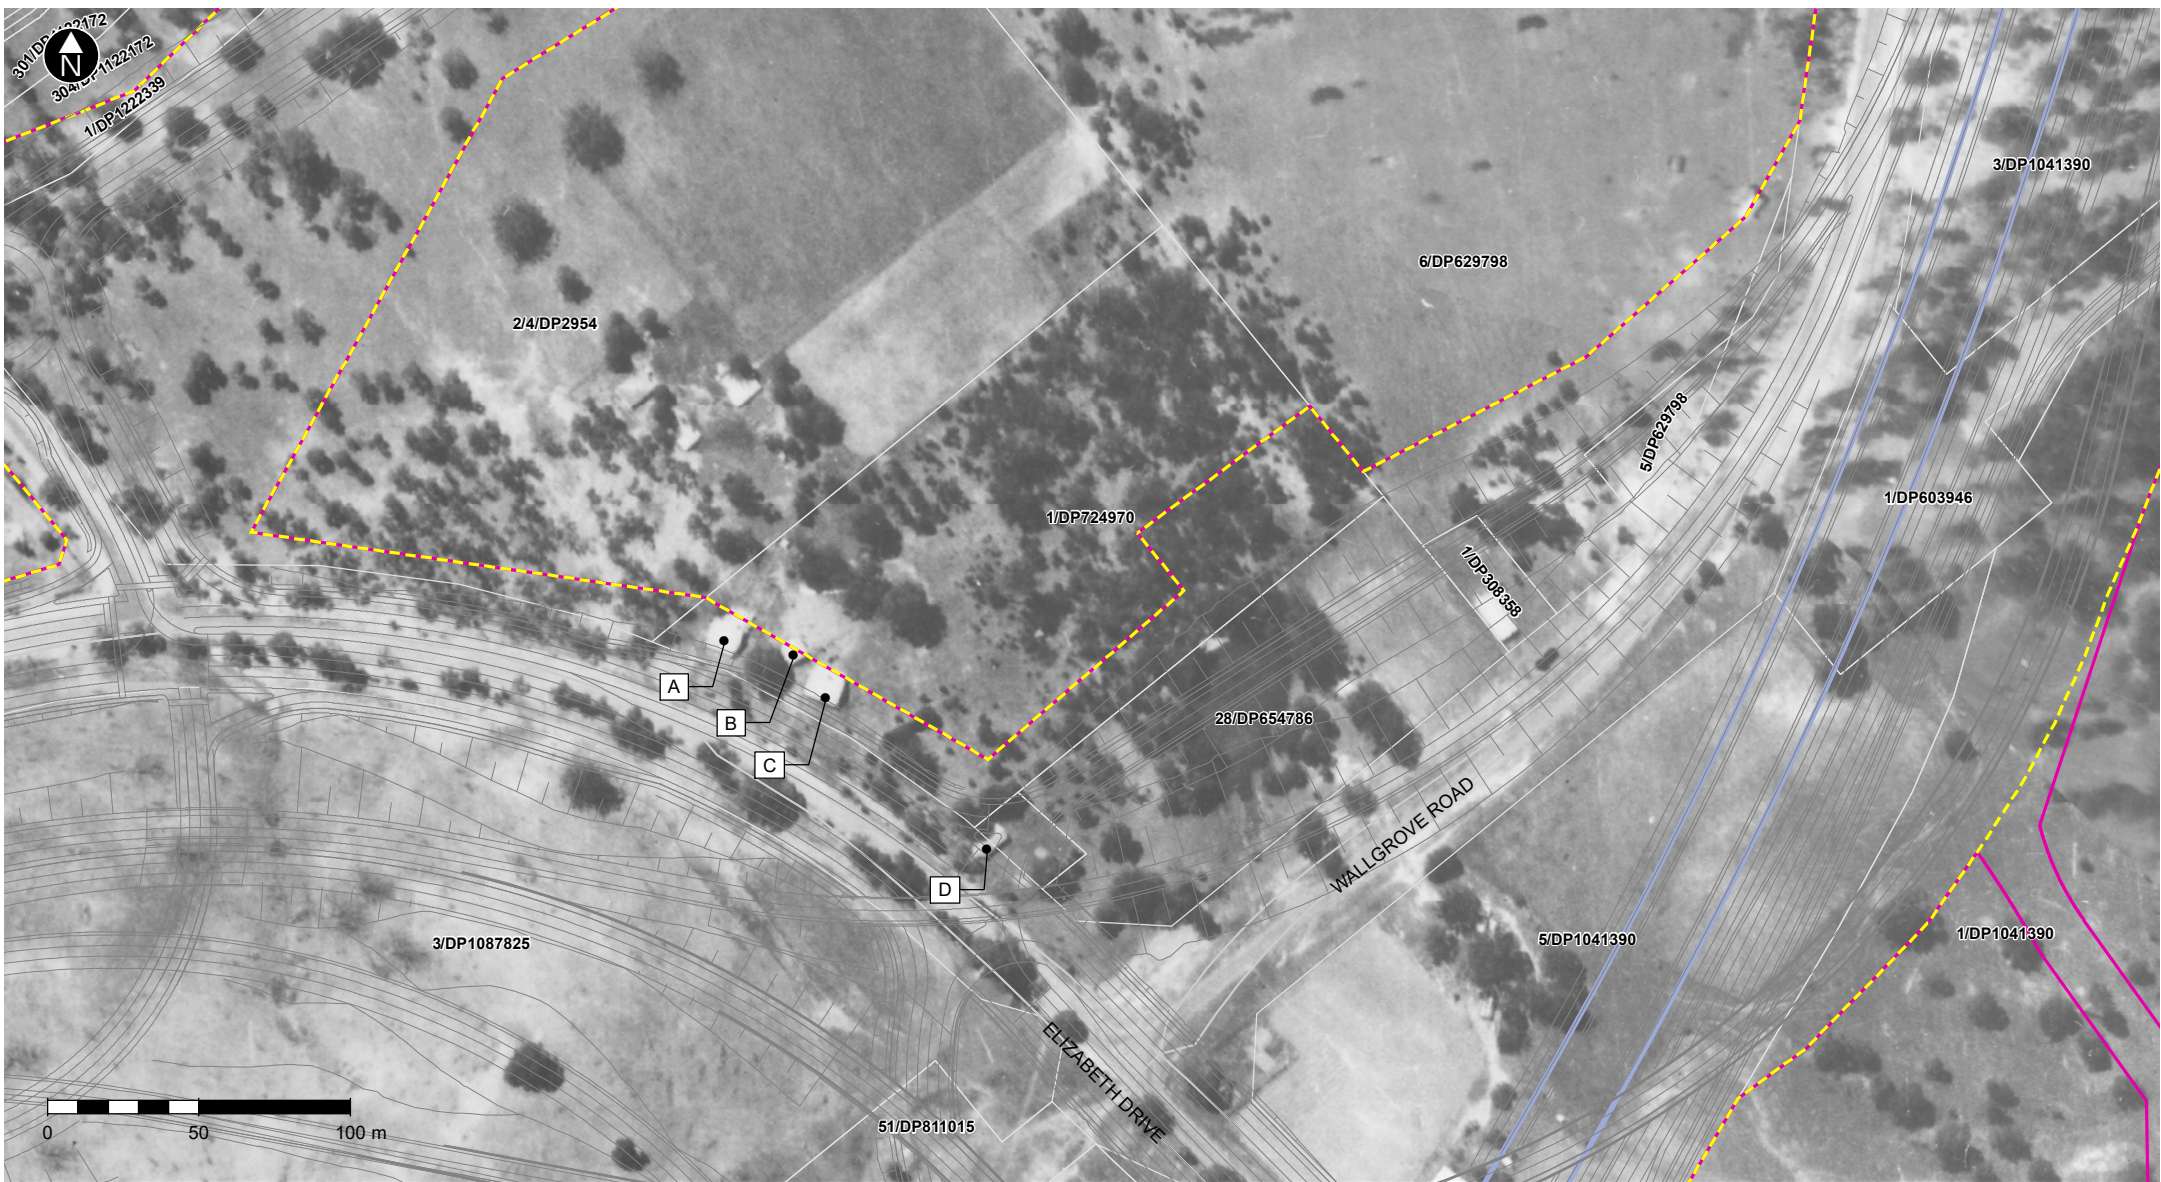
**Figure 2.3** 1947 historical aerial of site (Courtesy: NSW Department of Finance, Services and Innovation)

The configuration of the former school, teacher’s residence, post office and church is shown in the c1947 aerial photograph of the subject site (**Figure 2.3**).

In Test Trench 3 a demolition fill and associated cut into the natural ground was identified and is likely to be associated with the former Teacher's Residence shown in the c1947 aerial photo of the subject site (**Figure 2.3**). No in situ archaeological deposits or structural remains, however, were identified. Similarly, in Test Trenches 2 and 4 demolition fill and an embedded stone was identified but no in situ archaeological relics were found.

Overlays of the location of Test Trench 1 and the former locations of the buildings, as shown in the c1947 aerial photo, (**Figure 2.3**) suggest that the brick footings align with the rear wall of the former brick school building and appear to have supported part of an annex. Given the integrity of the footings, more substantial brick footings of the main school building are likely to be present towards Elizabeth Drive and may be found in association with *in situ* occupation and yard deposits. If artefact-rich deposits are present in this location, their excavation and analysis would likely provide further insights into the lives of the former teachers and children that attended Cecil Park school during the late 19<sup>th</sup> and early 20<sup>th</sup> century. Such remains are considered to be locally significant for their historical heritage value and research potential.

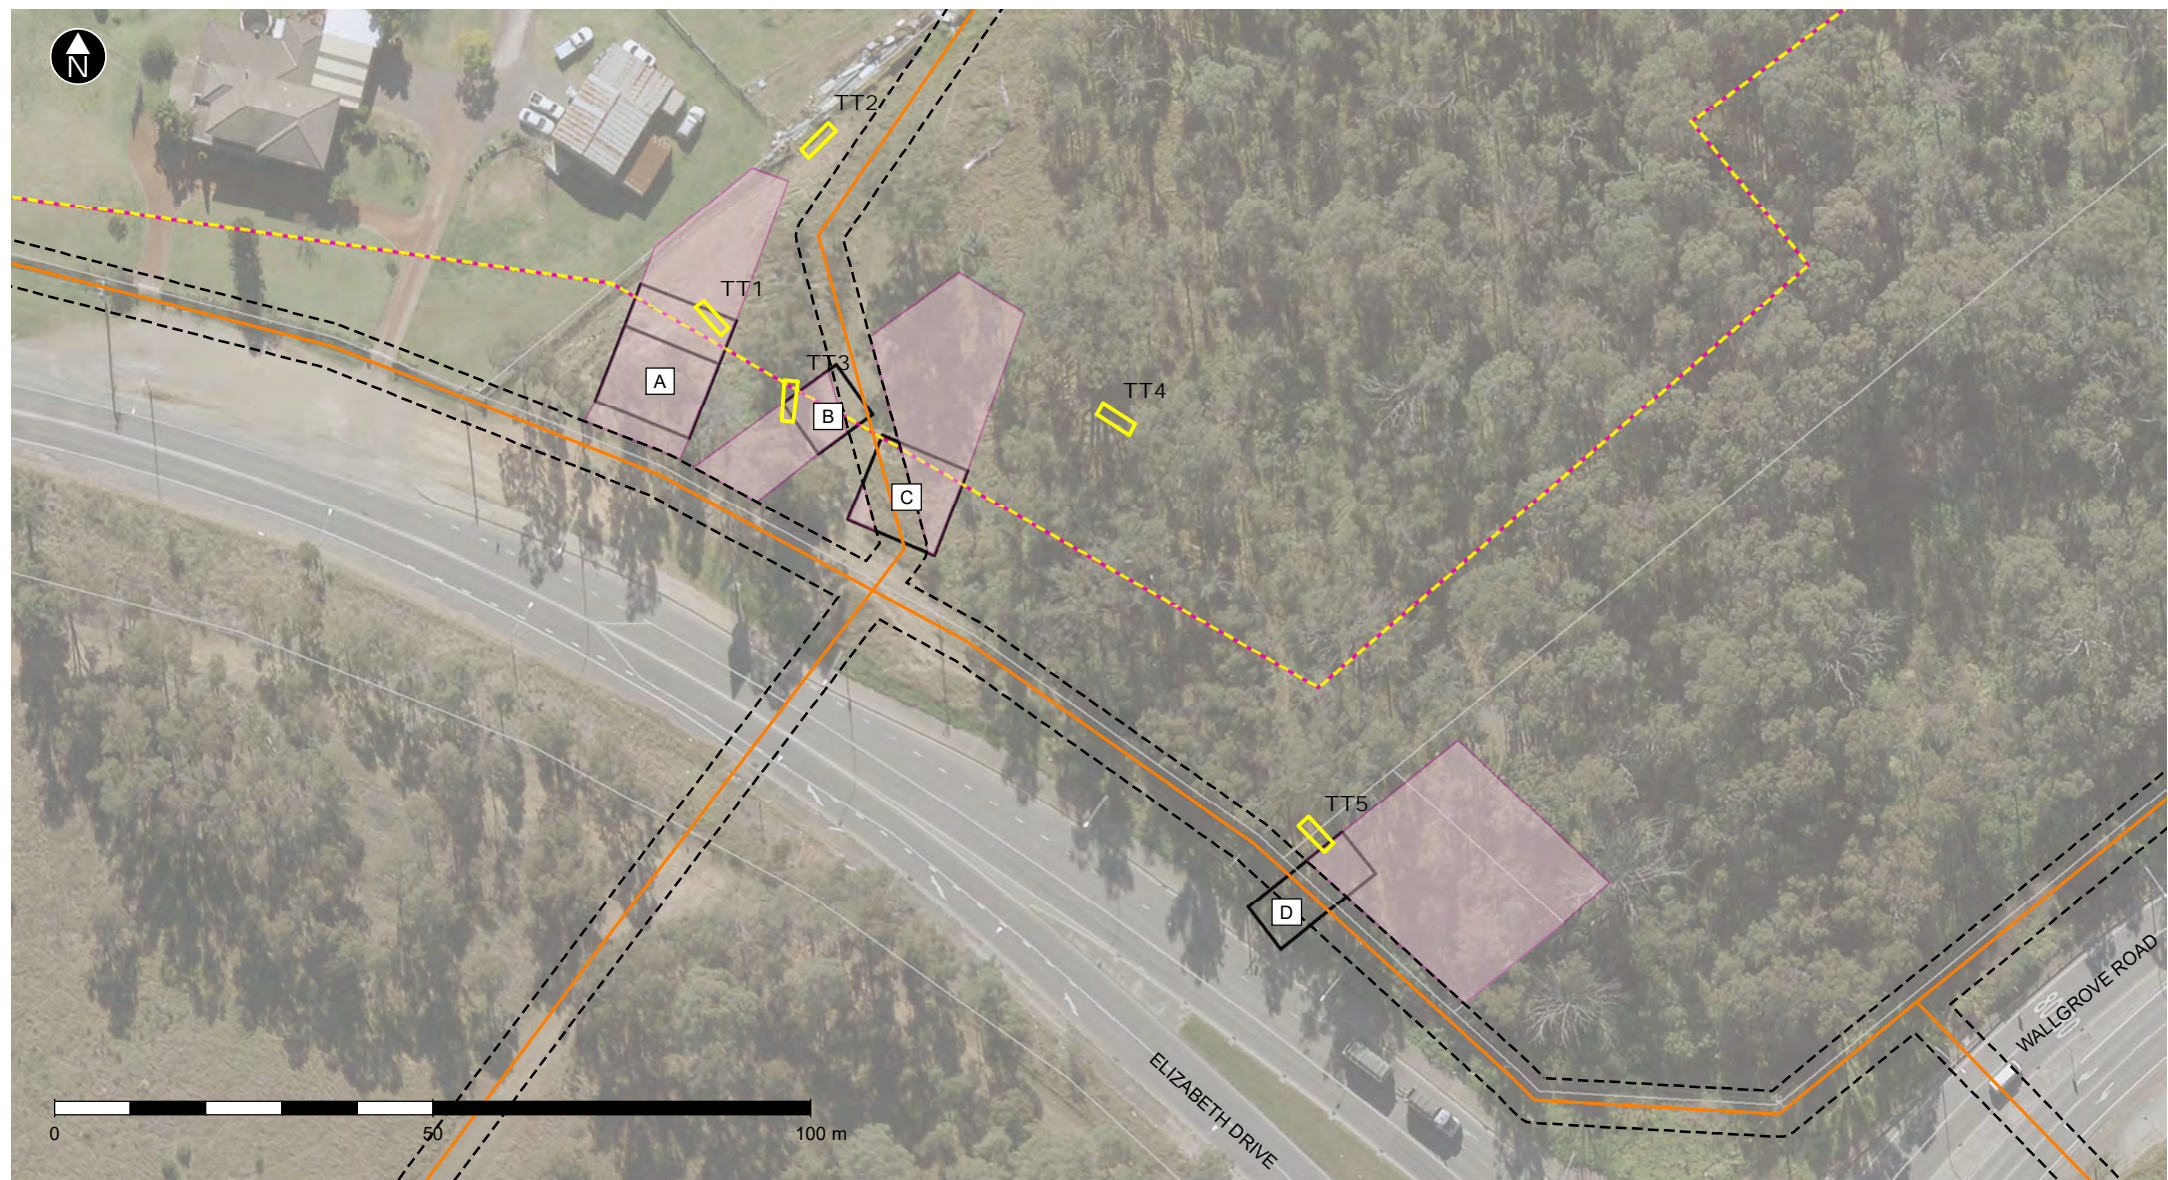
**Figure 4.1** Location of proposed open area excavation

If archaeological features or deposits are identified, then mechanical excavation will cease and manual hand excavation would be carried out in order to clarify, investigate and record the feature/deposit. Deposits will be manually excavated with trowels in 5-centimetre units, following cultural horizons where possible. The grid should be reduced to 1 metre x 1 metre for the excavation of artefact deposits. Excavation units (contexts) will be recorded in a single running sequence for Area D.

- The amended project
- The amended project construction footprint
- The amended project operational footprint
- Cadastre
- Existing gas line
- Existing gas line 6m corridor footprint
- Location of proposed open area excavation
- Test trenches 1 to 5 in test excavation (2019)
