NORTH STAR TO NSW/QUEENSLAND BORDER ENVIRONMENTAL IMPACT STATEMENT

Inland Rail North Star to NSW/QLD Border

Appendix F: Historical Heritage Technical Report

2-0001-270-EAP-10-RP-0405

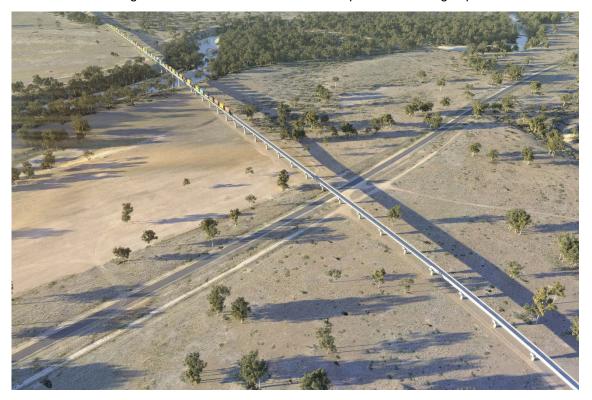
Figure 1.2 Aerial view of the NSW portion of the Macintyre River Viaduct (spanning Tucka Tucka Road, looking north-east)

The proposal includes an approximately 1.8 km long viaduct that crosses Whalan Creek, Tucka Tucka Road and the Macintyre River. Approximately 1.2 km of the viaduct is located in NSW, while the remaining 0.6 km is located in Queensland. An aerial view of the NSW portion of the Macintyre River Viaduct is shown in Figure 1.2, where the NSW/QLD border is defined by the centre point of the Macintyre River.

During the reference design phase, the design of the Macintyre River Viaduct was informed by geotechnical, flooding and biodiversity studies. Initially, three separate bridge structures were proposed over Whalan Creek, Tucka Tucka Road, and the Macintyre River. However, an iterative flood assessment of the design has resulted in a single viaduct structure that minimises upstream flooding impacts.

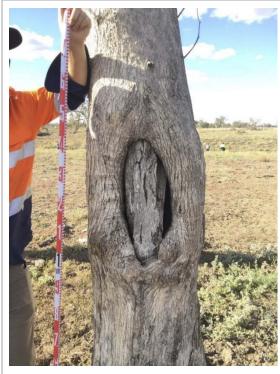
NS2B-19-H3 consists of a single scarred tree used as a survey marker. It is not currently mapped in the NSW Spatial Services Survey Mark database. The tree is a living box gum (*Eucalyptus populnea*). The scar is in fair condition, but the tree is hollowing out. The scar measures 480 millimetres (mm) in length, 201mm in width, and has a scar depth of 180mm. The scar is of a singular simple arrow design with tip facing to the top of the tree

Photograph 5.3 Tree scar

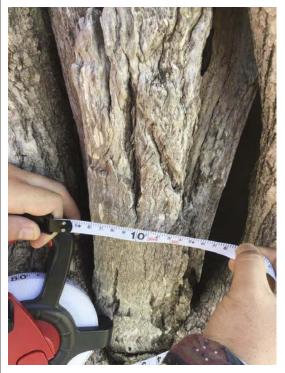
Photograph 5.4 Detail showing arrow mark

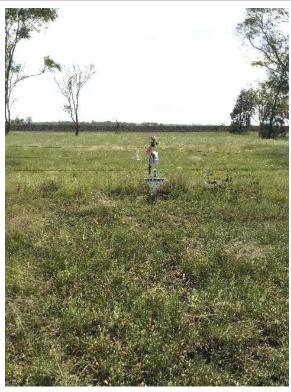
Photograph 5.15Roadside memorial looking east from Bruxner Way

Simple roadside memorial of a white metal cross with black writing "RIP HENRY", flowers and other personal mementoes. It is understood that the memorial is for Mr Henry Orchard, Goondiwindi who was killed in a vehicle accident at this location on 24 August 2018 (Jones 2018). The memorial is located on a property fenceline, east of the Bruxner Way within the temporary disturbance footprint.

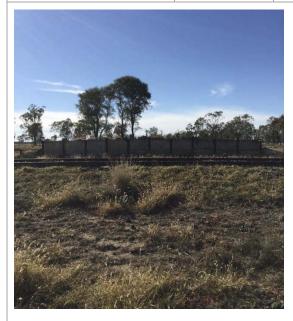
Site of former Wearne Siding. Currently consists of main rail line, a siding and an earthen embankment supported by a series of 10 concrete panels and braced with off cuts of rail track. All other associated infrastructure known to exist at the site including siding sign has been demolished or removed (refer NS2B-19-H10). A number of discrete highly concentrated broken glass scatters are located east and west of the main rail line. Majority of glass is mid-20th century brown beer bottle glass. Some non-description construction debris is also present likely from the removal of previous structures.

Photograph 5.18Wearne Siding platform looking west

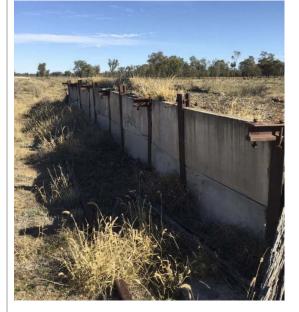
Photograph 5.19Wearne Siding platform looking south, showing rail tracks

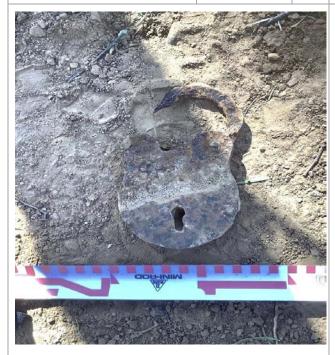
Key elements	Chainage (m)	GSV	GSI	Easting (GDA94 Z56)	Northing (GDA94 Z56)
Artefacts were largely industrial in nature, consisting of fragments of fire brick, charcoal, slag, and railway spikes.		80%	80%	247361mE	6815636mN

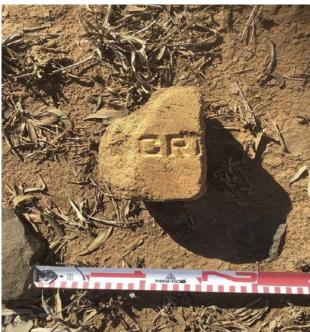
Artefacts were largely industrial in nature and extending approximately 400m north and south from a central loading embankment. Artefacts include bricks, concrete and metal. One brick is stamped with "GR" and a possible "A"

Photograph 5.29Brick is stamped with "GR" and a possible "A

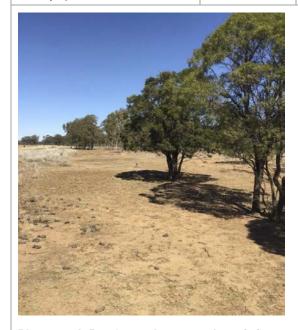
Photograph 5.30General context shot of site

Key elements	Chainage (m)	GSV	GSI	Easting (GDA94 Z56)	Northing (GDA94 Z56)
Artefacts were largely industrial in nature, consisting of fragments of fire brick, charcoal, slag, and railway spikes.		40%	60%	248861mE	6824701mN

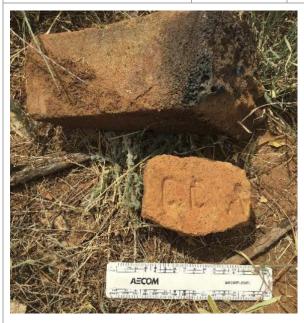
Approximately 50m long, continuous medium-density linear artefact scatter located to the west of the railway line. Interpreted to be a fettler's camp associated with upgrade/repair/replacement of the railway.

Photograph 5.34Brick detail showing maker's mark CCA
