# BOTANY RAIL DUPLICATION

Technical Report 5 –  
Contamination  
Assessment

Document No. BRD-G2S-CT-TPP-0001-05\_Contamination  
26 September 2019

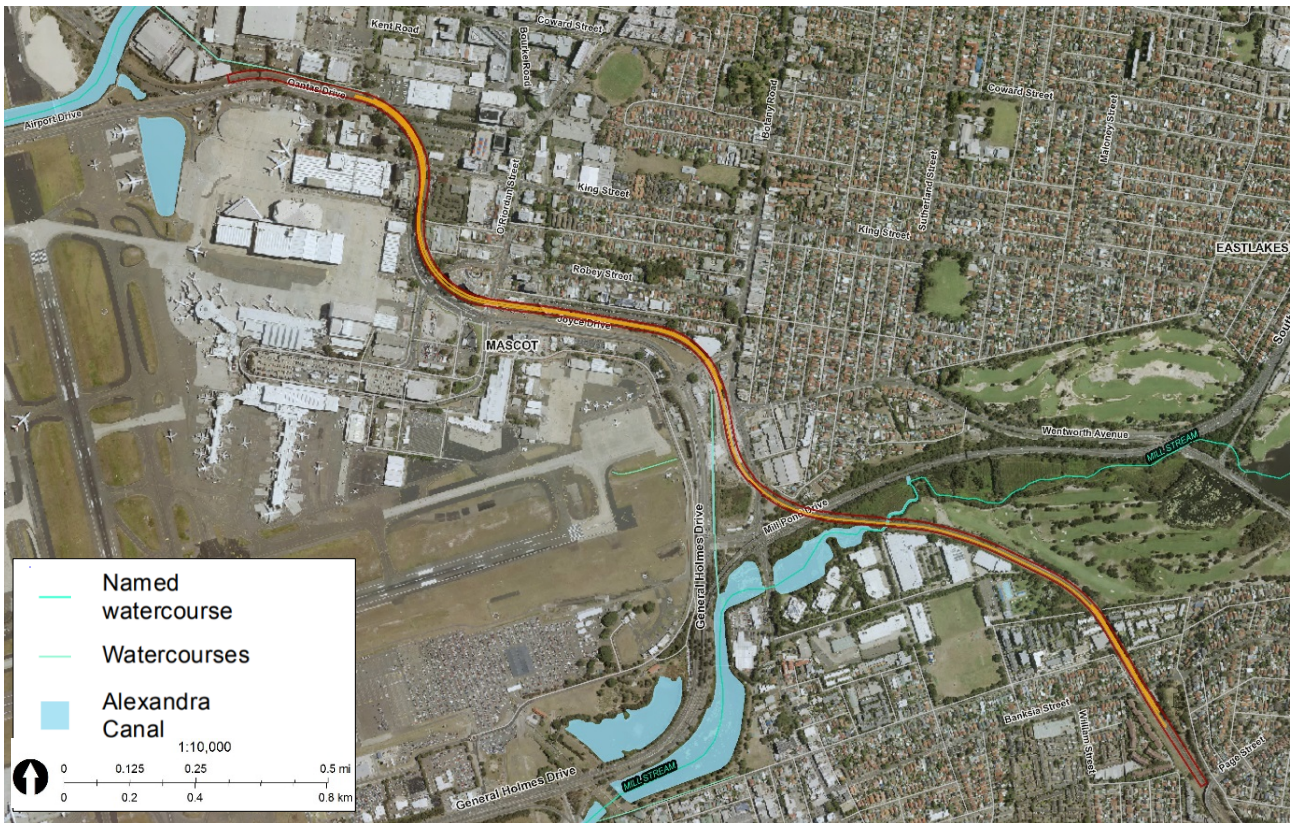
Figure 4.2 Surface water bodies in the vicinity of the project site

A map of surface water receptors is shown in Figure 4.2.

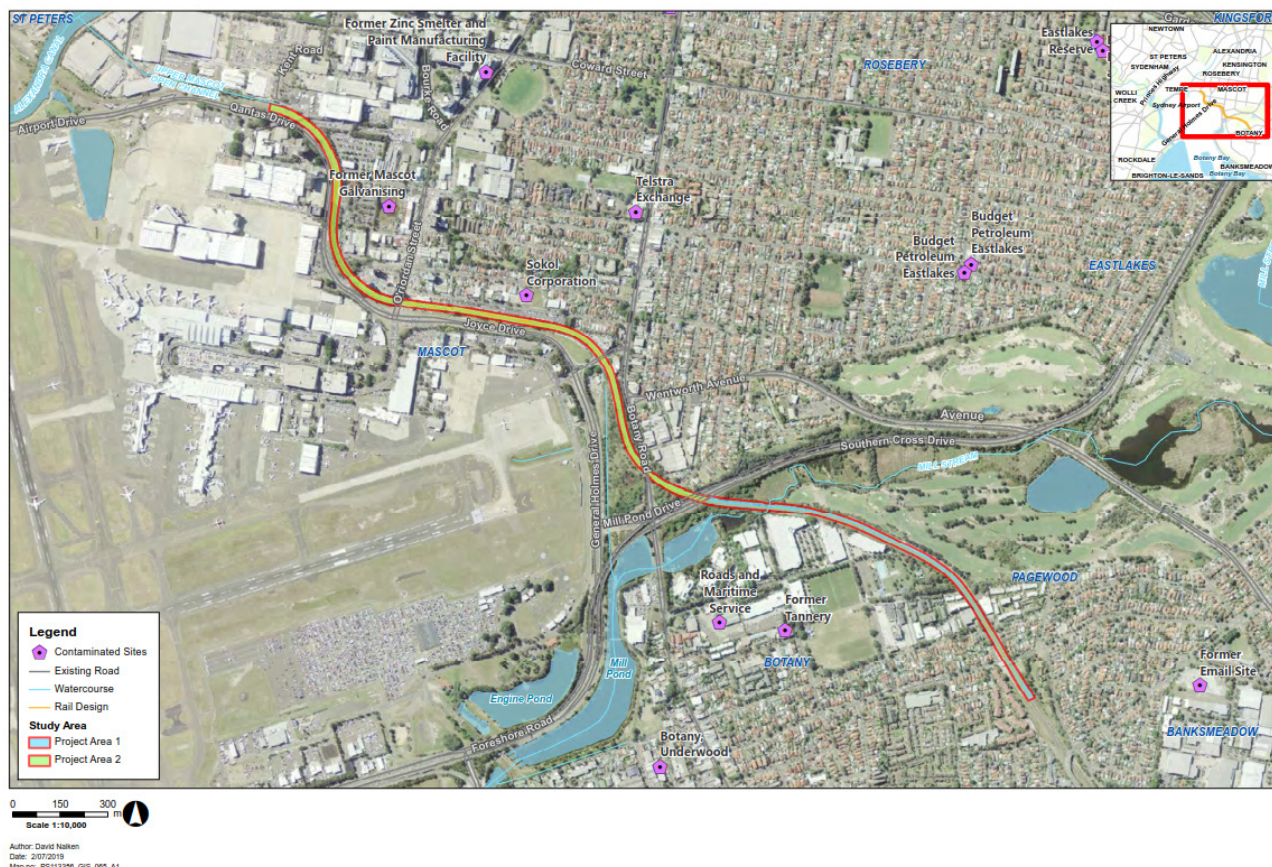
Figure 5.1 Sites on the NSW EPA contaminated land register within and surrounding the project site

Most of the sites listed above do not require regulation under the CLM Act. The two sites for which contamination requires regulation are also the subject of notices and are discussed further in Section 5.2.2.

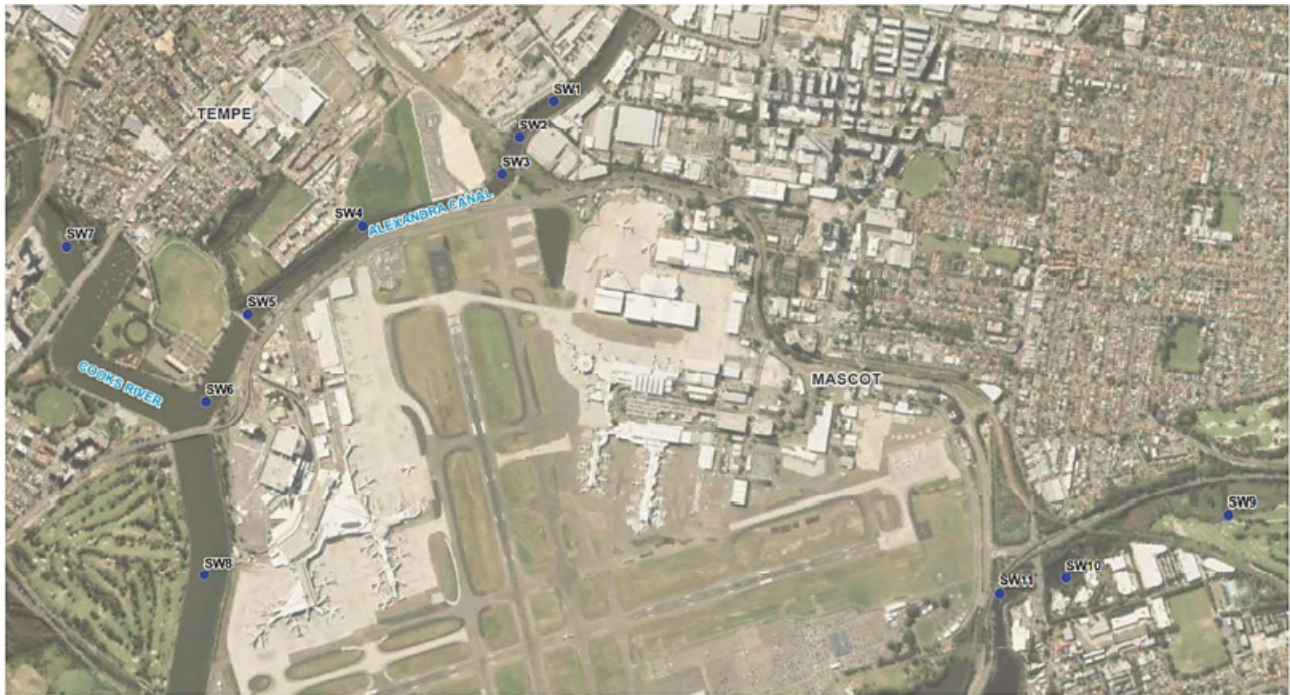
Figure 6.2 Sydney Gateway surface water monitoring locations (AECOM, 2018–2019)

- Concentrations of contaminants were generally higher upstream at SW9 and diminished further downstream.
- PFAS compounds, including PFOS and PFOA, were detected in all three sampling locations. Concentrations were generally below the PFAS NEMP (95% protection) marine criteria with the exception at SW11, where an exceedance of PFOS reported in a sample collected on 28 March 2018.

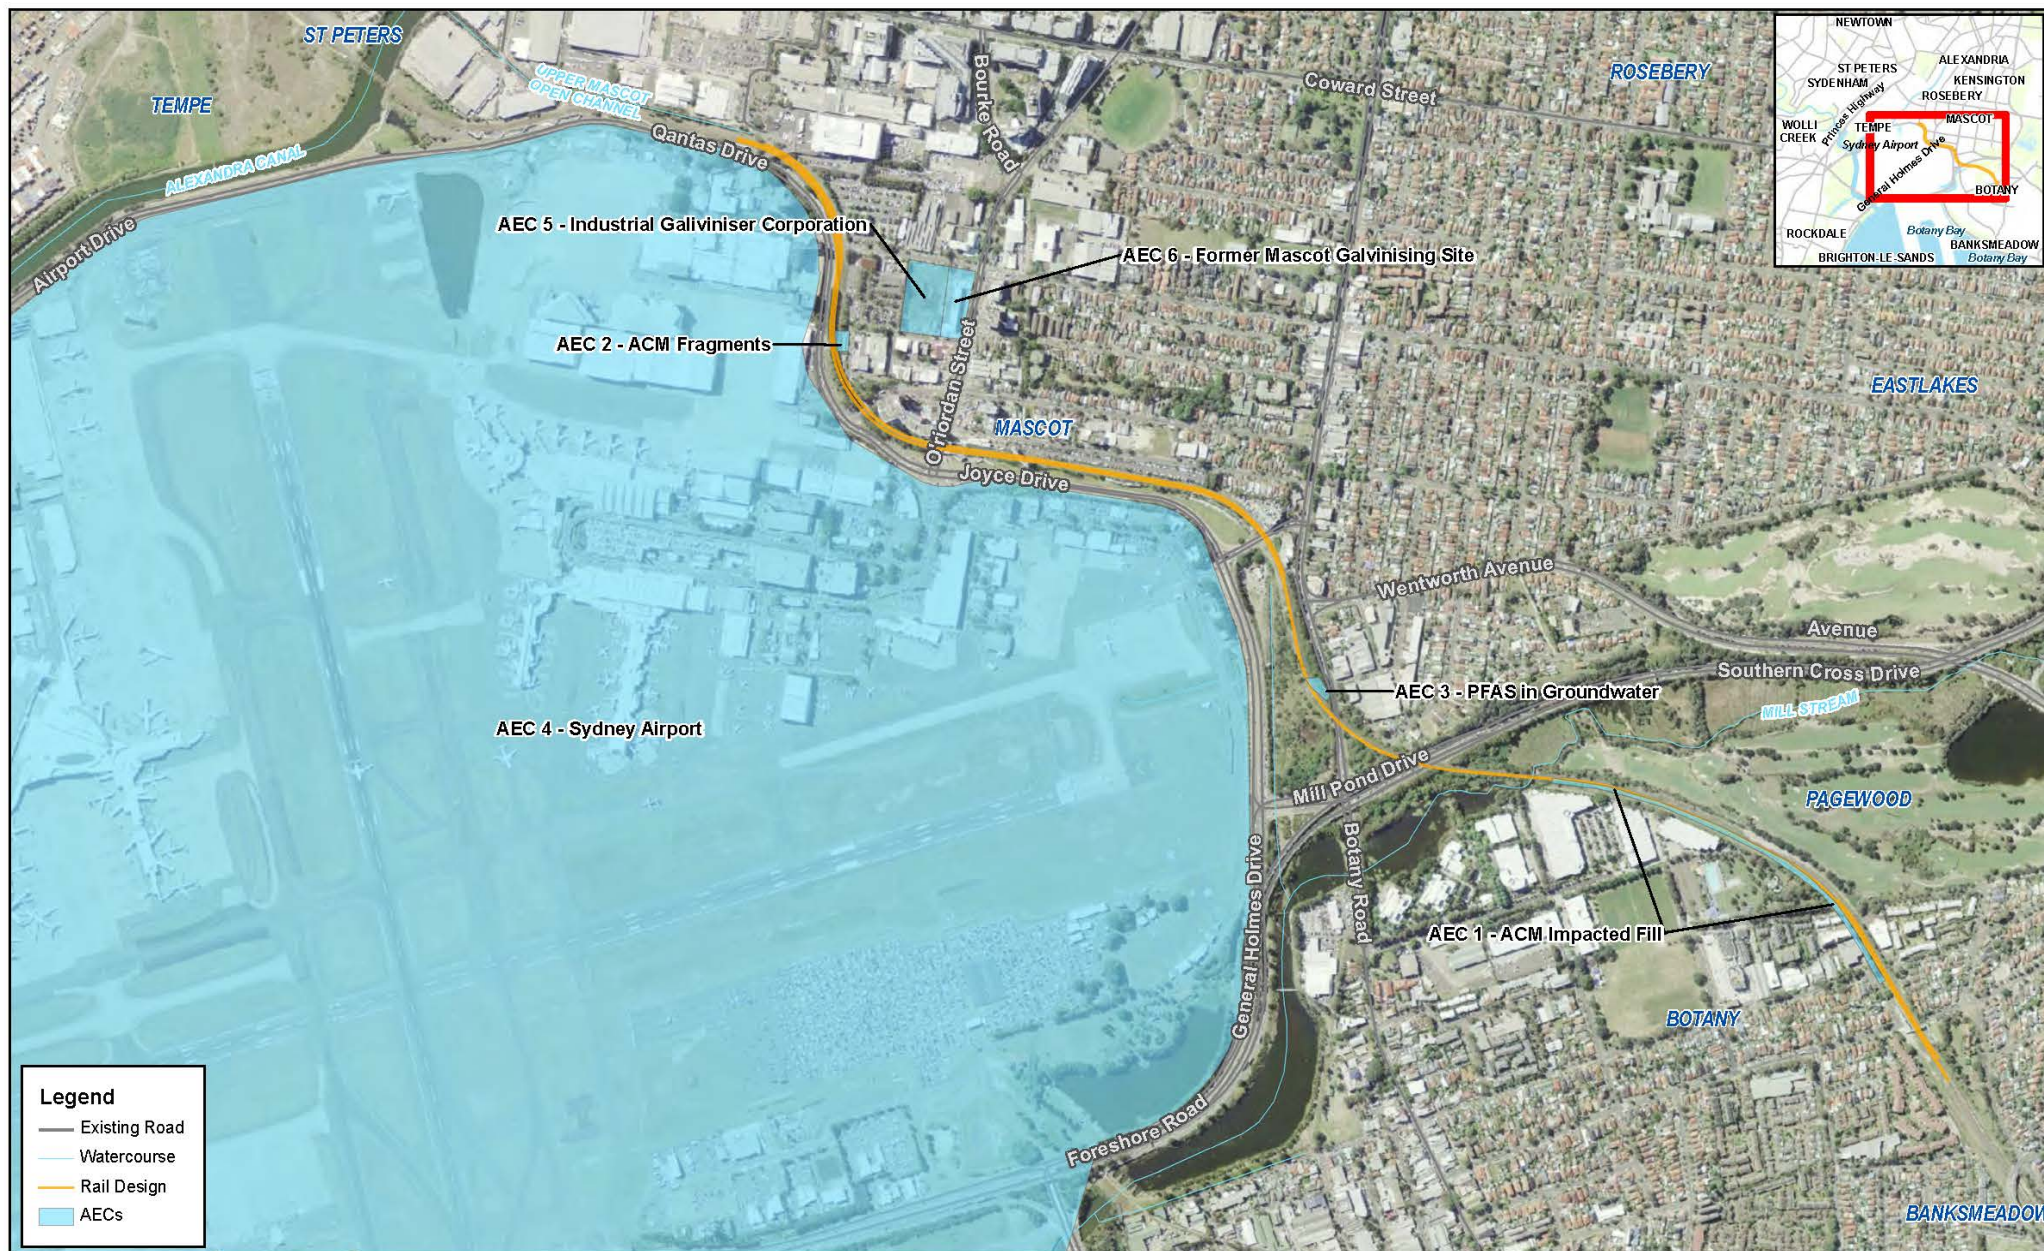
Author: David Naiken  
Date: 2/07/2019  
Map no: PS113386\_GIS\_060\_A1

The surrounding area includes several historic and current commercial and industrial activities. Based on a review of the NSW EPA contaminated sites notices and licenses under the POEO Act and considering proximity to the project site the following off-site AECs have been identified:

- AEC 4 – Sydney Airport (including the Qantas Jet Base)
- AEC 5 – Former Mascot Galvanising site.

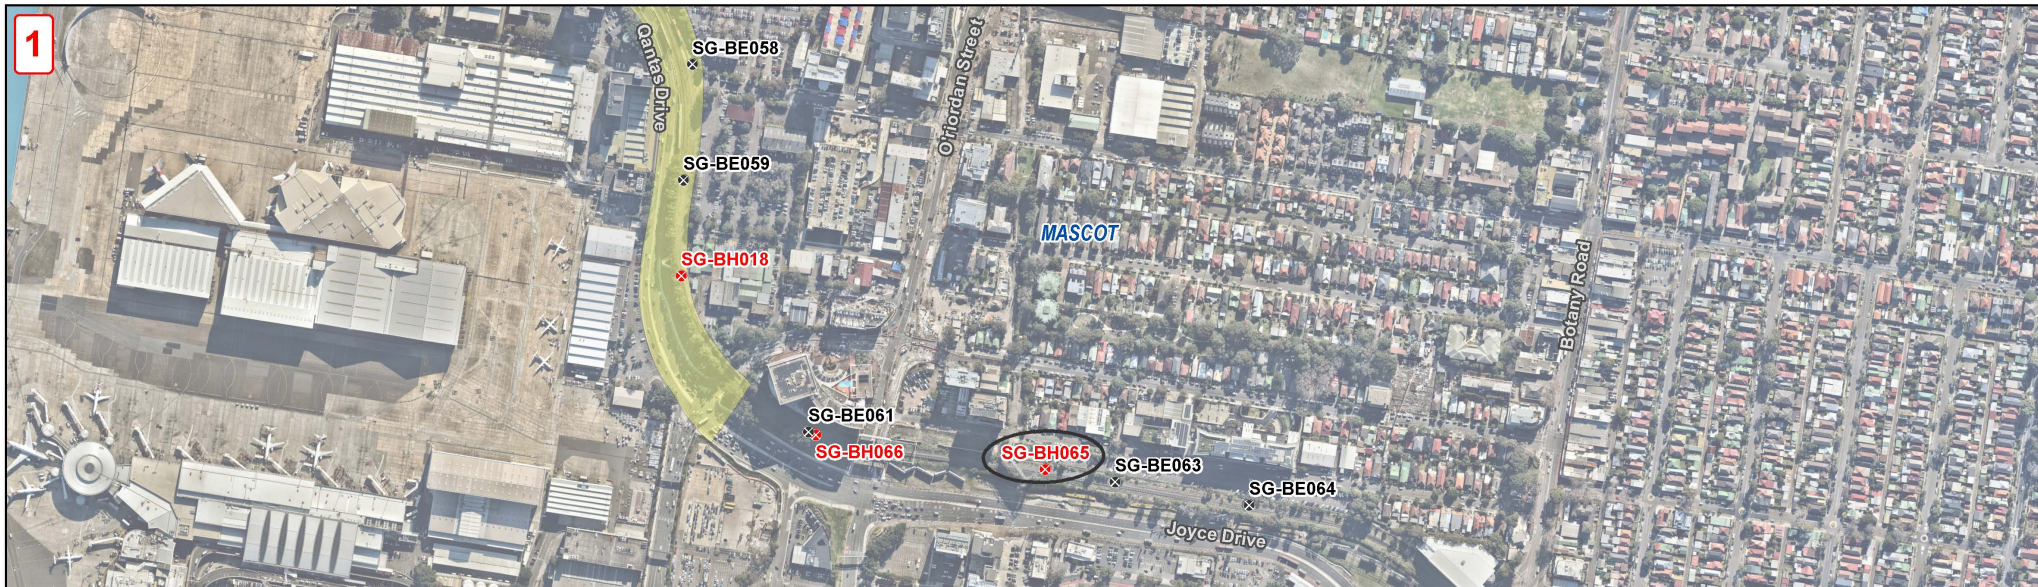
Figure 8.2

Limited investigation (involving three boreholes) has been undertaken to the west of Robey Street (AECOM 2017). Although no ACM has been detected, building/construction waste was recorded in two of the borehole locations. Also, ACM was observed on the surface during site inspection (6 July 2018). However, borehole drilling is not the preferred method for asbestos investigation (NEPM 2013) as only limited soil is available for visual examination due to the small diameter of the borehole. The preferred method to identify the presence of asbestos is via a trenching or test pit method, as this allows visual inspection of a greater surface area of soil. Therefore, given the observation of building/construction waste, further asbestos investigation with test pit or trench methods is recommended in the area west of Robey Street (as shown on Figure 8.2) during detailed design to better inspect the nature of the anthropogenic material recorded and confirm whether asbestos is present.

Limited groundwater monitoring has been undertaken to date along the project site. No significant dewatering is proposed during construction. If the need for significant dewatering is identified during detail design or construction, further groundwater monitoring should be undertaken to inform appropriate management and discharge options.

Project Site Investigation and Identified Data Gaps
