Hidden emissions: A story from the Netherlands

Case Study

November 2018 – ToxicoWatch

The youngest of Dutch incinerators: Reststoffen Energie Centrale

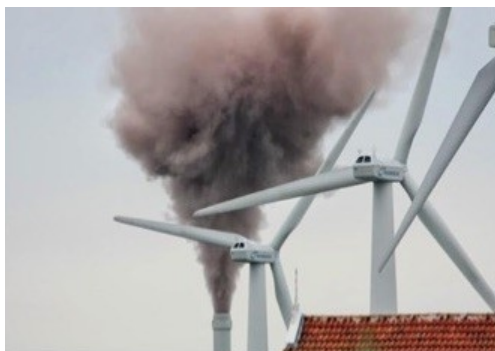
Figure 5: Emission of dust (dumpstack)

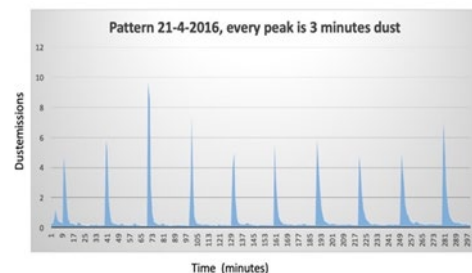
Figure 7: Most of the time, bypassing (dump stacks) takes only a few minutes

Although the AMESA test was prepared for operation during the start-up after the annual maintenance stop, it was blocked three times for unstated reasons. According to documents of the REC incinerator, several cleaning operations (flushing) have taken place in Phase 1, but without filtering. Sometimes this cleaning and dust emissions was visible (Figure 5), but most of the time these dump stacks took place at night. In Figure 7, regular patterns of 3-minute dust emissions are shown, just as a result of opening and closing the bypasses.
