STATEMENT OF HERITAGE IMPACT

Project No. 17-41

Proposed Additions and Alterations

The Former Roman Catholic Church of Perpetual Succour

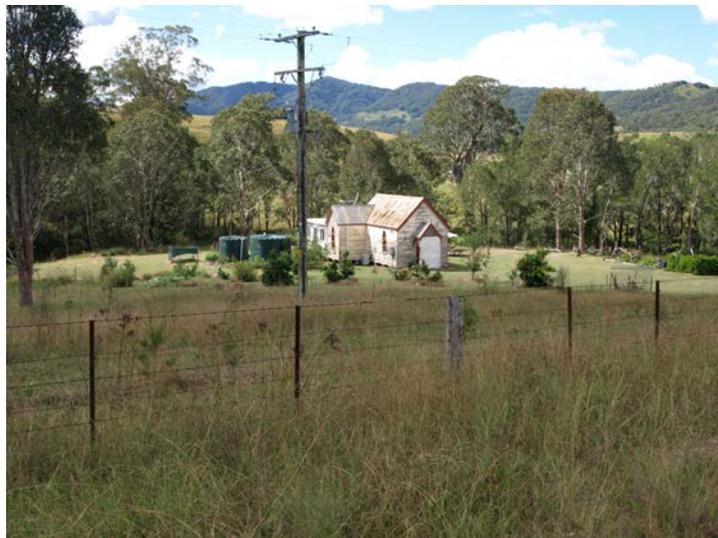
Figure 1. South west view of the Former Church

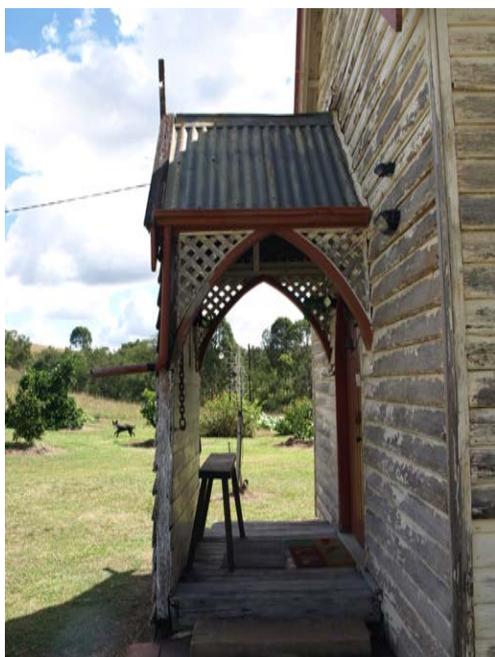
- 5.3.5 Gable end crosses are no longer attached to the building but they have been salvaged and stored intact on site for repair and remounting.
- 5.3.6 The Porch wall is a patchwork of weatherboards on the lower end, with corner capping moulds missing.

Figure 3. The southern Porch, east elevation

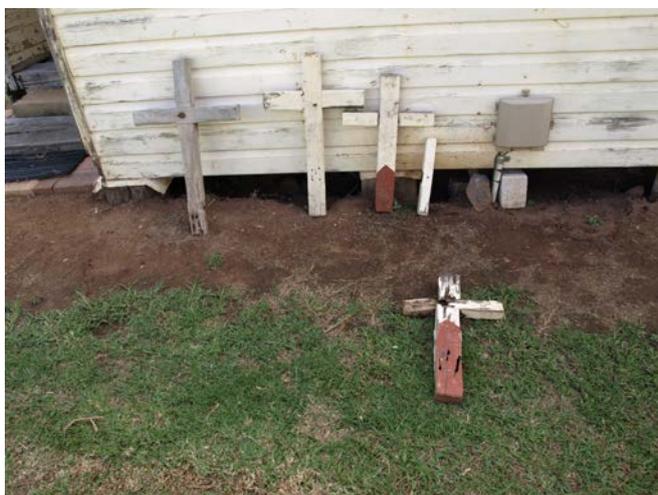
Figure 4. Gable crosses, salvaged and being repaired

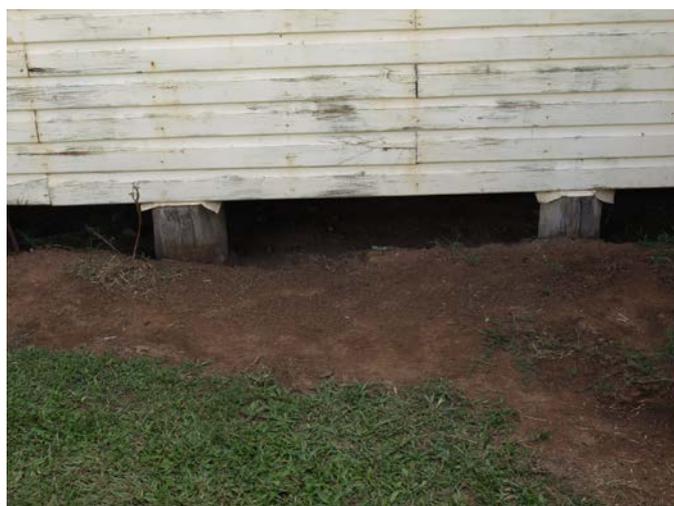
Figure 5. Timber stumps are still serviceable. Ant caps are in place. Soil levels have been built up in order to divert water from beneath the building.

- 5.3.8 Full sub floor examination was not carried out. Perimeter stumps appear to be in reasonable order.
- 5.3.9 Internally, the building is in good order, with the floors having been maintained and sealed, and the timber walls and ceiling (Cypress Pine) remaining unpainted but oiled / Shellac coated and in a very good condition.

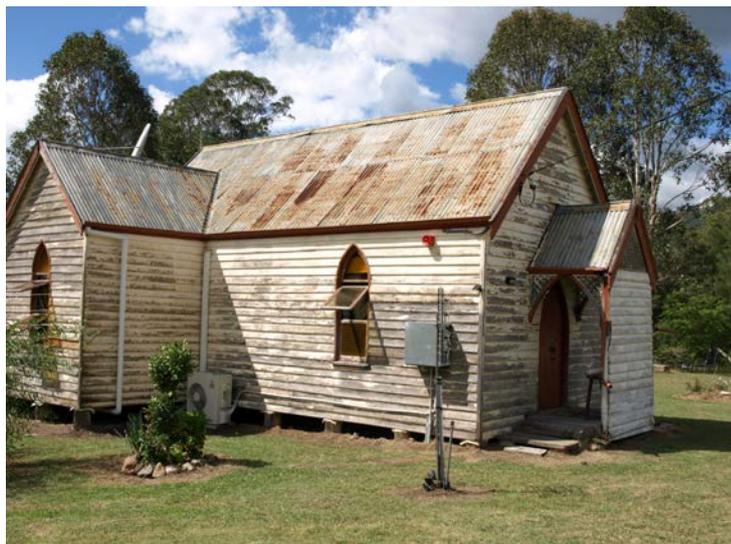
- 5.3.1 Despite some surface deterioration of the steel roof and the weatherboards being depleted of paint in many areas, the exterior is in a sound and serviceable condition. Some repairs are needed on the walls, and indenting of new weatherboards where the existing have severe damage and deterioration.

Figure 6. Roofing is in short sheet lengths, some corrosion but in serviceable condition. Cleaning down and anti corrosion treatment would be necessary. Walls require some repairs and cleaning down of old lead paint and sanding prior to priming and recoating

- 7.3.8 The roof sheeting of the addition shall be natural galvanised or zincalume finish.
- 7.3.9 Should the existing roof be required to be painted following the application of anti-rust treatment (Penetrol or similar), the colour should be a Colorbond Shale Grey or Windspray.

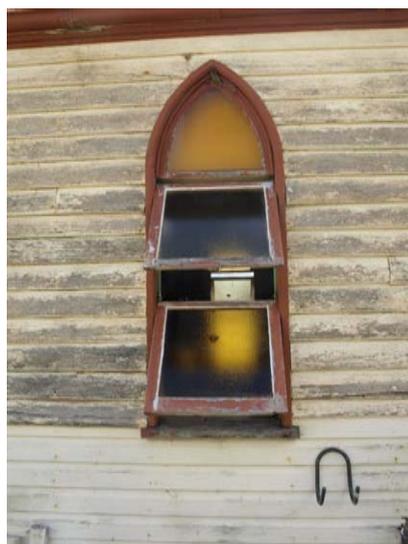
Figure 7. Windows are serviceable, but in need of some glazing repairs and replacement as well as reputtying using traditional linseed putty

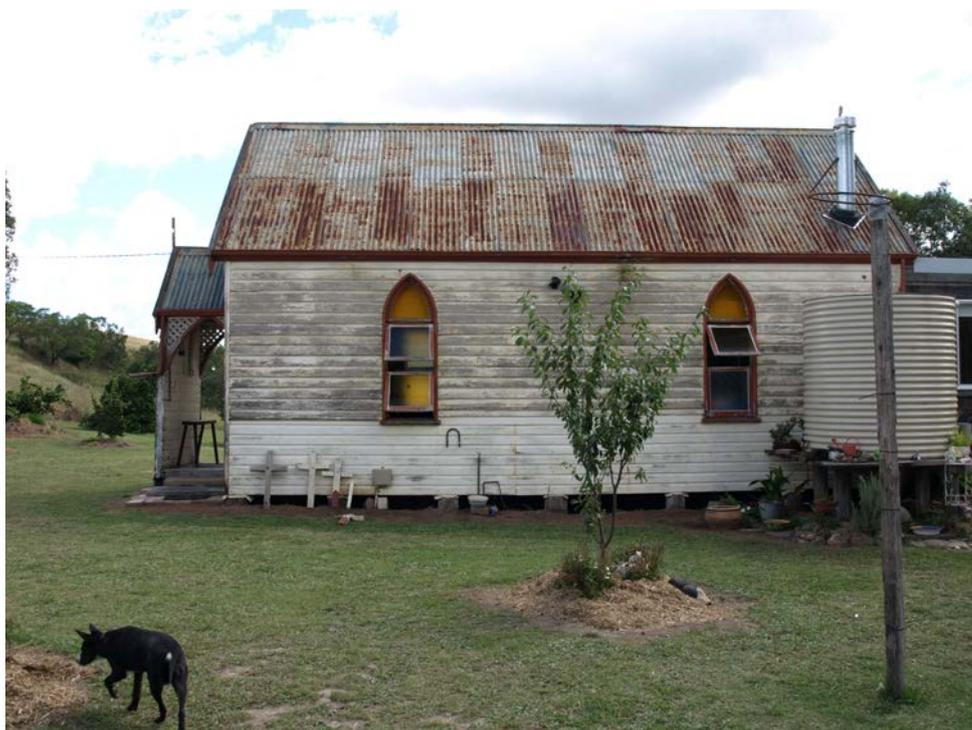
Figure 8. East Elevation showing the general condition of the exterior. Water tanks are new and plumbed into the guttering.

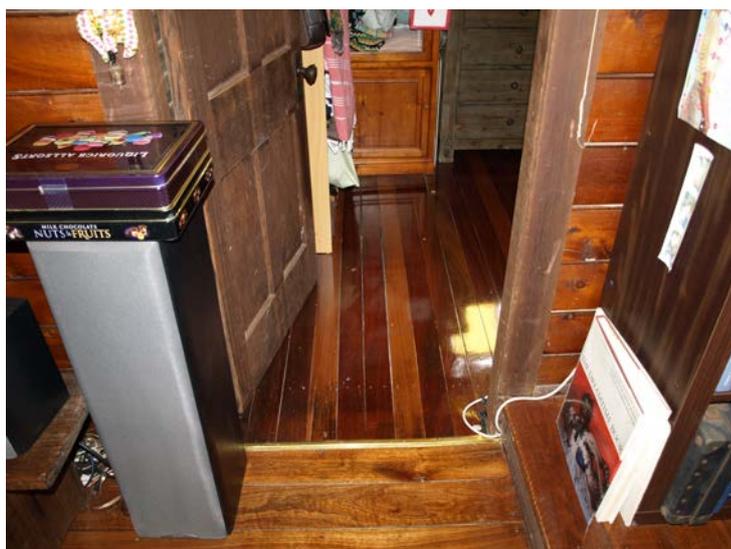
Figure 9. Doorway to the former Vesting Sacristy and the Nave showing the change in flooring material and direction.

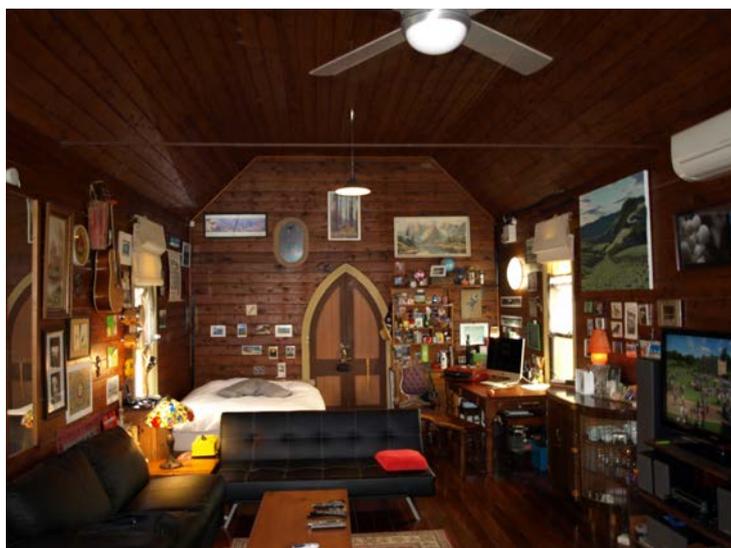
Figure 10. Former Nave looking south from the Sanctuary. The interior condition is very good and well maintained.

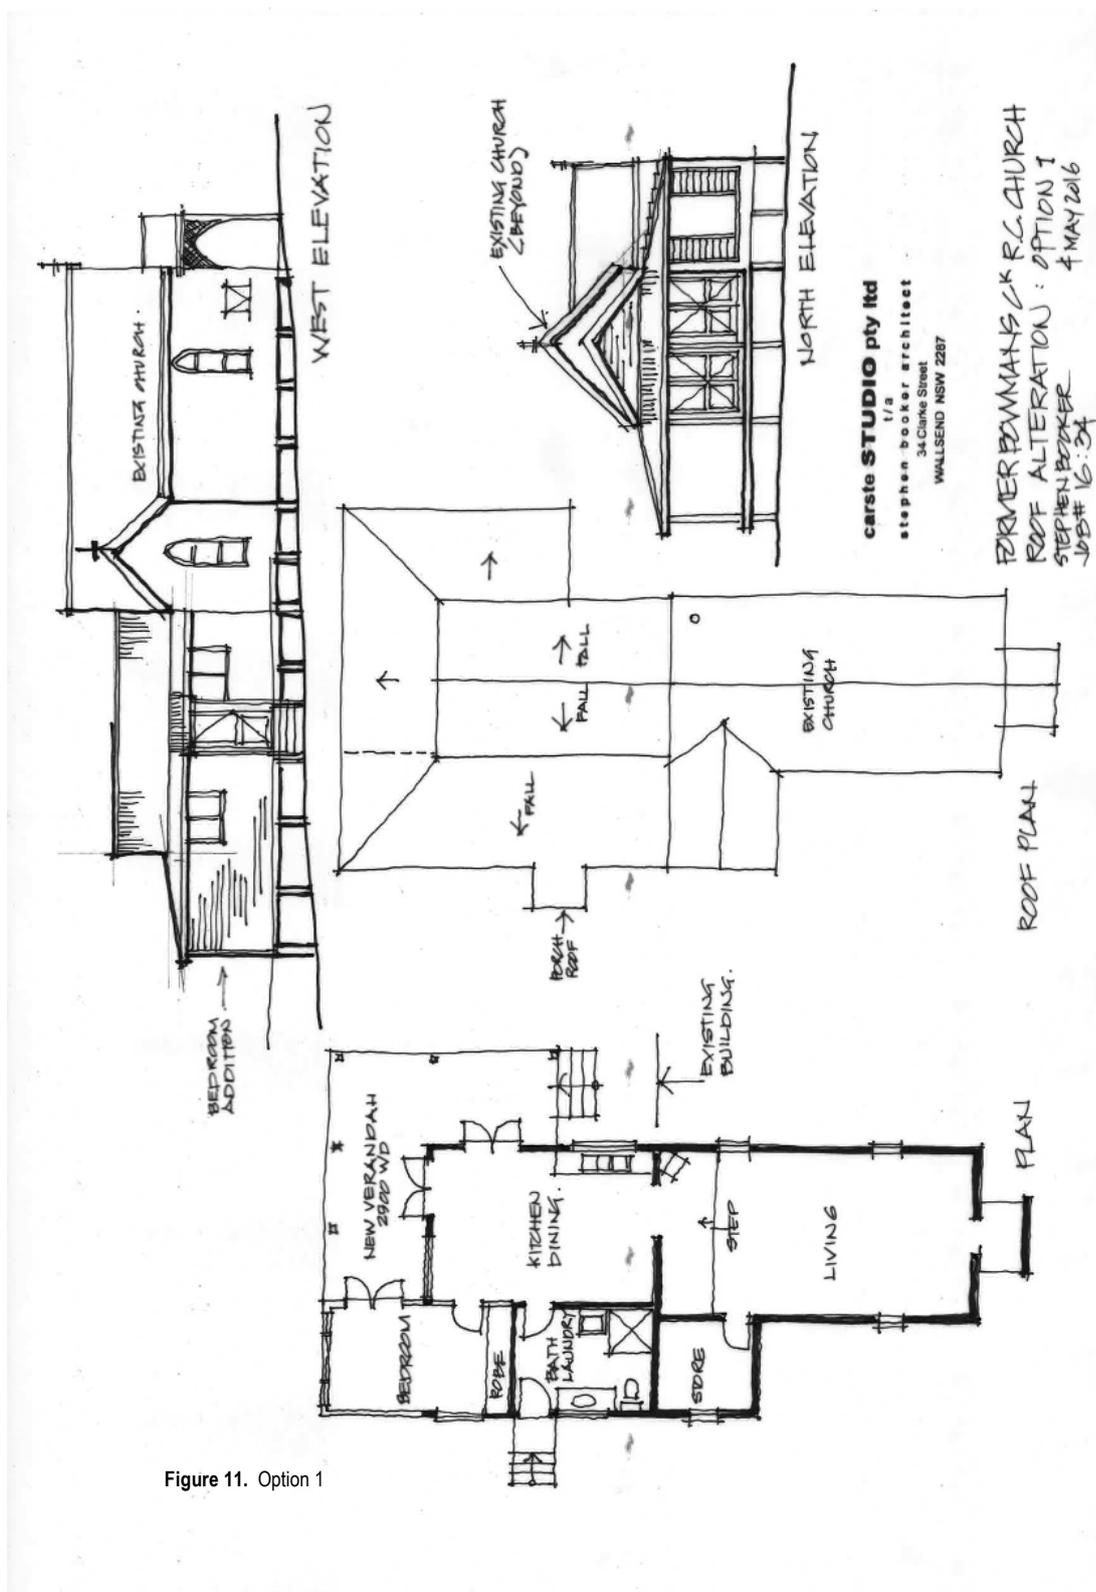
Figure 11. Option 1

7.2.10 **Option 1** was prepared taking the approach of replacing the roof with a lower pitched gable roof, following the existing north-south axis of the existing building and enveloping the addition on three sides with a low pitched verandah roof, providing covered outdoor space and weather protection and shading to the exterior glazing and facilitating a small addition to the Bedroom space, enabling it to be walled and separated from the main living spaces.

7.2.11 The physical benefit of this is that the addition would adopt the architectural language of the former church, whilst enabling the original form to remain discernible.

- 7.2.16 Following the owner's deliberations, **Option 1 was elected to be the optimum solution**, satisfying the physical criteria of providing a better fit for the addition as it generally stands in a form that could be simply and affordably constructed and providing a congruent form sitting adjacent the former church. The design option would not overwhelm the form of the existing church building.

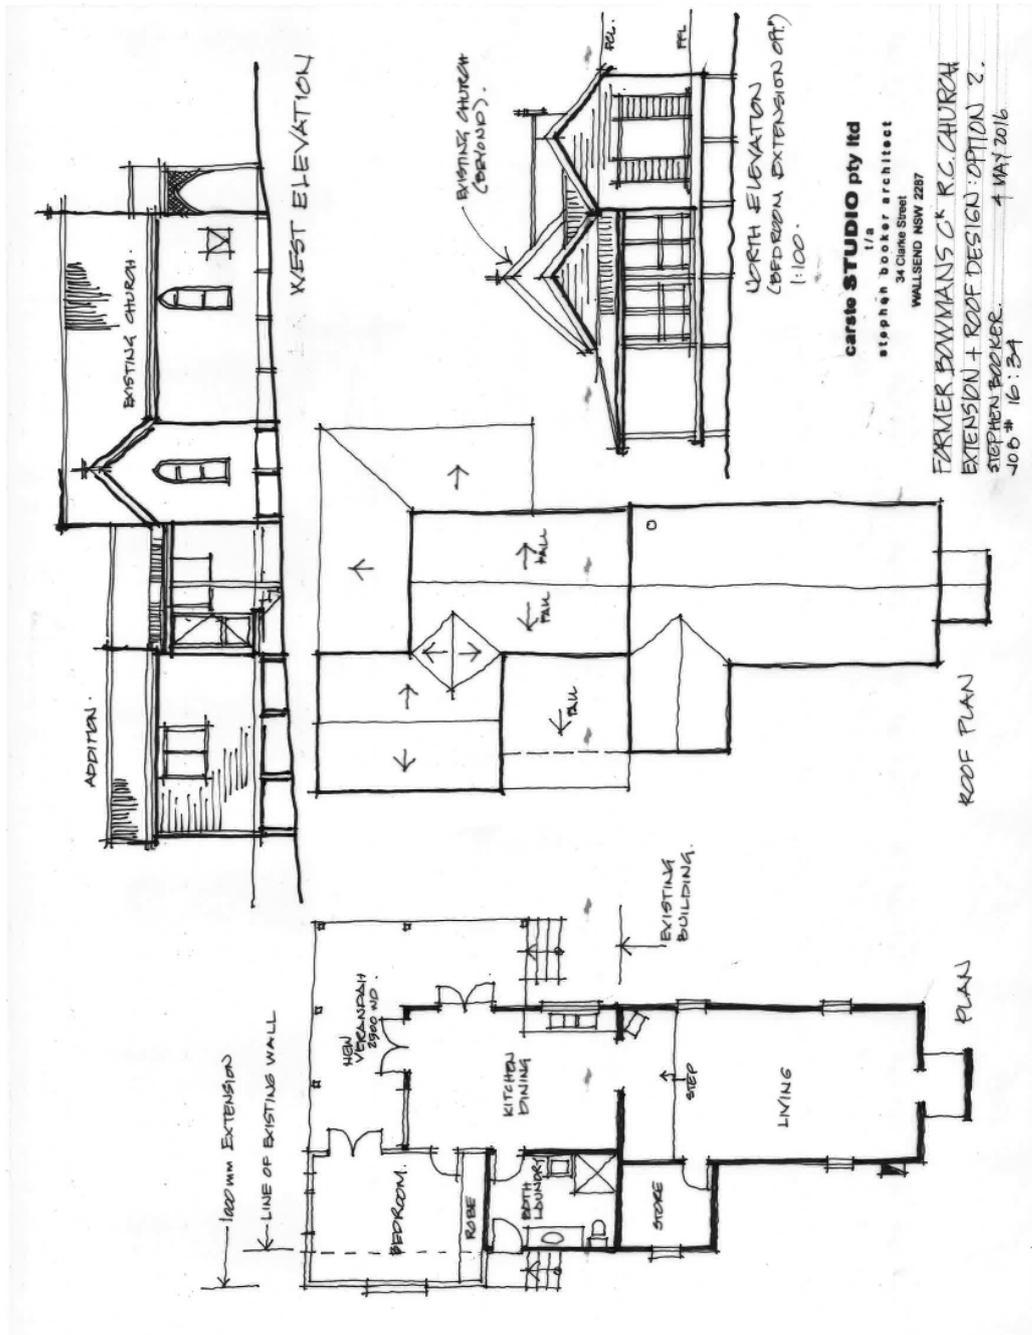
Figure 12. Option 2

- 7.2.12 **Option 2** went one step further than Option 1, in separately roofing an expanded width Bedroom and wrapping the north and east side of the addition with a low pitched verandah roof.
- 7.2.13 The gable roofed Bedroom pavilion is offset from the main north-south axis of the Church and reads as an integral part of the whole.
- 7.2.14 Option 1 and derivatives were discussed on site with Orbit Planning and the owner and were generally agreed upon as the simplest, most appropriate and affordable adaptation of the existing addition.
- 7.2.15 Option 2 was devised after the site visit, as an expansion of the Bedroom, expanding the building without the introduction of box gutters and providing an integrated overall appearance.

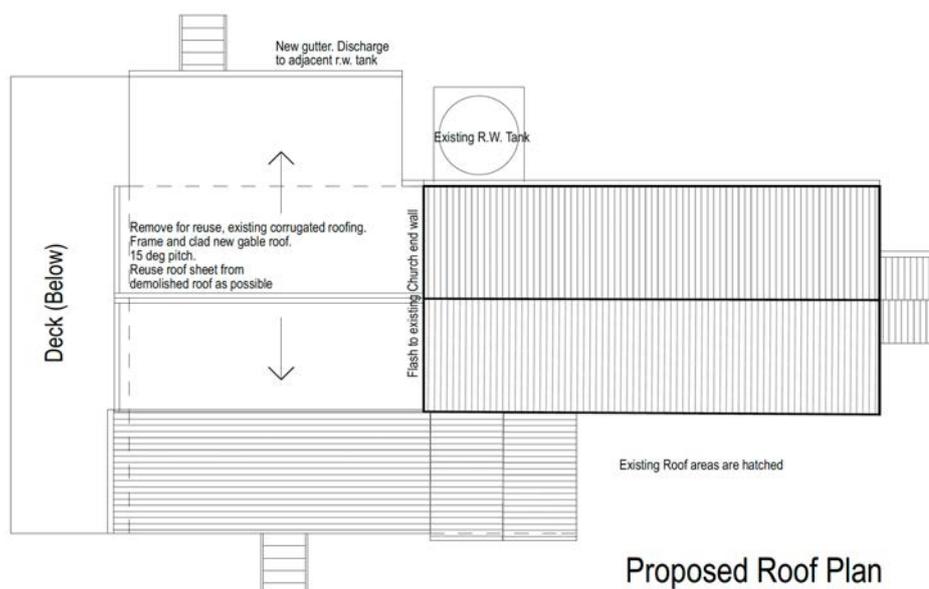
- 7.3.2 Recladding the low pitched roof with a profile more appropriate such as Trimdeck or Kliplok, which can be used for almost flat roofs. Custom orb as is already present has been applied to a roof too shallow in pitch for its appropriate application and will ultimately lead to leakage.

Figure 13. The Final Design option Roof Plan

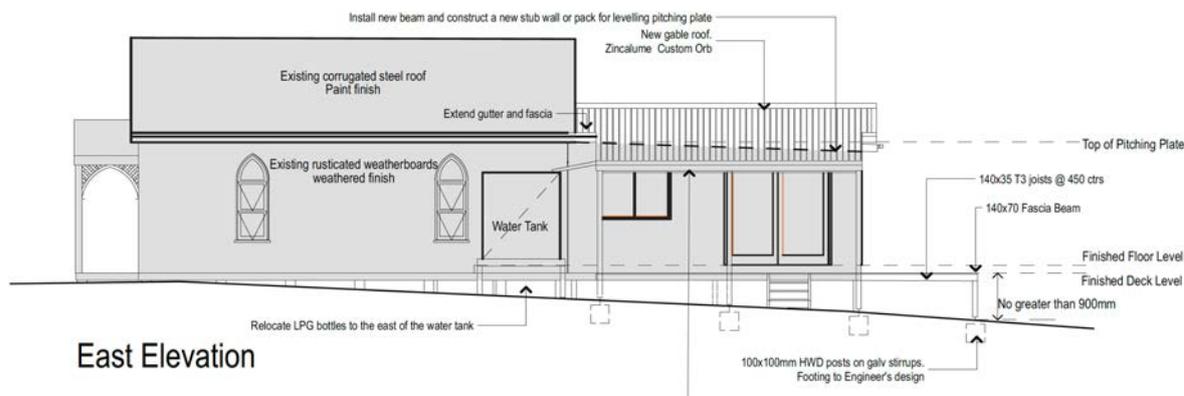
Figure 13. The Final Design option East Elevation

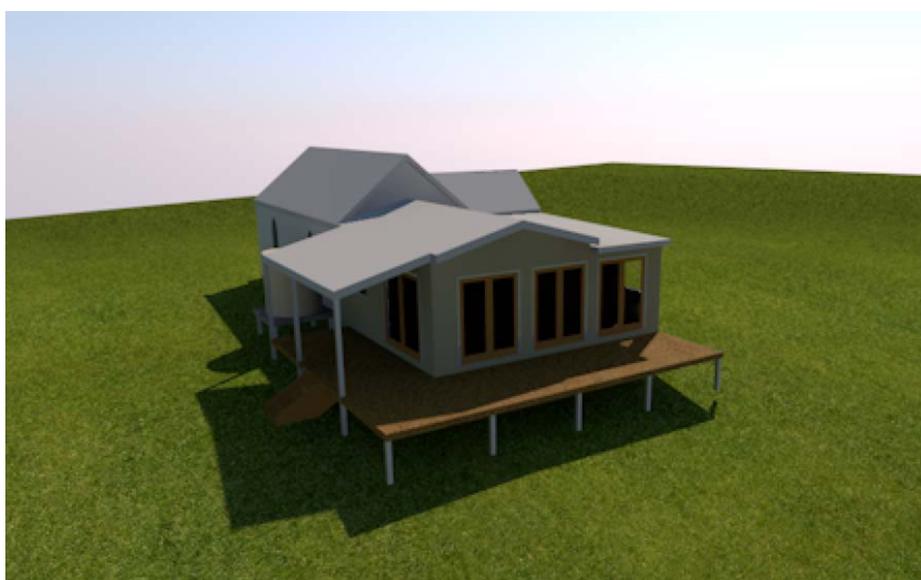
- 7.3.3 The arrangement presented maintains the existing floor plan, while providing for more usable outdoor space through the north and eastern decking and the covered eastern area which becomes a verandah, in a location that doesn't suffer from the late western sun and the heat load associated and has the best outlook. The area would otherwise be unusable as the sun is on this location for the greater part of the day.

Figure 14. The Final Design option North Eastern view

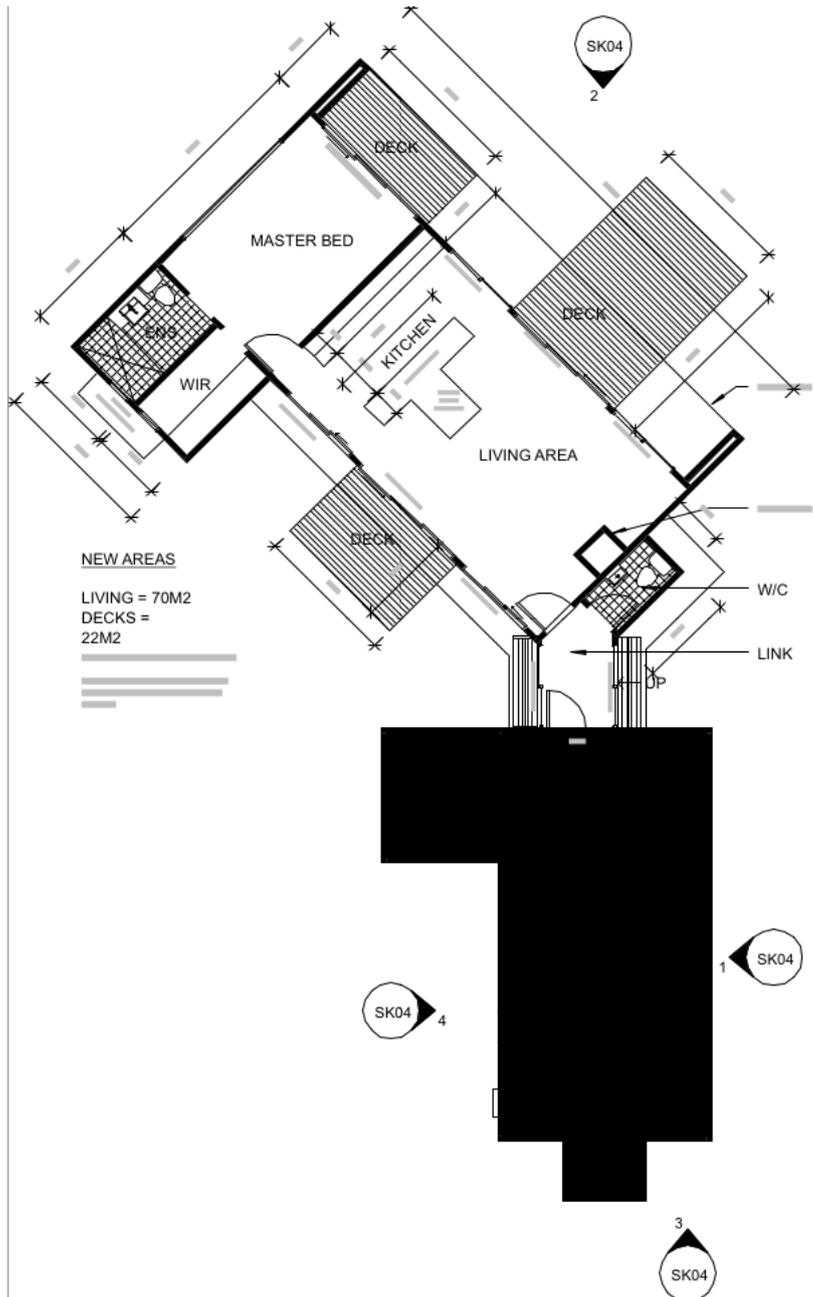
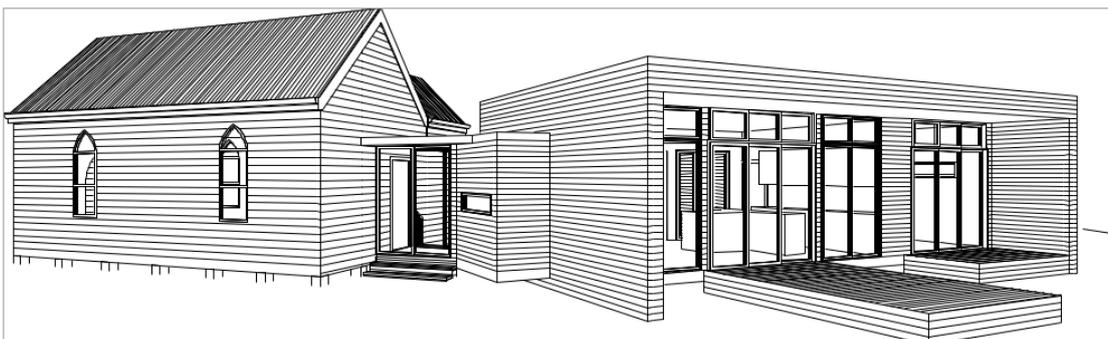
OPTION 2

The BDD PAVILION DESIGN
