ABORIGINAL DUE DILIGENCE ARCHAEOLOGICAL ASSESSMENT

**East–West Bypass, Moree
Moree Plains LGA
January 2019**

Report Prepared by
OzArk Environmental & Heritage Management Pty Ltd
for Moree Plains Shire Council

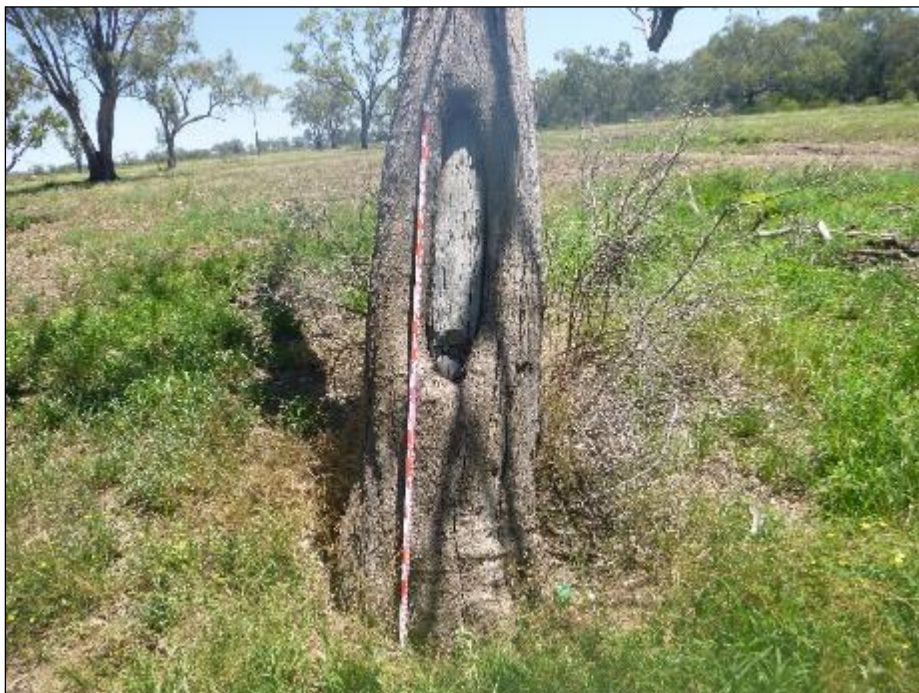
View of #10-3-0063 and scar.

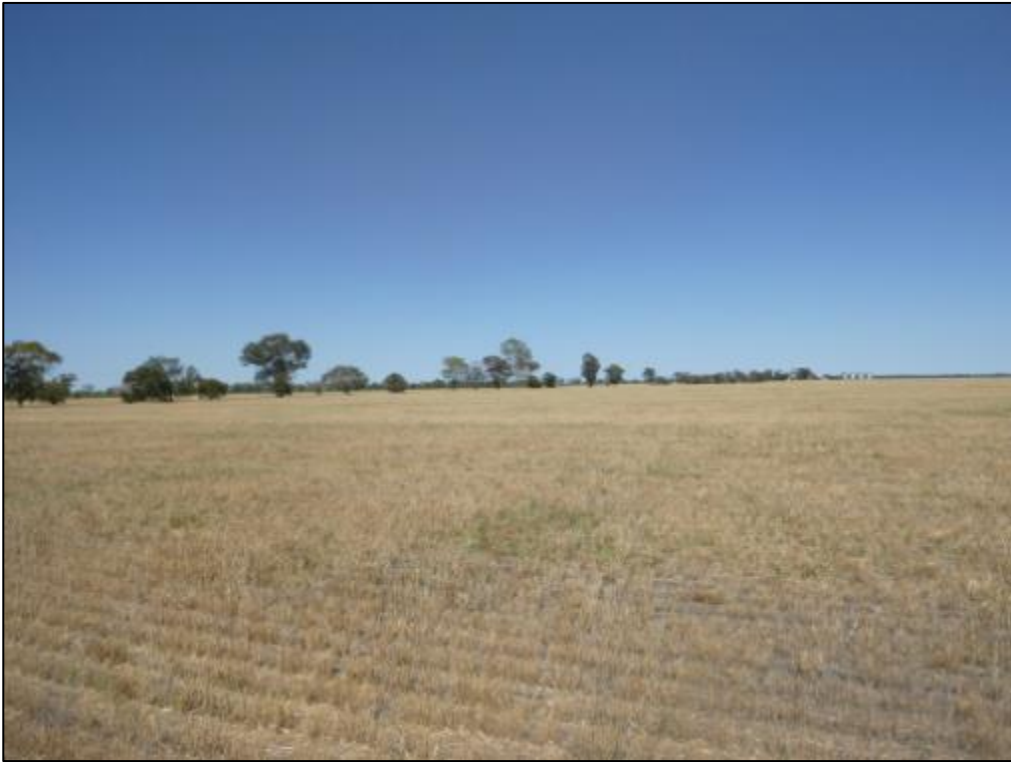
Plate 1: View southwest along East–West Bypass section of study area.

The East–West Bypass section of the study area is predominantly ploughed paddocks, or dirt access tracks (**Plate 1** and **Plate 2**). There is minimal vegetation remaining in this section of the study area, except around Mehi River (**Plate 3** and **Plate 4**). The southernmost section of the North-South Link Road section of the study area was a dirt access track (**Plate 5**) and the majority of the northernmost section of the north-south link road section was also a dirt access track (**Plate 6**).
