**INVINCIBLE COLLIERY AND CULLEN VALLEY MINE
MODIFICATIONS TO EXISTING DEVELOPMENT APPROVALS
BSAL SITE VERIFICATION ASSESSMENT PROCESS – CULLEN VALLEY MINE**

This document undertakes a review against the '*Biophysical Strategic Agricultural Land (BSAL) Verification Process*' as it applies to the Modification proposed for the Cullen Valley Mine. A separate document for the Invincible Colliery Modification has also been submitted.

4 SITE VERIFICATION ASSESSMENT FOR CULLEN VALLEY MINE MODIFICATION

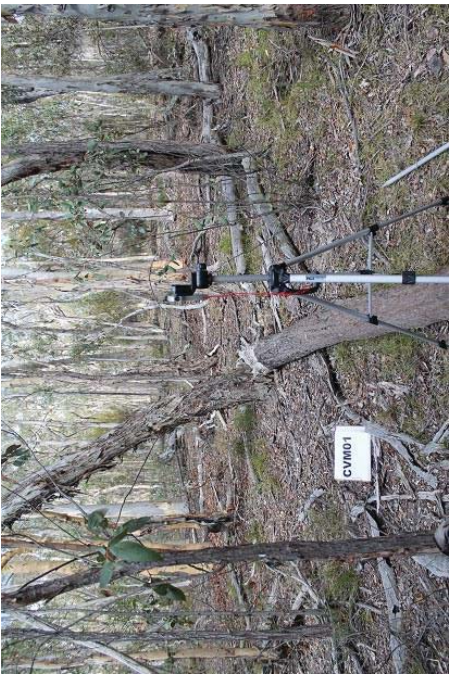
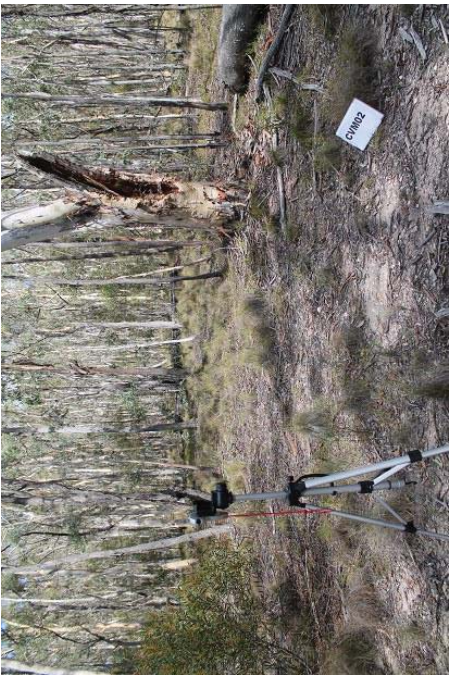
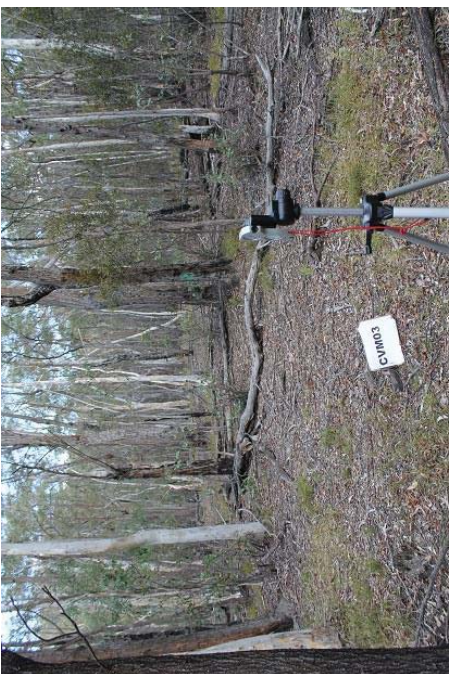
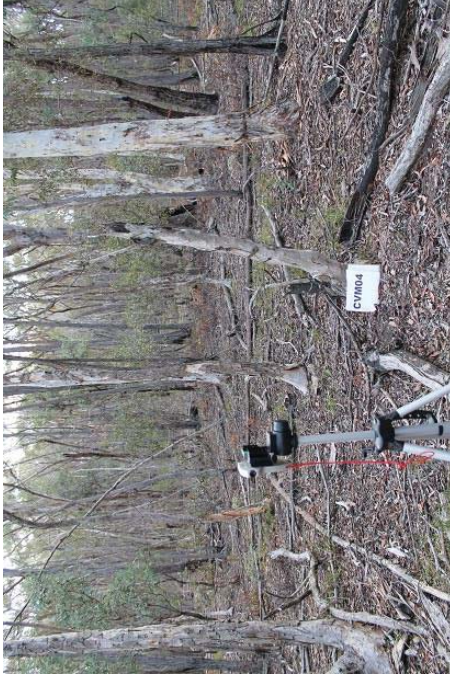
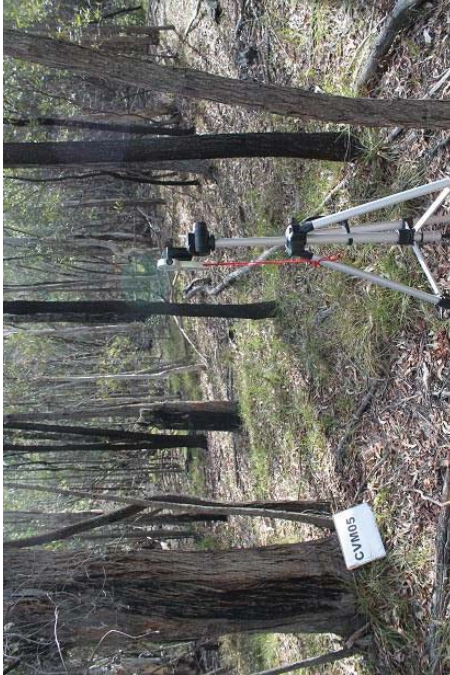
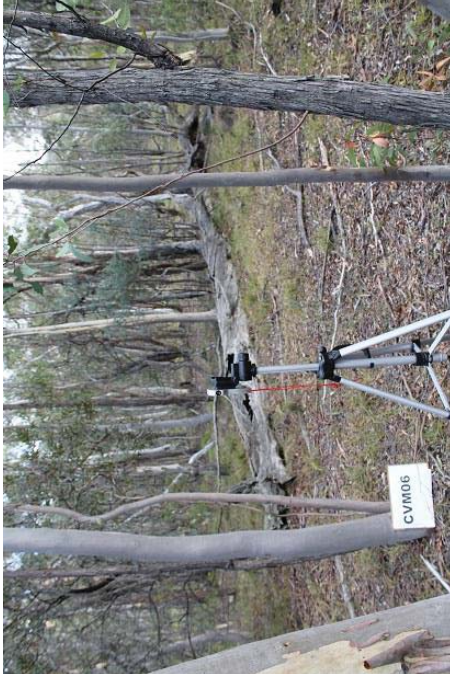
CVM01	CVM02	CVM03

Cullen Valley Mine - Exclusion Sites photographic record, 24 February 2014.

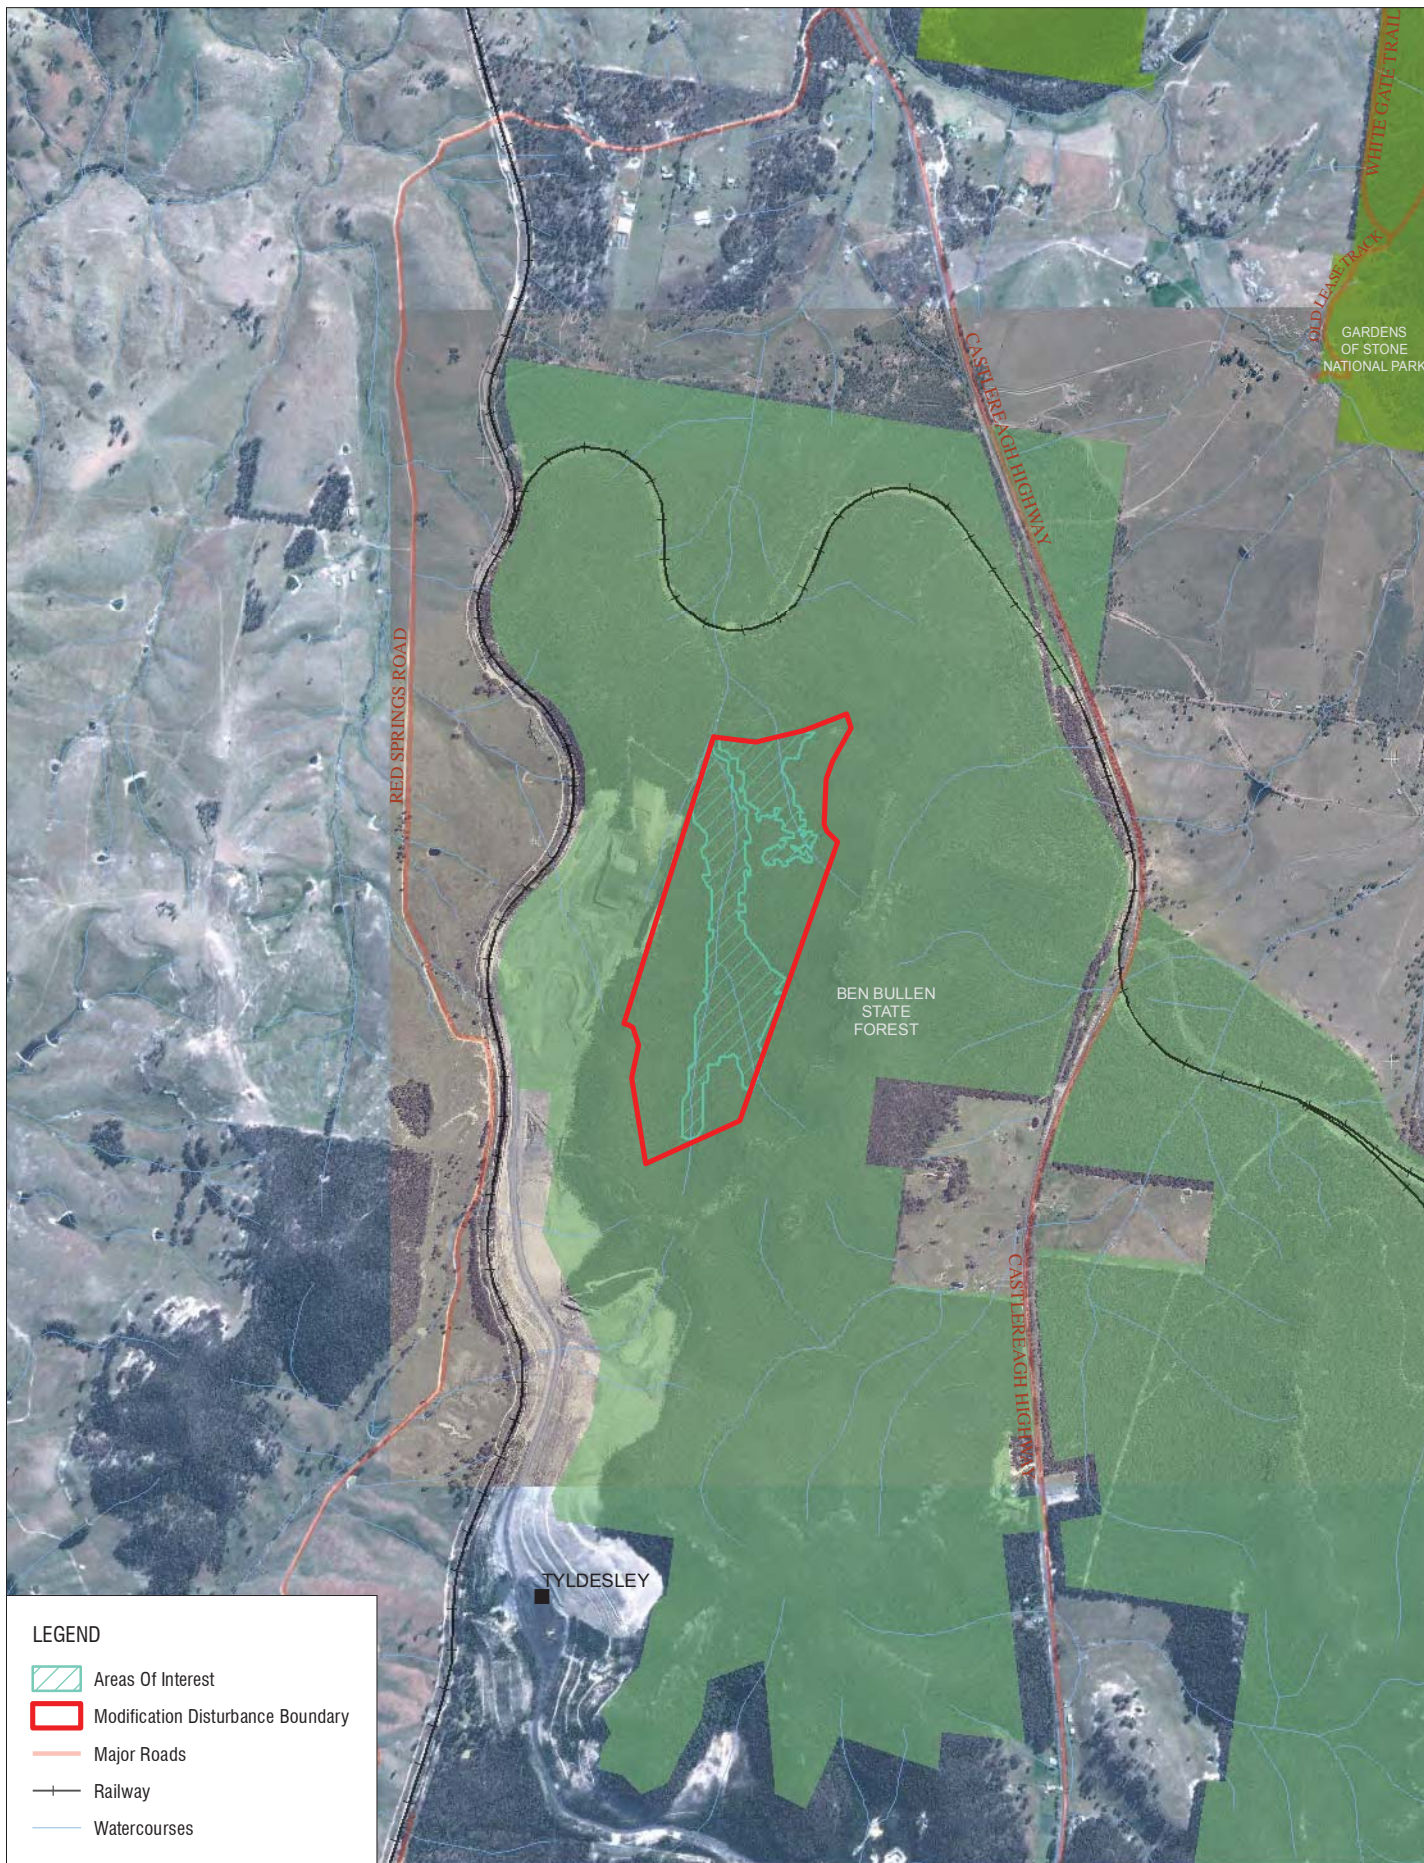
FIGURE 1

The Study Area for the Project that is subject of this Site Verification Assessment is land that is not mapped as BSAL under the Policy; however, requires verification as it will be impacted upon by the Project. The Study Area (also referred to as the Area of Interest) is located in the Ben Bullen State Forest and is approximately 24.5 ha (**Figure 1**).

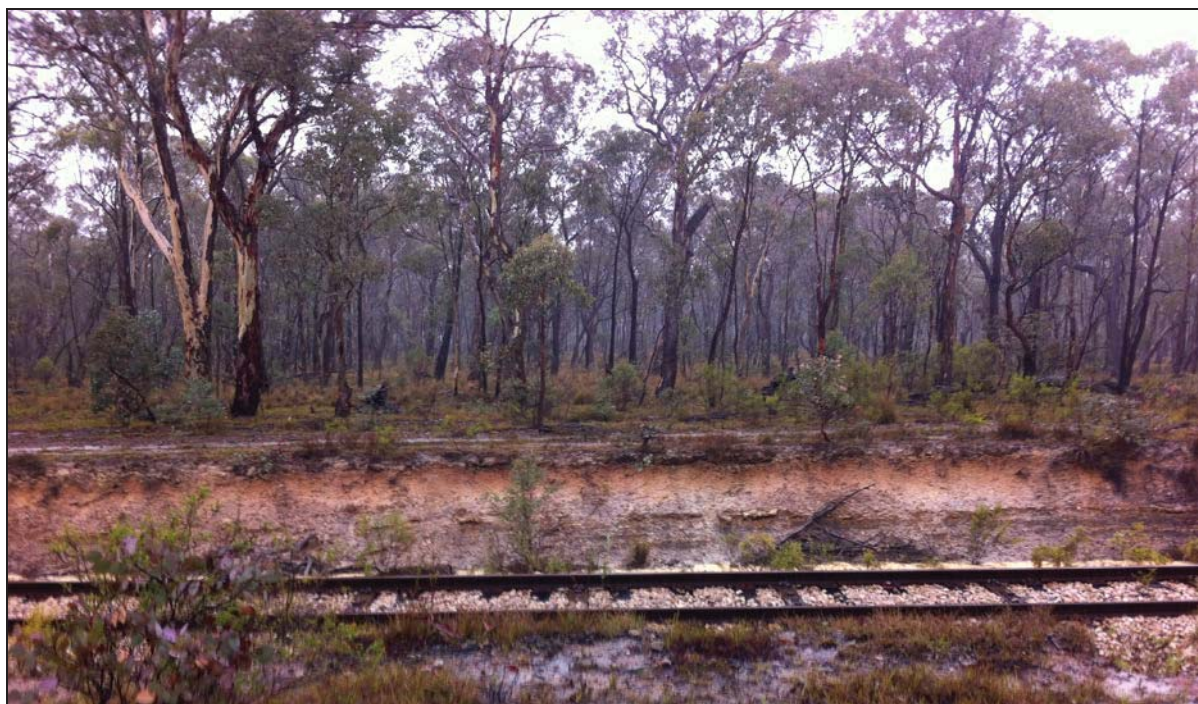
Plate 1 – Exposed Profile: Typical Site

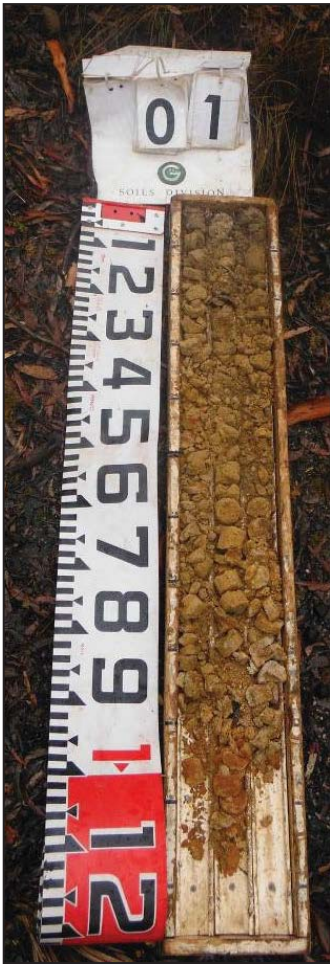
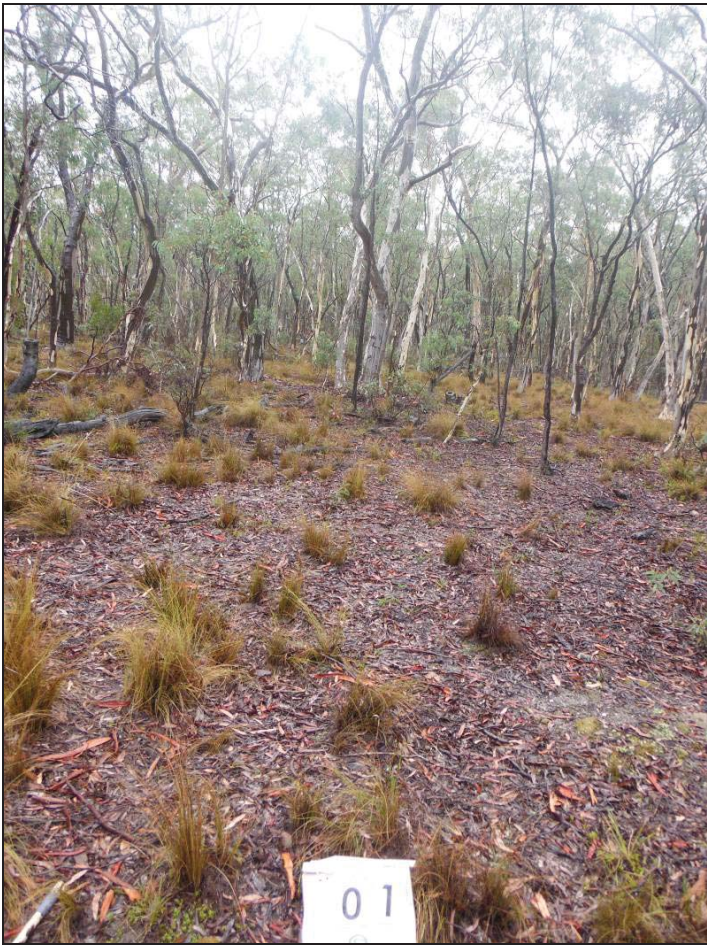
Plate 2 – Profile (Site 1)	Plate 3 – Landscape (Site 1)
ASC Name	Yellow Kurosol
Representative Site	Site 1
Dominant Slope Association	Gently inclined (5-10%)
Land Use	State Forest
Soil Fertility	Moderately low
BSAL	No

Horizon	Depth (m)	Description		
A1	0.00 – 0.10	Very dark greyish-brown (10YR 3/2) loamy sand with weak structure of 1-2 mm subangular blocky peds and a very weak consistence. Very strongly acidic (pH 5.0); nil mottling; 30-50% <2mm stone content, abundant fine roots and well drained. Clear and even boundary.		
B1	0.20 – 0.30	Yellowish-brown (10 YR 5/4) sandy clay loam, moderate structure grade of 2-5 mm subangular blocky peds and a weak consistence. Very strongly acidic (pH 5.0); five percent (5%) yellowish-red (7.5 YR 6/8) mottles, 30% <2 mm stone content; many fine roots and moderately well drained. Even and gradual boundary.		
B2	0.30 – 0.60	Brownish-yellow (10 YR 6/6) light clay, moderate structure grade of 2-5 mm subangular blocky peds and a moderate consistence. Very strongly acidic (pH 5.0); thirty percent (30%) yellowish-red (7.5 YR 6/8) mottles; 30% 2 mm stone content; common fine roots and poorly drained. Abrupt and wavy boundary.

Further, Soil Type 1 failed the physical criteria of depth to bedrock (criteria 8) and internal drainage (criteria 9) as the soil profile encountered a weathering zone at 0.6 m and the subsoil was poorly drained. It also failed the pH criteria (criteria 10) and the chemical barrier criteria (criteria 12) as the topsoil horizon (A1) exhibited pH values of less than pH 5.0.

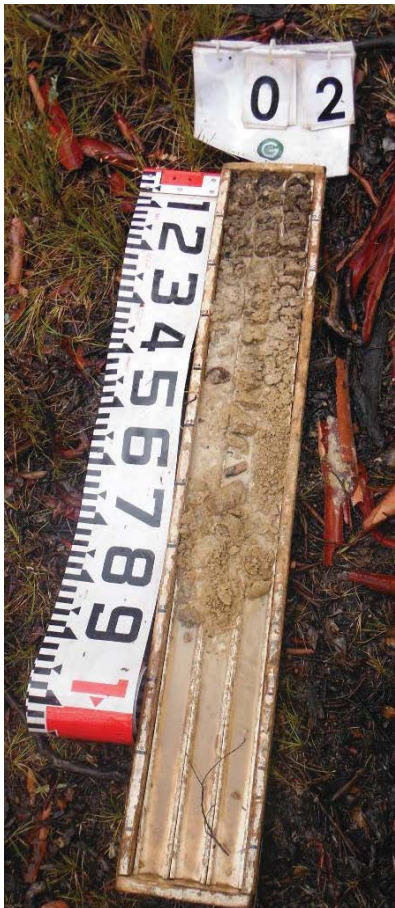
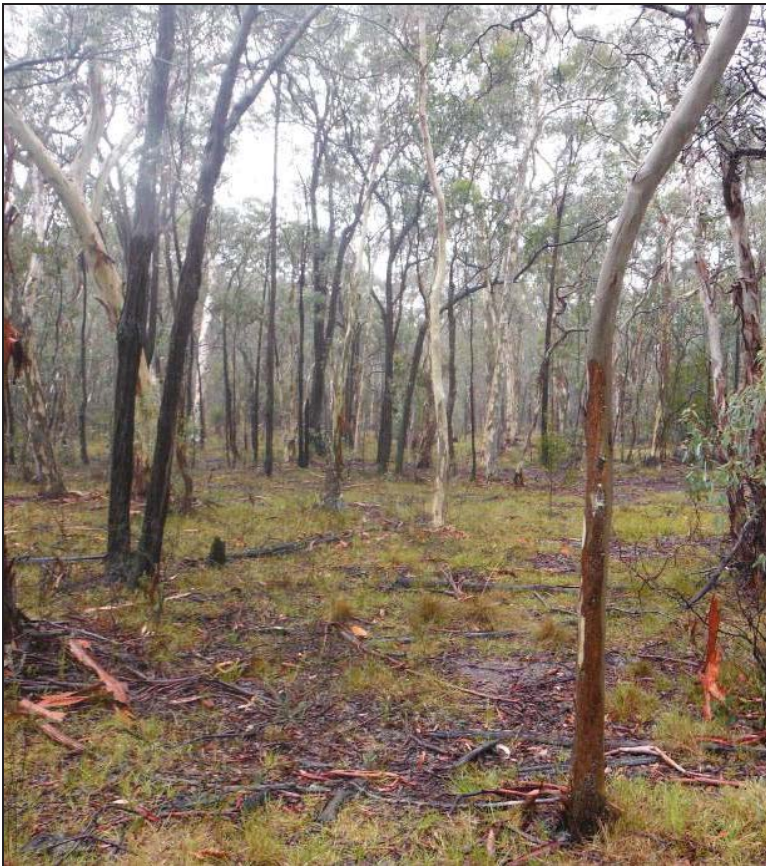
Plate 4 – Profile (Site 2)	Plate 5 – Landscape (Site 2)
ASC Name	Brown Kurosol
Representative Site	2
Dominant Slope Association	Gently inclined (3-10%)
Land Use	State Forest
Soil Fertility	Moderately low
BSAL	No

Horizon	Depth (m)	Description		
A1	0.00 – 0.20	Dark grey brown (2.5 Y 4/2) clay loam with moderately strong structure of 5-10 mm subangular blocky peds and a moderate consistence. Very strongly acidic (pH 5.0); nil mottling; 5-10% <2 mm stone content, abundant fine roots and well drained. Clear and even boundary.		
B1	0.20 – 0.40	Brown (10 YR 5/3) light clay, moderate structure grade of 10-20 mm subangular blocky peds and a moderate consistence. Very strongly acidic (pH 5.0); nil mottling; 10 – 20% <2mm stone content; many fine roots and well drained. Gradual and even boundary.		
B2	0.40 – 0.60	Brown (10 YR 5/3) medium clay, weak structure grade of 2-5 mm subangular blocky peds and a weak consistence. Very strongly acidic (pH 5.0); thirty percent (30%) yellowish-brown (2.5Y 6/3) mottles; 20-30% 2 -10 mm stone content; few to nil roots and imperfectly drained.		
C	0.60+	Weathering bedrock; sandstone

Soil Type 2 failed the physical criteria of depth to bedrock (criteria 8) with bedrock encountered at 0.6 m. Soil Type 3 failed the internal drainage (criteria 9) as the subsoil was very poorly drained.

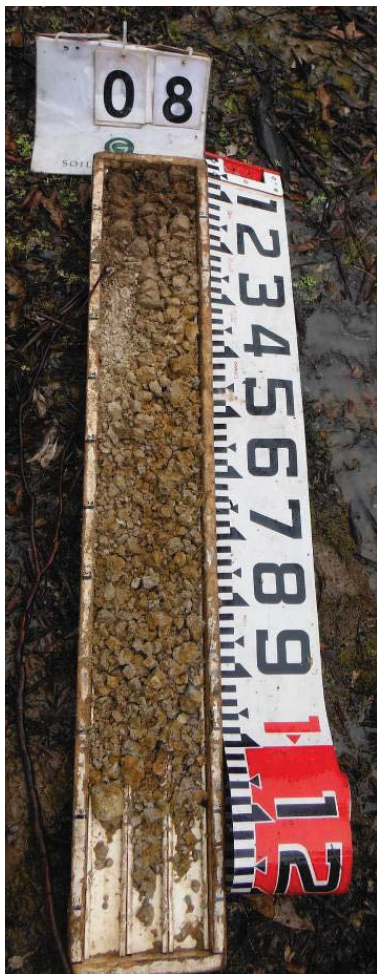
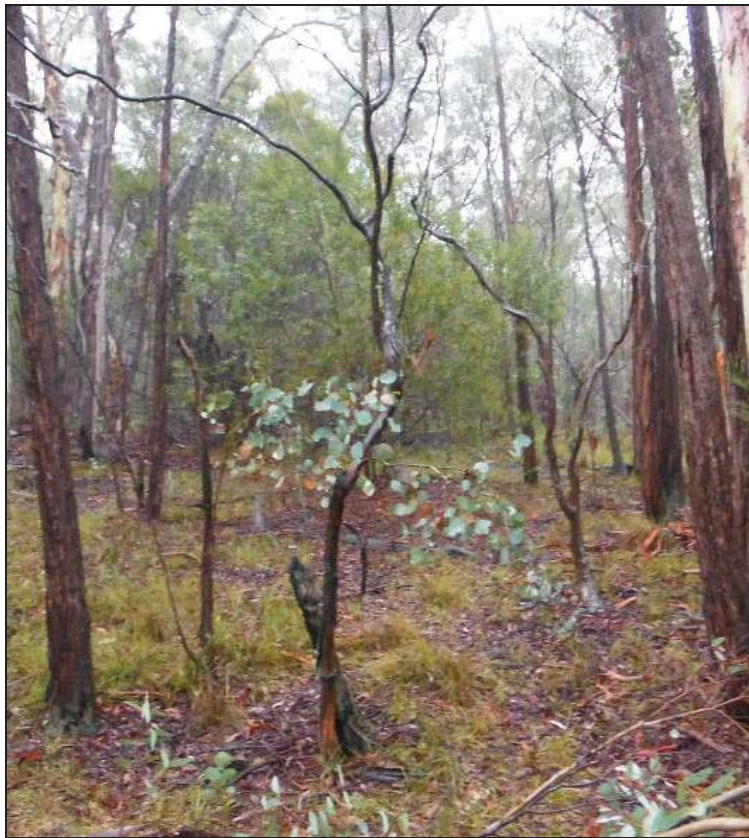
Plate 6 – Profile (Site 8)	Plate 7 – Landscape (Site 8)
ASC Name	Grey Kurosol
Representative Site	8
Dominant Slope Association	Gently inclined (5-10%)
Land Use	State Forest
Soil Fertility	Moderately low
BSAL	No

Horizon	Depth (m)	Description		
A1	0.0 – 0.15	Very dark greyish-brown (10 YR 3/2) clay loam with strong structure of 10-20 mm subangular blocky peds and a moderate consistence. Very strongly acidic (pH 5.0); nil mottling; nil stone content, abundant fine roots and well drained. Clear and abrupt boundary.		
B1	0.15 – 0.40	Grey-brown (10 YR 5/2) light clay, moderate structure grade of 5-10 mm subangular blocky peds and a moderate consistence. Very strongly acidic (pH 5.0); ten percent (10%) brownish yellow (10 YR 6/8) mottles; nil stone content; common roots and moderately well drained.		
B21	0.40 – 0.60	Light brownish grey (10 YR 6/2) medium clay with moderate structure grade of 2-5 mm subangular blocky peds and a moderate consistence. Very strongly acidic (pH 5.0); thirty percent (30%) brownish-yellow (10 YR 6/8) mottles; nil stone content; common roots and imperfectly drained.		
B22	0.40 – 1.00	Light grey (10 YR 7/1) medium clay with moderate structure grade of 2-5 mm subangular blocky peds and a moderate consistence. Very strongly acidic (pH 5.0); fifty percent (50%) brownish-yellow (10 YR 6/8) mottles; nil stone content; few roots and poorly drained.
