**LIDDELL COAL MINE**

**Liddell Coal Operations Pty Limited**

March 2018

## **APPLICATION FOR A SITE VERIFICATION CERTIFICATE**

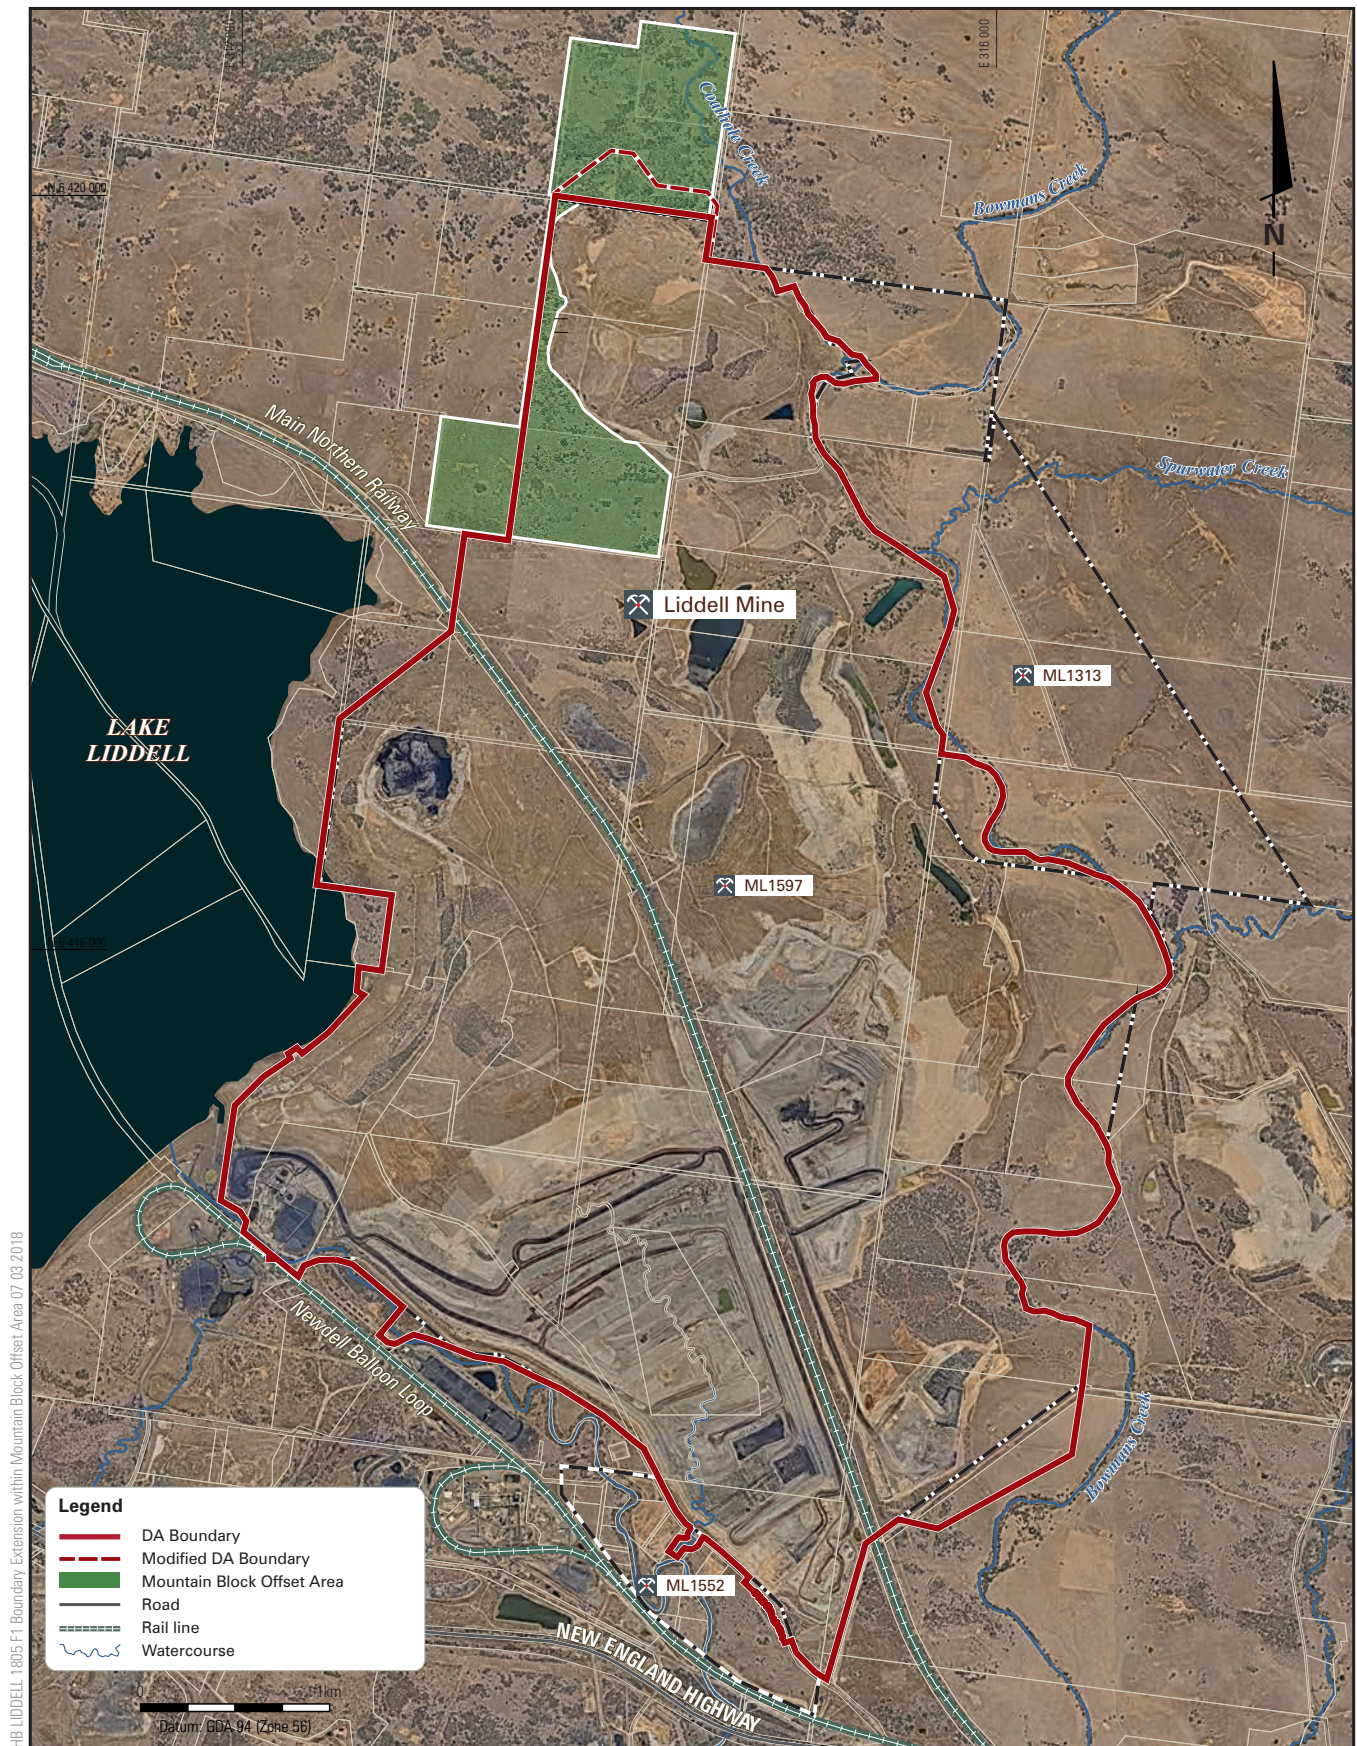
**FIGURE 1**

Boundary Extension within Mountain Block Offset Area

The Modification seeks to amend some administrative conditions of the DA 305-11-01 to facilitate operational efficiencies whilst providing the flexibility required for the development of a cost effective and practical environmental outcome for the final landform leading into the final years of mining operations at Liddell. Specifically, and the subject of the Site Verification application, the Modification requires a minor adjustment of the DA Boundary to which DA 305-11-01 applies. The extension of the DA Boundary to the north is required to include an approximate 14.64 hectare (ha) portion of the Mountain Block Offset to facilitate required remediation works. The proposed boundary extension is shown in **Figure 1**.

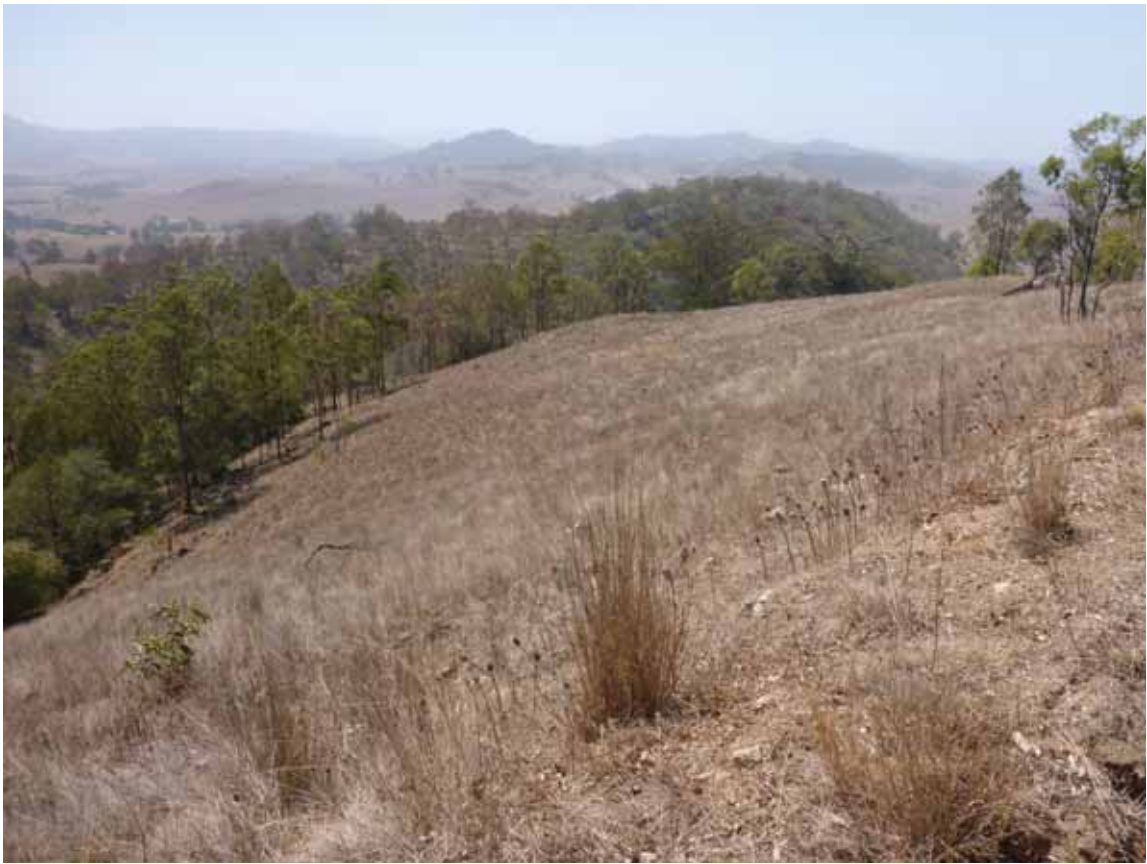
**Table 3 Summary: Eutrophic Brown Kandosol (Site 1)**

| Overview | |
|---|---|
| ASC Name | Eutrophic Brown Kandosol |

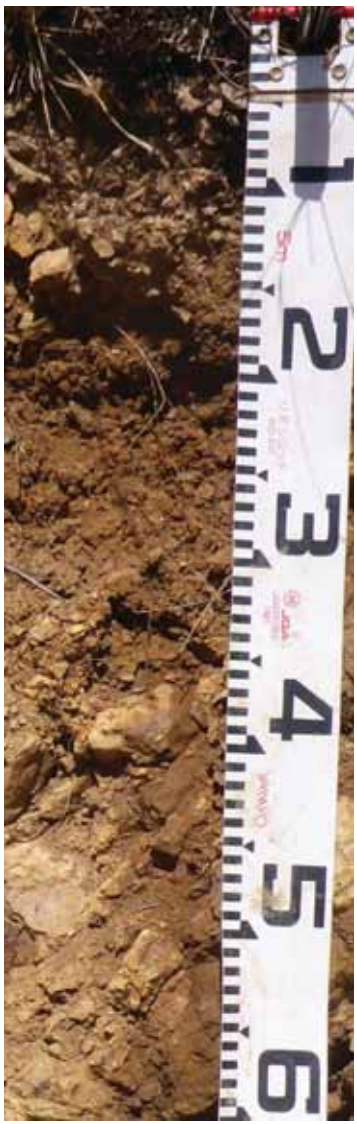
**Table 4 Profile: Eutrophic Brown Kandosol (Site 1)**

| Profile | Horizon / Depth (m) | Description |
|---|---|---|
| | A1<br>0.0 – 0.15 | Very dark greyish brown (10YR 3/2) loam, weakly structured 5-10 mm crumb peds with weak consistence and a rough fabric. Nil mottling, 30% gravel 5-30 mm, abundant fine roots. Well drained with a gradual and even boundary. Sampled 0.0 – 0.10 |
| | B2<br>0.15 – 0.40 | Dark yellowish brown (10YR 3/6) light-medium clay, weakly structured 5-20 mm blocky peds with a weak consistence and a rough fabric. Nil mottling, 15% gravel 5-50 mm, coarse roots common. Well drained with a clear and even boundary. Sampled 0.20 – 0.30 and 0.30 – 0.40 |
| | BC<br>+0.40 | Rock and weathered parent material. Not sampled |

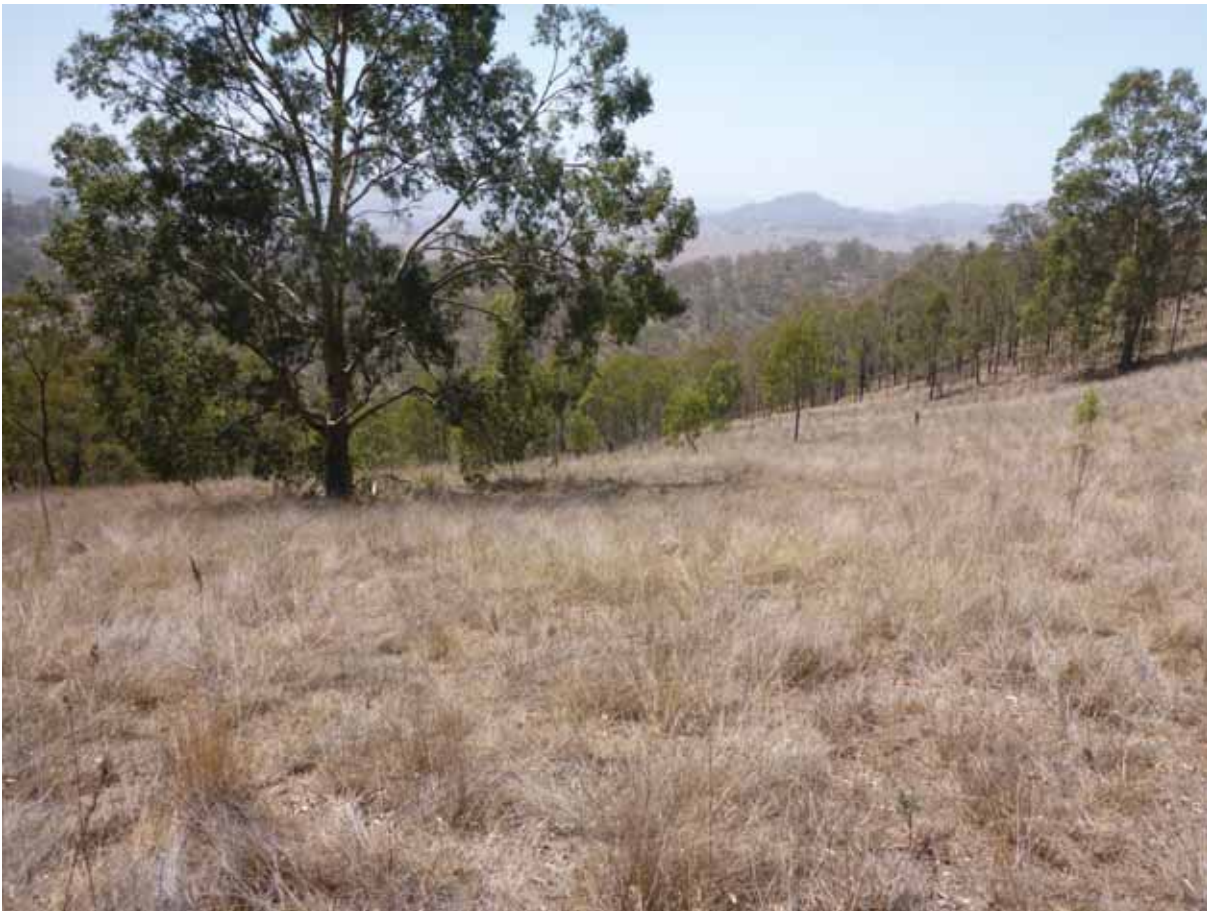
**Table 6 Summary: Eutrophic Brown Chromosol (Site 2)**

| Overview | |
|---|---|
| ASC Name | Eutrophic Brown Chromosol |

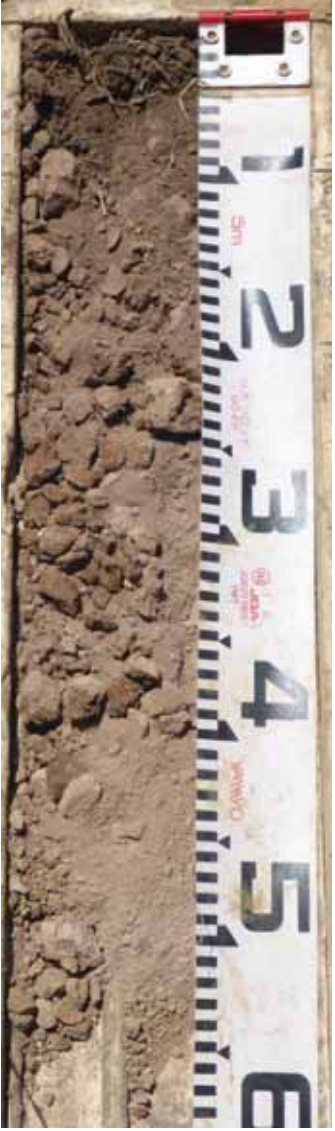
**Table 7 Profile: Eutrophic Brown Chromosol (Site 2)**

| Profile | Horizon / Depth (m) | Description |
|---|---|---|
| | A1<br>0.0 – 0.15 | Dark reddish-brown (5YR 2.5/2) loamy sand, weakly structured 5-10 mm crumb peds with weak consistence and a rough fabric.<br>Nil mottling, 20% gravel 5-25 mm, abundant fine roots. Well drained with a clear and even boundary. Sampled 0.0 – 0.10 |
| | B2<br>0.15 – 0.50 | Dark brown (7.5YR 3/4) clay loam, moderately structured 10-30 mm blocky peds with moderate consistence and a rough fabric. Nil mottling, 20% gravel 10-25 mm, coarse roots common. Well drained with clear and even boundary. Sampled 0.20 – 0.30 and 0.30 – 0.40 |
| | BC<br>+0.50 | Weathered parent material. Not sampled |

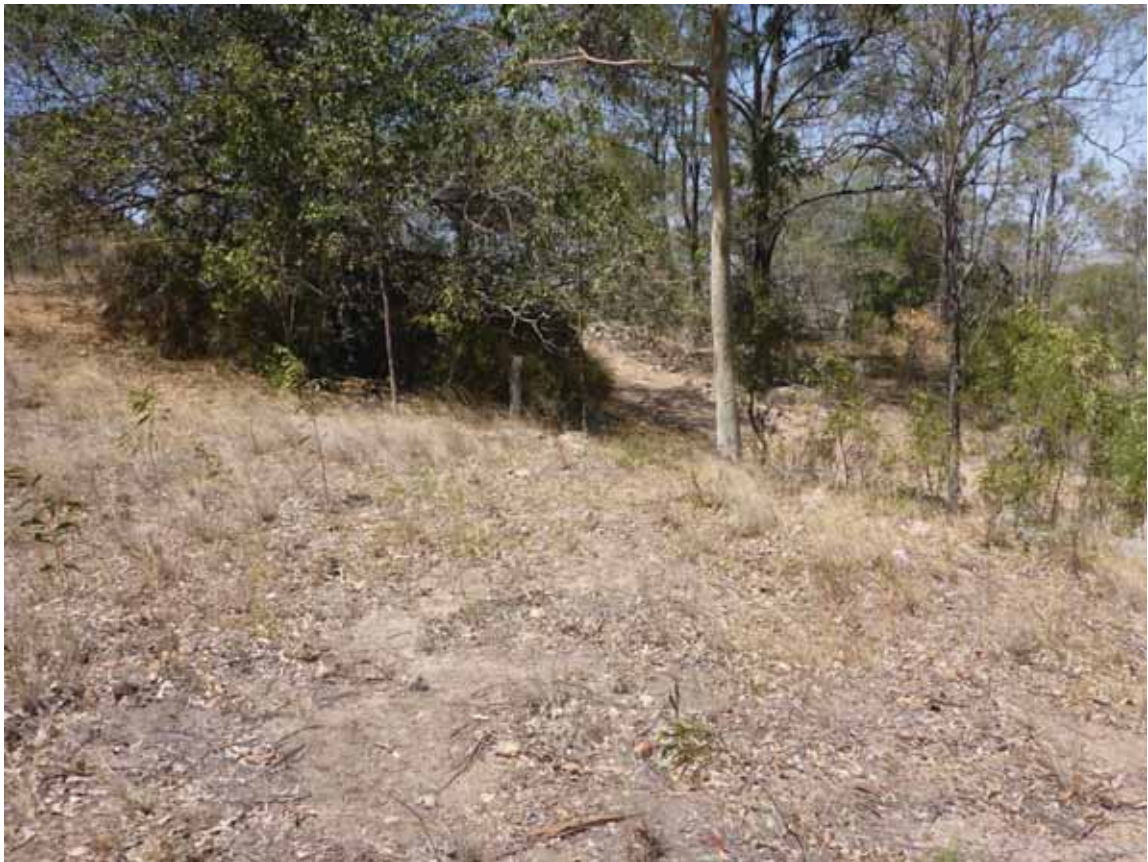
**Table 9 Summary: Black-Orthic Paralithic Tenosol (Site 3)**

| Overview | |
|---|---|
| <b>ASC Name</b> | Black-Orthic Paralithic Tenosol |

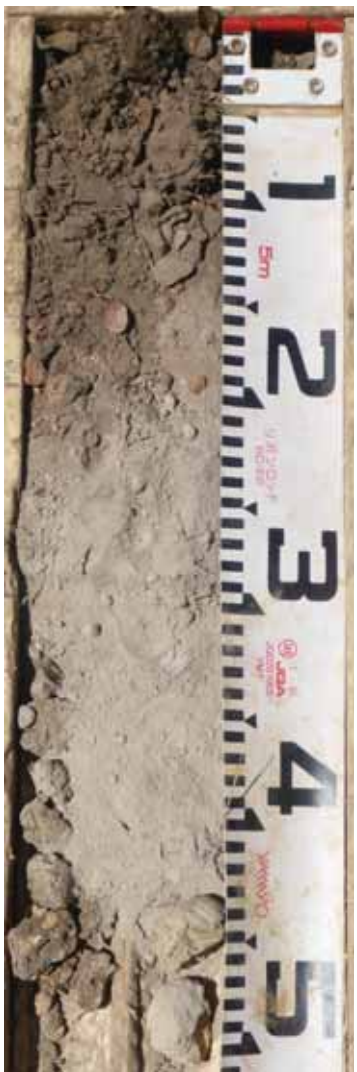
**Table 10 Profile: Black-Orthic Paralithic Tenosol (Site 3)**

| Profile | Horizon / Depth (m) | Description |
|---|---|---|
| | A1<br>0.0 – 0.15 | Very dark brown (10YR 2/2) loamy sand, weakly structured 5-10 mm crumb peds with weak consistence and a rough fabric. Nil mottling, 10% gravel 5-10 mm, abundant fine roots. Well drained with a clear and wavy boundary. Sampled 0.0 – 0.10 |
| | B2<br>0.15 – 0.45 | Dark brown (7.5YR 3/2) loam, apedal with a sandy fabric. Nil mottling, 10% gravel 5-20 mm, coarse roots common. Well drained with a clear and wavy boundary Sampled 0.20 – 0.30 and 0.30 – 0.40 |
| | BC<br>+0.45 | Weathered parent material. Not sampled |

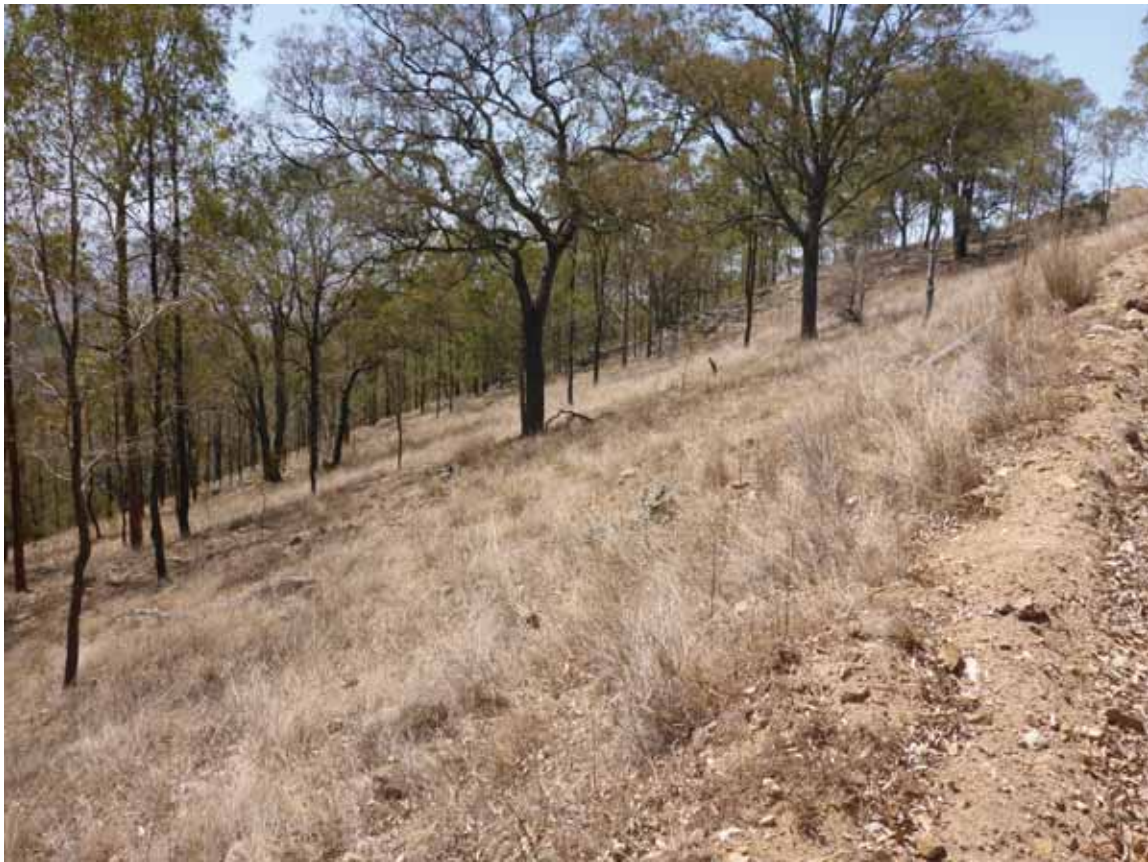
**Table 12 Summary: Brown Kandosol (Site 4)**

| Overview | |
|---|---|
| ASC Name | Brown Kandosol |

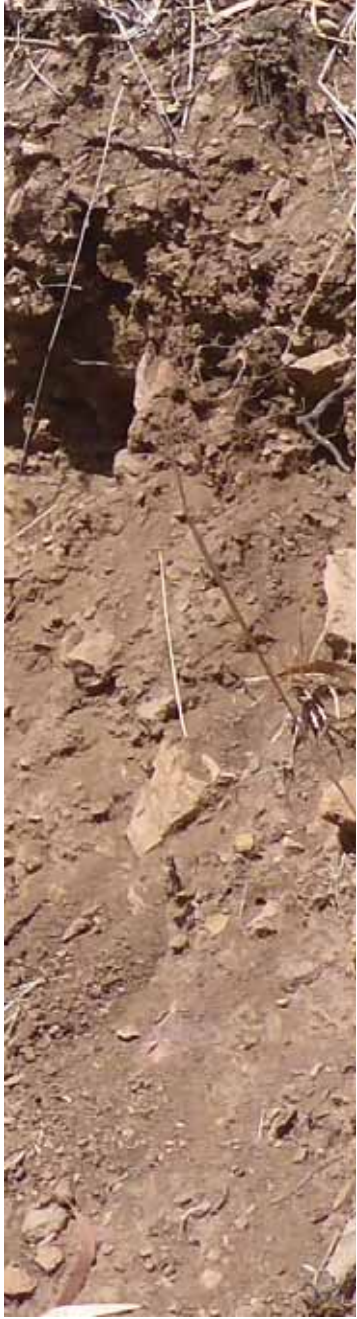
**Table 13 Profile: Brown Kandosol (Site 4)**

| Profile | Horizon / Depth (m) | Description |
|---|---|---|
| | A1<br>0.0 – 0.15 | Brown (10YR 4/3) loam, weakly structured 2-5 mm crumb peds with weak consistence and a rough fabric.<br>Nil mottling, 20% gravel 5-30 mm, abundant fine roots. Well drained with a gradual and even boundary. Sampled 0.0 – 0.10 |
| | B2<br>0.15 – 0.30 | Dark yellowish brown (10YR 3/4) light clay, weakly structured 5-10 mm blocky peds with a weak consistence and a rough fabric.<br>Nil mottling, 25% gravel 5-50 mm, coarse roots common. Well drained with a clear and even boundary. Sampled 0.20 – 0.30 |
| | BC<br>+0.30 | Weathered parent material. Not sampled |
