HUNTER VALLEY OPERATIONS

2019 Annual Environmental Review

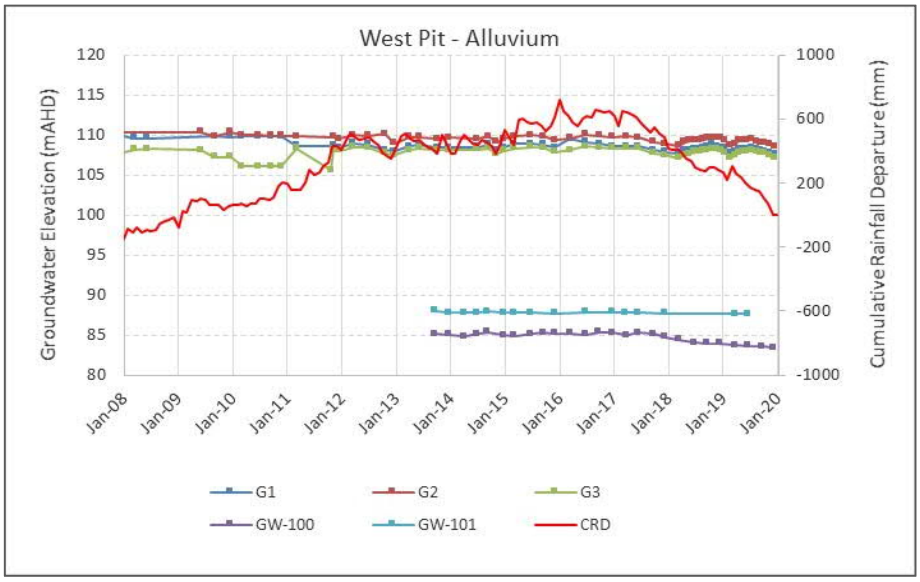
Figure 5-1 Hydrograph of Alluvial Bores – West Pit

Time series groundwater levels for the five alluvial/regolith bores north and north-west of West Pit are presented in Figure 5-1. Over 2019 groundwater elevations within the three bores (G1, G2 and G3) on the south-western side of Parnell's Creek Dam (18W) ranged between 107.12 mAHD and 109.52 mAHD (2.42 m and 0.46 m depth). Groundwater levels decreased slightly over 2019, consistent with rainfall trends.

Bores GW-100 and GW-101 are located along Parnell's Creek, downslope of the dam (18W). Comparison between groundwater levels and screened depths indicates the bores are likely dry and readings may relate to water within the sump at the base of the bore. Review of the bore construction log indicates GW-100 extends to 6 m depth and has screen from 4 m to 6 m within gravels (colluvial deposit). Bore GW-101 extends to 12 m depth and has a screen from 9 m to 12 m depth within clay. Groundwater levels within bore GW-100 show a general decline since 2017 from 4.2 m below top of casing (TOC) to 6.2 mTOC near the base of the bore. This decline in groundwater levels appears to correspond with a general declining trend in CRD since 2017 and is likely related to reduced rainfall recharge. Bore GW-101 has recorded groundwater levels over 12 mTOC and noted as dry or having insufficient water to sample since 2013. This may relate to the construction of the bore screen across low permeability clay.

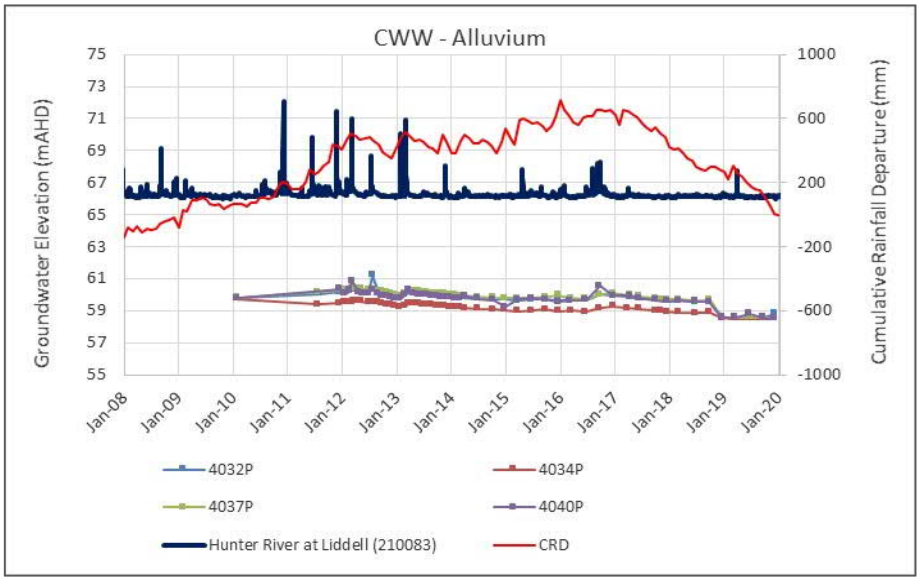
Figure 5-2 Hydrograph of Alluvial Bores – Carrington (Western Limb)

Time series groundwater levels for bores within the alluvium on the western limb of the paleochannel near Carrington and Carrington West Wing are shown in Figure 5-2. Over 2019 groundwater elevations within the four bores (4032P, 4034P, 4037P and 4040P) in this area ranged between 58.79 mAHD and 59.77 mAHD (10.36 m and 12.67 m depth). Groundwater levels declined in three of the bores by 0.02 m up to 0.05 m over 2019, which appears to correlate with climate and stream flow trends. The groundwater level of 4032P increased by 0.28 m over 2019. The cause for this trend is unclear as no other bores recorded this rise and there are no known changes in land use near the bore. The bore is located outside of the mine area on land used for cattle grazing and is located near a small stand of trees. It is recommended that the condition of the bore and local land use be reviewed to determine the cause of the increase.

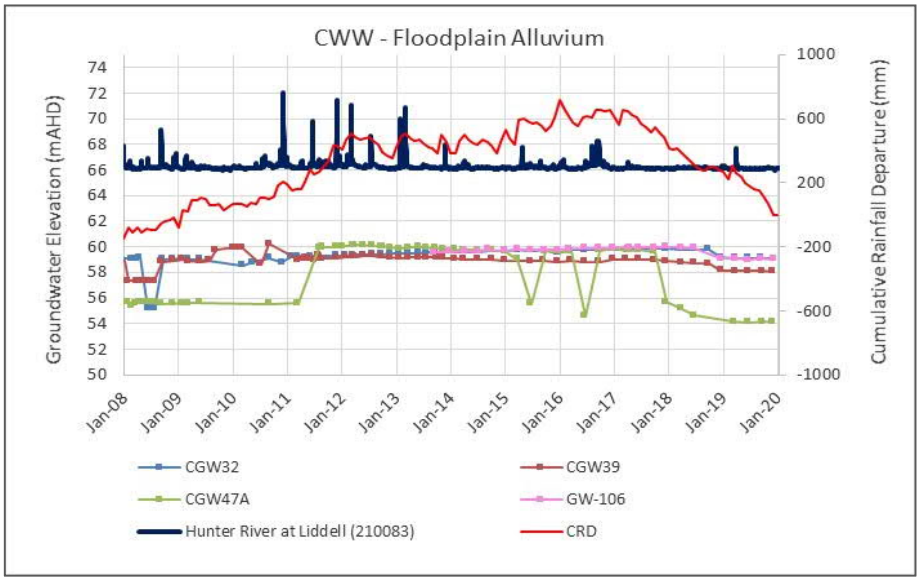
Figure 5-3 Hydrograph of Floodplain Alluvial Bores – Carrington (Western Limb)

Time series groundwater levels for bores within the floodplain alluvium on the northern end of the paleochannel (CGW32 and GW-106) and the two bores on the western limb of the paleochannel (CGW39 and CGW47a) near Carrington and Carrington West Wing are shown in Figure 5-3. Over 2019 groundwater elevations within the four bores in this area ranged between 54.55 mAHD and 59.88 mAHD (12.18 m and 23.30 m depth). However, bore CGW47a was recorded as dry throughout 2019. Groundwater levels declined by 0.05 m within the bores over 2019, which appears to correlate with climate and stream flow trends and may also relate to localised drawdown towards the Carrington Pit final void.

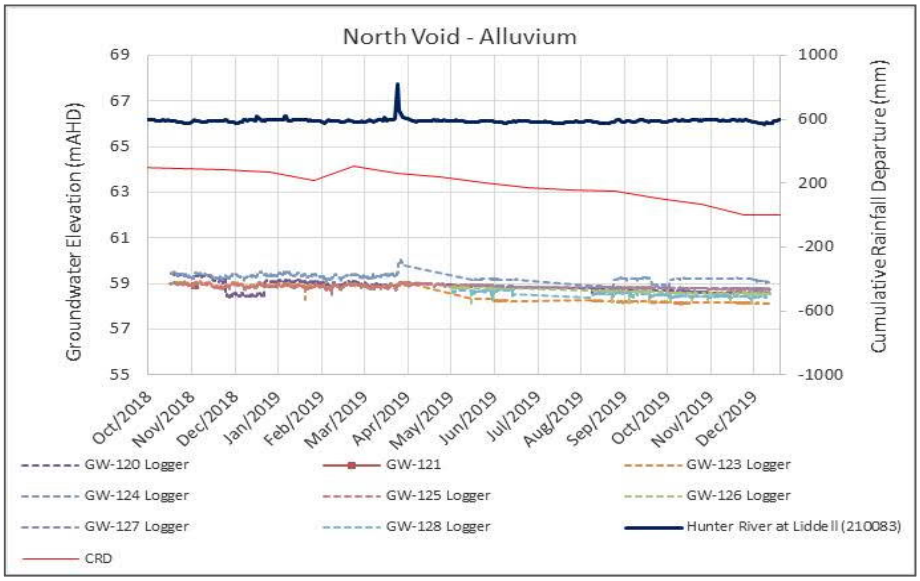
Figure 5-10 Hydrograph of Alluvial Bores – Carrington/North Void

Time series groundwater levels for the newly installed bores within the alluvium along the western edge of the North Void and south of Carrington Pit are shown in Figure 5-10. Monitoring began in the eight bores in October 2018. Over 2019 groundwater elevations within the eight alluvium bores in this area ranged between 58.44 mAHD and 58.91 mAHD (10.21 m and 12.30 m depth). Bore GW-121 was recorded as dry throughout 2019. Groundwater levels declined by 0.04 m to 0.12 within the bores over 2019. The purpose of the monitoring is to ensure no additional seepage into the alluvium at this location. The observed decline in groundwater levels over 2019 indicates a decline in seepage and corresponds with a general trend of below average rainfall.

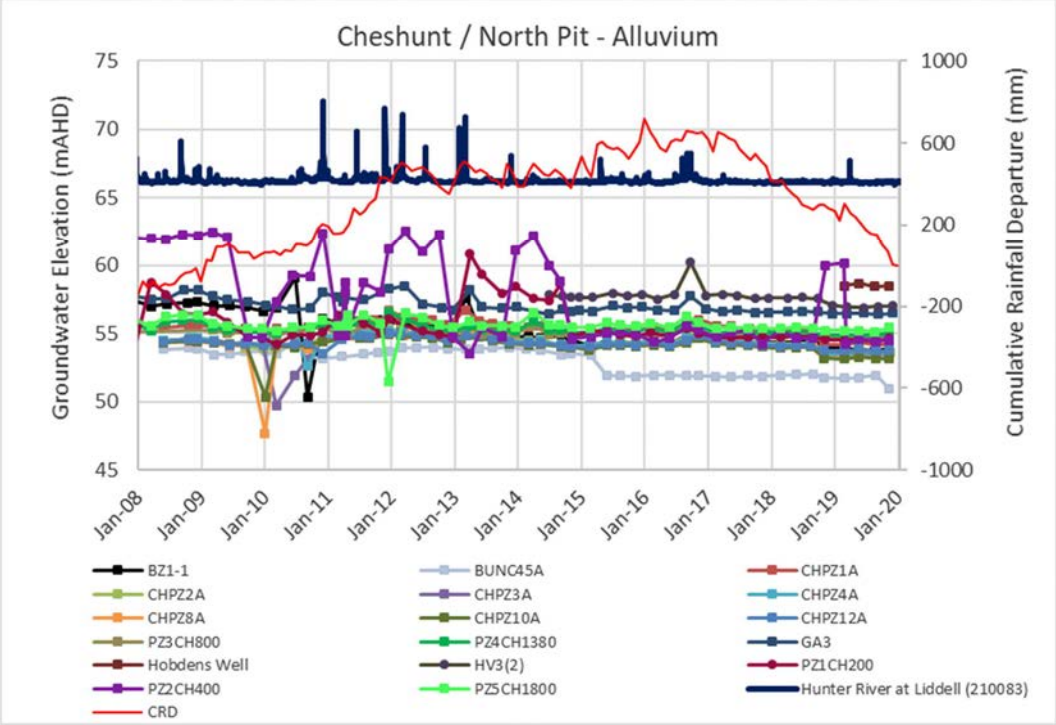
Figure 5-11 Hydrograph of Alluvial Bores – Cheshunt/North Pit

Time series groundwater levels for bores within the alluvium north and south of the Hunter River, between North Pit and Cheshunt Pit are shown in Figure 5-11. Two bores (CHPZ8A and BUNC45A) recorded groundwater levels at or below the base of the screen and are believed to be dry. Bore BZ1-1 was recorded as dry in Q2 and bore CHPZ2A was recorded as blocked in Q2. Where the alluvium is saturated, groundwater levels ranged between 53.94 mAHD and 60.27 mAHD (2.36 m and 17.68 m depth). With the exception of PZ2CH400, groundwater levels generally stable and increased slightly by up to 0.24 m within the alluvial bores over 2019.

Over 2019 groundwater levels in PZ2CH400 ranged from 2.36 m (60.27 mAHD) in Q1 to 8.02 m (54.61 mAHD) in Q4, but remained higher than upstream bore PZ3CH800, by 5.24 m by the end of the year. Bore PZ2CH400 is located immediately east of the North Pit barrier wall and around 180 m east of spoil bore 4119P. Bore 4119P recorded spoil water elevations between 53.56 mAHD and 53.85 mAHD over 2019, lower than alluvial levels at bore PZ2CH400. It was recommended that the bore construction and condition be reviewed in the 2018 Annual Review. It is noted that this is planned to be undertaken during 2020.

It is also noted that bore BZ1-1 is included in the WMP as being within the alluvium, however as identified in prior annual reviews (AGE, 2013a) the bore likely intersects interburden material. It is recommended that this bore be updated in the WMP as intersecting interburden.

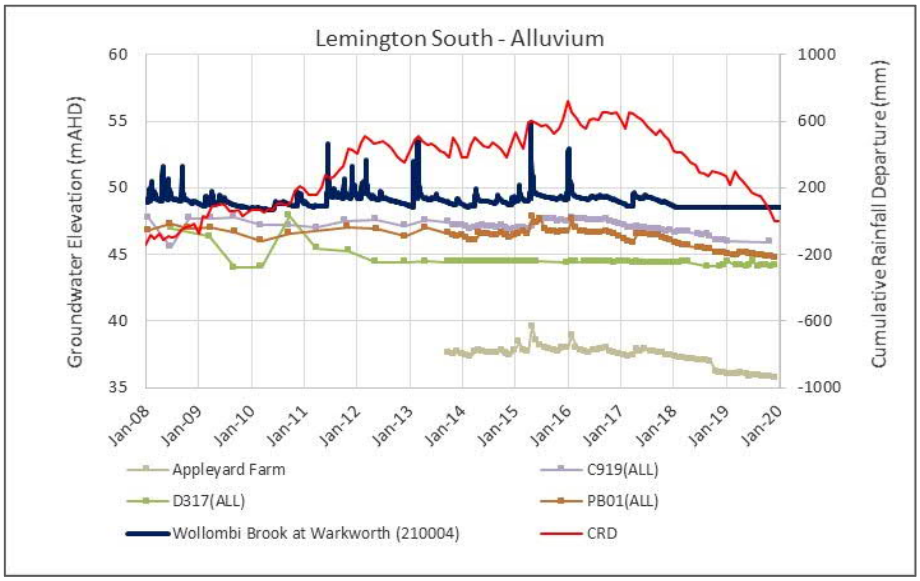
Figure 5-12 Hydrograph of Alluvial Bores – Lemington South

Time series groundwater levels for four bores within the alluvium at Lemington South, along the Wollombi Brook, are shown in Figure 5-12. As shown in Figure 5-12, groundwater levels fairly stable throughout 2019 with the a decline in groundwater levels of 0.36 m recorded within Appleyard Farm bore, which is located over 1.2 km upstream of Lemington South Pit and within 50 m of Wollombi Brook. Stream gauge Wollombi Brook at Warkworth is located approximately 350 m upstream of the bore. The groundwater level trends show a close correlation with declining stream flow levels and discharge for Wollombi Brook, with no discharge recorded since 2017.

Bore PB01(ALL) is located approximately 150 m from Wollombi Brook and shows a more muted response to stream flow with a decline in groundwater levels of 0.26 m. Bore C919(ALL) was recorded as dry in Q2, Q3 and Q4 of 2019. Bore D317(ALL) is located adjacent to the Lemington South Pit, approximately 190 m from Wollombi Brook.

Over 2019 groundwater elevations within the alluvial bores Appleyard Farm and PB01(ALL) ranged between 36.48 mAHD and 45.35 mAHD. Groundwater levels remained fairly stable over 2019, but showed a decline of up to 0.36 m in line with stream flow and rainfall.

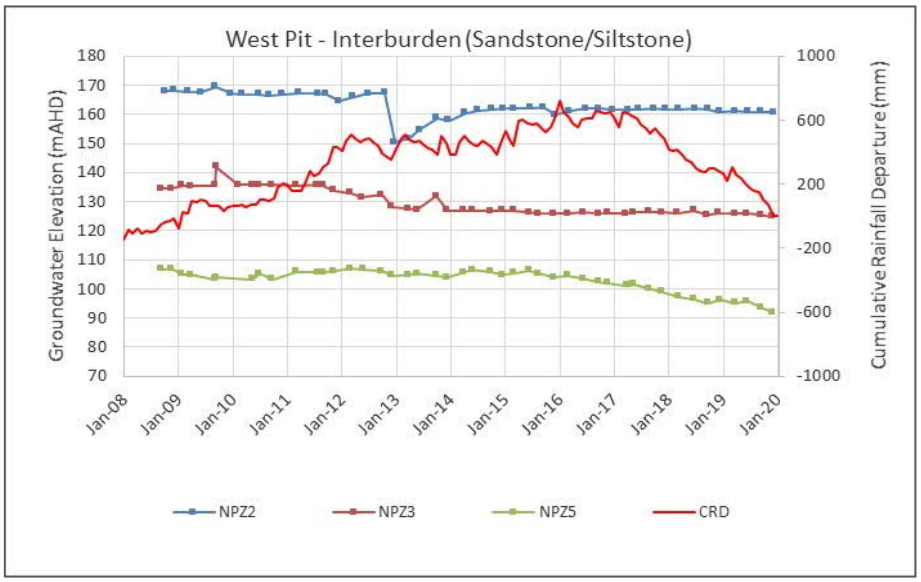
Figure 5-13 Hydrograph of Permian Coal Measures Bores – West Pit Bores

Bore NPz5 is located down-slope (south) of the West Pit highwall and recorded a 3.28 m decline in groundwater levels over 2019. This decline is likely a response to mining at West Pit, and consistent with groundwater drawdown predictions for the approved operations (see Section 2.2). With the removal of bores NPZ4 and NPZ5, ongoing monitoring of groundwater trends in the coal measures can be captured at VWP GW-103 to GW-105.

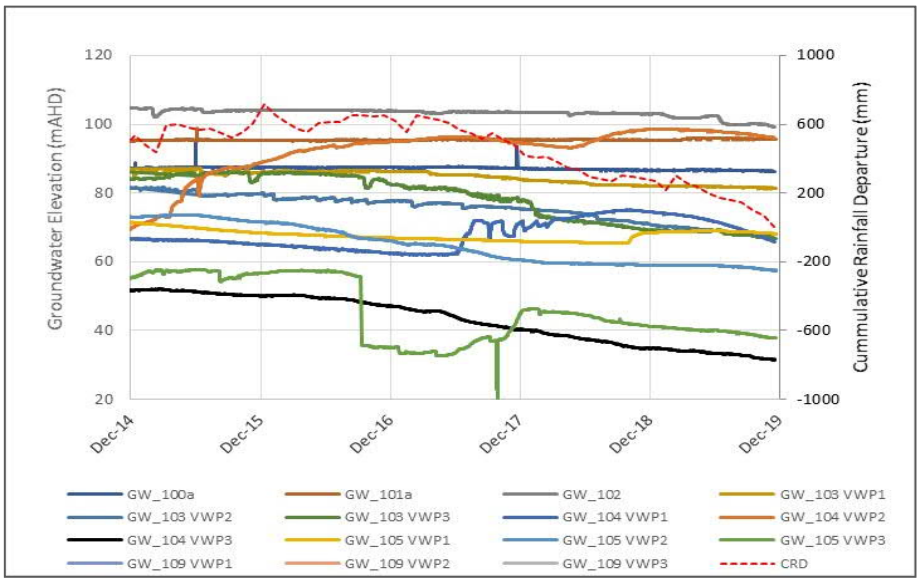
Figure 5-14 Hydrograph of Permian Coal Measures Bores – West Pit VWPs

VWP GW-103, VWP GW-104 and VWP GW-105 are located south of West Pit. GW-103 recorded relatively stable levels, while GW-105 shows a gradual decline in levels over time. GW-104 VWP1 (Lower Pikes Gully Seam), VWP2 (interburden material) and VWP3 (in sandstone above the Barrett Seam) all declined over time due to depressurisation from coal mining at West Pit.

VWP GW-109 is located within the west of the Carrington Pit and the sensor within weathered coal (GW-109 VWP1) recorded a slight rise in water levels over 2019, while the deeper sensor within tuffaceous coal (GW-109 VWP2) recorded a relatively stable groundwater levels at a lower elevation. The difference in the two sensors may relate to instrument drift or an additional source of recharge to the shallow stratigraphy. The area generally experienced below average rainfall and no water storage is known of at the site or upgradient of the VWP. Groundwater levels within the spoil in Carrington Pit 1.3 km to the north are also lower at around 24 mAHD (GW-109) and predicted to remain low due to the presence of the Carrington Pit void (AGE, 2016). It is recommended that local site conditions and the condition of the VWP GW-109 be reviewed, and groundwater conditions within the spoil in Carrington Pit continue to be monitored.

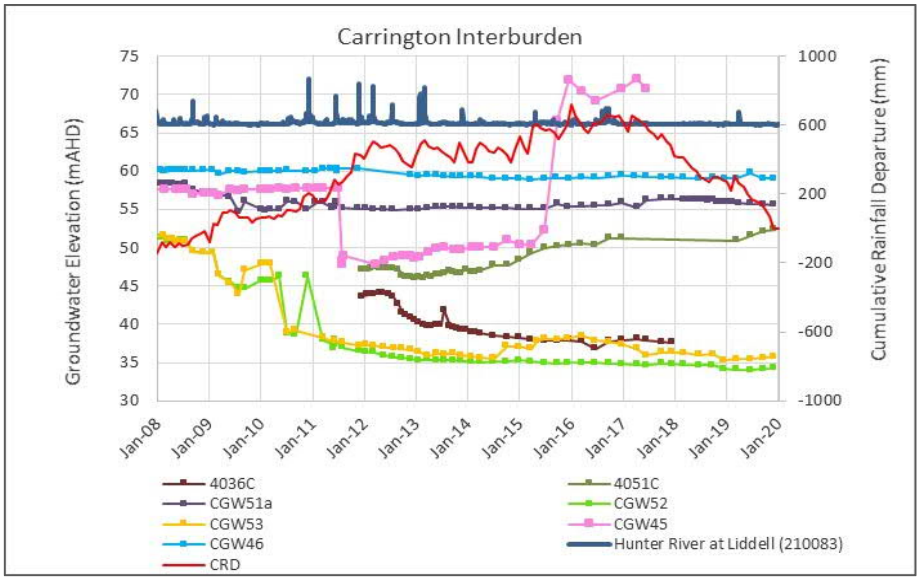
Figure 5-15 Hydrograph of Permian Coal Measures Bores – Carrington

Bore 4051C is located in the western limb of the paleochannel, screened within interburden. Groundwater levels in bore 4051C increased by 1.42 m over 2019. Nearby, bore 4040P, screened in alluvium, remained stable over 2019. Previous records indicated an obstruction within bore 4051C, it is recommended that the total depth of the bore be checked and a downhole camera survey conducted to verify if 4051C is providing representative groundwater data.

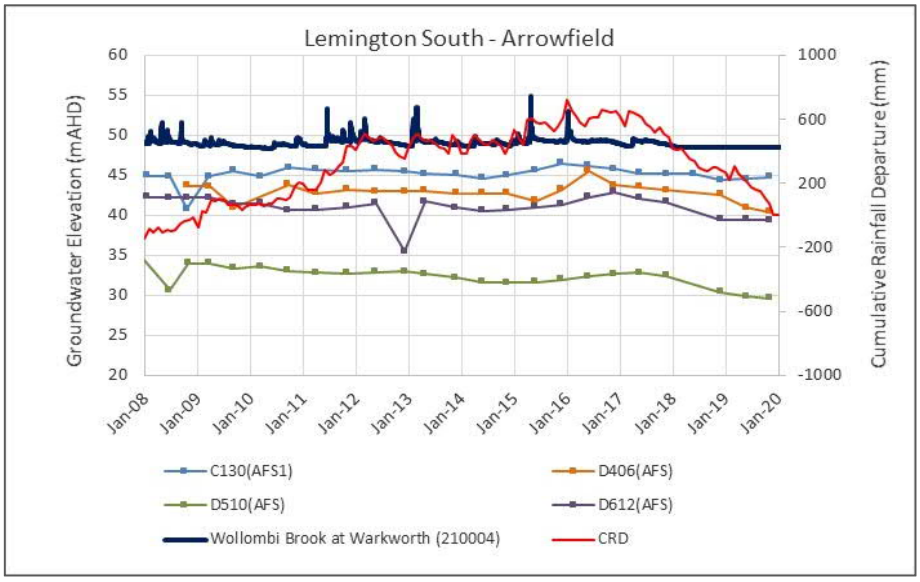
Figure 5-19 Hydrograph of Arrowfield Seam – Lemington South

Time series data for bores targeting the Arrowfield Seam are presented in Figure 5-19. As shown in Figure 5-19, two of the Arrowfield Seam bores recorded declining groundwater levels over 2019, consistent with climate trends. Bores D406(AFS) and D510(AFS) declined by up to 0.58 m during 2019. Bores D612(AFS) and C130(AFS1) remained stable over 2019. Groundwater levels in bores C130(AFS1) and D406(AFS) both remained stable over 2019.

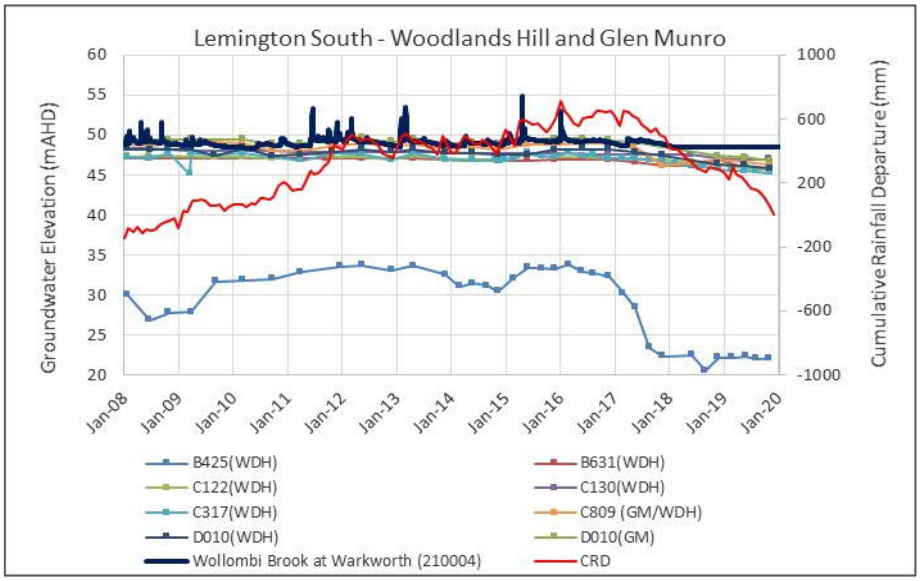
Figure 5-20 Hydrograph of Woodlands Hill Seam and Glen Munro Seam – Lemington South

Time series data for bores targeting the shallow interburden, Woodlands Hill Seam and Glen Munro Seam are presented in Figure 5-20. As shown in Figure 5-20 groundwater elevations for all bores except B425(WDH) ranged between 45.51 mAHD and 47.60 mAHD (8.73 m and 26.21 m depth). Over 2019 the groundwater levels declined between 0.02 m (C130(WDH)) and 0.46 m (D010(GM)). Following the decline of groundwater levels in bore B425(WDH) during 2017, the bore was recorded as dry throughout 2018 and 2019. These elevations and trends correspond more closely with trends observed for the Bowfield Seam bores. Further review of the construction and target lithology of bore B425(WDH) is required. From the network review it was suggested the bore be removed from the monitoring network in favour of ongoing monitoring at nearby bore C130(WDH).

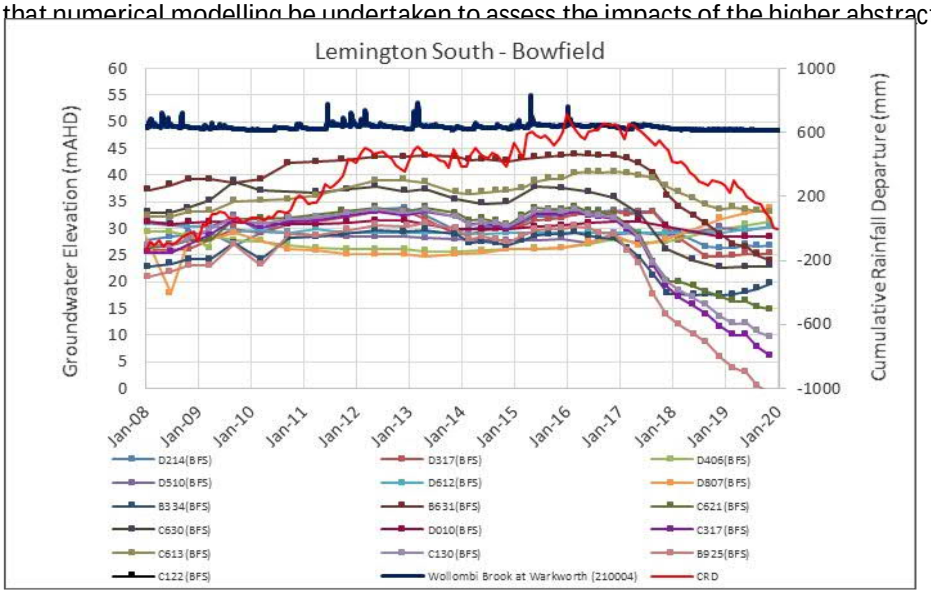
Figure 5-21 Hydrograph of Bowfield Seam – Lemington South

Time series data for bores targeting the Bowfield Seam are presented in Figure 5-21. As shown in Figure 5-21, groundwater elevations ranged between 6.58 mAHD and 34.22 mAHD (24.66 m and 55.66 m depth). Interpolated groundwater elevation contours for the Bowfield Seam are presented in Figure 5-22, based on December 2019 readings. Groundwater levels in bores C630(BFS), D317(BFS), D214(BFS), D010(BFS) and C613(BFS) have remained relatively stable over 2019. All of the bores are located west of Lemington South pit. In comparison, bore D807(BFS) rose by 0.88 m, D612(BFS) rose by 0.42 m, D406(BFS) rose by 0.79 m and B334(BFS) rose by 1.88 m over 2019. With the exception of B334(BFS), all of the bores are north-west of the Lemington South pit, close to Wollombi Brook. B334(BFS) is located south of Lemington South pit. Increasing water level trend likely relates to water level recovery following the cessation of mining in the nearby Glider Pit.

Bore C631(BFS) declined by 3.02 m, C621(BFS) declined by 1.48 m, C130(BFS) declined by 2.50 m, C317(BFS) declined by 3.82 m and B925(BFS) declined by 4.57 m. The bores are located between 300 m (B925(BFS)) and 1.3 km (C621(BFS)) of the LUG bore. The LUG bore intersects the historical Lemington Underground workings, which mined through the Bowfield Seam. Over the 2019 (calendar year) 1,732.5 ML of water was abstracted from the bore, at an average rate of 4,800 m^3/day. The groundwater level drawdown is therefore likely related to abstraction from the bore. This is shown in Figure 5-22, which illustrates groundwater flow towards LUG Bore to the southwest. This trend is visible in a range of bores intersecting the Permian coal measures in the area.

The observed drawdown is consistent with predicted drawdown in the coal measures with abstraction from LUG Bore, as modelled by SLR (2019b). SLR (2019b) utilised the existing numerical groundwater model developed for HVO Modification 5 to predict the change in groundwater levels and sustainable yield from LUG Bore. The model predicted groundwater level drawdown within the Mt Arthur Seam in response to abstraction from the historical Lemington Underground workings by LUG Bore. The abstraction was predicted to induce depressurisation in the coal measures correlating to the observed decline in groundwater levels for bores intersecting the coal measures near Lemington Underground.

Alluvial bore Appleyard Farm is the closest alluvial bore to the LUG Bore. As discussed in Section 5.2.1.4, groundwater trends within the bore reflect rainfall and stream flow trends. The bore shows no clear impacts related to groundwater abstraction from the historical underground mine beyond climate and streamflow changes. However, the abstraction rate from the LUG bore is higher than previously assessed. It is recommended that numerical modelling be undertaken to assess the impacts of the higher abstraction rate from the LUG bore.

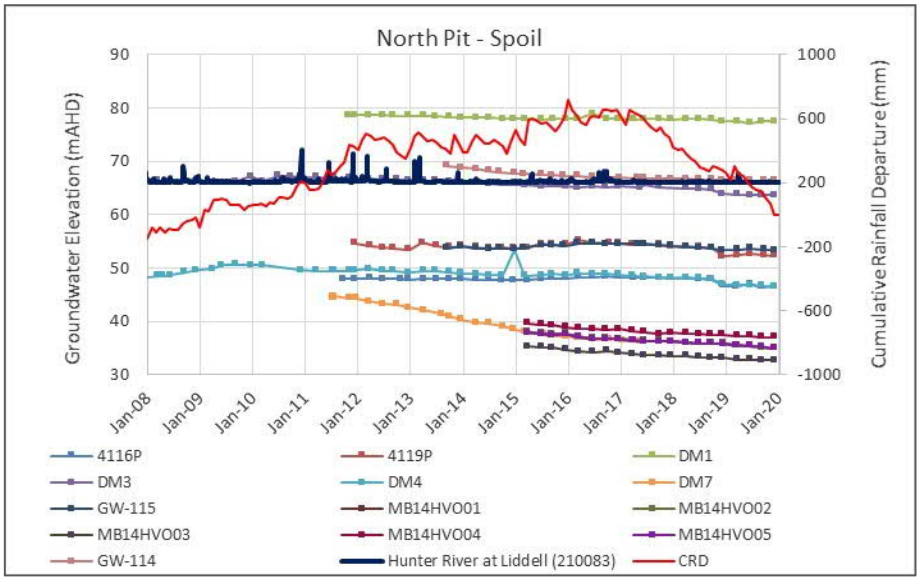
Figure 5-23 Hydrograph of Spoil Bores – North Pit

Time series groundwater levels for the spoil are presented in Figure 5-23. Over 2019 groundwater elevations within the bores ranged between 32.74 mAHD and 77.86 mAHD (10.89 m and 36.68 m depth). Groundwater within the spoil flows from northern-most bore DM1 (77.86 mAHD) in a southerly direction towards the southern-most bore MB14HVO03 (32.74 mAHD). Over the course of 2019 groundwater levels declined by between 0.01 m and 0.82 m, consistent with rainfall trends.

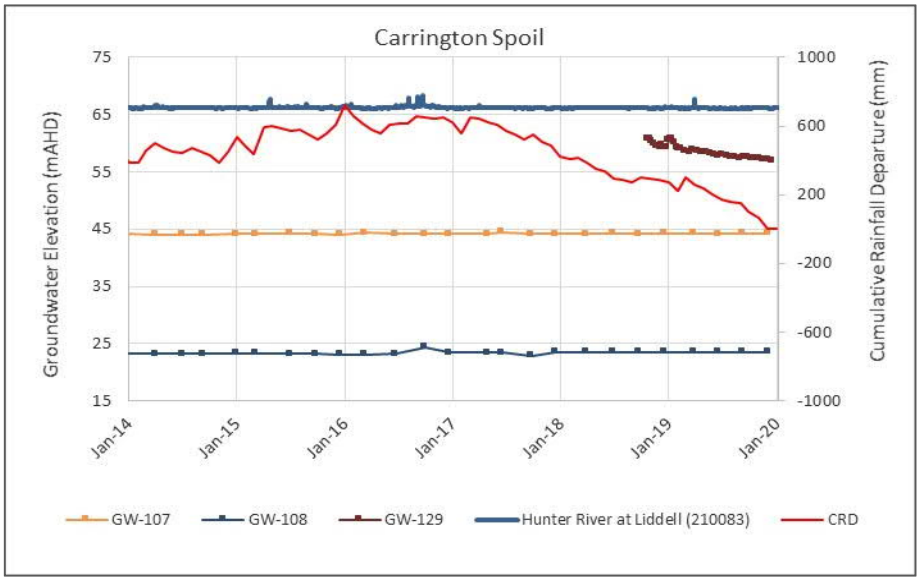
Figure 5-24 Hydrograph of Spoil Bores – Carrington

Time series groundwater levels for the spoil are presented in Figure 5-24. Over 2019 groundwater elevations within the bores ranged between 23.50 mAHD and 61.54 mAHD (11.49 m and 60.9 m depth). Groundwater within the spoil flows from northern-most bore DM1 (77.86 mAHD) in a southerly direction towards southern-most bore MB14HVO03 (32.74 mAHD). Over the course of 2019 groundwater levels declined by 3.49 m in bore GW-129, while bores GW-107 and GW-108 were essentially dry throughout 2019. It is likely the reduction in groundwater levels in these bores is a result of decanting of water from the North Pit/North Void and influence of the Carrington Pit final void.

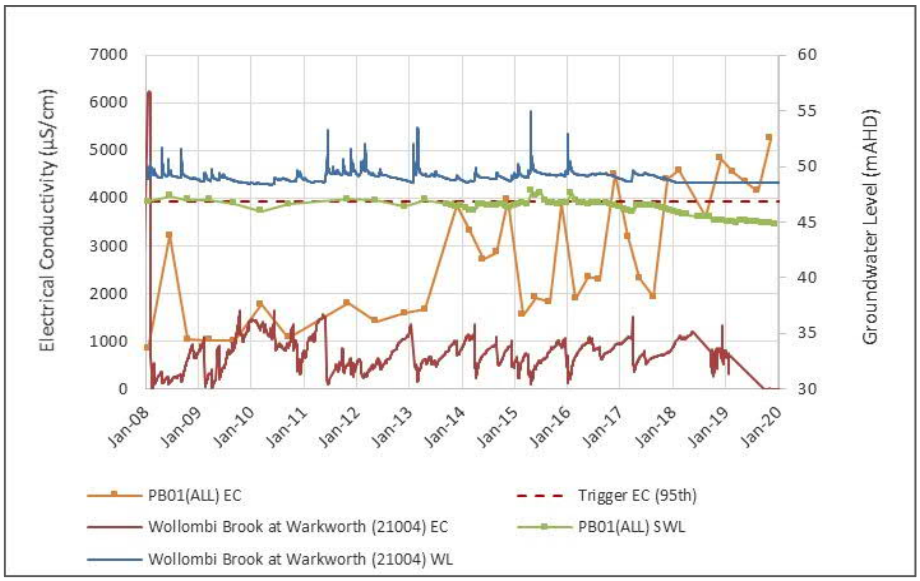
Figure 5-27 Water Level and EC Trends for PB01(ALL) and Wollombi Brook

Bore PB01(ALL) is located on the northern banks of the Wollombi Brook, in an area with no active mining or land clearance. The results indicate the spikes in EC likely relate to the natural decline in recharge to the alluvium. It is also understood that sampling methodology was revised over 2019, therefore the change in results may relate to increased purging of the bore and collection of more representative samples. No adverse impacts due to mining have been identified. It is recommended that the duplicate trigger level for the Lemington South alluvium be removed from the WMP, and one trigger level be applied based on representative data.

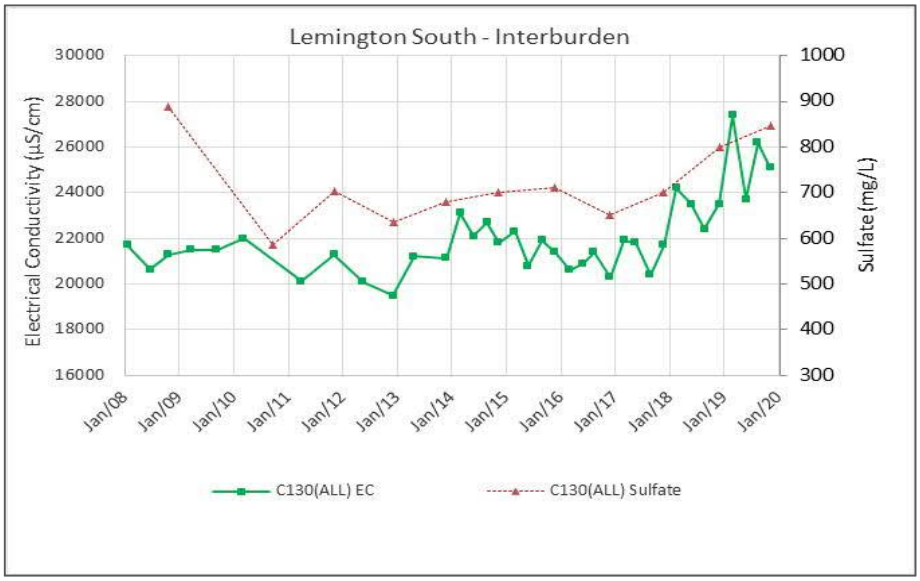
Figure 5-28 C130(ALL) EC vs Sulphate

It is also recommended that the water level of Lemington South Pit be monitored to understand the influence of in-pit water storage on the local groundwater regime. It is also noted that the trigger level for the Lemington South interburden was 22,780 µS/cm prior to a change in 2018 to 11,408 µS/cm. It is recommended that the trigger level for the interburden, and therefore C130(ALL), be reviewed.

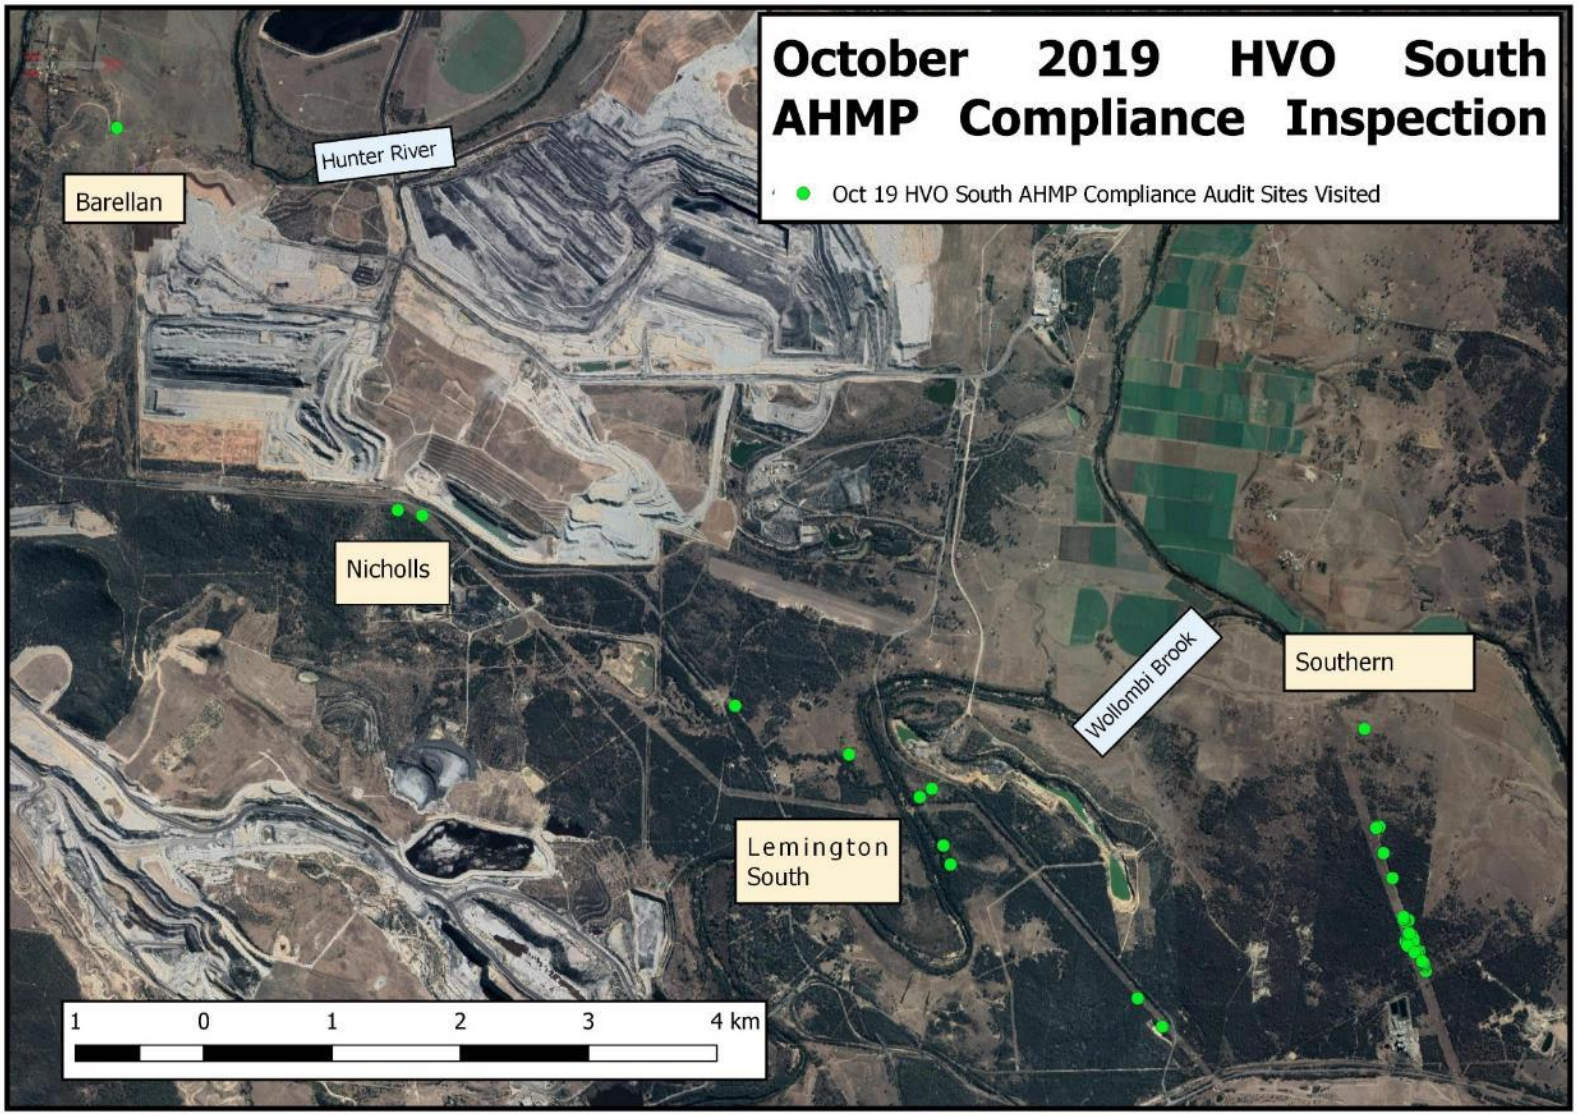
CM-CD1 is being managed well, with no evident impacts to the site's cultural heritage values. All recommended actions from the December 2018 compliance inspection have been implemented. No further management actions are recommended as part of this compliance inspection.
