ARDGLEN QUARRY

2023 Annual Environmental Management Report (AEMR)

PROJECT APPROVAL MP 06_0264 - MOD 2

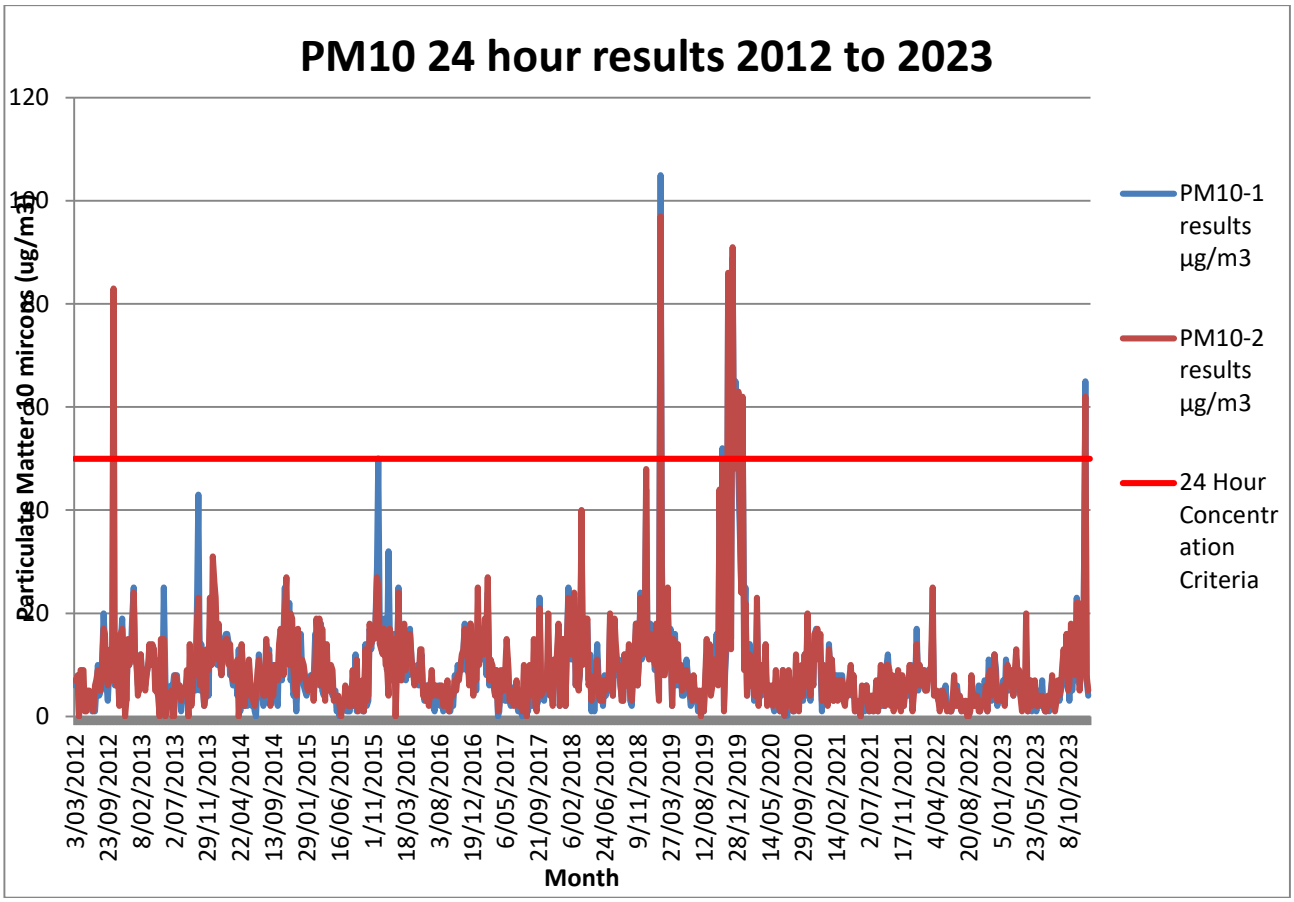
Figure 17: Twenty-four-hour concentration PM-10 results from 2012 to 2023

- **Figure 17** – This shows the HVAS PM-10 "24 hour" monitoring results from 2012 to 2023. As seen in this figure, the annual average results are all below the criterion apart from the results obtained in 2012 and more recently during late 2018, late 2021 into early 2020 and the result obtained for the 19th December 2023. For clarification regarding the prevailing weather conditions during this reporting period, please see also see below **Figure 20** (taken from the biodiversity monitoring report) which demonstrates that the region surrounding Ardglen quarry was experiencing 'non drought' conditions for most of the reporting period apart from the latter part of the year;

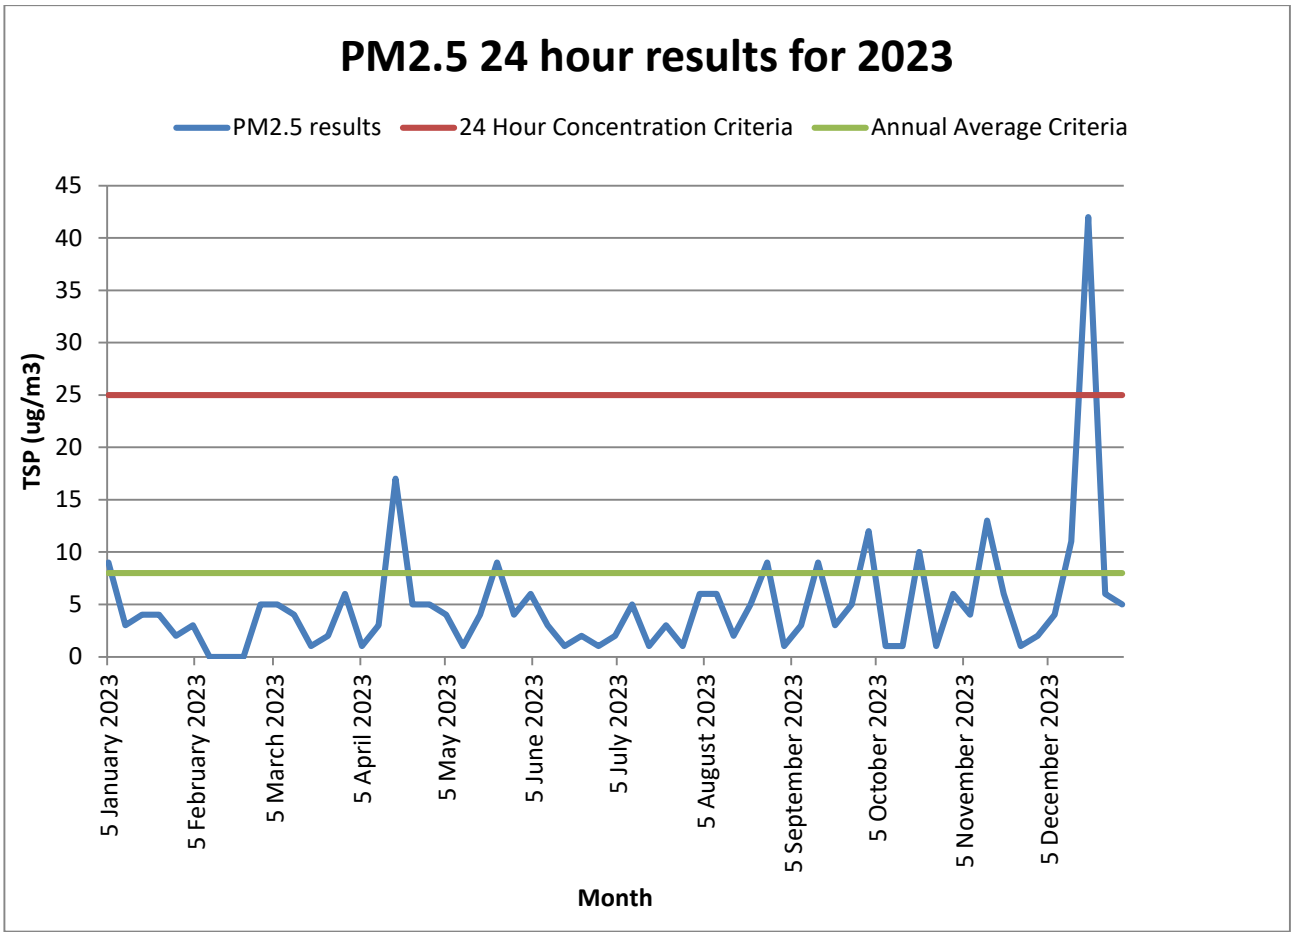
Figure 19: PM2.5 results for 2023

- **Figure 19** – This shows the PM2.5 monitoring results from 2022 to 2023. As seen in this figure, all results obtained are well below the 24 hour criteria apart from the result obtained for the 19th December 2023;

- Additionally, as mentioned previously in this report, the elevated air quality results obtained for the 19th December 2023 have been **excluded from annual averaging calculations**, as per Note c of Schedule 3 condition 15 of the consent and noted by DPHI in their correspondence dated 20th February 2024.

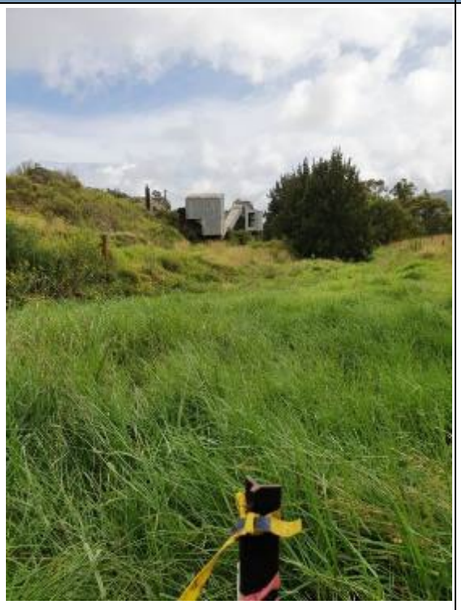
Plot Q02: River Oak (*Casuarina cunninghamiana*) Dry Sclerophyll Woodland

Photos not taken In 2023

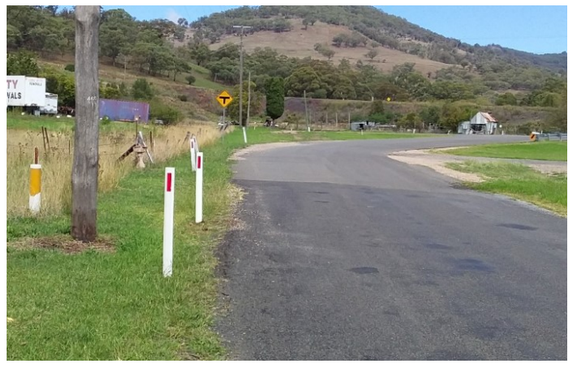
9	Main Street Intersection with Ardglen Road Northbound and Southbound Traffic signs	On Main Street approach to Ardglen Road, the existing speed zone repeater signage appears faded. This may increase the likelihood of readability issues for drivers, and increase the likelihood of a driver failing to travel to the sign posted speed limit. The likelihood of this risk may increase at night and / or adverse weather conditions. This may lead to vehicle crashes and injury to occupants of a vehicle(s).	As agreed with LPSC representative, Daracon proposes to install new speed limit signage as the existing sign is faded.	Completed on the 20th March 2019.		N/A
10	Main Street Approaching the Intersection with Ardglen Road Northbound and Southbound Roadside hazards	On Main Road approach to Ardglen Road, there is an existing power pole and fence posts within the clear zone. Errant vehicles at these locations may have a reduced ability to gain control of their vehicle and strike the power pole or fence post within the clear zone which may lead to rapid deceleration of the vehicle. This may be due to the combination of horizontal and / or vertical alignment of the road and / or drivers swerving to avoid striking an animal (i.e. animal carcass). The likelihood of this risk may increase at night and / or adverse weather conditions. This may result in vehicle crashes and injury to occupants of a vehicle(s), not limited to.	As agreed with LPSC representative, Daracon proposes to install delineation in the form of additional guideposts adjacent to the roadway to highlight the presence of the existing power pole.	Completed on the 26th March 2019.
