REMEDIATION ACTION PLAN REV 4

Aspect Industrial Estate, Mamre Road, Kemps Creek, NSW 2178 – Rev 4

Prepared for Mirvac Projects Pty Ltd

02 MAY 2022

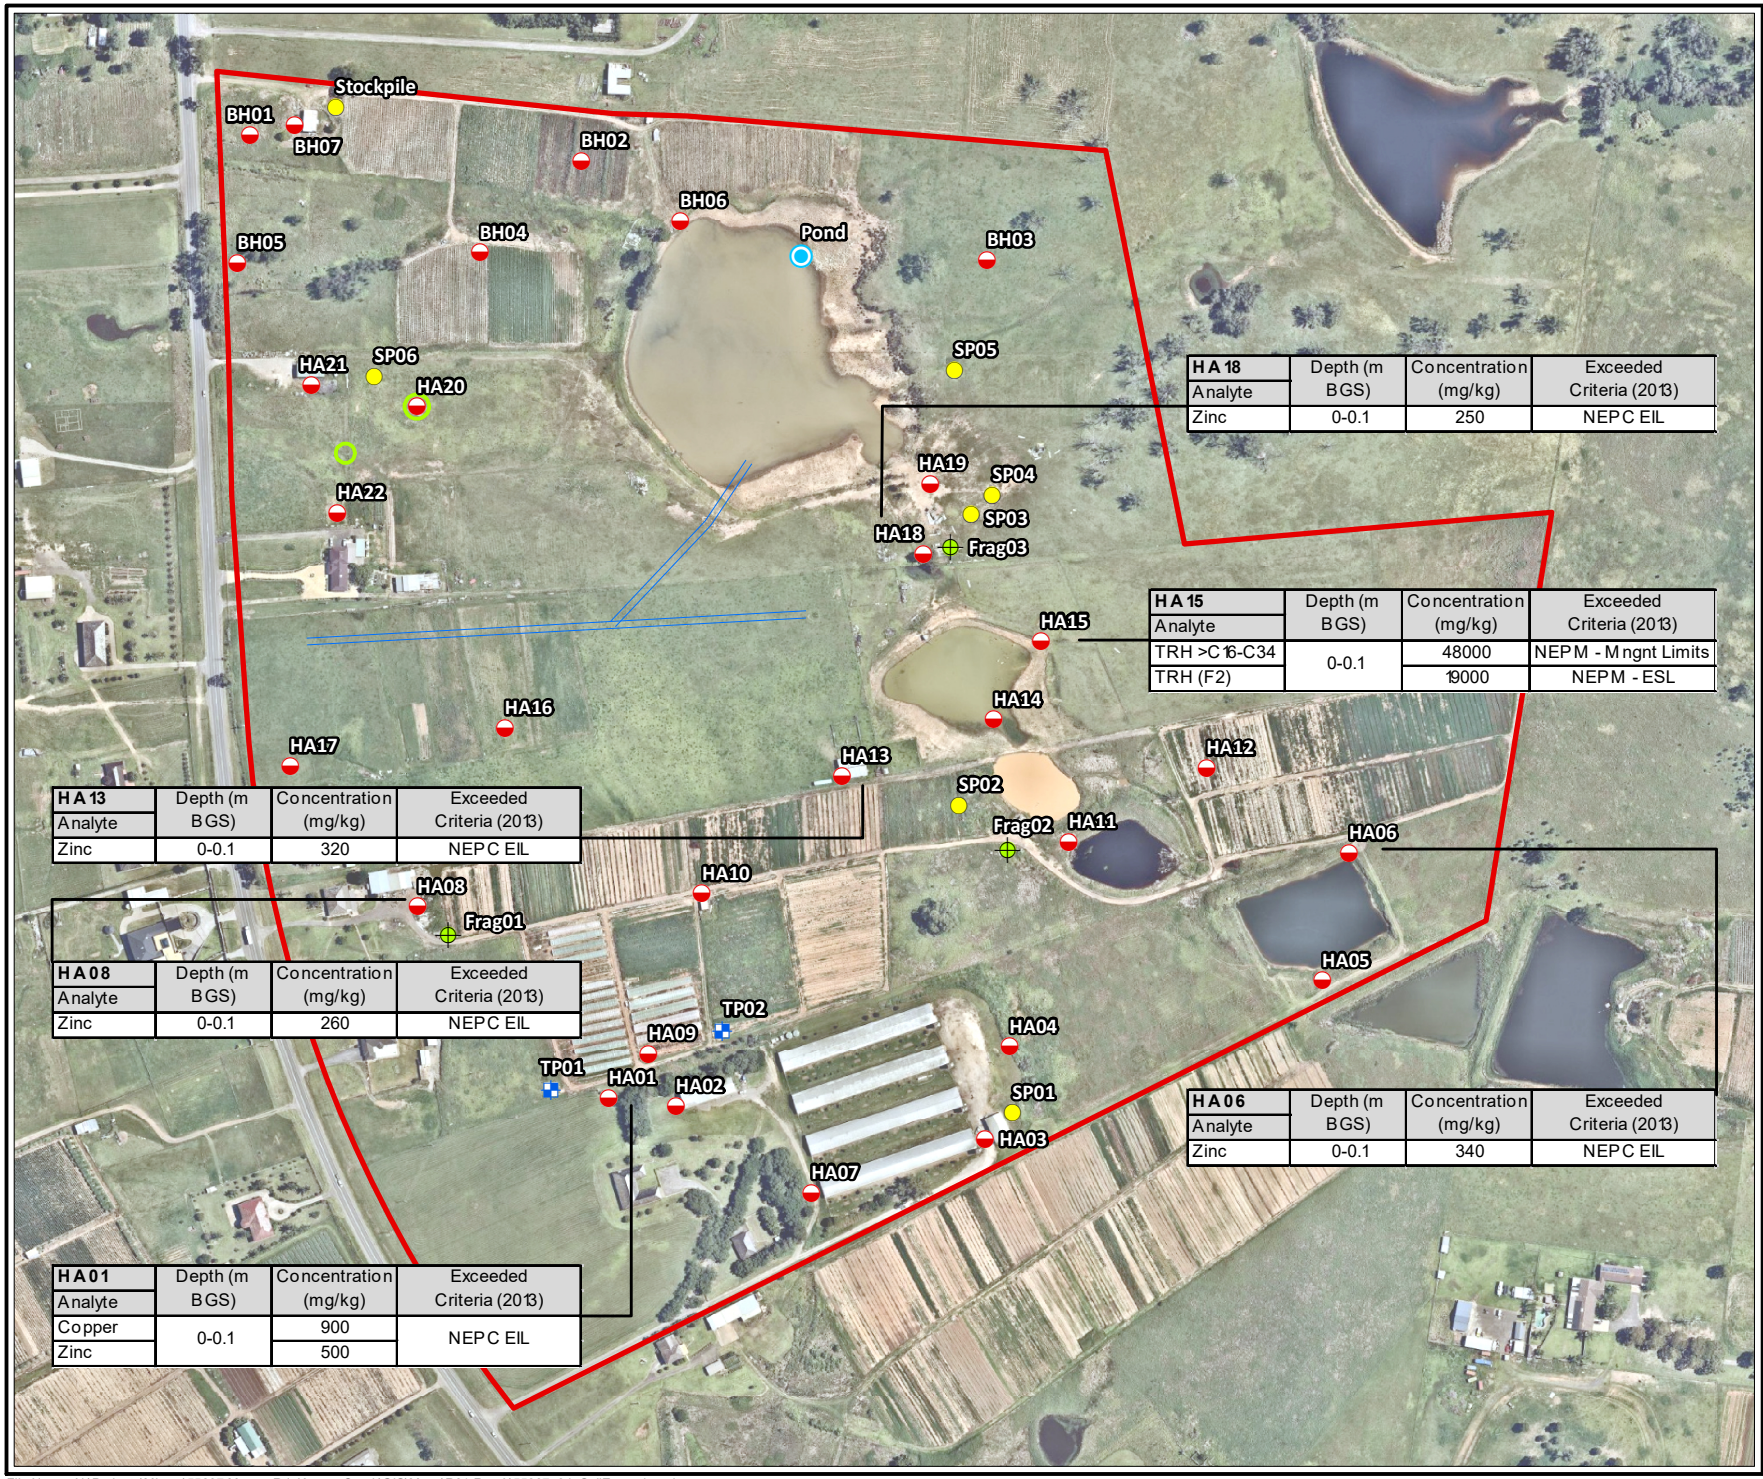
Figure 1, Appendix C - Summary PSI exceedances

HA18	Depth (m BGS)	Concentration (mg/kg)	Exceeded Criteria (2013)
Analyte			
Zinc	0-0.1	250	NEPC EIL

HA15	Depth (m BGS)	Concentration (mg/kg)	Exceeded Criteria (2013)
Analyte			
TRH >C16-C34	0-0.1	48000	NEPM - Mngnt Limits
TRH (F2)		19000	NEPM - ESL

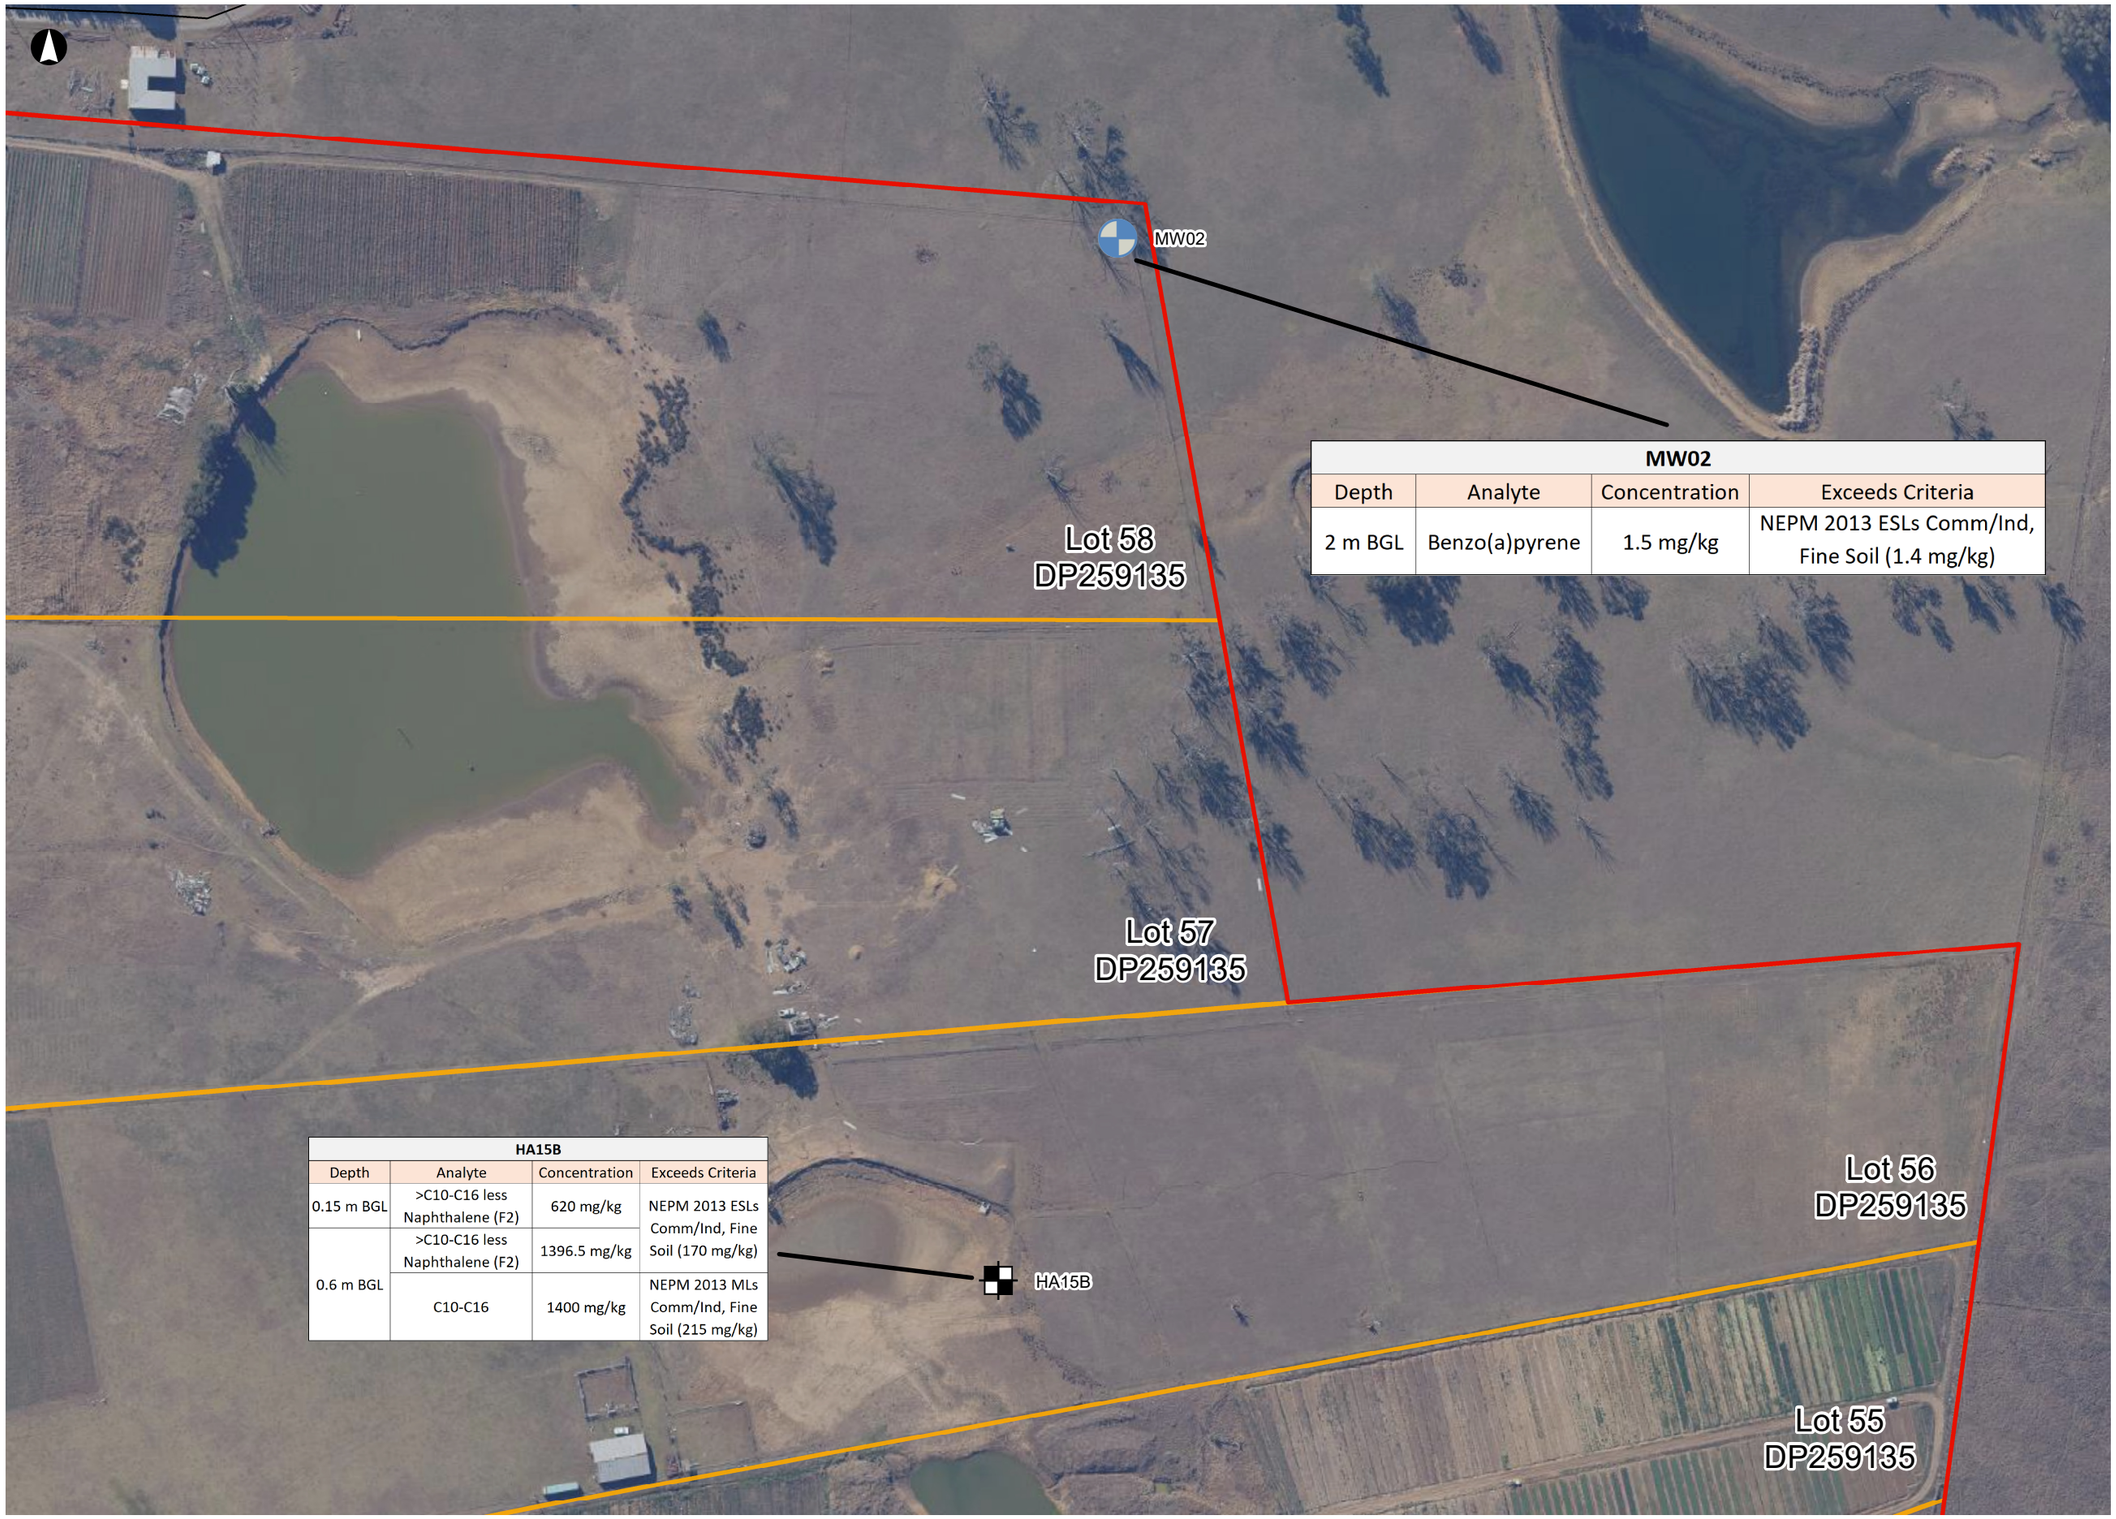
MW02			
Depth	Analyte	Concentration	Exceeds Criteria
2 m BGL	Benzo(a)pyrene	1.5 mg/kg	NEPM 2013 ESLs Comm/Ind, Fine Soil (1.4 mg/kg)

HA15B			
Depth	Analyte	Concentration	Exceeds Criteria
0.15 m BGL	>C10-C16 less Naphthalene (F2)	620 mg/kg	NEPM 2013 ESLs Comm/Ind, Fine Soil (170 mg/kg)
0.6 m BGL	>C10-C16 less Naphthalene (F2)	1396.5 mg/kg	
	C10-C16	1400 mg/kg	NEPM 2013 MLs Comm/Ind, Fine Soil (215 mg/kg)

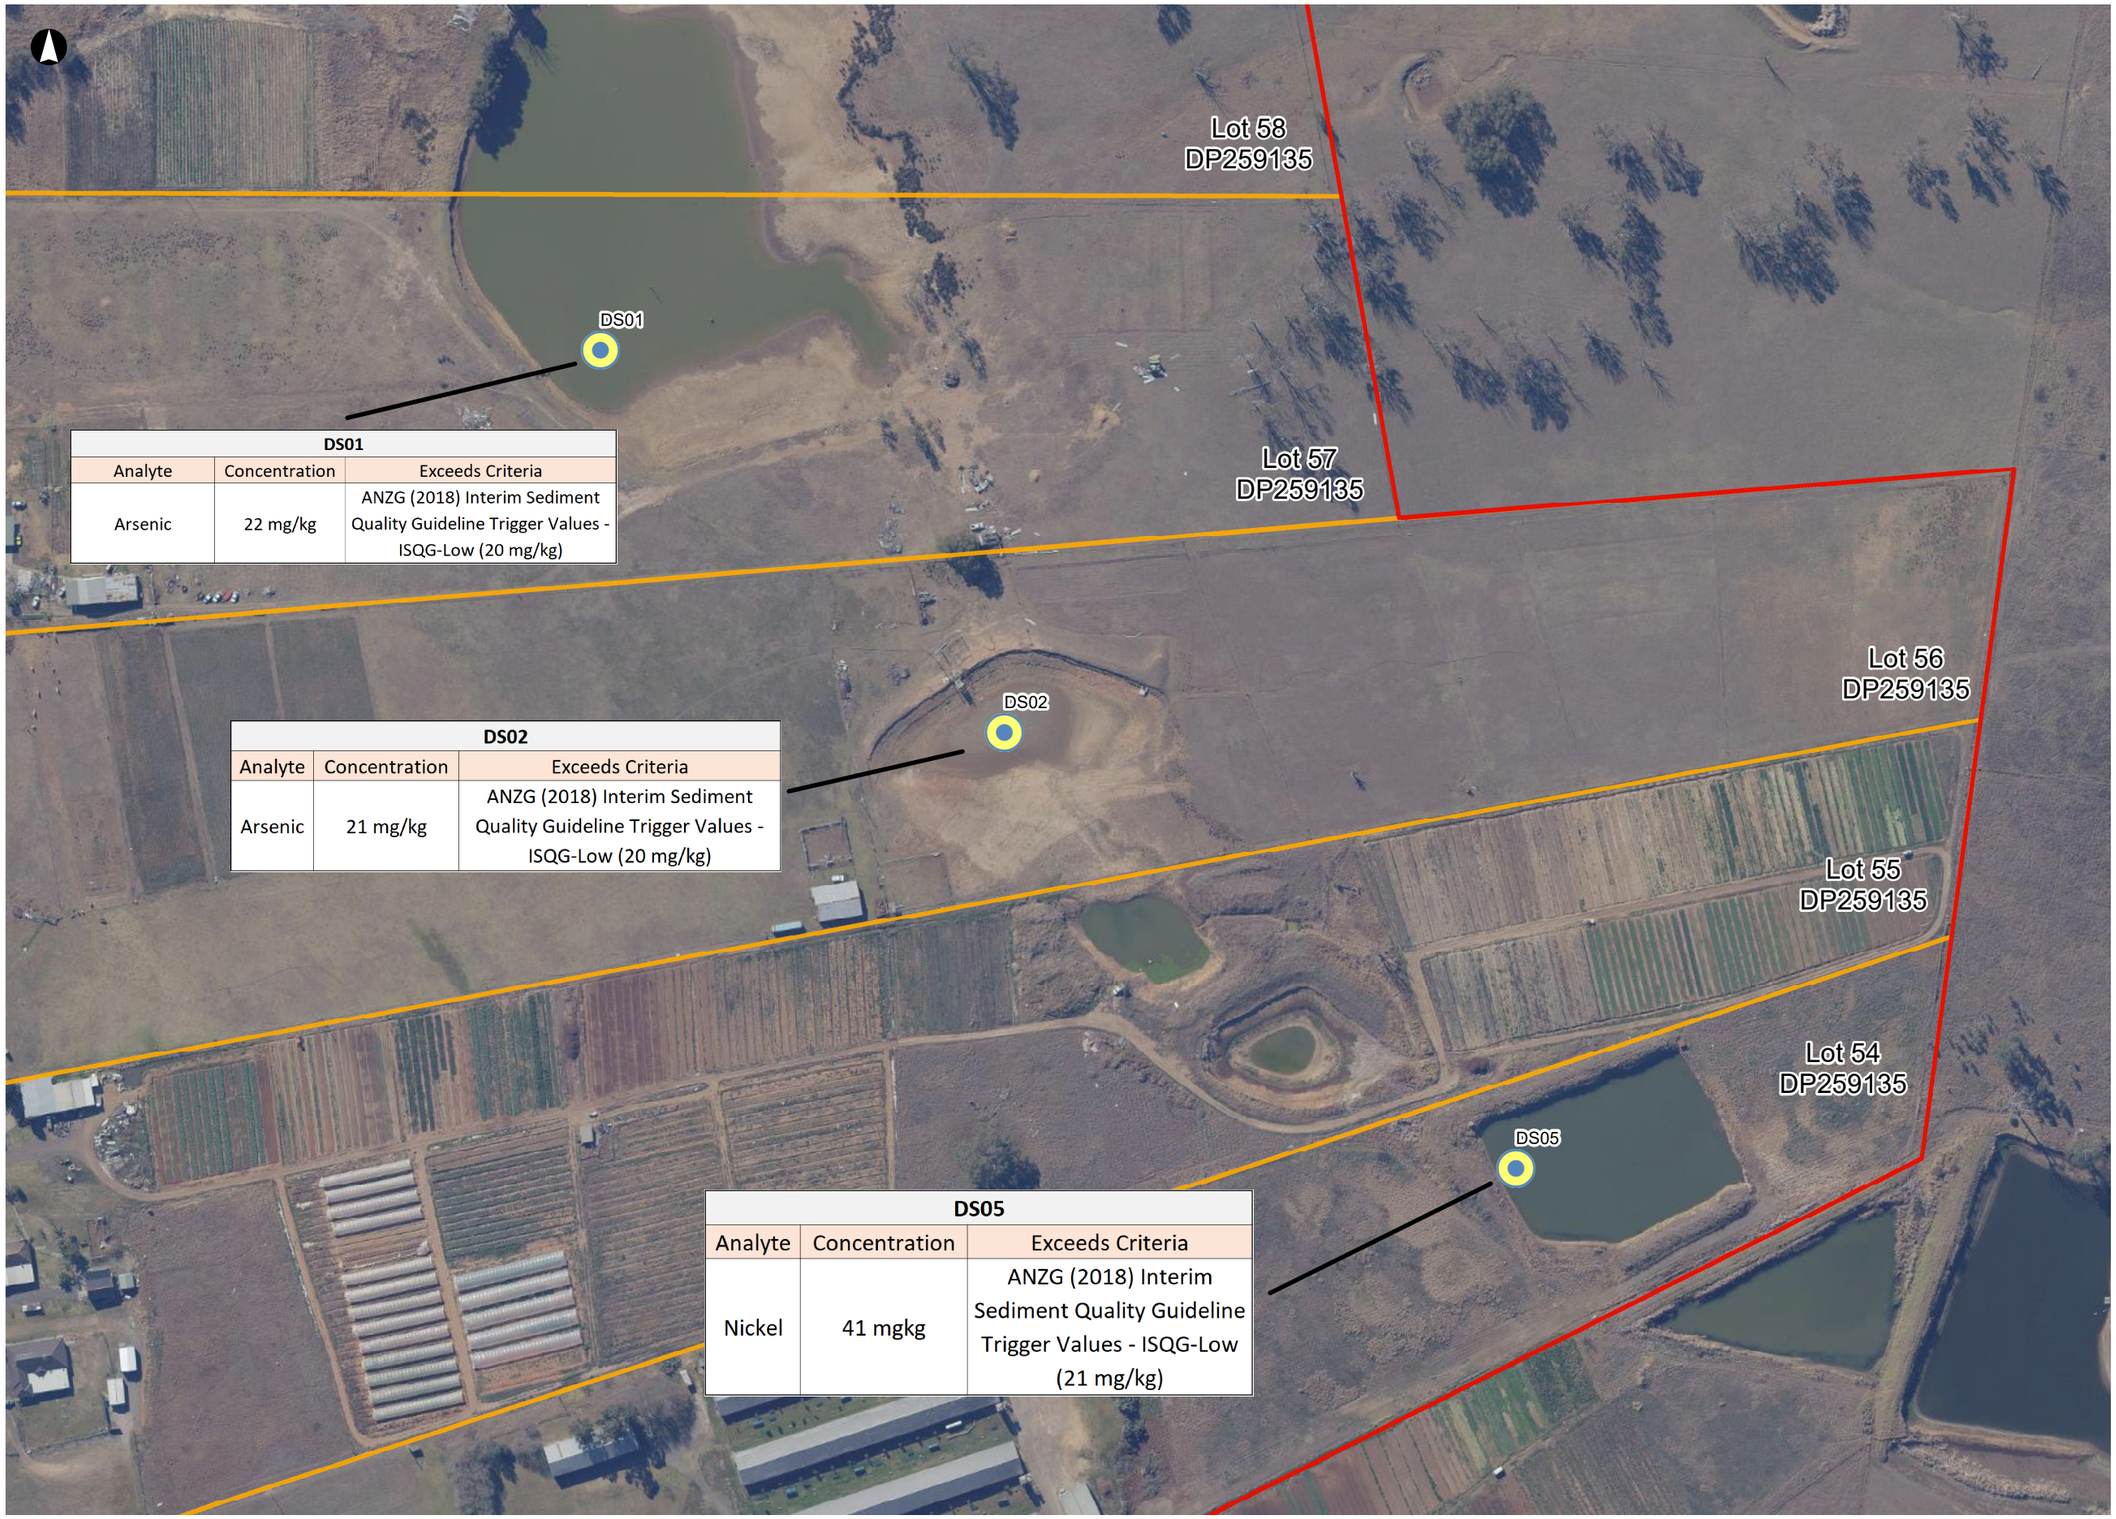
DS01		
Analyte	Concentration	Exceeds Criteria
Arsenic	22 mg/kg	ANZG (2018) Interim Sediment Quality Guideline Trigger Values - ISQG-Low (20 mg/kg)

DS02		
Analyte	Concentration	Exceeds Criteria
Arsenic	21 mg/kg	ANZG (2018) Interim Sediment Quality Guideline Trigger Values - ISQG-Low (20 mg/kg)

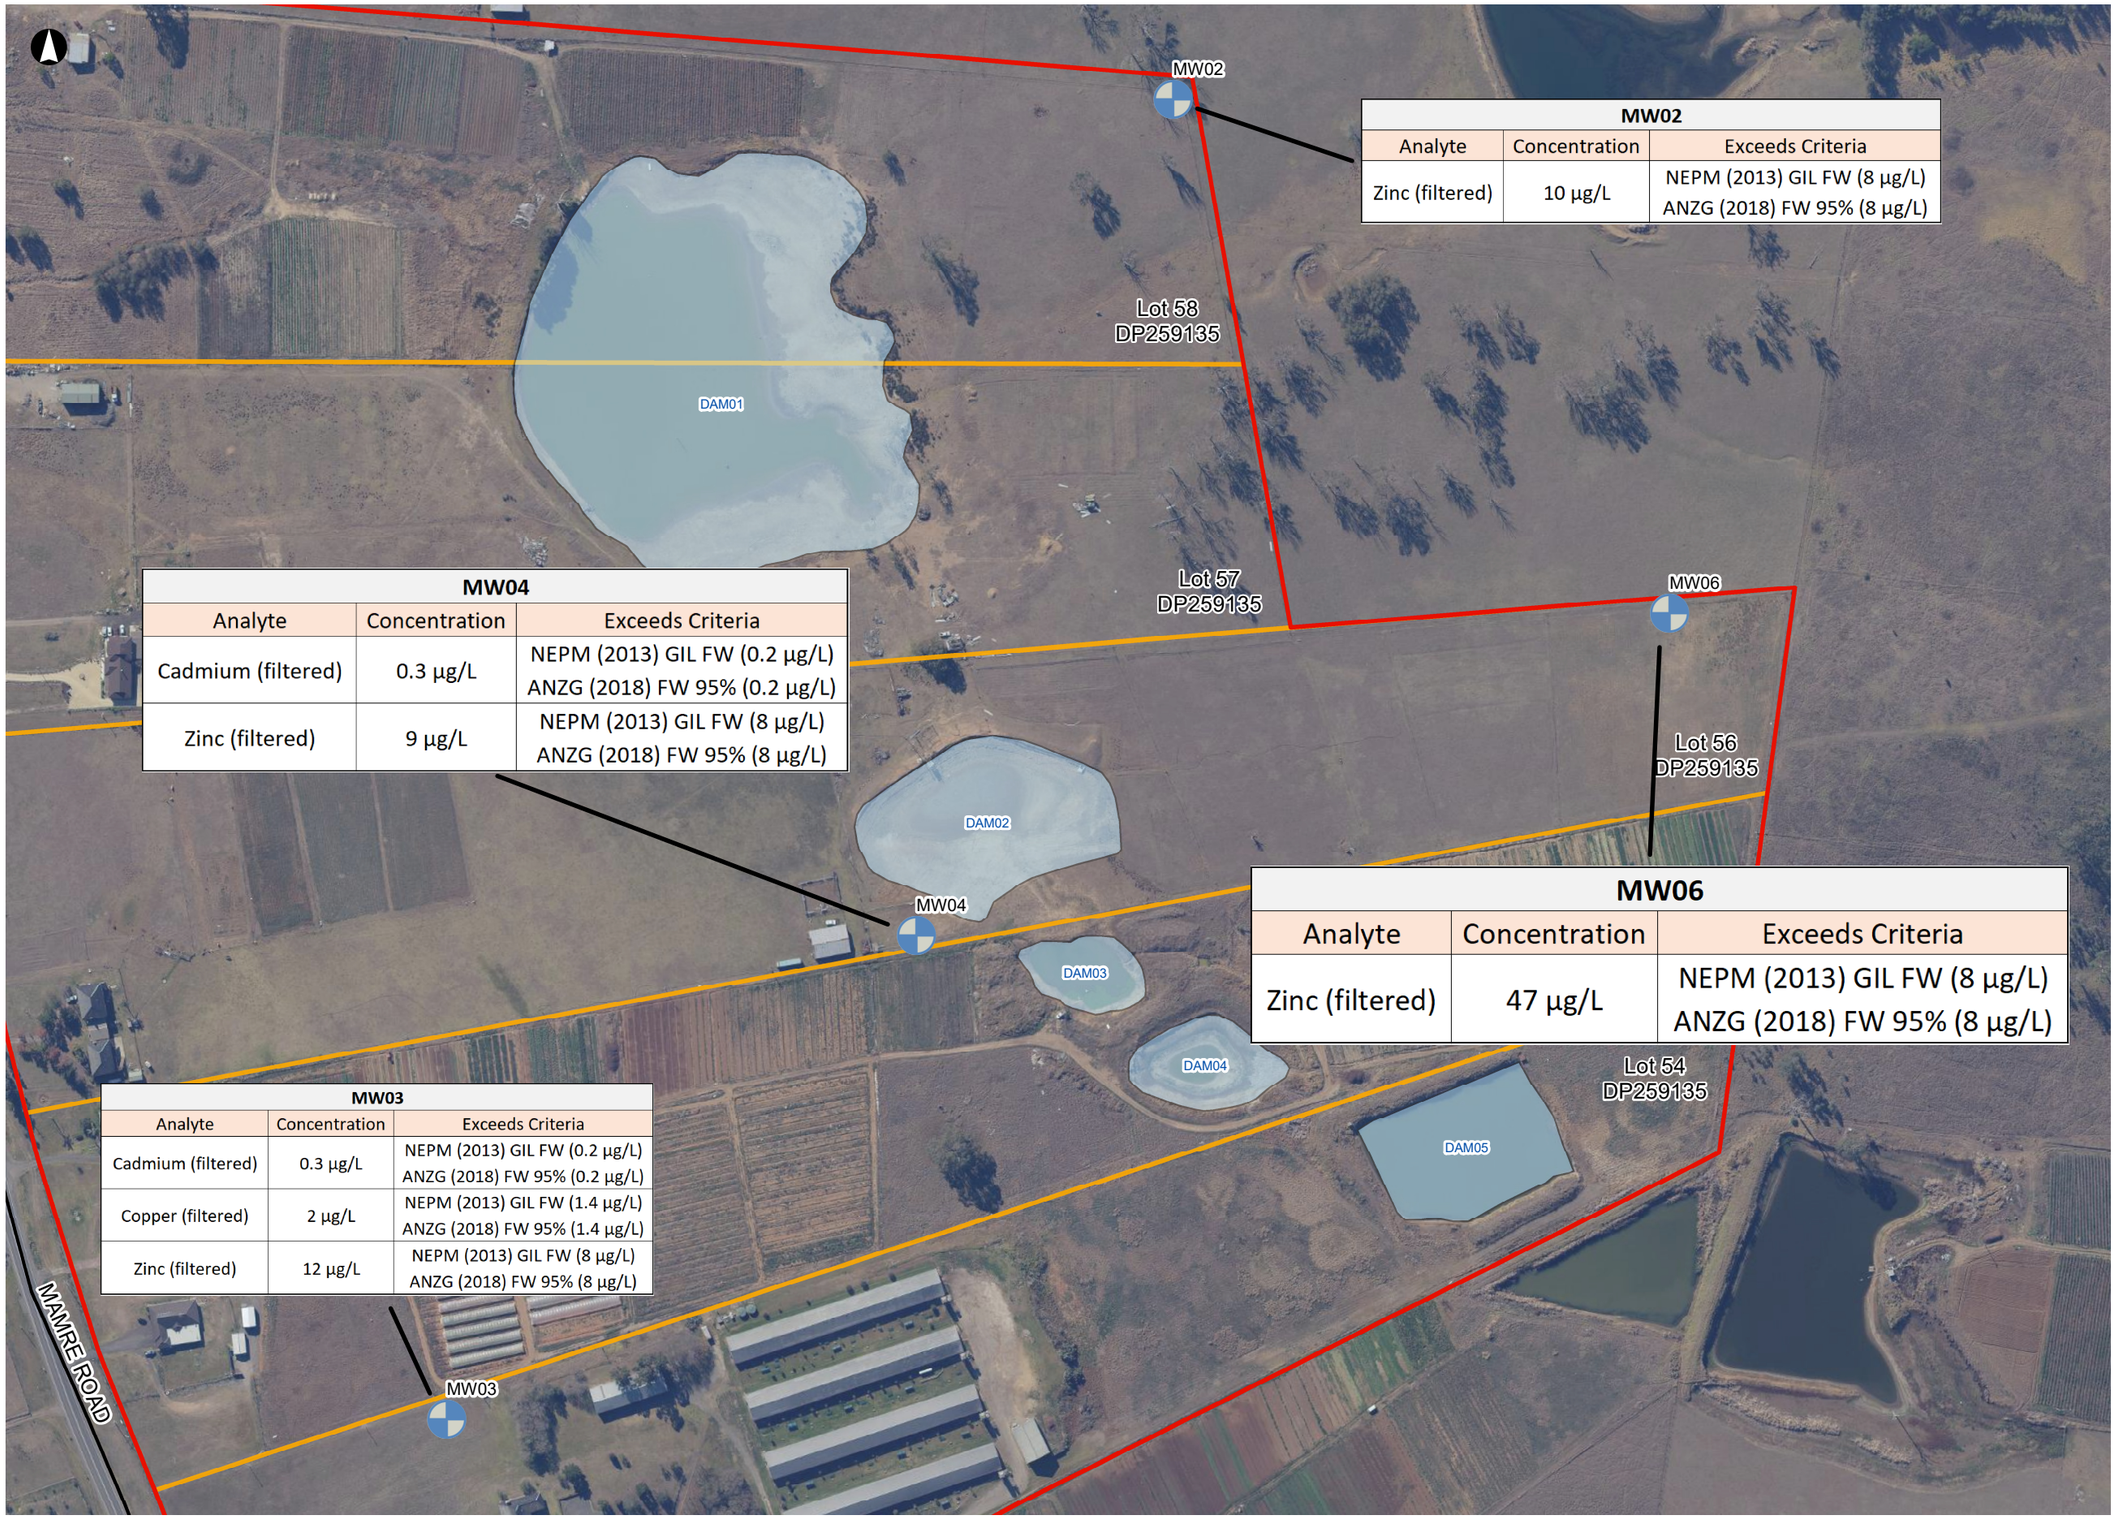
MW02		
Analyte	Concentration	Exceeds Criteria
Zinc (filtered)	10 µg/L	NEPM (2013) GIL FW (8 µg/L) ANZG (2018) FW 95% (8 µg/L)

MW04		
Analyte	Concentration	Exceeds Criteria
Cadmium (filtered)	0.3 µg/L	NEPM (2013) GIL FW (0.2 µg/L) ANZG (2018) FW 95% (0.2 µg/L)
Zinc (filtered)	9 µg/L	NEPM (2013) GIL FW (8 µg/L) ANZG (2018) FW 95% (8 µg/L)
