Report on Preliminary Site Investigation (Contamination) with Limited Sampling

Taronga Wildlife Hospital, Sydney
- Nutrition Centre

Prepared for
Taronga Conservation Society Australia

Project 99931.00
December 2021

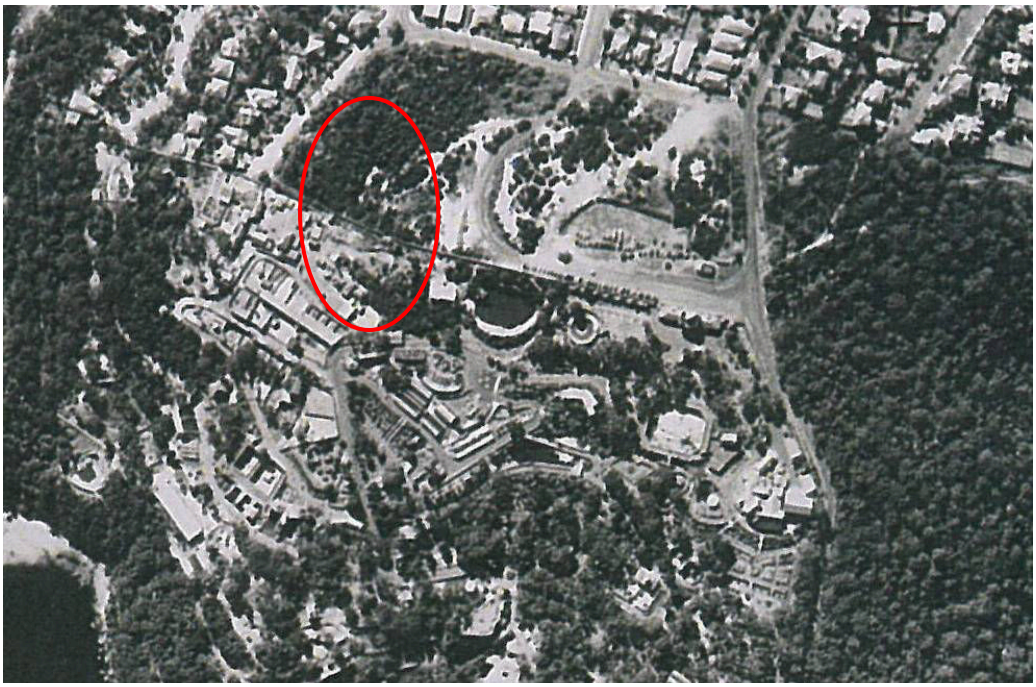
Photo 2 – Aerial photograph from 1951

The 1951 photograph shows some development on and adjacent to the site. Numerous buildings are evident including what may be a pool-type structure to the east. The 1961 photograph shows similar conditions although some of the vegetation in the north-east of the site has been cleared.
