Tahmoor Coal Pty Ltd

SIX MONTHLY SUBSIDENCE IMPACT REPORT

Tahmoor South Domain Longwalls South 1A – South 6A

1 January 2024 – 30 June 2024

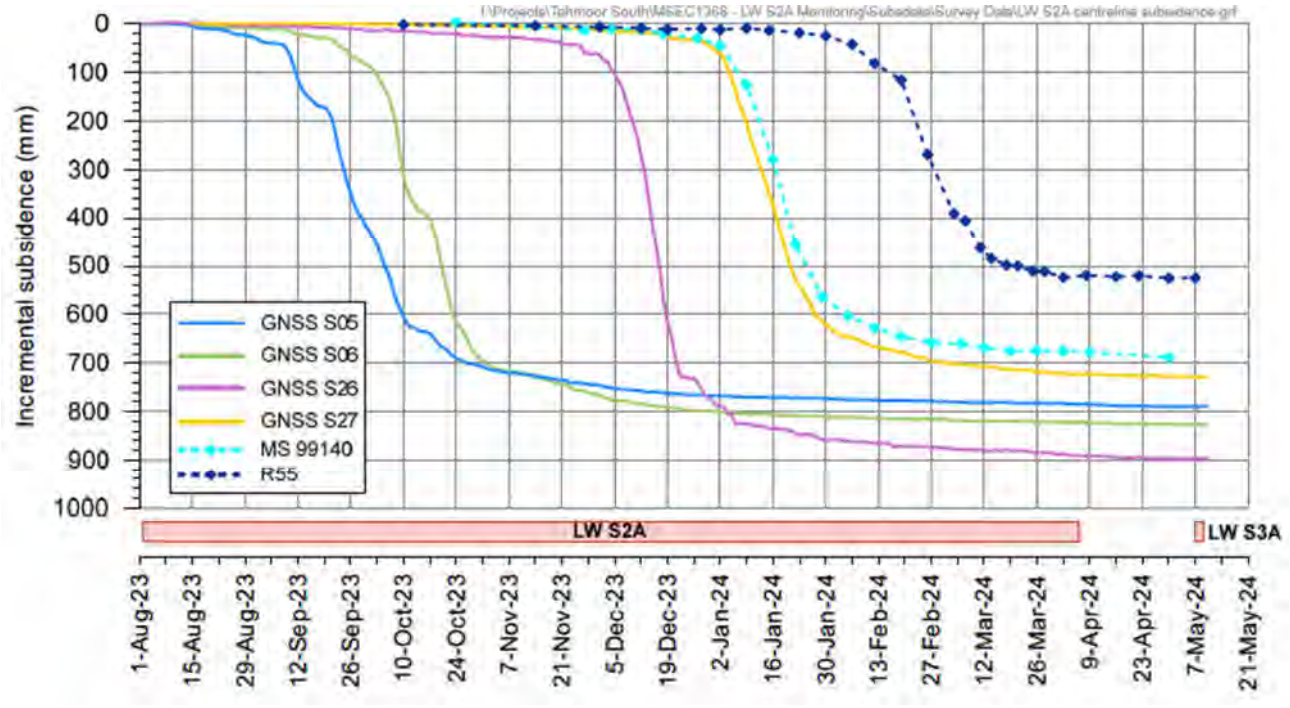
*Figure 3-2 Development of observed subsidence above LW S2A (source: MSEC1368 Subsidence Monitoring Report 37, **Appendix A**)*

Since the commencement of LW S2A, mining-induced movements showed development at the GNSS units, with maximum measured incremental subsidence of 896 mm at Site S26. Subsidence is increasing at Site S27 above LW S2A, but at a reduced magnitude at the equivalent stages of mining compared to GNSS S26. Rate of change are reducing at both sites. Subsidence observations above LW S2A are greater than observed above LW S1A because it is the second panel in the longwall series (MSEC1368 Subsidence Monitoring Report 37 (**Appendix A**)).

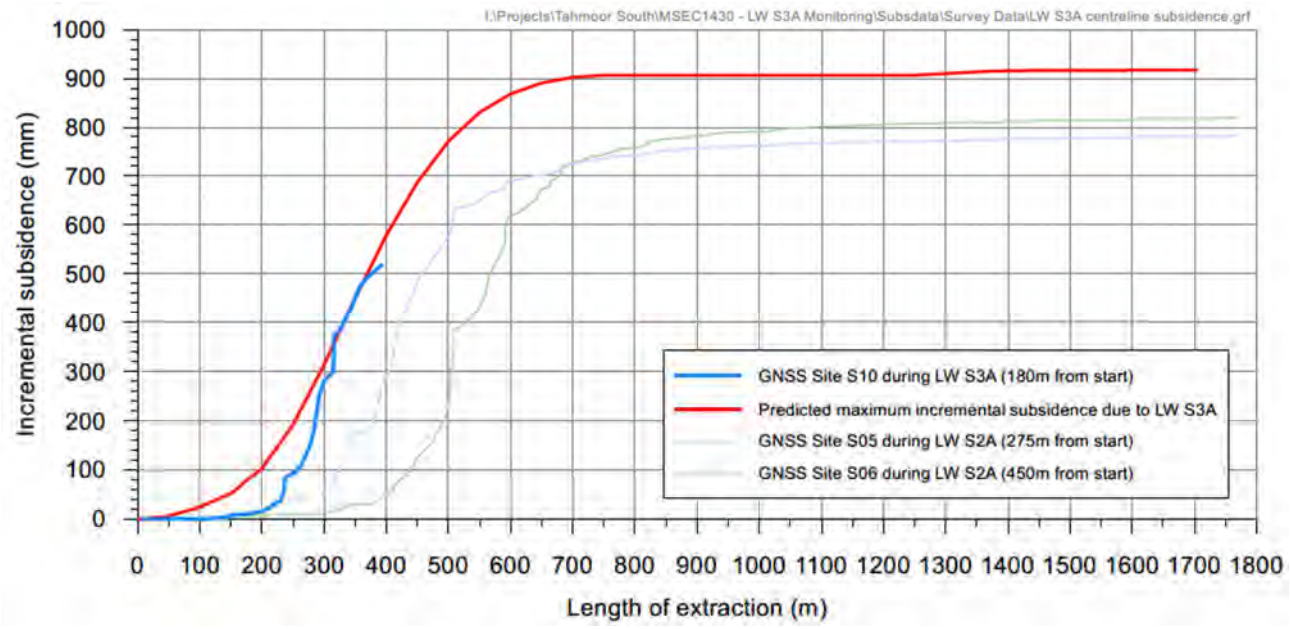
*Figure 3-3 Development of observed subsidence above LW S3A (source: MSEC1430 Subsidence Monitoring Report 5, **Appendix A**)*

Since the commencement of LW S3A, mining-induced movements have developed at the GNSS units, with maximum measured incremental subsidence of 533 mm at Site S10 above LW S3A. Rates of change continue at previously observed maximum rates. It was predicted that subsidence above LW S3A would be greater than observed above LW S2A because it is the third panel in the longwall series (MSEC1430 Subsidence Monitoring Report 5 (**Appendix A**)).

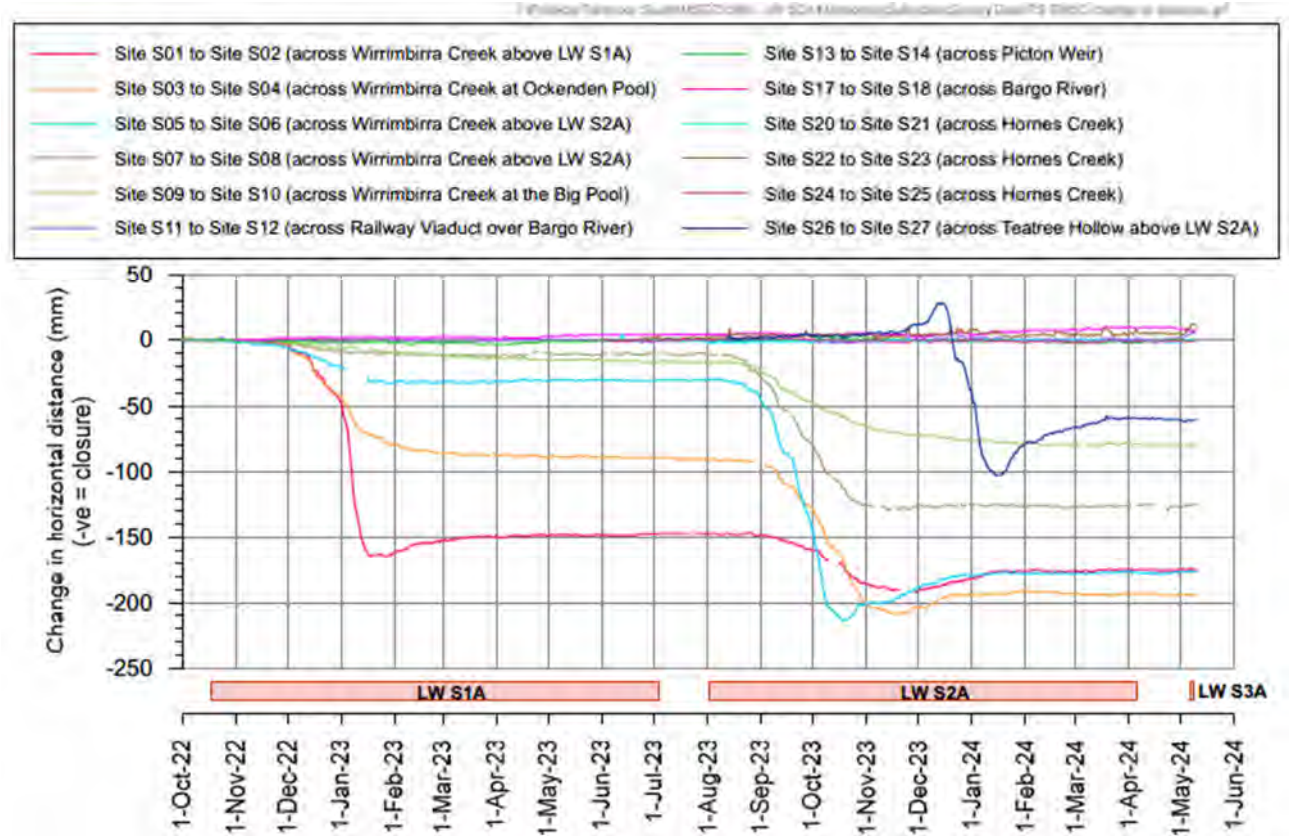
*Figure 3-4 Observed changes in horizontal distances between GNSS units during LW S2A extraction (source: MSEC1368 Subsidence Monitoring Report 37, **Appendix A**)*

During the extraction of LW S2A, changes in horizontal distances between paired GNSS units that are stationed close together on opposite sides of Teatree Hollow and Teatree Hollow Tributary (also known as 'Wirrimbirra Creek') are illustrated in **Figure 3-4**. The following trends have been observed since the commencement of LW S2A:

- Closure has developed across the Tributary to Teatree Hollow (Wirrimbirra Creek), particularly between Sites S07 and S08 directly above LW S2A;
- Closure has reduced between Sites S05 and S06, as previously observed between Sites S01 and S02 during the mining of LW S1A;
- Closure has reduced between Sites S03 and S04; and
- Closure has developed across Teatree Hollow between Sites S26 and S27 directly above LW S2A, and is now reducing.

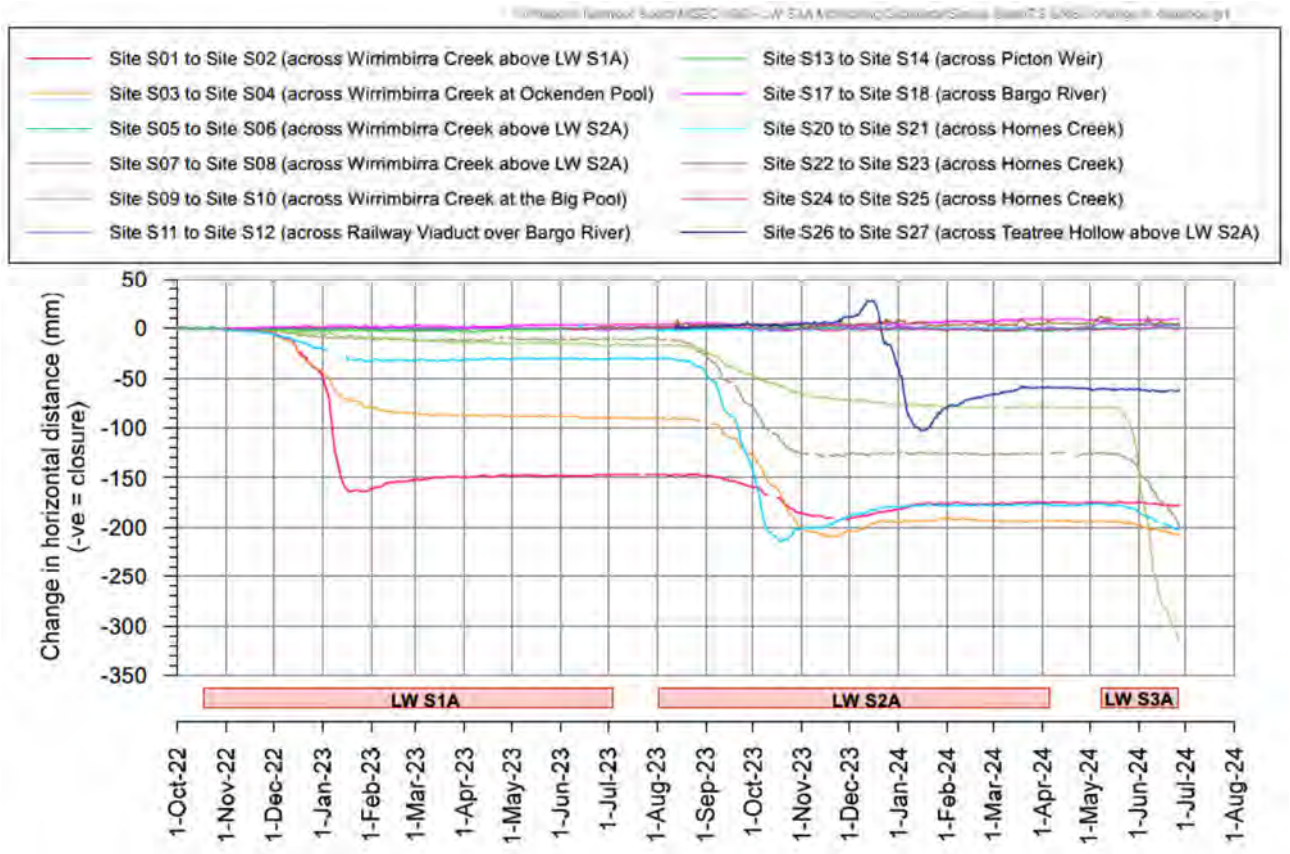
*Figure 3-5 Observed changes in horizontal distances between GNSS units during LW S3A extraction (source: MSEC1430 Subsidence Monitoring Report 5, **Appendix A**).*

During the extraction of LW S3A, changes in horizontal distances between paired GNSS units that are stationed close together on opposite sides of Teatree Hollow and Teatree Hollow Tributary (also known as 'Wirrimbirra Creek') are illustrated in **Figure 3-5**. Closure is currently developing across Wirrimbirra Creek between Sites S09 and S10 directly above LW S3A.

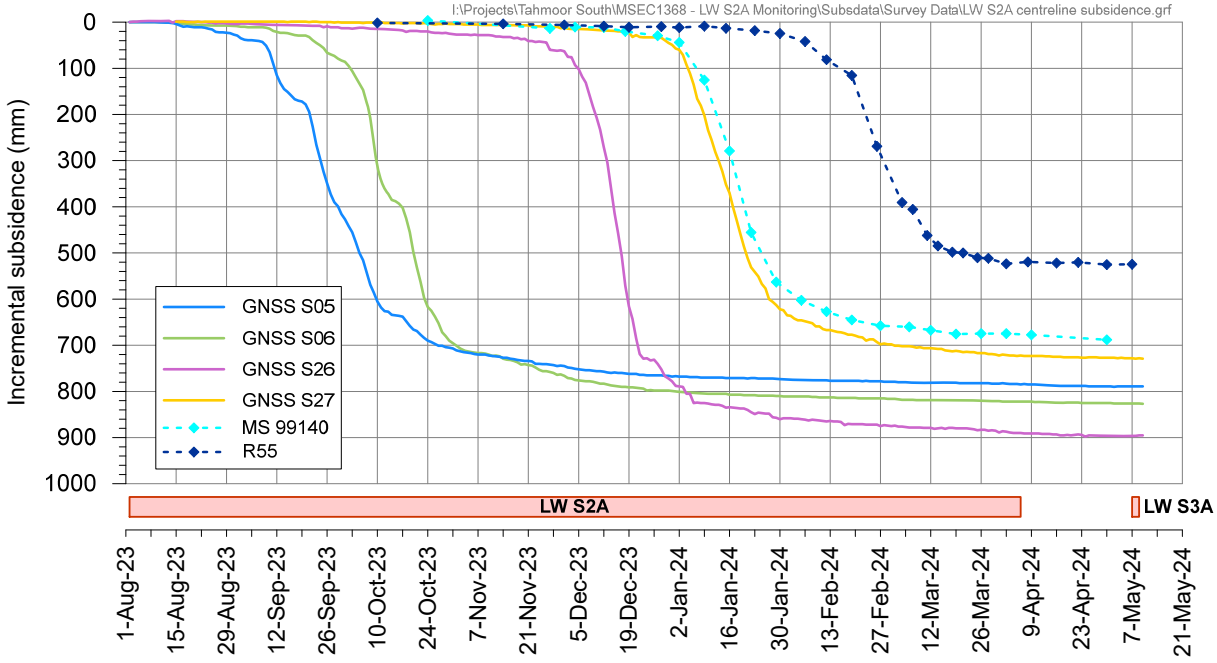
Figure A Observed development of incremental subsidence above LW S2A over time

Observed development of subsidence above LW S2A over time is shown in Figure A.

It was predicted that subsidence above LW S2A would be greater than observed above LW S1A because it is the second panel in the longwall series.

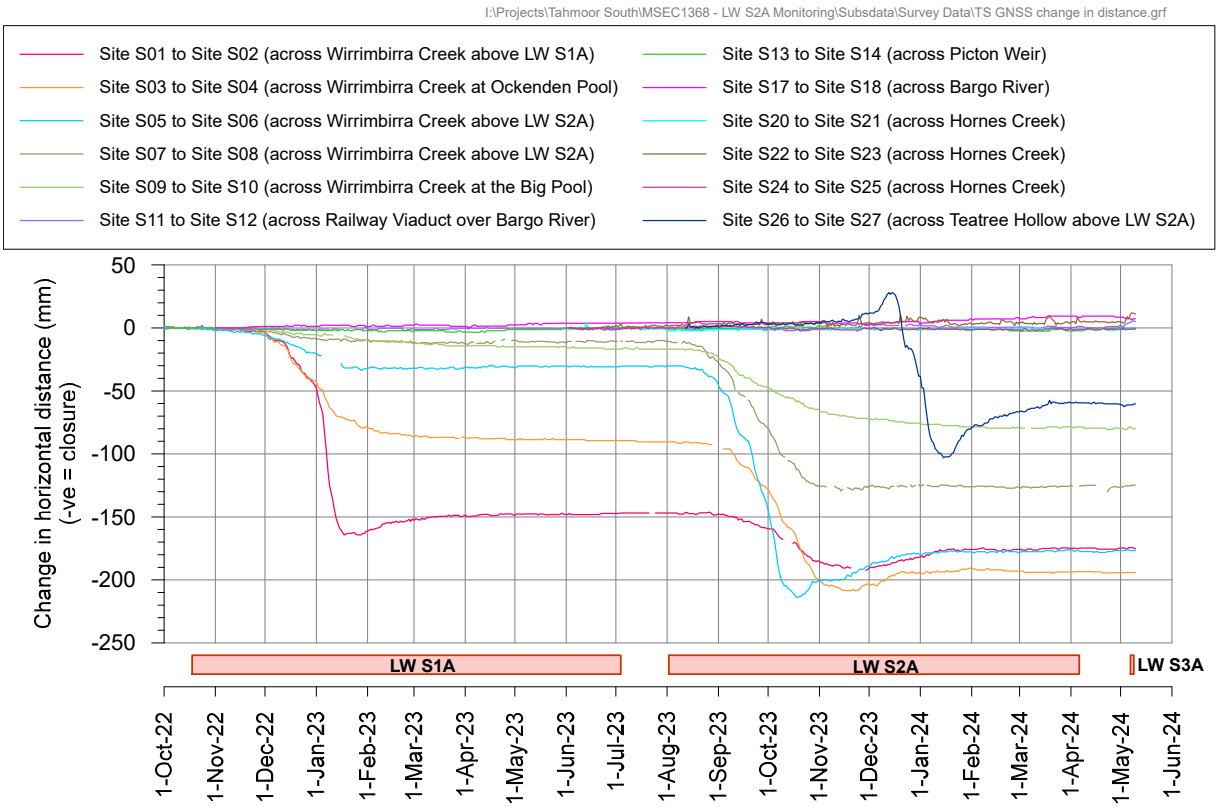
Figure B Observed changes in horizontal distances between GNSS units

Changes in horizontal distances can be calculated between GNSS units that are stationed close together and results are shown in Figure B. Closure has developed across the Tributary to Teatree Hollow (Wirrimbirra Creek), particularly between Sites 07 and 08 directly above LW S2A. Closure has reduced between Sites 05 and 06, as previously observed between Sites S01 and S02 during the mining of LW S1A. Closure has also reduced between Sites 03 and 04. Closure has developed across Teatree Hollow between Sites S26 and S27 directly above LW S2A and is now reducing.

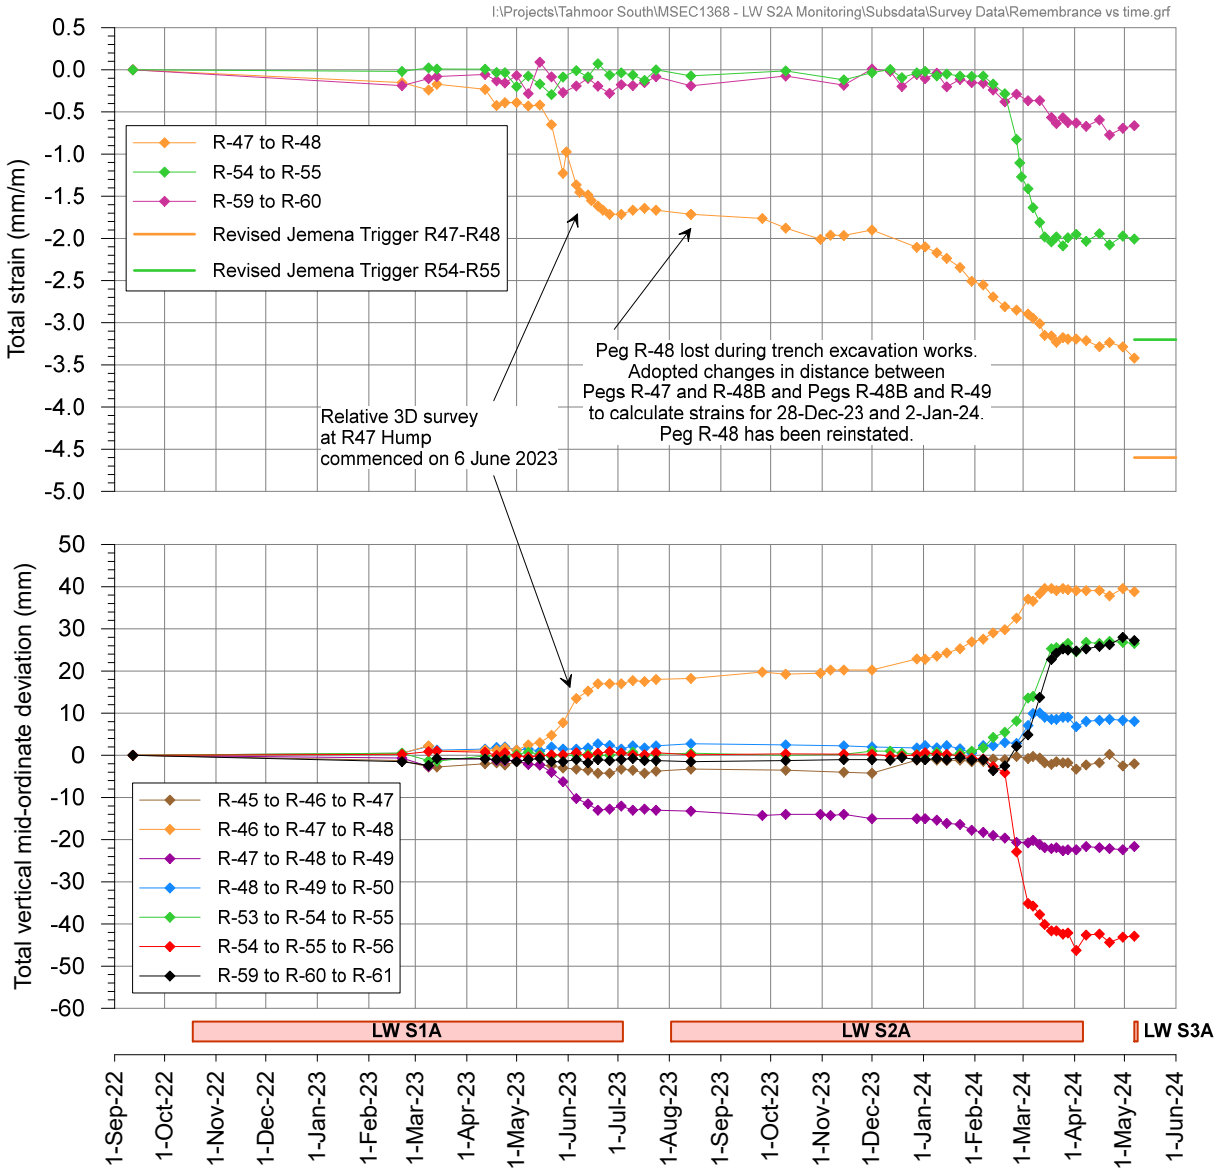
Figure C Observed development of ground strain and changes in vertical alignment at selected pegs along Remembrance Drive

Increased compressive strain is observed between Pegs R54 and R55, accompanied by a small bump in the observed subsidence profile at Peg R54, as shown in Figure C. Rates of change are reducing

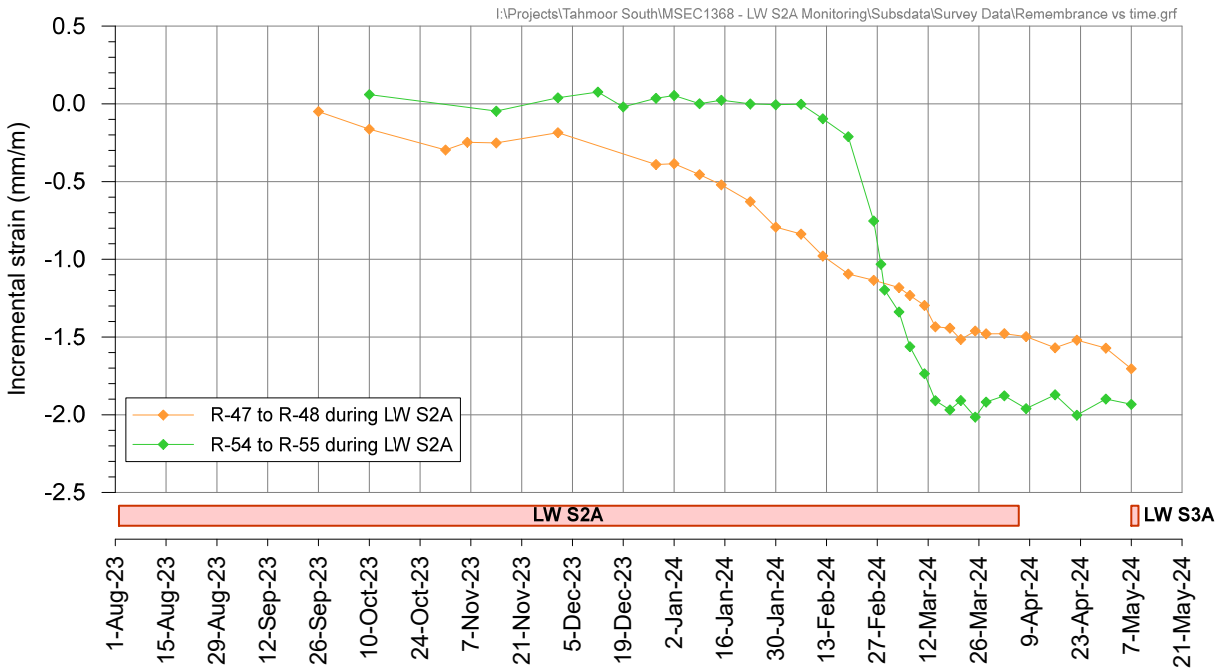
Figure D Observed development of ground strain between Pegs R47 and R48 and between Pegs R54 and R55 over time

Observed incremental strains between Pegs R47 and R48 due to the mining of LW S2A are plotted in Figure D. Rates of change in compressive ground strain have reduced as expected following the completion of LW S2A, though a minor trend of increasing compressive strain continues.

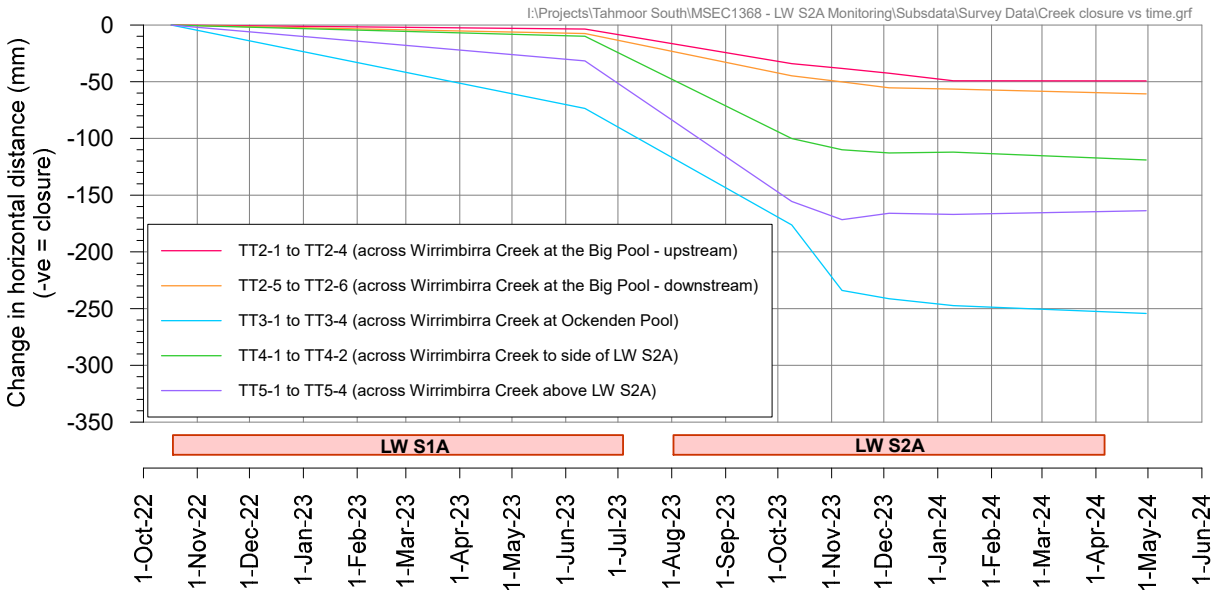
Figure K Observed development of closure across Tributary to Teatree Hollow from ground surveys

An end of LW S2A survey was conducted on 30 April along ground survey lines that were installed across the Tributary to Teatree Hollow, and a summary is shown in Figure K. The results correlate reasonably well with the observations from GNSS units, taking into account the shorter lengths of the survey lines, which are based within the floor of the creek valley, compared to the distances between the GNSS units, which are mounted at the tops of the valleys.

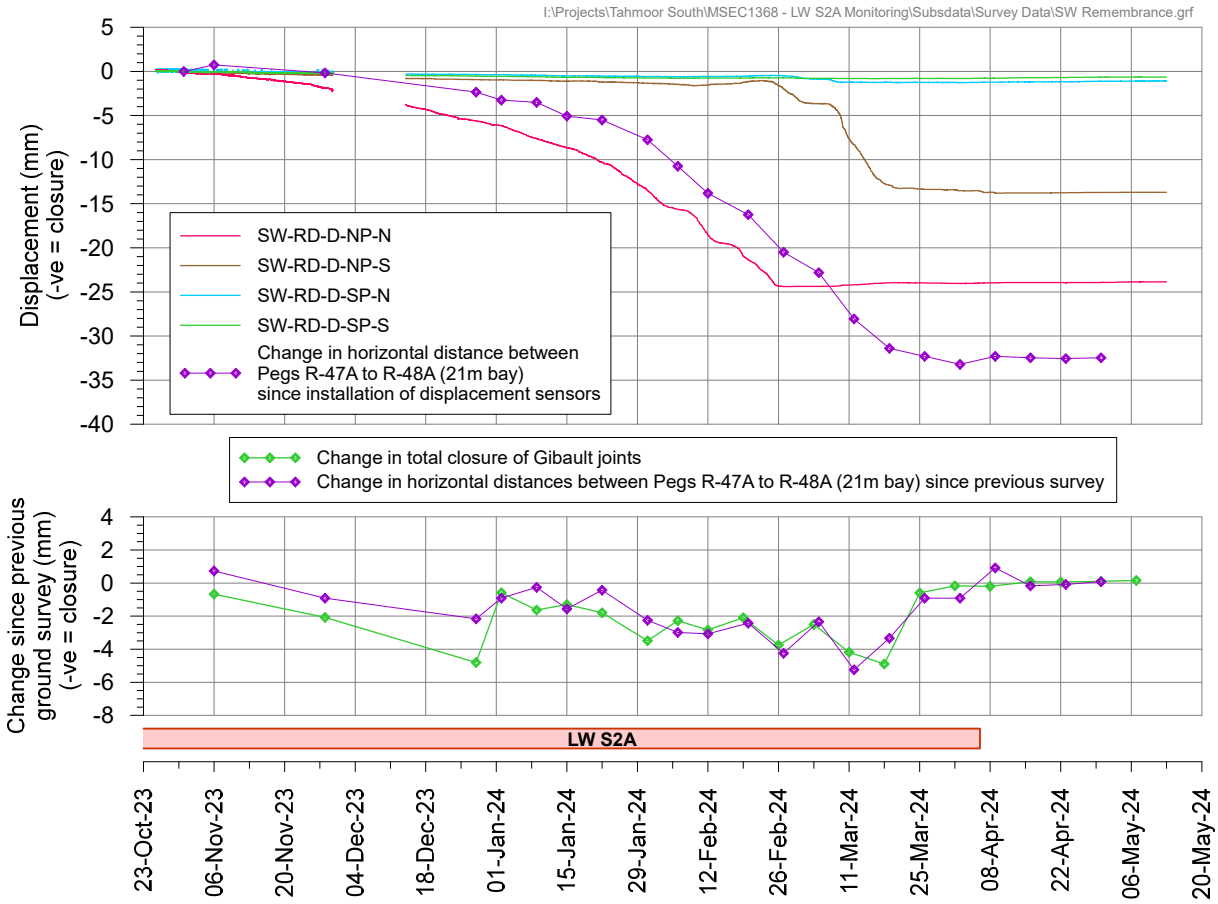
Figure M Observed change in distance across Gibault joints at Remembrance Drive between Pegs R47A and R48A on Sydney Water potable water main

The observed changes are compared with changes in horizontal distance between Pegs R47A and R48A, which are located on either side of the joints. It can be seen from Figure M that the joint displacement is now less than measured between the survey pegs, though there is currently good correlation between the survey methods on weekly changes.

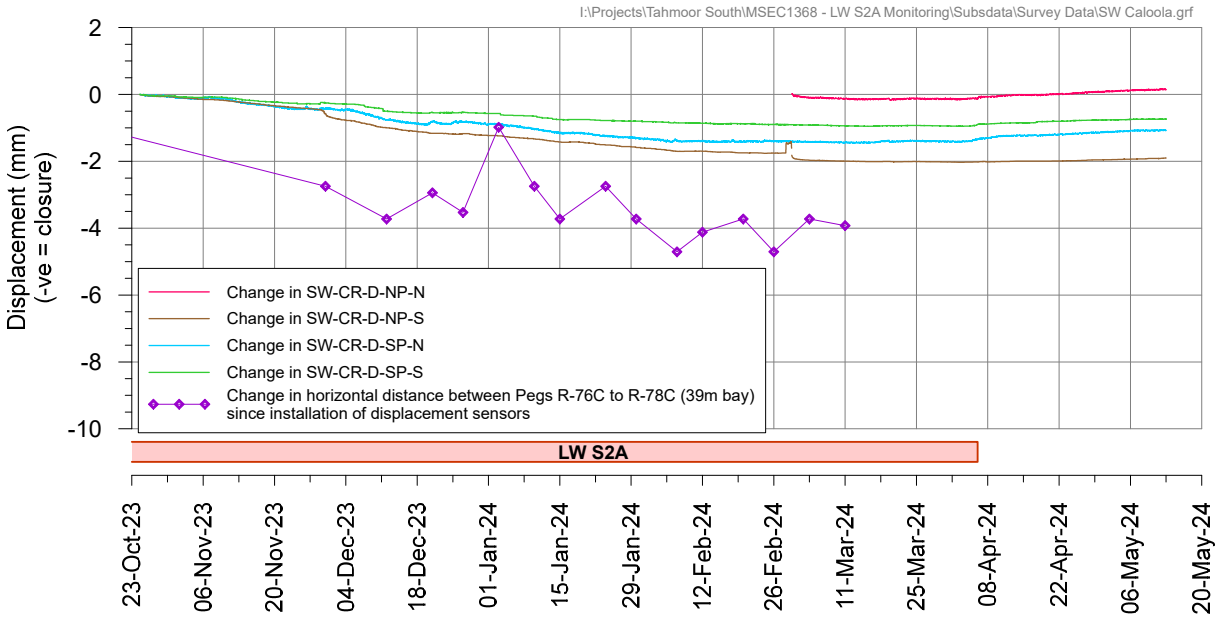
Figure N Observed change in distance across Gibault joints at Caloola Road on Sydney Water potable water main

Displacement sensors were also installed on the four Gibault joints of the 100 mm water main on Caloola Road. Minor changes have been observed, as shown in Figure N. The northern displacement sensor across the southern joint has been replaced in late February 2024. The observed changes are compared with changes in horizontal distance between Pegs R76C and R78C, which are located on either side of the joints. It can be seen from Figure N that the measured changes are within survey tolerances. A very small trend of closure observed on the joint sensors is gradually reversing.

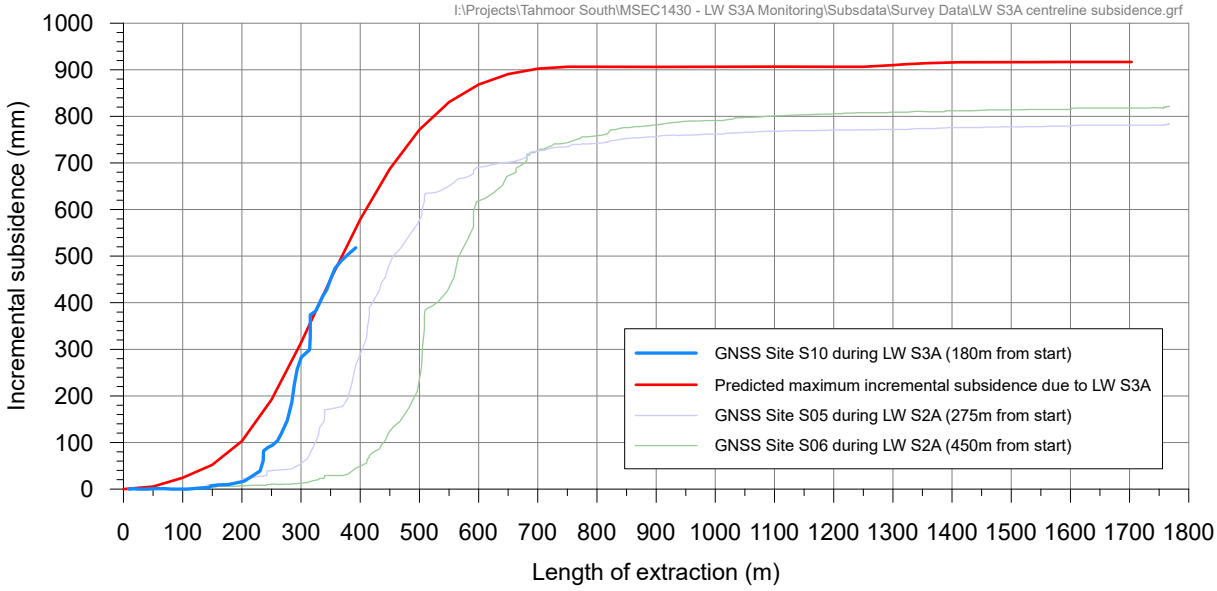
Figure A Observed development of incremental subsidence above LW S3A

Observed development of subsidence above LW S3A relative to the length of extraction is shown in Figure A. It was predicted that subsidence above LW S3A would be greater than observed above LW S2A because it is the third panel in the longwall series.

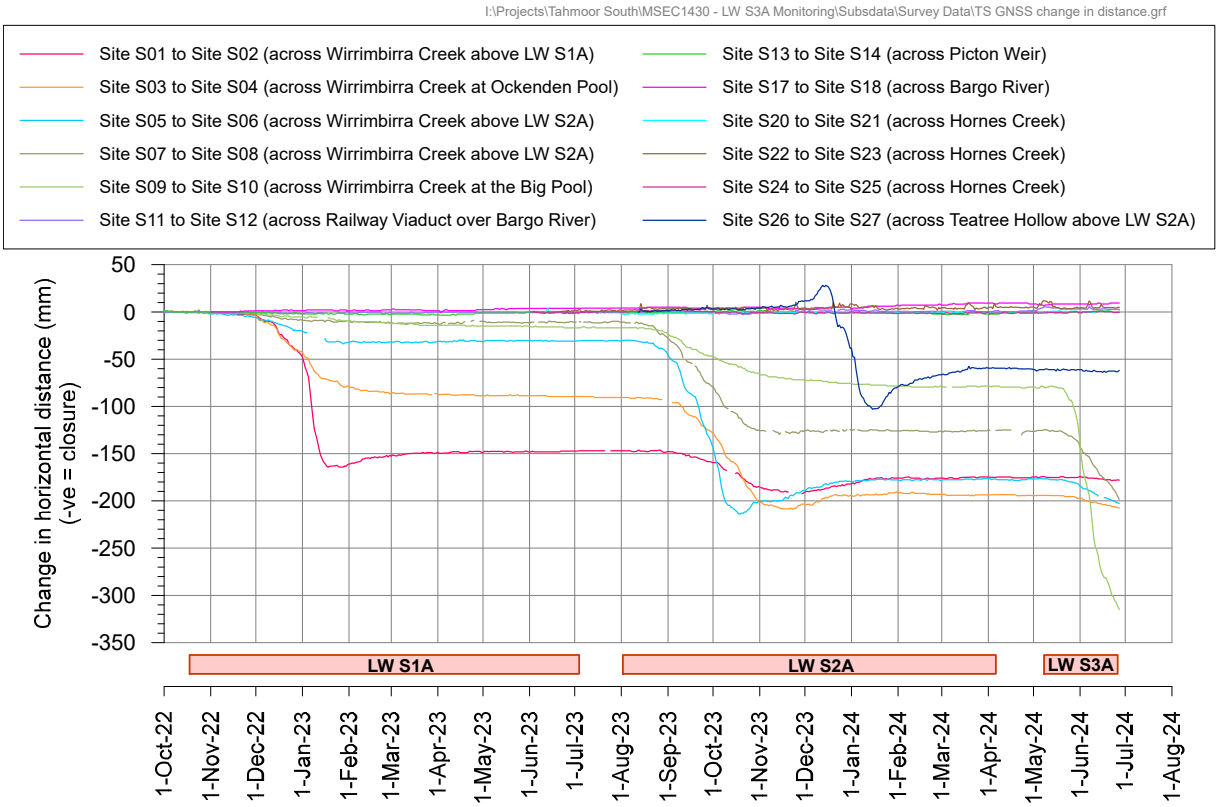
Figure B Observed changes in horizontal distances between GNSS units

Changes in horizontal distances can be calculated between GNSS units that are stationed close together and results are shown in Figure B. Closure has developed across the Tributary to Teatree Hollow (Wirrimbirra Creek). Closure is currently developing across Wirrimbirra Creek between Sites S09 and S10 directly above LW S3A. Rates of change were slightly reduced this week.

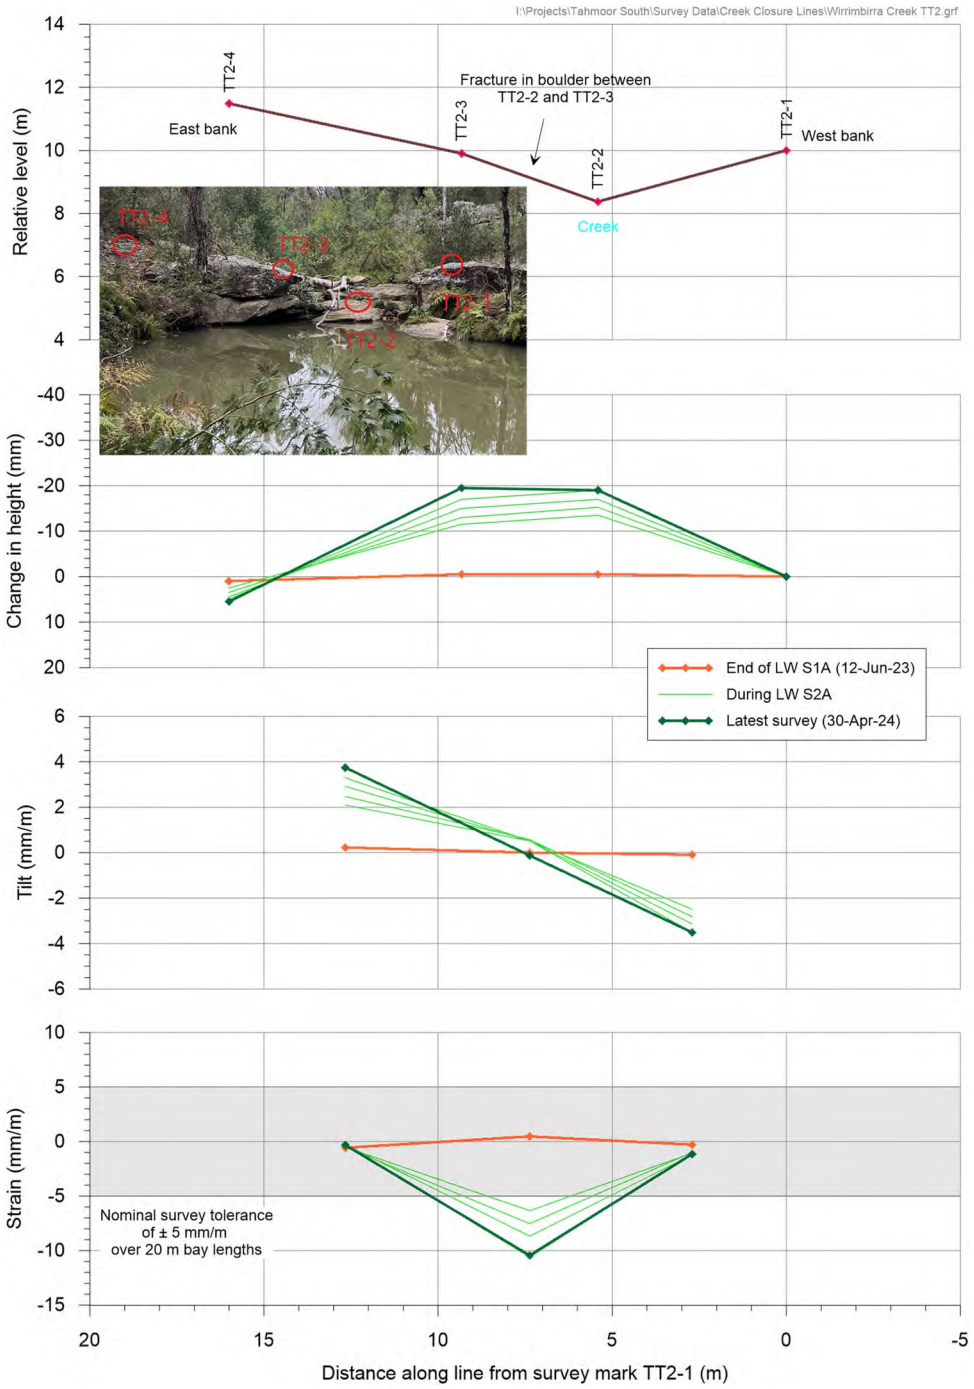
Figure D Observed subsidence, tilt and strain along TT2 line, upstream of Pool TT2

A local 3D ground survey was conducted on 9 October 2023 along the TT2 line that is located upstream of Pool TT2 and very close to the fracture in the boulder. The results are shown in Figure D. It can be seen that very little tilt or strain had developed after the mining of LW S1A but valley closure strains and

upsidence have developed since the completion of LW S1A. The fracture in the boulder is located between Pegs TT2-2 and TT2-3. The latest survey on 30 April measured no change in compressive strain.

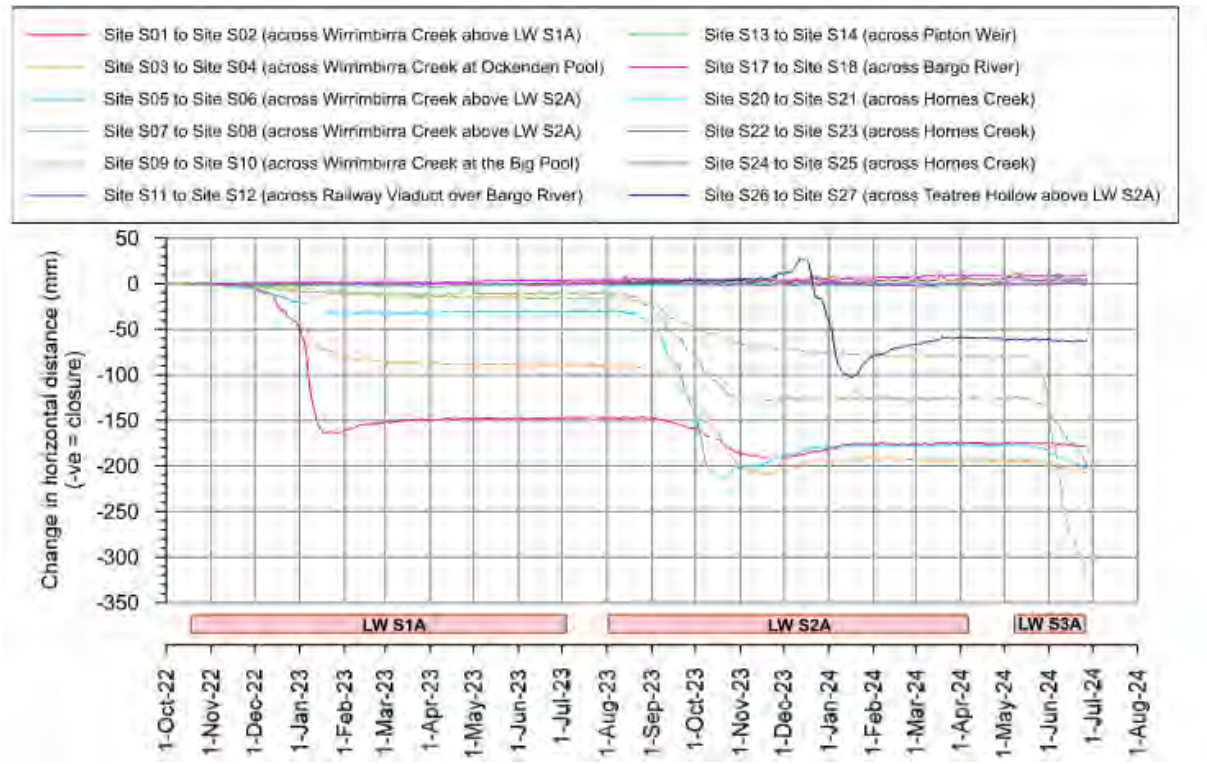
DIAGRAM 1: OBSERVED CHANGES IN HORIZONTAL DISTANCES BETWEEN GNSS UNITS (SOURCE: MSEC, 2024)

Subsidence monitoring of surface water features indicates the following:

- The rate of change of closure recorded between sites S01 to S02 (across Teatree Hollow - above LW S1A) was slight during the review period.
- The rate of change of closure recoded between sites S05 to S06 (across Wirrimbirra Creek above LW S2A) was negligible from January to mid-May 2024. Following commencement of mining of LW S3A, a further 20 mm of closure developed with approximately 200 mm of closure recorded in total between sites S05 to S06 as at end of June 2024.

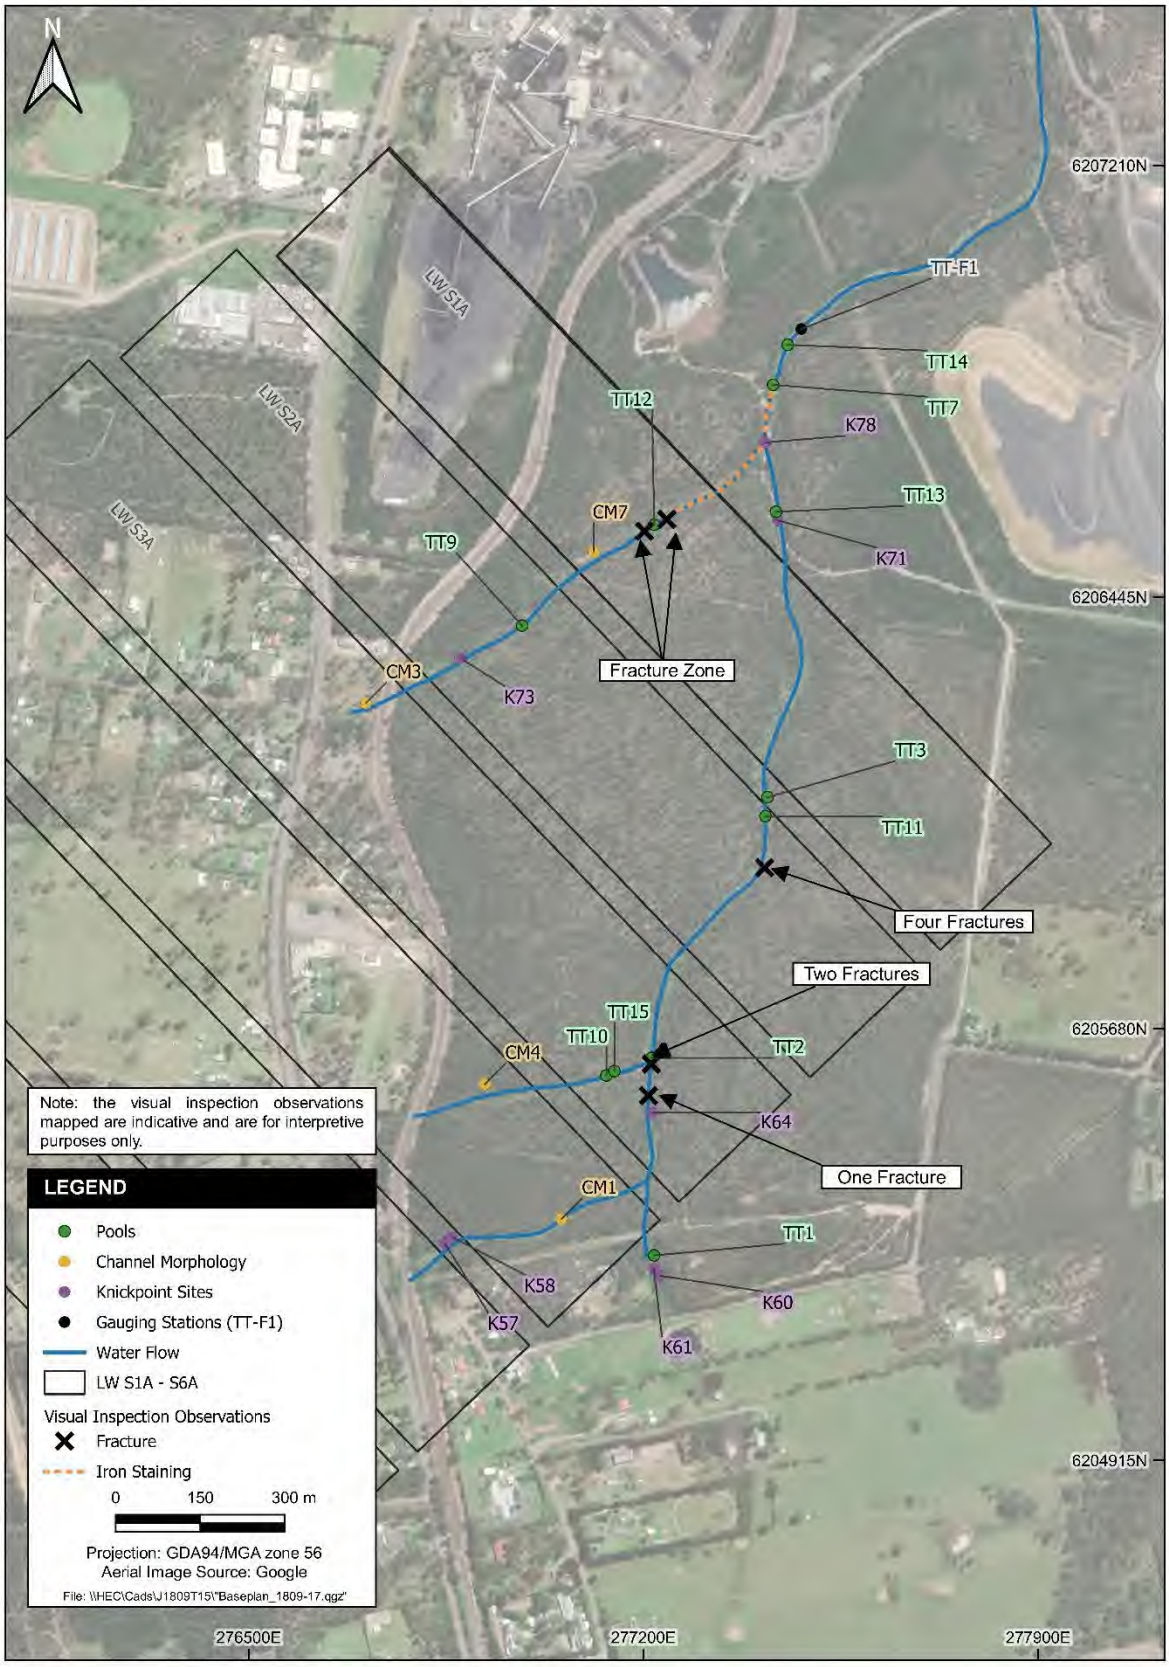
MAP 7: VISUAL DEPICTION OF SURFACE WATER CHARACTERISTICS AND PHYSICAL EFFECTS (JUNE 2024)

A visual depiction of the Teatree Hollow and Teatree Hollow tributary surface water conditions and physical effects is presented in **MAP 7**. The information presented in **MAP 7** was predominately collated from the visual inspection records (ENRS, 2024a-f) and represents conditions observed in June 2024.

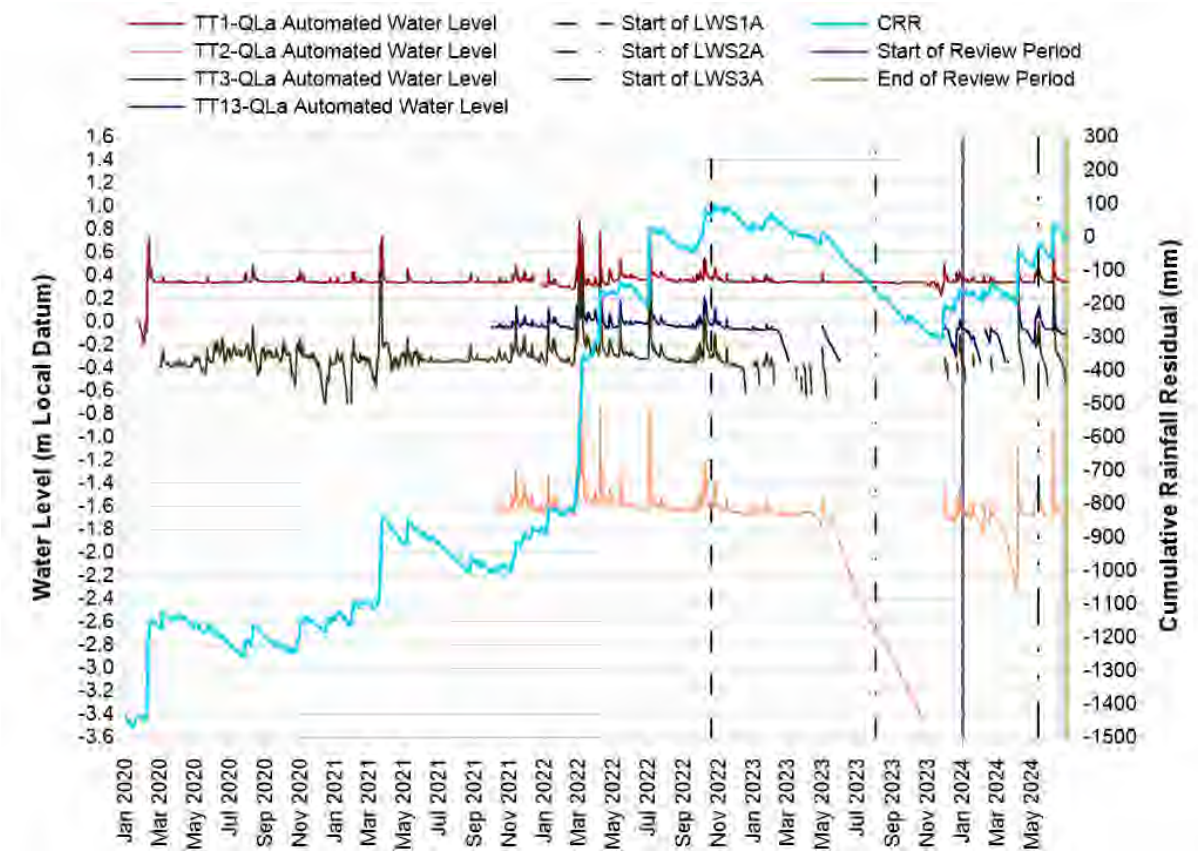
DIAGRAM 5: TEATREE HOLLOW TRIBUTARY WATER LEVEL COMPARISON

As illustrated in **DIAGRAM 5**, the water level trends recorded at pool TT1 (reference site TT1-QLa) were consistent with climatic conditions during the review period.

As such, it is considered that the water level decline recorded at pool TT2 during the review period is related to mining effects in combination with the prevailing climatic conditions.

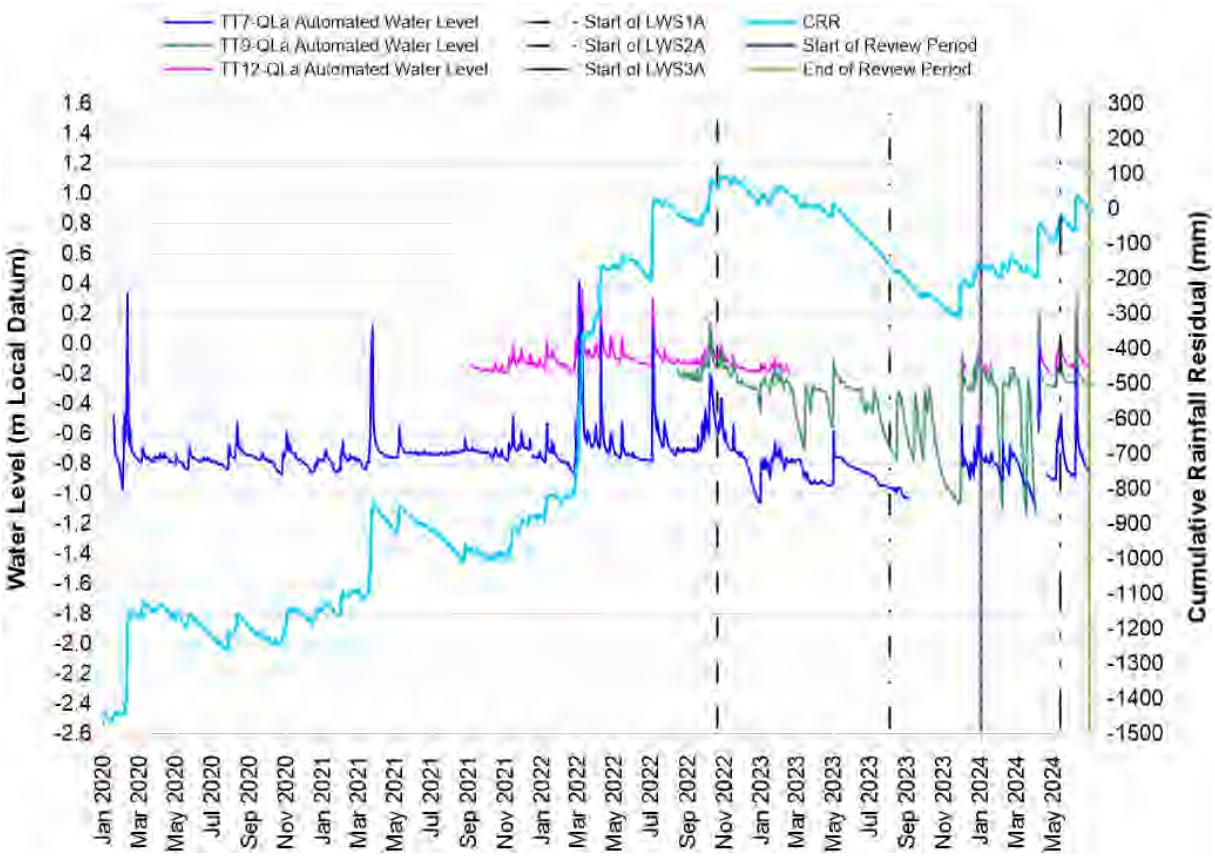
DIAGRAM 6: TEATREE HOLLOW WATER LEVEL COMPARISON

As illustrated in **DIAGRAM 6**, the water level recorded at pool TT7 during the review period was generally consistent with climatic conditions, fluctuating in response to rainfall trends. From late March to early April 2024, a decline in water level was recorded equating to a Level 1 trigger.

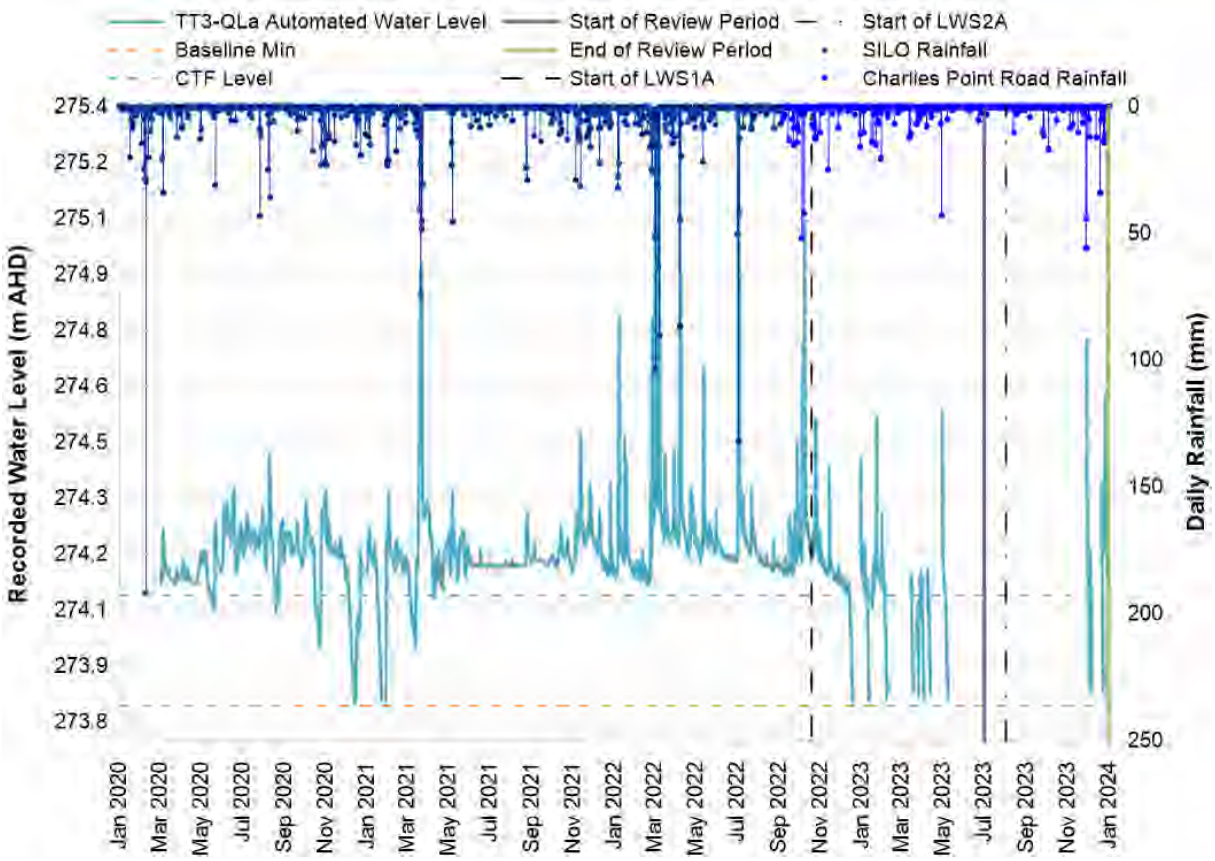
DIAGRAM B1.3: MONITORING SITE TT3-QLA WATER LEVEL RECORDS

Monitoring Site	Classification	Summary of Water Level Trends	Appendix B - Graph Reference
Teatree Hollow Catchment			
TT1-QLa	Reference Site	The water level trends were consistent with climatic conditions for the duration of the review period. The water level was recorded below the CTF for short periods in early-March, consistent with below average rainfall conditions. The water level rose considerably in early April and early June in response to high rainfall events.	B1.1
TT2-QLa	Potential Impact Site	The water level rose and fell periodically in response to rainfall conditions. The water level declined below the trigger level for a brief period in February 2024 and from mid-March to early April.	B1.2
TT3-QLa	Potential Impact Site	The water level was recorded above the CTF level for brief periods during and following rainfall events. During low rainfall periods, the water level declined below the sensor level or the pool was dry.	B1.3
