Tahmoor Coal Pty Ltd

SIX MONTHLY SUBSIDENCE IMPACT REPORT

Tahmoor South Domain Longwalls South 1A – South 6A

1 January 2024 – 30 June 2024

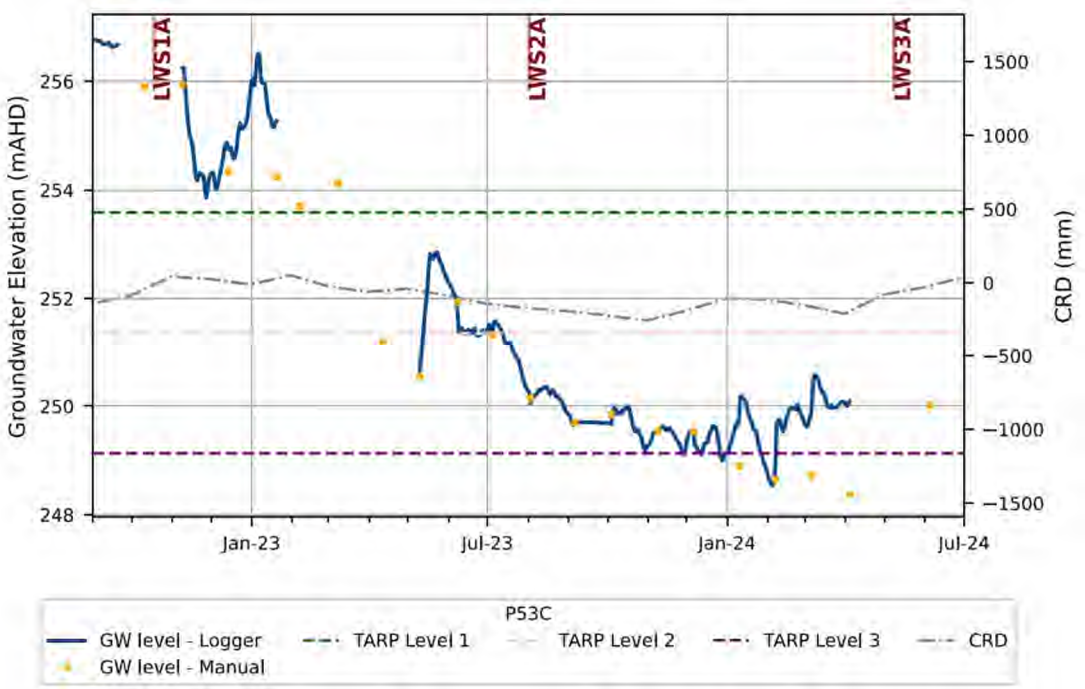
Figure 8 P53C Hydrograph

- P53C – Level 2 TARP (see **Figure 8**)
  - At P53C, the groundwater elevation was lower than the TARP Level 2 trigger level in all monitoring rounds since August 2023. Over the reporting period, the groundwater level has fluctuated by approximately 2 m with groundwater potentially beginning to show some recovery.

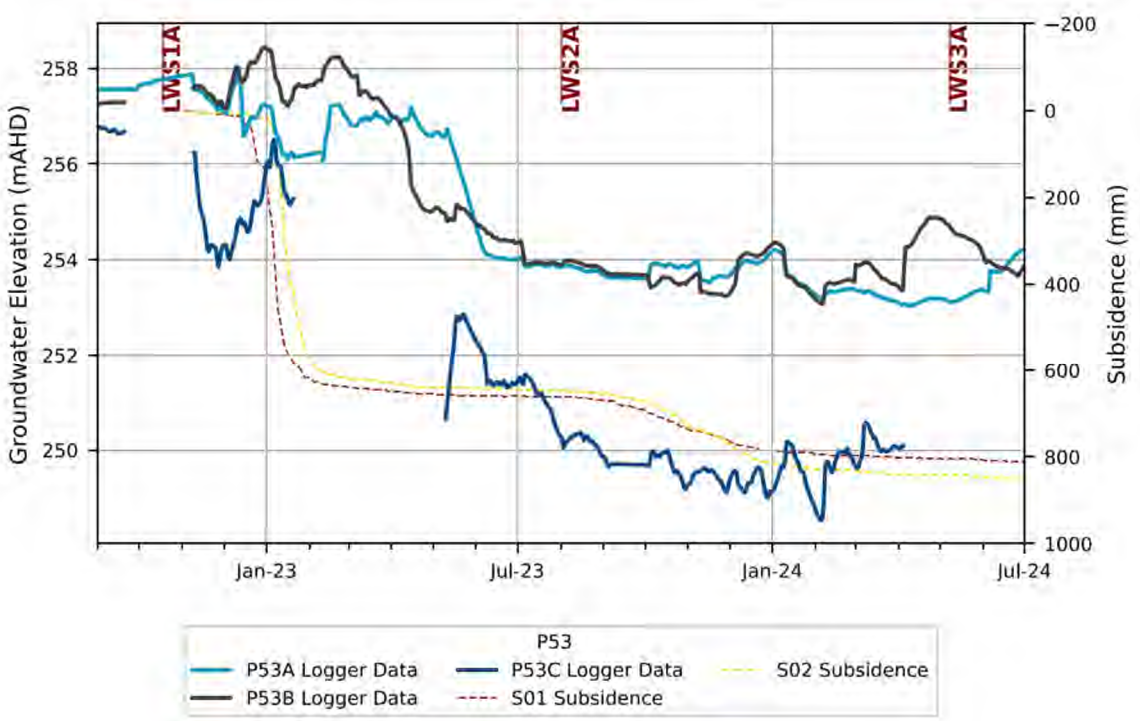
Figure 9 P53 Site Hydrographs and closest subsidence monitoring points

The notable decline observed in April/May 2023 does not correlate directly with the extraction progression, with LW S1A nearing completion at this time (i.e. not mining adjacent to the bores at this time). **Figure 9** presents the hydrographs accompanied by the closest subsidence monitoring points (GNSS units), which overlie LW S1A (see **Figure 3**). The subsidence typically shows direct correlation to when extraction occurs directly beneath. The subsidence and groundwater level profiles over time show similar trends, with a short period of relatively rapid decline followed by stabilisation. Although the subsidence profile appears more responsive to longwall extraction activities directly. The groundwater drawdown appears to be more regional and potentially delayed response.

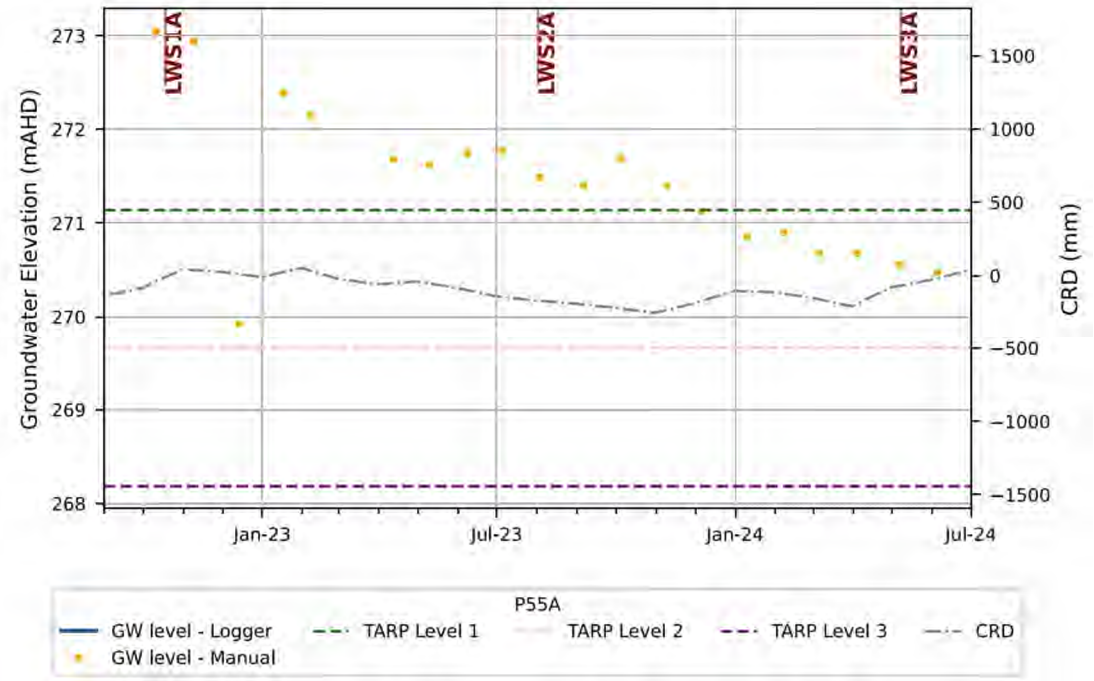
Figure 10 P55A Hydrograph

- P55A – Level 1 TARP (**Figure 10**)
  - Groundwater levels at P55A have shown relatively consistent decline over time, noting some fluctuations, with all monitoring points since December 2023 below the Level 1 TARP trigger. An overall decline of approximately 2.5 m has been observed since mid-2022.
- P55B – Level 3 TARP (**Figure 11**)
  - Groundwater elevation at P55B has shown relatively consistent decline over time, noting some fluctuations, with all monitoring points since December 2023 below the Level 3 TARP trigger.
- P55C – Level 2 TARP (**Figure 12**)
  - Groundwater elevation at P55C has more apparent fluctuation than the two shallower bores, although the overall trend is a decline in water levels.

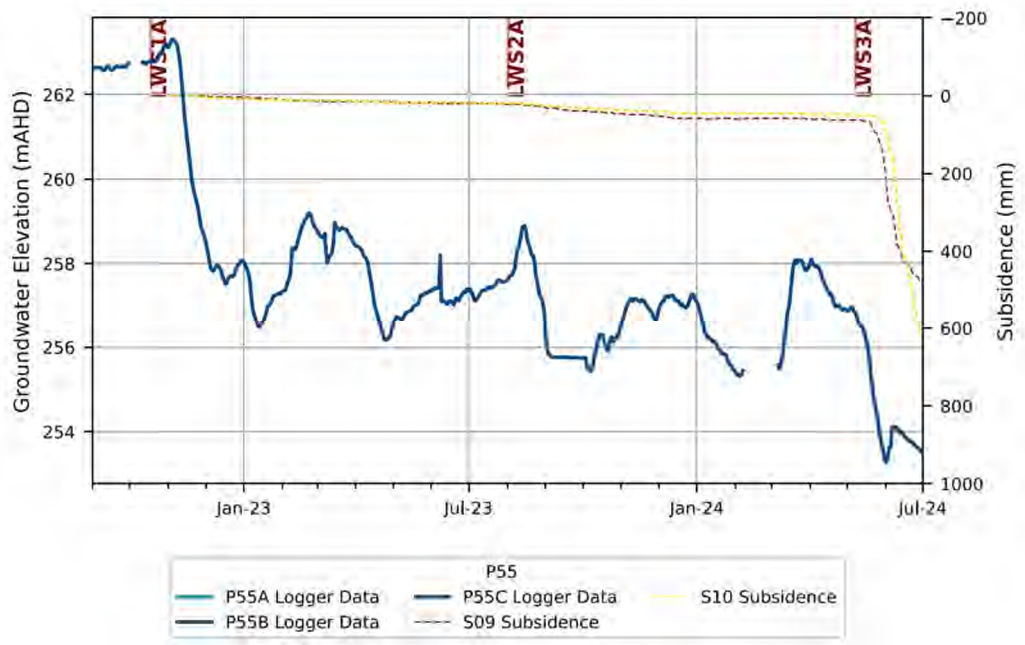
Figure 13 P55 Hydrograph and closest GNSS subsidence data

Review of groundwater levels in P55C (the only bore with logger data) against the closest GSSN units is provided in **Figure 13**. The GSSN units clearly show direct response to undermining, showing subsidence when the longwall passes beneath the unit. The groundwater response appears more regional, occurring over time as the regional groundwater levels drawdown. This consistent decline over time is likely resultant from mining extraction activities.

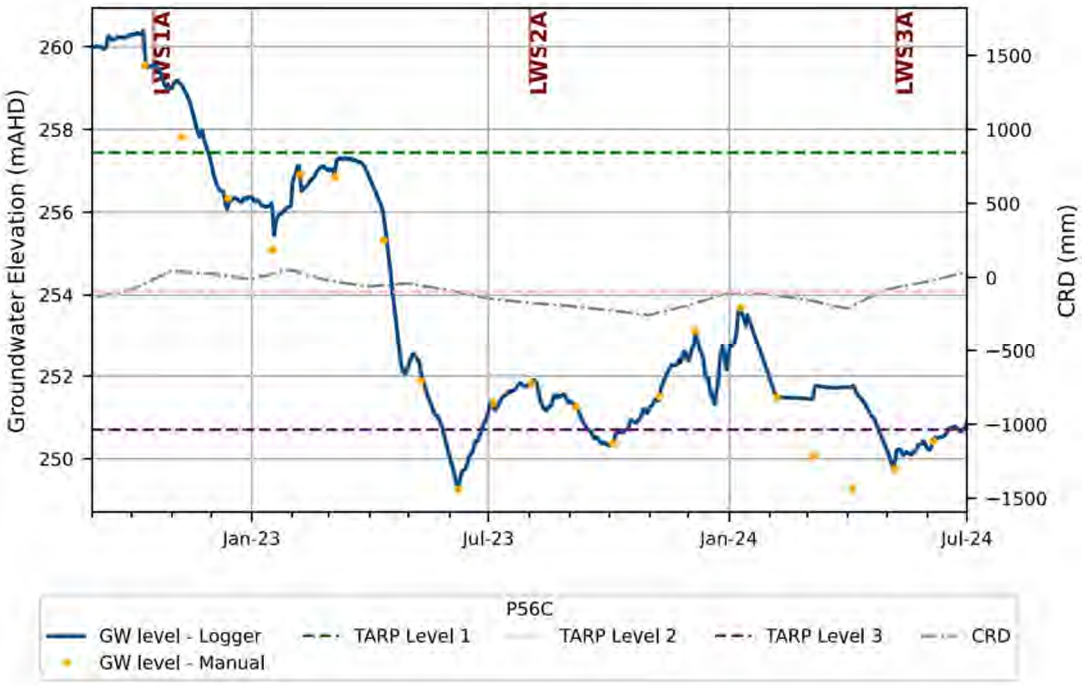
Figure 14 P56C Hydrograph

- P56A – normal conditions,
- P56B – normal conditions
- P56C – Level 2 TARP in January through June 2024 (see **Figure 14**).
    - Groundwater levels at P56C have shown periods of decline, with intermittent periods of stabilisation and minor recovery, although the overall trend is of decline. March through June (4 months) saw water levels drop below the Level 3 trigger, although a trend of recovering water levels may be apparent. Ongoing monitoring required to ascertain trends.

P56A has no indication of decline in water levels, maintaining stable at baseline conditions. P56B has some minor decline but also periods of significant increase (above baseline conditions). Given the groundwater trends are not consistent across all nested piezometers and show notable fluctuations that do not appear to align with longwall progression, the declining water levels in P56C are not deterministically attributable to mining operations at this point in time.

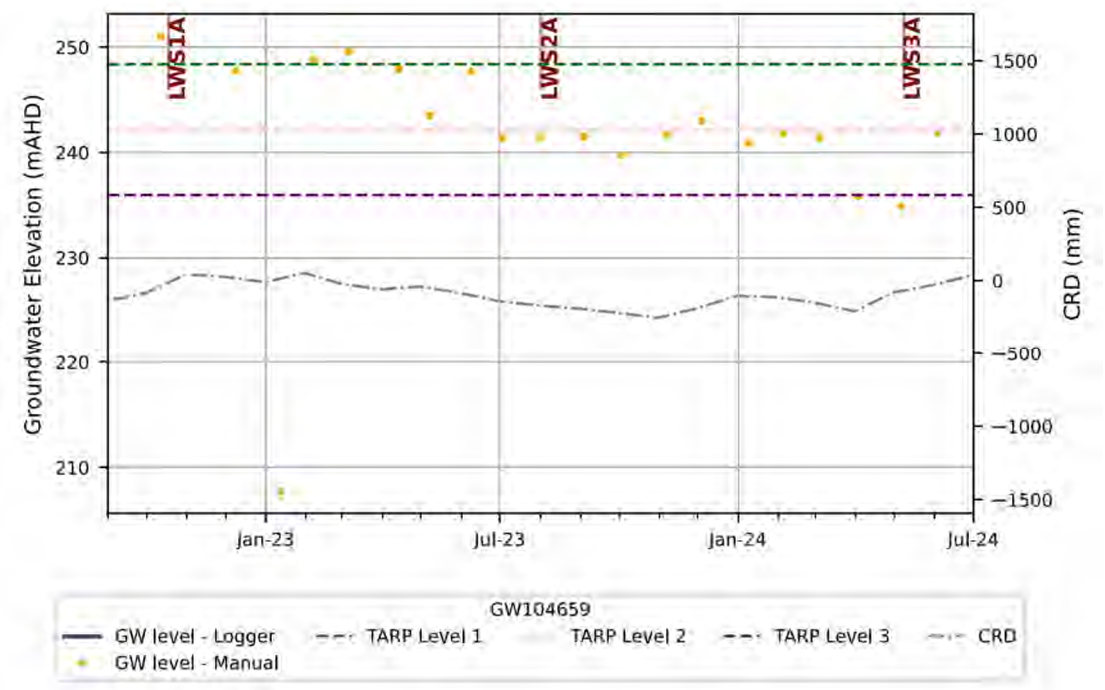
Figure 15 GW104659 Hydrograph

Bore GW104659 is located to the north of the end of LW S1A. Groundwater levels were relatively stable until July 2023 when a decrease below the TARP Level 2 trigger was observed, after which another period of relative stability (noting fluctuations) occurred (**Figure 15**). A drop below the TARP Level 3 trigger occurred in April and May of 2024 prior to a return to the previous stable level in June 2024.

The fluctuations observed in the bore appear to correlate to the CRD (rainfall fluctuations), however there appears to be an overarching trend of groundwater decline.

During the initial private bore survey, this bore was reported to be utilised regularly to replenish the adjacent dam. In order to ascertain if drawdown is due to use or mining the pumping schedule would need to be reviewed. There has been no reported issue with bore operation from the bore owner, and groundwater quality indicated no variation over time that aligns with extraction activities. Consequently, the declining groundwater levels are not definitively attributed to mining activity.

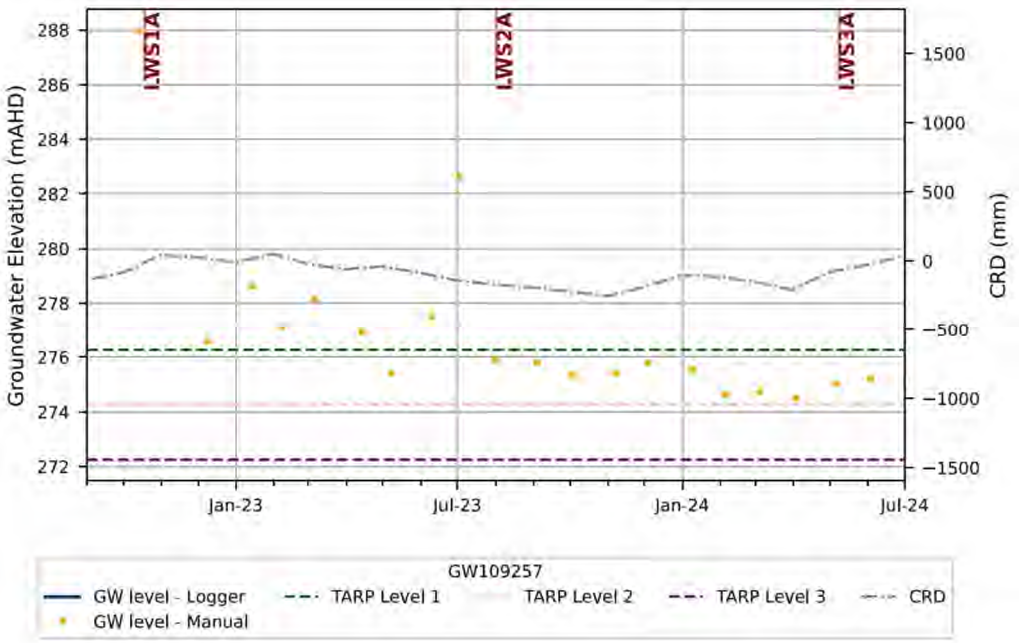
Figure 16 GW109257 Hydrograph

Bore GW109257 is located near the start of LW S6A, to the south of current extraction areas. All monitoring points since July 2023 are below the Level 1 TARP trigger (**Figure 16**). The groundwater levels are quite reflective of the CRD. Given the spatial disparity from the current extraction and the reflection of rainfall conditions, this TARP trigger is not definitively attributed to mining activity. Ongoing monitoring and review is recommended.

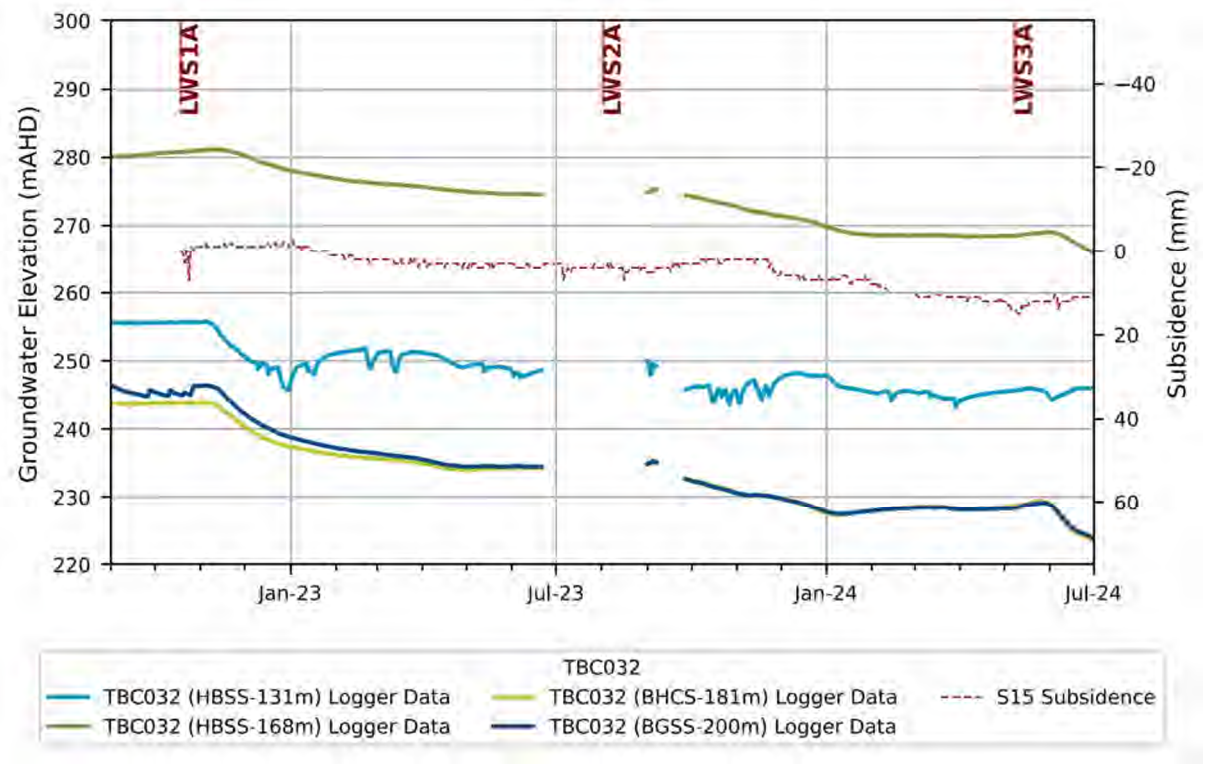
Figure 17 TBC032 Hydrograph with closest GNSS unit subsidence

- HBSS – 131 metres: TARP Level 3
- HBSS – 168 metres: normal conditions
- BHCS – 181 metres: TARP Level 1
- BGSS – 200 metres: TARP Level 1

The declines observed in TBC032 are relatively consistent across all sensors and show similar trends to the shallower OSPs, with periods of more rapid decline followed by some stabilisation. However, overall, there is an observed trend of declining groundwater levels in all sensors. **Figure 17** presents the TBC032 hydrographs, with the closest GNSS unit subsidence data. Minimal subsidence (< 15 mm) has been observed here. The groundwater decline is likely a regional groundwater drawdown in response to mining activity.

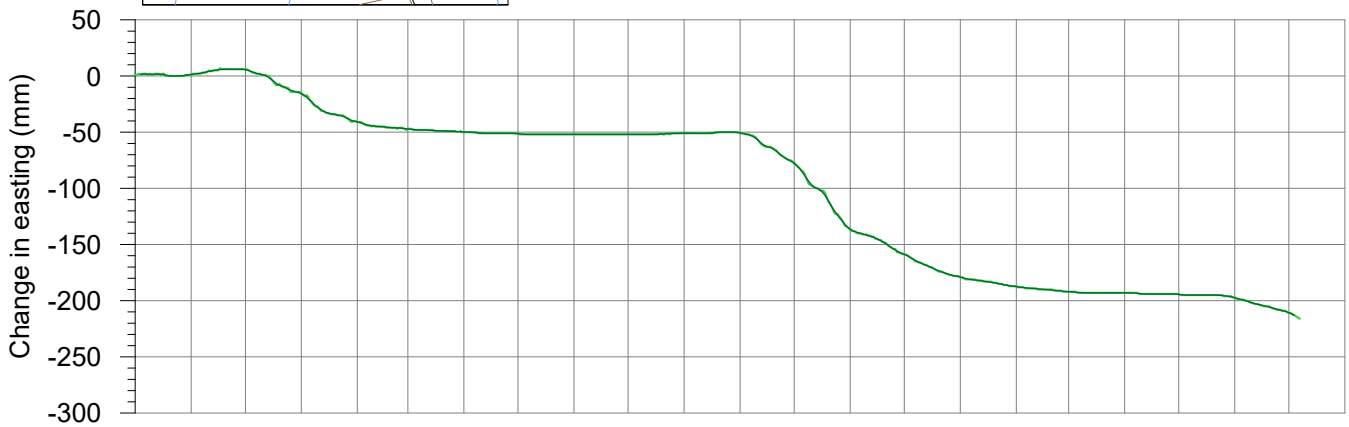
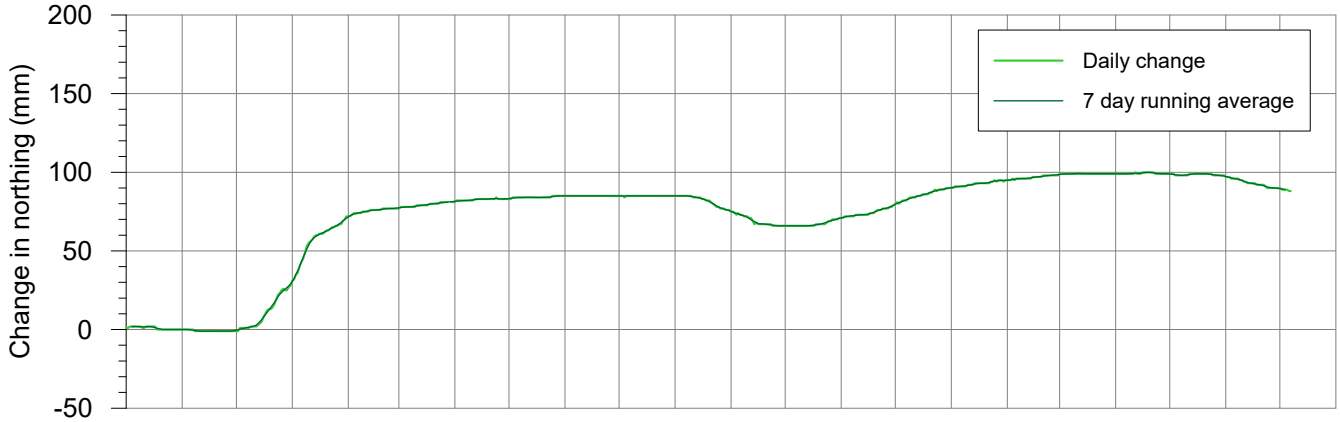
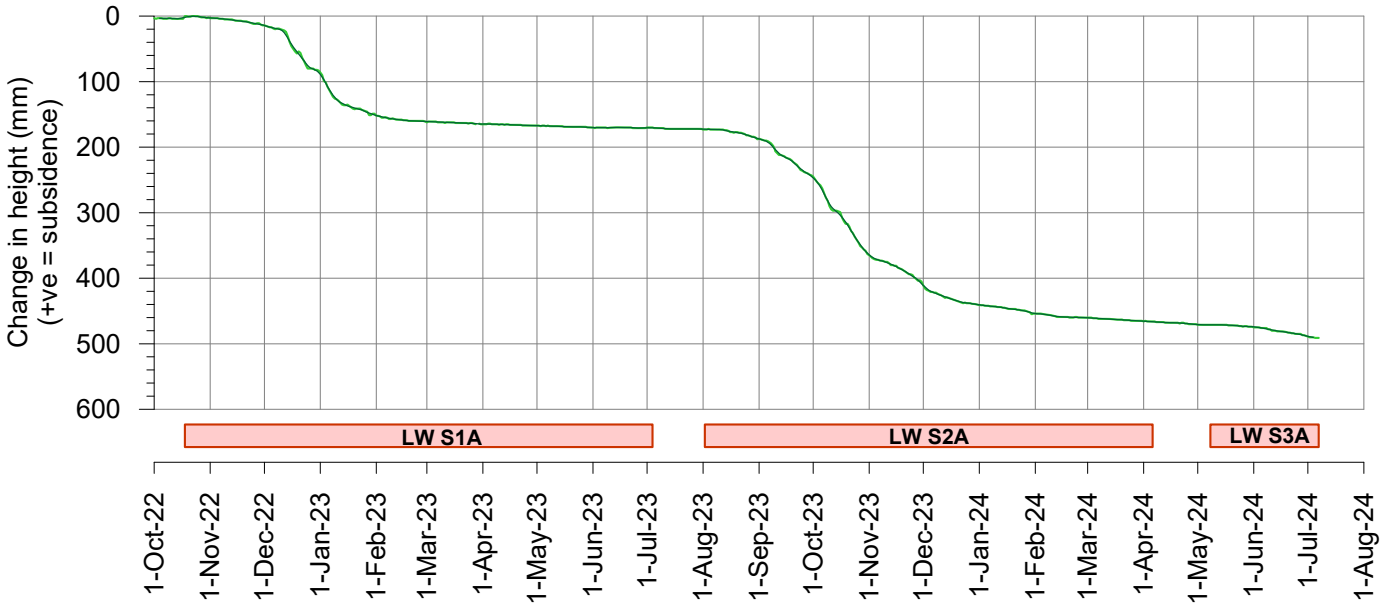
Fig. S03-R06

Site S03 above LW S1A at Teatree 3

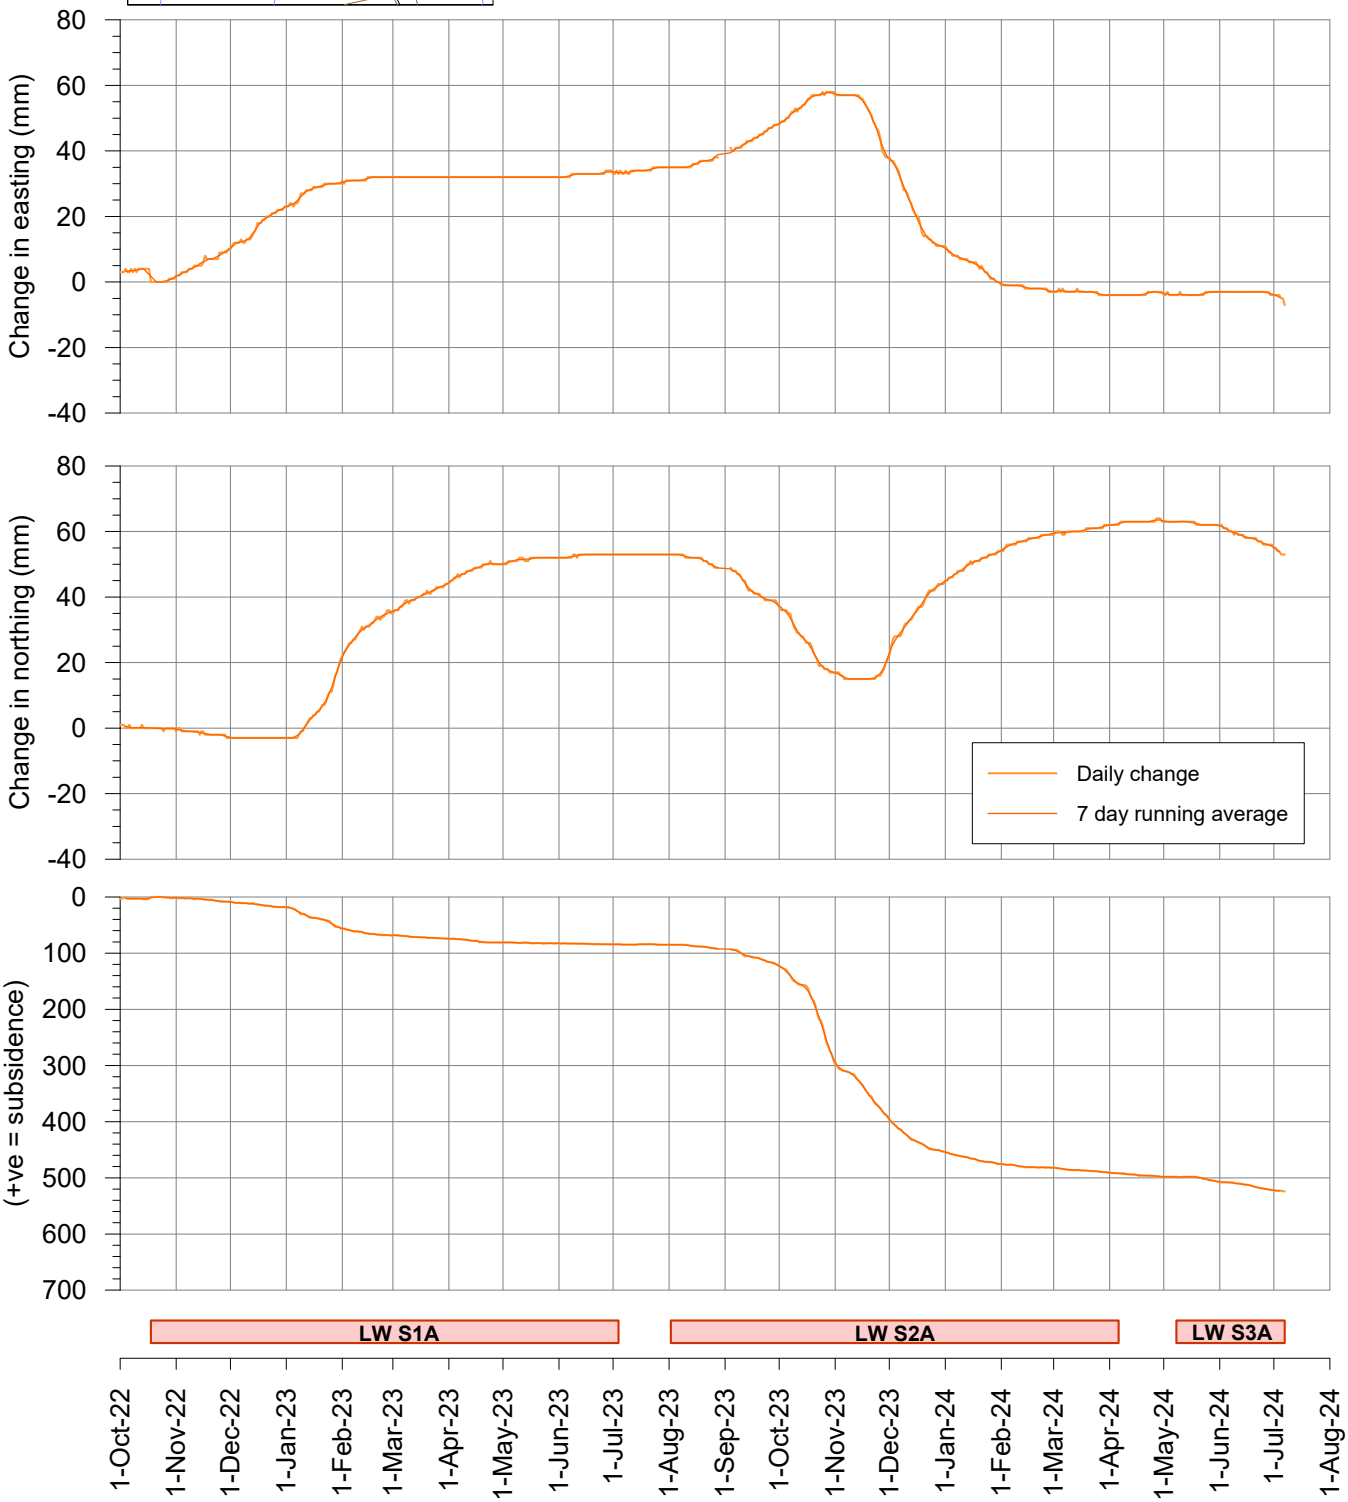
Fig. S04-R06

Site S04 above LW S2A at Teatree 3

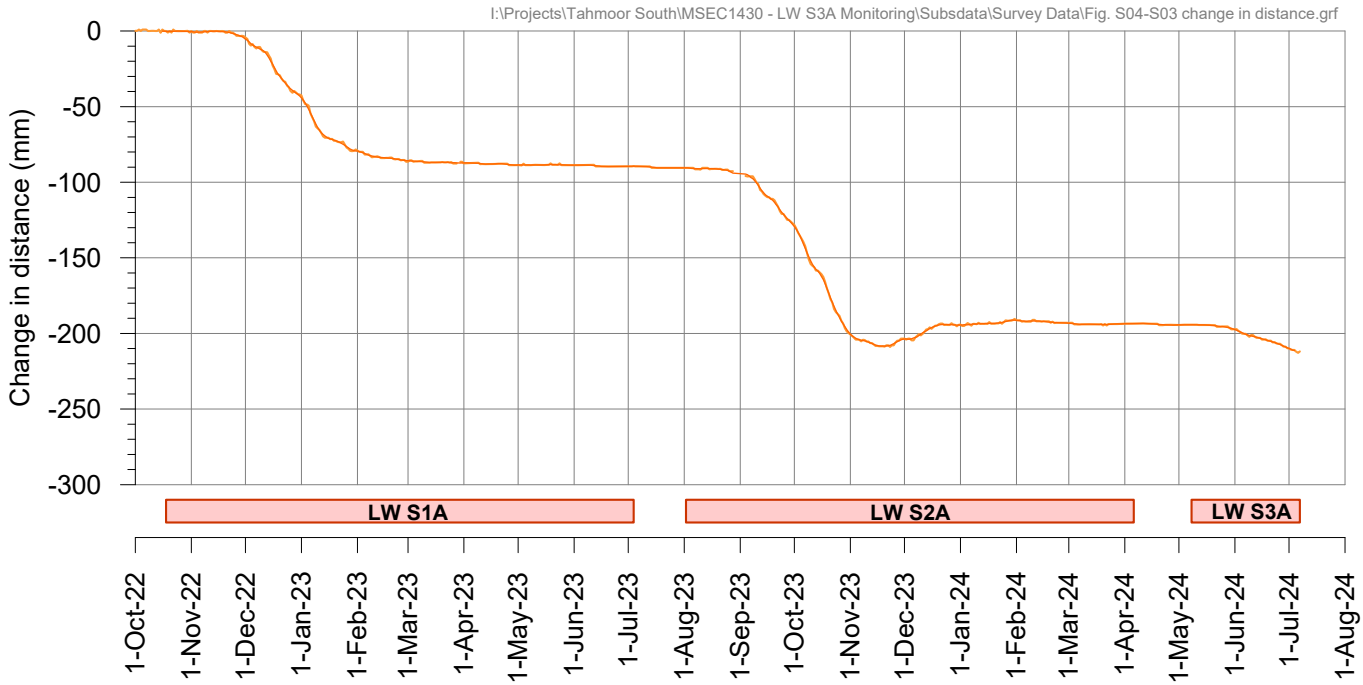
Change in distance across Wirrimbirra Creek at Teatree 3
Site S03 above LW S1A and Site S04 above LW S2A

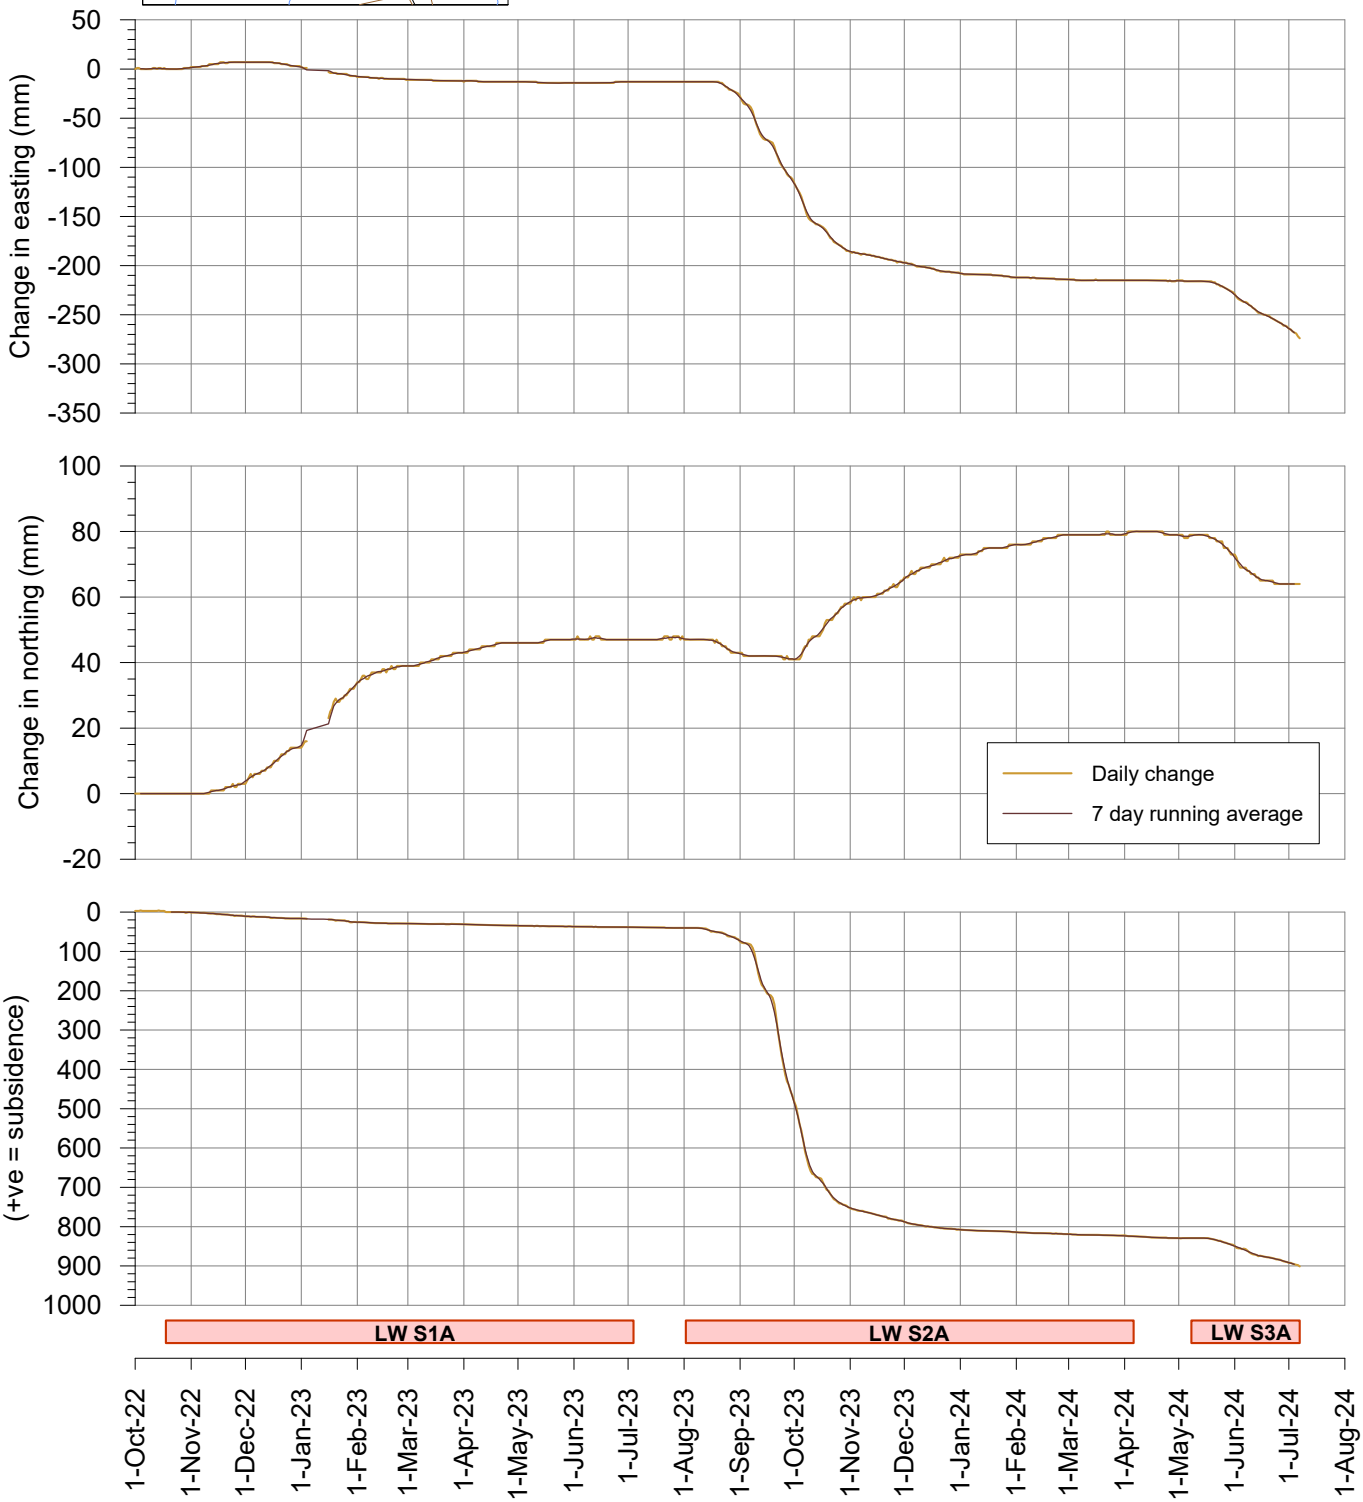
Fig. S05-R06

Site S05 above LW S2A

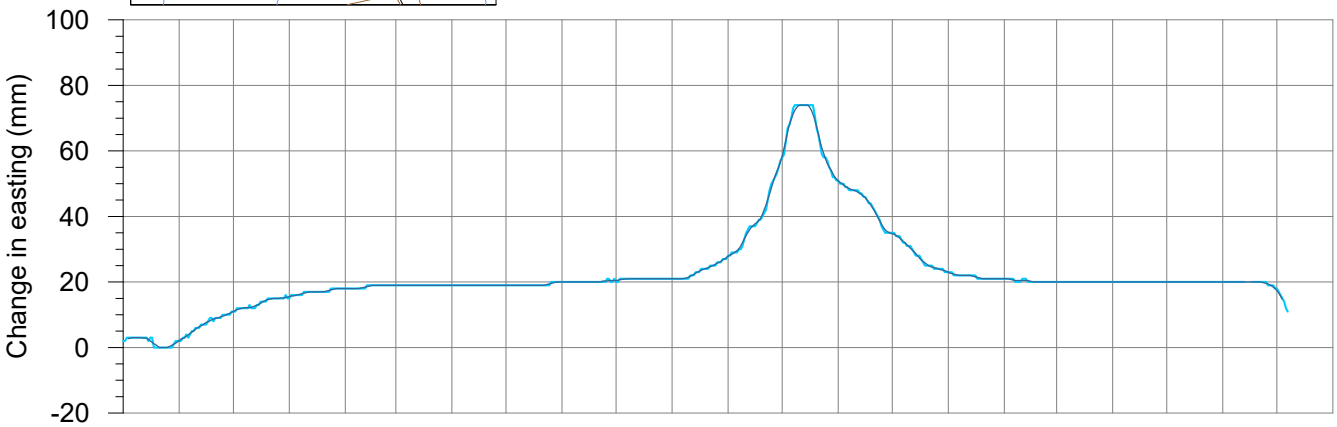
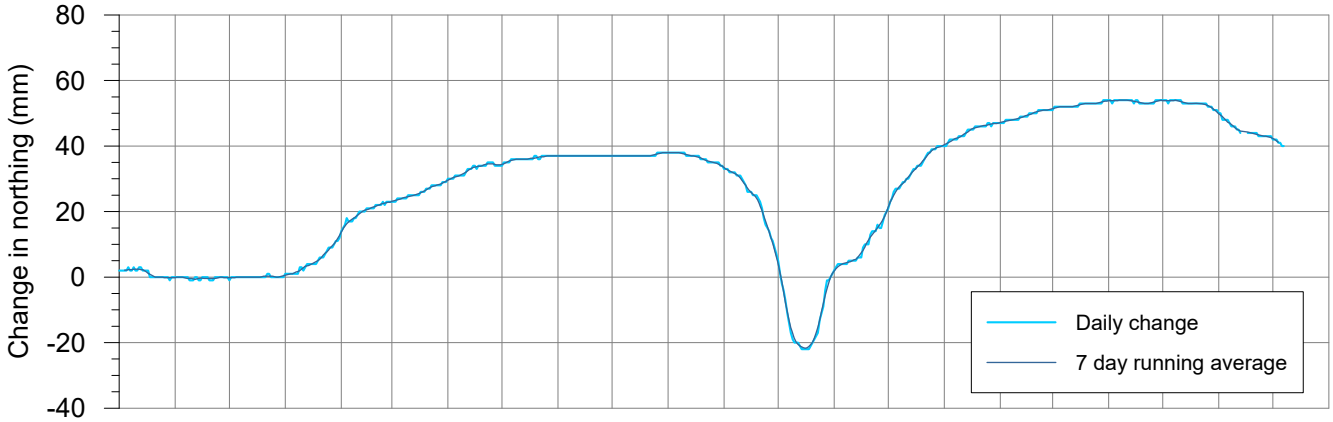
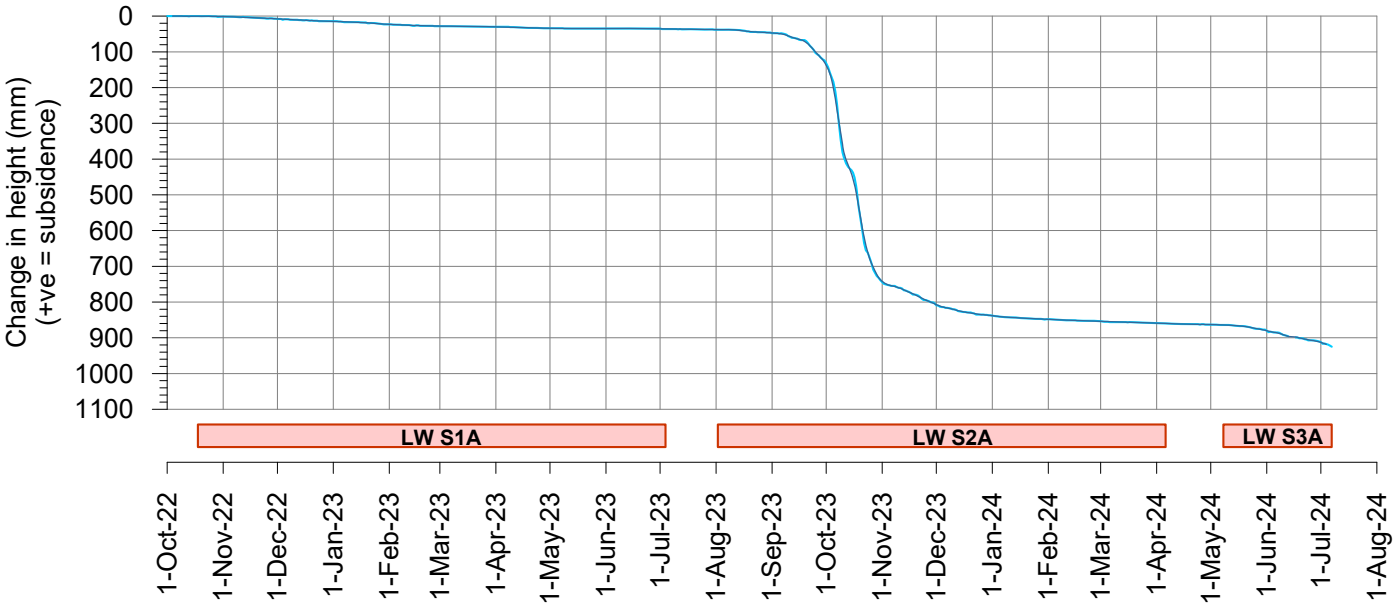
Fig. S06-R06

Site S06 above LW S2A

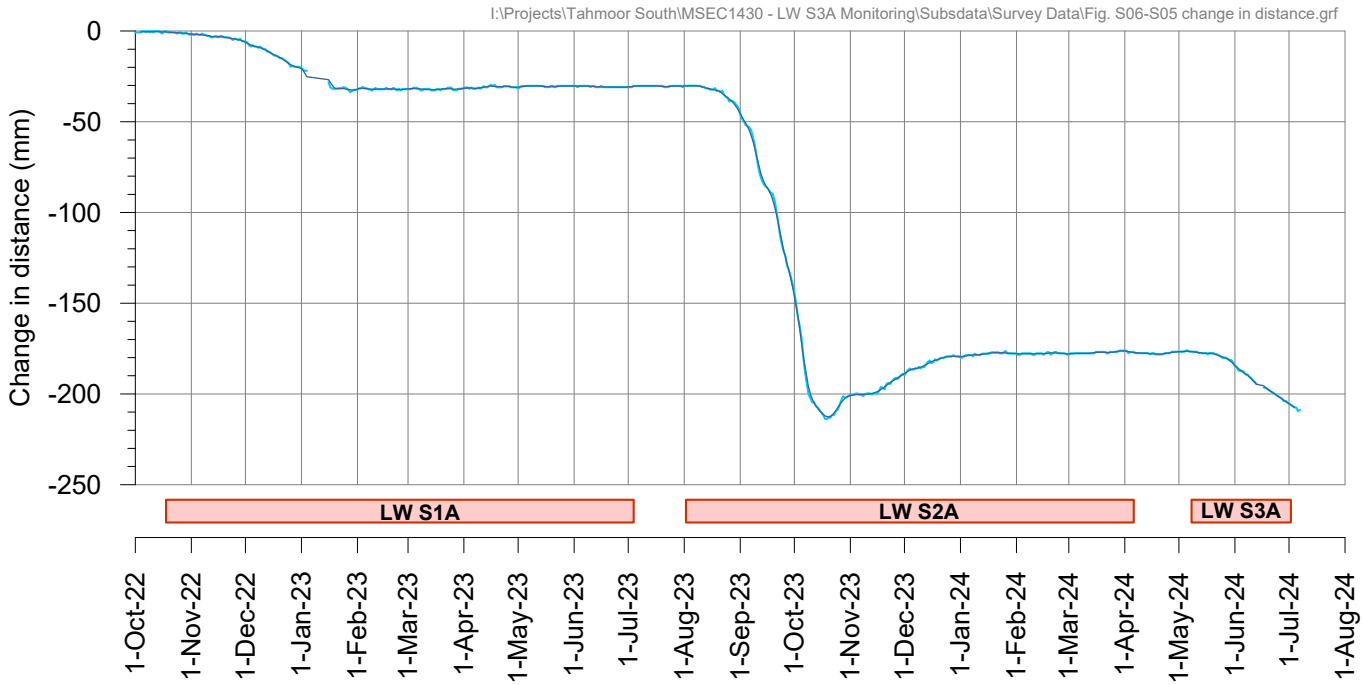
Change in distance across Wirrimbirra Creek
Sites S05 and S06 above LW S2A

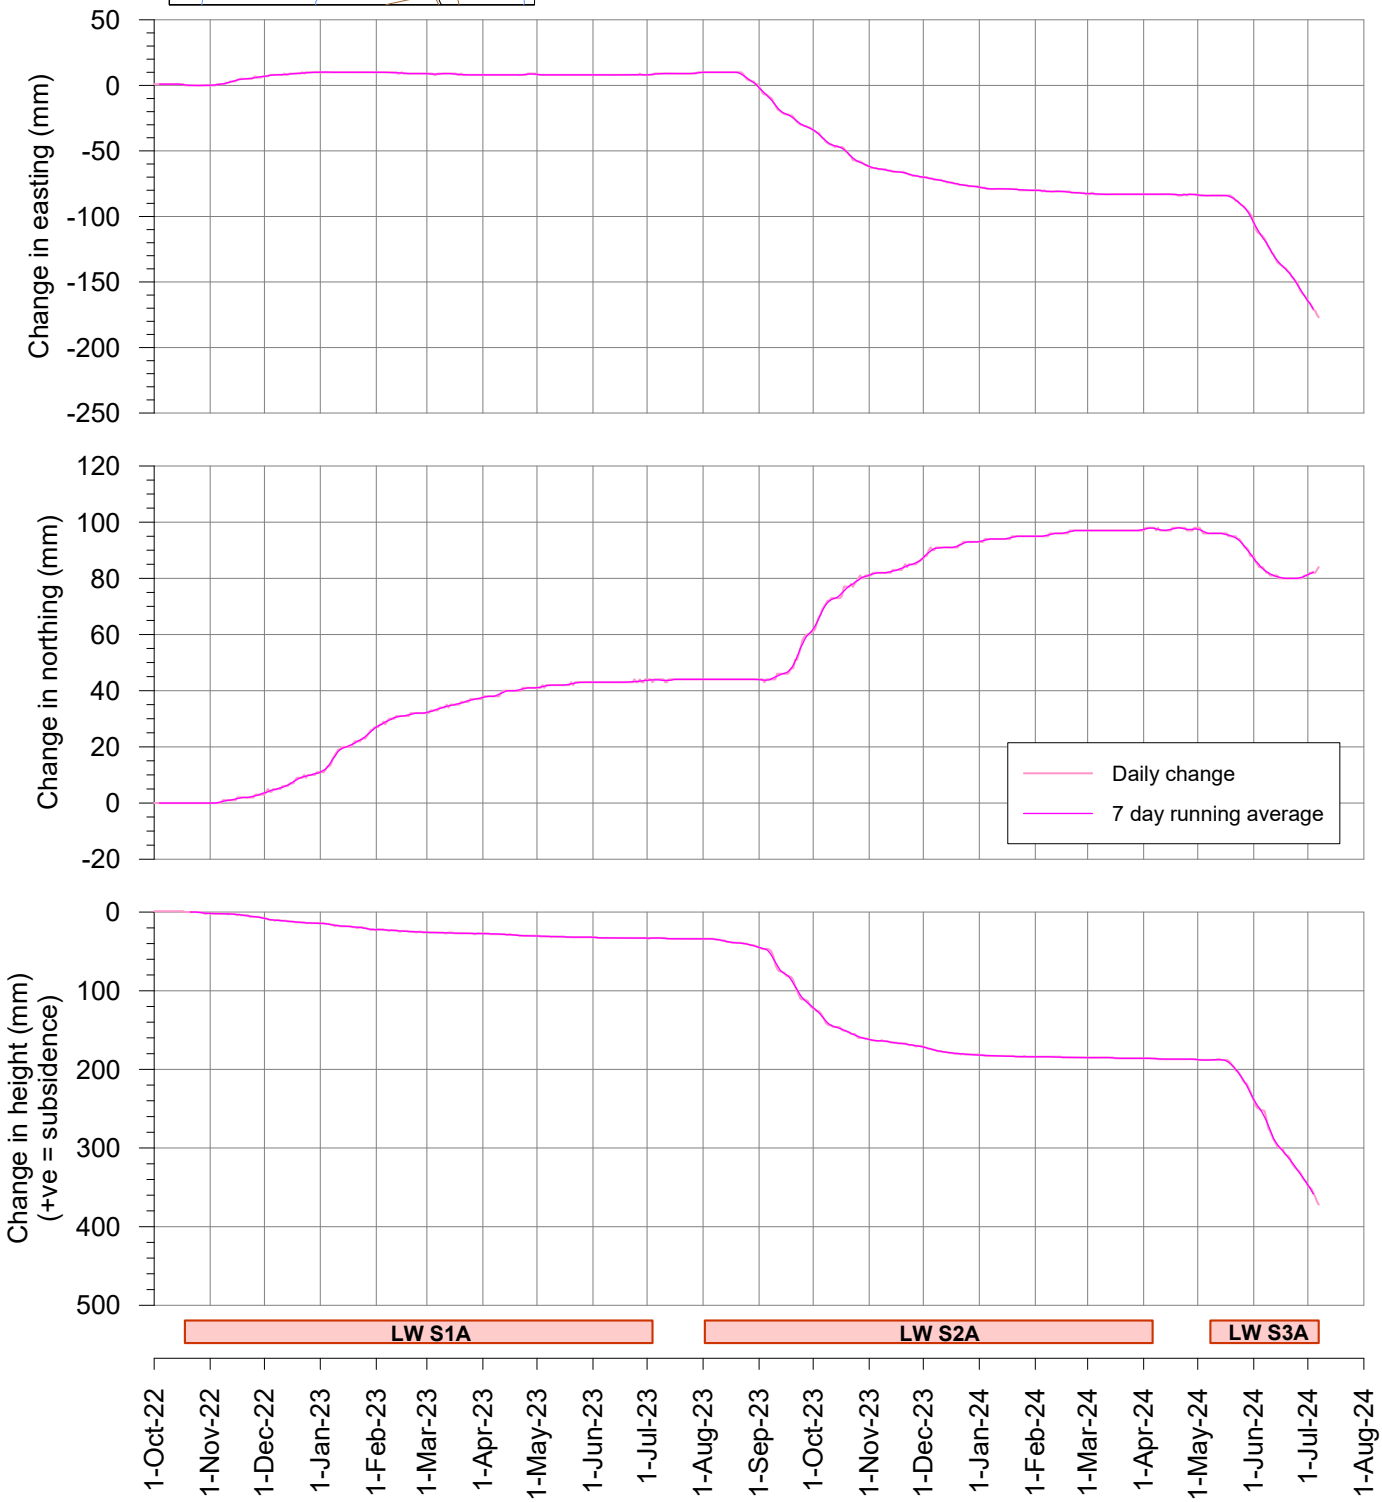
Fig. S07-R06

Site S07 above LW S2A

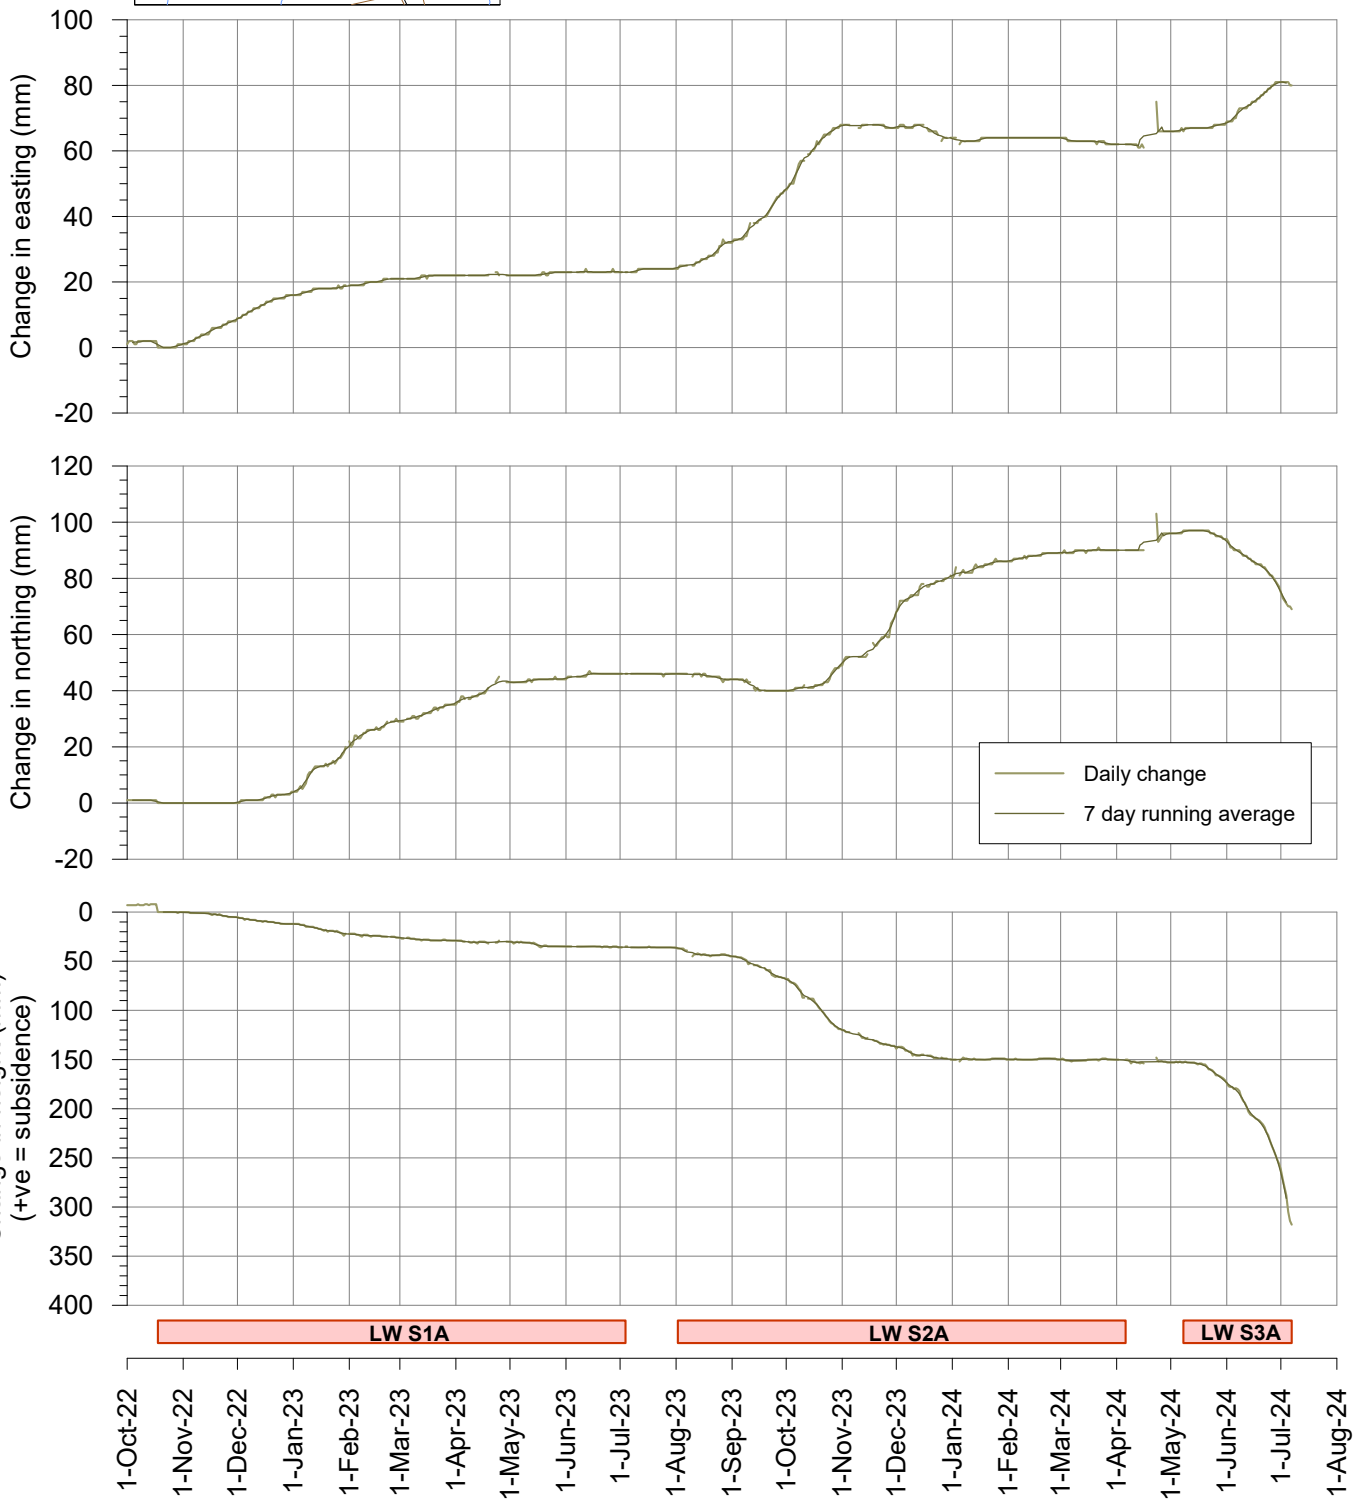
Fig. S08-R06

Site S08 between LW S2A and LW S3A

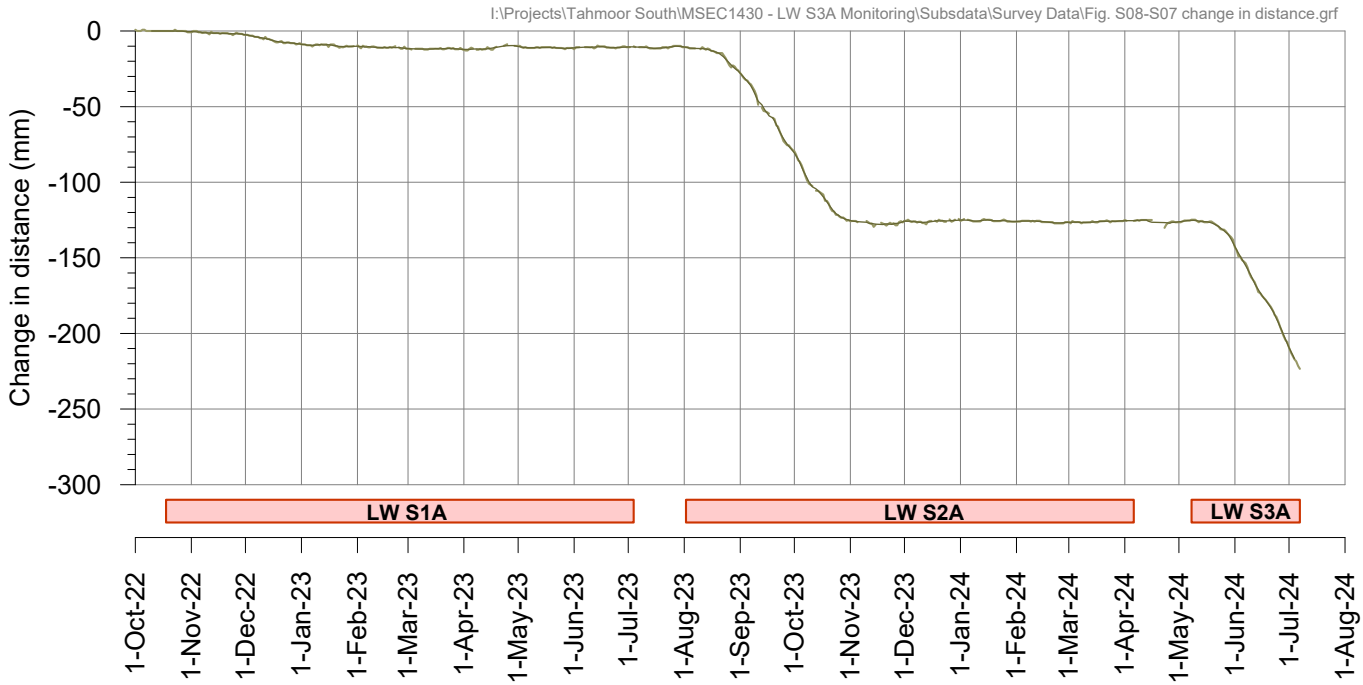
Change in distance across Wirrimbirra Creek
Site S07 above LW S2A and Site S08 between LW S2A and LW S3A
