Tahmoor Coal Pty Ltd

SIX MONTHLY SUBSIDENCE IMPACT REPORT

Tahmoor South Domain Longwalls South 1A – South 6A

1 January 2024 – 30 June 2024

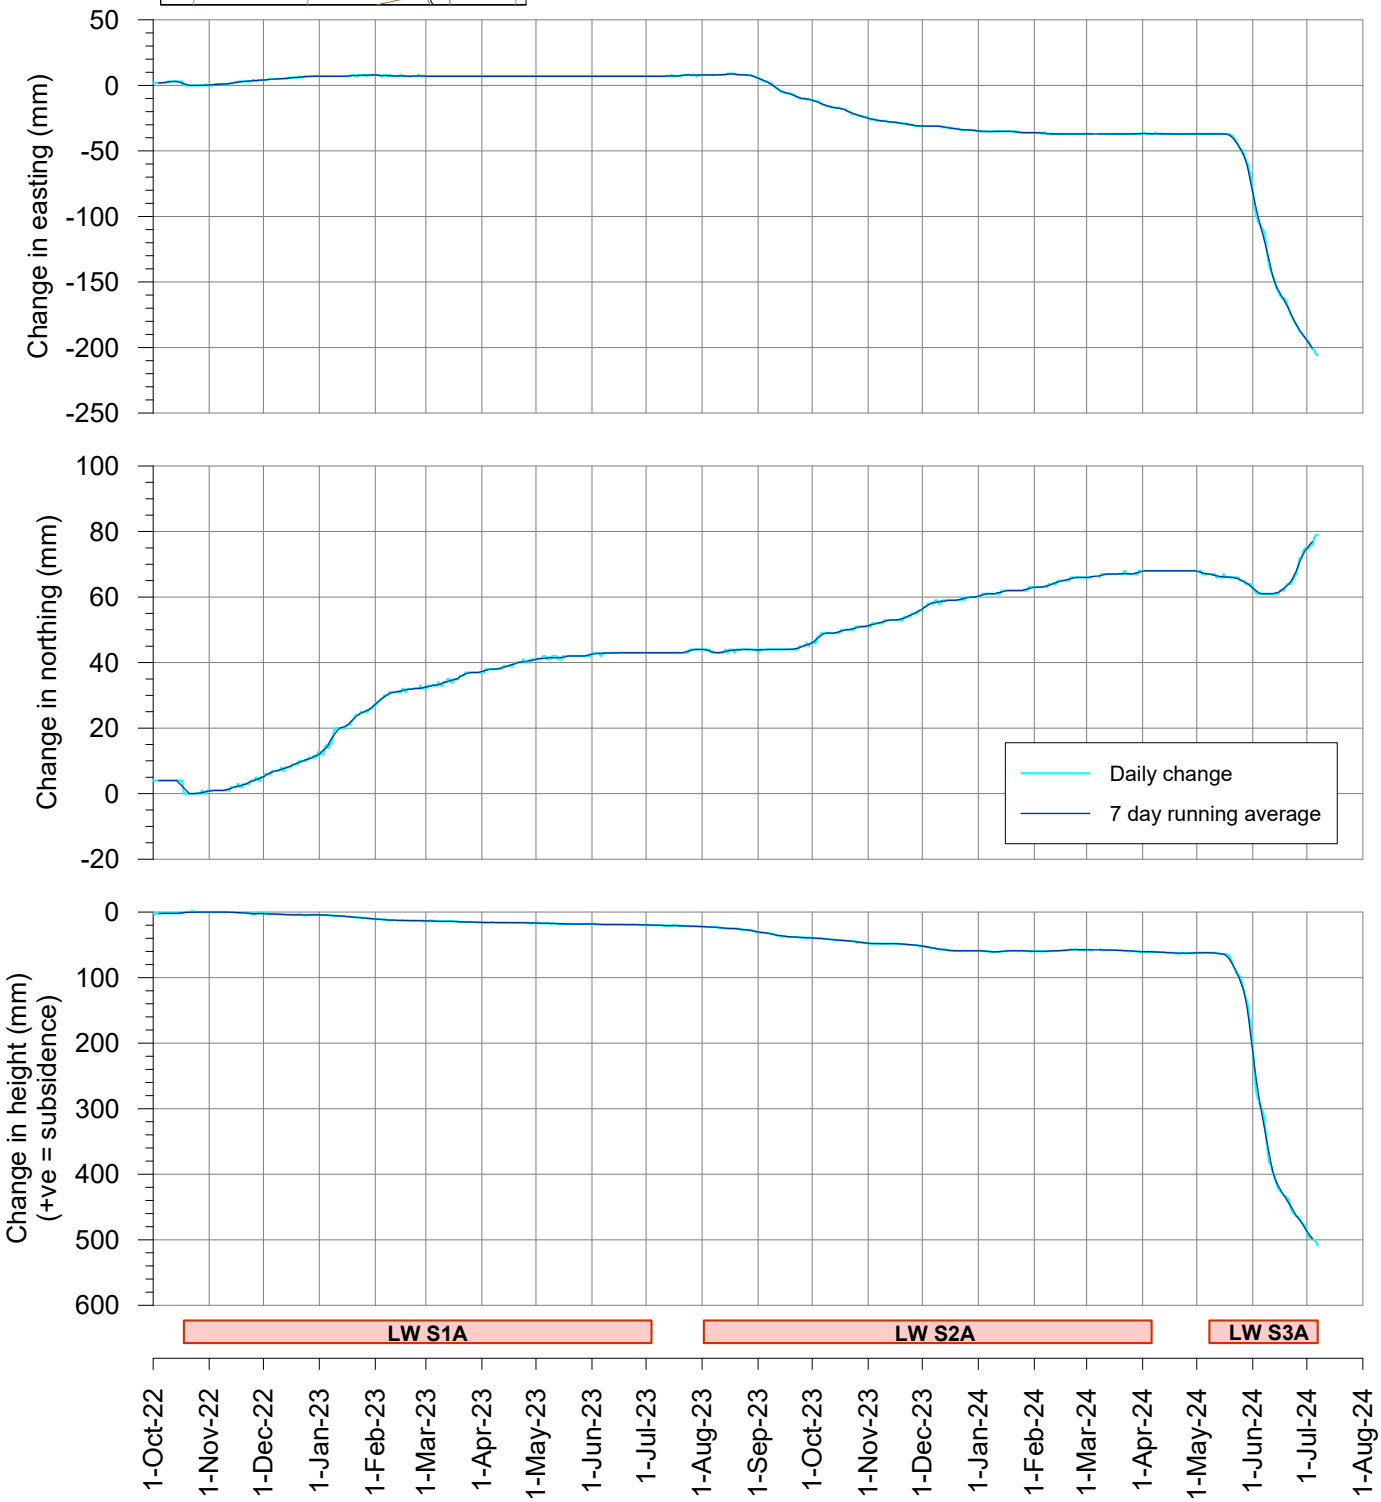
Fig. S09-R06

Site S09 above LW S3A at Teatree 2

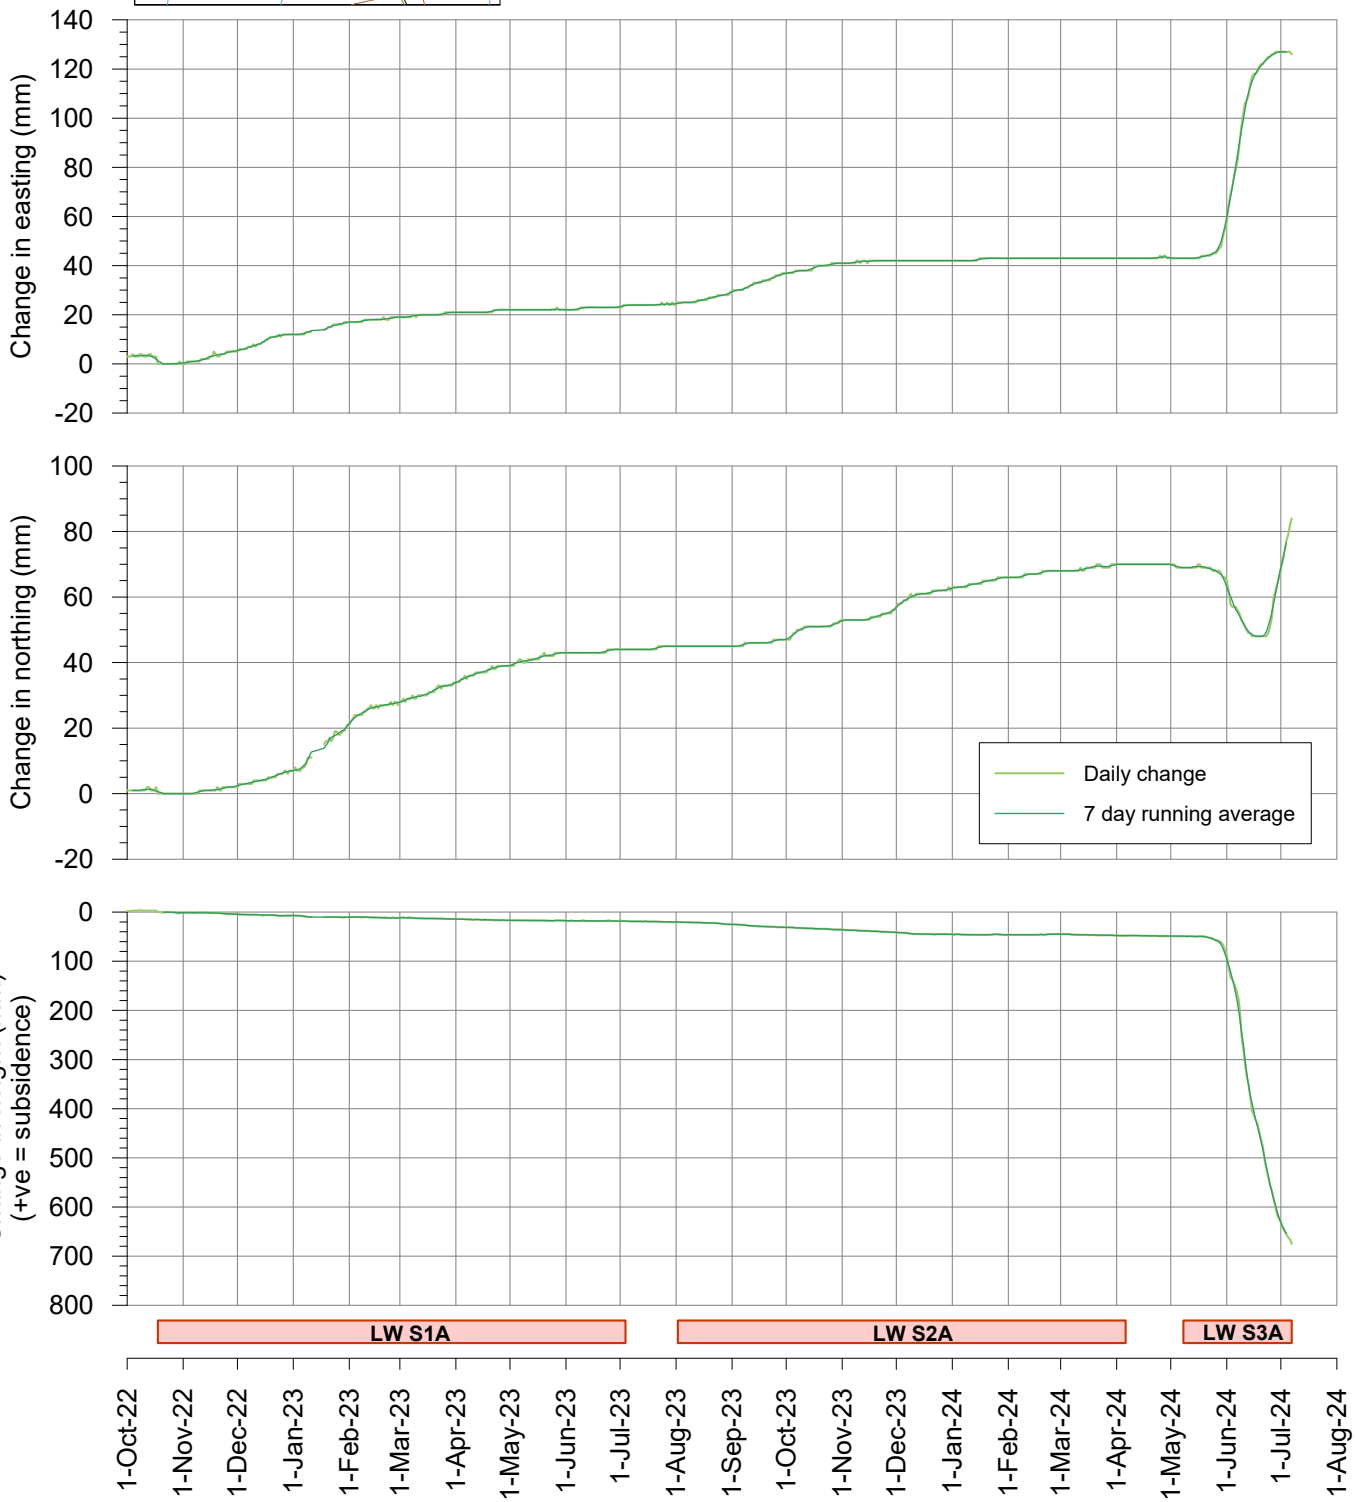
Fig. S10-R06

Site S10 above LW S3A at Teatree 2

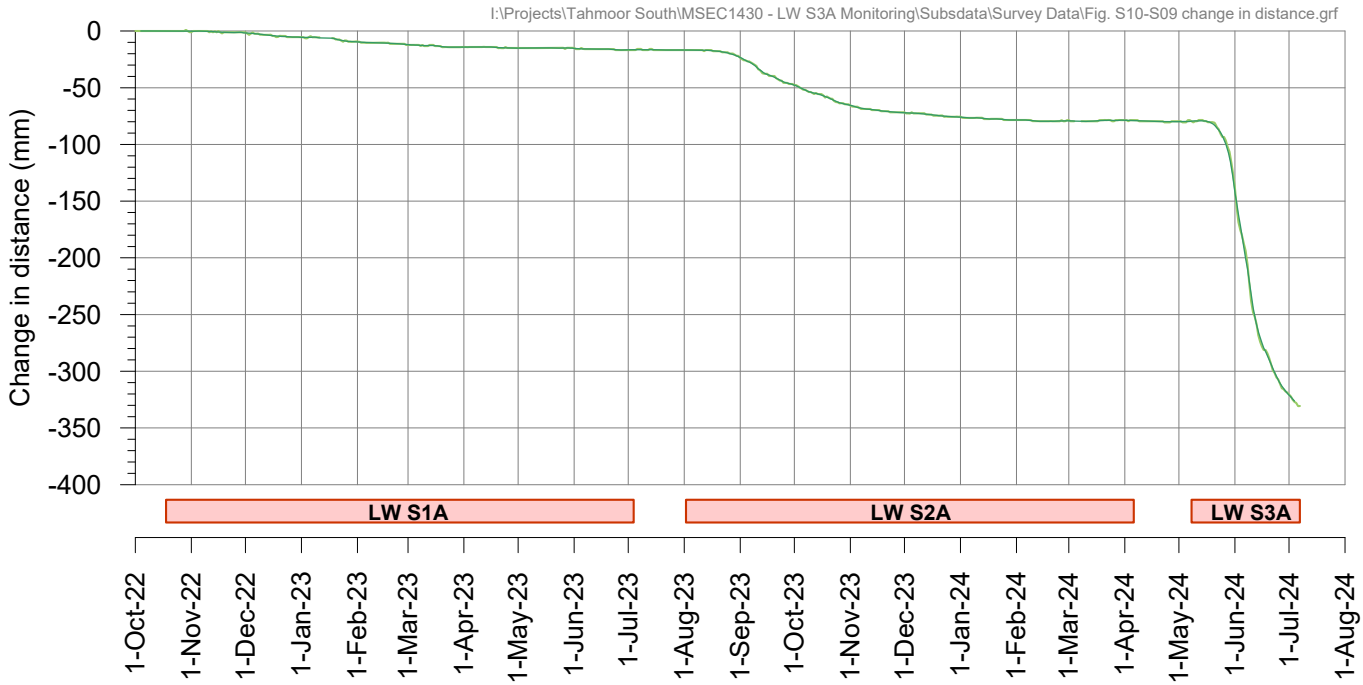
Change in distance across Wirrimbirra Creek at Teatree 2
Sites S09 and S10 above LW S3A

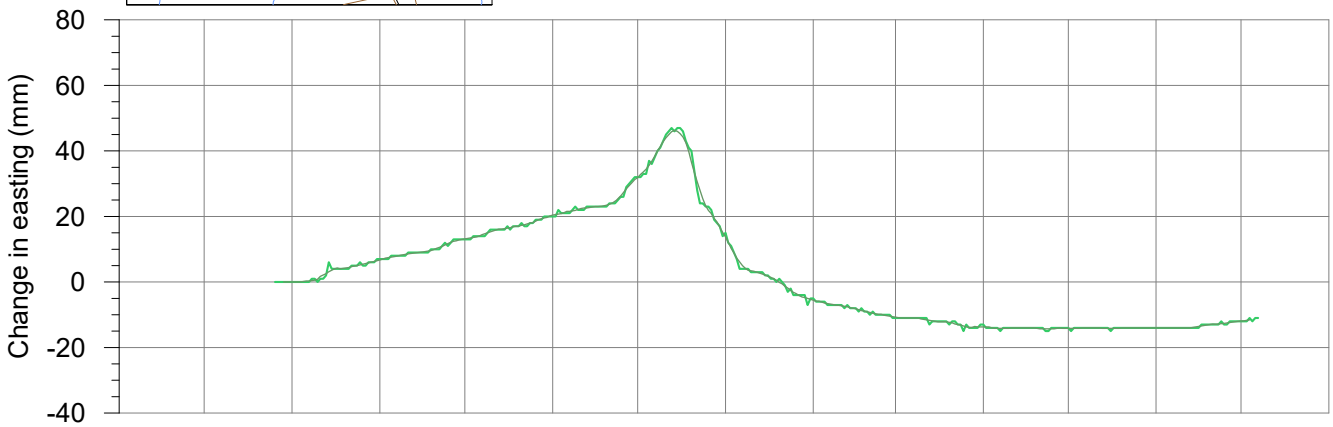
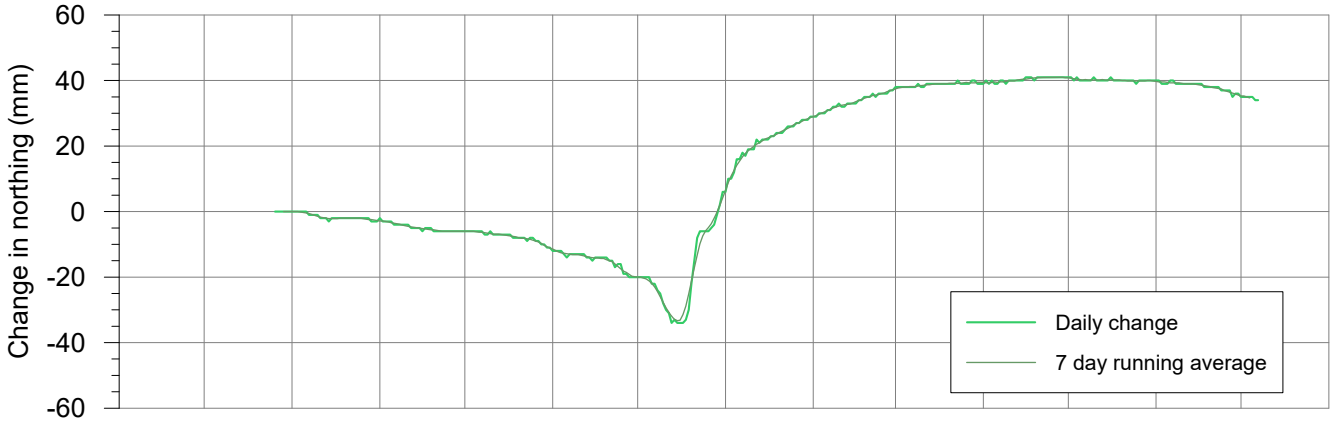
Site S26 above LW S2A

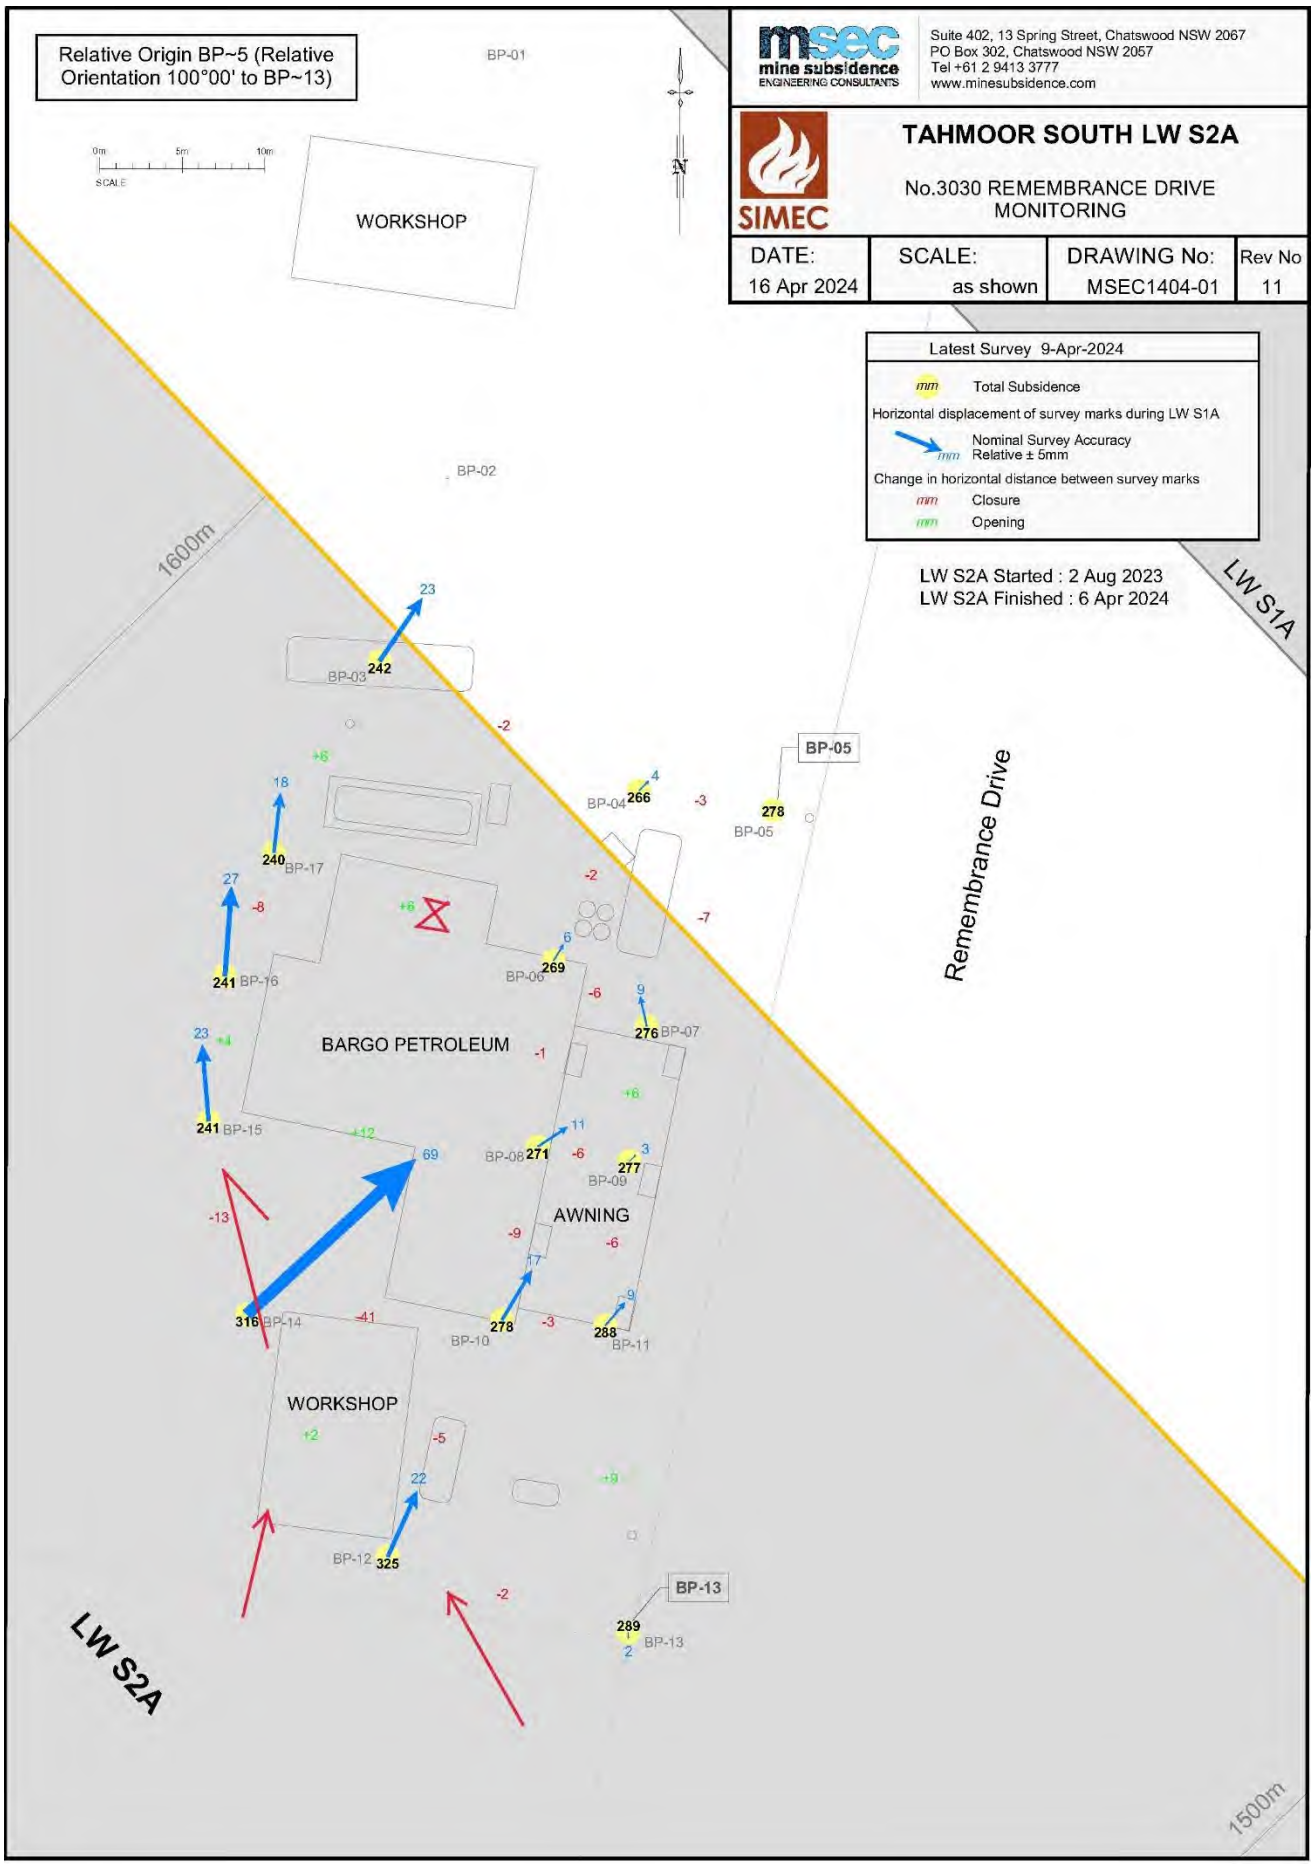
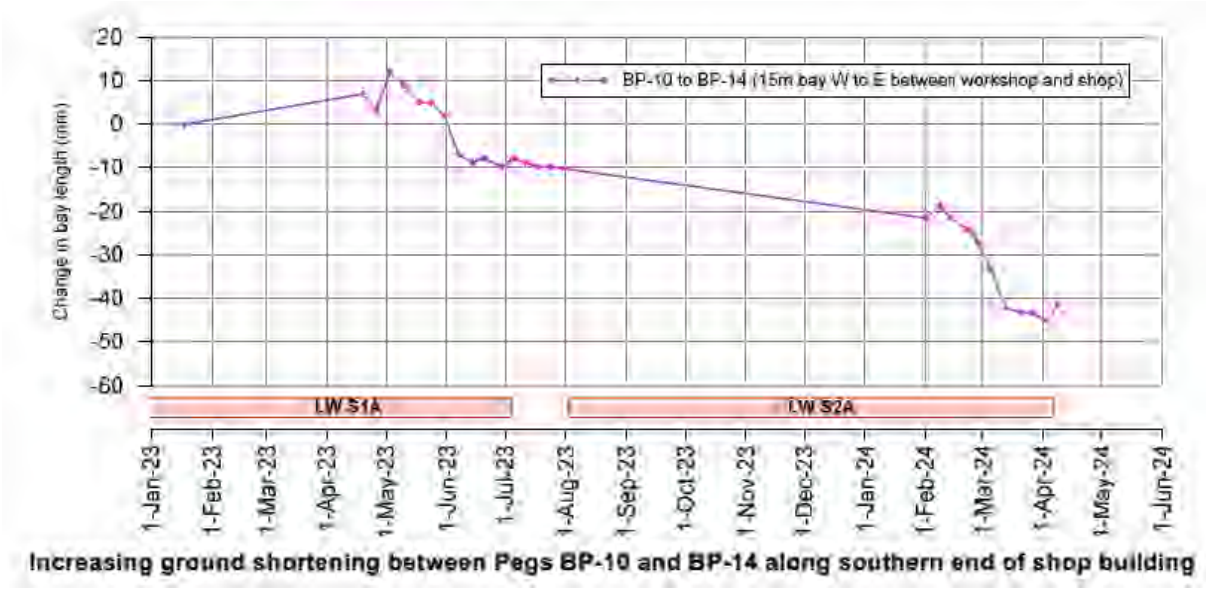
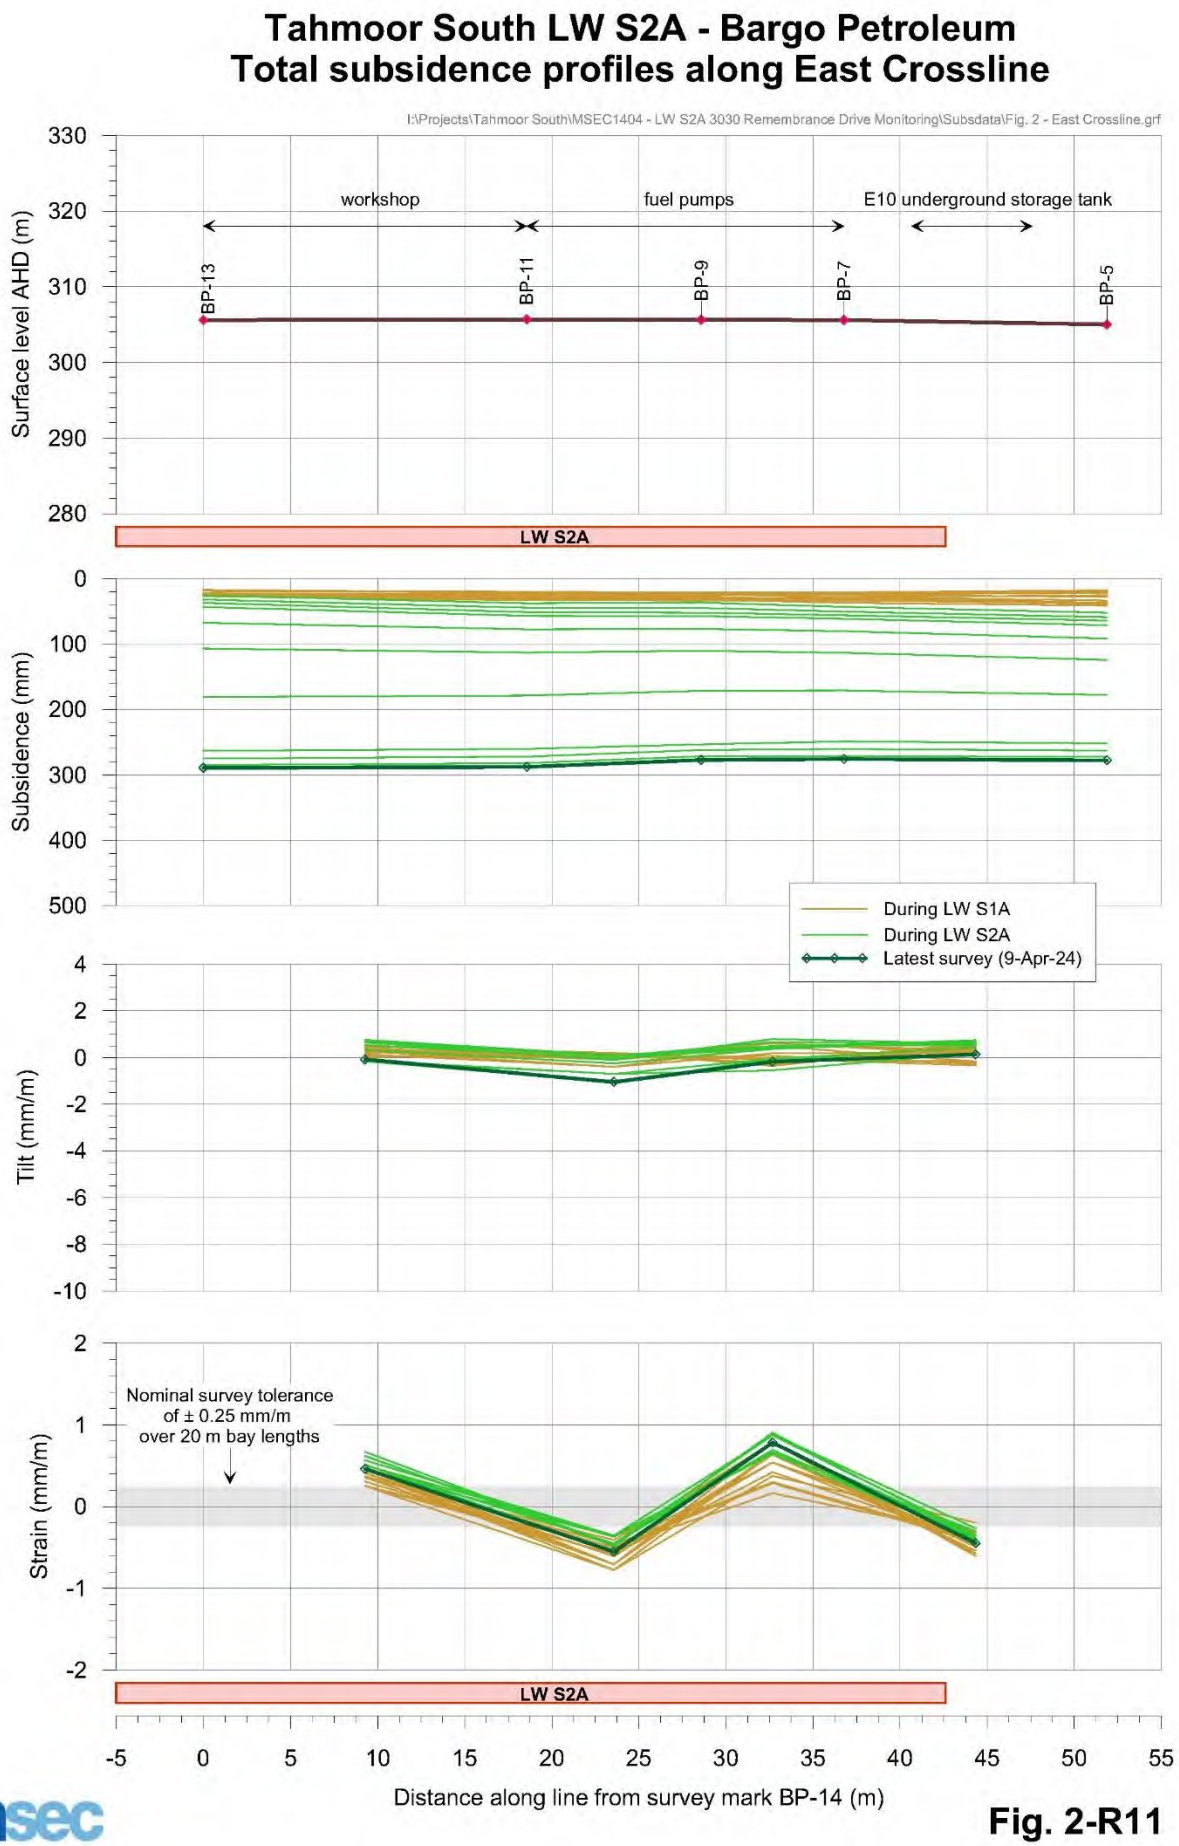
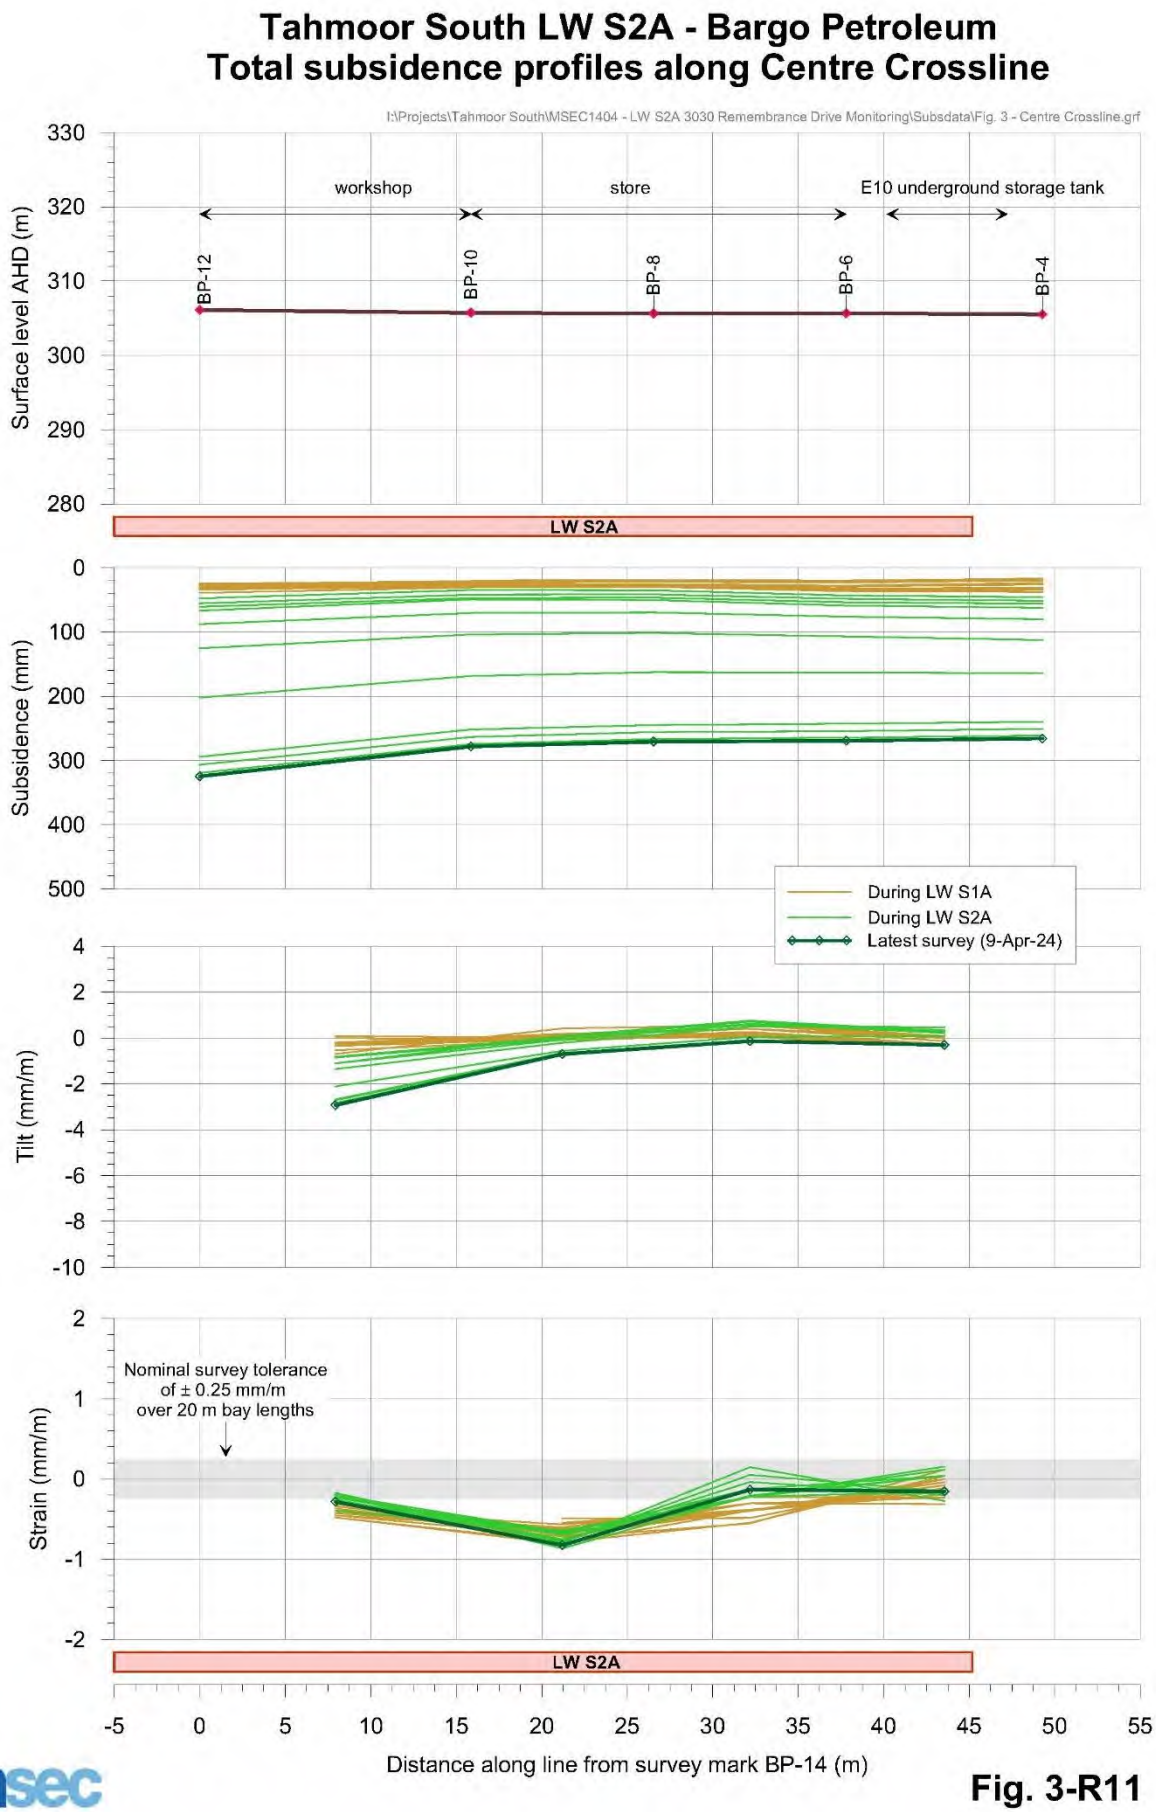
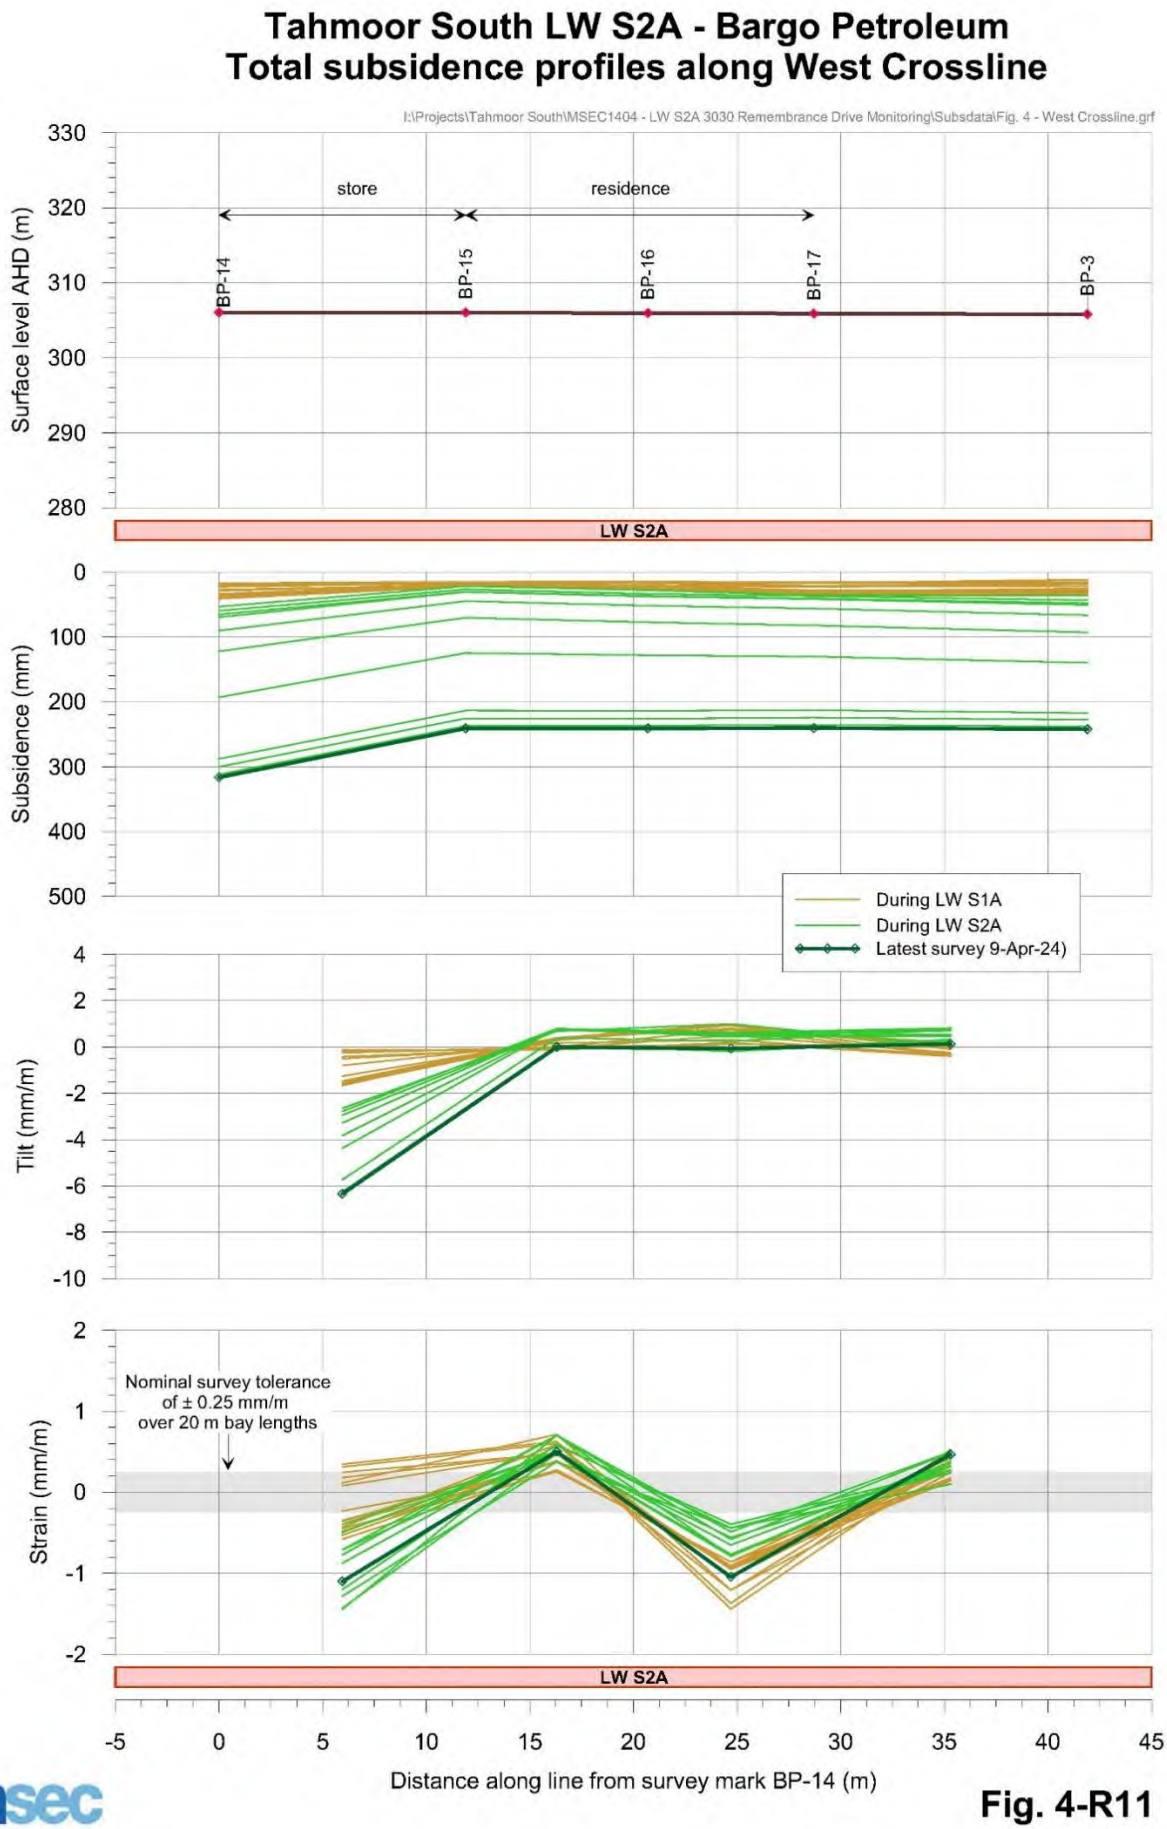
Figures 2-6 – Observed ground strain and subsidence

The Structural Response Group (SRG) met on Tuesday 16 April at approximately 9.30am and reported 41mm of closure between survey pegs 10 and 14 across the mechanic workshop at 3030 Remembrance Drive Bargo. Noting this closure had occurred, the SRG recommended a subsidence inspection take place to check the vehicle hoist levels. Until approximately 4 weeks ago the garage workshop was not occupied and vehicle hoists were not in use.

During the inspection, significant levelling issues were observed with the northern vehicle hoist (bay 3). The southern post is now tilting 11mm/m to the south, whilst the northern post is close to vertical in that plane. This is requiring the lifting arms to extend as the hoist is raised. The tenant advised there is a large movement of the post when a car is approximately 1m off the ground. The posts and ground are also tilting around 15 mm/m to the west. These issues mean the hoist is non-serviceable and an 'Out of Service' tag was applied to cease use. Prior to mining the posts on this hoist were close to vertical and the concrete slab had a 4mm/m tilt.

- On receiving the advice, Tahmoor Coal immediately advised the tenant that the 3T vehicle hoist could not be used due to the tilt observed. On the same day, Tahmoor Coal demarcated the 3T vehicle hoist and attached an 'Out of Service' tag to cease use.
- Tahmoor Coal arranged a slab survey on 18/04/24 confirming the strain of -41mm between Pegs 10 and 14.
- Tahmoor Coal scheduled hoist specialist (Norm Mechanical) to conduct an inspection on 22/04/24 to provide a remediation scope (see below).
- Inspection by hoist specialist completed 22/04/24 with the following discussed:
  - Tahmoor Coal to complete core holes to determine concrete thickness and integrity.
  - Norm Mechanical to provide quote to supply and fit replacement hoist (due 27/04/24).

1. Notify regulators and stakeholders of possible mining impact to workshop infrastructure.
2. Complete a comprehensive visual inspection of the site to observe any further damage – completed 16/04/2024.
3. Arrange an urgent inspection (22/04/24) by hoist specialist to conduct a temporary repair (if feasible) and prepare a remediation scope.
4. Arrange a core hole investigation to determine concrete integrity (subject to agreement).
5. Review results from core sampling by Structural Engineer to provide input into footing design.
6. Install replacement hoist as soon as possible (subject to agreement).
7. Maintain regular communication with landowners, Bargo Petroleum (lessee) and Prestige Car Restorations (sub-lessee) to minimise business disruption.

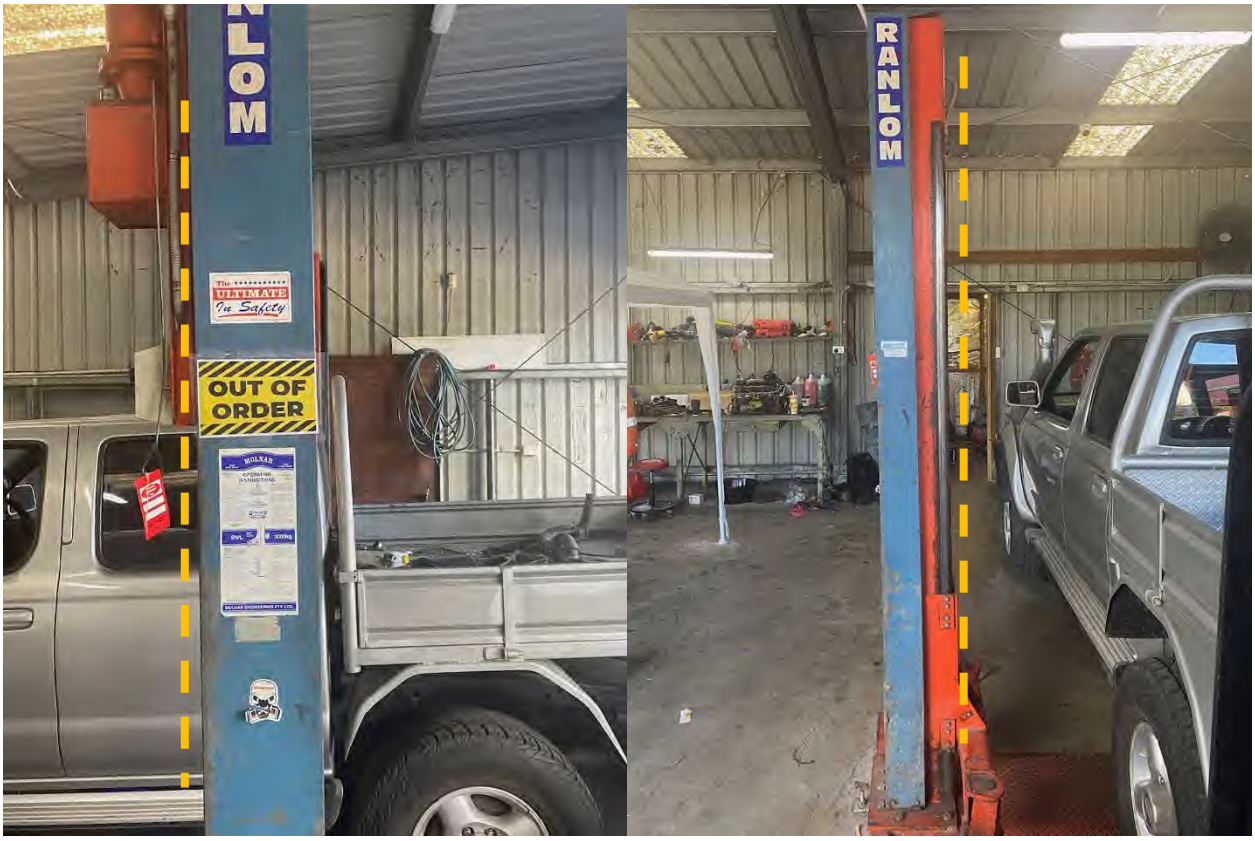
Figure 1 Northern hoist out of level – 16/4/24 – dashed line represents vertical (Photos Ross Barber).

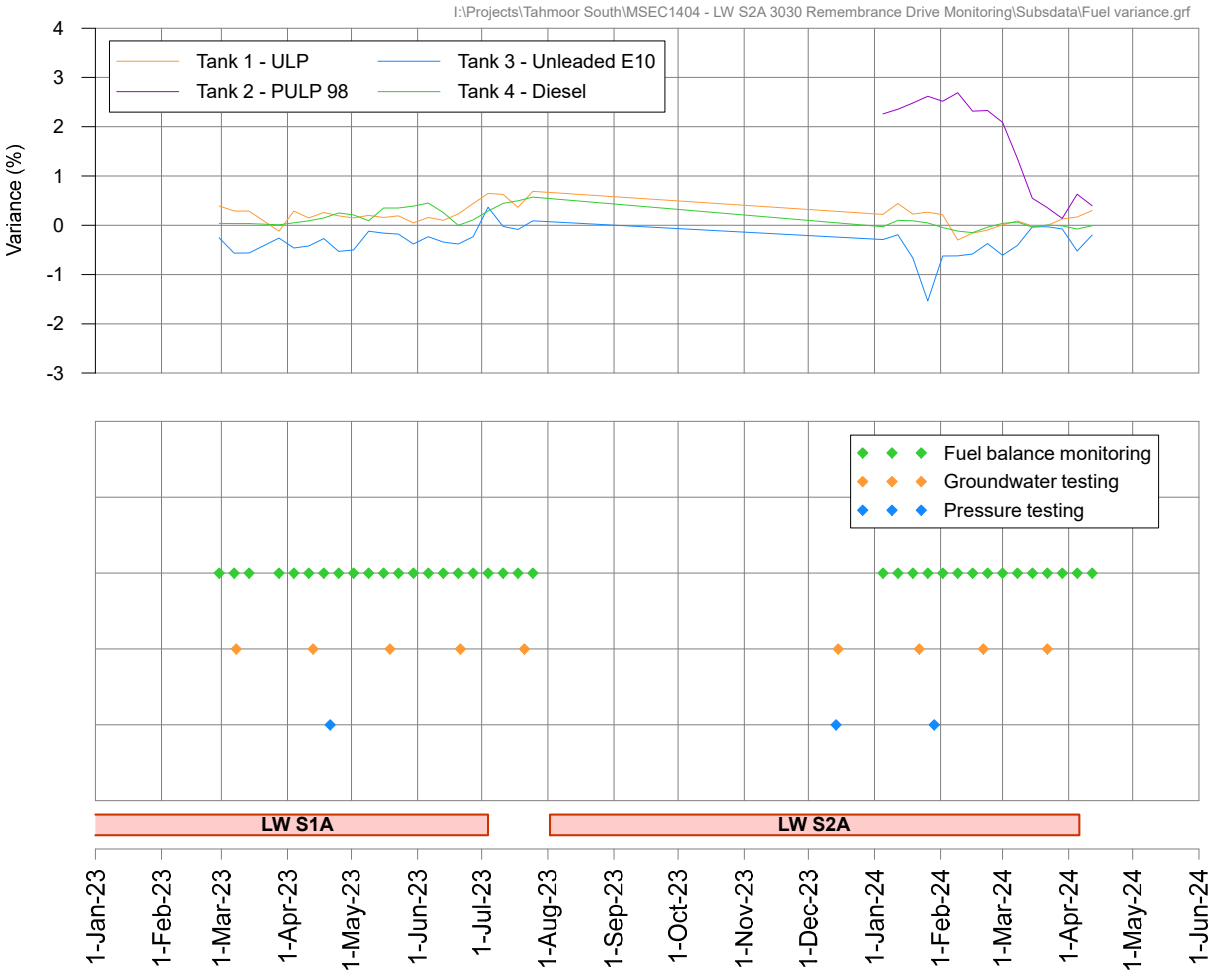
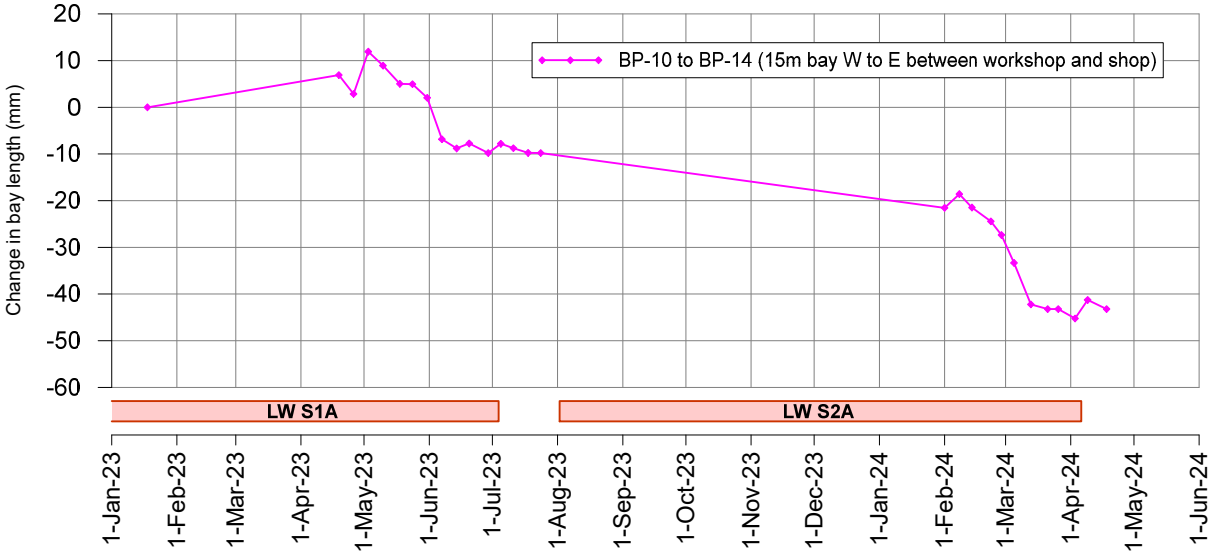
Structures				
Local 3D survey	18 Apr	Weekly	N/A	Minor subsidence movements this week. 2 mm increase this week in ground shortening between Pegs BP-10 and BP-14 along the southern end of the shop building, with compressive strain up to 2.8 mm/m. Further surveys required to confirm a change in trends. Peg BP-14 has been gradually moving relative to adjacent marks.
Visual inspections	16 Apr	Weekly	Impacts obser-ved	Bargo Petroleum has reported potential cracking in external pavements. The cracks have been inspected by Tahmoor Coal and compared to pre-mining inspections. The cracks identified appear to be unchanged from pre-mining inspections, but visual inspections will continue to focus in this area. A new crack has formed in internal plasterboard lining above a door opening at the northern end of the Bargo Petroleum shop building. The crack will be inspected by a structural engineer. New cracking to floor tiles in rear room. 3000kg vehicle hoist measured as out of alignment and tagged “out of use.”

Increasing ground shortening between Pegs BP-10 and BP-14 along southern end of shop building

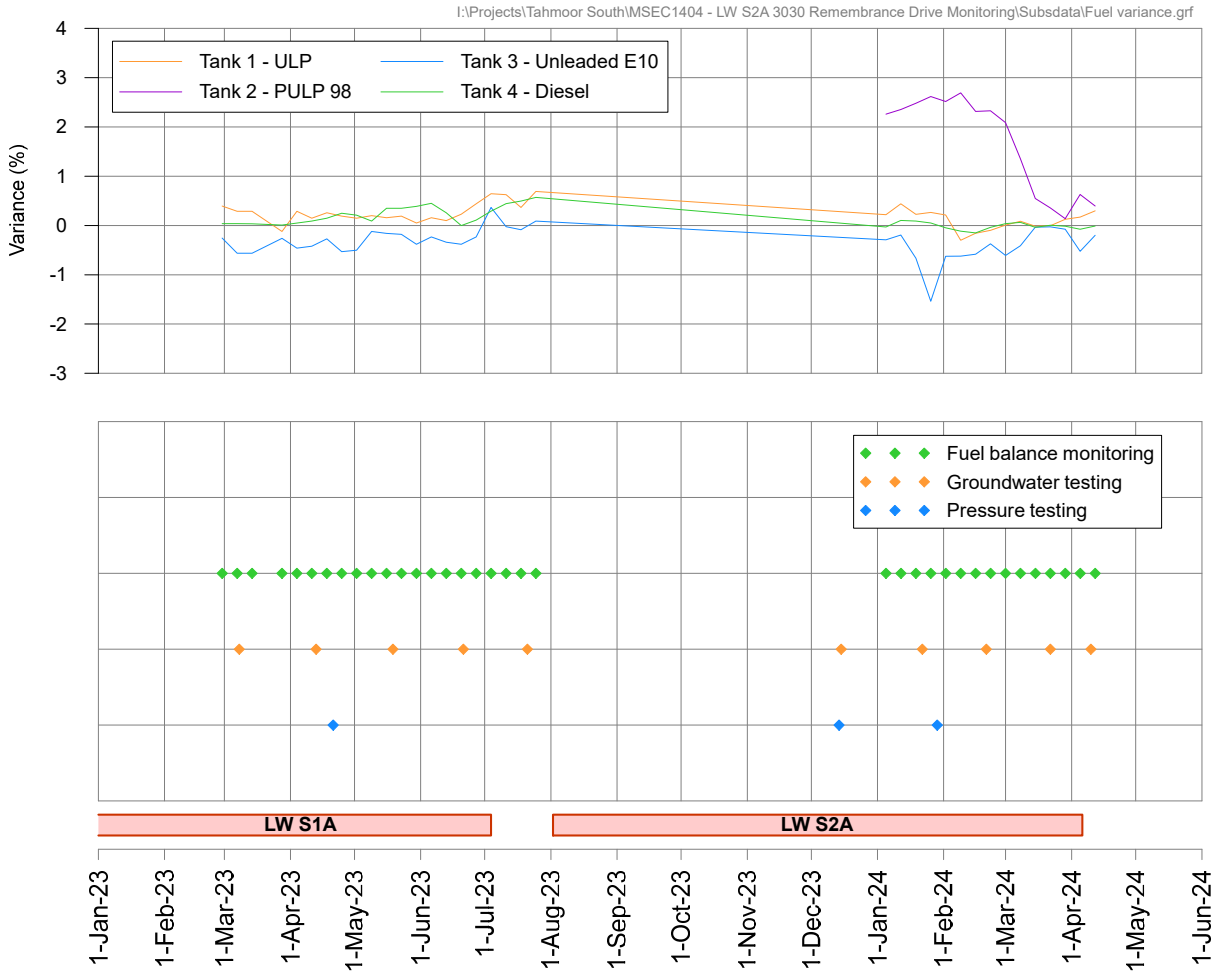
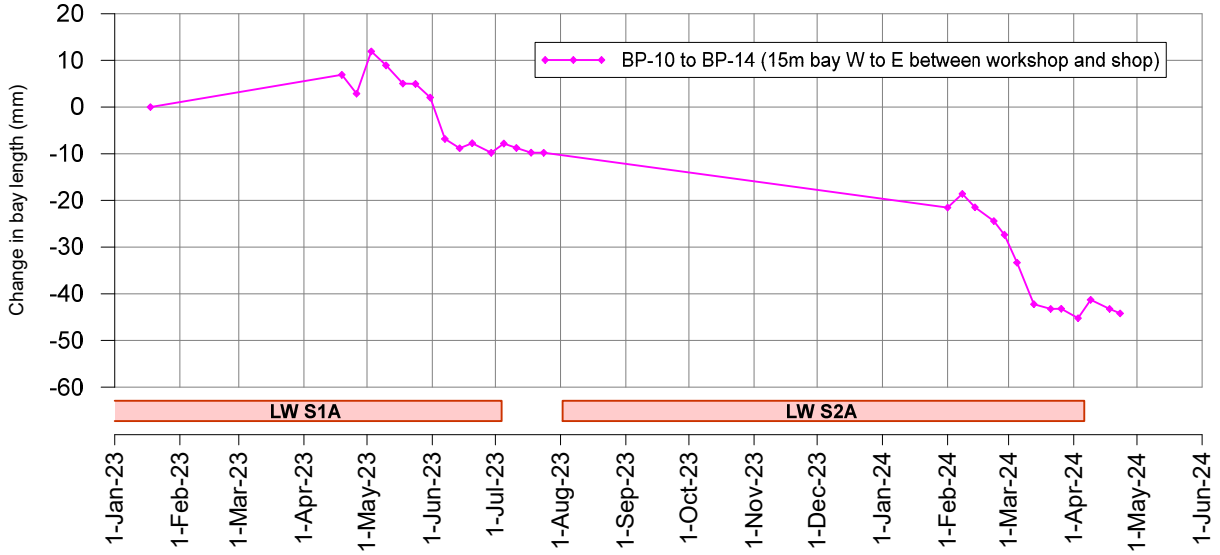
Increasing ground shortening between Pegs BP-10 and BP-14 along southern end of shop building
