Tahmoor Coal Pty Ltd

SIX MONTHLY SUBSIDENCE IMPACT REPORT

Tahmoor South Domain Longwalls South 1A – South 6A

1 January 2024 – 30 June 2024

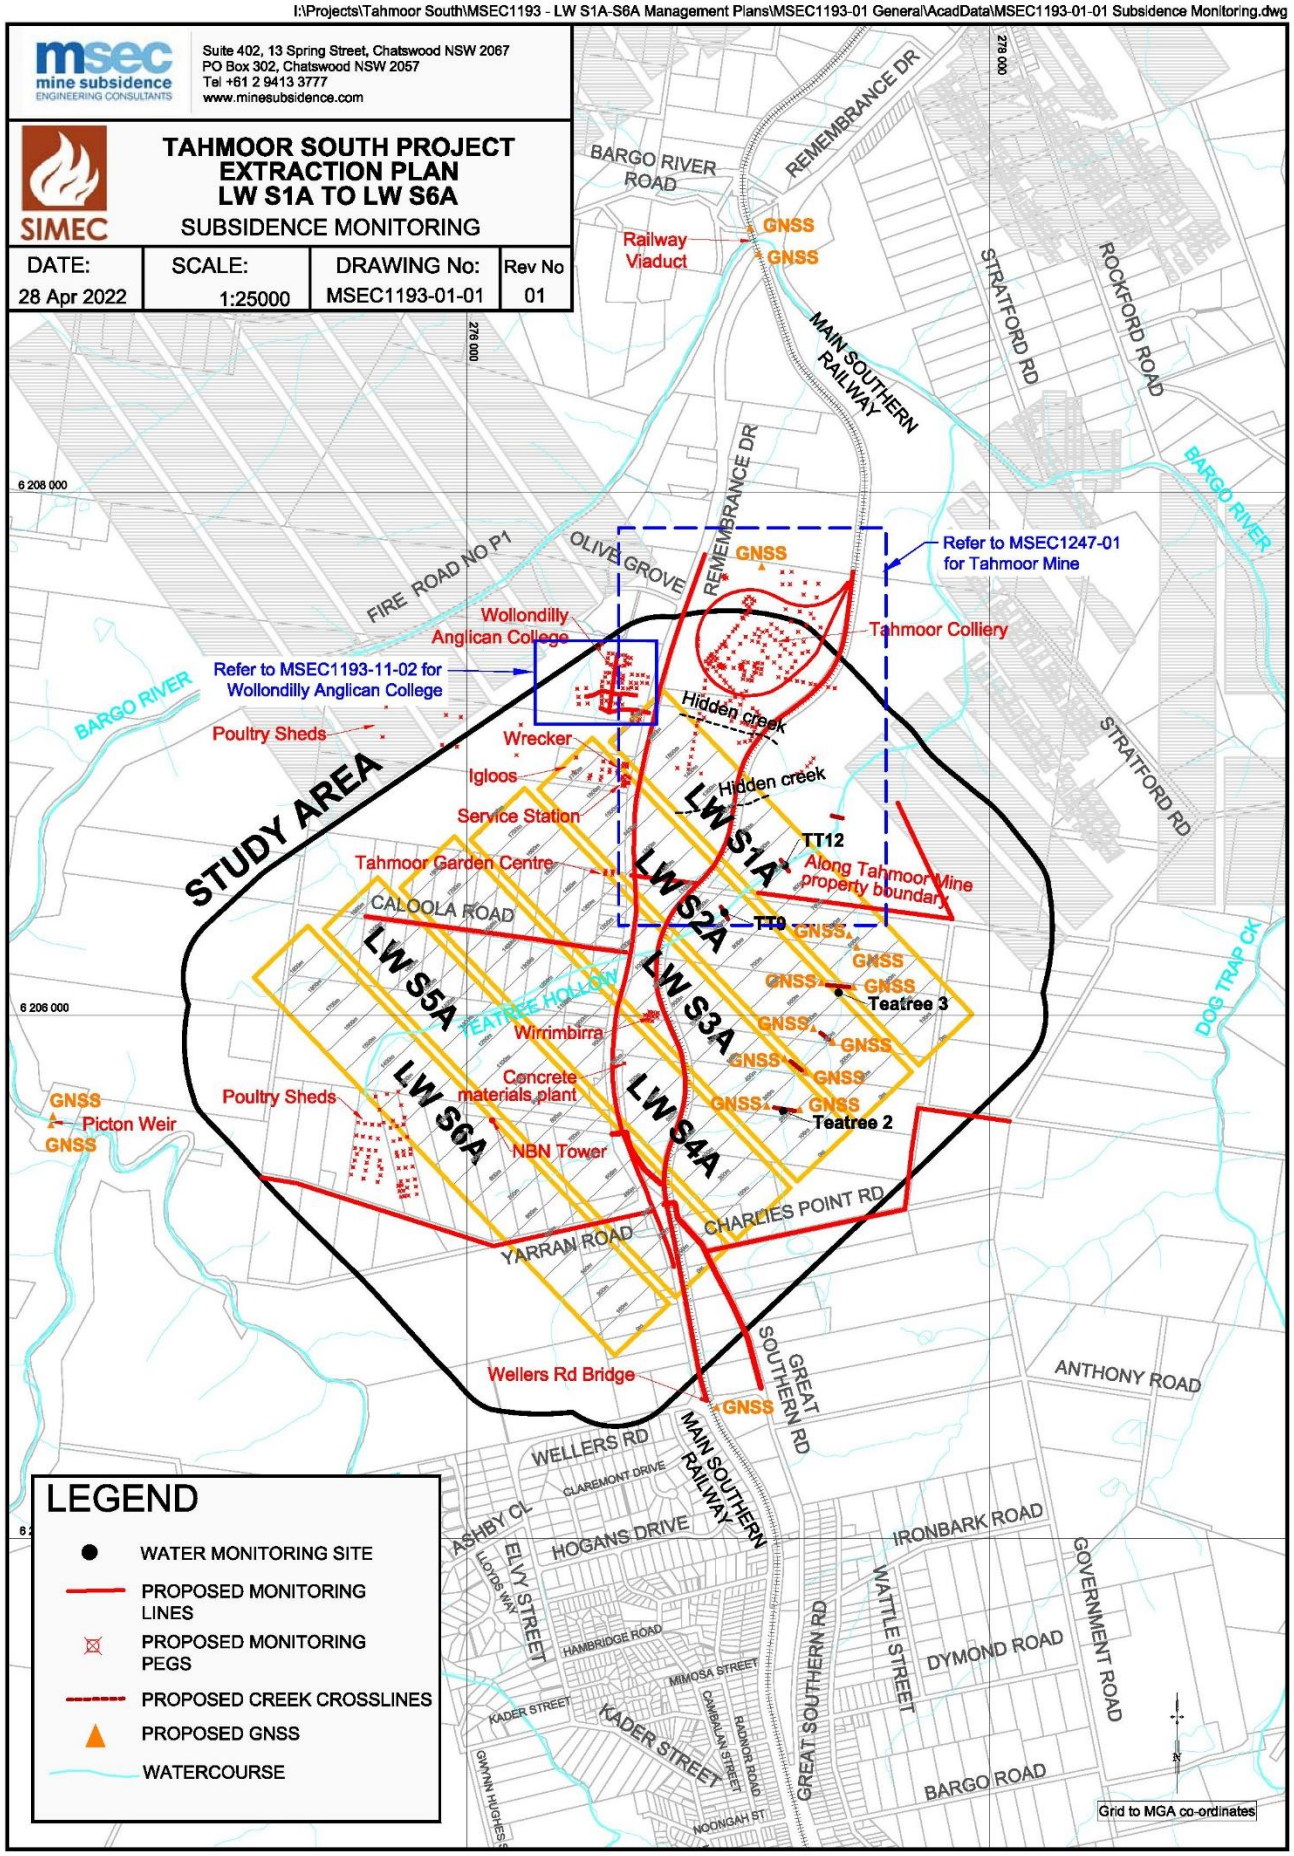
Figure 3-1 *LW S1A-S6A Subsidence Monitoring Program (source: LW S1A-S6A Subsidence Monitoring Program)*

During the reporting period, the LW S1A-S6A Subsidence Monitoring Program have been implemented to monitor subsidence impacts within the Study Area. The details of the Subsidence Monitoring Program are illustrated in **Figure 3-1**.

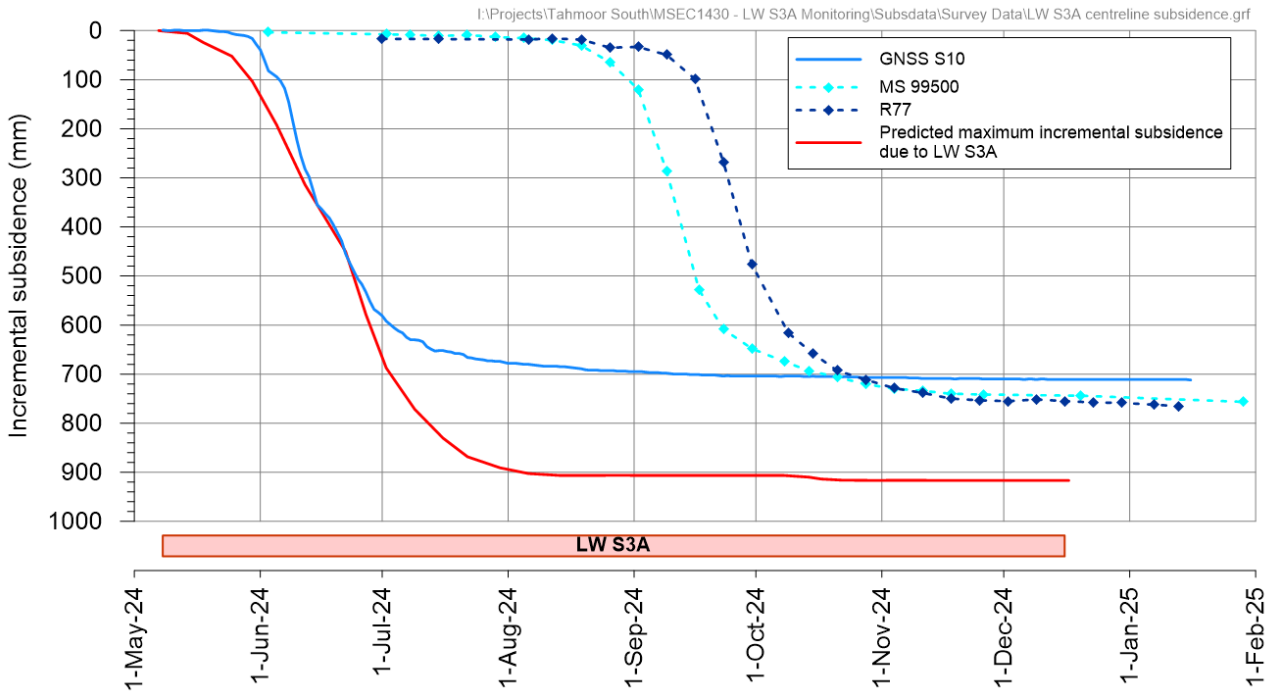
*Figure 3-2 Development of observed subsidence above LW S3A (source: MSEC1430, Report R34, **Appendix A**)*

Since the commencement of LW S3A, mining-induced movements have developed at the GNSS units, with maximum measured incremental subsidence of 712 mm at Site S10 above LW S3A. Rates of change have reduced to low levels. Observed development of subsidence above LW S3A has developed within predictions. Rates of change in subsidence has reduced to low levels along the Main southern Railway and Remembrance Driveway (MSEC1430 Subsidence Monitoring Report 34, **Appendix A**).

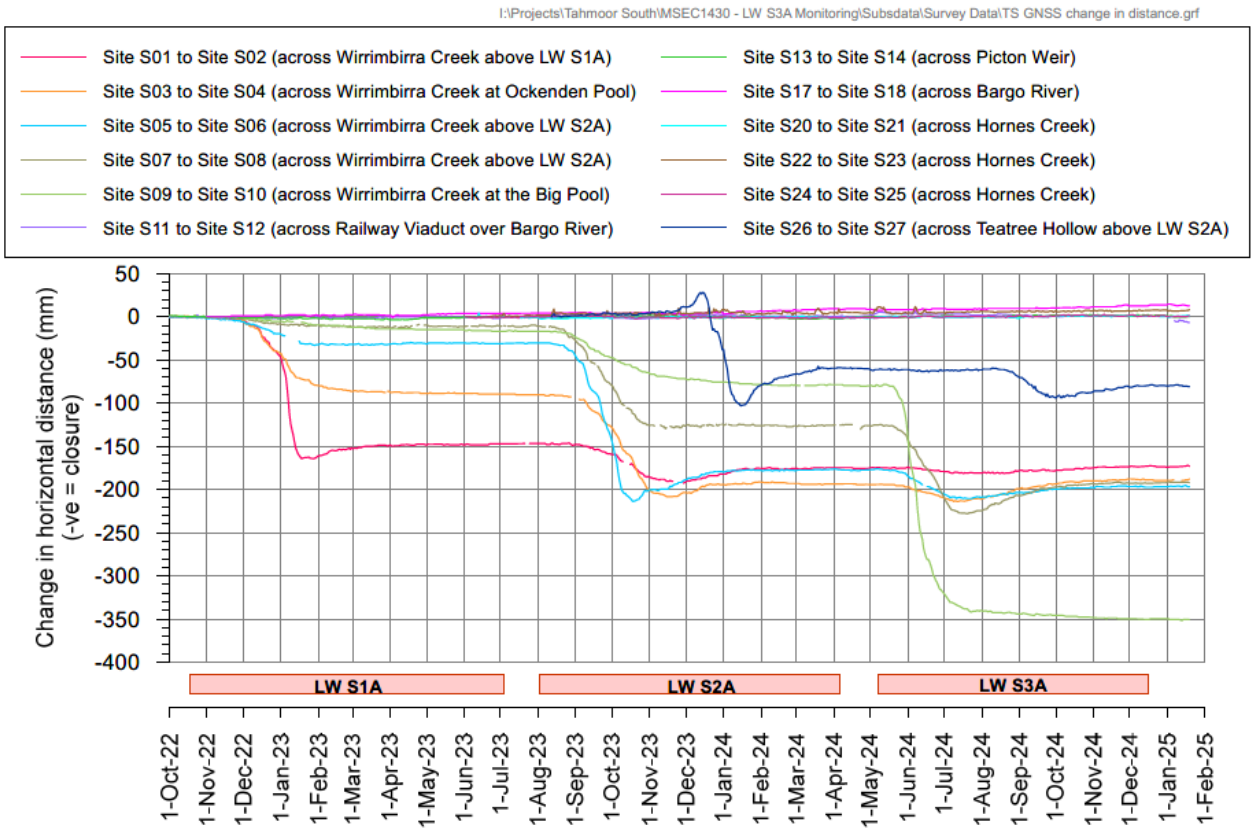
*Figure 3-4 Observed changes in horizontal distances between GNSS units during LW S3A extraction (source: MSEC1430 Subsidence Monitoring Report 34, **Appendix A**)*

During the extraction of LW S3A, changes in horizontal distances between paired GNSS units that are stationed close together on opposite sides of Teatree Hollow and Teatree Hollow Tributary (also known as 'Wirrimbirra Creek') are illustrated in **Figure 3-4**. Closure has developed across Wirrimbirra Creek. The greatest closure across Wirrimbirra Creek during the mining of LW S3A between Sites S09 and S10 directly above LW S3A. Rates of change have reduced at all sites.

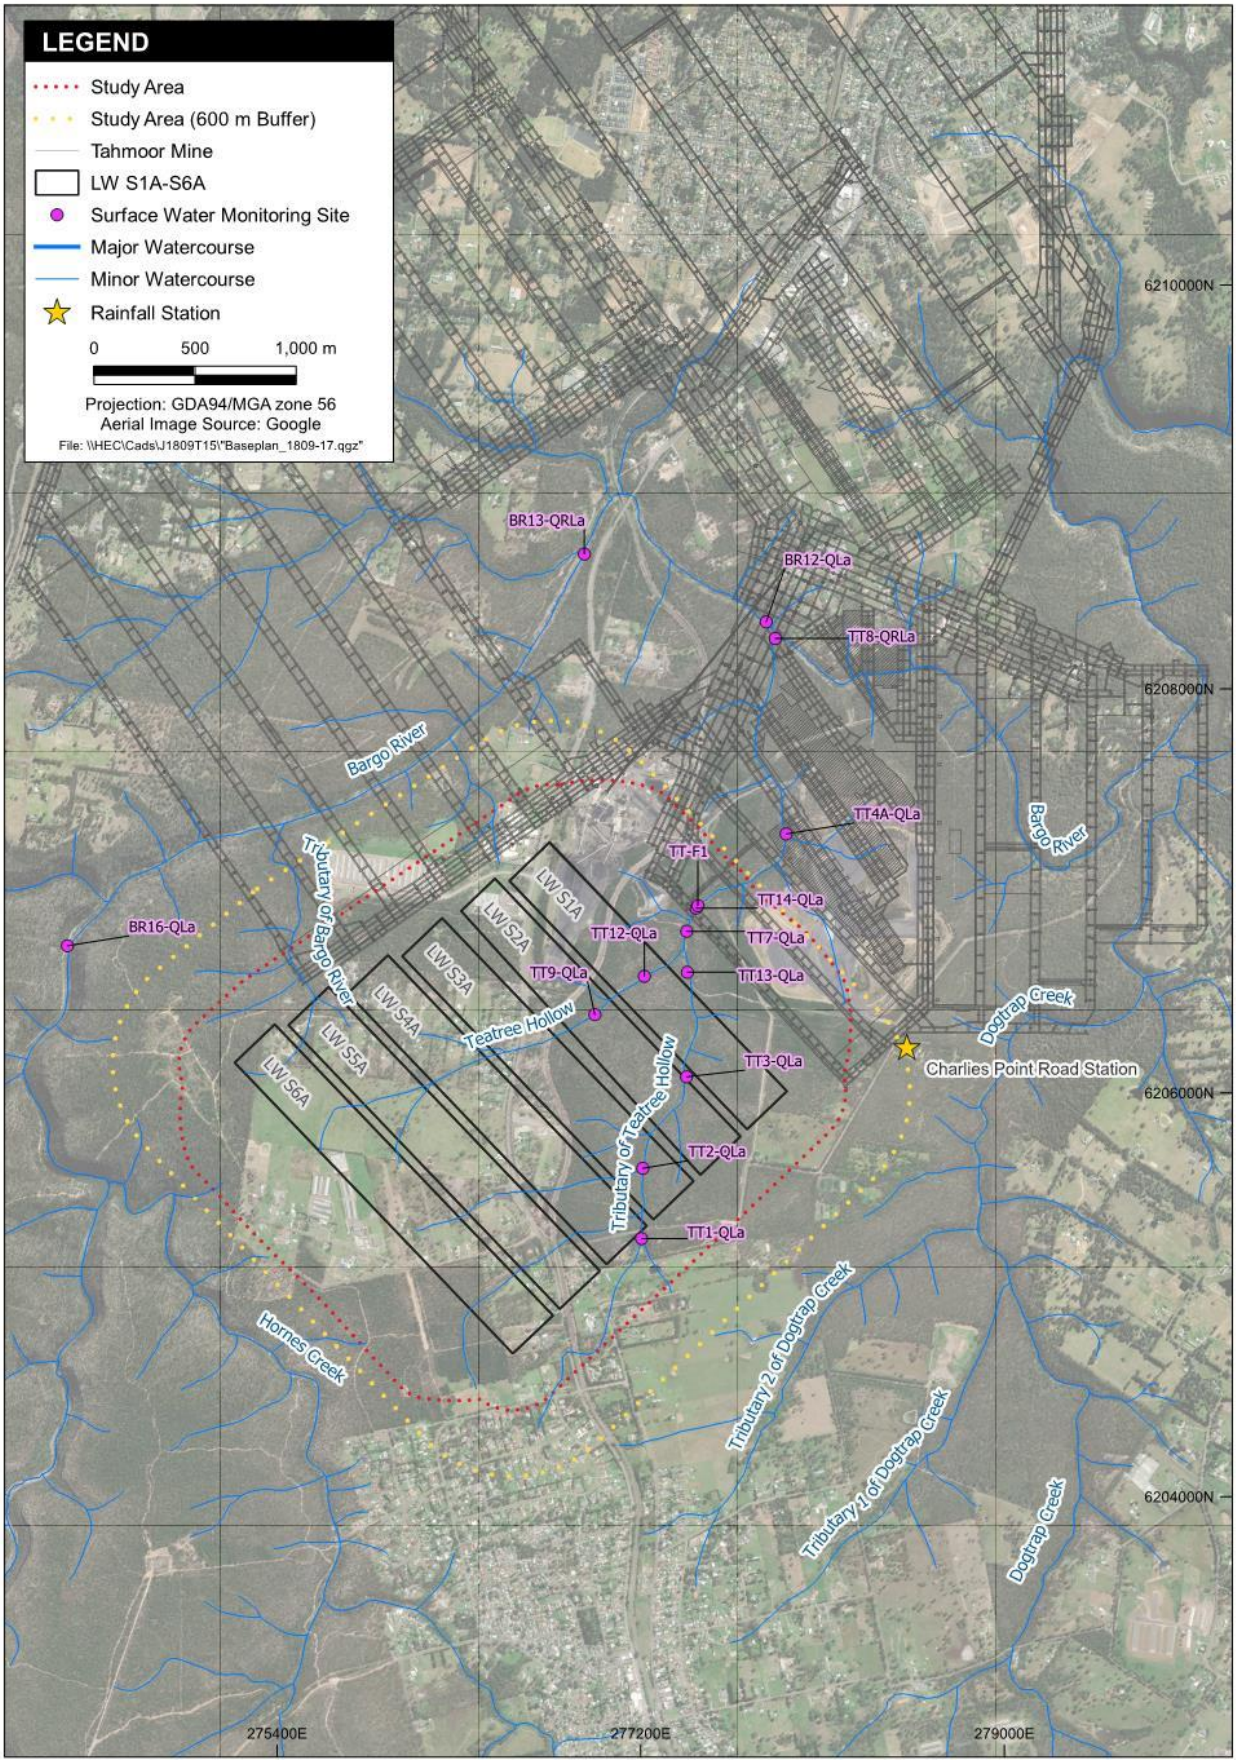
Figure 3-5 *LW S1A-S6A Surface Water Monitoring Sites Specific to LW S1A-S6A (source: ATC Williams, 2025a; **Appendix B**)*

Surface water quality data has been recorded at the following sites (refer to **Figure 3-5**):

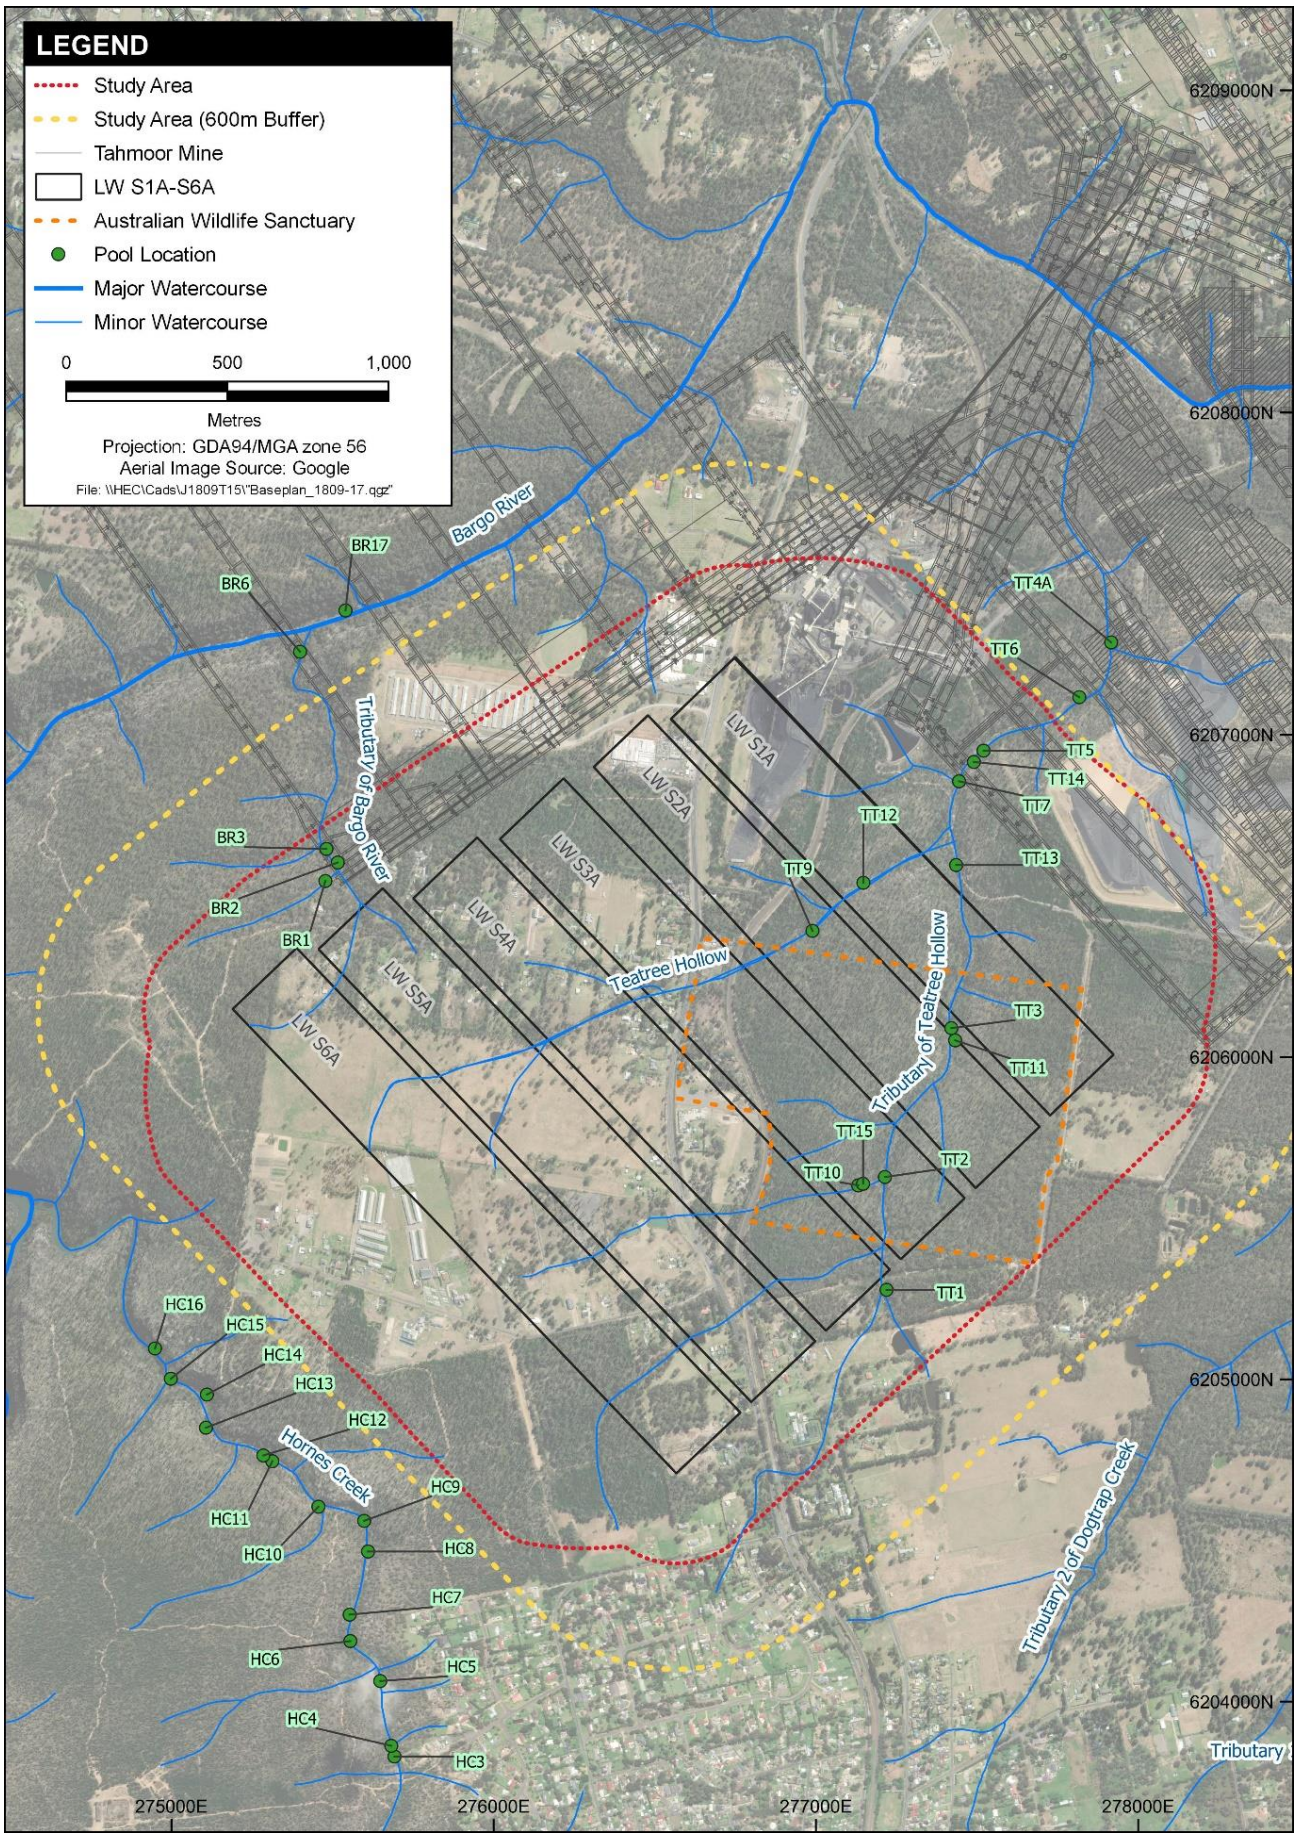
Figure 3-6 *LW S1A-S6A Pool Visual Inspection Sites (source: LW S1A-S6A Water Management Plan)*

Surface water level data has been recorded at the pool monitoring sites on Teatree Hollow, Teatree Hollow Tributary (also known as Wirrimbirra Creek), Bargo River, and Bargo River Tributary as shown in **Figure 3-6**. Continuous surface water level data and manual monthly water level measurements have been recorded at

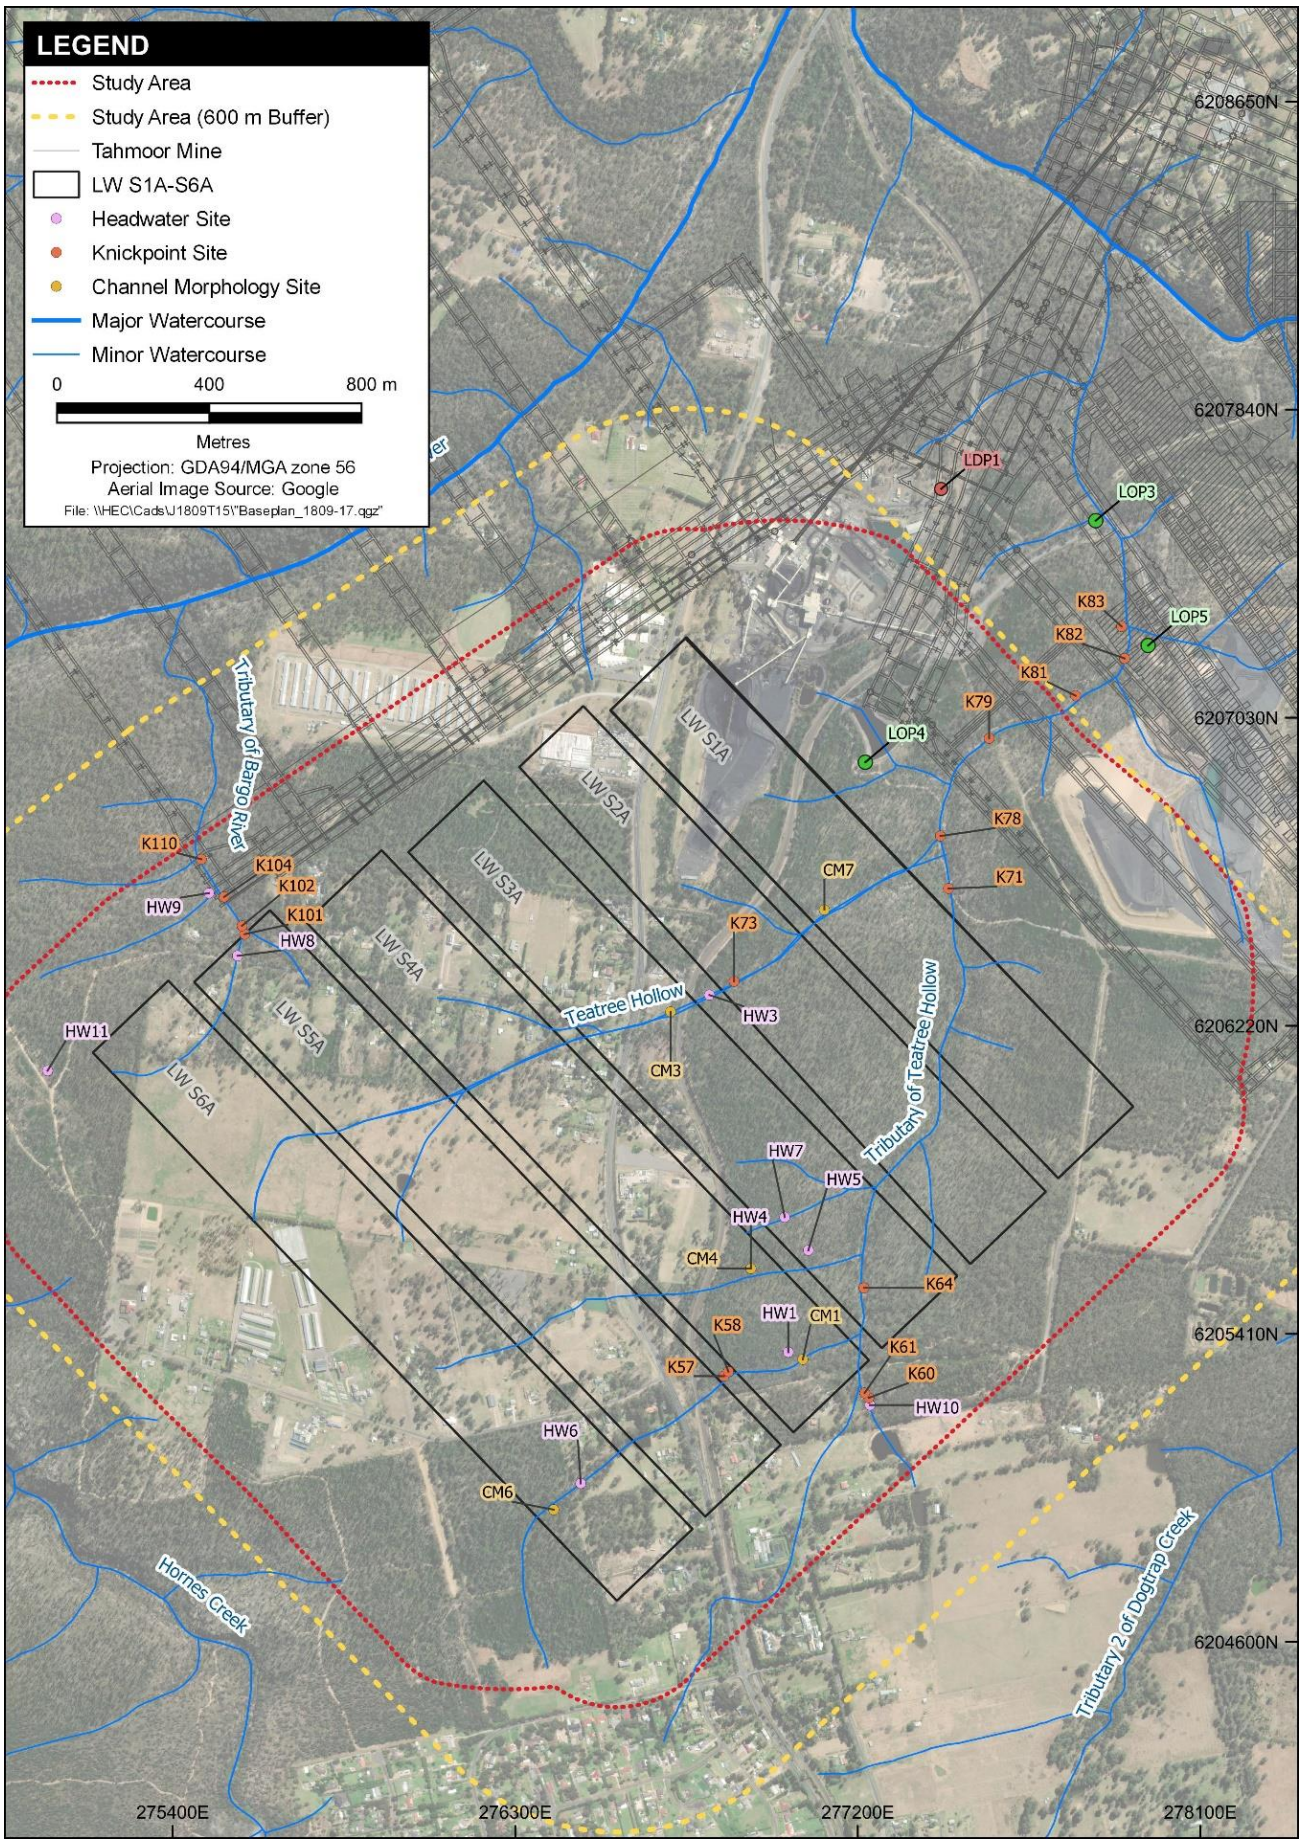
Figure 3-7 presents the location of flow re-emergence, fracturing, ponded water, iron staining and overland flow observed at the end of the reporting period (December 2024).

Figure 3-7 *Visual depiction of surface water characteristics and physical effects in December 2024 (source: **Appendix B**)*

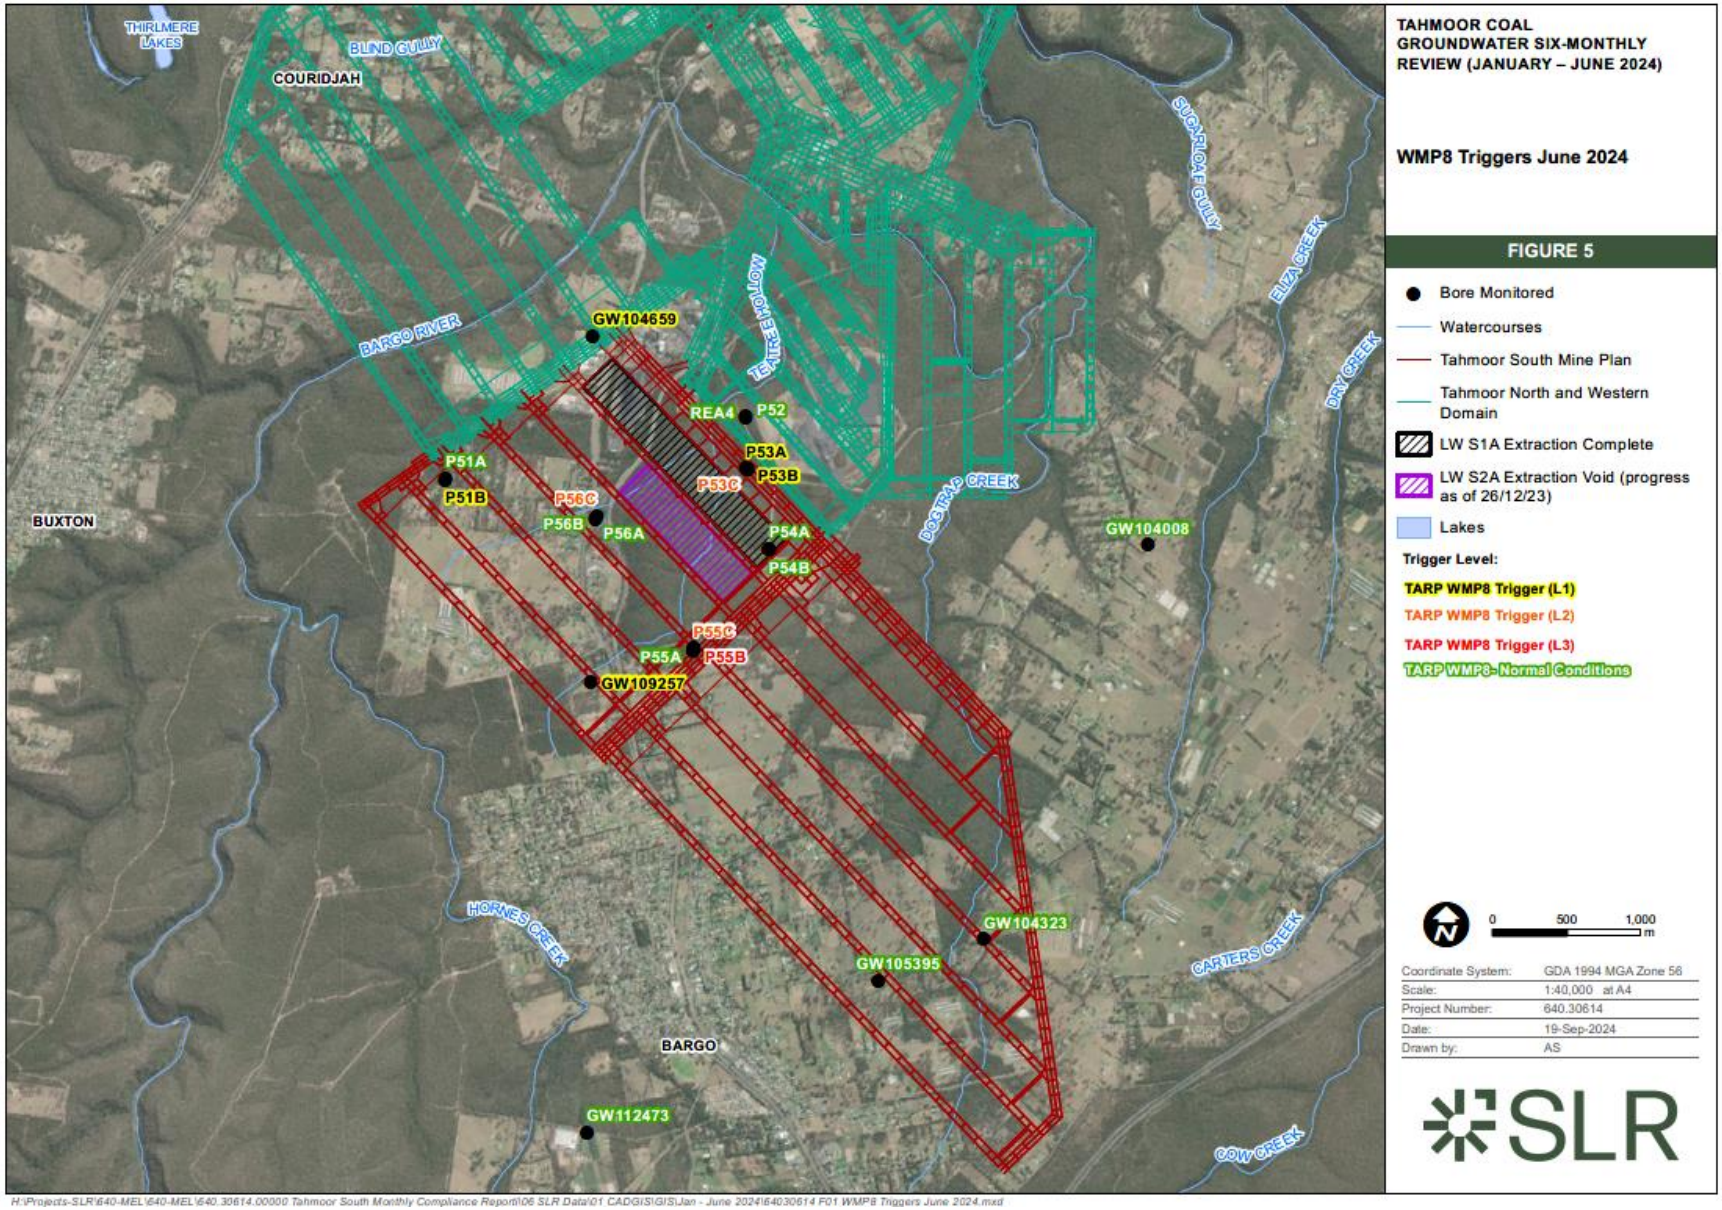
The spatial distribution of these triggers is illustrated in **Figure 3-11**. Further discussion of these triggers is provided in the Groundwater Monitoring Report (refer to **Appendix C**).

Figure 3-11 *WMP8 Shallow Groundwater Level (Open Standpipes and Private Bores) TARP triggers (source SLR, 2025;* ***Appendix C****).*

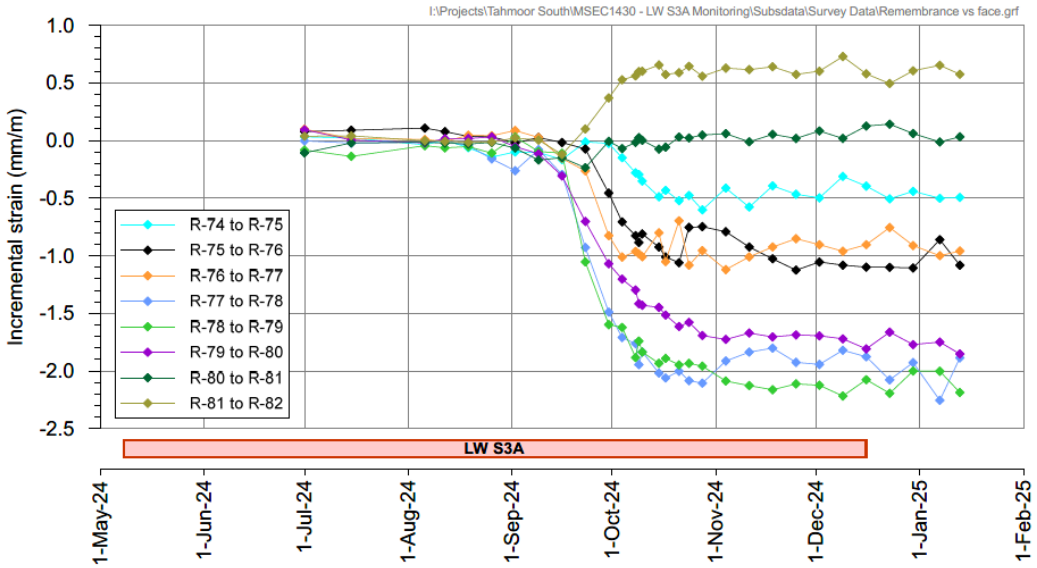
Remembrance Drive has experienced the most active period of subsidence due to the extraction of LW S3A with rates of change reducing. The observed subsidence profile is relatively smooth, with compressive strains developing broadly above the central section of LW S3A as seen in **Figure 3-19** (Report MSEC 1430 R34, **Appendix A**).

Figure 3-19: Observed development of ground strain along Remembrance Drive above central section of LW S3A over time

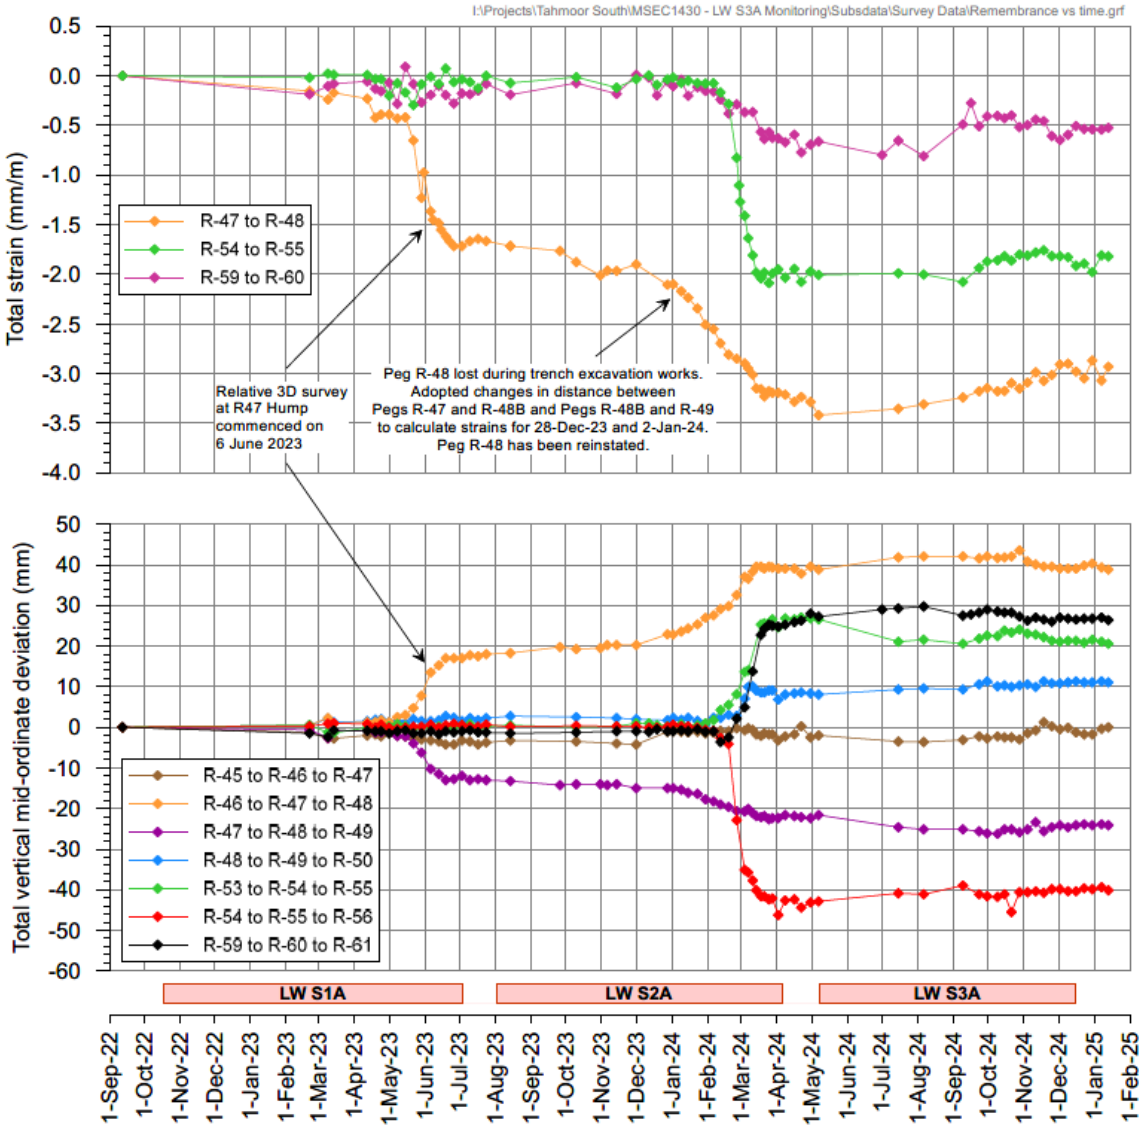
The observed development of non-conventional compressive strain at previously observed impact sites, including Pegs R46 to R48 and Pegs R54 and R55, during the mining of LW S1A and LW S2A has reduced to minor changes during the latest survey as seen in **Figure 3-20** (Report MSEC 1430 R34, **Appendix A**). No further impact has been observed on Remembrance Drive during the reporting period.

Figure 3-20: Observed development of ground strain and changes in vertical alignment at previously observed impact sites along Remembrance Drive

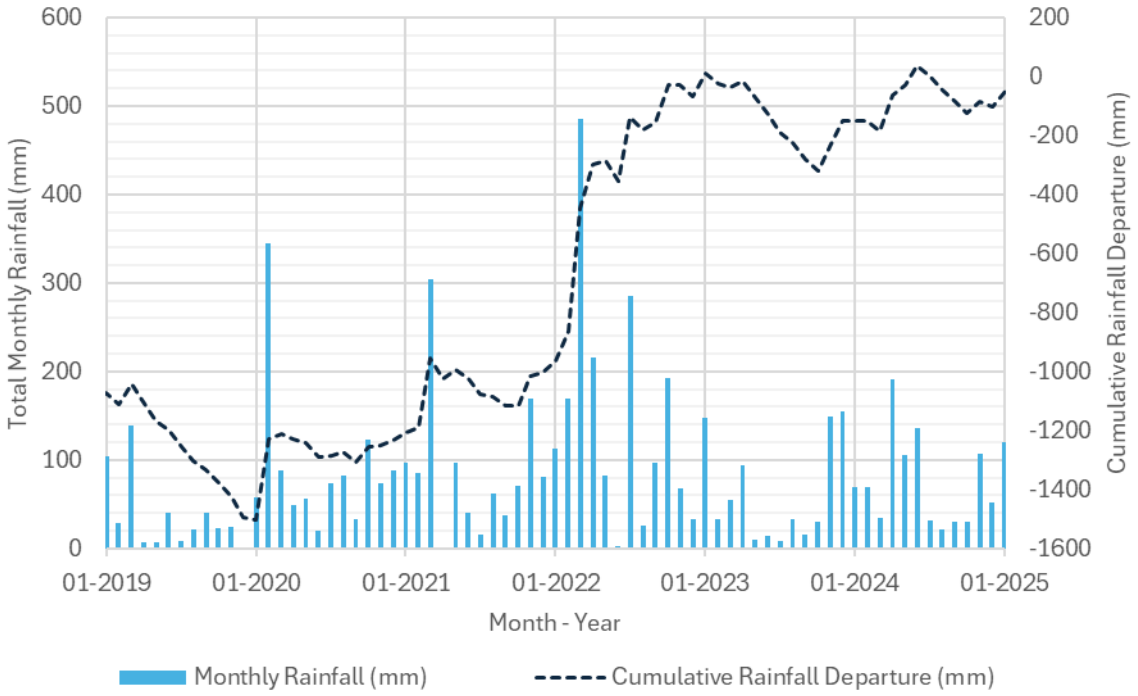
Figure 3 Tahmoor Monthly Rainfall and Cumulative Rainfall Departure

Total site rainfall in 2024 was approximately 878.7 mm, which is about six per cent above the long-term annual average (~828.8 mm). Within the year, January – March were below their long-term monthly means, April – June were above average (approximately 119 mm, 50 mm and 73 mm, respectively), August was below average (approximately 25 mm), and November exceeded its monthly mean; the remaining months were close to average. Consistent with these departures, the CRD exhibits a pronounced rise through autumn 2024, a flattening to slight decline in late winter, and a smaller rise in November (**Figure 3**).

Placed in the broader context since 2019, the CRD indicates a wetter-than-average phase through much of 2020 to early 2023, a drier interval during mid to late 2023, and conditions that were broadly near average through 2024 apart from the autumn wet pulse noted above.

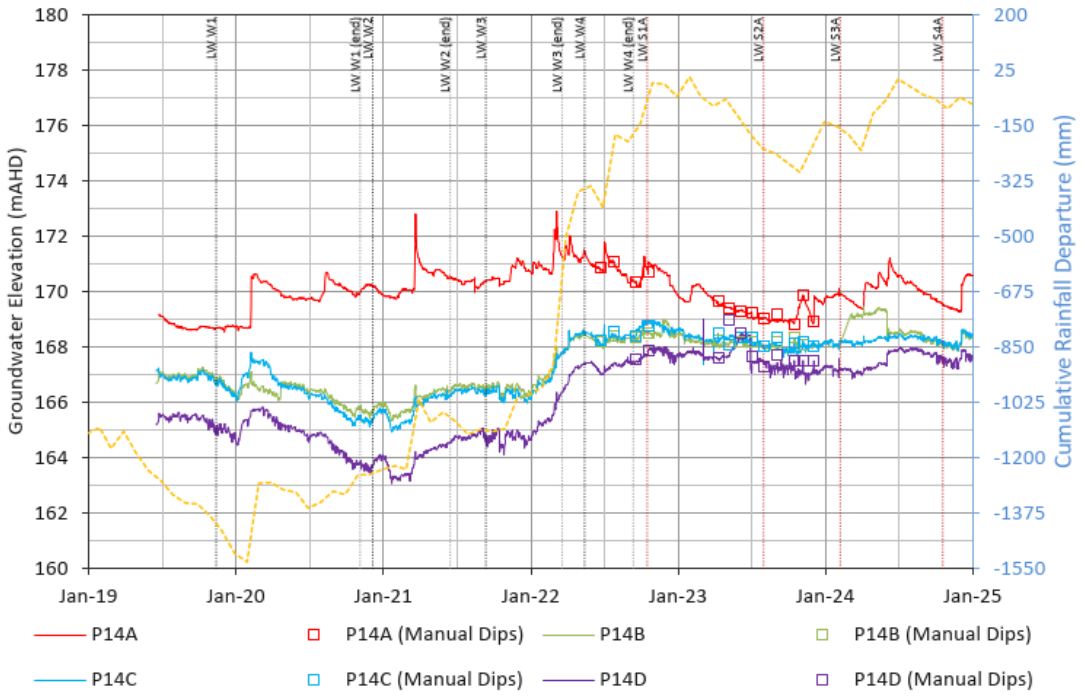
Figure 4 P14A–D groundwater elevations and CRD

At P14D, the recent-window slope is −0.013 metres per year with p = 0.95, and the post-mining slope is +0.043 metres per year with p = 0.46. The maximum drawdown was 2.37 metres, and current heads are 2.35 metres above baseline.

The hydrograph for P14A–D is shown in **Figure 4**.

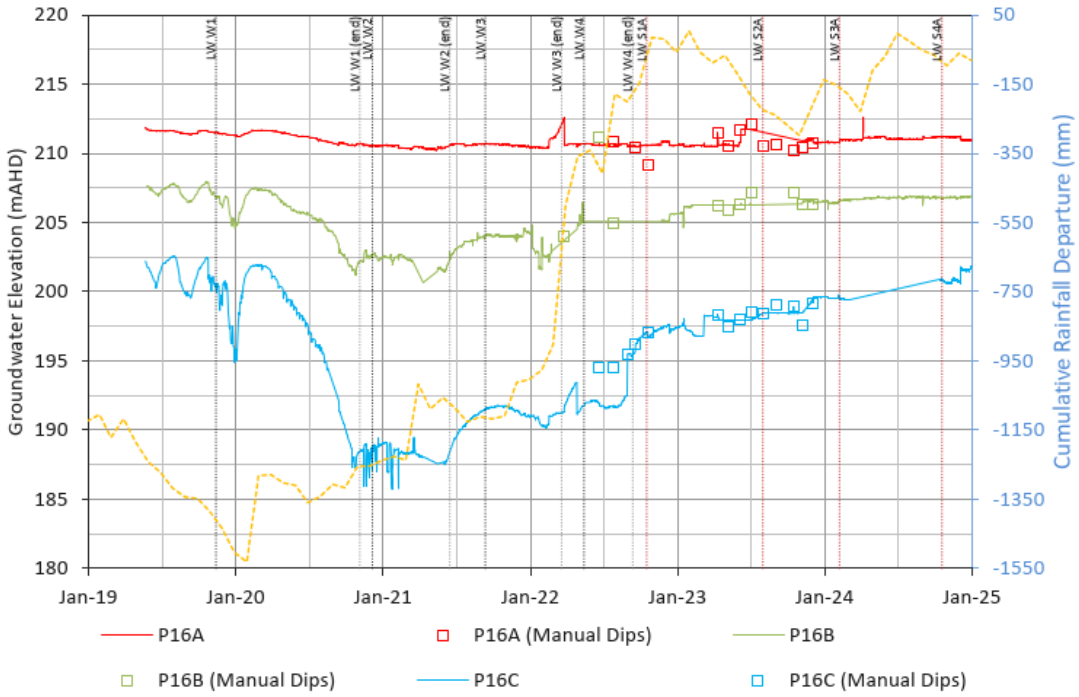
Figure 5 P16A–C groundwater elevations and CRD

At P16C, the recent-window slope is +0.416 metres per year with p = 0.60 (nine months of recent data), and the post-mining slope is +1.861 metres per year with p = 9.0 x10^{-10}. The maximum drawdown was 15.62 metres, and heads are now 0.10 metres above the pre-extraction baseline, indicating effective completion of recovery.

The hydrograph for P16A–C is shown in **Figure 5**.

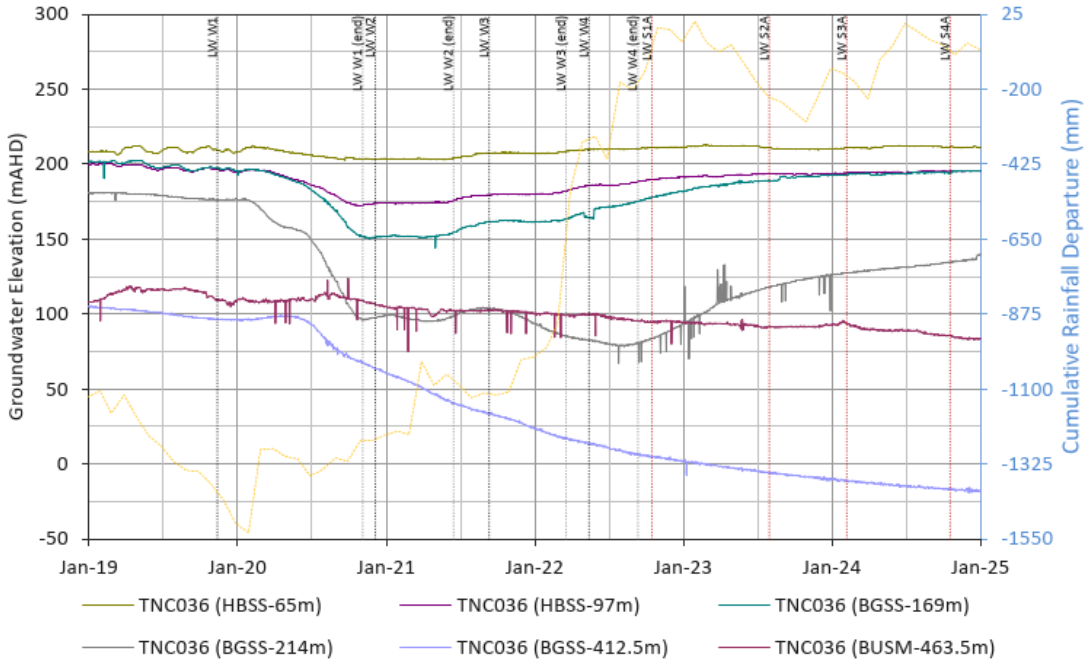
Figure 6 TNC036 groundwater elevations and CRD

BUSM-463.5 m (Bulli Coal seam). The post-mining slope is −5.490 metres per year ($p < 0.001$) and the recent-window slope is −3.068 metres per year ($p = 0.044$). The maximum drawdown during the extraction window was 13.73 metres. The present residual drawdown is 29.69 metres, also greater than the mining-period drawdown, which is consistent with ongoing depressurisation within the coal measures, likely associated with ongoing extractive operations in Tahmoor South.

The hydrograph for TNC036 is shown in **Figure 6**.

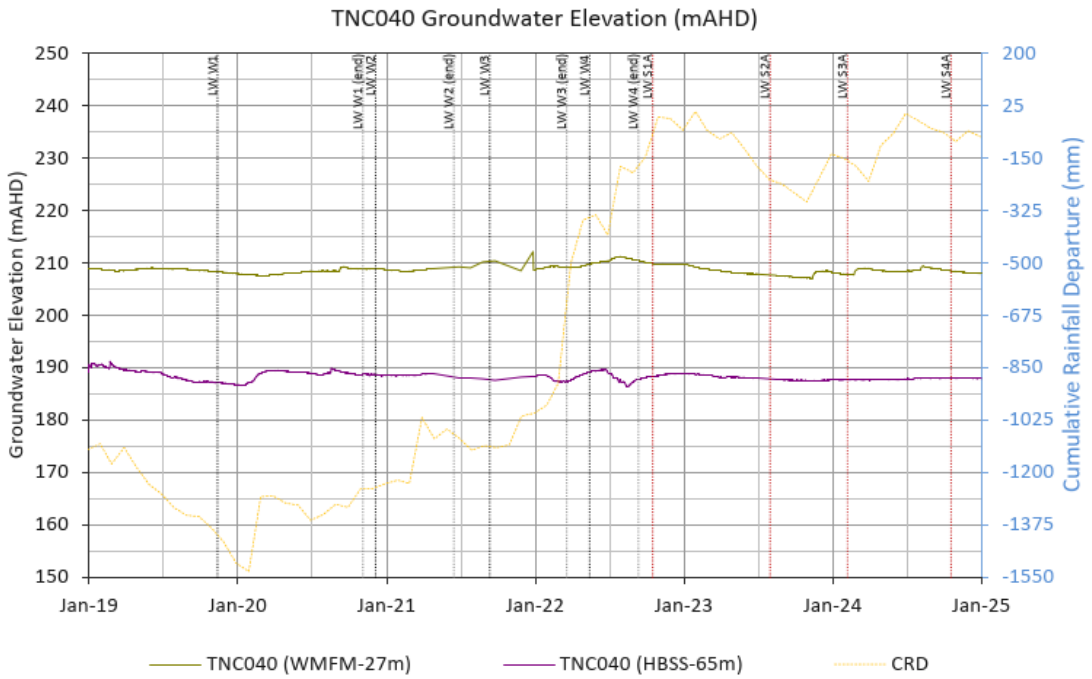
Figure 7 TNC040 groundwater elevations and CRD

WMFM-27 m (Wianamatta Formation). The post-mining slope is −0.482 metres per year (p = 0.0286), indicating a detectable decline over the post-mining interval. The recent-window slope is −0.600 metres per year (p = 0.0769), which is not statistically distinguishable from zero at the 0.05 level. The maximum drawdown during extraction was 0.484 metres. The current residual drawdown is 0.034 metres, which corresponds to approximately ninety-three per cent recovery.

The hydrograph for TNC040 is shown in **Figure 7**.

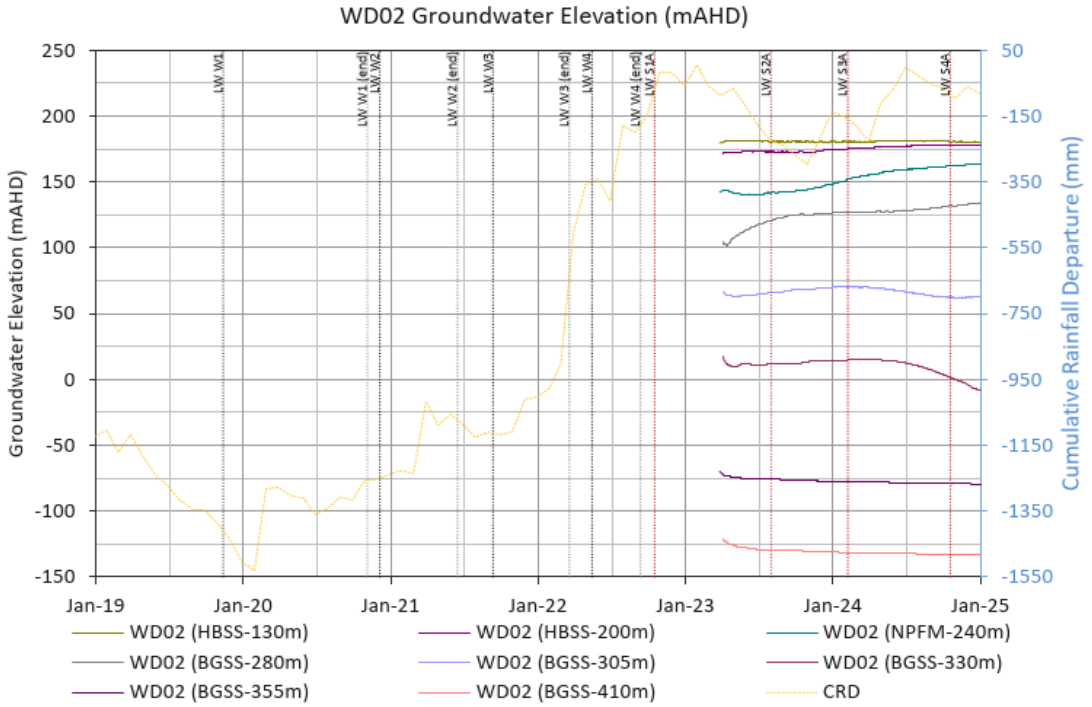
Figure 8 WD02 groundwater elevations and CRD

BGSS-410 m (Bulgo Sandstone). The post-mining slope is −1.757 metres per year (p < 0.001) and the recent-window slope is −0.273 metres per year (p = 0.044), indicating continued decline with a modest, statistically detectable, recent rate.

The hydrograph for WD02 is shown in **Figure 8**.

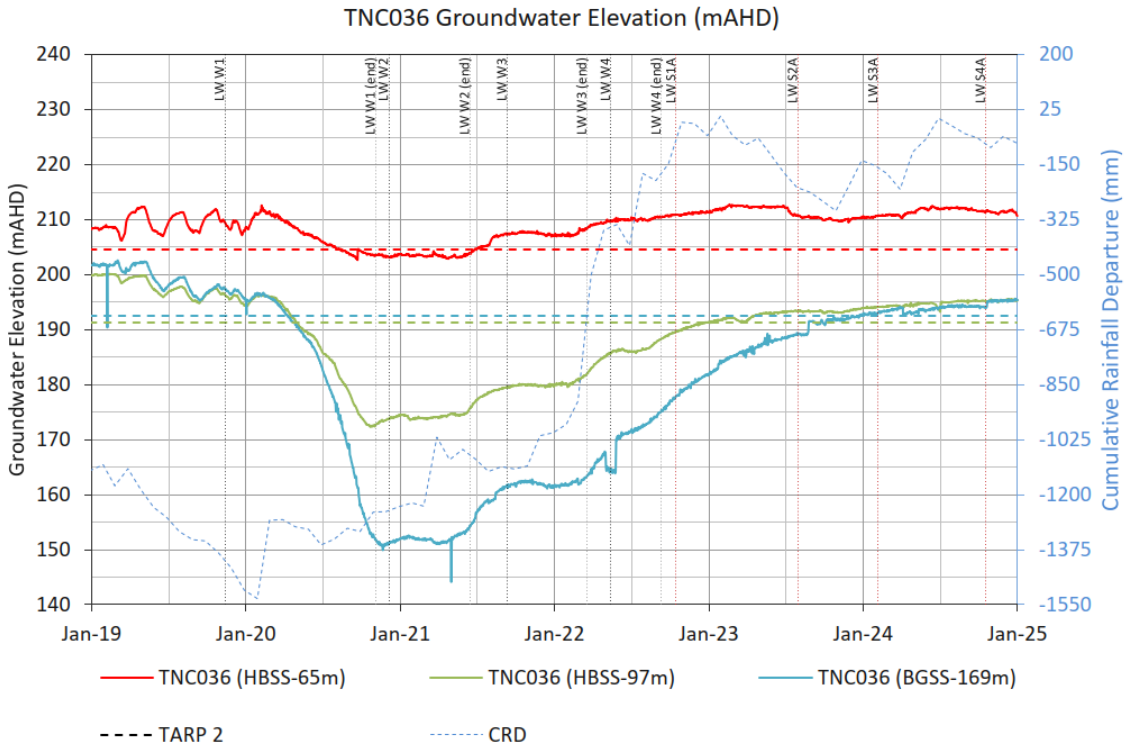
Figure 11 TNC036 shallow sensors (<200m) groundwater elevations with TARP Level 2 trigger

The shallow VWP sensors and they're associates TARP Level 2 triggers are presented in **Figure 11**. All sensors indicate no exceedance of the Level 2 trigger, indicating baseline conditions exist.
