Tahmoor Coal Pty Ltd

SIX MONTHLY SUBSIDENCE IMPACT REPORT

Tahmoor South Domain Longwalls South 1A – South 6A

1 January 2024 – 30 June 2024

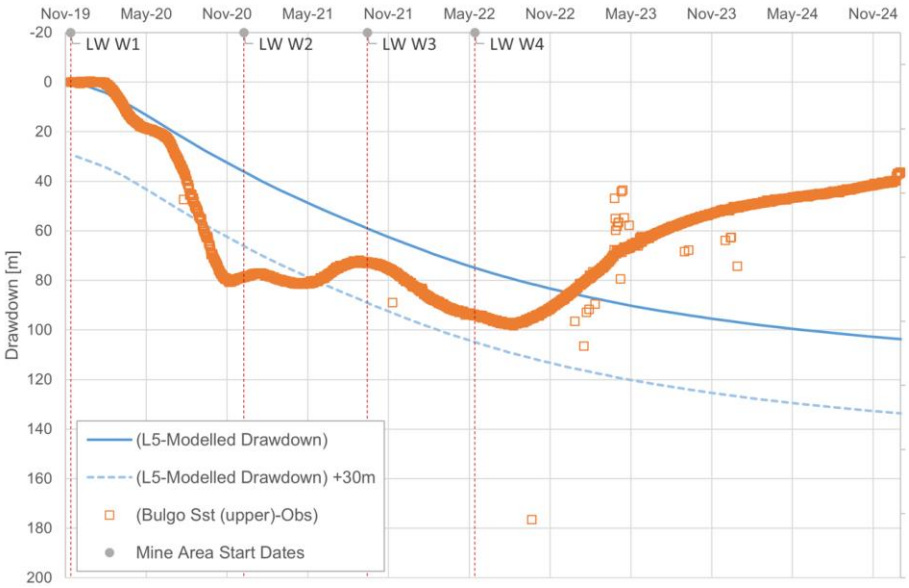
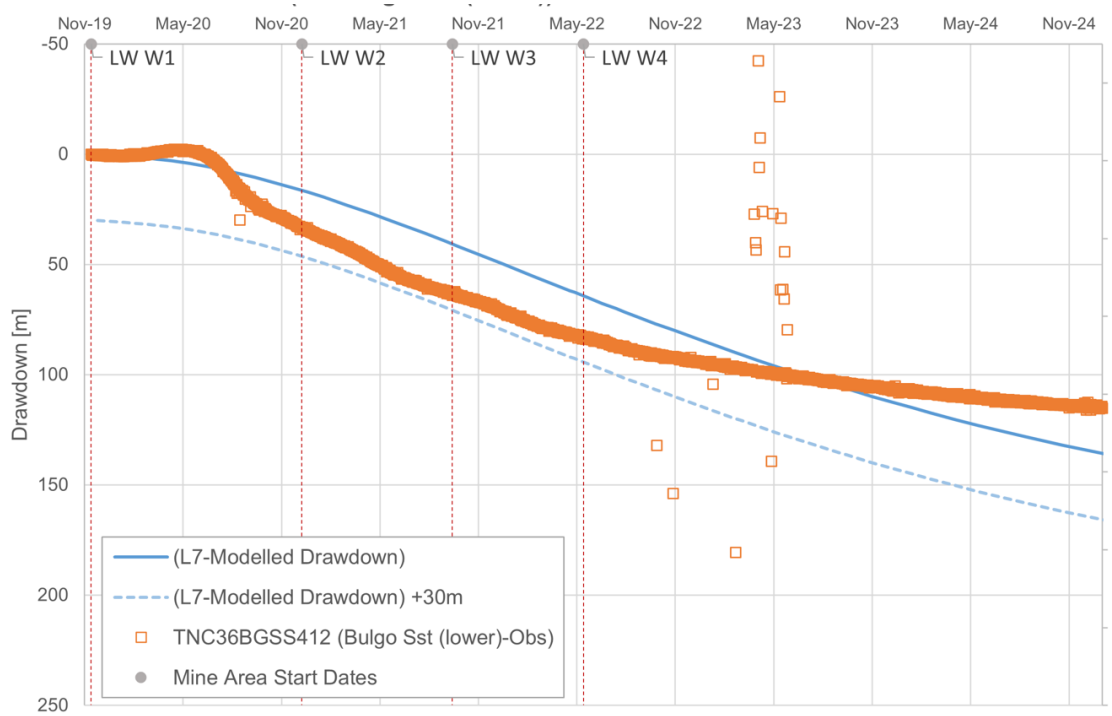
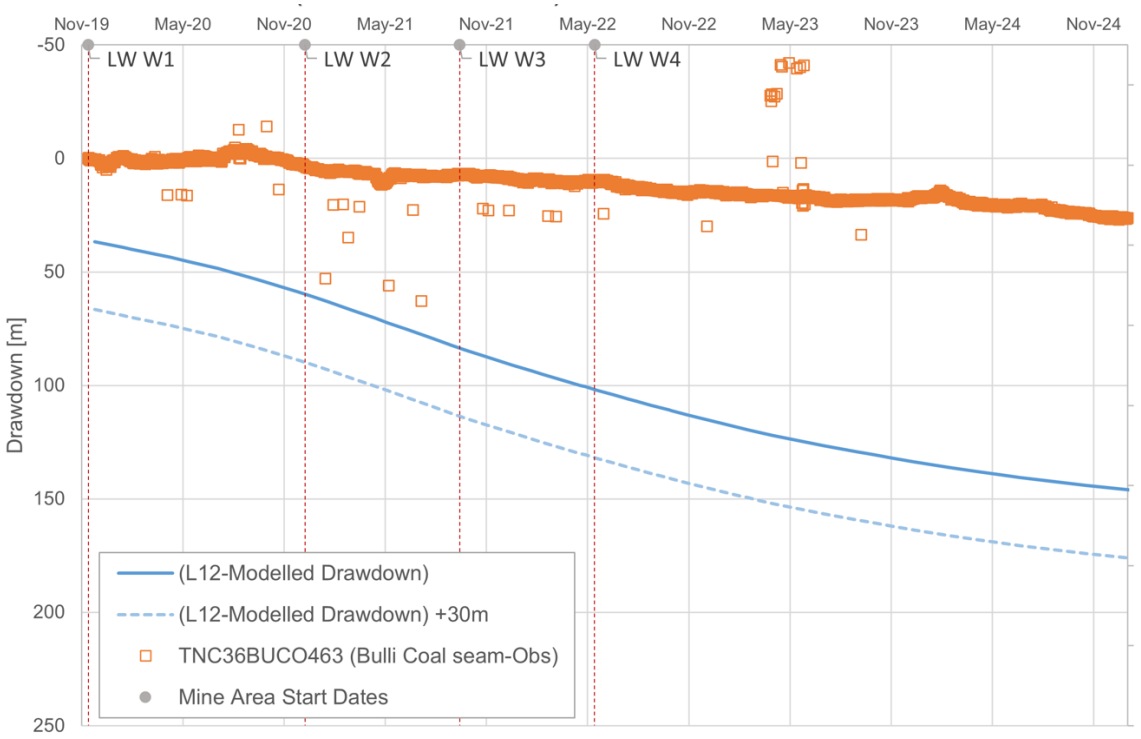
The deep (>200 metres) sensors have approved drawdown criteria upon which the TARP levels are based. A level 1 (or no exceedance) is active if the observed drawdown does not exceed the predicted drawdown. **Figure 12** through **Figure 14** show the observed and modelled drawdown for the three deep sensors at TNC036. None of the deep sensors exceed predicted drawdown.

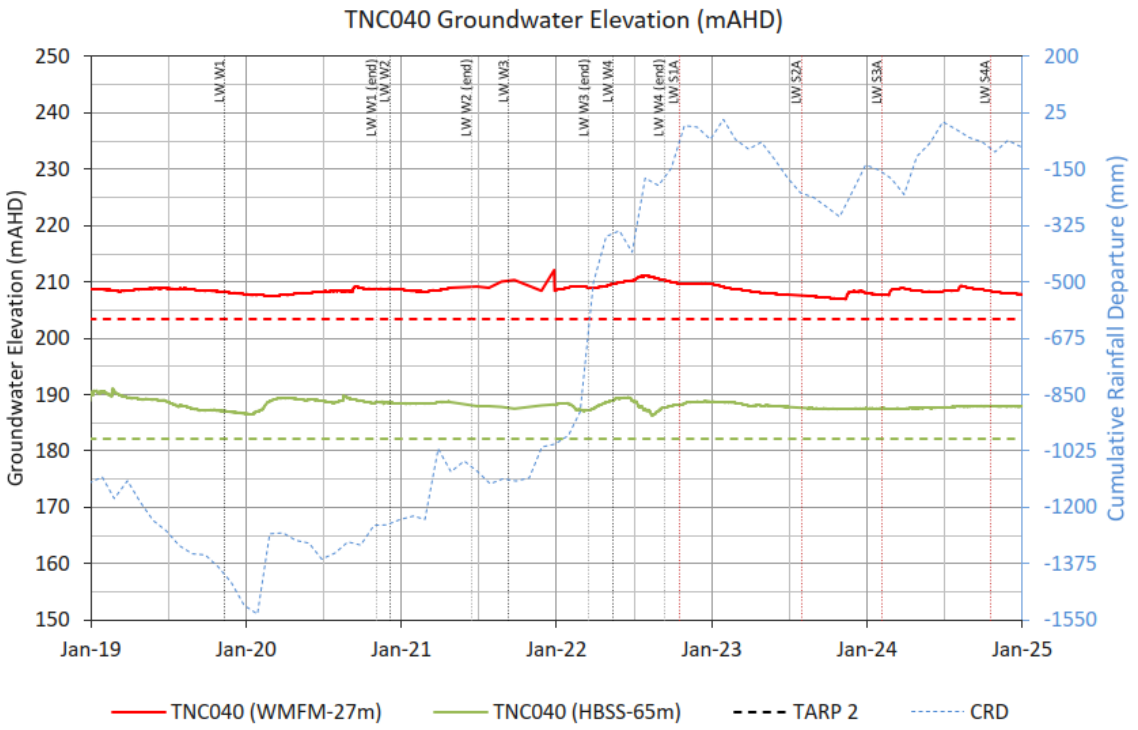
Figure 15 TNC040 shallow sensors (<200m) groundwater elevations with TARP Level 2 trigger

Both sensors of VWP TNC040 are above the Level 2 TARP Trigger, indicating they are representative of baseline conditions (**Figure 15**).
