Tahmoor Coal Pty Ltd

SIX MONTHLY SUBSIDENCE IMPACT REPORT

Western Domain Longwalls West 1 – West 4

1 January 2023 – 30 June 2023

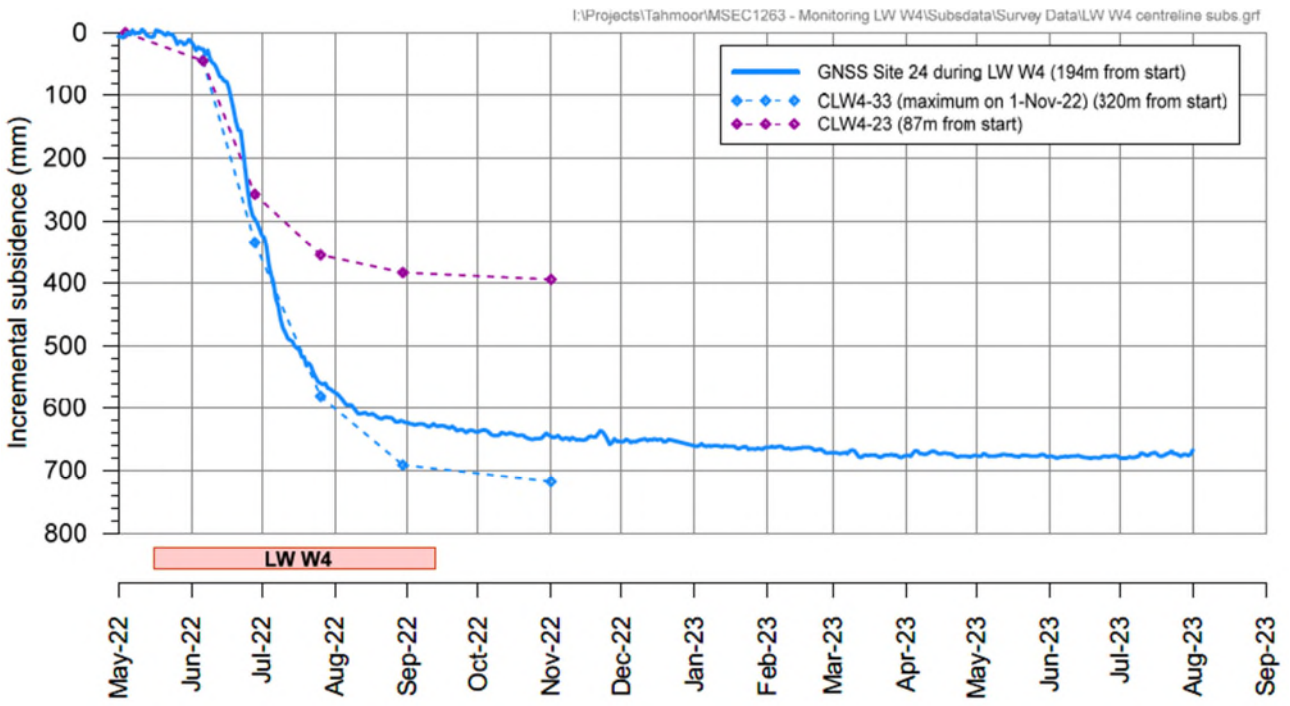
Figure 2-1 Development of subsidence along centreline of LW W4 (source: MSEC, Subsidence Monitoring Report 21, Appendix A).

GNSS Site 24 is located directly above the centreline of LW W4, approximately 200 metres from the commencing end. The unit has recorded approximately 660 mm subsidence and has also moved to the east and south. Rates of change have reduced to very low levels. GNSS Site 24 recorded an additional 16 mm of vertical subsidence in the reporting period, which is likely to be attributed to normal ground movement from climatic variations.

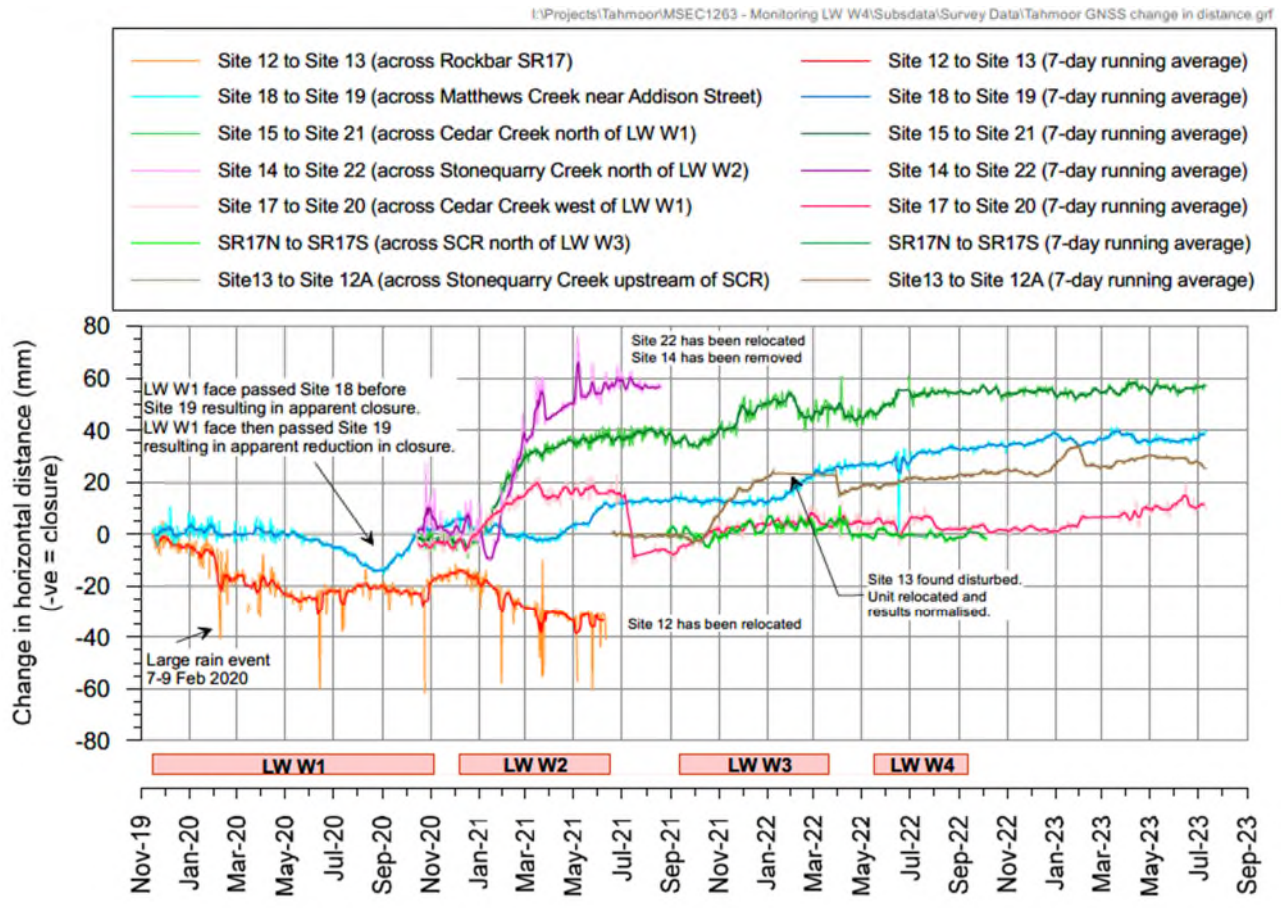
Figure 2-2 Observed changes in horizontal distances between GNSS units during LW W1-W4 extraction (source: MSEC, Subsidence Monitoring Report 21, Appendix A).

Changes in horizontal distances between GNSS units stationed near each other and on opposite sides of a waterway as a result of the extraction of LW W1-W4 are shown in **Figure 2-2**. During LW W4 extraction, only minor changes have been observed between the GNSS units.

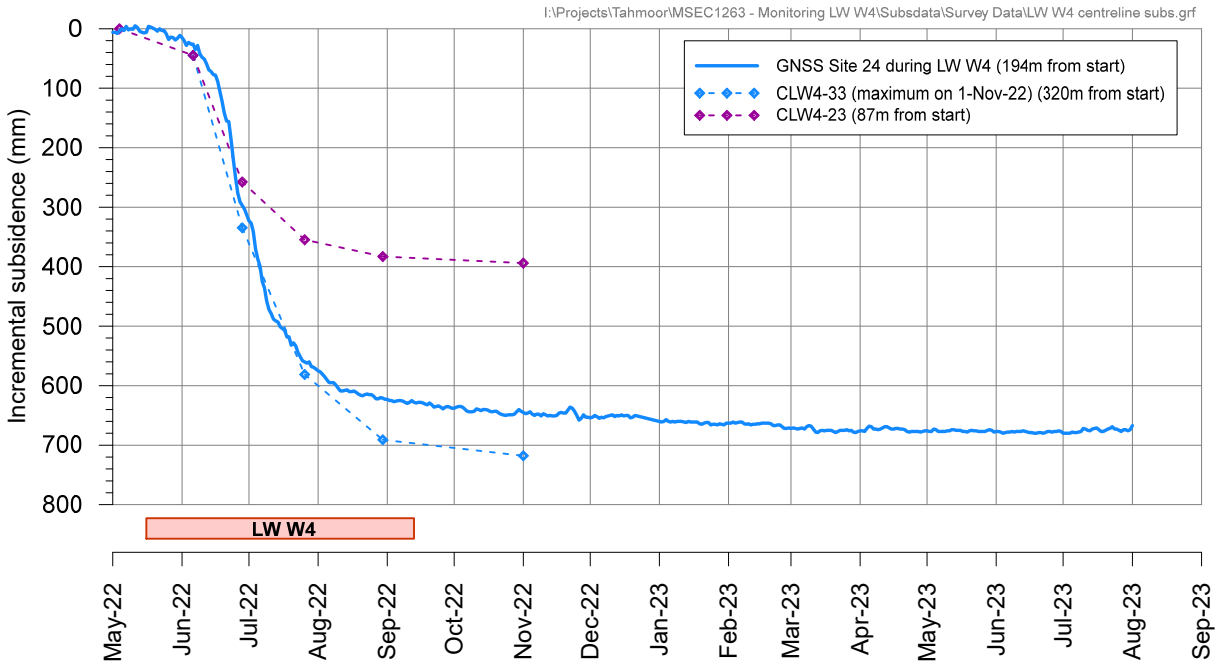
Figure A Development of subsidence along centreline of LW W4

GNSS Site 24 is located directly above the centreline of LW W4, approximately 200 metres from the commencing end. The unit has recorded approximately 660 mm subsidence and has also moved to the east and south. Rates of change have reduced to very low levels.

The development of subsidence over time, at sites of interest along the centreline, is shown in Figure A. GNSS Site 24 recorded an additional 16 mm of vertical subsidence between 1 January 2023 and 30 June 2023.

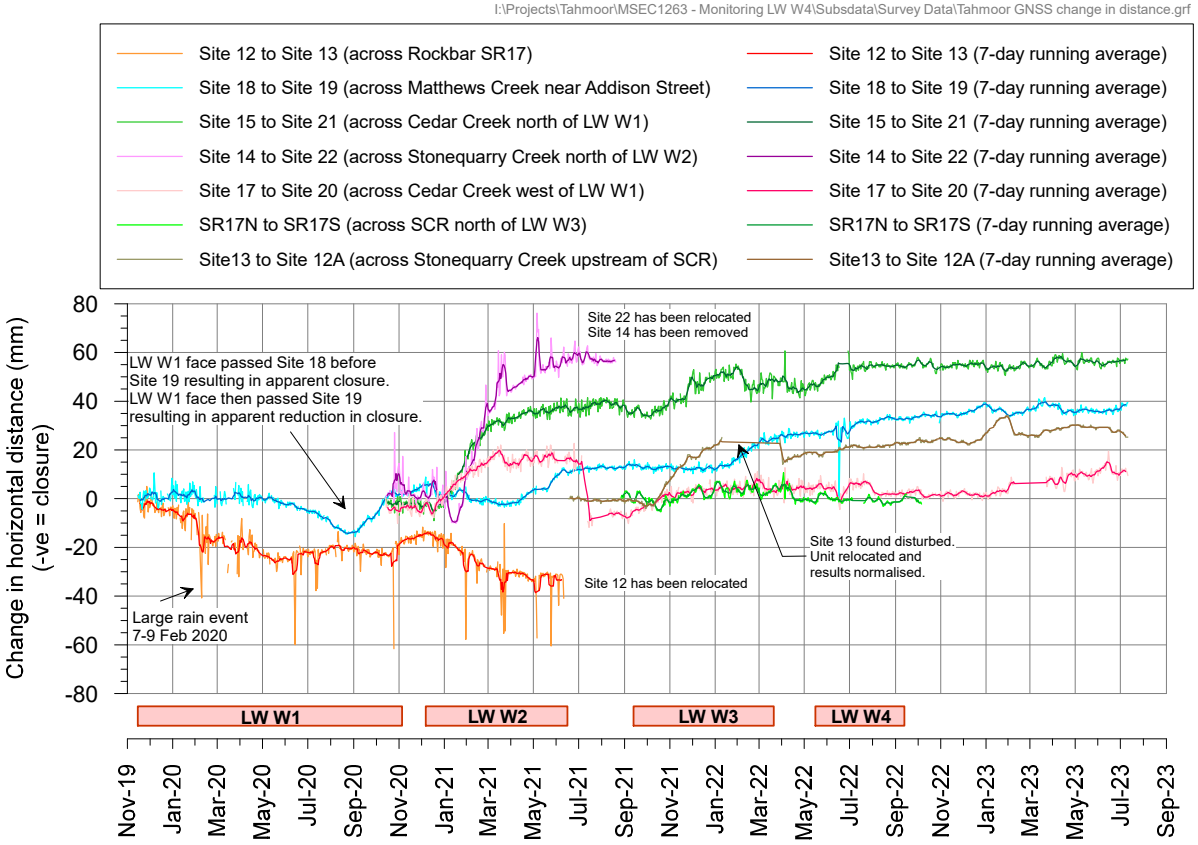
Figure B Observed changes in horizontal distances between GNSS units

Changes in horizontal distances can be calculated between pairs of GNSS units that are stationed close together and results are shown in Figure B.

It can be seen that the remaining pairs of units have recorded a net ground extension when monitoring ceased in July 2023. Trends of increasing ground extension across Sites 18 and 19 (Matthews Creek) and Sites 15 and 21 (Cedar Creek) ceased in January 2023, with very little change recorded during the reporting period to July 2023.

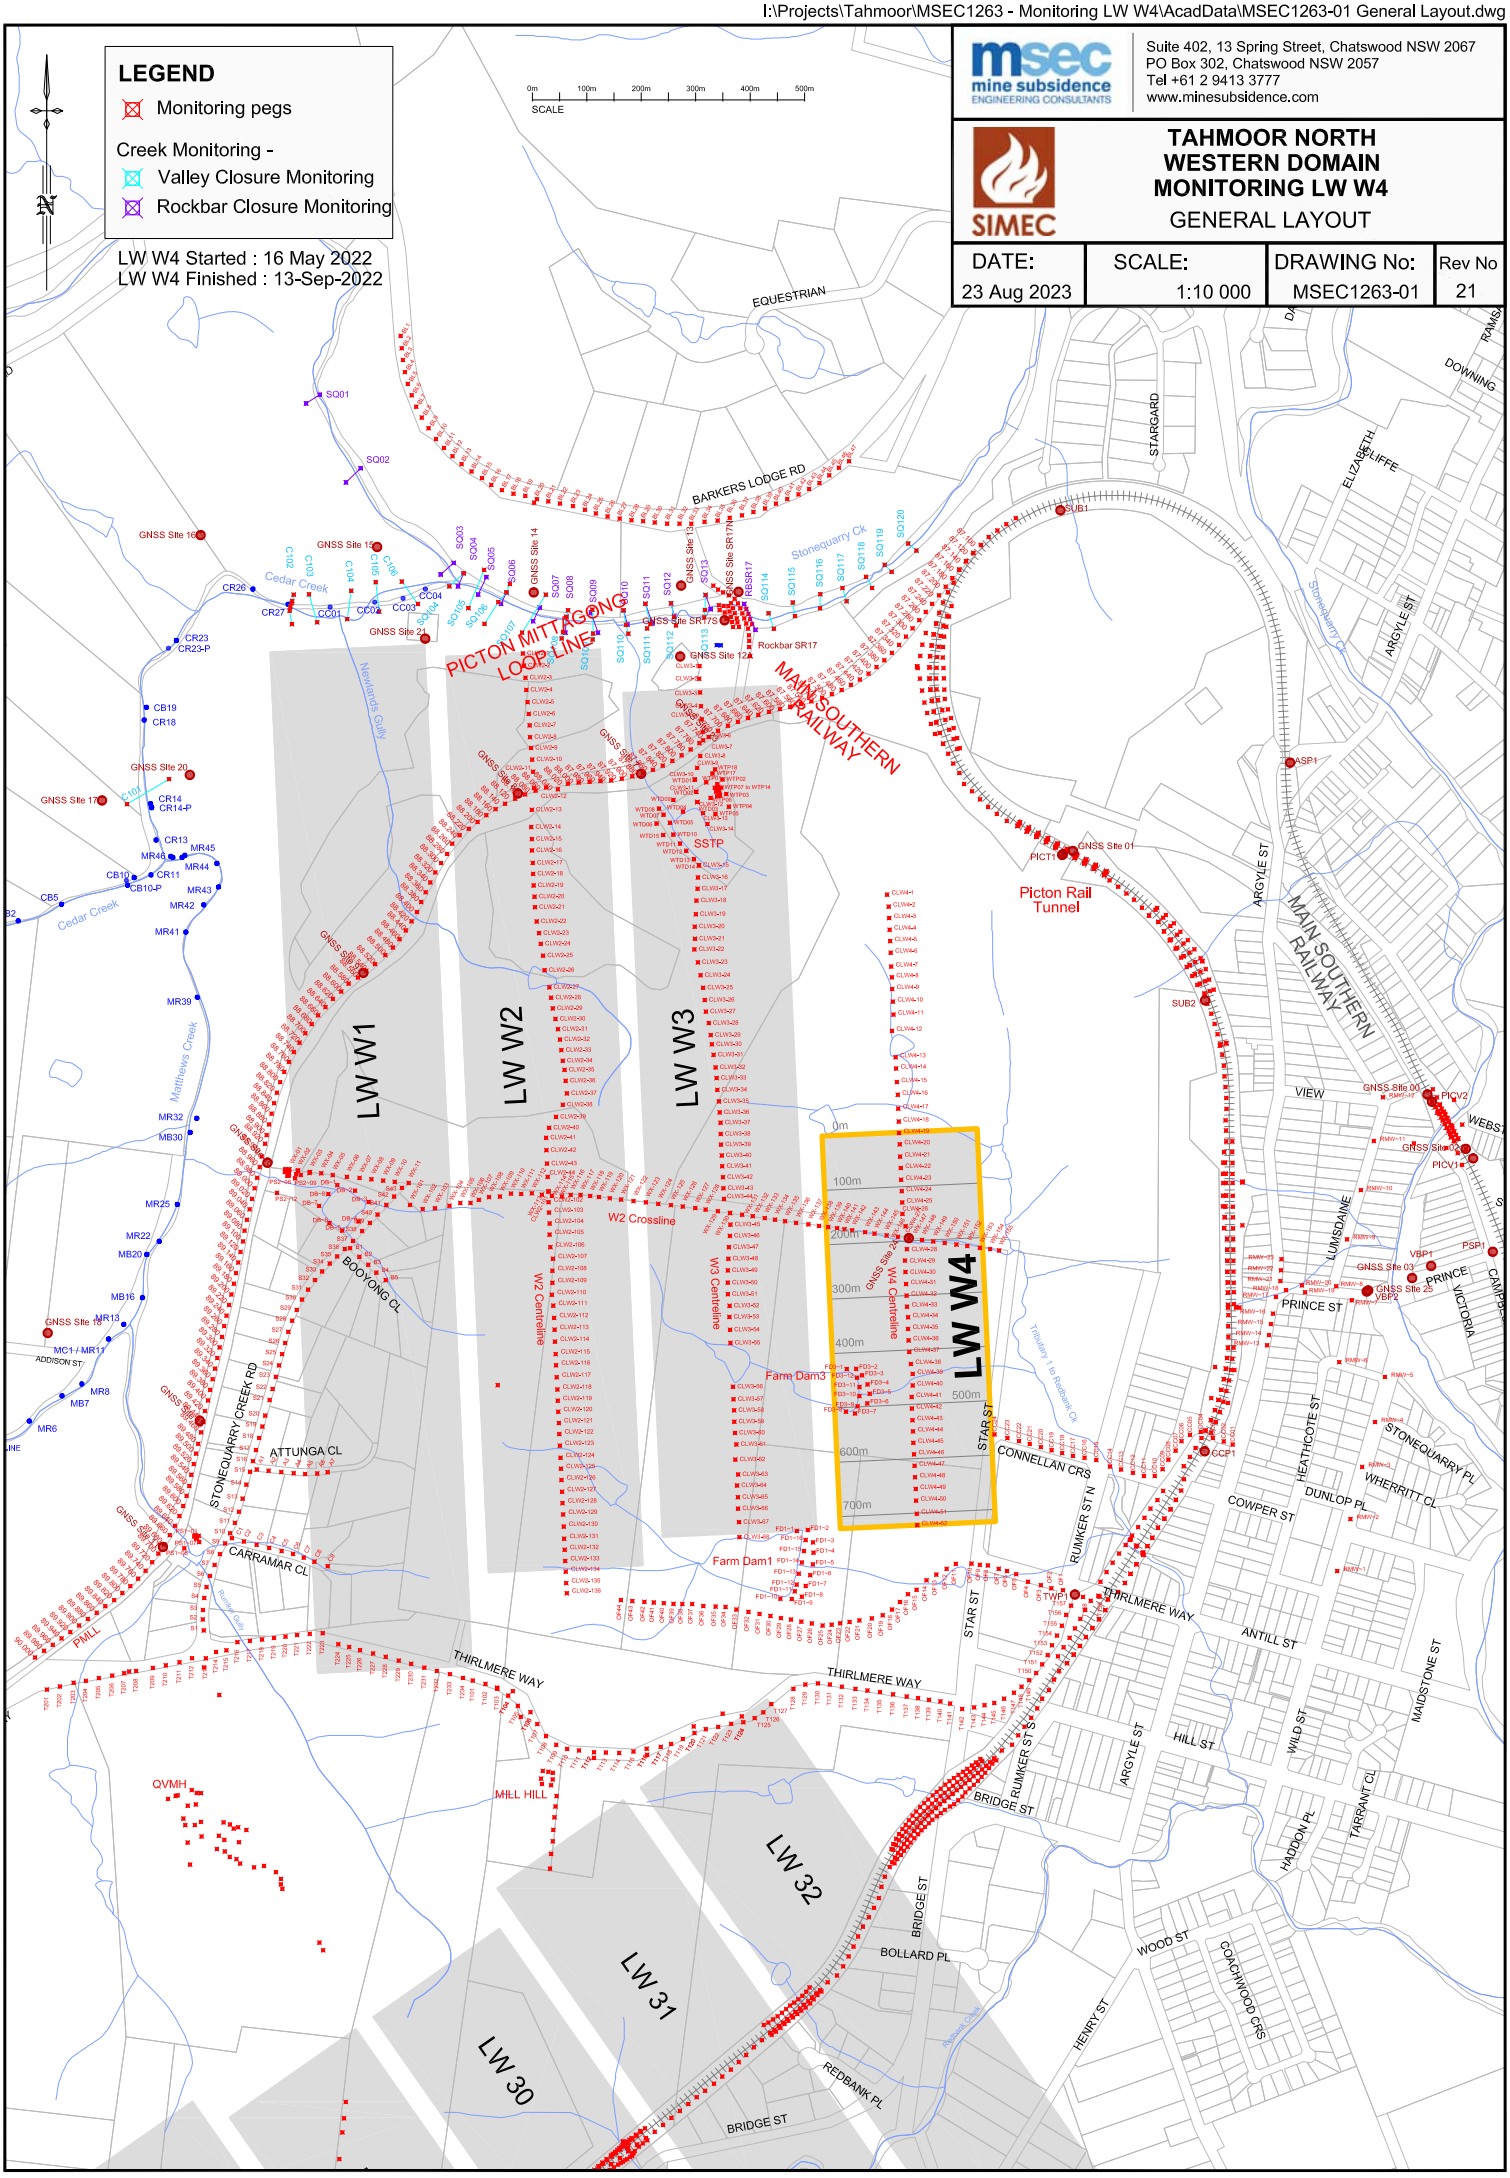
Regular surveys and inspections were conducted at Farm Dam FD-1 and Farm Dam FD-3 during LW W4.

Subsidence was observed to develop gradually at both dams, with compressive strains developing across and along the dam walls. No mining-induced-impacts were observed.

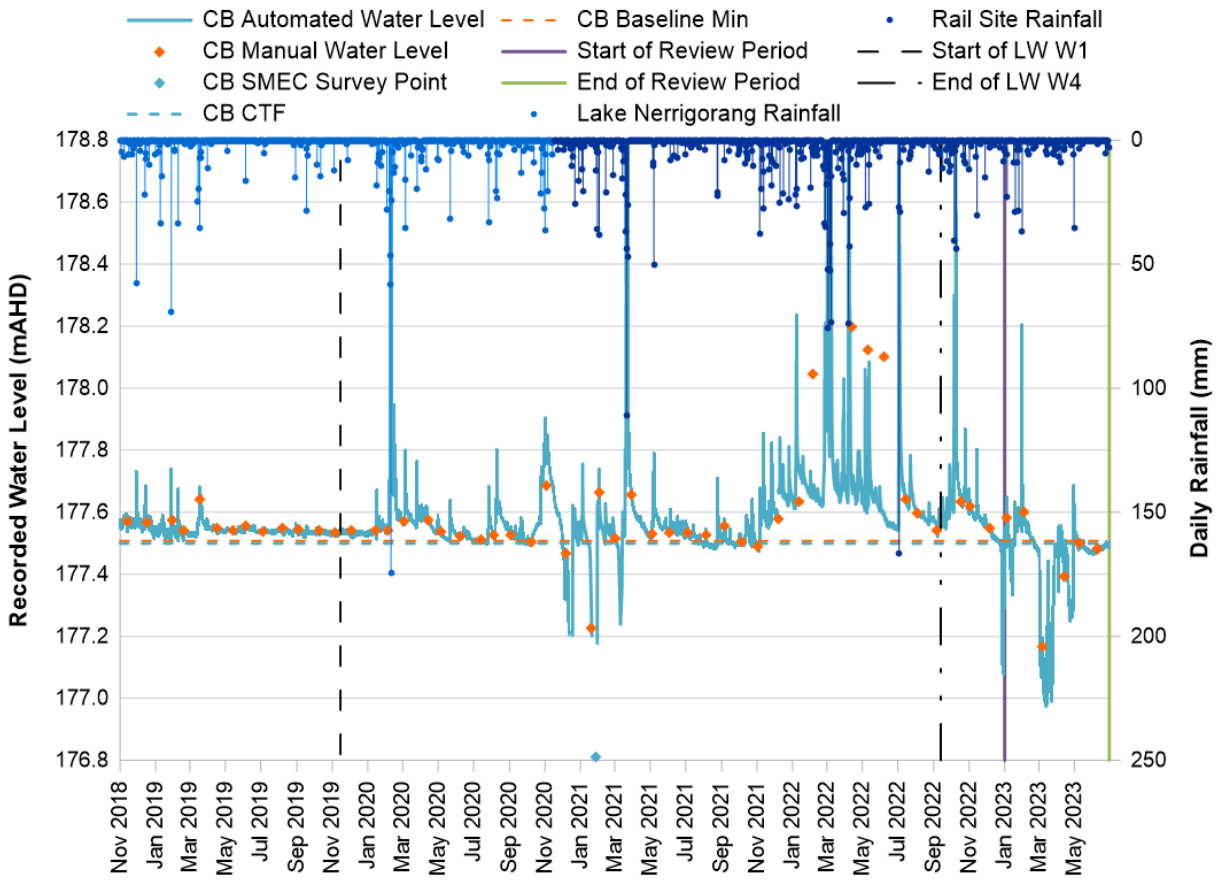
DIAGRAM B11: MONITORING SITE CB WATER LEVEL RECORDS

It is noted that a Level 4 TARP significance was originally triggered in relation to surface water level decline for the period 19 to 29 January 2021 at monitoring site CB (pool CR14) in Cedar Creek. As stated in HEC (2022), whilst not visible on the surface, it was likely that mining induced subsidence had mobilised existing fractures resulting in changes in the water level recession rate of pool CR14 (monitoring site CB). In addition, it was considered likely that mining induced groundwater drawdown had resulted in the surface water system in the vicinity of pool CR14 transitioning from a gaining stream (baseflow discharge from the groundwater system to the stream) to a weakly gaining or losing stream (surface water recharge to the groundwater system) (HEC, 2022).

When comparing the monitoring data directly to the TARP level descriptions included in **Table 8**, it is noted that a Level 3 may apply for the period 6 May to 30 June and a Level 4 may apply for the period 2 to 3 January, 9 to 18 January and 19 February to 28 April 2023. However, it is considered that the TARP level descriptions do not accurately reflect the nuanced behaviour of water level recorded during the review period.

A decline of 4 cm below the baseline minimum is considered negligible, not atypical and related to a reduction in surface flow reporting from Matthews Creek to Cedar Creek, consistent with below average rainfall conditions. Accordingly, a Level 2 trigger is considered to apply in relation to water level decline recorded at monitoring site CB from 6 May to 30 June 2023.

As noted in HEC (2022), the presence of fractures in the base of pool CR14 or in the subsurface would prohibit, to some extent, gaining conditions (dependent on the nature of the fractures) occurring at pool CR14 (pers. comm. SLR, 16 December 2021). The decline in water level at monitoring site CB (pool CR14) suggests that, although gaining conditions were prevailing in the vicinity of monitoring site CB, it is likely that fractures in the base of pool CR14 or in the subsurface, resulted in losing conditions occurring at monitoring site CB.

Consequently, the Environmental Response Group convened and the surface water level data was reviewed in relation to climatic conditions, subsidence monitoring data and groundwater level trends.

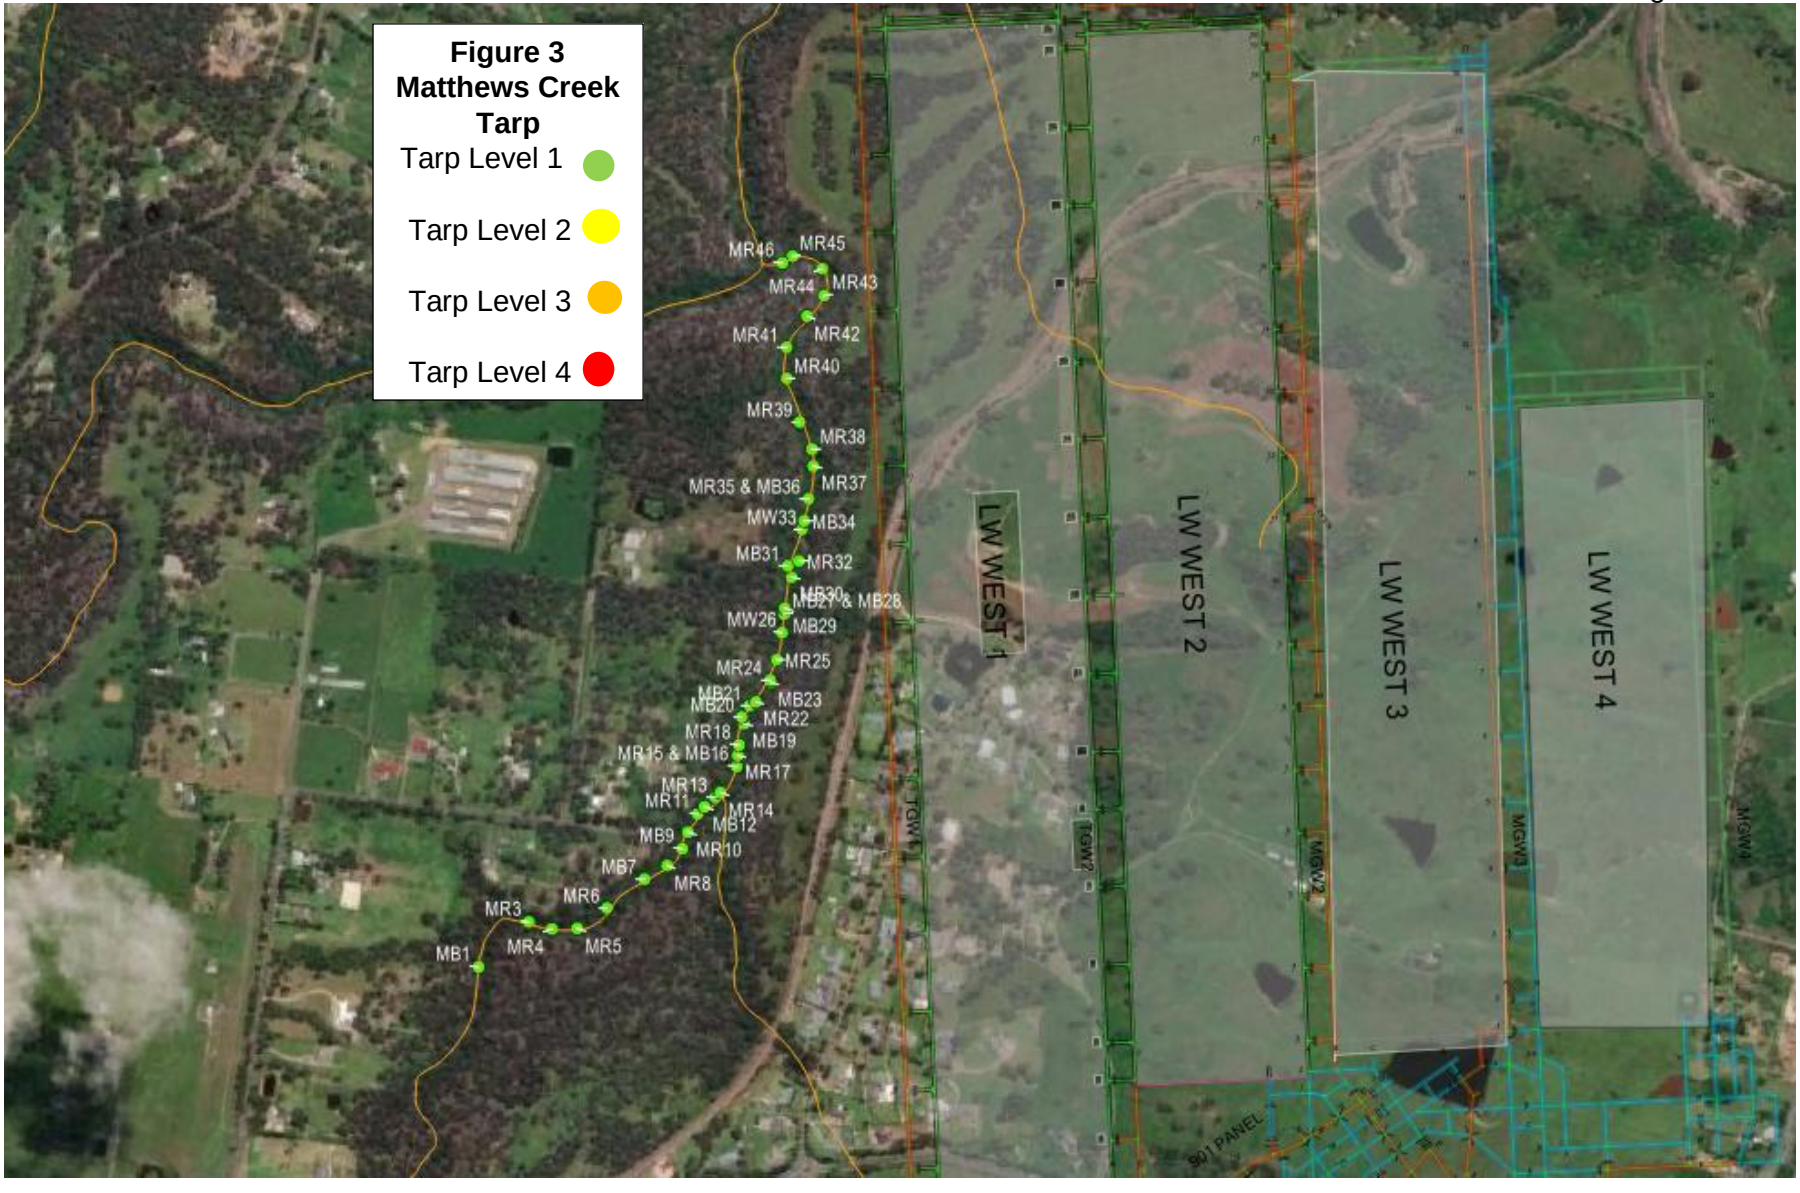
Figure 2
Cedar Creek Tarp

Visual inspections of Cedar Creek's pools and associated rock bars adjacent to Longwall West 3 and West 4 active subsidence area were conducted on 8 February 2023. The inspections at the sites shown in **Figure 2,** indicated that no mine-induced surface fracturing, gas release, reduction in pool levels or connective overland flow was observed. Iron-oxy hydroxide precipitation has significantly reduced due to the 30 mm of rain on the 14th of November 2022. Turbidity has significantly reduced since the last inspection in November 2022, due to no rain in the previous 8 days.

All observed Cedar Creek sites were within TARP Level 1 for the observations of individual pool water level and flow, iron oxyhydroxide precipitation and gas releases as compared to previous surveys or the baseline survey conducted in August 2019.

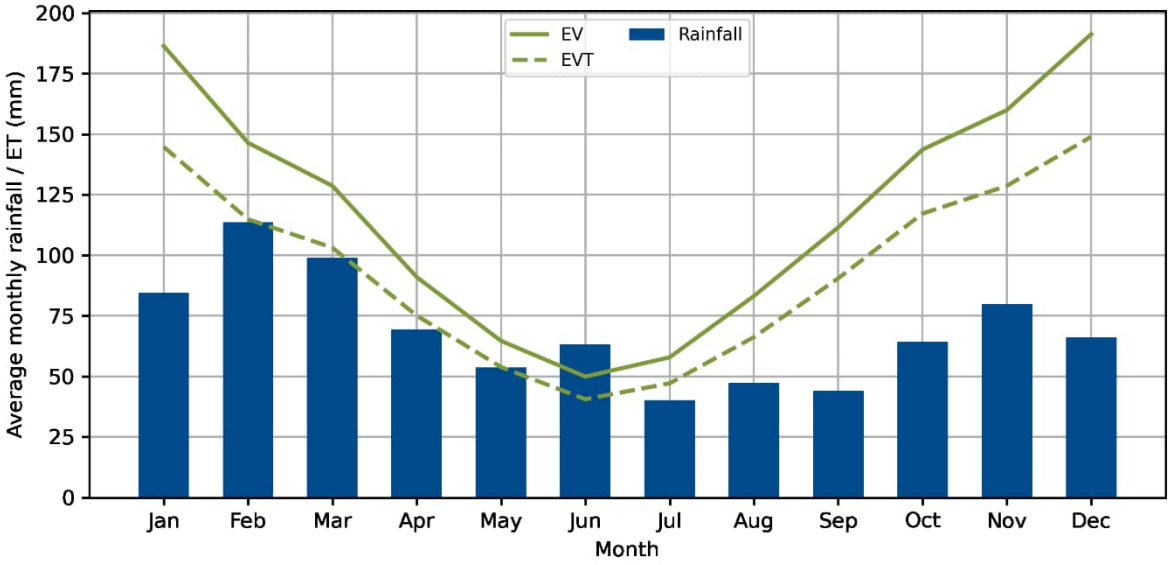
Figure 2 Average Monthly Rainfall, Evaporation and Evapotranspiration

During the reporting period, April 2023 was a particularly wet month, where above average rainfall was observed with a total monthly total rainfall of 101.9mm. Comparatively, the remainder of the reporting period was relatively dry with below average rainfall observed. May and June 2023 were particularly dry conditions with a total monthly rainfall of 10.3mm and 16.8mm respectively.

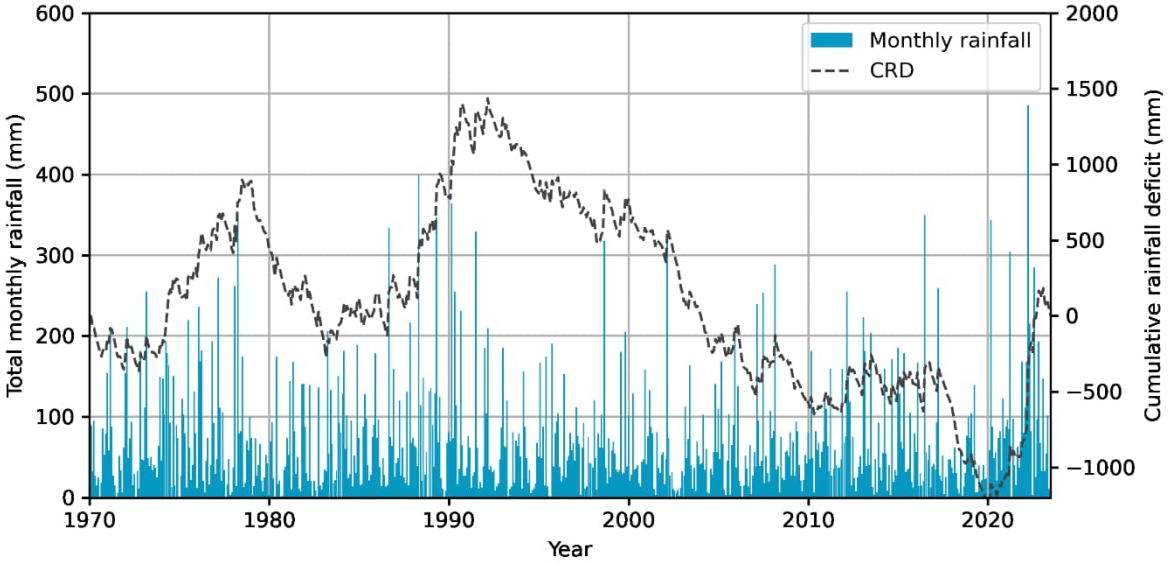
Figure 3 Cumulative Rainfall Departure and Total Monthly Rainfall

The historical record of monthly rainfall and the calculated trend in rainfall, using the cumulative residual departure from mean method, is presented in Figure 3 where a positive gradient indicates above average rainfall, whilst a declining trend represents below average. During the reporting

period, there have been below average rainfall conditions.

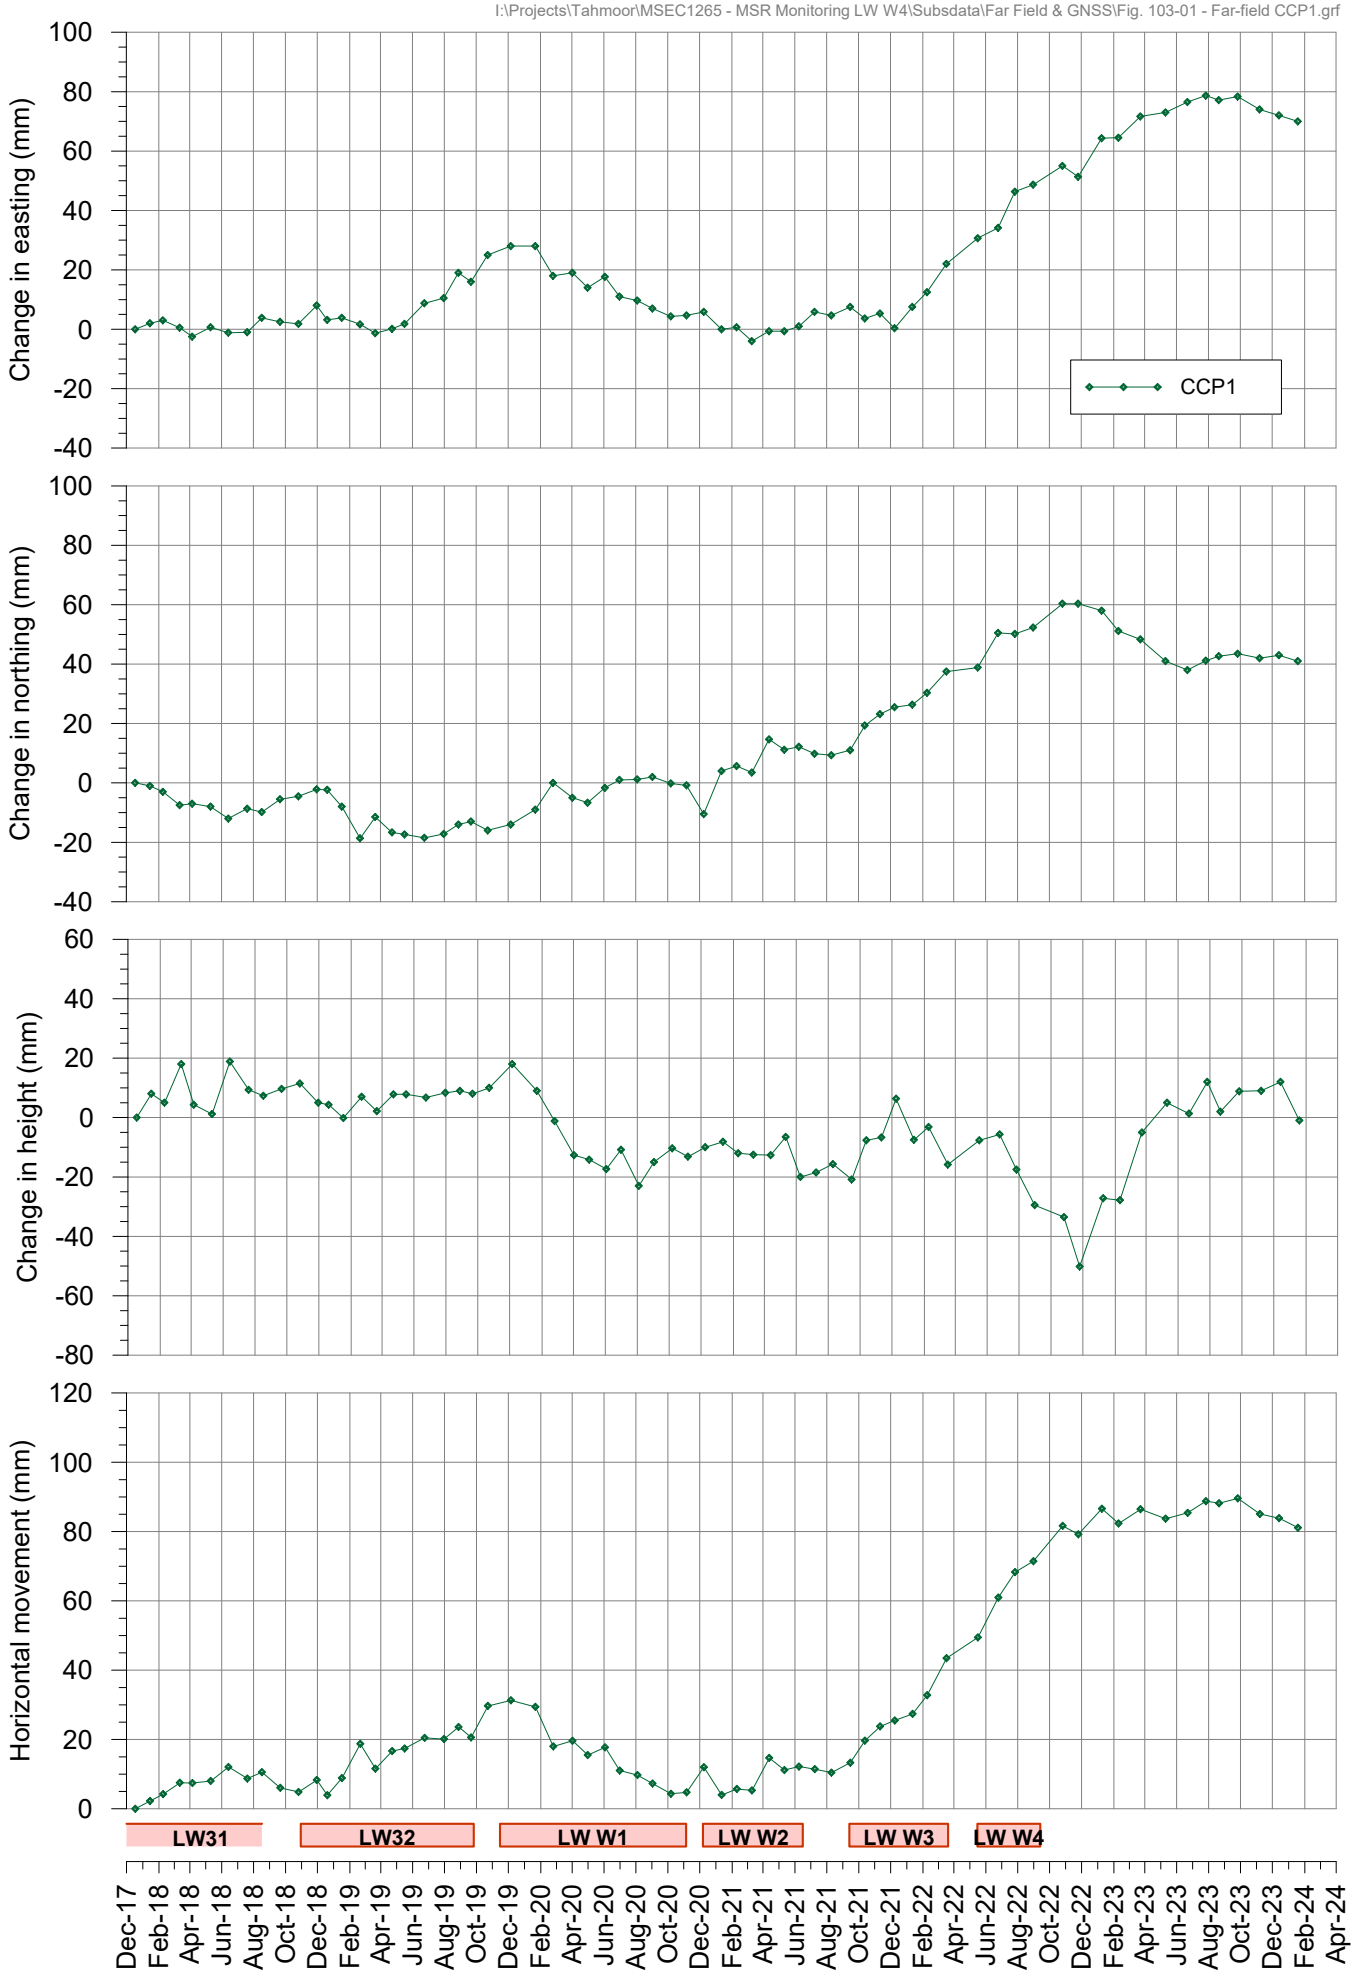
Fig. 102-01-R22

Continued ongoing minor horizontal movements had been observed along the Railway and at the Thirlmere Way Underbridge and Connellan Crescent Overbridge but rates of change had reduced to low levels between 1 July 2023 and 31 December 2023.

Tahmoor - LW W4
Far-field Monitoring - Thirlmere Way Underbridge

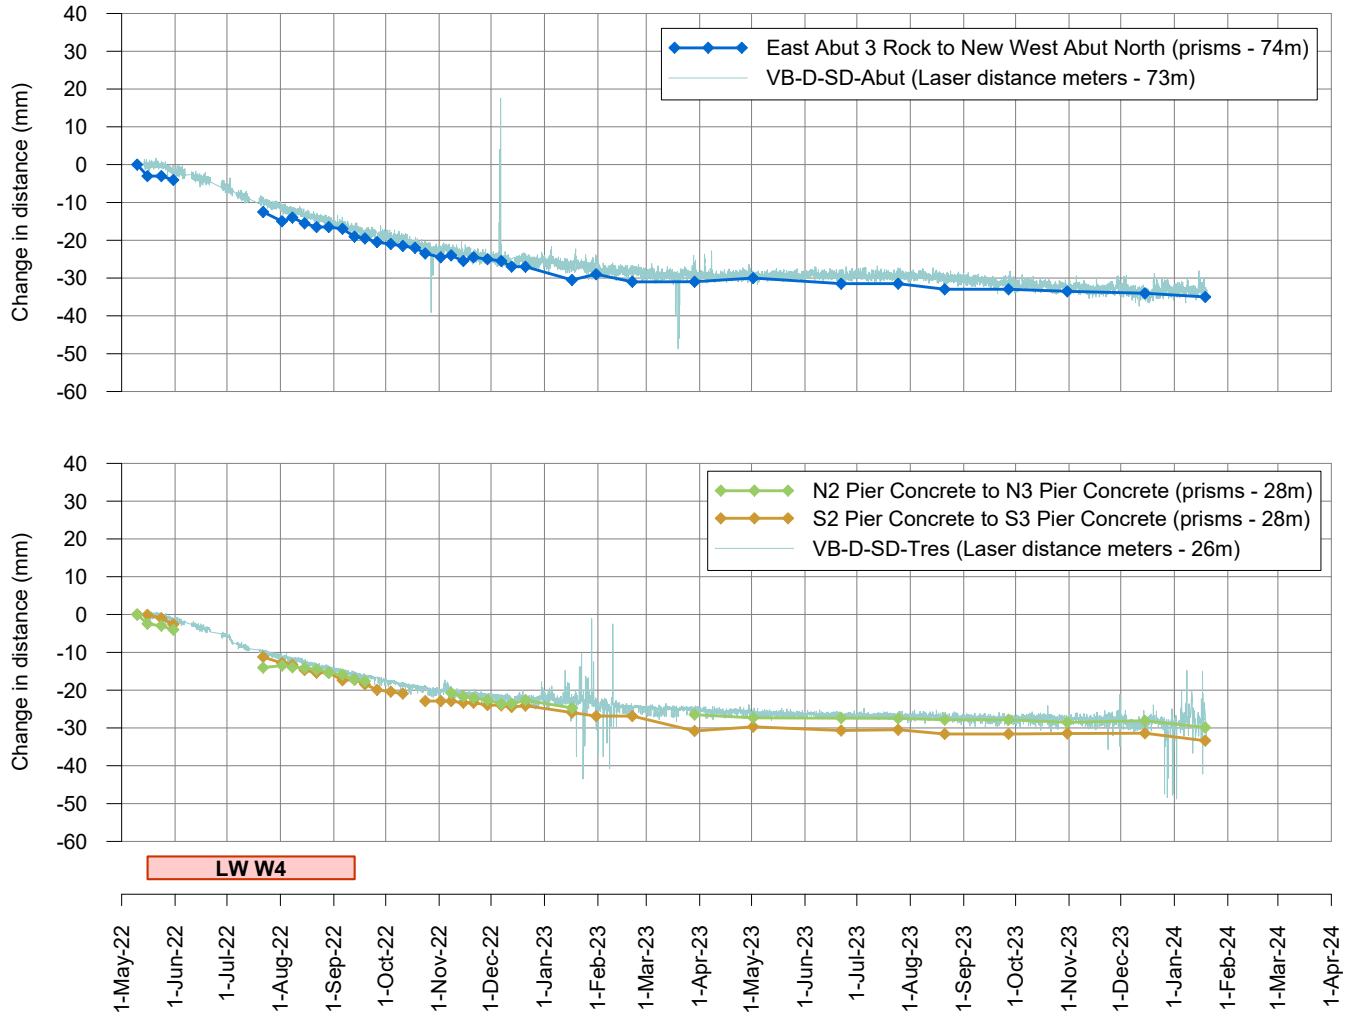
Fig. 115-02 R22

Regular surveys were conducted at the Victoria Bridge over Stonequarry Creek during and after the mining of LW W4. Very small and gradual closure was observed across Stonequarry Creek.

Visual inspections did not identify any impacts associated with mine subsidence but the gap between the deck and the eastern abutment was observed to almost close during the mining of LW W3. The buffer board was replaced on 7 June 2022 and the gap reinstated. A gap of 35 mm was measured between the structural cross beam and abutment on 10 June 2022. The gap between the deck and the eastern abutment was reinstated on 24 January 2023. The gap has gradually reduced over time to 19 mm. Rates of change are reducing to be very low levels. Quarterly monitoring and reporting continues.

Victoria Bridge over Stonequarry Creek

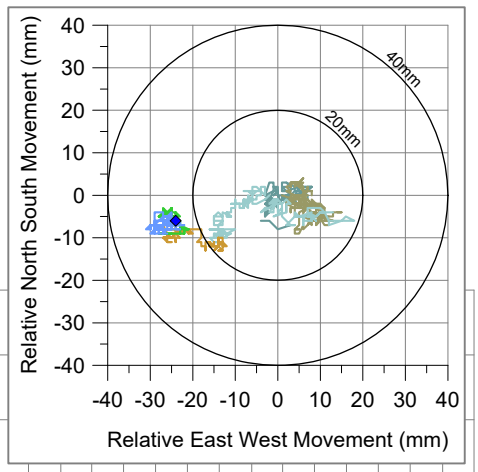
Fig. G01-R22

GNSS unit 1 is located above the Picton Tunnel on the Main Southern Railway. Very minor changes within survey tolerances were observed between July 2023 and October 2023. A minor trend is currently observed since October 2023, which may be due to environmental factors. Monitoring continues.

Tahmoor LW W4 - Main Southern Railway
GNSS Monitoring at Picton Tunnel (Site 01)

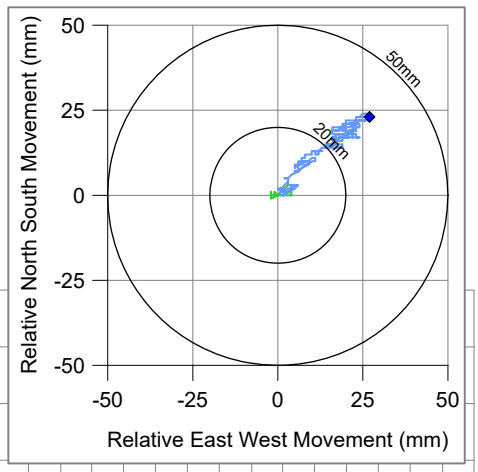
Fig. G02-R22

GNSS units 0 and 2 are located at each end of the Picton Viaduct on the Main Southern Railway. Very minor changes within survey tolerances were observed between July 2023 and December 2023. Monitoring continues.

Tahmoor LW W4 - Main Southern Railway
GNSS Monitoring at Picton Viaduct (Sites 00 and 02)

Site investigation on 28 June confirmed drift due to sensor sliding down post as a result of vibration caused by passing trains. Sensor unit fixed to post on 4 July 2019.

Sensor unit replaced on 4 July 2020.

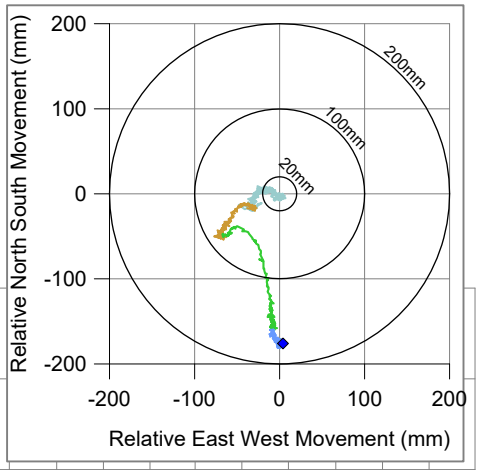
Fig. G03-R22

GNSS units 3 and 25 are located at each end of Victoria Bridge. Very minor changes within survey tolerances were observed at GNSS unit 3 on the eastern abutment between July 2023 and December 2023. A very minor ongoing trend of movement has been measured at GNSS unit 25 on the western abutment, which correlates with the observation of a gradual closure across Stonequarry Creek at the Bridge. Monitoring continues.

Tahmoor LW W4 - Main Southern Railway
GNSS Monitoring at Victoria Bridge (Sites 03 and 25)

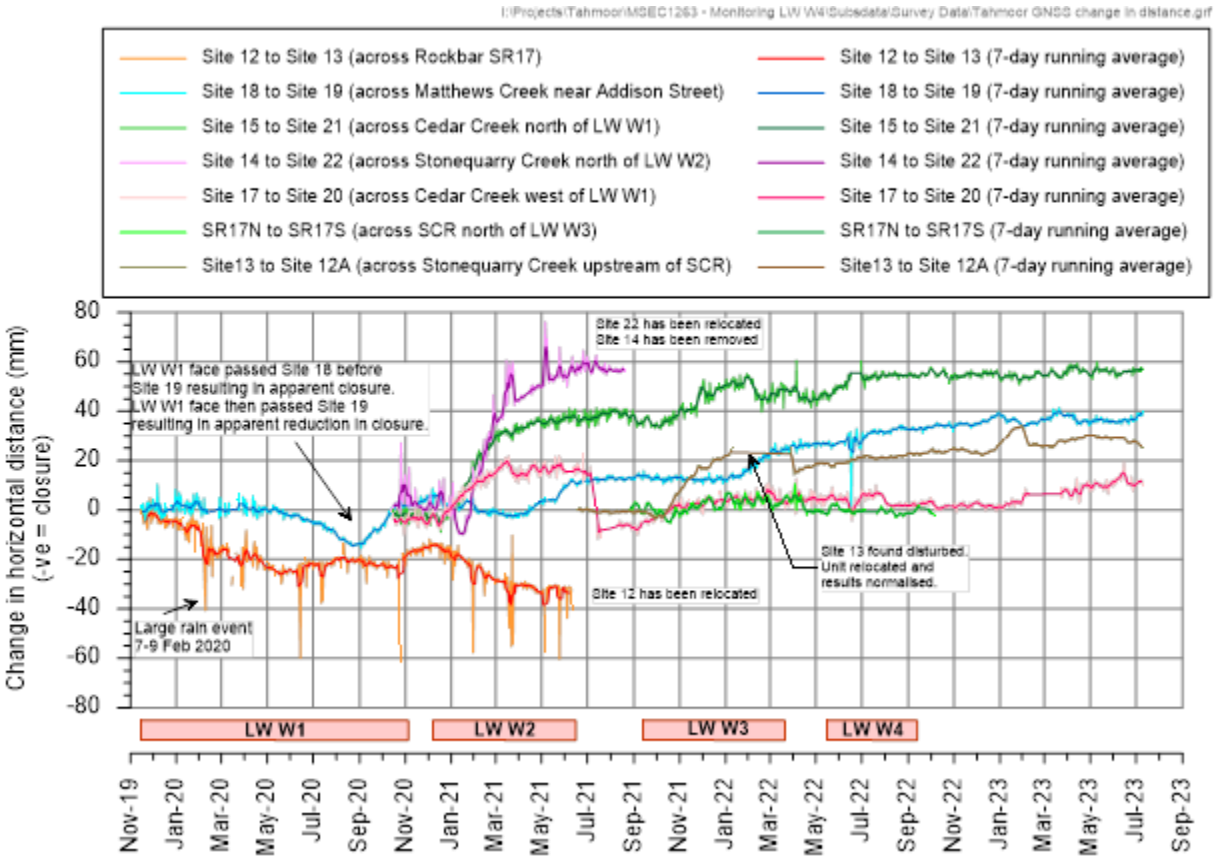
DIAGRAM 1: OBSERVED CHANGES IN HORIZONTAL DISTANCES BETWEEN GNSS UNITS (SOURCE: MSEC, 2023)

Changes in horizontal distances calculated between GNSS[1] units that are stationed close together are presented in **DIAGRAM 1**.

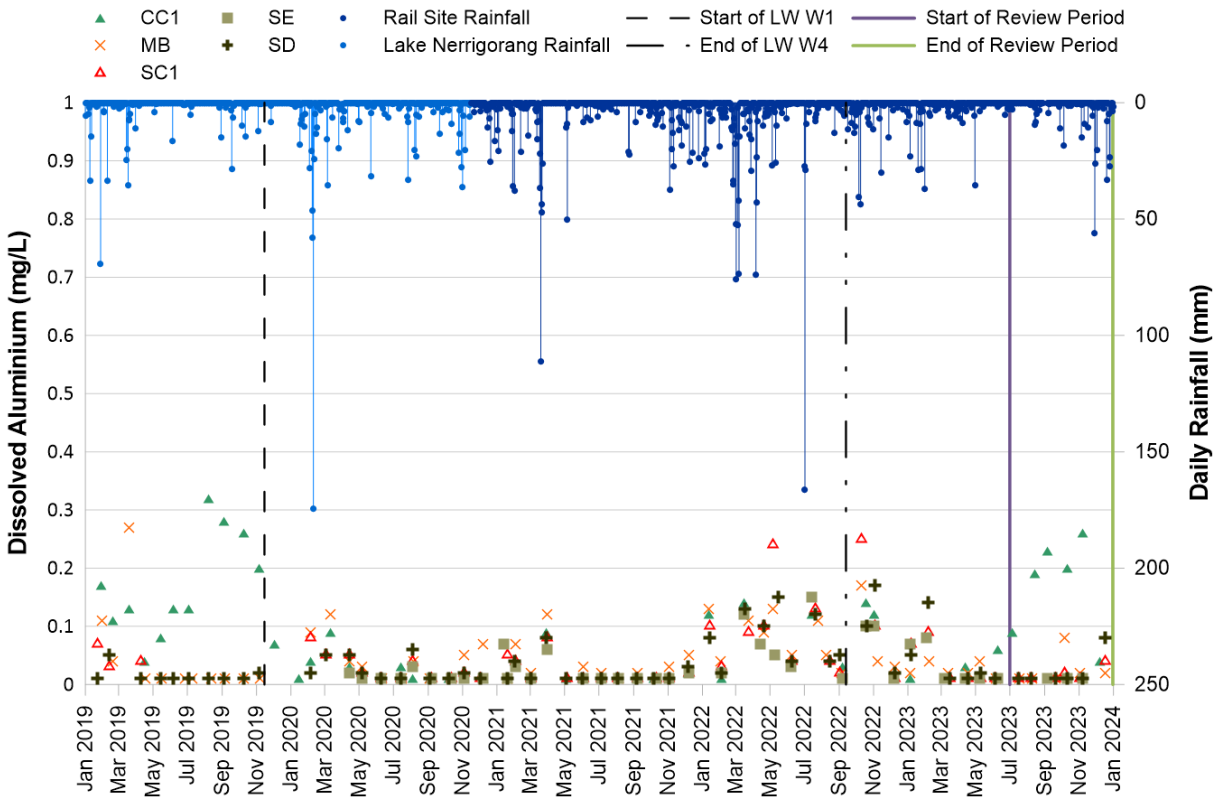
DIAGRAM 4: DISSOLVED ALUMINIUM

DIAGRAM 4 indicates that the concentration of dissolved aluminium recorded in December 2023 at monitoring site SD was slightly elevated (0.08 mg/L), exceeding the site specific trigger value. Although a similar exceedance did not occur at the reference sites on Stonequarry Creek in December 2023, elevated dissolved aluminium concentrations, equal to or in excess of 0.08 mg/L, were recorded at reference site CC1 on Cedar Creek and MB on Matthews Creek in the proceeding months. It is noted that elevated concentrations of dissolved aluminium, in excess of 0.08 mg/L, have been recorded at several sites historically, including during the baseline period.

As such, it is considered that the slightly elevated dissolved aluminium concentration recorded at monitoring site SD in December 2023 was related to the prevailing climatic conditions and to the contribution of flow from Cedar Creek to Stonequarry Creek containing elevated concentrations of dissolved aluminium.

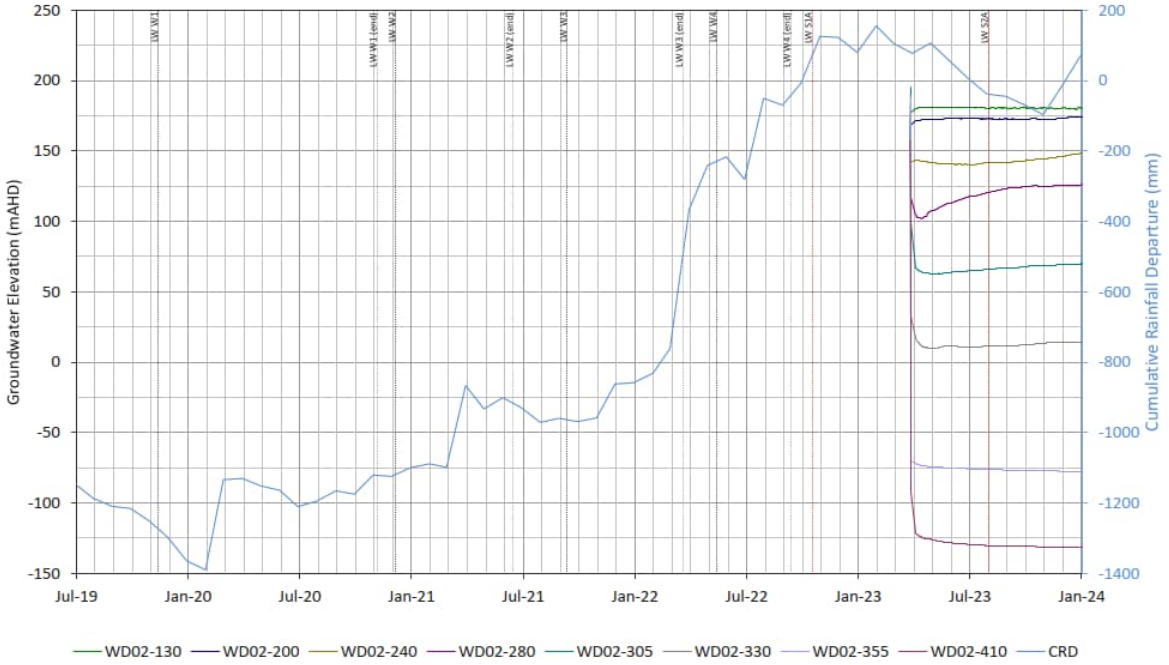
Figure 4 Groundwater Elevation over time at WD02.

The sensors all show relatively stable groundwater pressures, excluding the sensor at 280 metres which indicates an increase in pressure over time (**Figure 4**).
