Tahmoor Coal Pty Ltd

SIX MONTHLY SUBSIDENCE IMPACT REPORT

Western Domain Longwalls West 1 – West 4

1 January 2023 – 30 June 2023

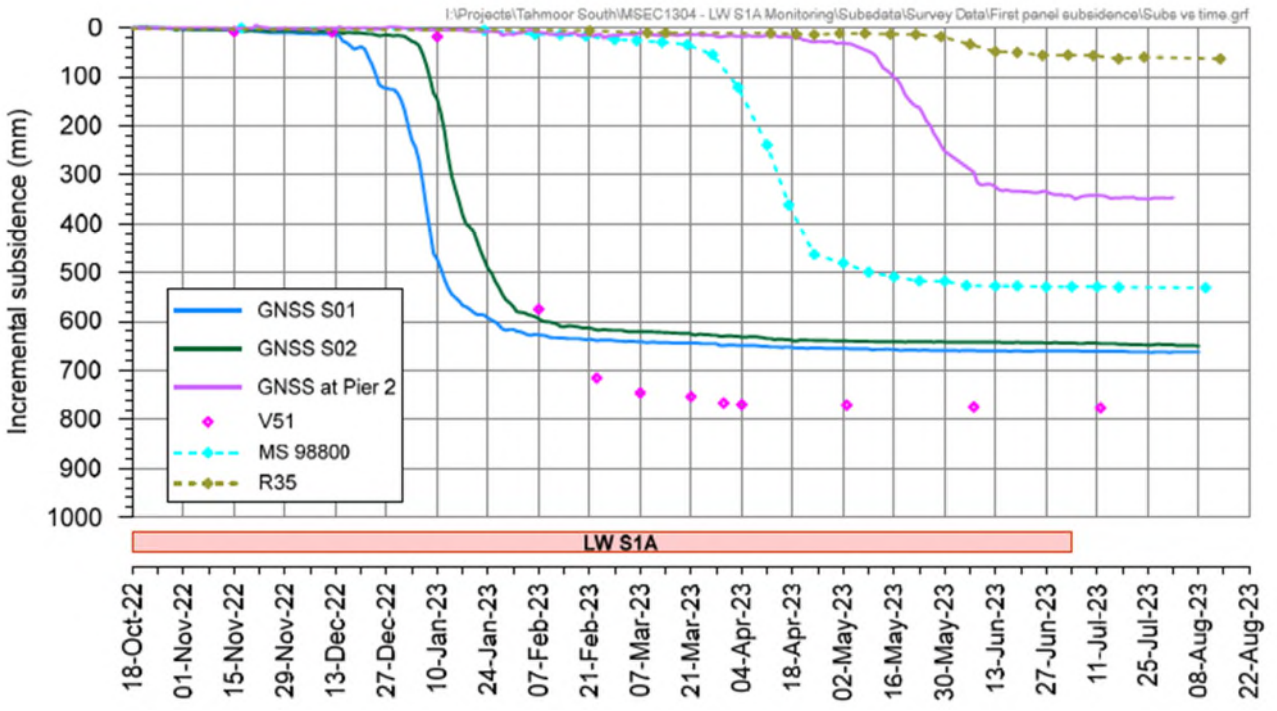
The development of subsidence above LW S1A is illustrated in **Figure 2-2**. Subsidence has developed within predictions, with magnitudes of subsidence slightly greater than observations above previously extracted LW 22, as predicted due to the shallower depth of cover above LW S1A. Subsidence at Peg V-51 along the V Line is greater than observed at the GNSS units, and very slightly greater than predicted. Rates of change have reduced to very low levels at the end of this reporting period.

*Figure 2-2 Development of observed subsidence along LW S1A (source: MSEC, Subsidence Monitoring Report 38, **Appendix A**)*

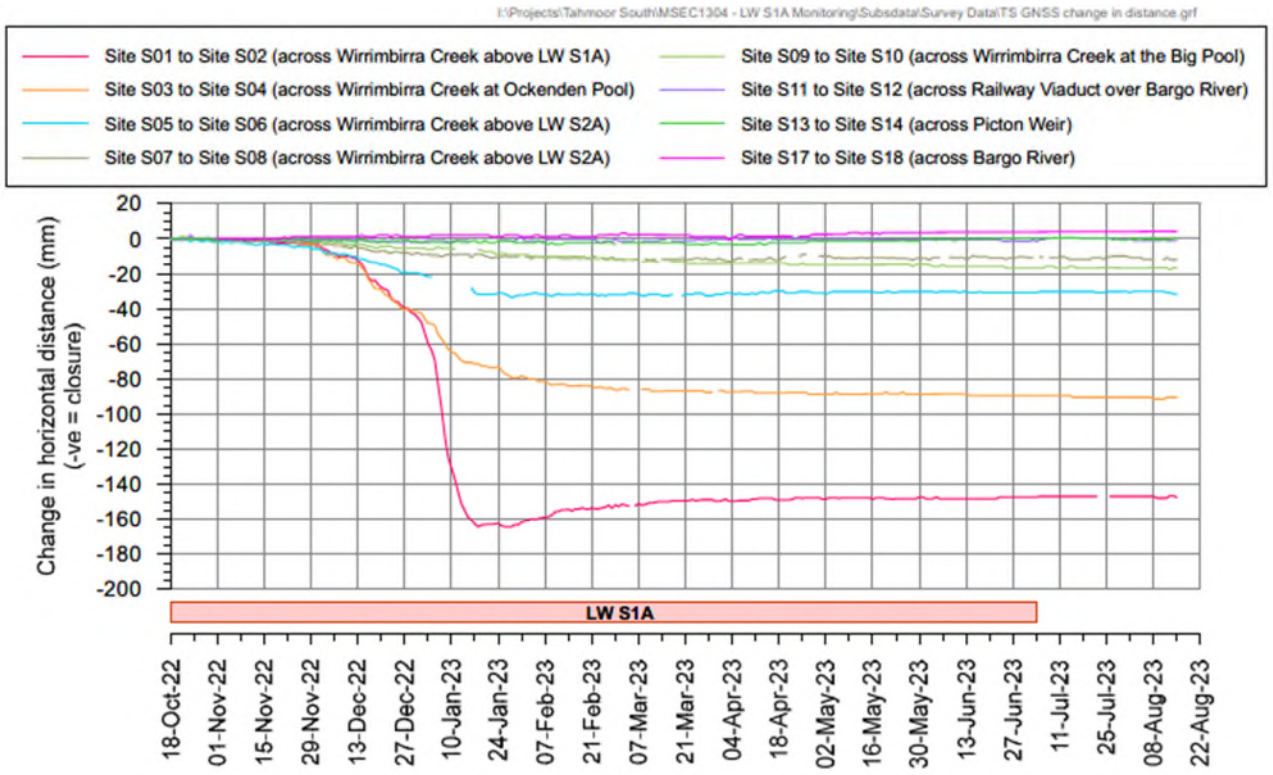
Changes in horizontal distances between paired GNSS units that are stationed close together on opposite sides of Teatree Hollow and Teatree Hollow Tributary (also known as 'Wirrimbirra Creek') are illustrated in **Figure 2-3**. From the commencement of LW S1A to 30 June 2023, the following was recorded:

- Greater than 20 millimetres (mm) closure has developed at sites in Teatree Hollow tributary (Wirrimbirra Creek) overlying LW S1A and LW S2A;
- Approximately 145 mm closure was recorded at Teatree Hollow tributary above LW S1A (Site S01 to Site S02) as of 30 June 2023;
- Approximately 90 mm closure was recorded at pool TT3 (Ockenden Pool) as of 30 June 2023 (Site S03 to Site S04);
- Approximately 30 mm closure was recorded at pool TT5 as of 30 June 2023 (Site S05 to Site S06).
- Less than 20 mm closure was recorded at upstream sites across Teatree Hollow tributary including at pool TT2 (Site S09 to Site S10); and
- Negligible change in horizontal distance has been recorded at sites across the Bargo River.

*Figure 2-3 Observed changes in horizontal distances between GNSS units during LW S1A extraction (source: MSEC, Subsidence Monitoring Report 38, **Appendix A**).*

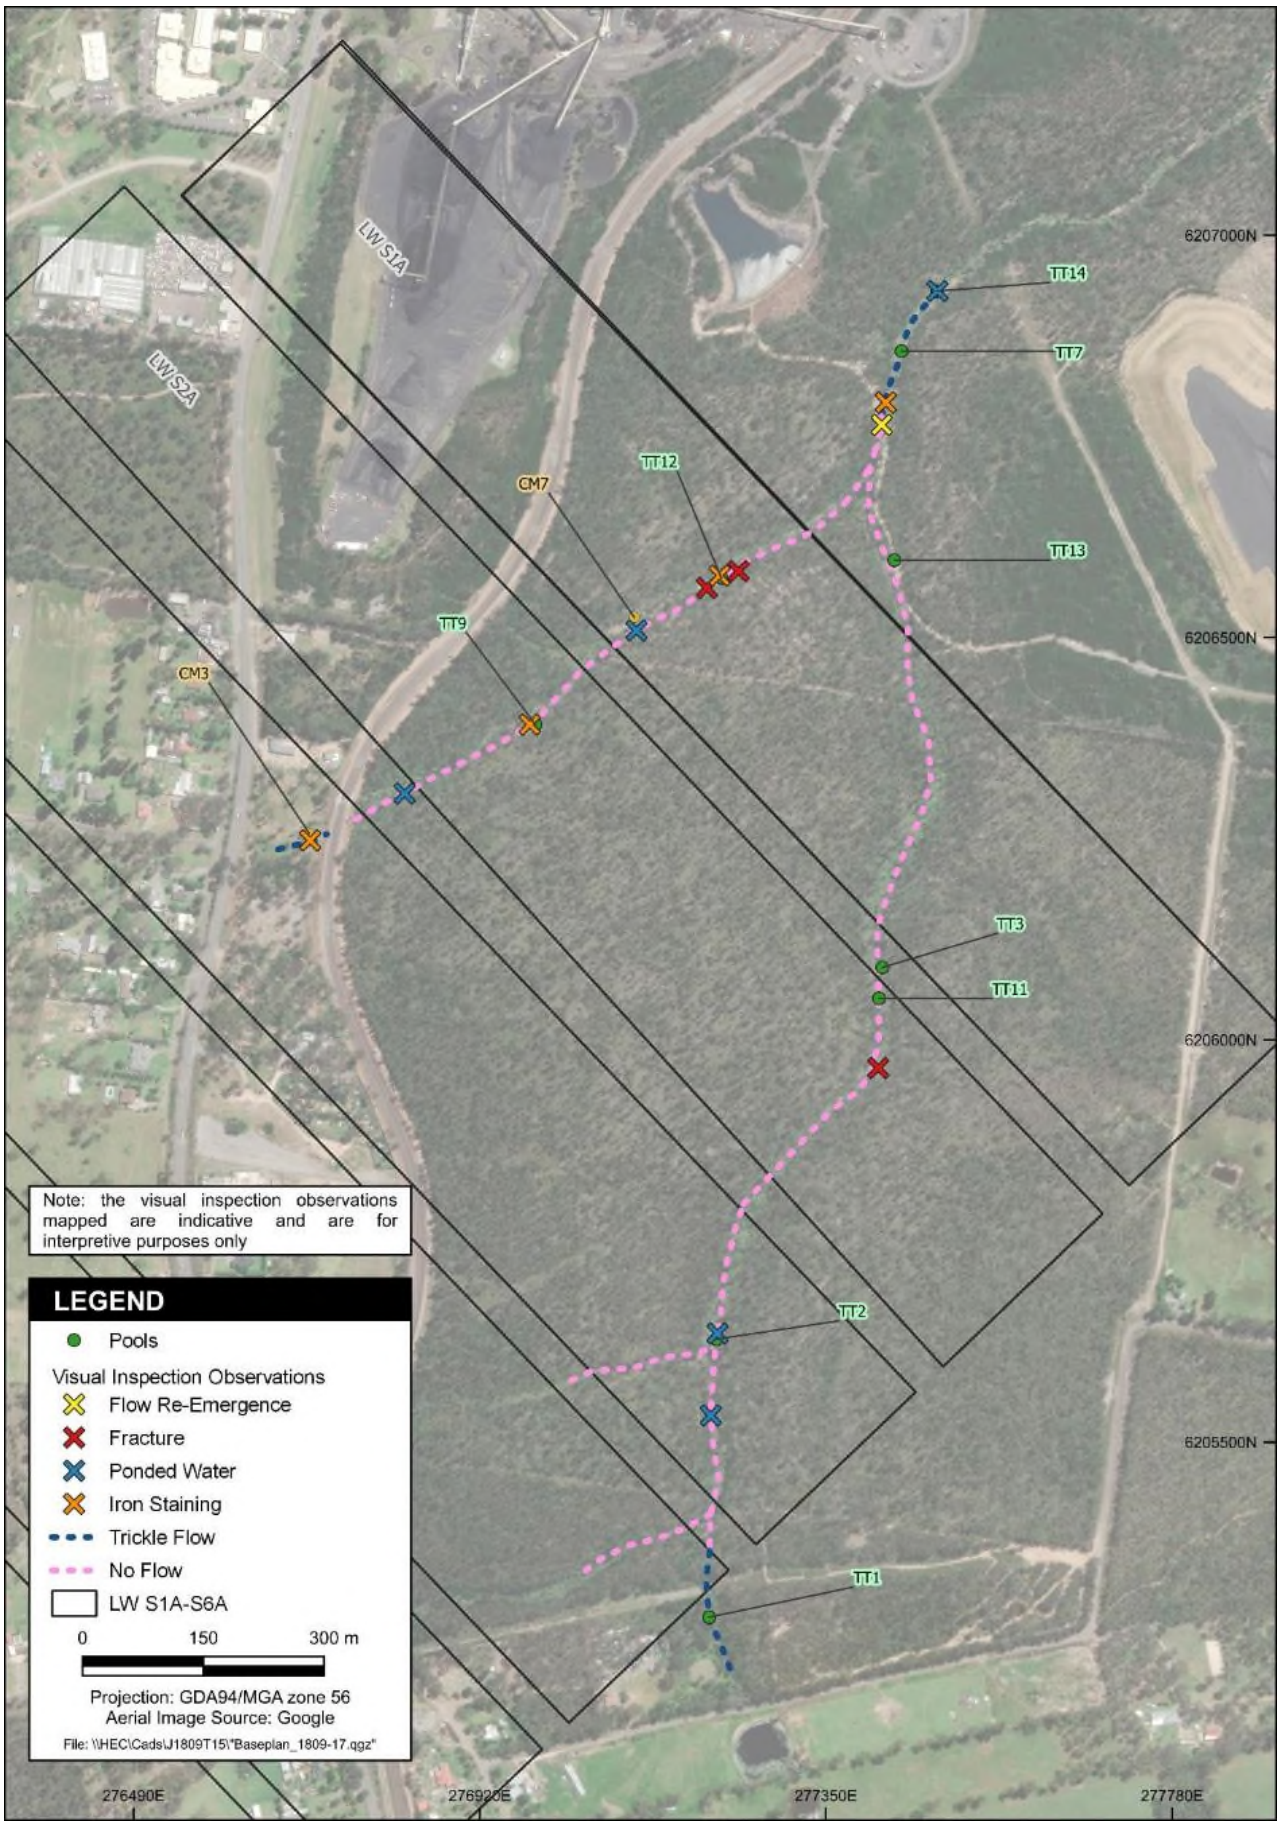
Figure 2-7 demonstrates the location of flow re-emergence, fracturing, ponded water, iron staining and overland flow observed during this reporting period.

*Figure 2-7 Visual depiction of surface water characteristics and physical effects for this reporting period (source: **Appendix B**)*

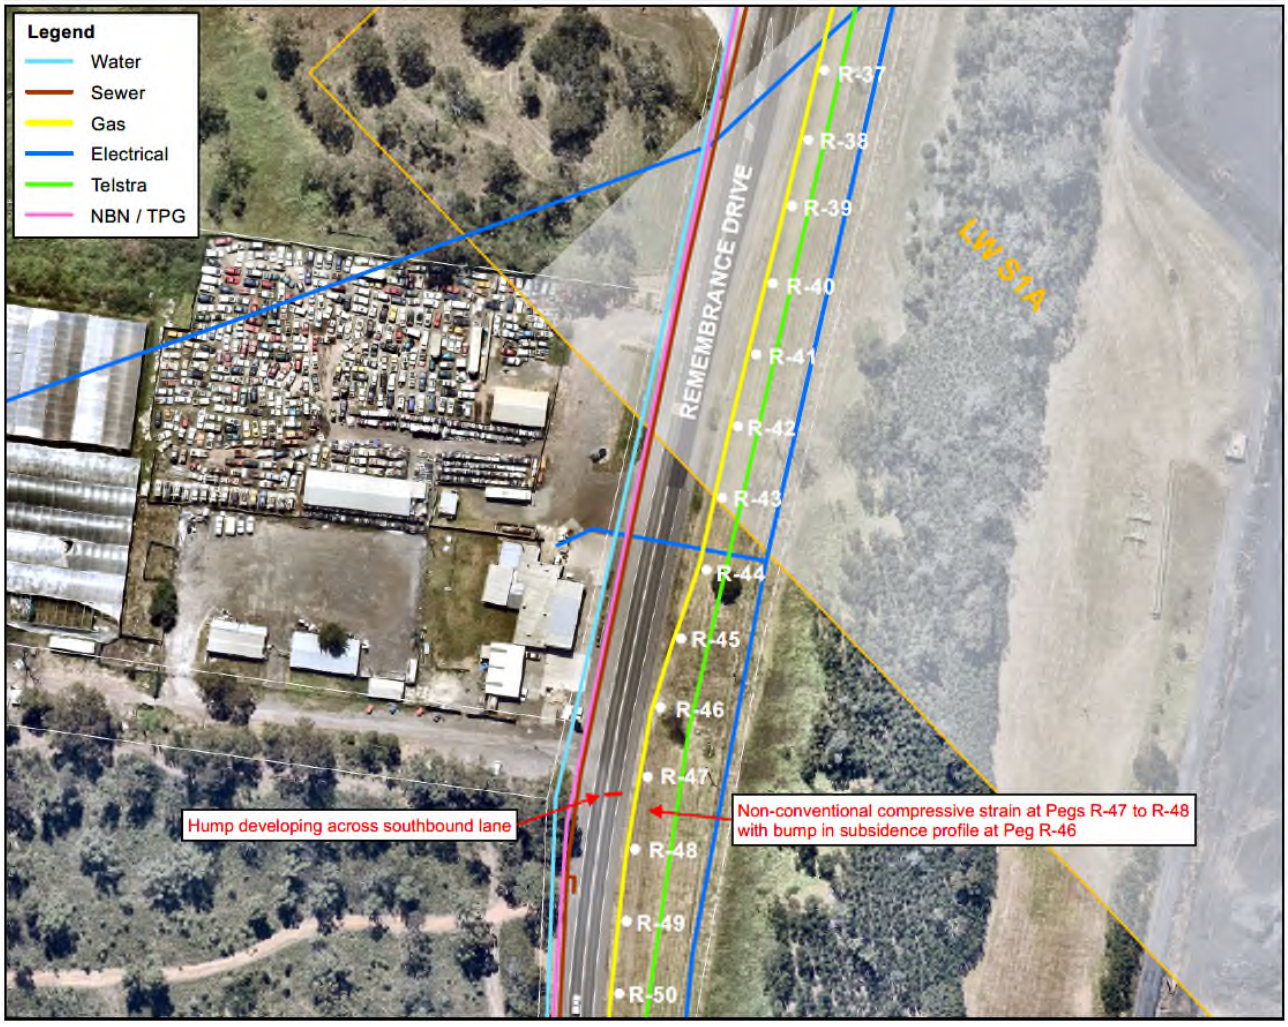
Figure 2-18 Location of non-convensional compressive strain, bump and hump on (Source: MSEC1304 Report 38, Appendix A)

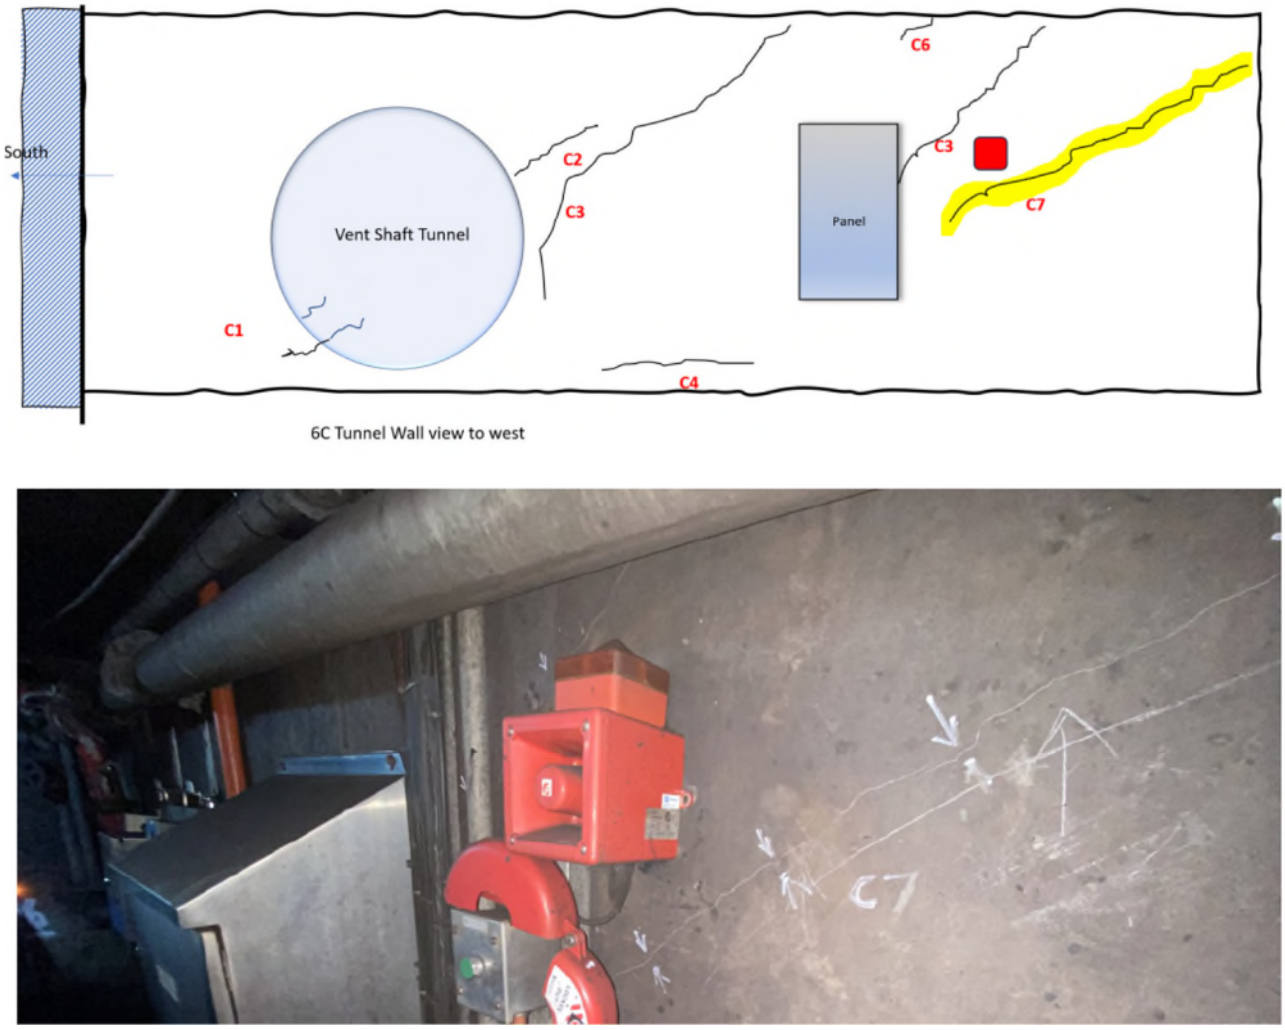
Figure 2-20 Schematic of cracks located in 6C Tunnel and example of crack (crack C7 taken 27 June 2023) (Source: Photo report: Tahmoor Mine Conveyors 27/9/2023, Appendix G)

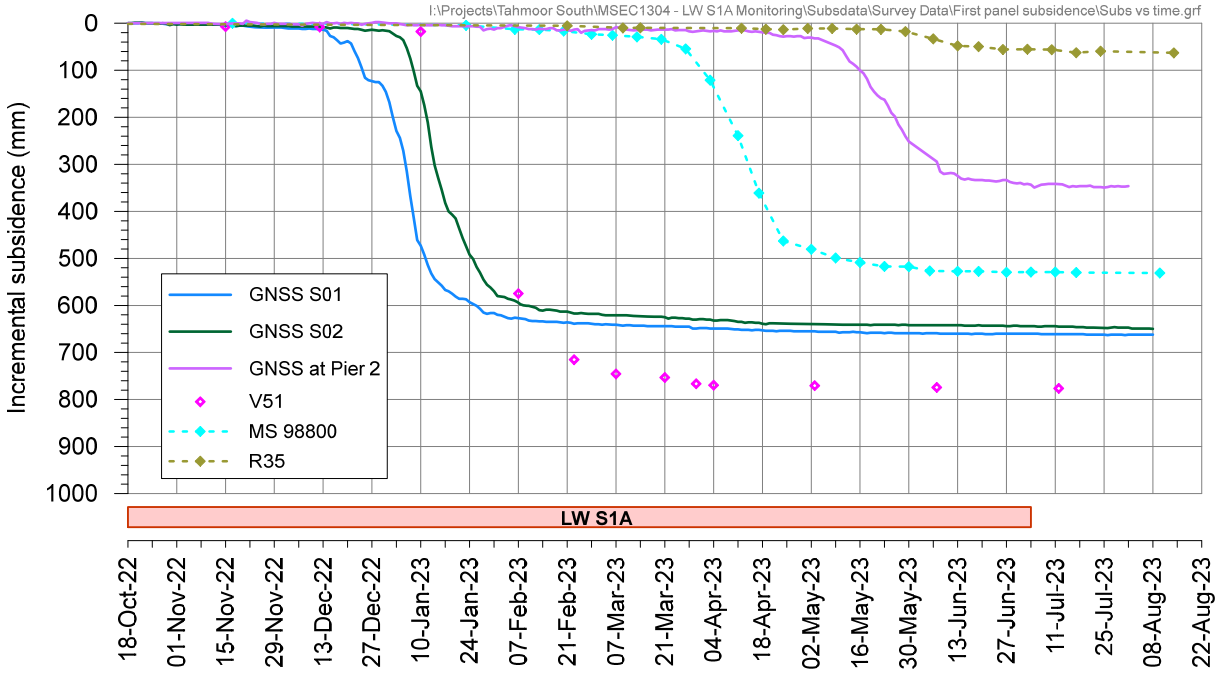
Observed development of subsidence above LW S1A is shown in Figure A. Subsidence has developed within predictions, with magnitudes of subsidence slightly greater than observations above previously extracted LW 22, as predicted due to the shallower depth of cover above LW S1A. Subsidence at Peg V-51 along the V Line is greater than observed at the GNSS units, very slightly greater than predicted. Rates of change have reduced to very low levels.

Figure A Observed development of subsidence above LW S1A

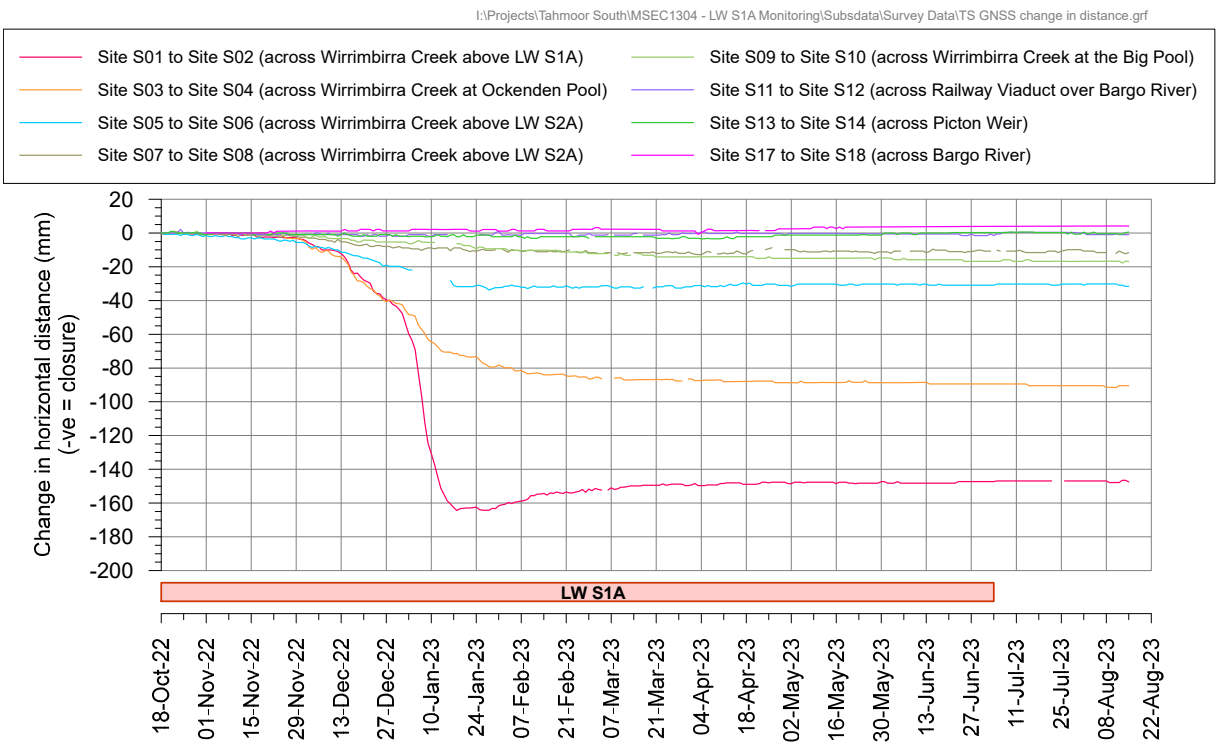
Figure B Observed changes in horizontal distances between GNSS units

Changes in horizontal distances can be calculated between GNSS units that are stationed close together and results are shown in Figure B. Closure has developed between Sites 01 and 02, and Sites 03 and 04 across Wirrimbirra Creek. Rates of change at these sites have reduced to low levels. Minor changes currently observed between other pairs of GNSS units.

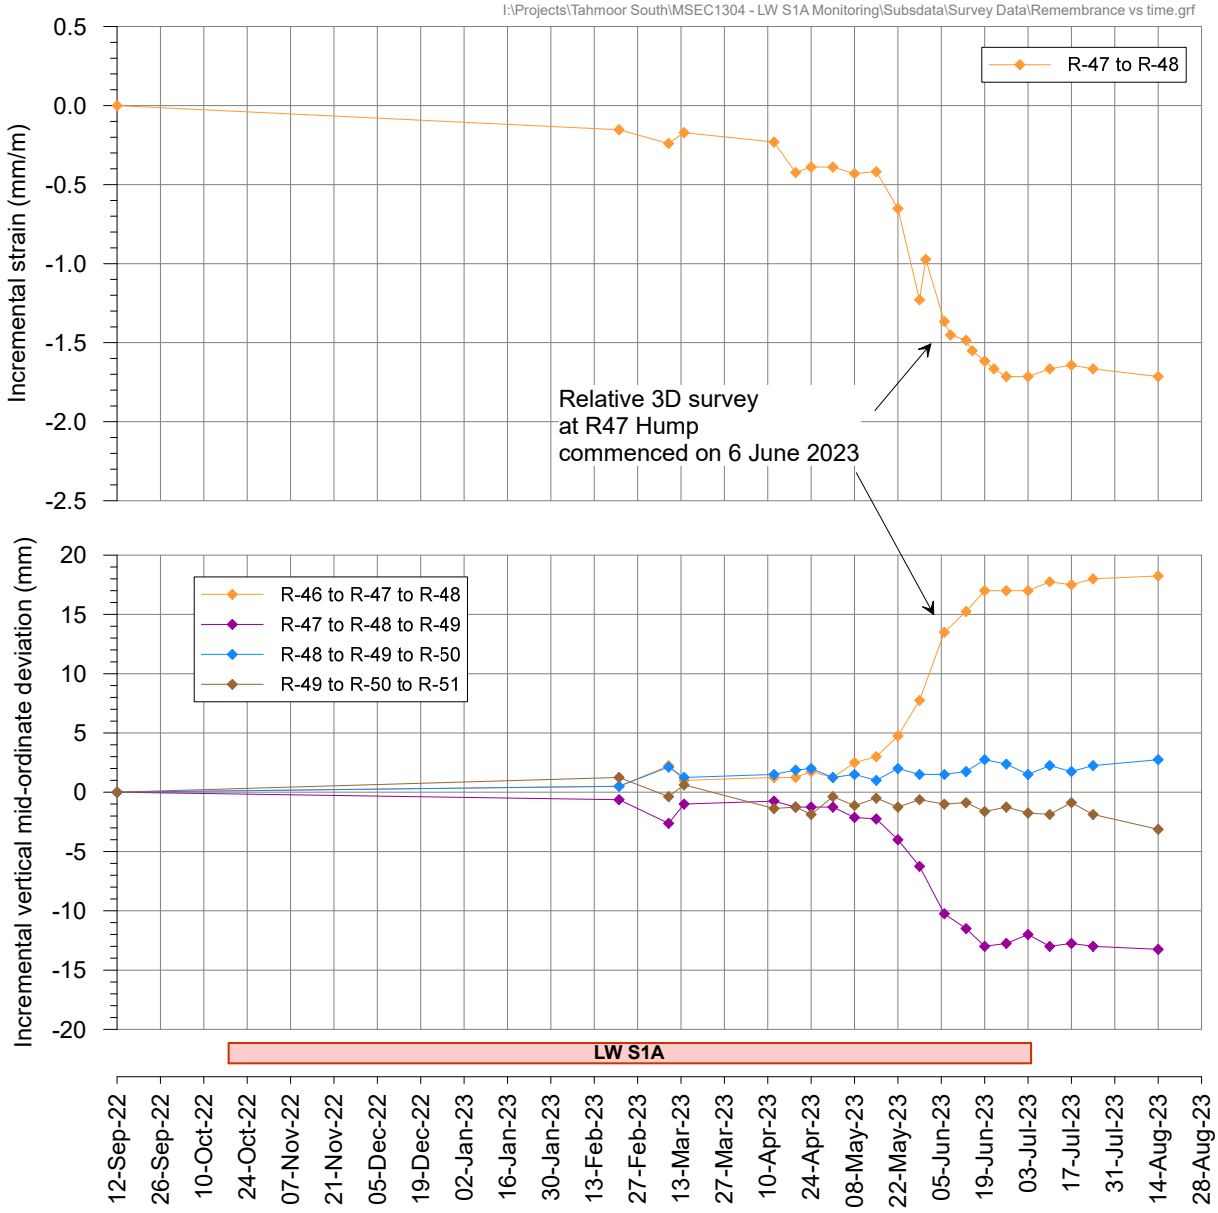
Figure C Observed development of ground strain and changes in vertical alignment at selected pegs along Remembrance Drive

Non-conventional subsidence movements are observed at Pegs R46 to R48. Increased compressive strain is observed between Pegs R47 and R48, accompanied by a bump in the observed subsidence profile at Peg R47.

The observed development of compressive strain is shown in Figure C. Increased compressive strain and a small bump in the observed subsidence profile was first identified from the ground survey on 22 May 2023.

Compressive strain was measured to have increased between Pegs R47 and R48 on 29 May 2023. A localised resurvey of strain distances on 31 May 2023 found that compressive strain had reduced very slightly but remained approximately 1 mm/m. Compressive strain was measured to have increased between Pegs R47 and R48 on 6 June to approximately 1.4 mm/m. A localised resurvey of strain distances on 8 June found that compressive strain had increased very slightly to approximately 1.5 mm/m. No change was measured on 13 June. A localised resurvey of strain distances on 15 June found that compressive strain had increased very slightly to approximately 1.6 mm/m. No change was measured on 19 June. A localised resurvey of strain distances on 22 June found that compressive strain had increased very slightly to approximately 1.7 mm/m.

The latest survey on 14 August measured changes within survey tolerances.

As shown in Figure C, the observed compressive strain between Pegs R47 and R48 is accompanied by a bump in the observed subsidence profile at Peg R46, and the dip in the observed subsidence profile at Peg R47. The survey on 29 May 2023 found that the bumps in the observed subsidence profile had increased since 22 May 2023. The survey on 6 June 2023 found that the bumps in the observed subsidence profile had increased since 29 May 2023. Minor changes were observed in the survey of 14 August. Monthly surveys will continue as LW S2A is extracted.

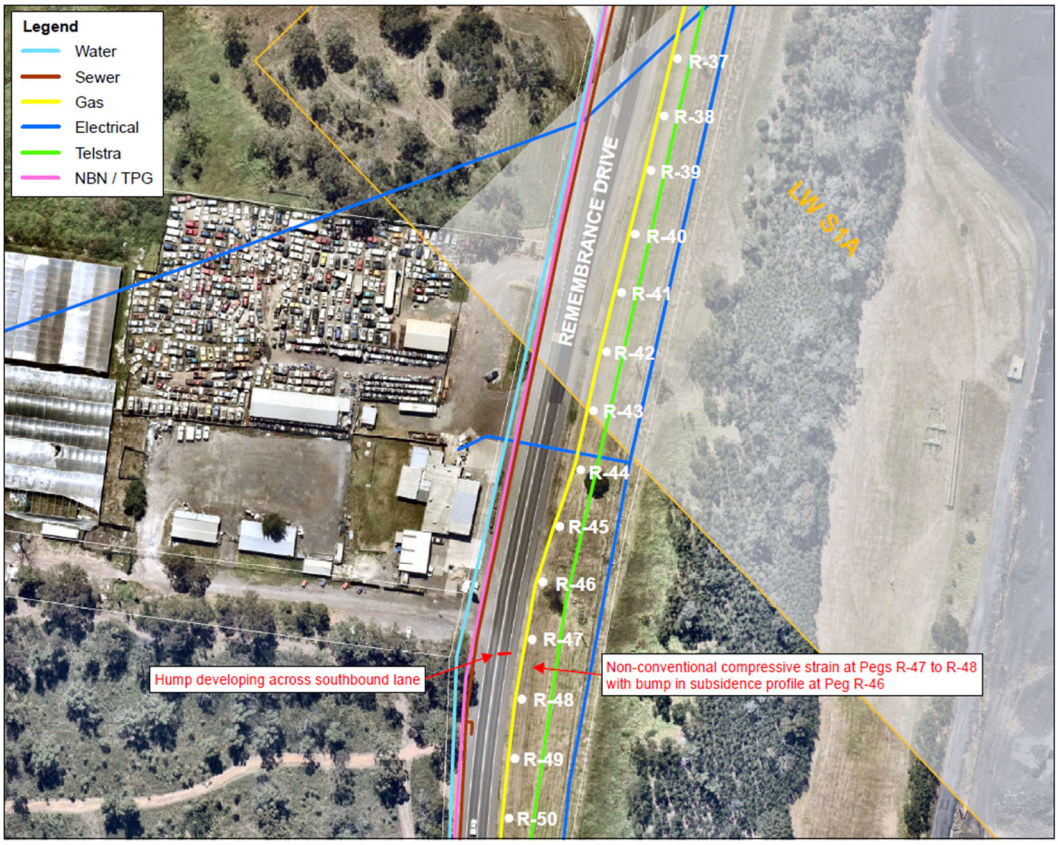
Figure E Location of small bump observed in southbound lane of Remembrance Drive near Peg R46 on 2 June 2023

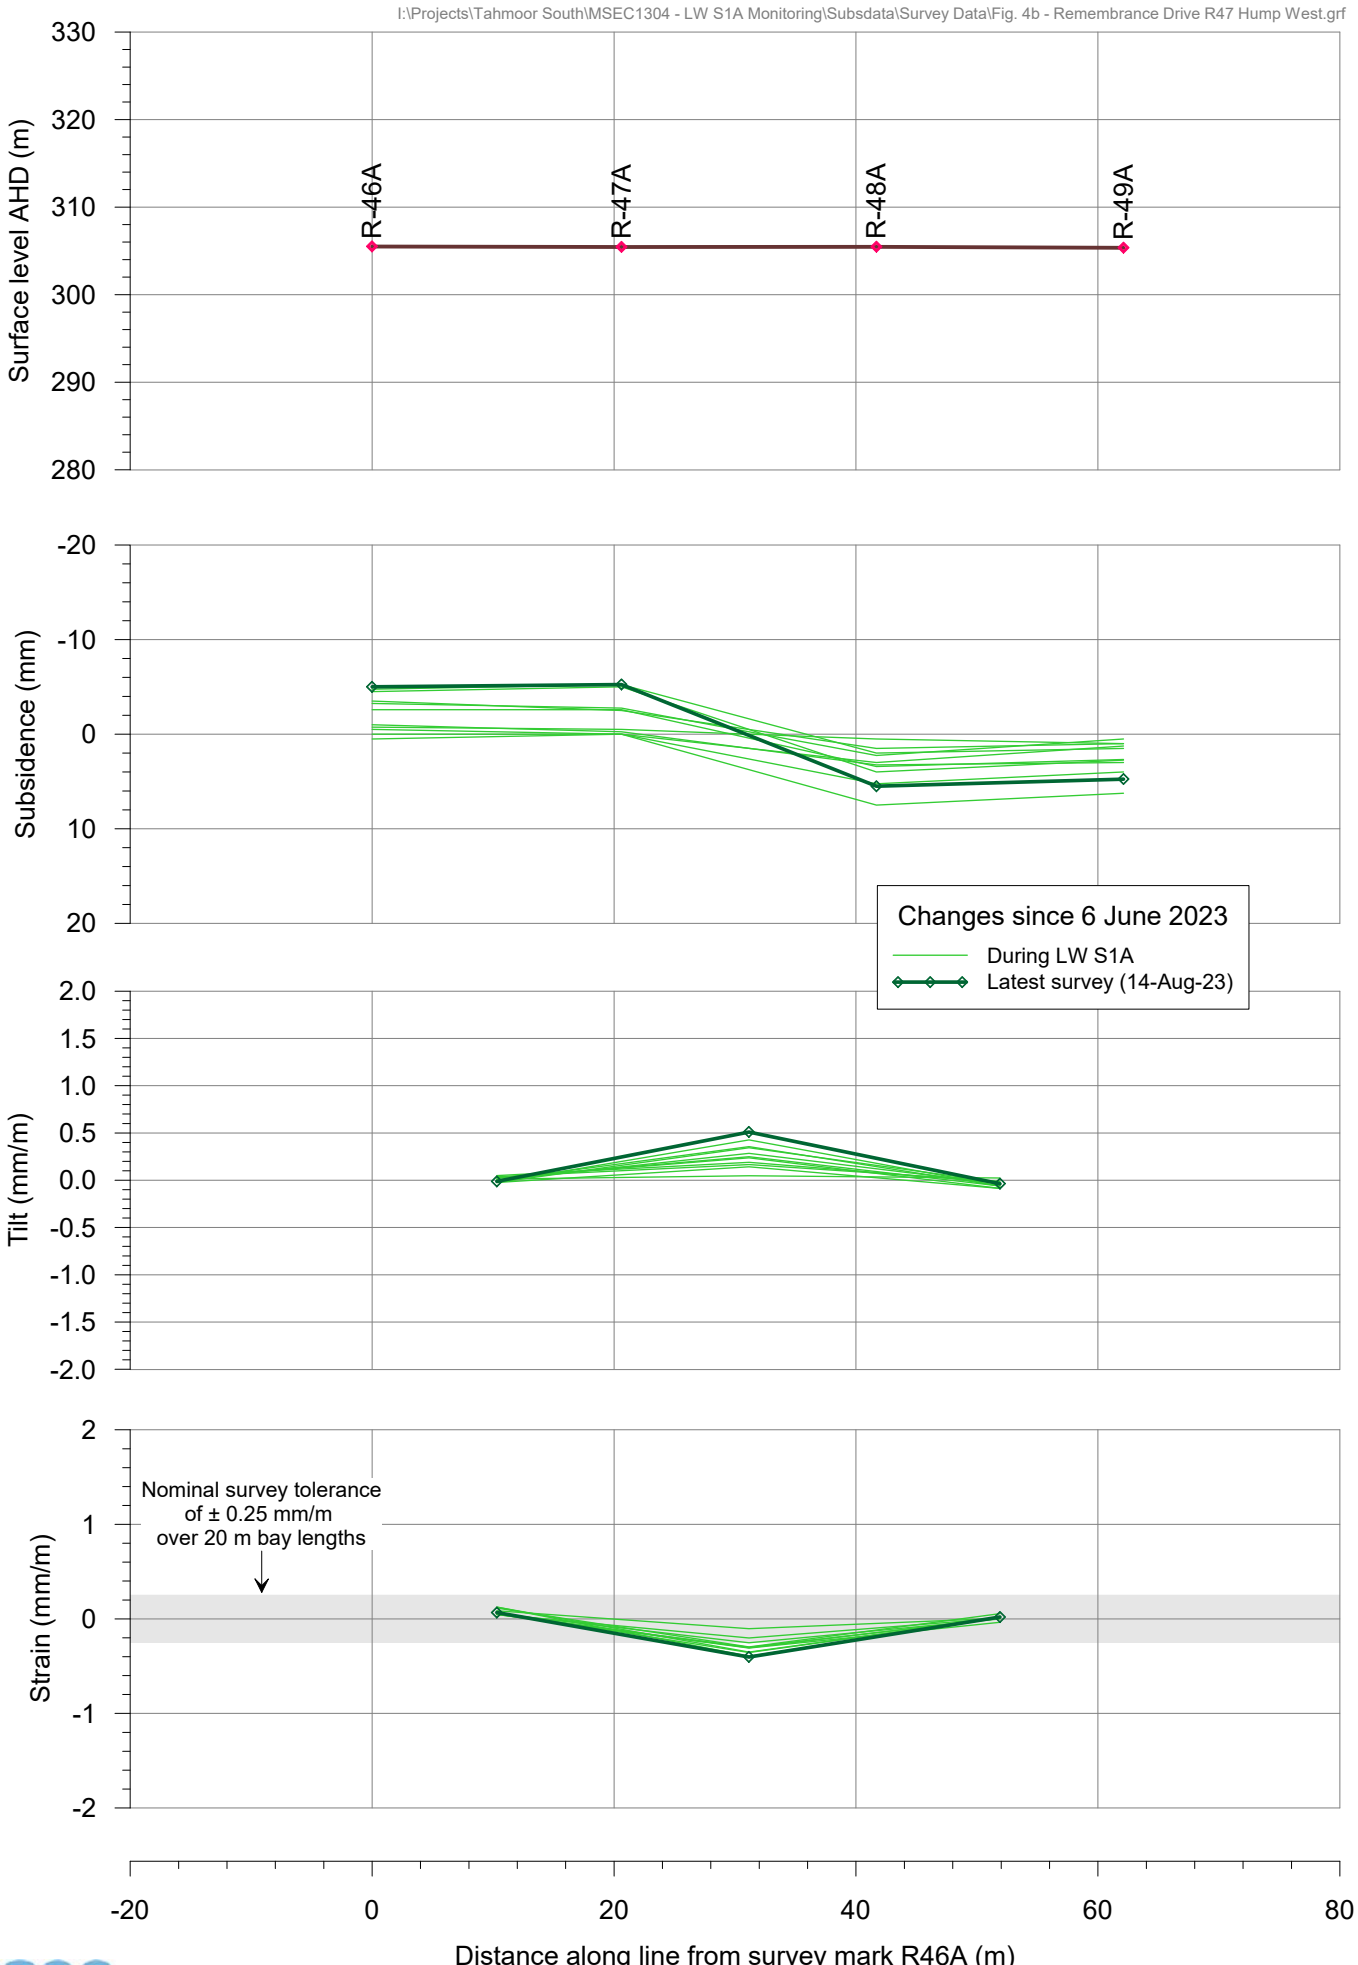
Tahmoor South LW S1A - Remembrance Drive R47 Hump
Incremental subsidence profiles along eastern side of pavement

A focussed detailed inspection on 31 May identified a bump in the southbound lane of Remembrance Drive where non-conventional subsidence movements have been observed between Pegs R46 and R48.
A visual inspection on 9 June found that the bump had extended slightly across towards the Northbound lane since the inspection on 31 May. Minor changes were observed on 20 and 23 June. A faint bump is visible on the edge line of the northbound lane south of Peg R46. No significant changes were observed on 18 August.

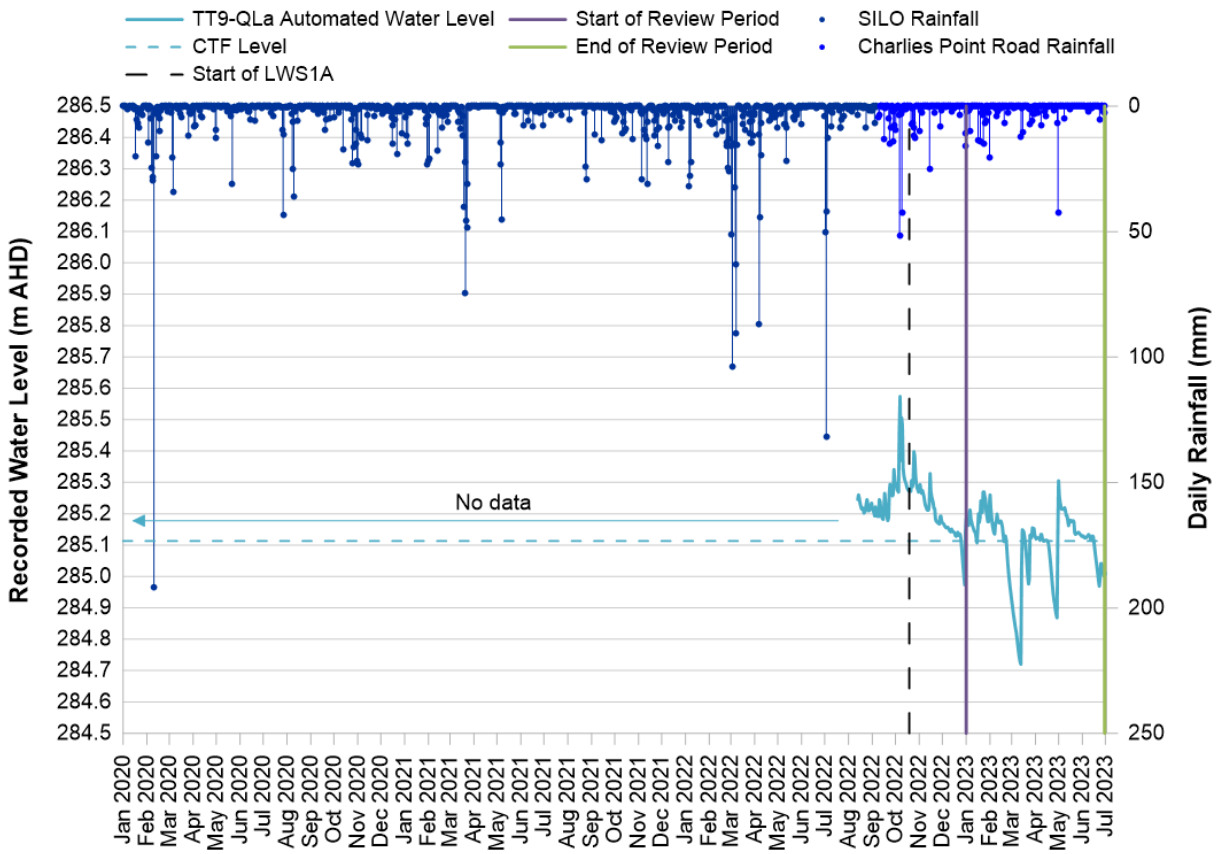
DIAGRAM B1.5: MONITORING SITE TT9-QLA WATER LEVEL RECORDS

As stated in **Table 1**, the pool TT9 water level declined intermittently below the CTF level and baseline minimum during periods of below average rainfall. It is noted that only two months of baseline data are available for this site prior to the commencement of mining of LW S1A. As such, there is potential that the water level at monitoring site TT9-QLa declined to similar levels historically.

Based on the monitoring data recorded during the review period, it is considered that the intermittent decline in water level recorded at pool TT9 during the review period is related to the prevailing climatic conditions and unrelated to mining effects associated with LW S1A.

It is recommended that the baseline minimum for pool TT9 is revised to consider the water level data recorded to the cessation of mining of LW S1A (4 July 2023).

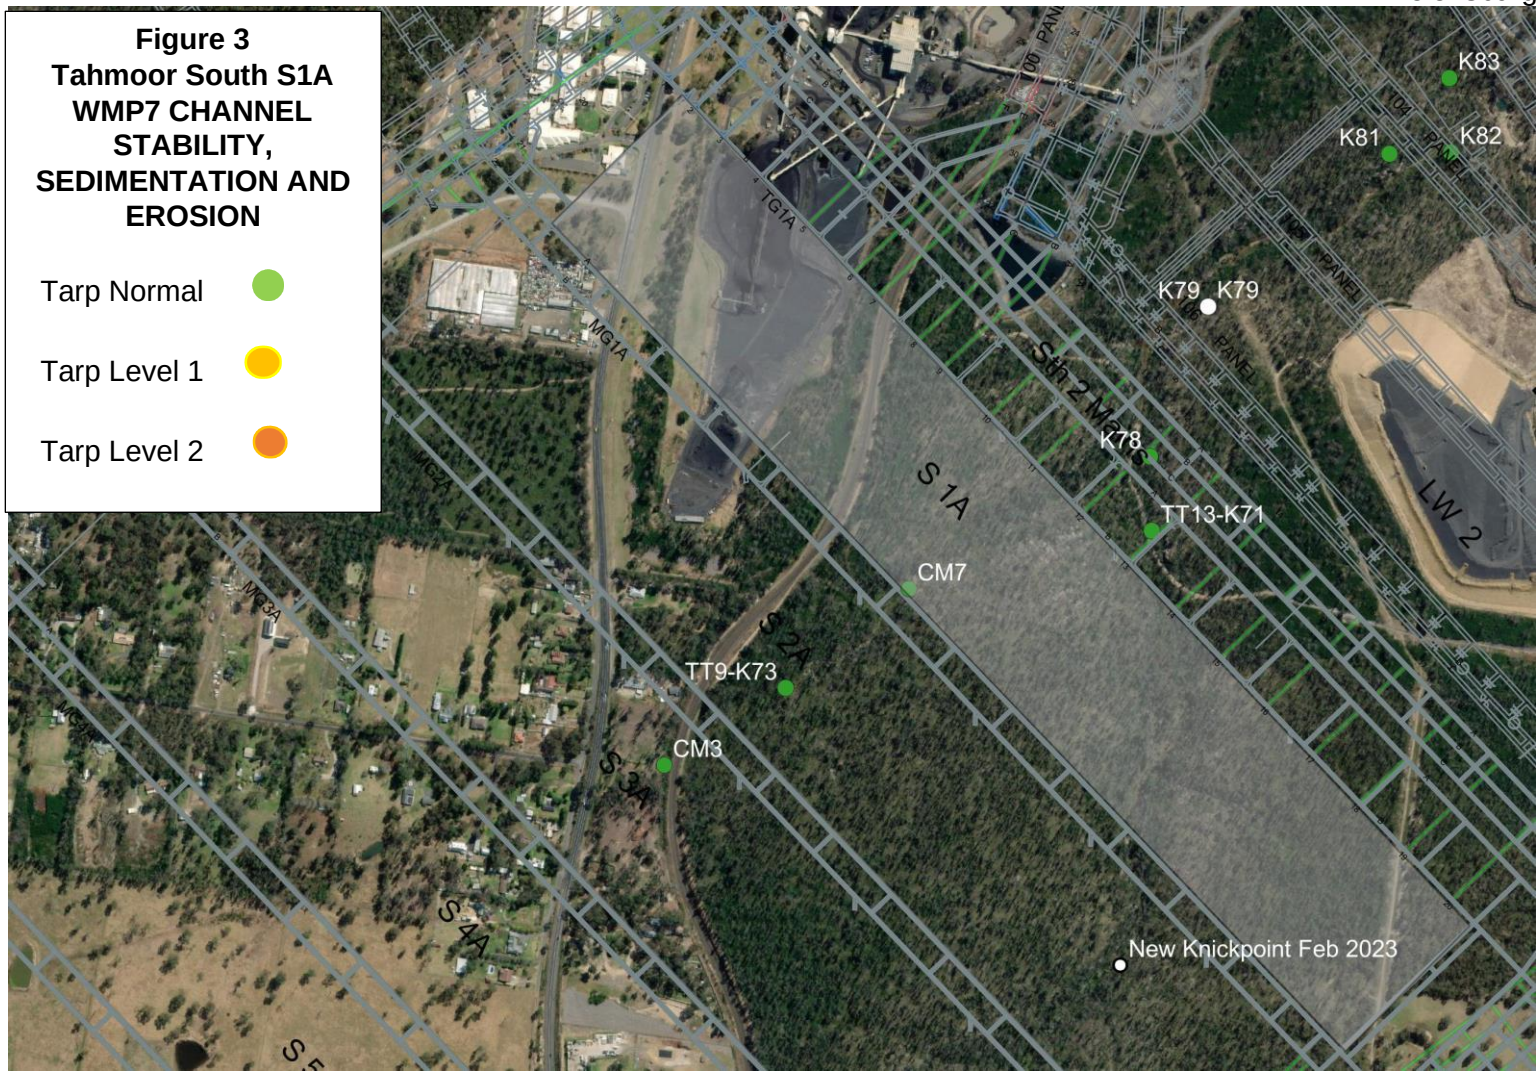
Figure 3
Tahmoor South S1A
WMP7 CHANNEL STABILITY, SEDIMENTATION AND EROSION

Visual inspections within the Longwall S1A active subsidence area at site CM3 on 15 March 2023 as shown in **Figure 3**, identified that the hydraulic control on the downstream end of the pool was 280mm wide with 25 mm of water flowing over the hydraulic control. No shearing or cracking was identified. No additional iron seeps were noted beyond what was identified the baseline survey. No gas discharge was detected.

At site CM3, there was no evidence of further development of soft knickpoints as compared with baseline conditions conducted in October 2022. CM3 was therefore within TARP Level Normal Condition.

Visual inspections within the Longwall S1A active subsidence area at site CM7 on 15 March 2023 as shown in **Figure 3**, identified that the 8 depressions within the rockbar area were all flowing over their hydraulic control. No further shearing or cracking was identified beyond what was noted in the baseline survey of October 2022. No additional iron seeps were noted beyond what was identified the baseline survey at depression 5 and rockbar 5. No gas discharge was detected. The cracking on the southern side of rockbar 2 that was identified in the November survey showed no sign of increase in size from the last inspection on 1 March 2023.

At site CM7, there was no evidence of further development of soft knickpoints as compared with baseline conditions conducted in October 2022. CM7 was therefore within TARP Level Normal Condition.

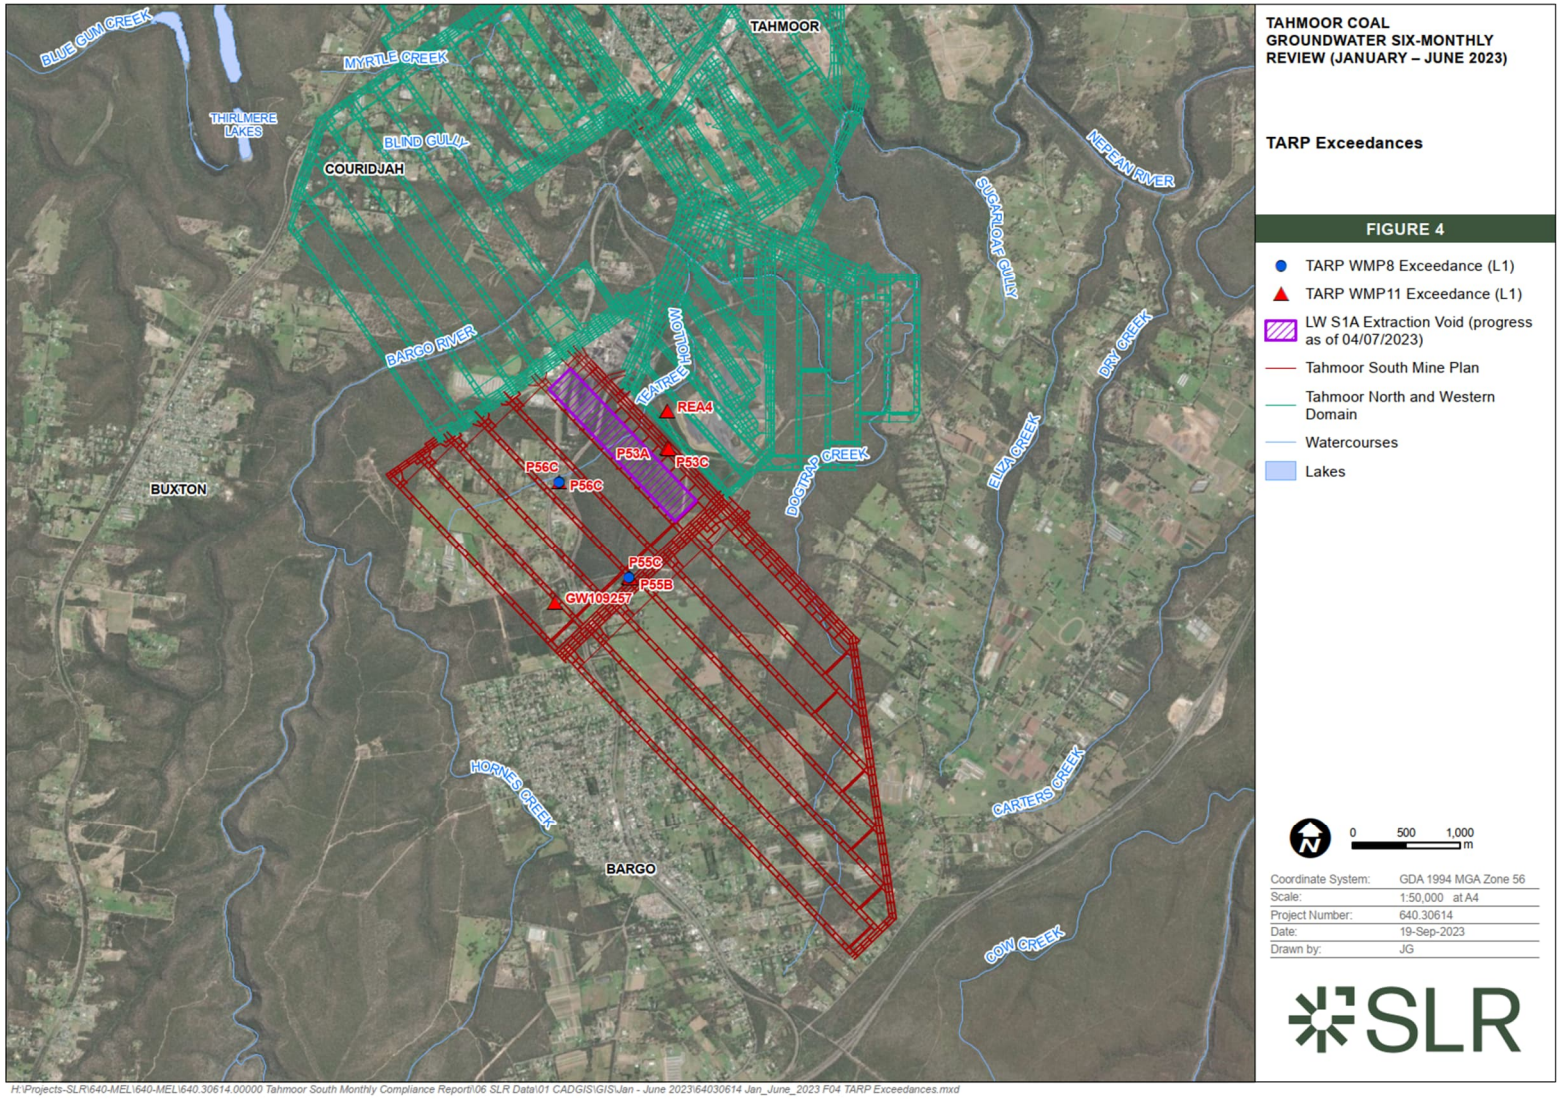
Figure 4 TARP Exceedances

Exceedance Site	Breach Parameter (Criterion 1 met)	Exceedance Parameter (Criteria 1 and 2 met)	Exceedance Level	TARP
P55C	Zn	Mn	1	WMP11
P56B	Al		1	WMP11
P56C		Mn	1	WMP11
REA4	Zn, Ni, Li,	Mn, Sr, Ba	1	WMP11
GW109257		Sr	1	WMP11
GW104323	Fe		1	WMP11

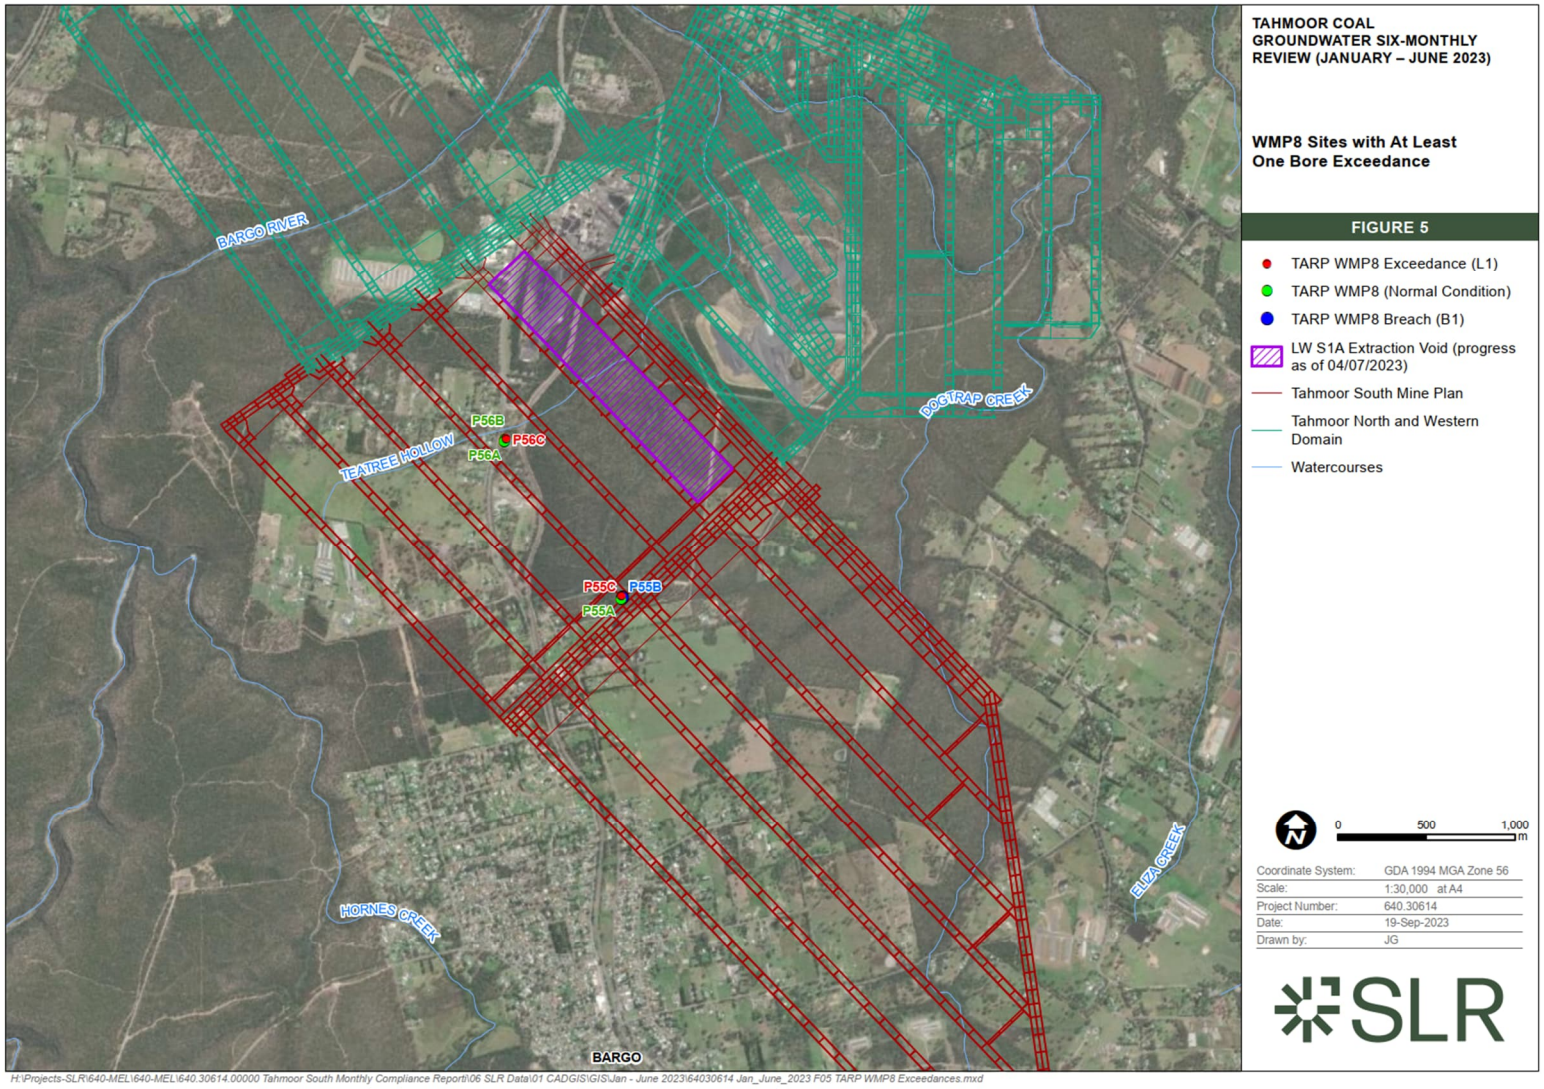
Figure 5 Sites with at least one TARP WMP8 Exceedance

The potential influences driving the observed exceedances at P55C and P56C, as listed in Table 3, are discussed in this section. The spatial distribution of observed groundwater levels above the trigger level, and the identified TARP Level 1 exceedances, at the P55 and P56 sites are shown in Figure 5.
