Tahmoor Coal Pty Ltd

SIX MONTHLY SUBSIDENCE IMPACT REPORT

Western Domain Longwalls West 1 – West 4

1 January 2023 – 30 June 2023

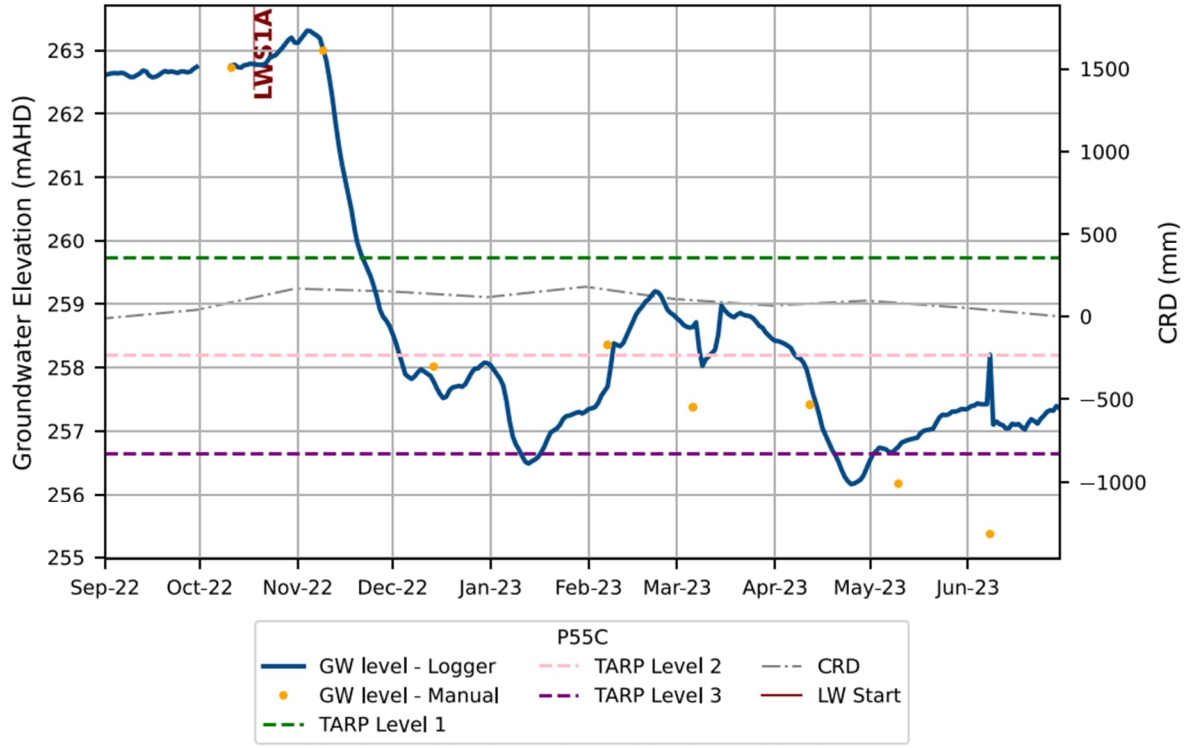
Figure 6 TARP WMP8 Level 1 Exceedance – P55C

As of 30 June 2023, a TARP Level 1 exceedance of the trigger level occurred at P55C. This observed exceedance is presented in Figure 6.

At P55C, the groundwater elevation was lower than the TARP L1 trigger level in all monitoring rounds since November 2022. Over the reporting period, the groundwater elevation has fluctuated by approximately 5 m with groundwater levels decreasing to below the TARP L3 trigger level in April 2023 before slightly increasing to below the TARP L2 trigger level in May and June 2023.

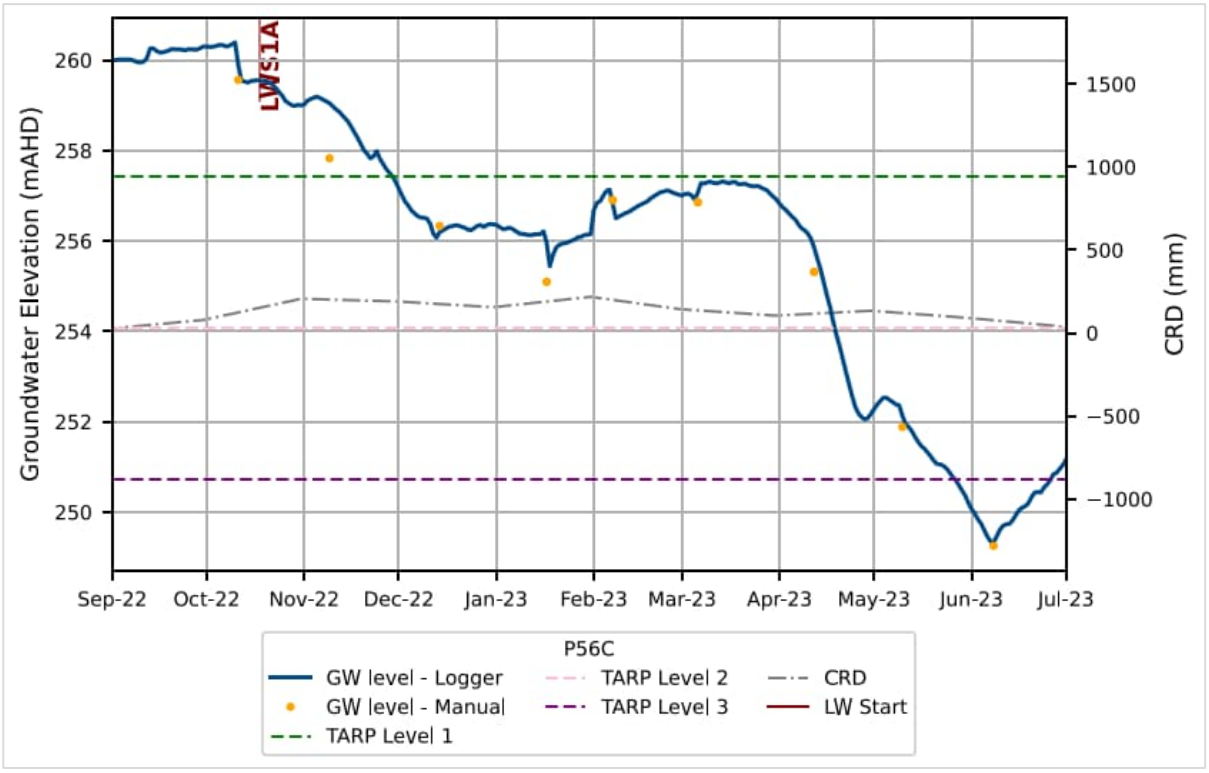
Figure 7 TARP WMP8 Level 1 Exceedance – P56C

As of 30 June 2023, a TARP Level 1 exceedance of the trigger level occurred at P56C. This observed exceedance is presented in Figure 7.

At P56C, the groundwater elevation was lower than the TARP L1 trigger level in all monitoring rounds since December 2022. Over the reporting period, the groundwater elevation has overall decreased by approximately 6 m with groundwater levels decreasing to below the TARP L2 trigger level in April 2023 and further decreasing to below the TARP L3 trigger level in June 2023.

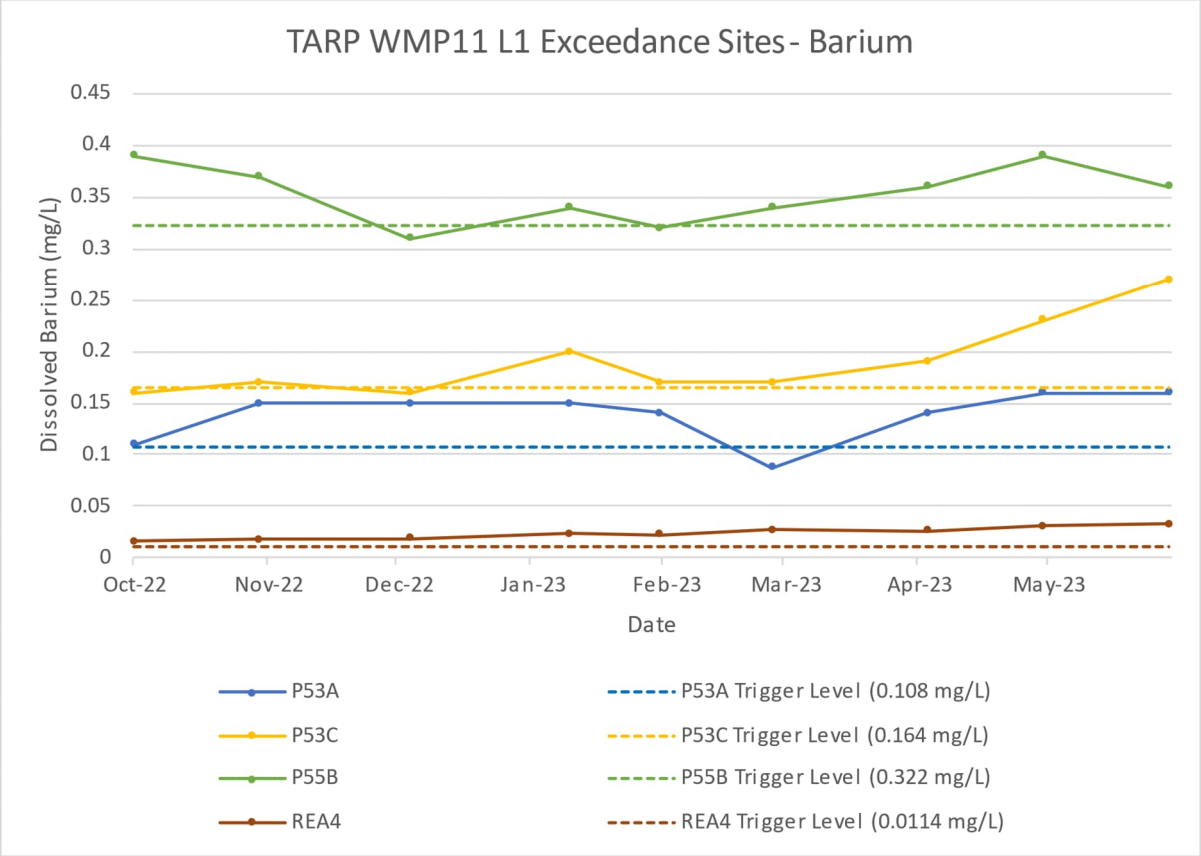
Figure 8 TARP WMP11 Level 1 Exceedance – Barium

As of 30 June 2023, a TARP Level 1 exceedance of the barium trigger level occurred at P53A, P53C, P55B, REA4. Each of these observed exceedances are presented in Figure 8 and discussed in Table 8. The spatial distribution of observed barium concentrations above the trigger level, and the identified TARP Level 1 exceedances, are shown in Figure 9.

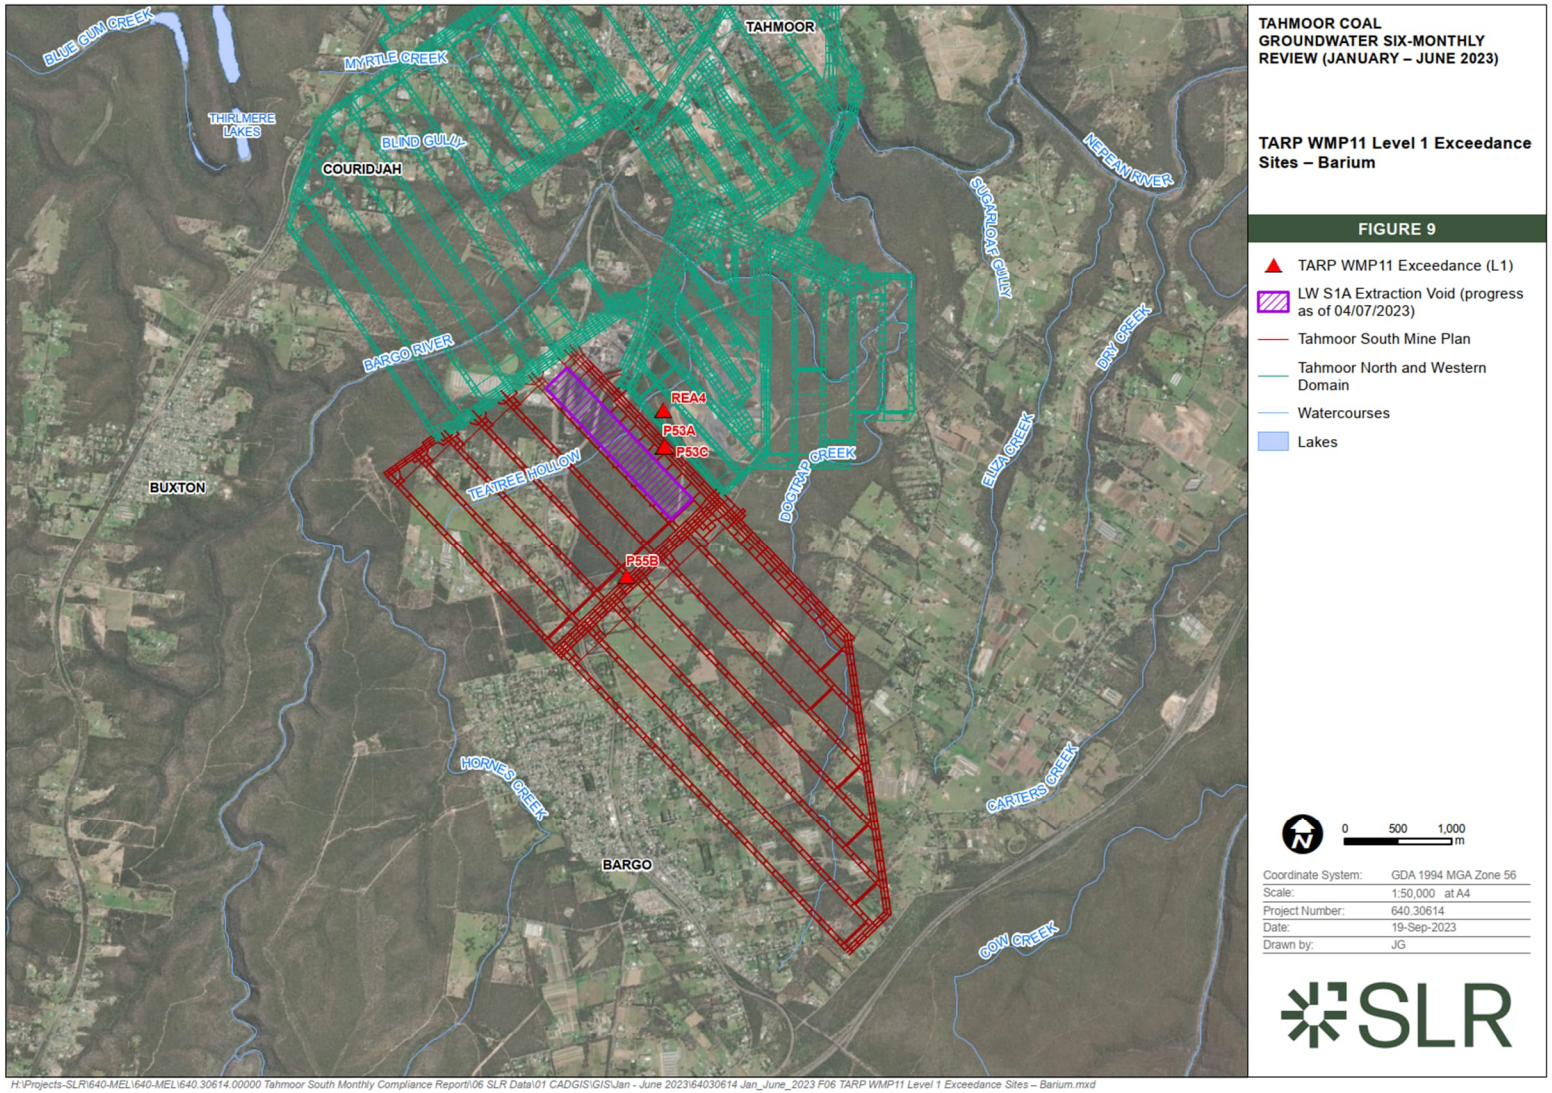
Figure 9 TARP WMP11 Level 1 Exceedance Sites – Barium

The spatial distribution of the bores showing trends in barium, manganese, and strontium (refer to Figures 9, 12, and 14 of **Appendix D**) are inconsistent with a response to mining, with bores spatially disparate from extraction activities showing this trend. For example, bores located at a similar distance (or closer) to extraction are not showing similar trends and hence the trends are not easily attributable to mining activities. Additionally, nested sites are not showing consistent trends in barium, manganese, and strontium.

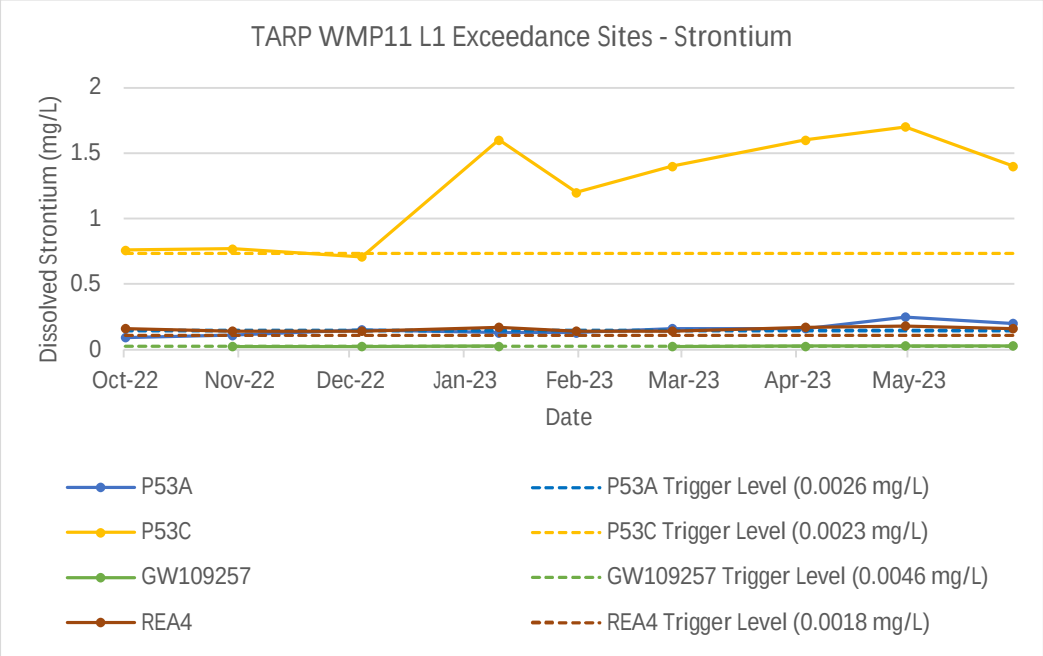
Figure 10 TARP WMP11 Level 1 Exceedance – Strontium

As of 30 June 2023, TARP Level 1 exceedances of the strontium trigger level occurred at P53A, P53C, REA4 and GW109257. Each of these observed exceedances are presented in Figure 10 and Figure 11 and discussed in Table 9. The spatial distribution of observed strontium concentrations above the trigger level, and the identified TARP Level 1 exceedances, are shown in Figure 12.

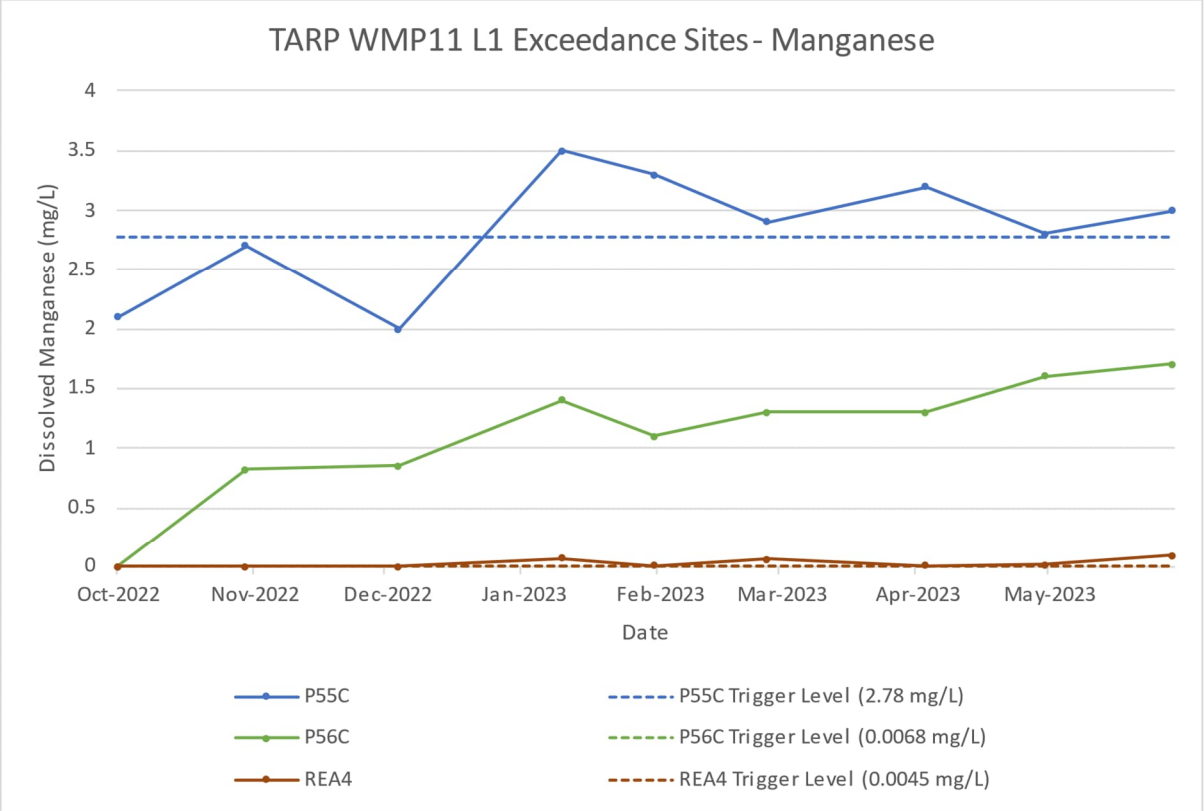
Figure 13 TARP WMP11 Level 1 Exceedance – Manganese

As of 30 June 2023, TARP Level 1 exceedances of the manganese trigger level occurred at P55C, P56C and REA4. Each of these observed exceedances are presented in Figure 13 and discussed in Table 10. The spatial distribution of observed manganese concentrations above the trigger level, and the identified TARP Level 1 exceedances, are shown in Figure 14.

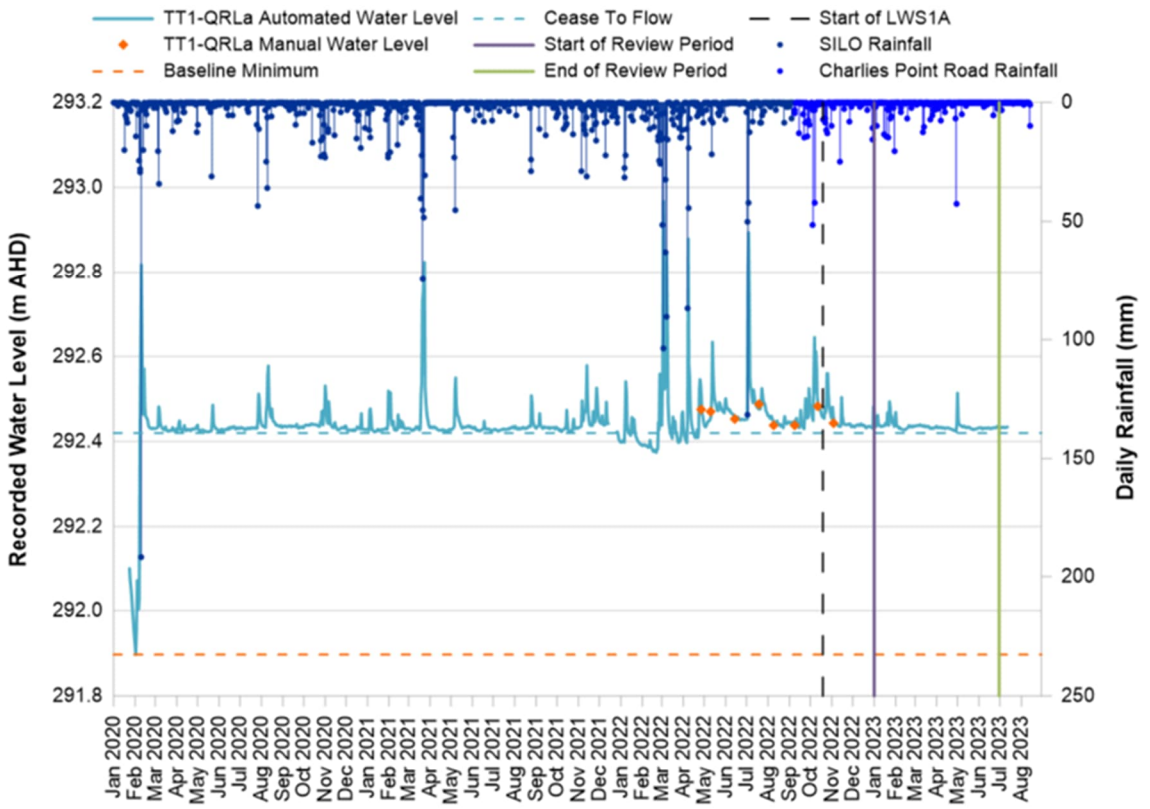
Figure 15 Recorded Water Level and daily rainfall for TT1-QRLa

P55C is associated with surface water monitoring site TT1-QRLa and the two can be considered together when reviewing the surface water – groundwater connectivity TARP (WMP12). The water level plot for TT1-QRLa is provided in Figure 15, and the groundwater hydrograph reproduced again here for context in Figure 16.

The cease to flow level at this SW site is 292.42 mAHD, and the baseline minimum is 291.897 mAHD. The groundwater elevation range recorded at P55C (the deepest of the nested bores at P55) is 256 mAHD to 265 mAHD.

There is no apparent correlation at this point in time between the apparent decline in groundwater level and trigger breach at P55C and the nearby surface water gauging station.

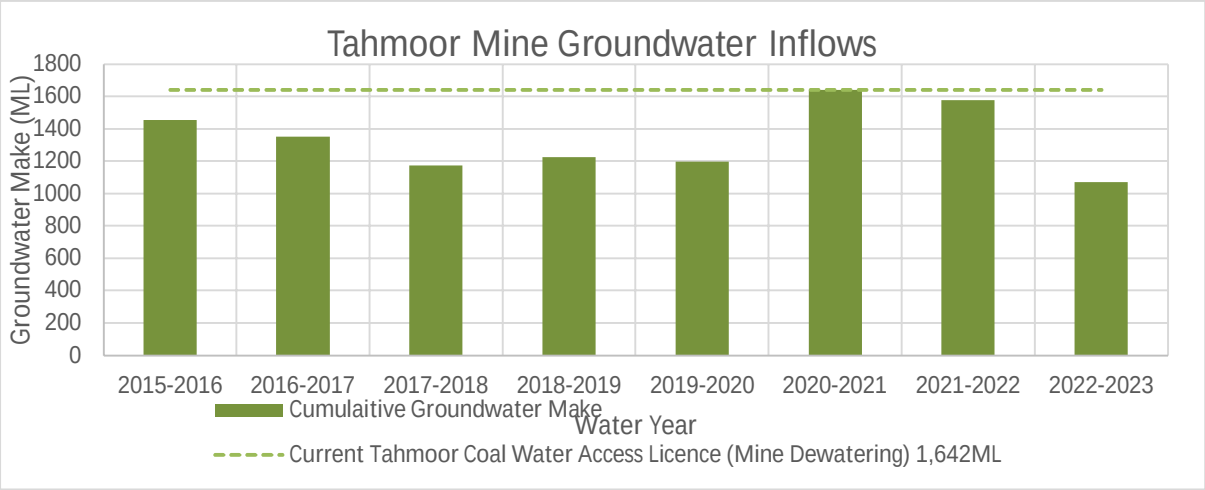
Figure 17 Tahmoor Mine Groundwater Inflows

The reporting period occurs within the water year 2022-23. As of 30 June 2023, the cumulative groundwater make for water year 2022-23 is 1,068 ML, which remains below the groundwater entitlement of 1,642 ML/y (Figure 17).

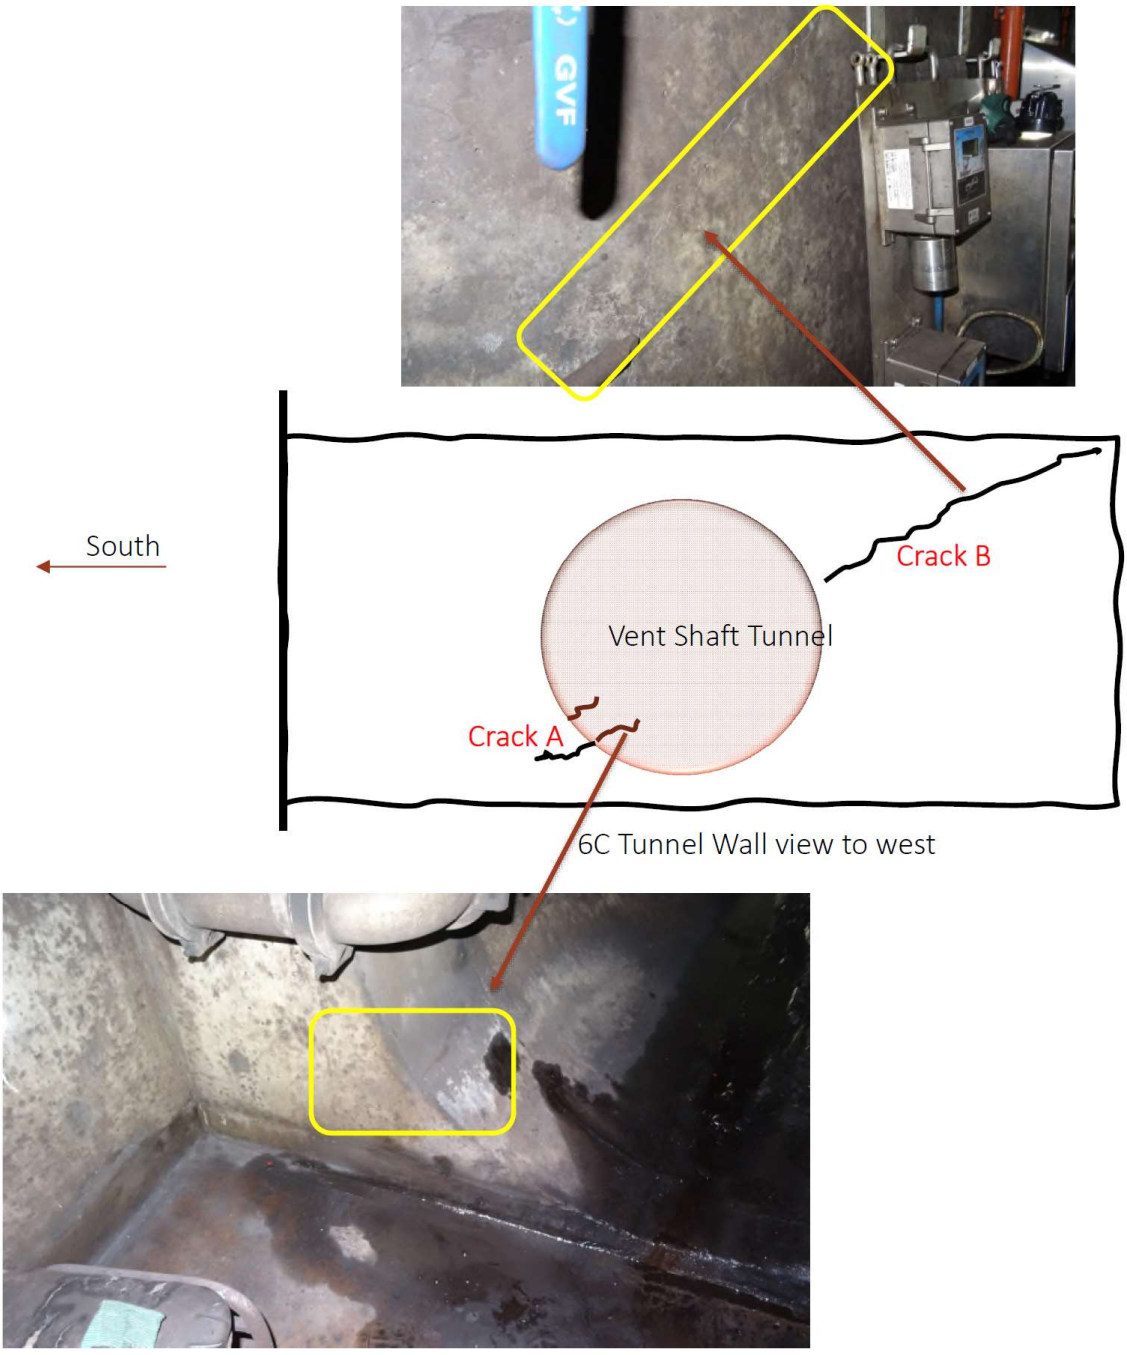
Plate 4.1 **Location of cracks A(C1) and B (C2) within Tunnel 6C (David Talbert 29 May 2023).**

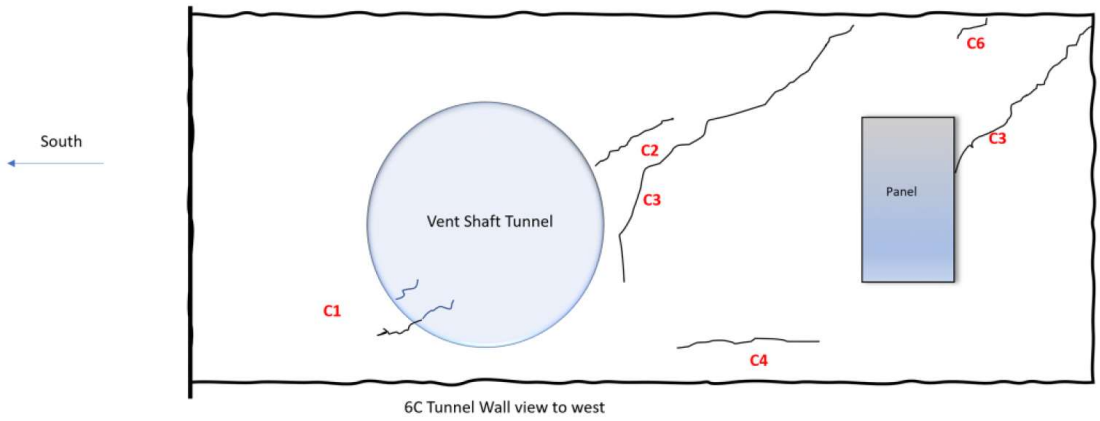
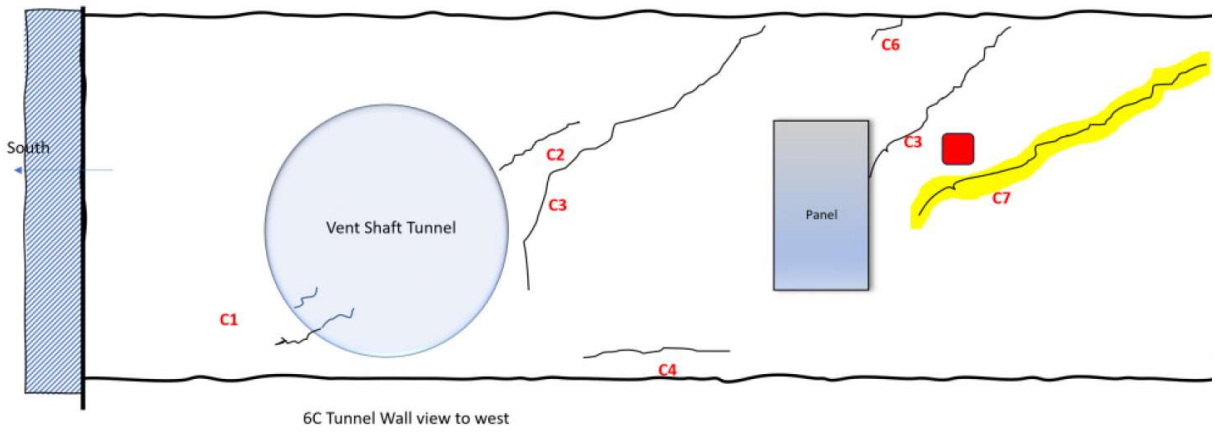
On 29 May 2023, during extraction of LW S1A, two cracks were observed by the structural engineer at the Tahmoor Mine site within the 6C tunnel and vent shaft interface (Plate 4.1 – Plate 4.2). The site continued to be monitored with weekly inspections and on 6 June, four additional cracks were observed (Plate 4.3 - Plate 4.5). An additional crack was detected on 27 June 2023 (Plate 4.6). The site continues to be monitored with weekly inspections.

It is considered that the hairline cracks (<1 mm) in the concrete within tunnel 6C are minor and, if required, could be repaired in a manner that preserves the heritage value of the mine. The Tahmoor Mine Site is a working site and minor impacts such as hairline cracks are unlikely to affect its heritage values. As the heritage values of the item is not expected to be significantly impacted, this therefore is not considered to be a reportable trigger exceedance under the TARP.

Plate 4.2 Crack B (C2), width <1 mm (David Talbert 29 May 2023).

2. At the conclusion of mining of LW S1A – S6A, the cracks within Tunnel 6C should be assessed by a suitably qualified heritage advisor to determine whether remediation is required.

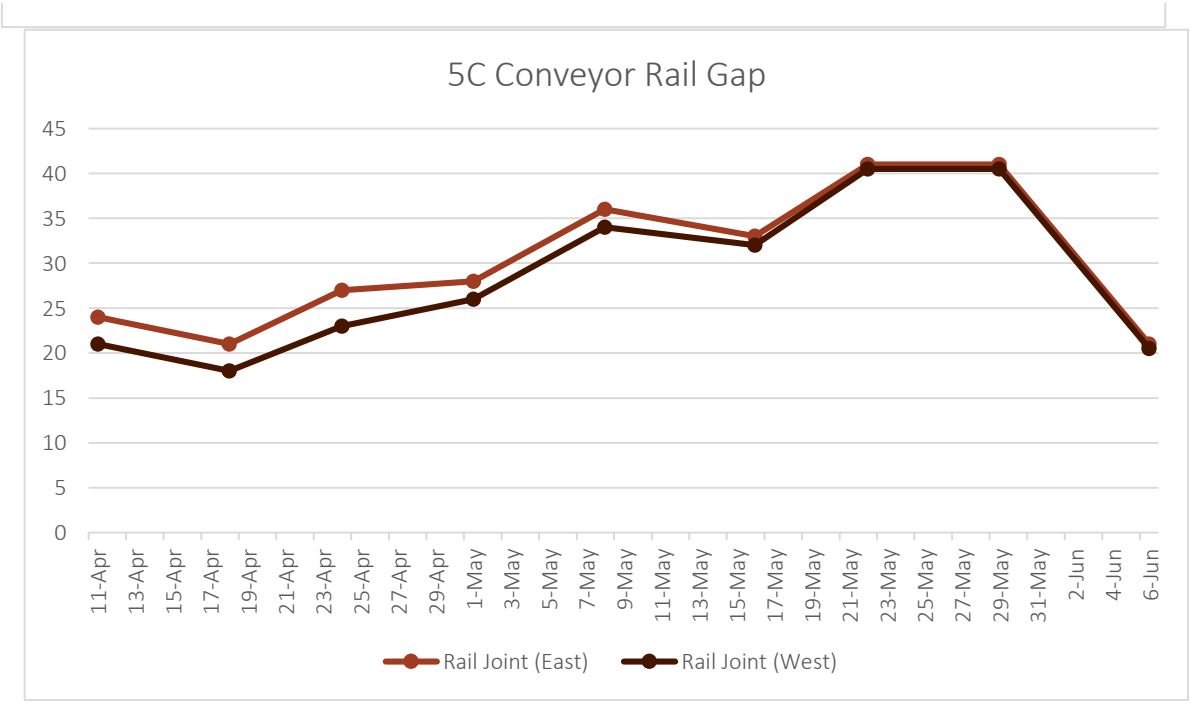
Rail joint gap has **closed significantly**. 20mm spacer has been removed.

Figure 1: 5C slide joint east showing closure of gap (29/05 vs 06/06)

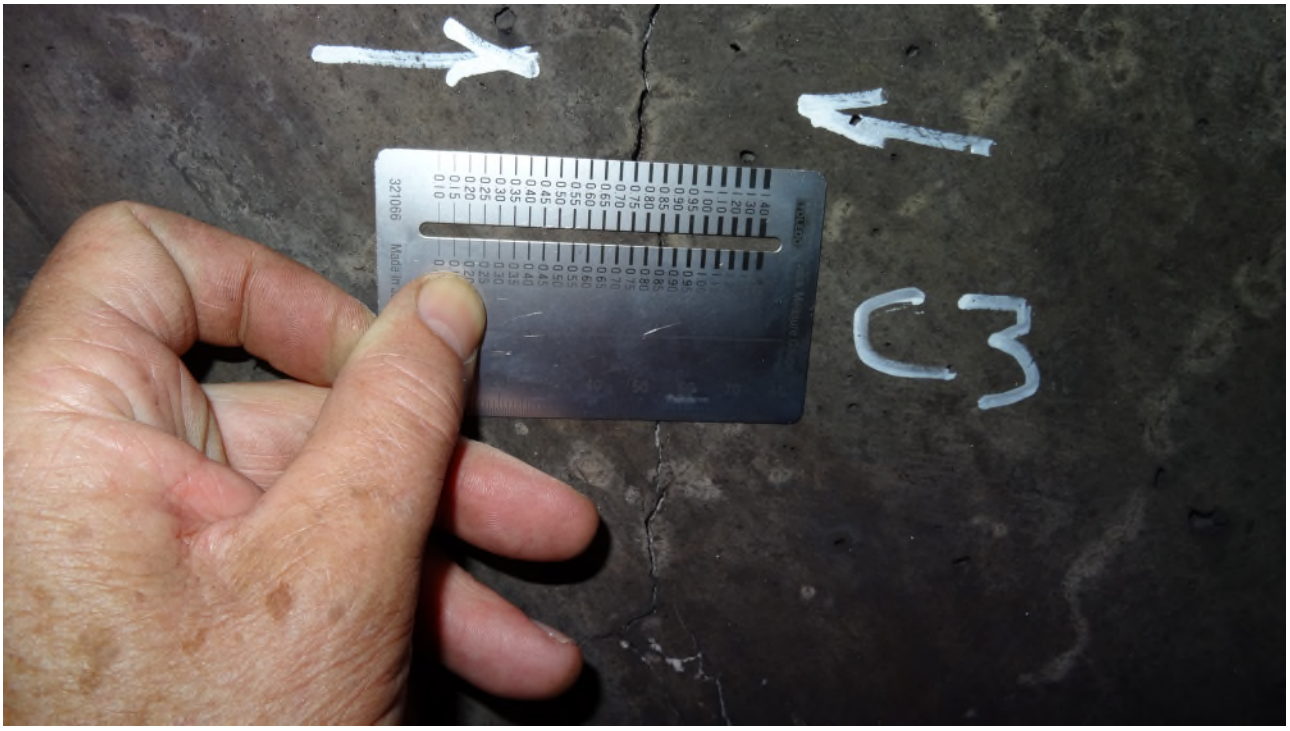
Photo 7: Width of crack C3.

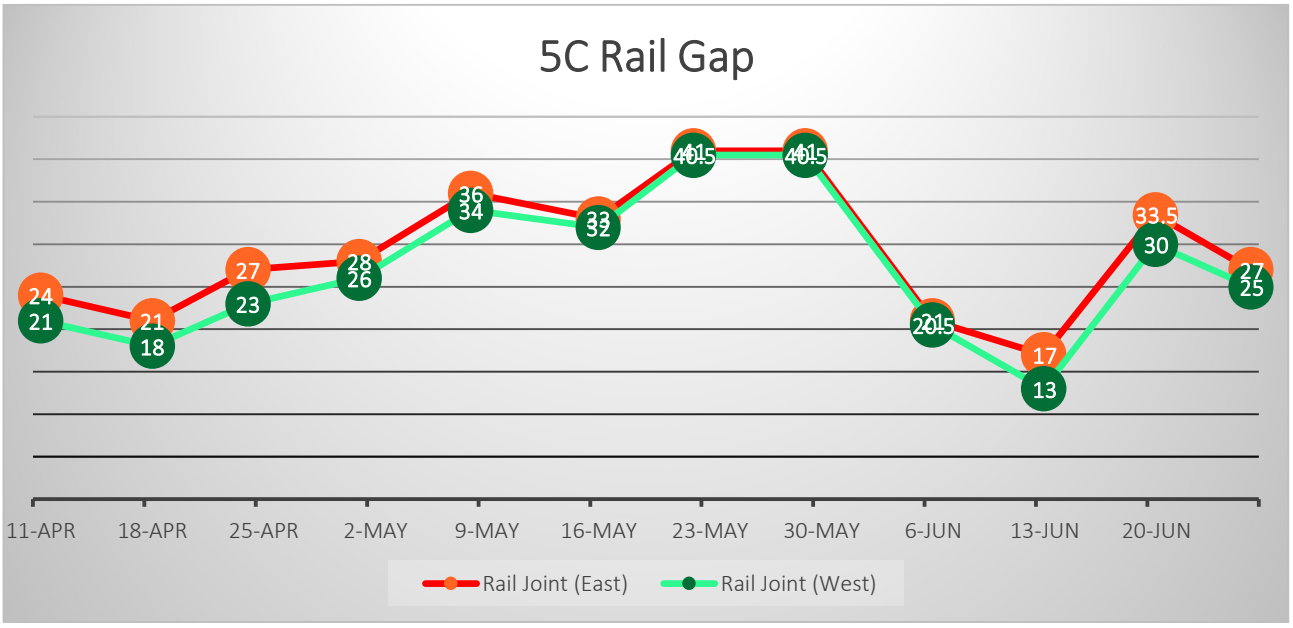
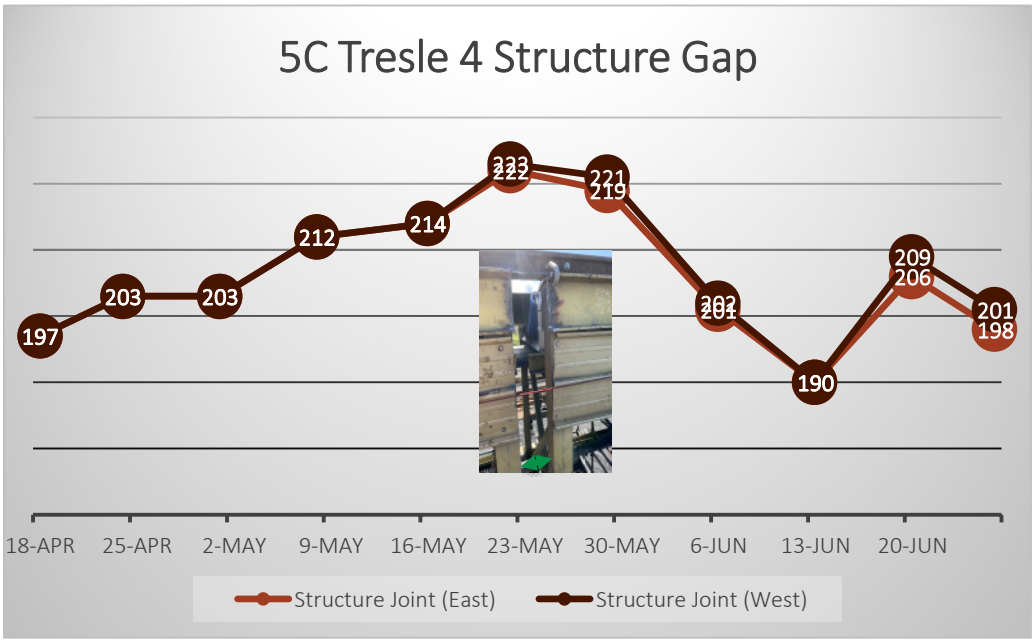
Rail joint gap has **closed a further 5-7mm**. Measurements indicate the west has closed 2mm more that the east.

Figure 1 and 2: 5C slide joint east showing variation 13/06 to 27/06.

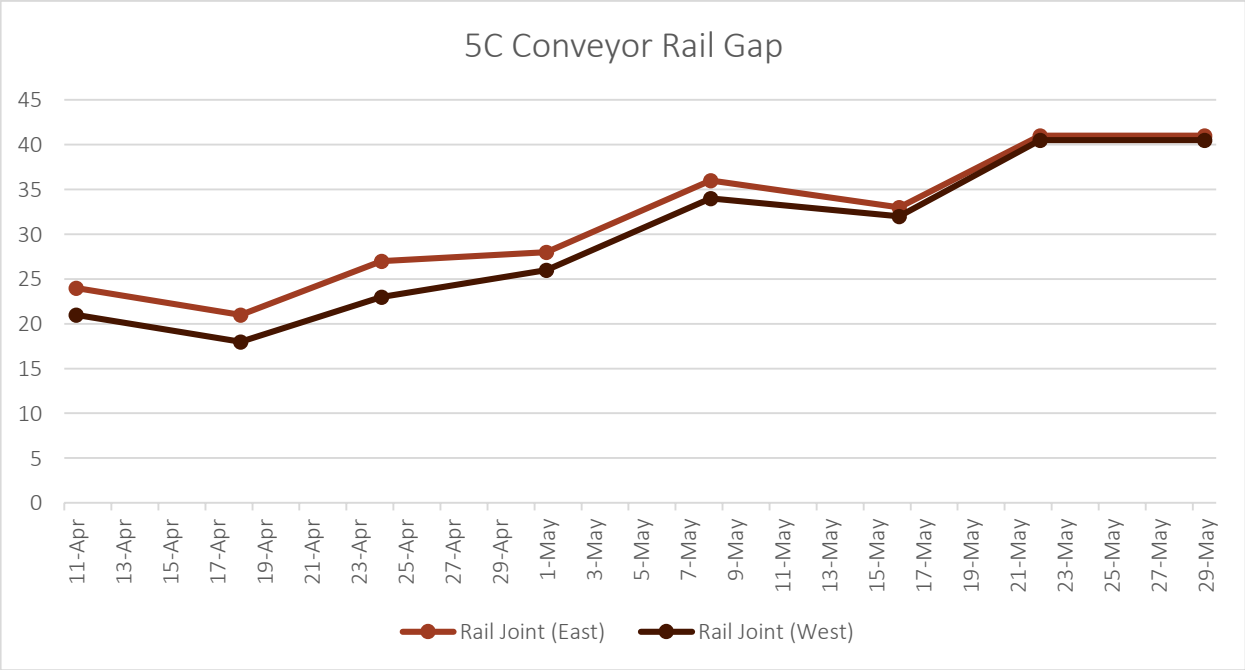
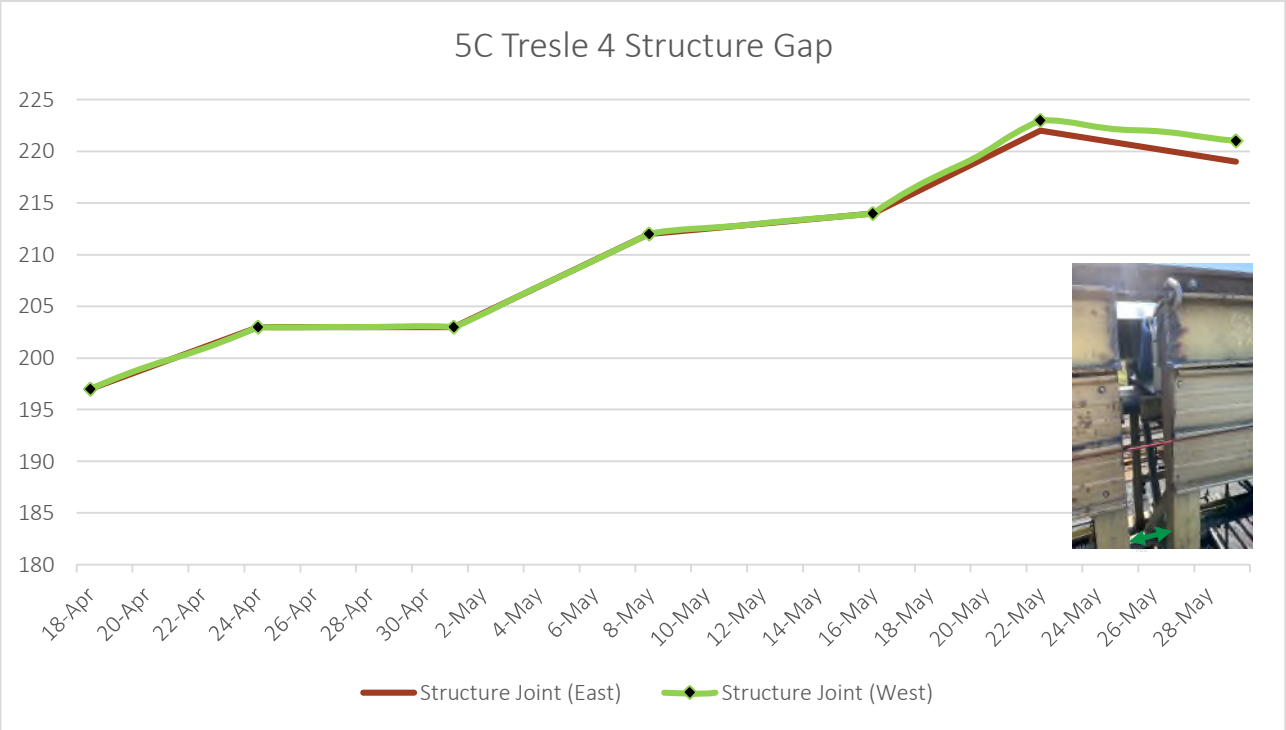
Rail joint gap has remained the same and is likely starting to close.

Figure 1: 5C slide joint East with spacer installed (29/05)

Structure gap at 5C conveyor at slide joint (T4) has **closed** 2mm.

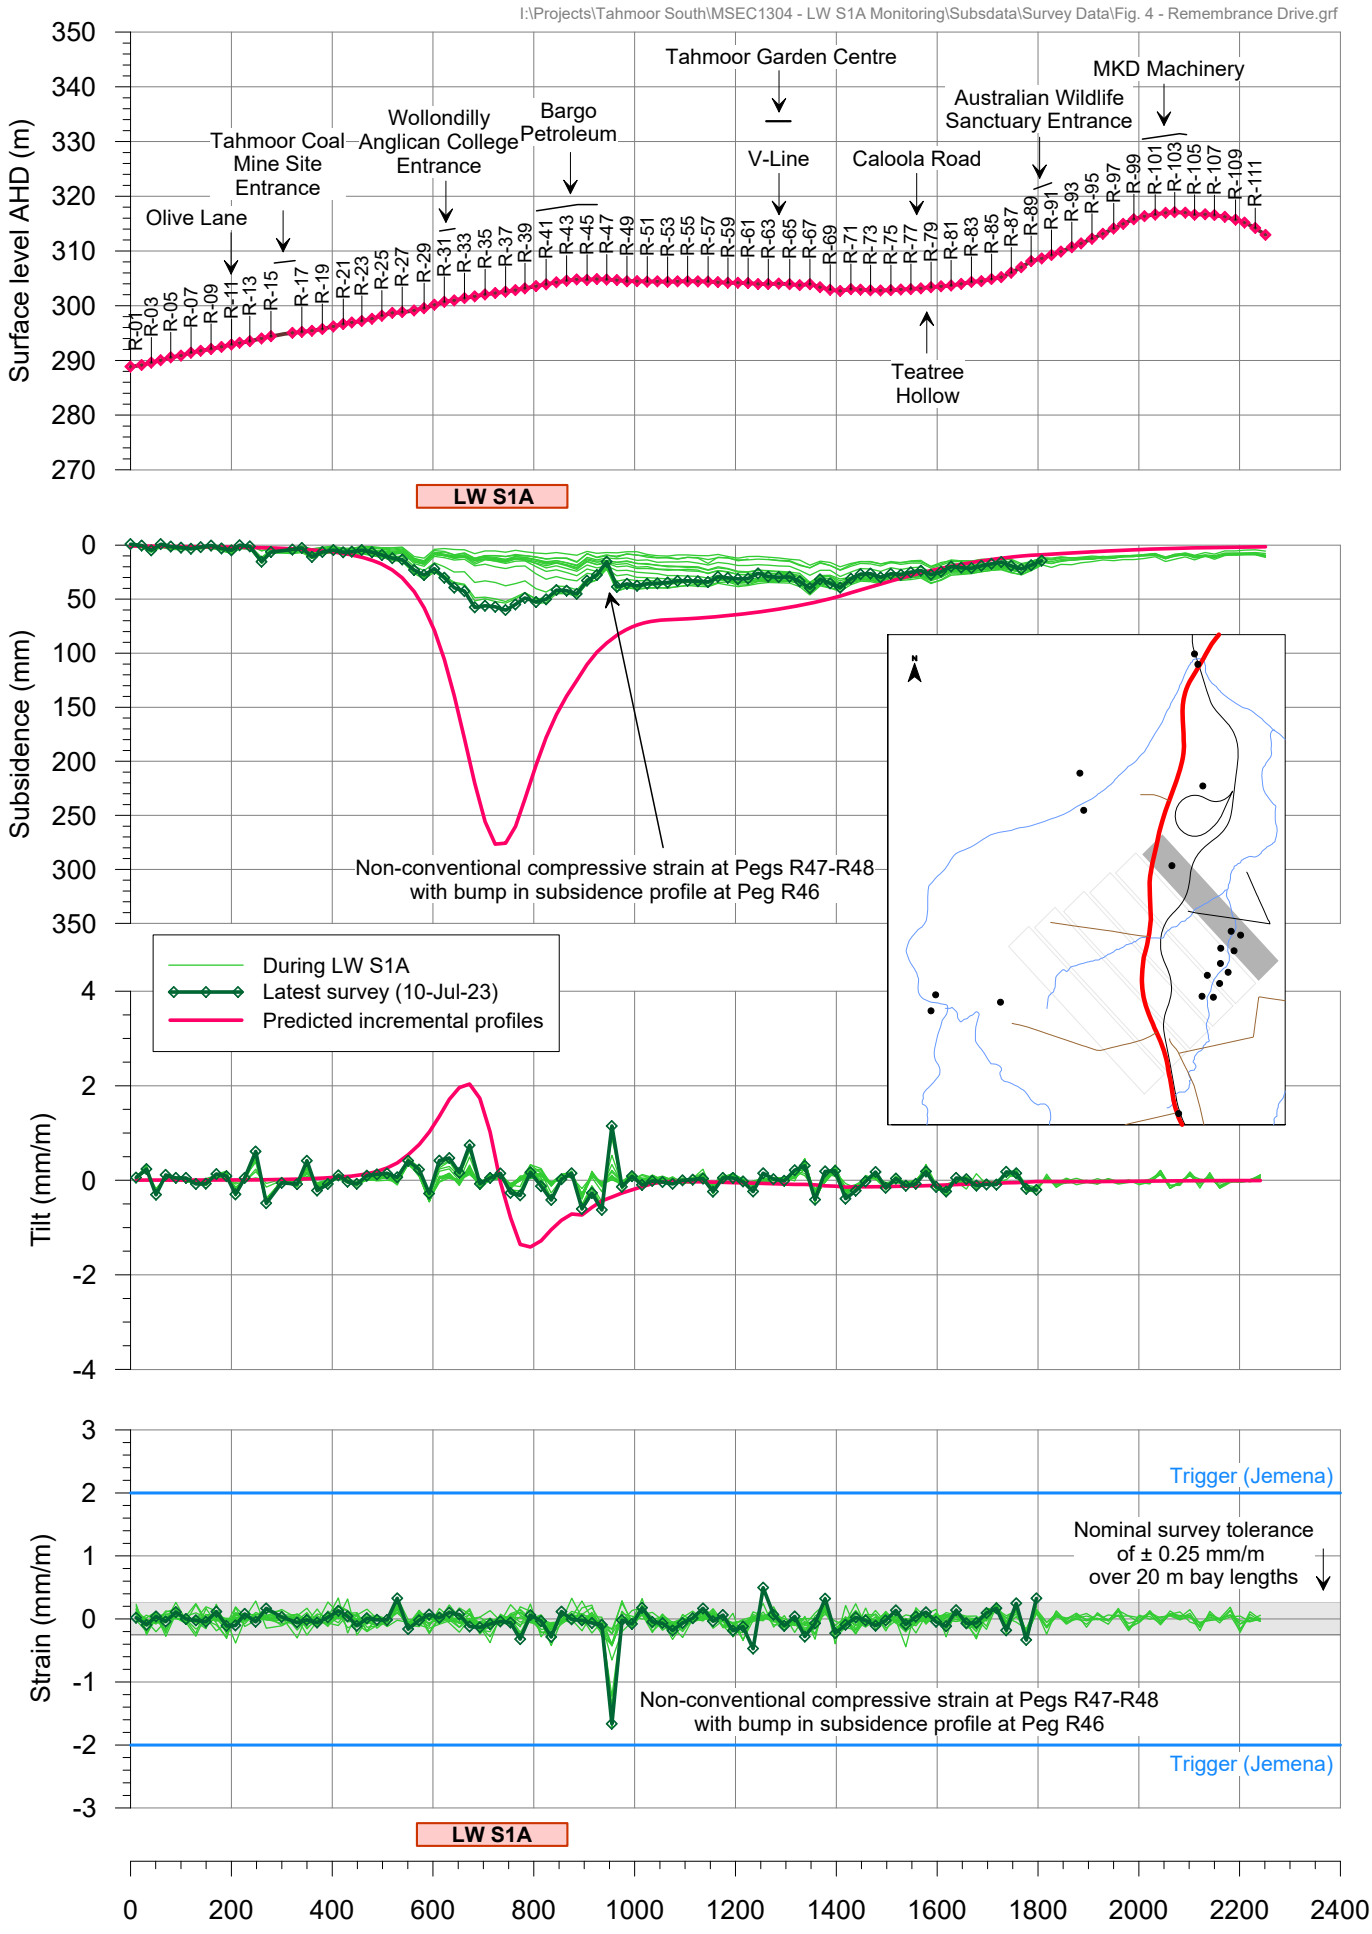
Fig. 4-R35

Tahmoor South LW S1A
Incremental subsidence profiles along Remembrance Drive
