Water Cycle Management for Proposed Subdivision of Lot 2 DP 250984 (Grandfathers Gully)

Report Prepared for:
David Brewer

February 2006
Project No. G491

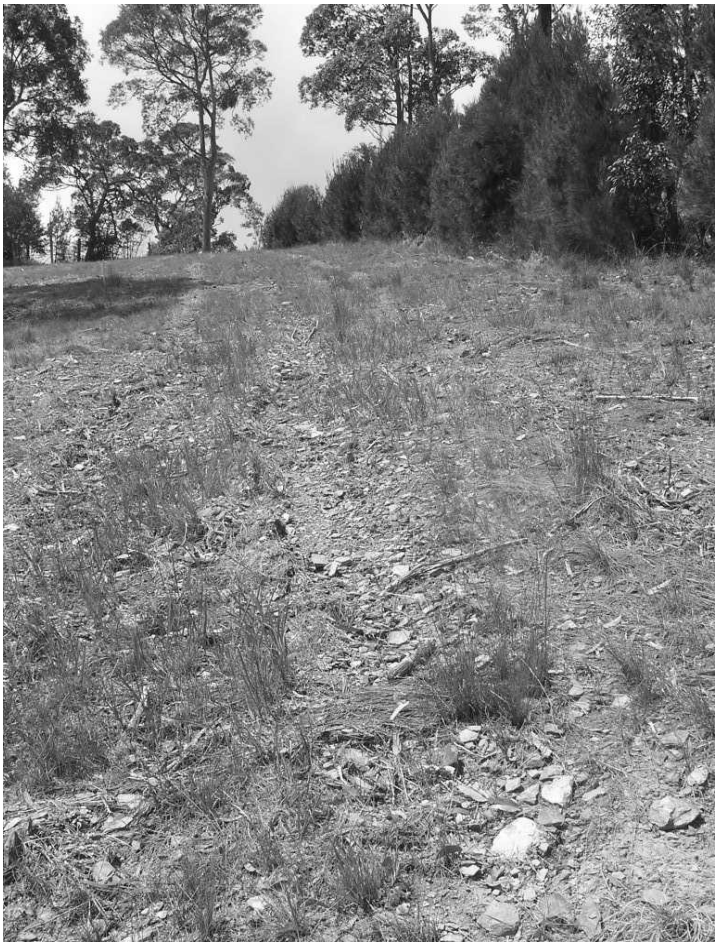
Looking from the top of the ridge over lot 12. Note - vegetated drainage line in the midground and cleared areas on lots 5 and 6 on the other side of the drainage line.
	Example of soil on top of the ridge. Note, skeletal soils (i.e. minimal topsoil), yellow clayey soils with a high percentage of shale gravel.

Looking north on the western side of the ridge at the top of the property over proposed lots 12 and 13.

Looking east upslope on lot 12. Evidence of erosion starting down tracks created by slashing.
