Soil investigation report – Farm shed

771 Cudgen Road,
Cudgen, NSW

January 2019, Ref. 18084 R03 V2

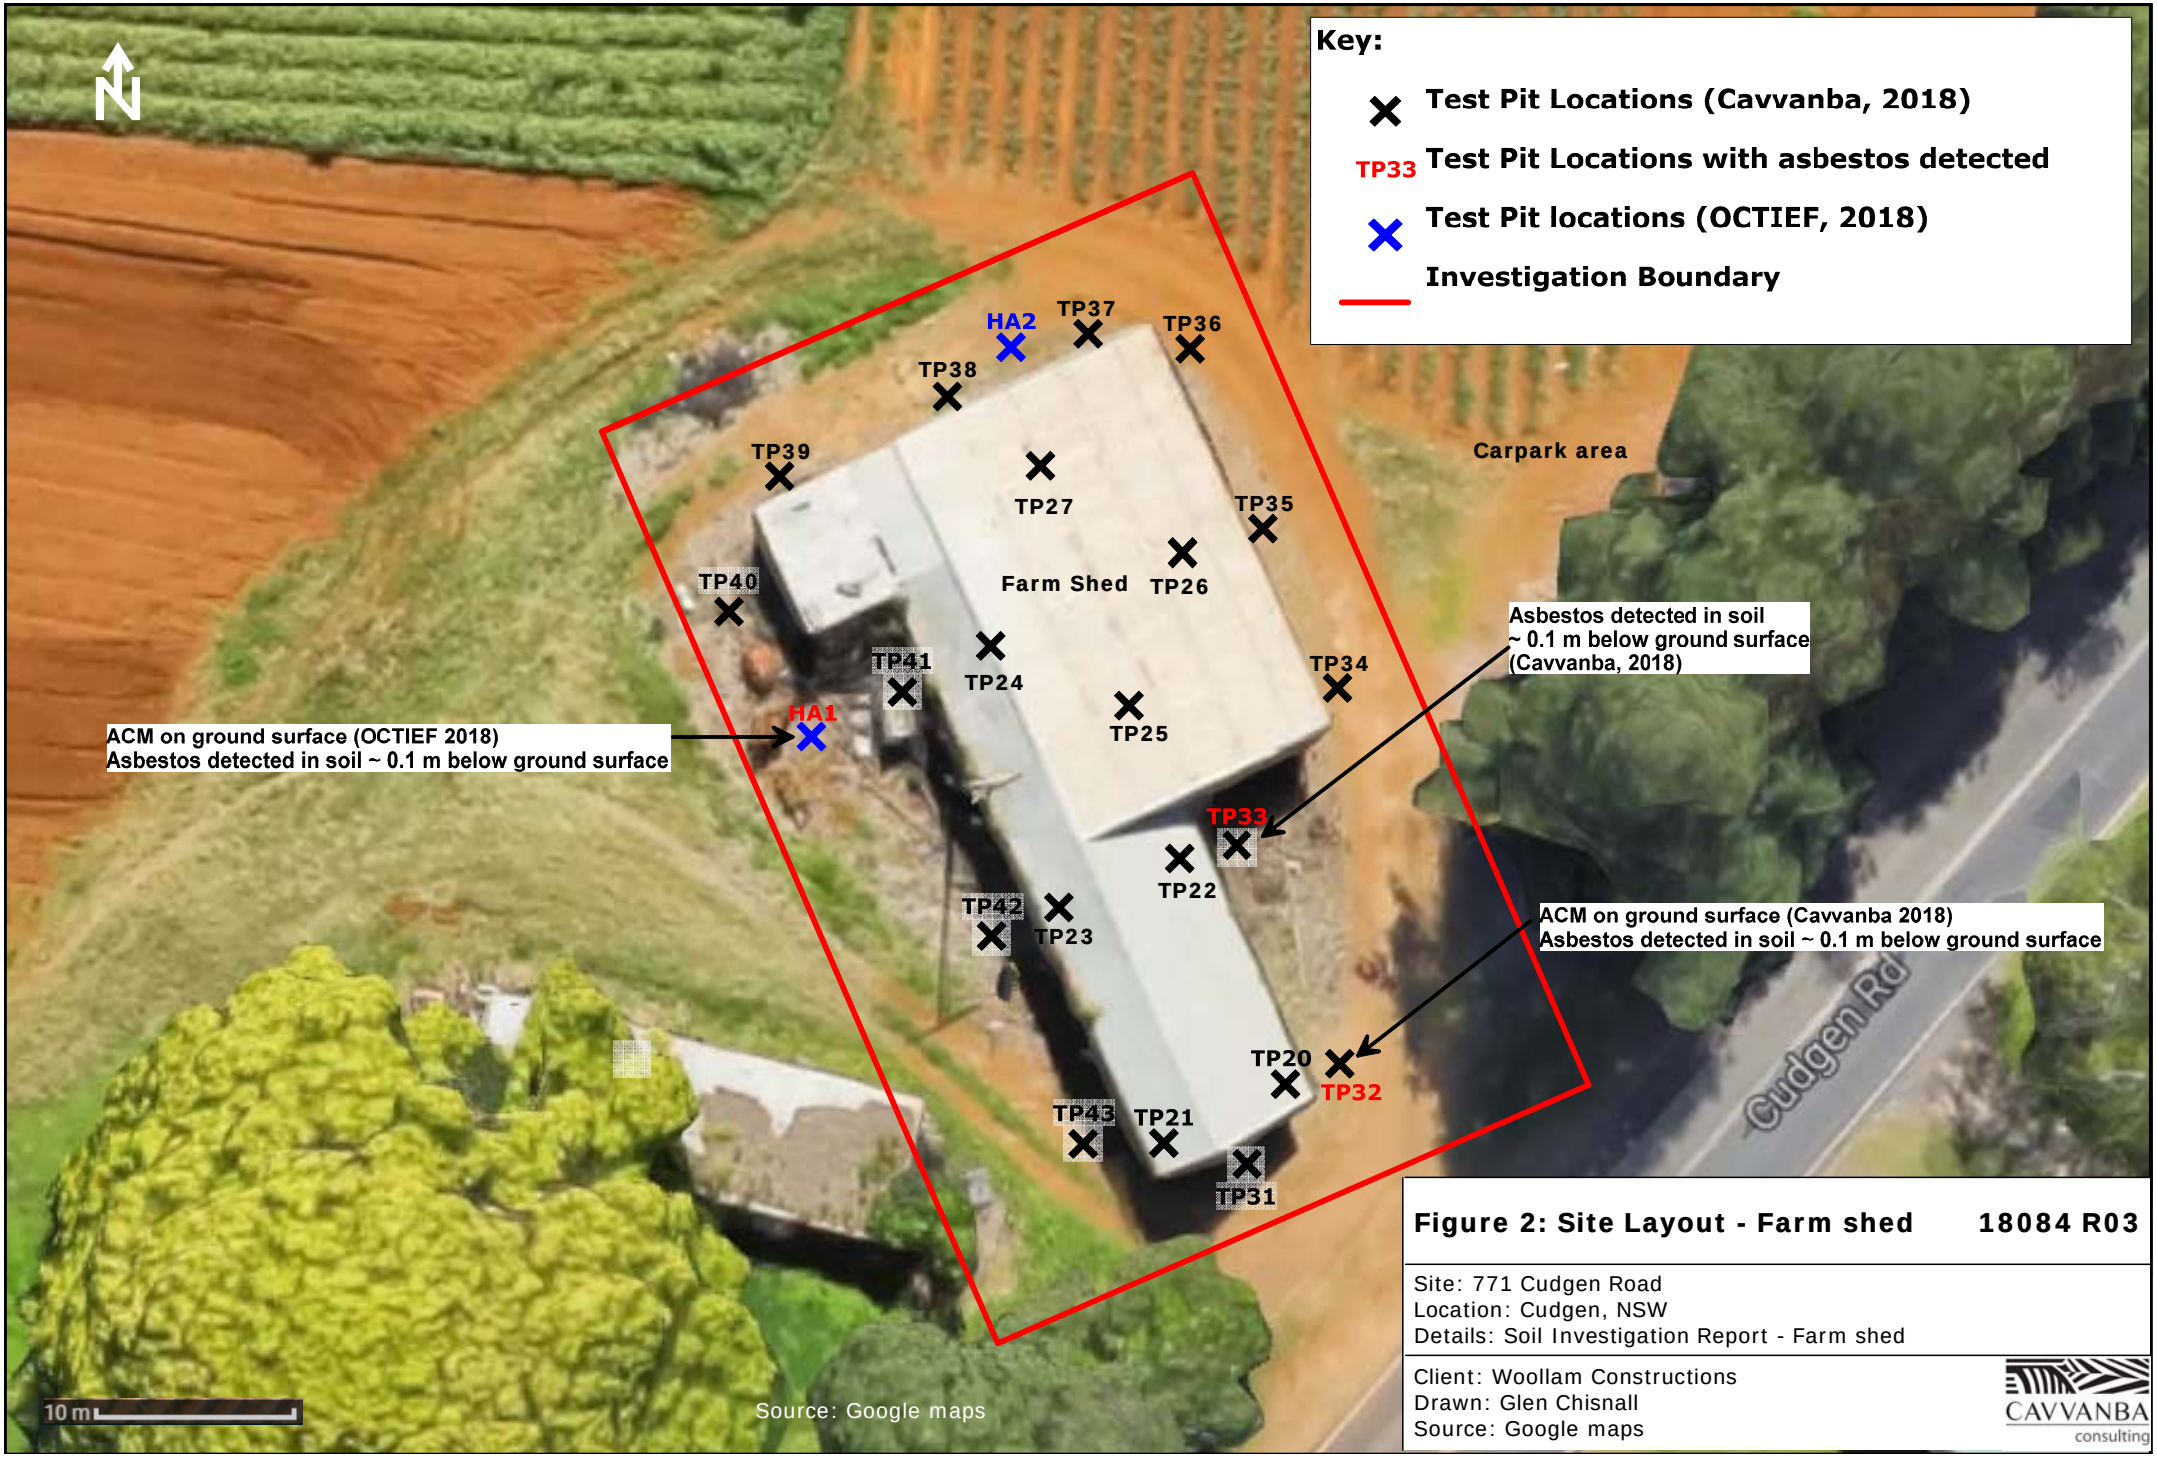
Figure 2: Site Layout - Farm shed **18084 R03**

It was also noted that:
- guttering which contained ACM was present on the western side of the farm shed, and was considered to be in relatively poor condition;
- other ACM was observed on the western edge of the shed roof; and
- small stockpiles containing ACM material were noted against the western wall of the shed.

In addition, ACM fragments were noted on the ground surface by OCTIEF during the previous investigation at sample location HA1. Observations of ACM were limited to disturbed soil only.
