Structural Inspection Report

Hotham House

65 Hotham Road, Kirrawee, NSW 2232

Report Number: DN190017.R2

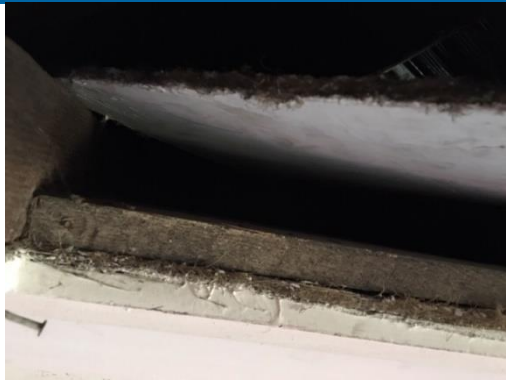
Item No.	Component	Observation Assessment	Recommended Work Upgrade	Photo No.	Photographic Observation	Condition Grade
7	Ceiling manhole to the gymnasium roof void	Detail of the removed manhole panel	A specialist company should be engaged to undertake sampling, testing for asbestos fibres	8

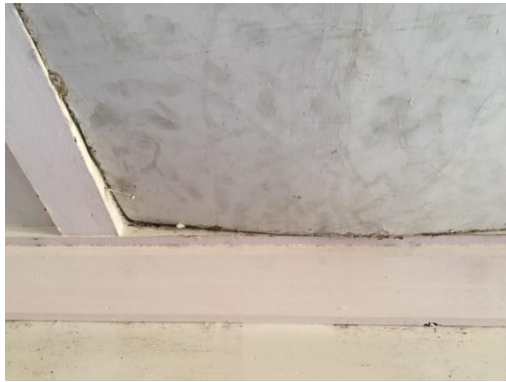
N/A
8	Ceiling manhole to the gymnasium roof void	Refer to item 7 above	Refer to item 7 above	9

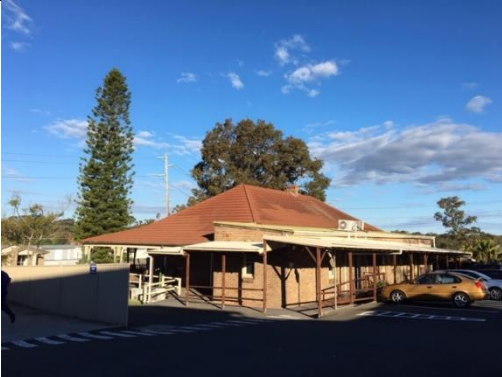
Type 2
17	North- East Elevation of the Hotham House	View of the relative roof levels and material used and type of construction. Natural surface levels fall towards the house	Review and reassess to improve roof and site drainage system.	18

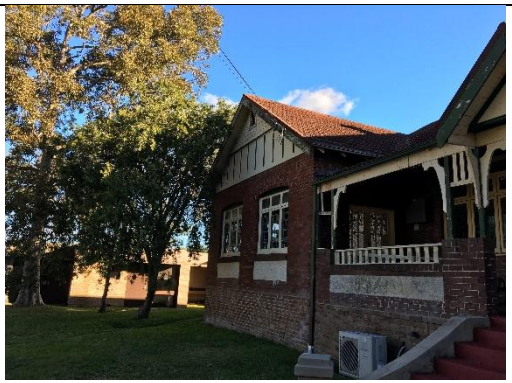
Type 2
25	South-East corner elevation of the house	Brick damage has been previously repaired, more brick movement / damage is evident requiring remediation	Review and remediate the site drainage, collect and affectively connect and discharge into the existing piped drainage system prior to brick remediation	26

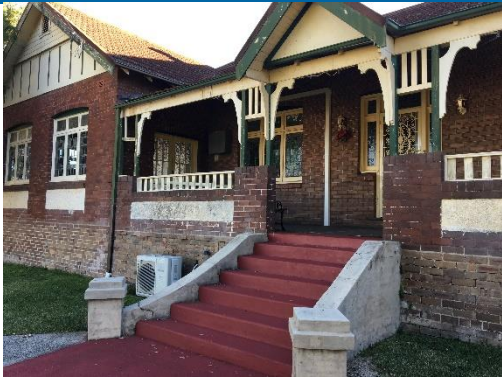
Item No.	Component	Observation Assessment	Recommended Work Upgrade	Photo No.	Photographic Observation	Condition Grade
26	South-East elevation of the house	Refer to item25 above	Refer to item25 above	27

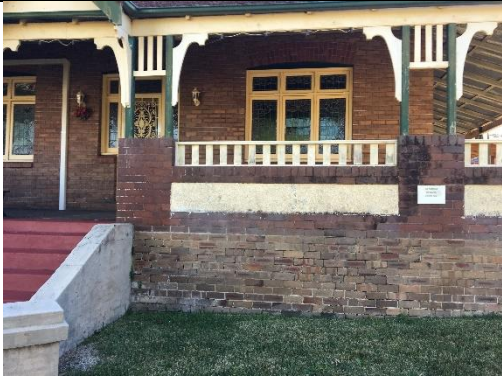
- iii. Differential footing movement has caused damage to main curved stairs. The likely cause is poor drainage in this area, which needs to be investigated before remedial work is contemplated. Once drainage is improved, the movement should be measured and monitored over a period of time. Once the movement has been stabilised and considered static, remedial repairs can be carried out. *Refer to Photos 27 & 32.*

Type 2
27	South-East elevation of the house	Refer to item25 above	Refer to item25 above	28

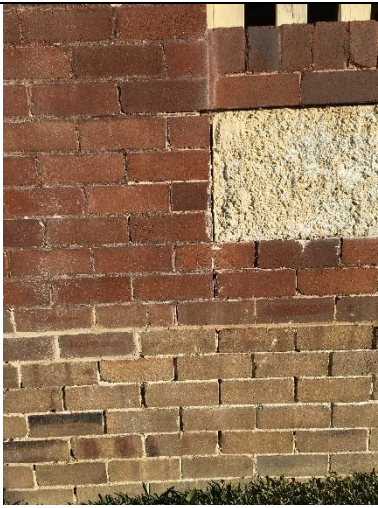
Type 2
35	Looking West, the front verandah	There is footing movement and associated stepped brick cracking. Brick cracking is in the order of < 5.0 mm. With reference to AS2870 Classification of damage with reference to walls, fall is the category of slight	Review and remediate the site drainage, collect and affectively connect and discharge into the existing piped drainage system prior to brick remediation	34

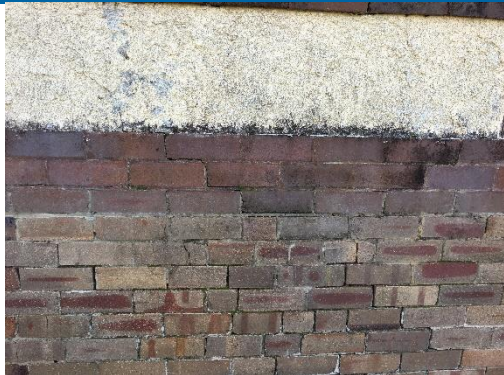
Item No.	Component	Observation Assessment	Recommended Work Upgrade	Photo No.	Photographic Observation	Condition Grade
36	Looking West, the front verandah	Refer to item 35 above	Refer to item 35 above	35

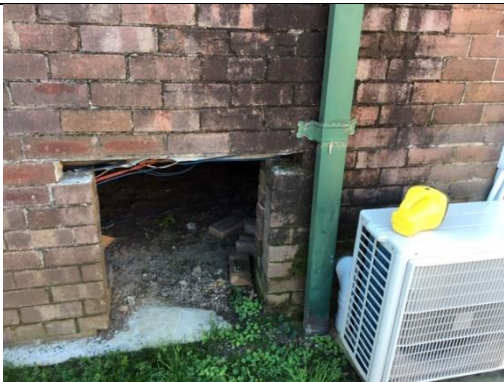
Type 2
44	Southern elevation of the house	Access manhole located below the Dirty Utility room	Check the DP's connection below the ground	43

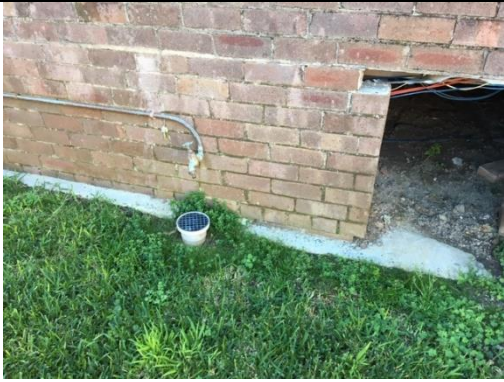
Type 2
45	Southern elevation of the house	Water tap and gully located to this wall	N/A	44

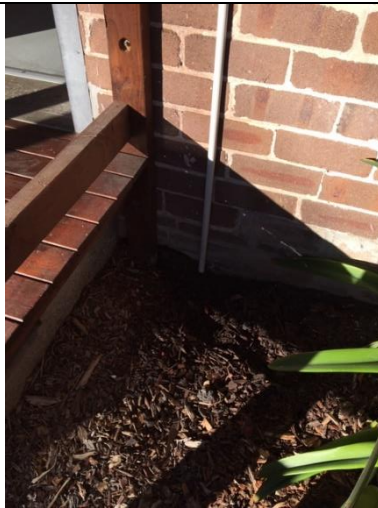
- b) Introduced topsoil may have covered the brick weep holes and cross air ventilation holes in the walls.
- ii. A water tap (without an overflow relief gully) and A/C drain pipes are located and fixed to the wall. Even small water leakages from these will seep under the footings and run along the existing watercourse trenches saturating the subfloor areas, which can be responsible for serious erosion. *Refer to Photos 46 & 47.*

Type 2
47	Western wall, end of the access ramp	A/C Unit pipe discharge water in the garden bed	Pipe and discharge water away form house footings	46

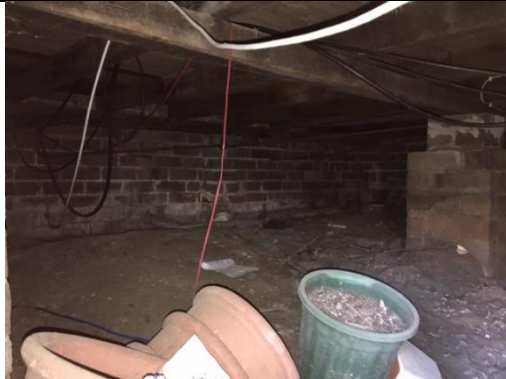
Type 2
50	Subfloor area below the raised garden bed	The brick wall is wet, and the soil is saturated.	Refer to Item 49. above	49

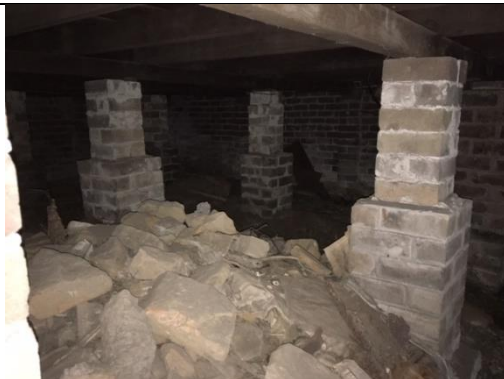
Type 2
53	Subfloor isolated brick piers supporting the gymnasium floor	Soil erosion caused by stormwater runoff under the subfloor area has caused instability to the isolated piers. Some piers are out of vertical while others have settled.	Refer to item 55 above, and thoroughly investigate the condition of all isolated piers and make good to affectively support the gymnasium timber floor	52

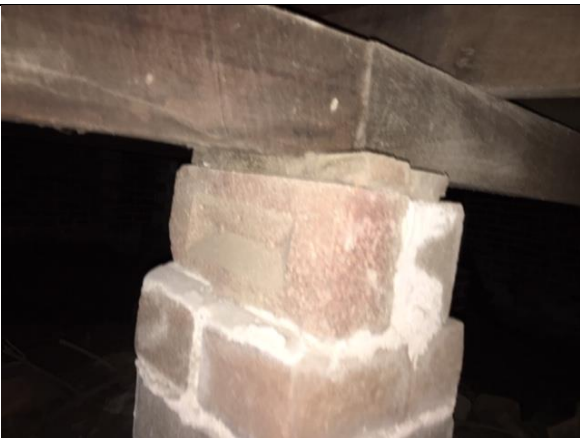
Type 1
55	Subfloor isolated brick piers supporting the gymnasium floor	General soil erosion under stormwater channel flow conditions, has caused settlement and movement to the isolated brick piers. We note that white ant capping is missing throughout the subfloor area, this is not acceptable practice.	Check all displaced isolated pier to ensure bearers are full supported, use timber hardwood wedges to fill gaps between the underside of the timber bearer and top of the brick pier. Retrofit white ant capping	54

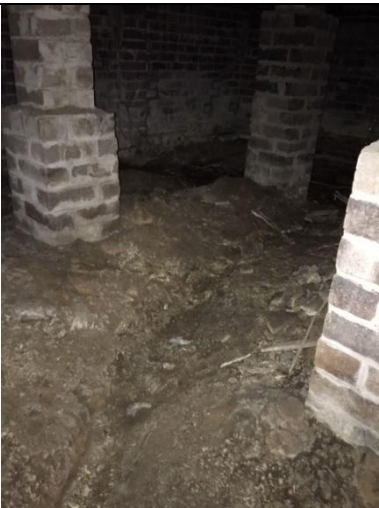
Type 2
57	Subfloor stormwater channel directs flow from under the norther office areas	There appears to be a system of stormwater channels und the house. Generally, channels sizes vary in dimension, but approximately they are in the order of 0.5 x 0.3 deep	Review and remediate the site drainage, collect and affectively connect and discharge into the existing piped drainage system	56

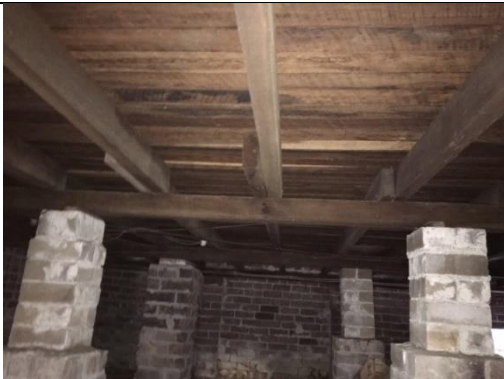
Type 3
63	Subfloor view under the office rooms	The timber floor construction appears of similar construction to the rest of the house.	Adequate cross air ventilation will not satisfy current code requirements and needs further investigation.	58

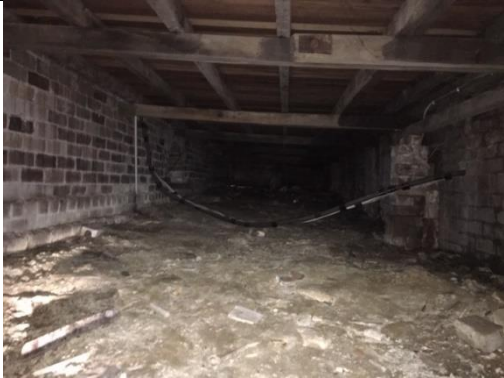
Type 2
64	Subfloor view under the office rooms	Timber floor construction is of different construction to the rest of the house.	Adequate cross air ventilation will not satisfy current code requirements and needs further investigation.	59

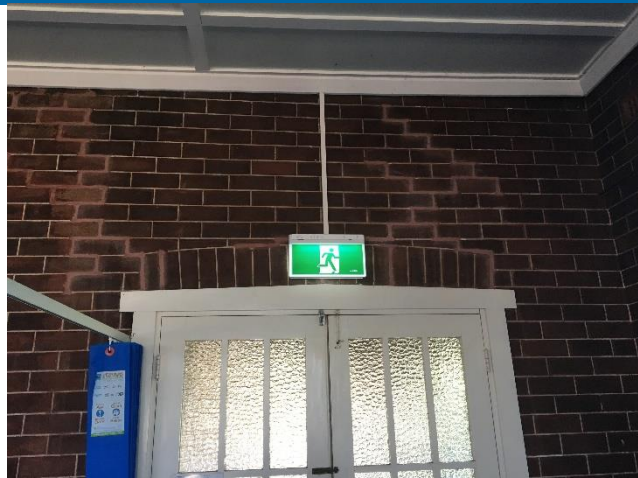
There is visual evidence of extensive brick remediation having been undertaken above most windows and doors. Damage appears to be brick movement either caused from differential footing settlement and/ or from expansion forces caused by the effect of rusting of the steel arch bar spanning across each opening. *Refer to Photo 60.*

Item No.	Component	Observation Assessment	Recommended Work Upgrade	Photo No.	Photographic Observation	Condition Grade
65	Remediated brickwork	Typical Damage above windows and doors	Review and remediate the site drainage, collect and affectively connect and discharge into the existing piped drainage system	60
