Harbourside

## Excavation Phase - Construction Noise and Vibration Management Plan

## 16.8 APPENDIX H – HAZARDOUS BUILDING MATERIAL SURVEY (JBS&G)

Mirvac Retail Sub SPV Pty Ltd  
Hazardous Building Materials Survey  
Harbourside Shopping Centre Redevelopment  
2-10 Darling Drive,  
Sydney, NSW

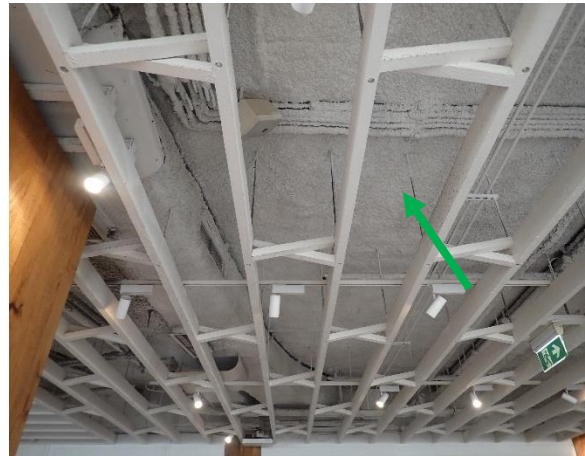
Photo 17: Harbourside – non-asbestos containing vermiculite to the steel beams & ceiling in Shop 198 (Cyren) on Level 1

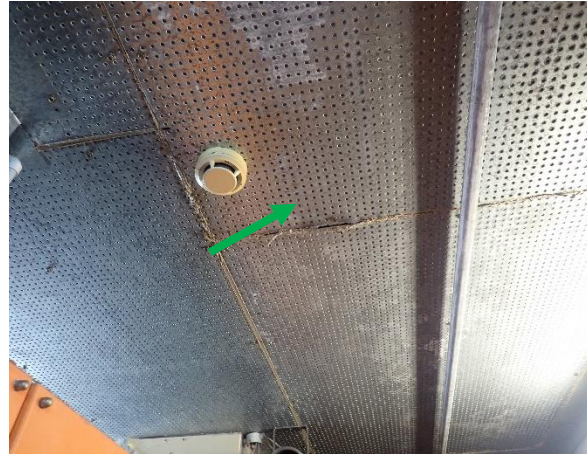
Photo 20: Harbourside – non-asbestos containing fibre cement sheeting to the internal core of the ceiling panels in the main switchroom on Level 1

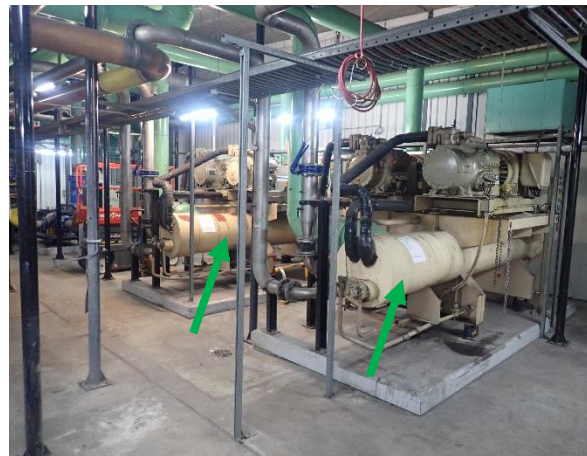
Photo 23: Harbourside – non-lead based cream paint to Chillers #1, #2 & #5 in the chiller plant room on Level 1

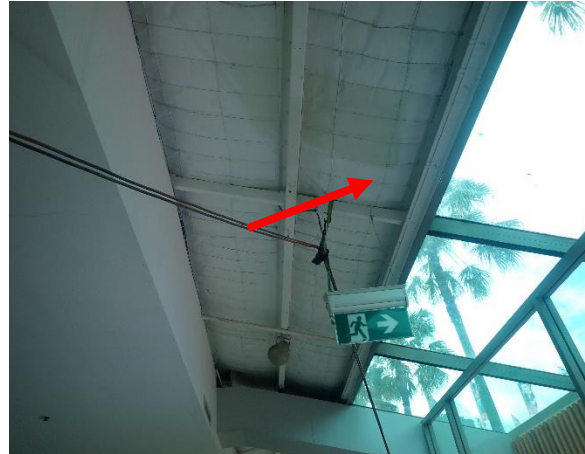
Photo 26: Harbourside – assumed SMF insulation to the roof sarking within the ceiling cavities/plant rooms on Level 1

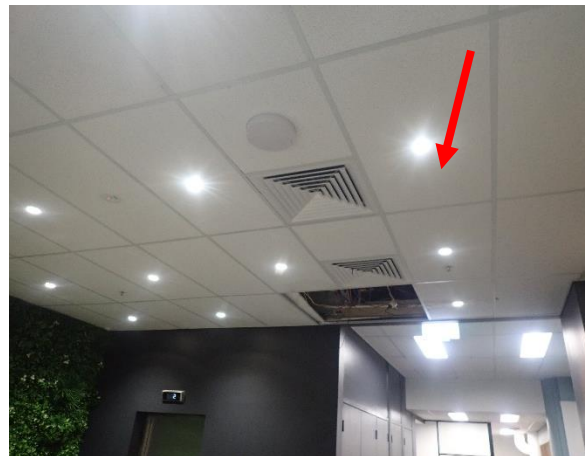
Photo 29: Harbourside – assumed SMF suspended ceiling tiles throughout the Mirvac Offices on Level 1

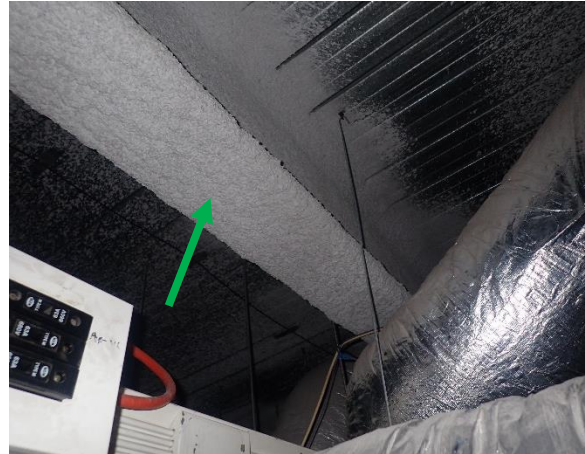
Photo 32: Harbourside – non-asbestos containing vermiculite to the steel beams within the ceiling cavity of Shop 316 (formerly Racecentre) on Level 2

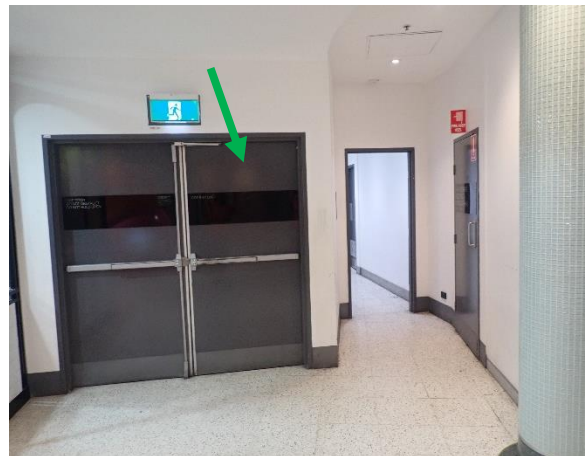
Photo 35: Harbourside – non-lead based grey paint to the common area doors and frames on Level 2

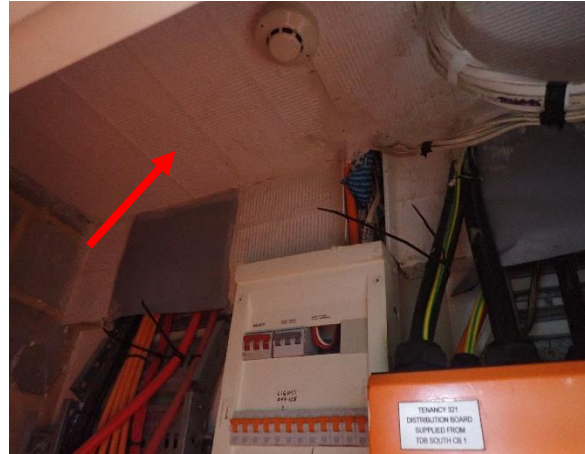
Photo 38: Harbourside – assumed SMF insulation to floor, wall and ceiling penetrations on Level 2

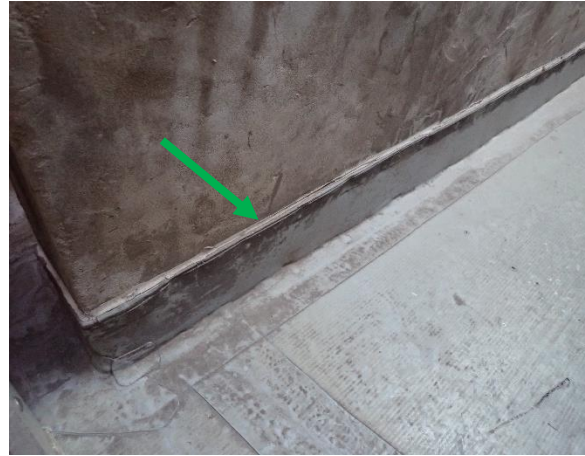
Photo 44: Harbourside – non-asbestos containing white mastic sealant to the edge of the waterproofing membrane throughout the cooling tower area on Level 3

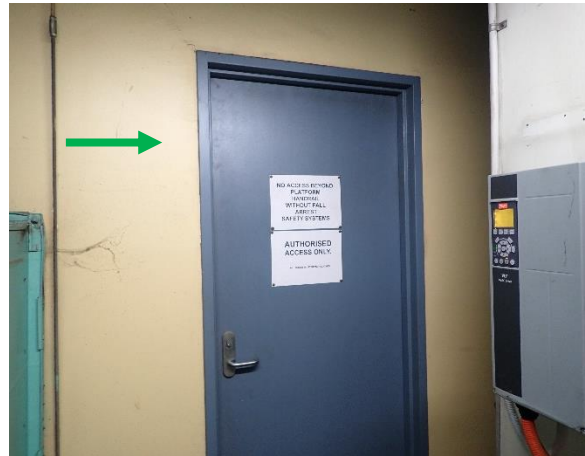
Photo 47: Harbourside – non-lead based cream paint to the plant room walls on Level 3

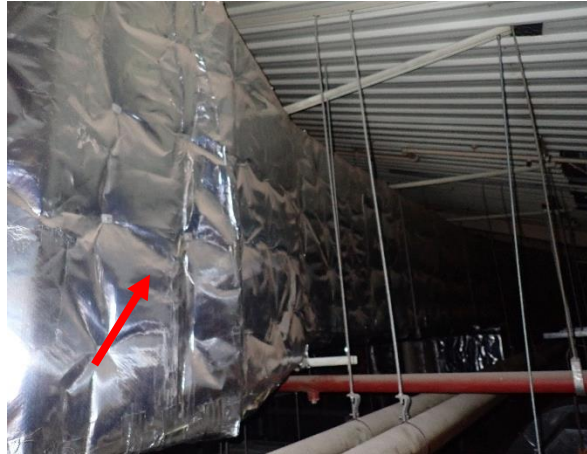
Photo 50: Harbourside – assumed SMF insulation to the HVAC ducting in the plant room on Level 3

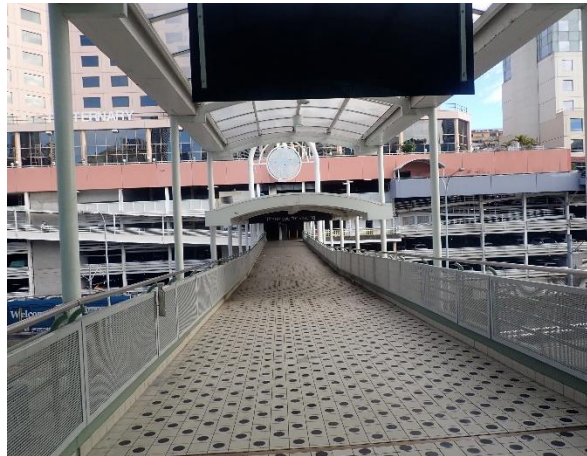
Photo 53: Overview of Pedestrian Link Bridge

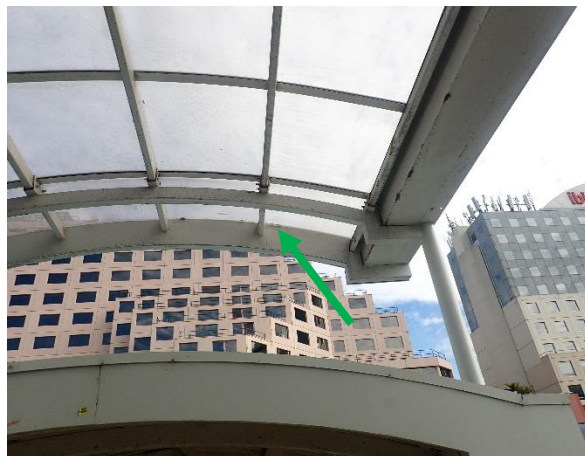
Photo 56: Pedestrian Link Bridge – non-lead based white paint to the steel framework

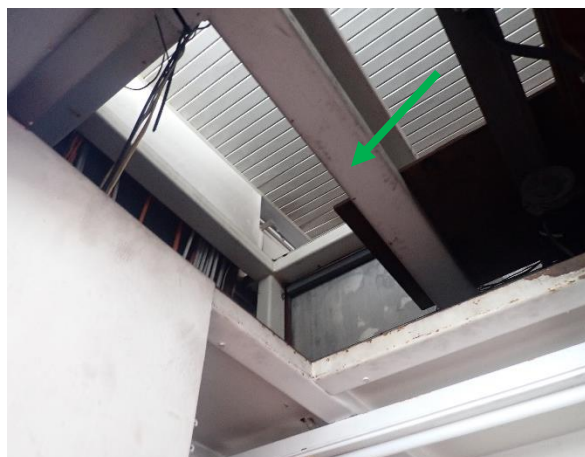
Photo 59: Former Monorail Station – non-lead based grey paint to the steel framework
