1527 – Former Department of Lands Building

22-33 Bridge Street, Sydney

Trial Salvage & Prototype Off Site Repair and Reinstatement Report

Report A – TRIAL SALVAGE

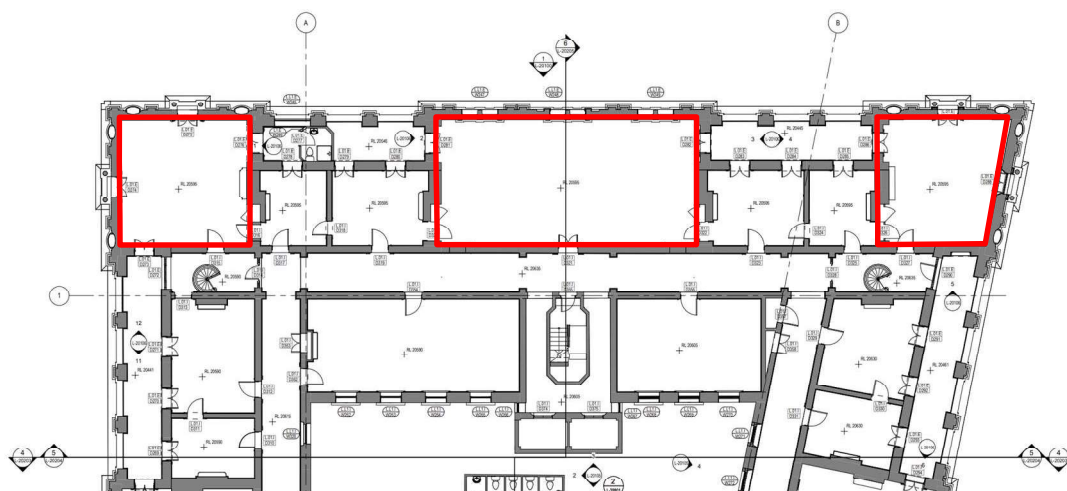
IMAGE 1.1 – Proposed Final Location of ‘Lathe & Plaster’ Cornice Salvage

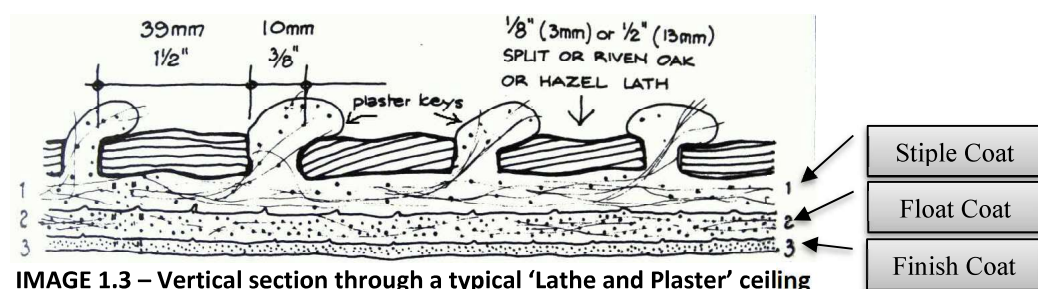
'Lathe and Plaster' is typically formed 'in situ' meaning that a timber main support frame is constructed and attached to the brick/masonry and steel substructure over which soaked timber lathes are nailed forming a continuous timber substrate over which plaster will be applied (Refer to Image 1.3 below).

- I. Timber frame of either hardwood or softwood
- II. Soaked timber lathes fixed with flat head nails into the substrate spaced to allow for the passage of the first plaster 'Stipple' coat.
- III. Plaster 'Stipple' coat consisting of lime, sand and hoarse hair or sisal fibres for reinforcement. This coat is coursed pressed through the lathes to form plaster 'keys' above the timber lathes.
- IV. Float coat of mix without reinforcement is then applied over the 'Stipple Coat' and floated to a flat finish.
- V. A finishing coat of plaster is applied and cured fully prior to decoration.

The integrity of the build up is not based on any cement (Strong Hydraulic Lime) which modern construction would expect to use to secure the materials into place. The ceilings are usually fragile, subject to structural failure as a consequence of the sheering off or fracturing of the plaster 'Keys' by builders, tradesman and homeowners attempting to access subfloor cavities for services OR movement and vibration due to building works or seismic events.
