**Report on Hazardous Building Materials  
(HAZMAT) Survey**

**270-272 Pacific Highway  
Crows Nest NSW**

**Project 214296.04**

**18 July 2025**

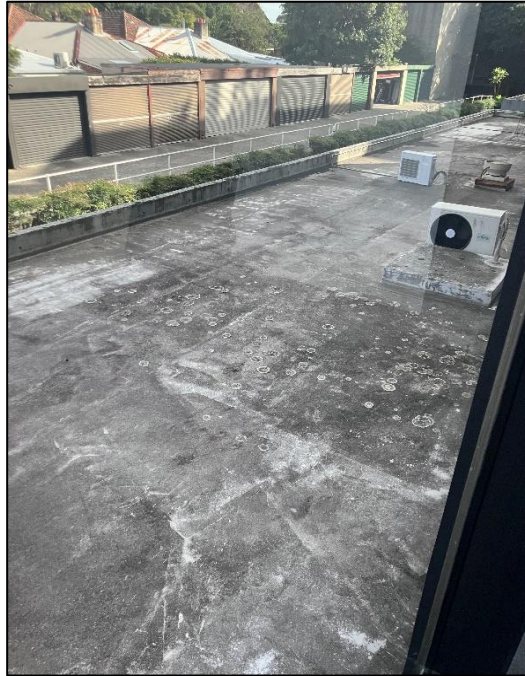
Photograph 33: South Tower, exterior, Ground Level to Level 1, open roof top areas (northeast and southwest), waterproofing membranes, inaccessible.

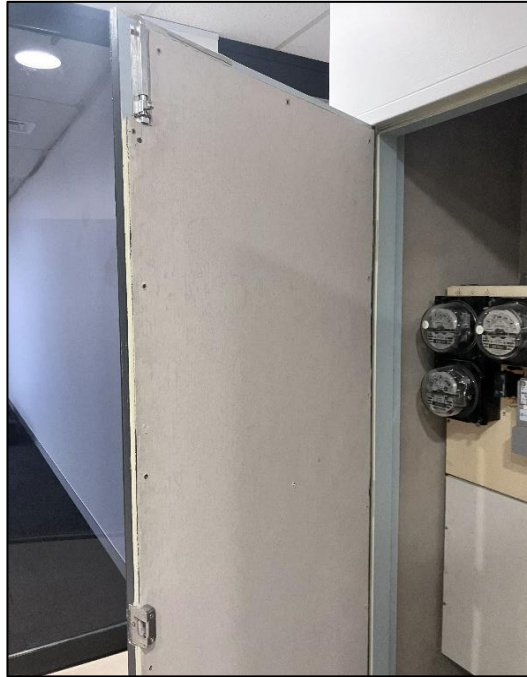
Photograph 35: South Tower, Level 4, lift foyer, EDB cupboard, doors, fibre cement linings, no asbestos detected by analysis.

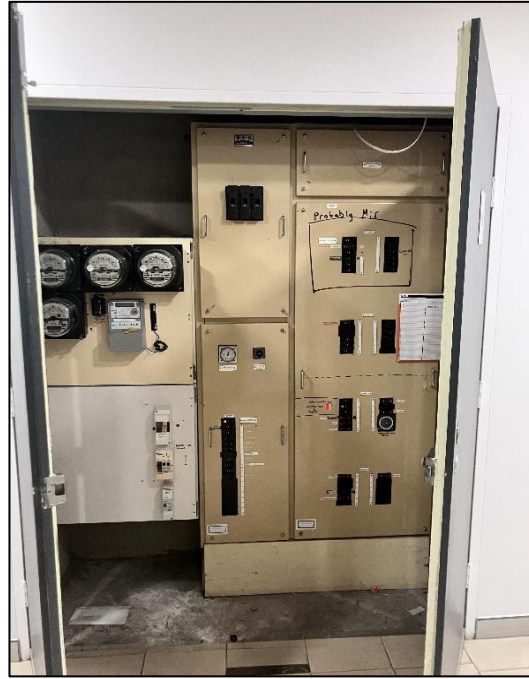
Photograph 37: South Tower, Levels 1 to 4, lift foyer, EDB cupboard, electrical cabinets, internal components, inaccessible.

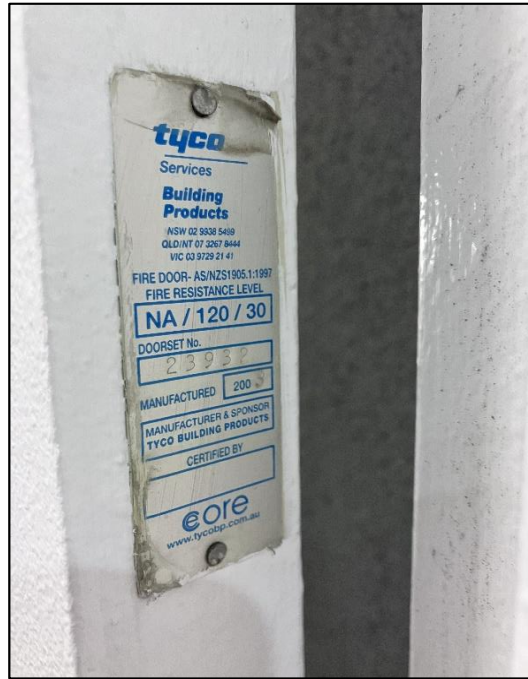
Photograph 39: South Tower, fire stairs and tunnels generally, fire doors c. 2000's (e.g. typically "Tyco" or "DEM" brand) , insulation, suspected non-asbestos.

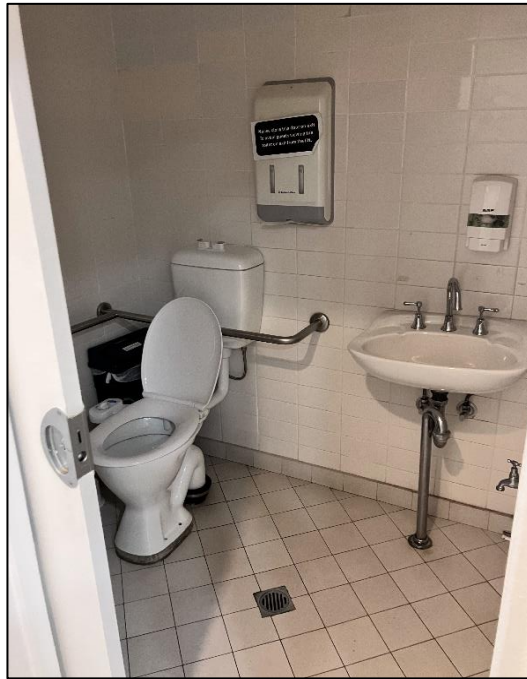
Photograph 41: South Tower, Levels in general, lift foyers, amenities generally, below ceramic floor and wall tiles, substrate, inaccessible.

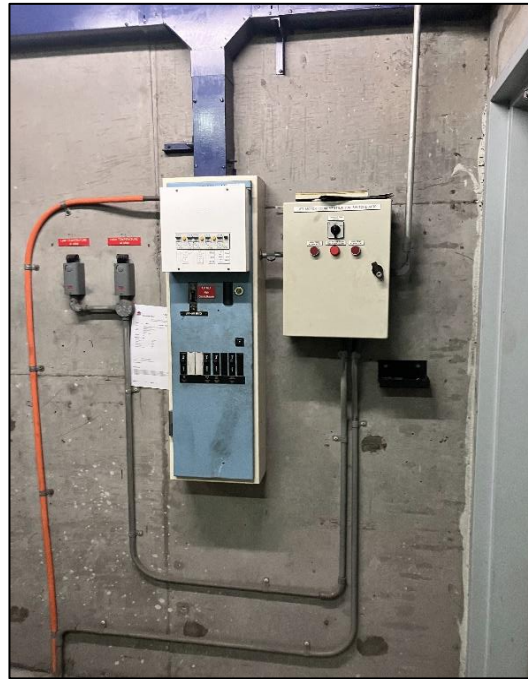
Photograph 49: South Tower, Level 5, Lift Motor Room, electrical panels, internal components (e.g. backing boards), inaccessible.
