HUNTER INDOOR SPORTS CENTRE (HISC)

ARBORICULTURAL IMPACT ASSESSMENT

SEPTEMBER 2025

Arboricultural Impact Assessment

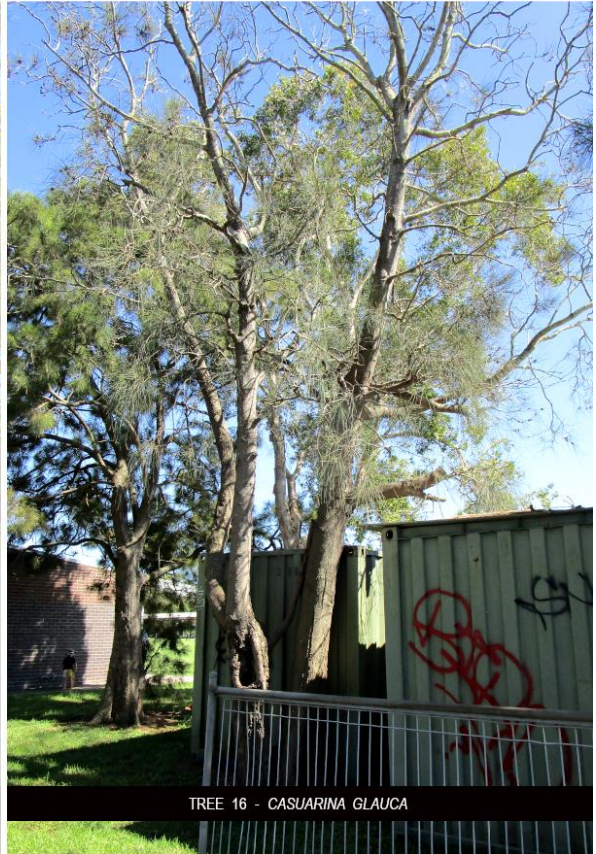
TREE 16 - CASUARINA GLAUCA

Tree 16 has also been noted as being "Removed". This tree is in severe decline and even if left undisturbed, it is likely to fail. By removing the existing containers and making changes nearby, it is likely that its decline will be hastened although not directly affected by the construction works. Changes to the design of the proposal, even if practical, would not prevent this tree from failing.

- that Trees 1, 2, 16-21 and 24, occurring on-site, be removed;
- that Trees 3-15, 22, 23, A-C and E be retained; and,
- that Trees D, F and G be retained by following the requirements of the Preliminary Tree Protection Manual (refer Appendix D) subject to careful detailing during the detailed design and documentation phases and further investigations occurring at the commencement of construction to ensure major roots are not damaged and/or further action taken.
