Fax Transmission

To	Ben Fryer	From	Matt Rowbotham
Fax No		Date	12/12/07
Company	Doug Gow and Associates	Reference	Preliminary Geotechnical Assessment Workshop Letter
cc		Page	1 of
Subject	Preliminary Geotechnical Assessment - The Lakes Estate Stages 1.2 to 9.2

client:	DOUG GOW AND ASSOCIATES PTY LTD
project:	THE LAKES ESTATE STAGES 1.2 to 9.2
title:	SITE PLAN SHOWING APPROX. TEST PIT LOCATIONS
project no:	GEOTCOFH02233AA
figure no:	FIGURE

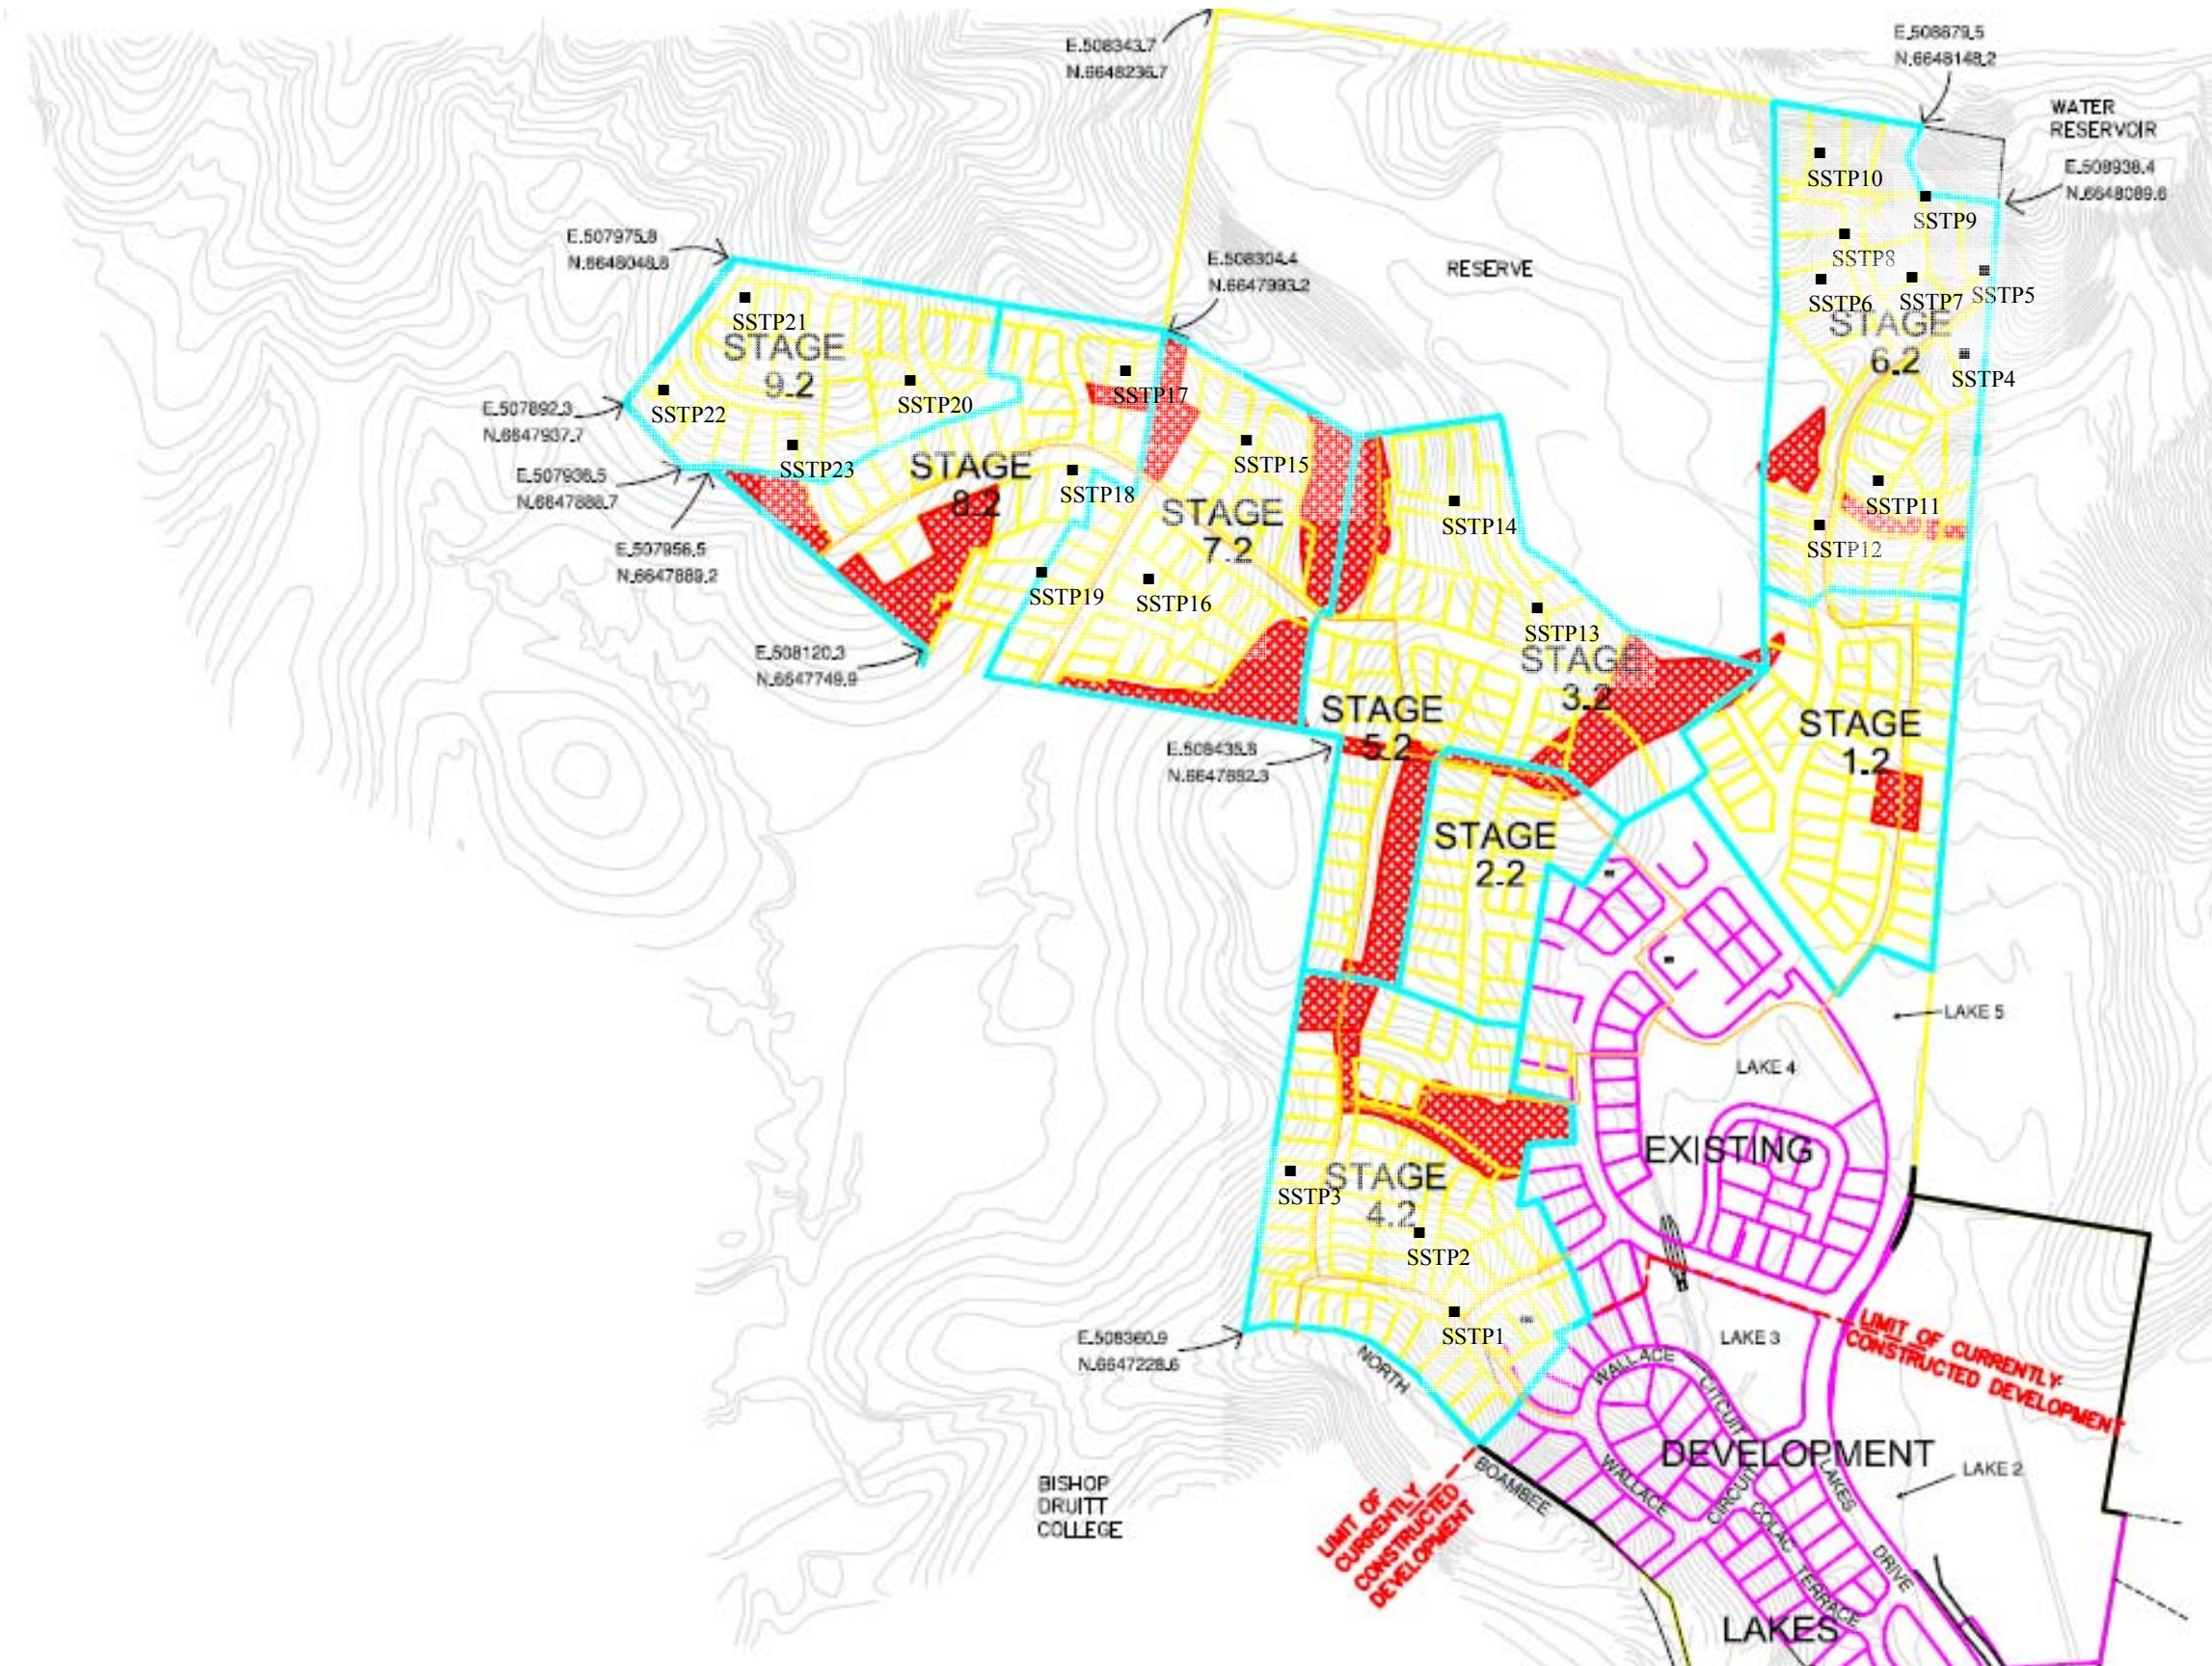
Draft plan – annotated to show areas of steep ground and specific foundation conditions.

LLA2 is located between Stage 7.2 and Stage 8.2 in the axis of the valley. From the test pit investigation subsurface conditions are known to comprise moist to wet and firm to stiff 'hillwash' clay extending to some 1m depth overlying stiff to very stiff clay. Within the upper 1m groundwater seepage was observed.

Based on the plans provided, an access road and residential lots are to be located in this area. Similar to LLA1 improved drainage and the replacement of superficial clay with appropriately moisture conditioned clay fill or granular fill (rock fill) is likely to be needed.

LLA3 is located in Stage 2.2. Based on our earthworks experience in the adjacent stage it is likely that similar conditions will present to that of LLA1.
