Holcim Dunloe Sands Quarry

Dunloe Sands Quarry Access/ Pottsville Road Intersection

Response to Road Safety Audit

March 2018

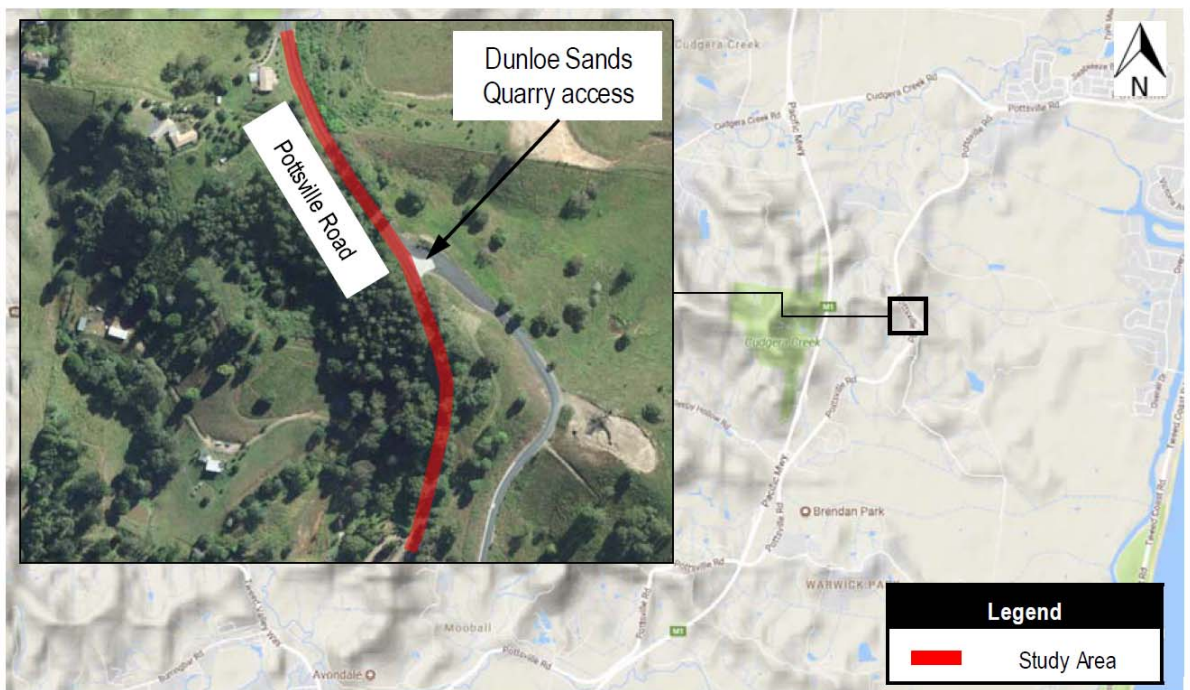
Figure 1: Extent of study area on Pottsville Road (excerpt from the RSA report)

The purpose of this document is to address the following significant issues raised in the Road Safety Audit conducted by Bitzios (refer Appendix A) on section of Pottsville Road, which is relevant to the existing Dunloe Quarry access road/ Pottsville Road intersection (refer Figure 1).

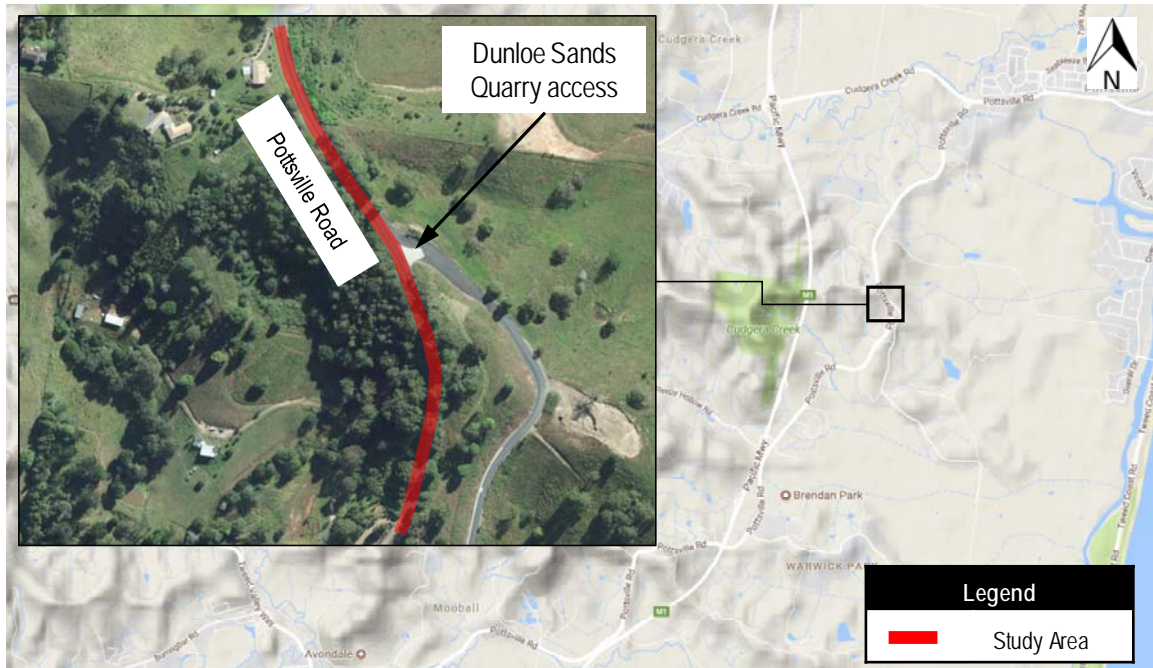
Figure 1.1: Extent of Study Area on Pottsville Road

The study area extends approximately 250m to the north and 250m to the south of the Dunloe Sands Quarry access. The study area is presented in Figure 1.1.

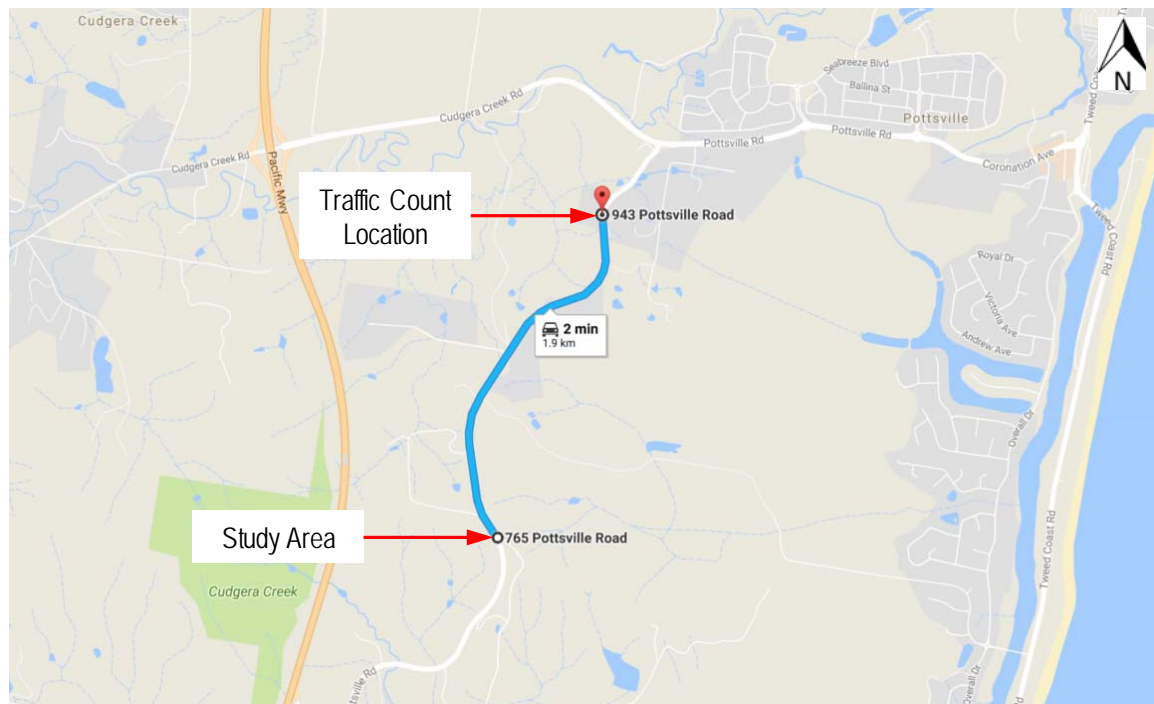
Figure 2.1: Traffic Count Location with Respect to Study Area

Traffic data was obtained from Tweed Shire Council for Pottsville Road. The traffic count location is at No. 943 Pottsville Road, which is approximately 1.9km north of the Dunloe Sands Quarry access. The traffic data is presented in Table 2.1. The traffic count location with respect, to the study area is shown in Figure 2.1.

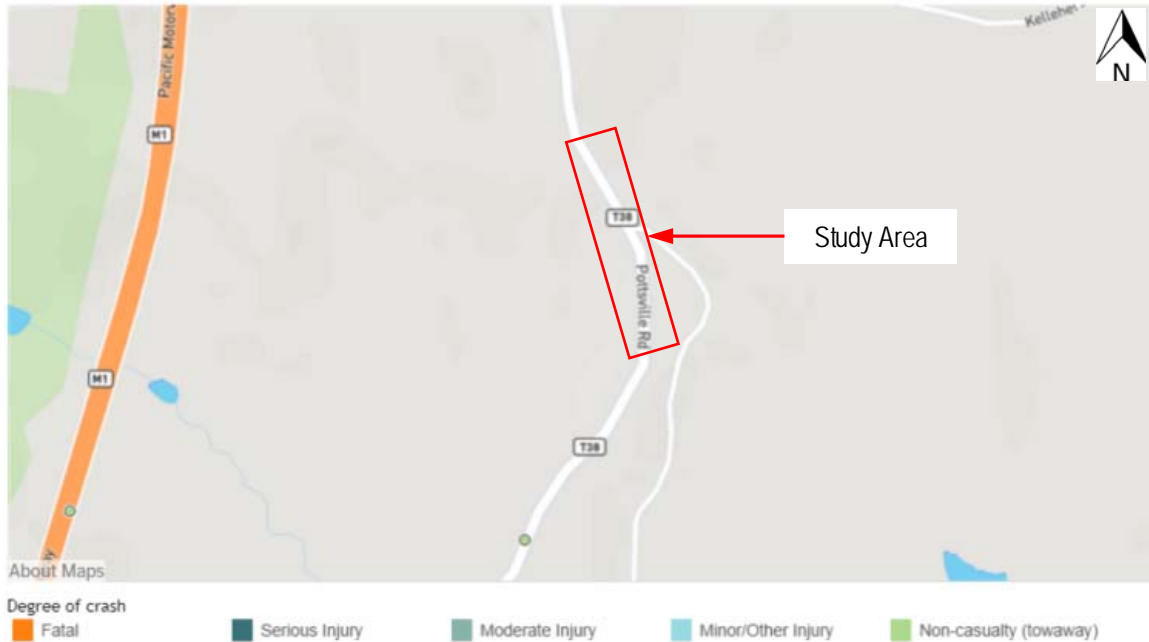
Figure 2.2: Pottsville Road Crash History

The available data is available for the 5-year period from 2012 to 2016. Figure 2.2 shows a map of crashes in the study area and immediate surrounds. As demonstrated, during the period that crash data is available for, no crashes were recorded in proximity to the study area. The nearest crash was approximately 800m to the south of the Dunloe Sands Quarry access. The single crash occurred in 2012 and was a non-casualty (towaway) crash. The crash was an off bend into object crash (RUM Code 85).

As demonstrated in Figure 2.2, there is no significant crash history or trend of crashes recorded within the study area.

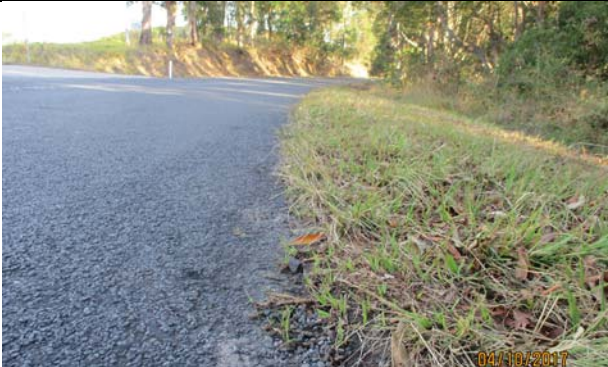
1.11	C	<p>No edgeline provided on western side of Pottsville Road and is inconsistent with adjacent sections of where edgelines have been provided on both sides</p>

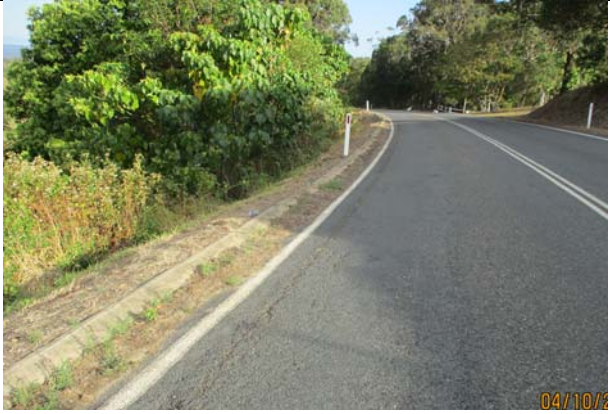
1.20	A	Possible surface water drainage issues / water pooling on eastern side on Pottsville Road due to kerb design and crossfall

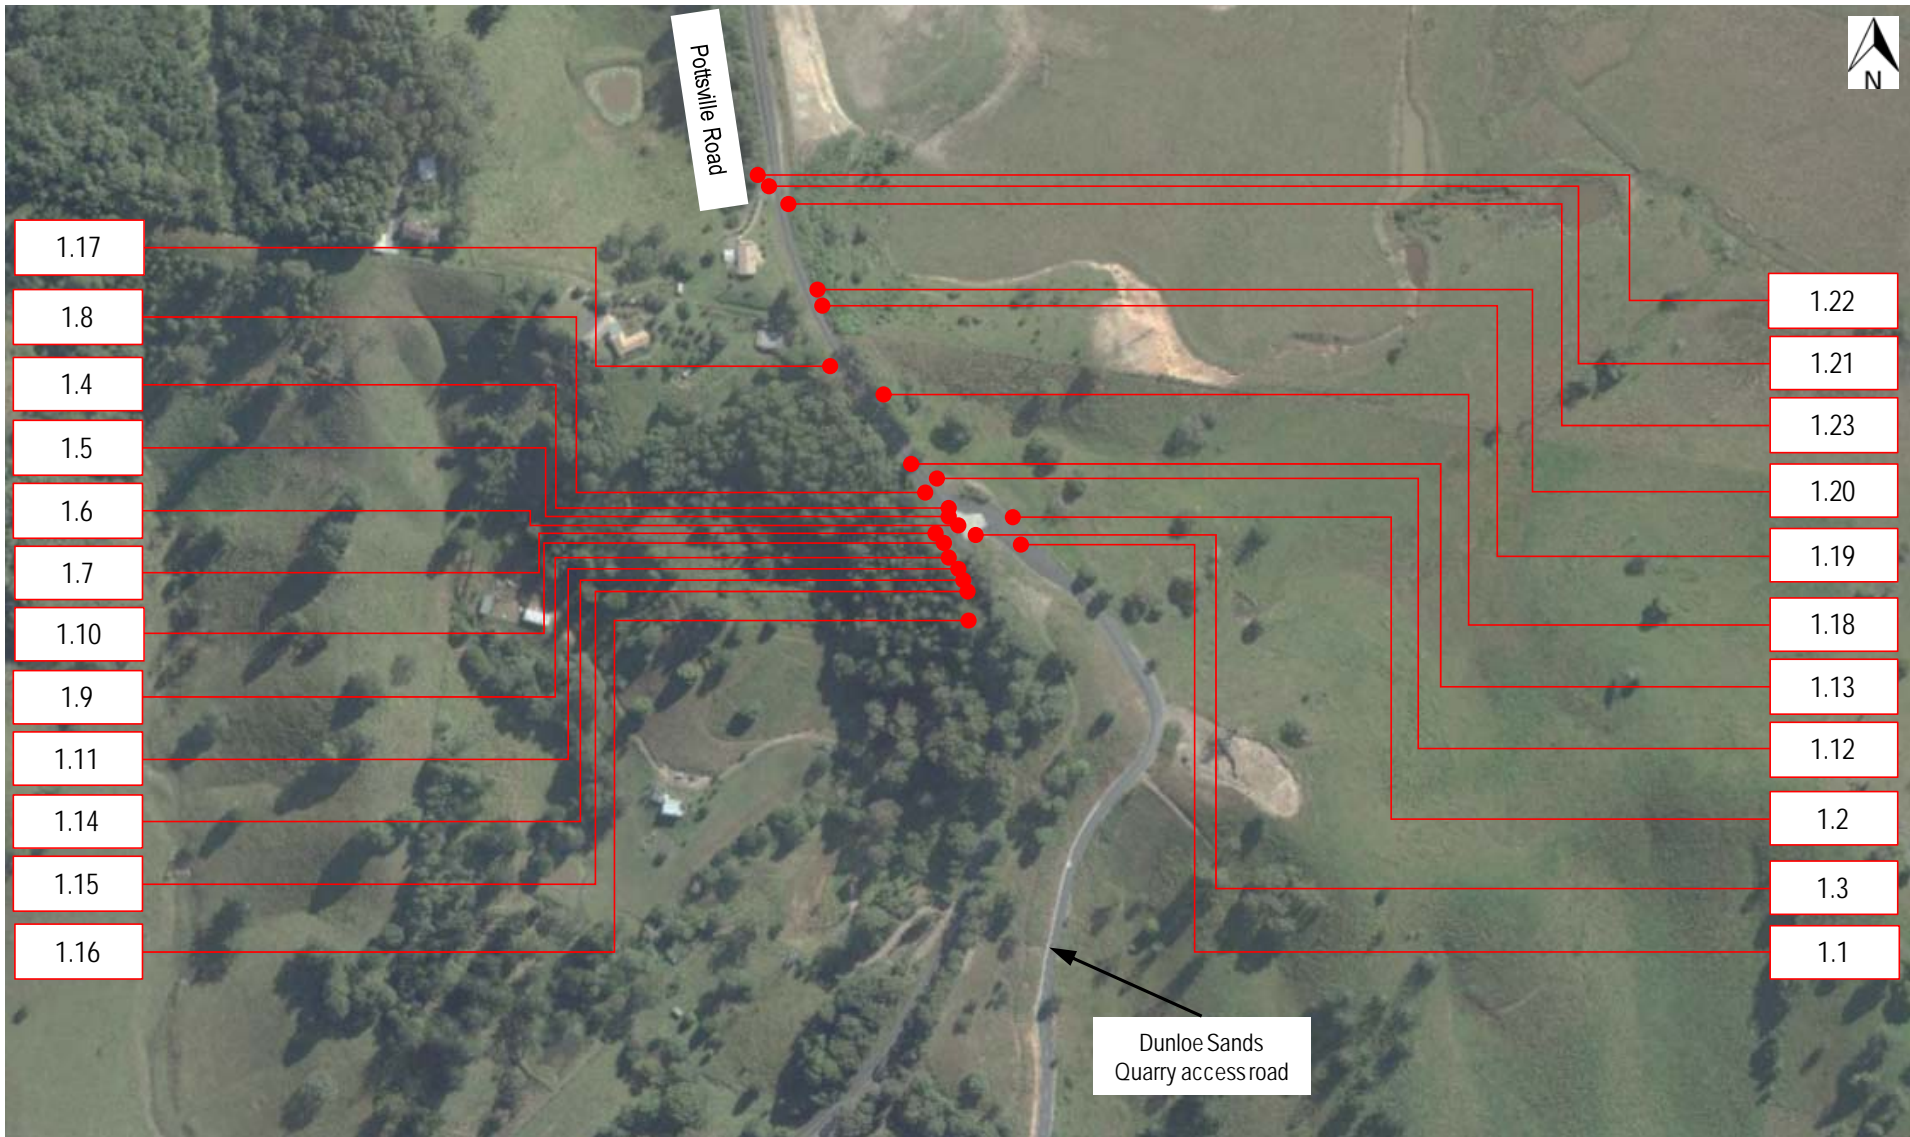
Figure 3.1: Indicative Item Locations

The safety issues, suggested treatments and prioritisation for the study area are detailed in Table 3.2. The location of each issue is summarised in Figure 3.1.
