# HUNTER VALLEY OPERATIONS

## **2020 Annual Environmental Review**

This Annual Environmental Review (Annual Review) reports on the environmental performance of Hunter Valley Operations (HVO) during the 2020 calendar year and satisfies the requirements of HVO's Development Consents and Mining Leases. The structure of the 2020 Annual Review intends to align with the NSW Government Post-approval requirements for State significant mining developments – Annual Review GUIDELINE (October 2015).

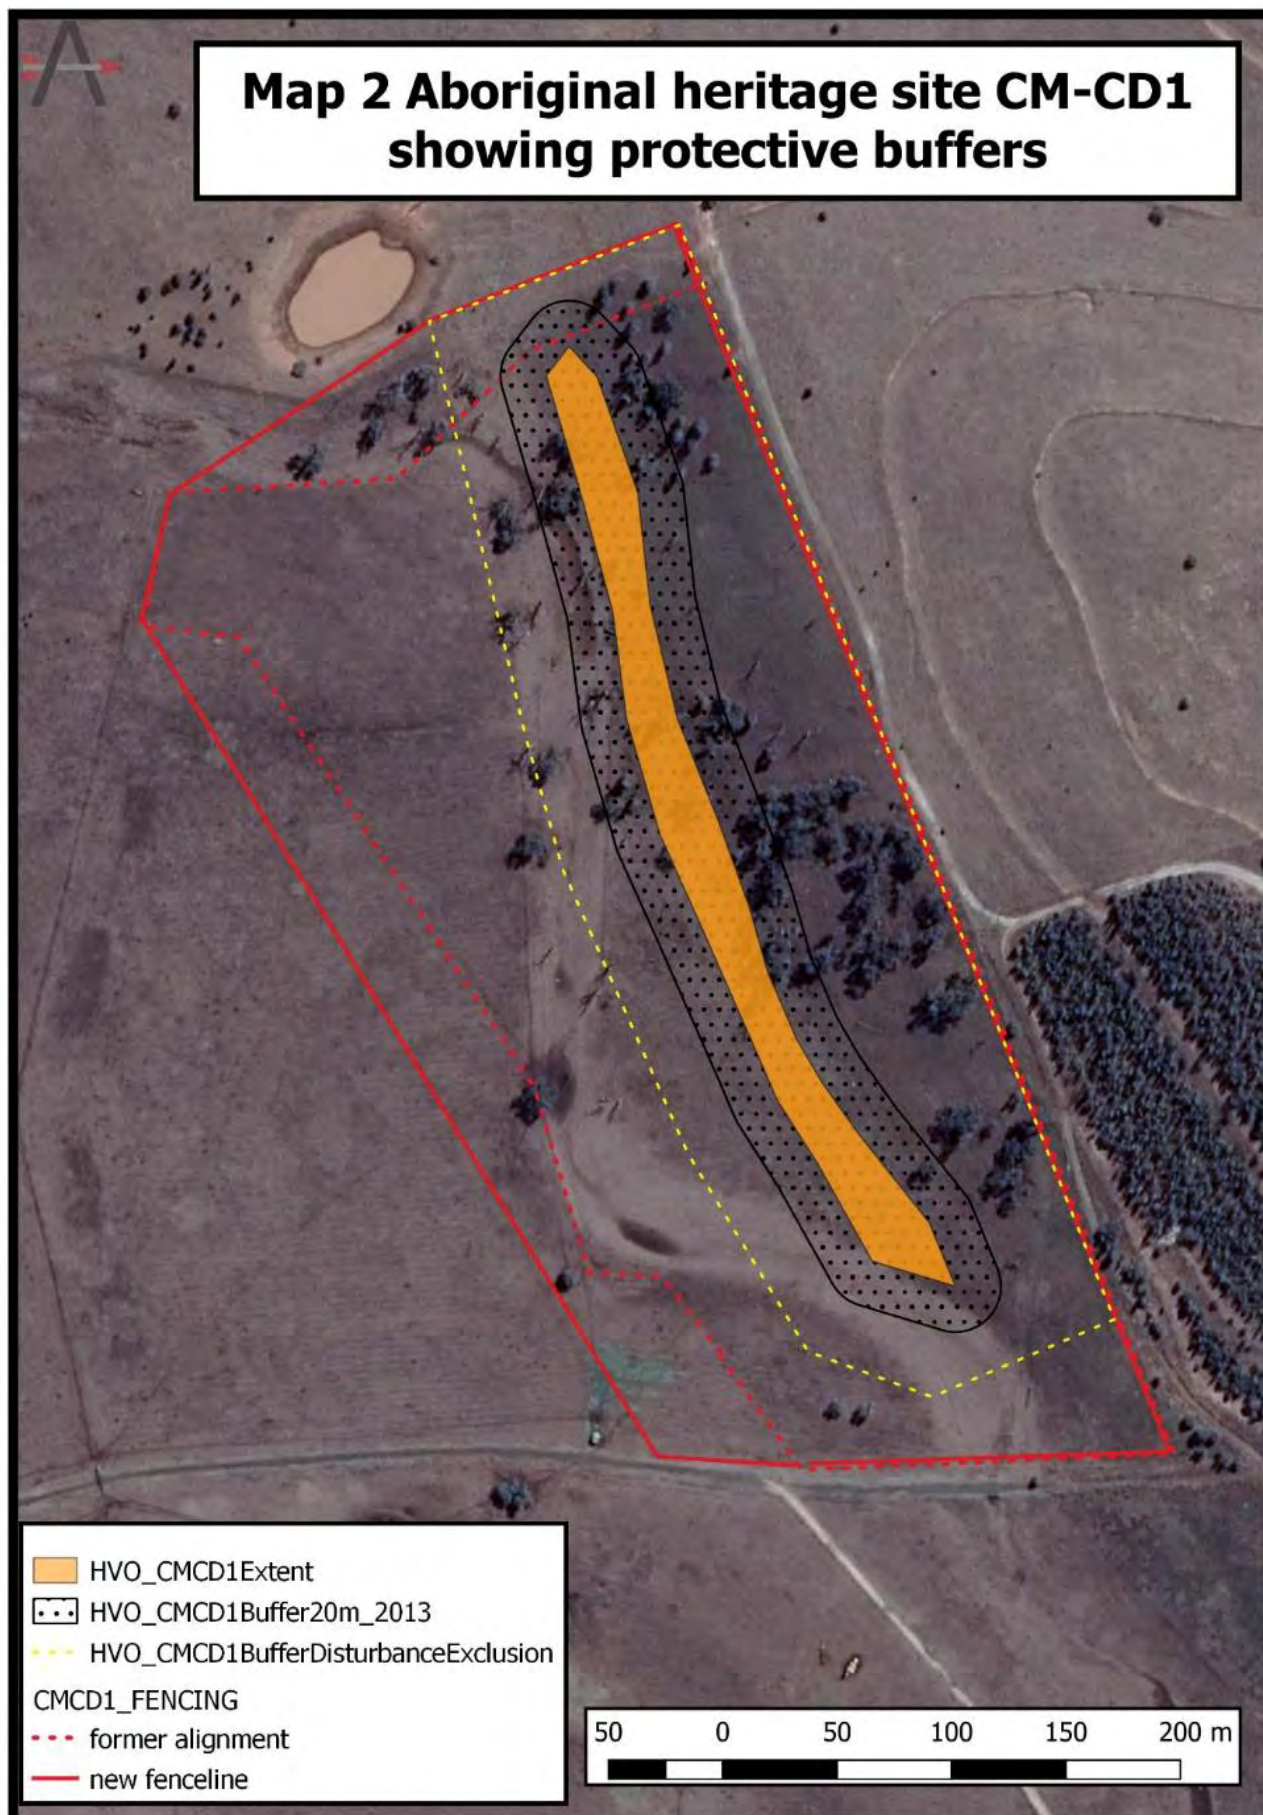
**The CM-CD1 exclusion area is zoned as Zone 1 in the HVO North CHZS.**

3. The CM-CD1 disturbance exclusion buffer area is to be zoned as a Zone 1 Restricted Access Area within the HVO North Cultural Heritage Zoning Scheme (CHZS). All development disturbance activities are to be excluded from within the buffer area.

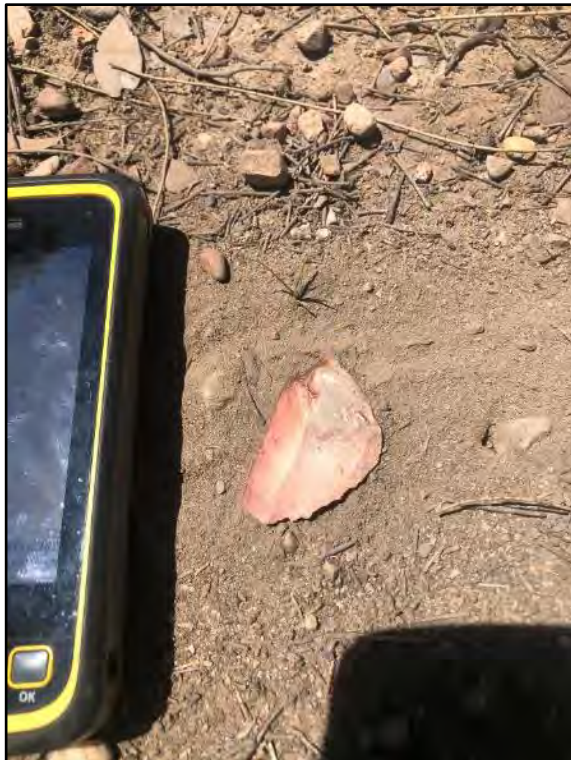
This site consists of dozens of flakes of mudstone and silcrete located mainly upon the existing power-line track that runs through the site. The site extends c.60 x 30m and may extend further, however visibility precluded the identification of artefacts outside the recorded boundary. Several artefact sites are located to the west of HVO-2139, on an elevated ridge above Sandy Hollow Creek.

**Mudstone flake at HVO-2138**

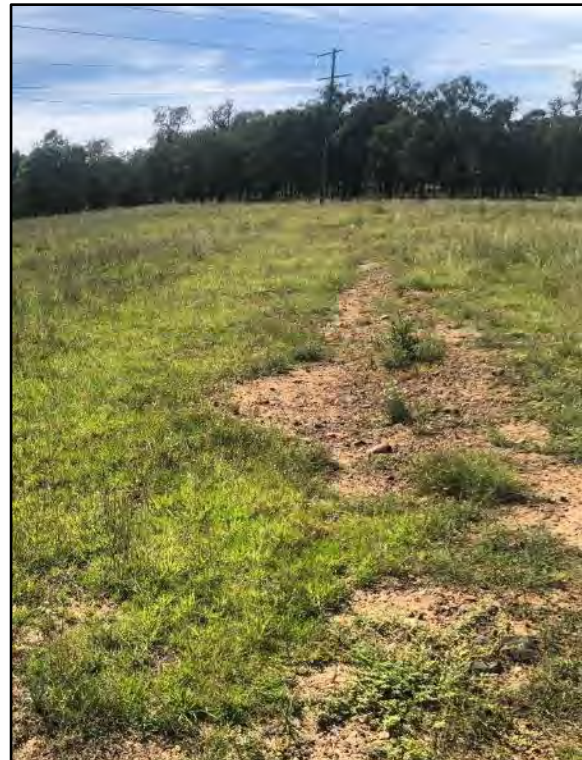
**Track along which HVO-2139 is located**

These sites are located either on or within close proximity to an existing track used to access along the power-line easement. It is recommended that these sites be barricaded to protect them from inadvertent vehicle disturbance, which, in the northern section, would also result in the existing track being re-routed away from the site extent (see Map 4). Consultation with Transgrid/Ausgrid is recommended to devise the best strategy for managing this shared area.

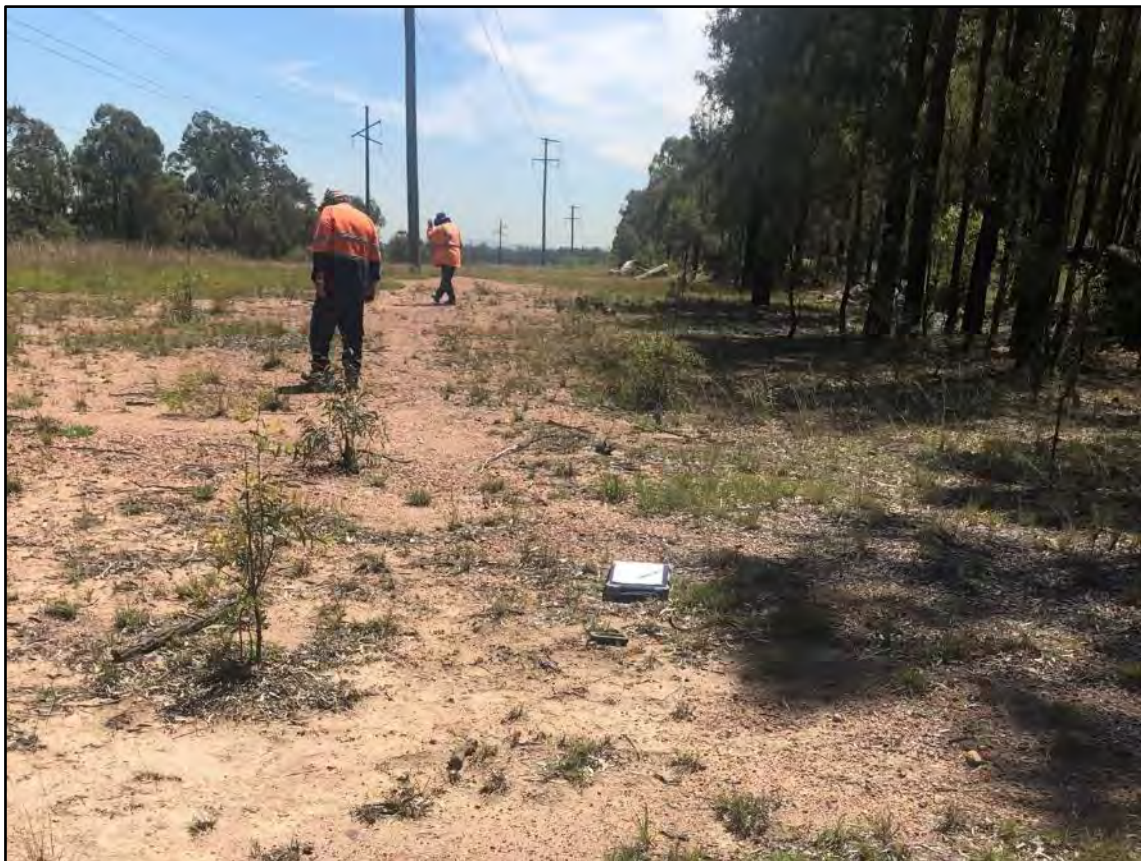
***View north through HVO-1534 within power-line easement***

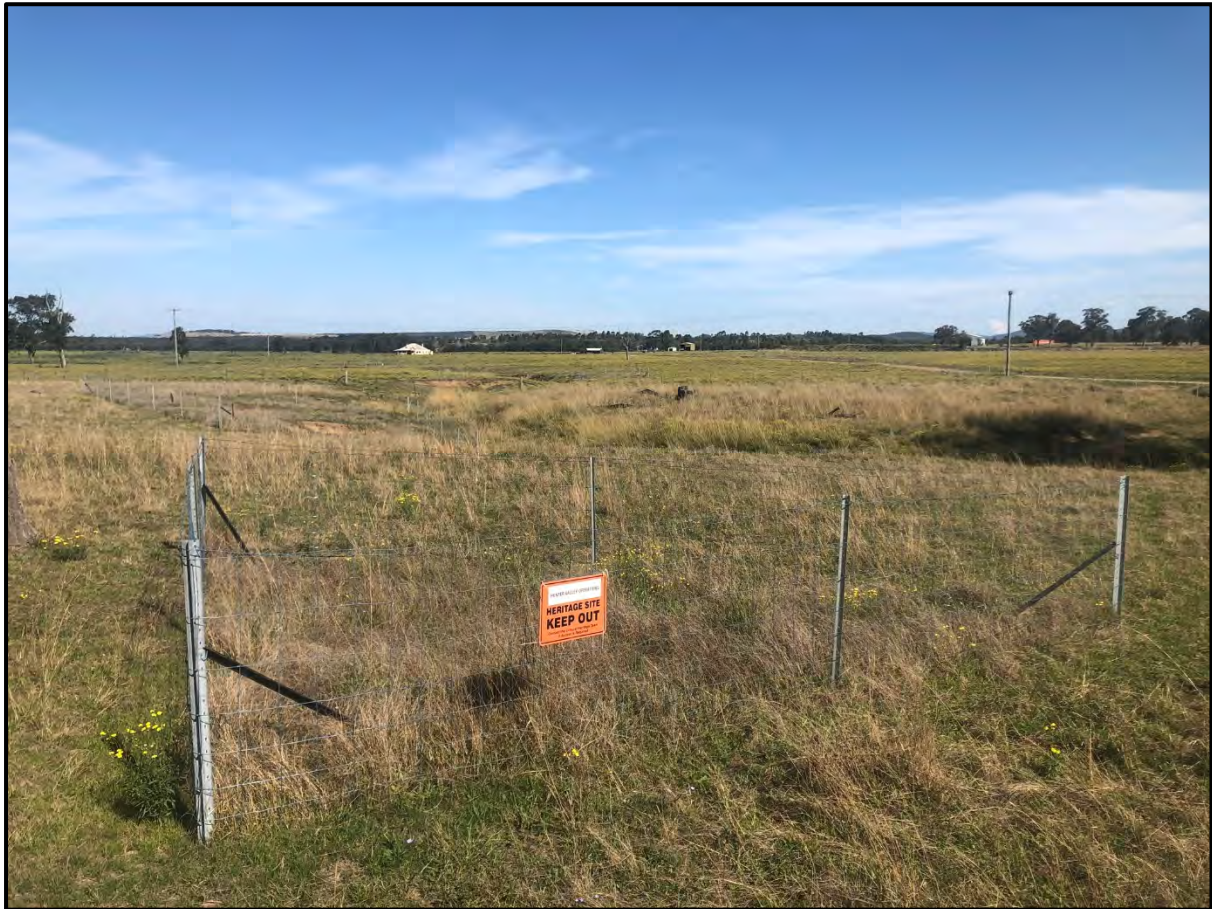
***Example of new ACH site fencing technique***

These sites (as well as all other sites in the vicinity) have been recently hard fenced, much to the satisfaction of the CHWG representatives present. The future use of this fencing method, in preference to barricading, was thoroughly endorsed, with the suggestion put forward that sediment fencing be installed along the downslope edge of those sites located close to water-courses. This would help prevent the erosion of and wash of artefacts out of the fenced areas and into these water-courses. This recommendation was understood and well received by the HVO Environment and Community Officer present and will be included in future fencing scopes where required.

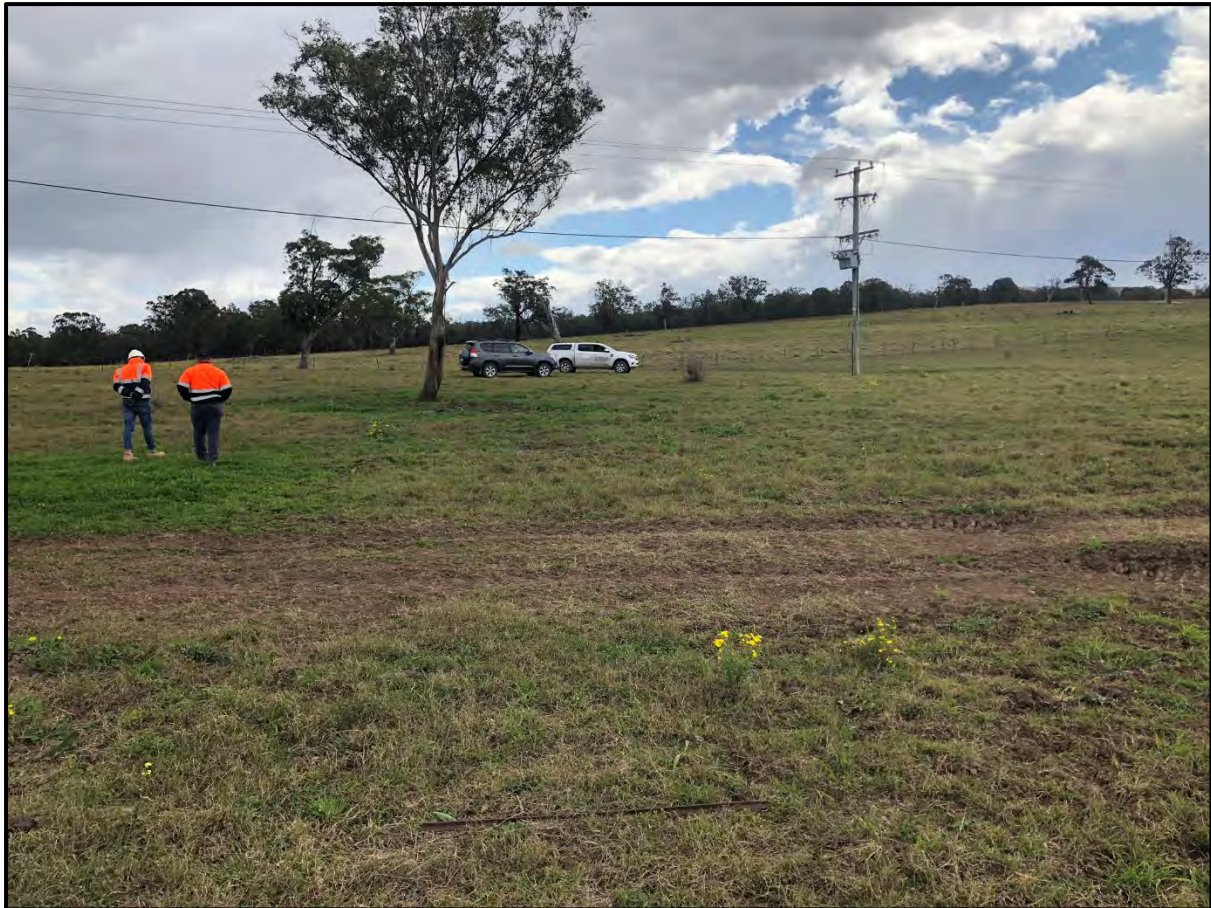
Both these sites are located within an active farming area, in close proximity to high traffic areas where fencing would not be a practical option. HVO-134 consists of a single mudstone flaked piece in a heavily grassed area within a gateway. HVO-135 consists of five flaked pieces of mudstone and a flaked piece of quartz within a 50m diameter area. This area is in a high impact area where cattle regularly gather. Due to the risk of further disturbance to these sites it was recommended by the CHWG representatives that they be salvaged. An AHIP is not required to implement this measure, as the salvage of these sites, with Aboriginal community participation, is authorised under the HVO South AHMP.

*Location of HVO-135 (between picket in foreground and vehicles)*

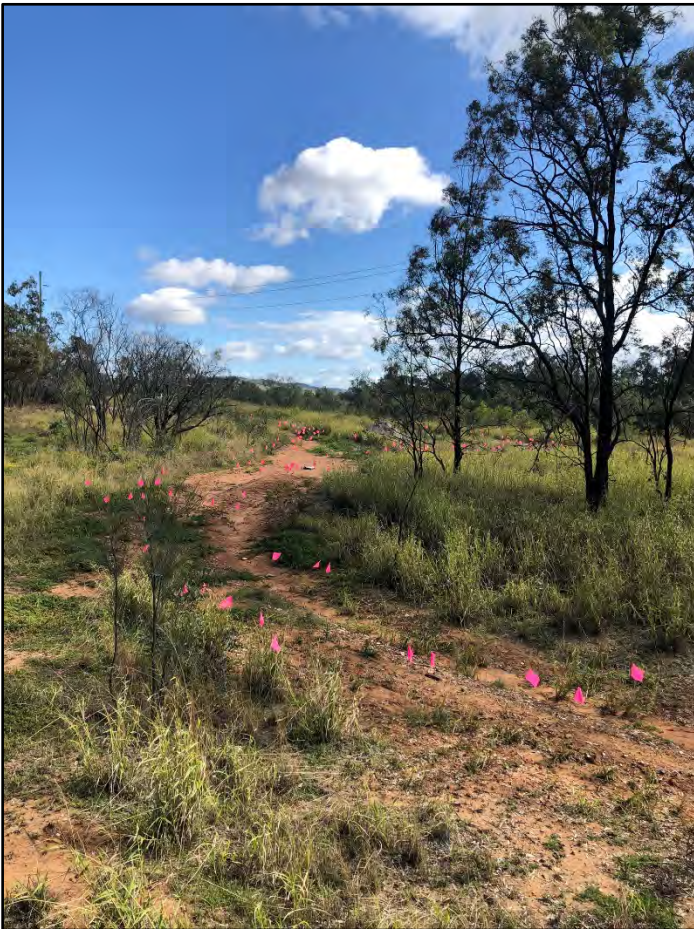
The audit inspection confirmed that, despite some considerable disturbance due to vehicle tracks and rehabilitation activities, Aboriginal stone artefacts remained in situ in rather large numbers. Between 100-200 artefacts were flagged in the area, mainly on the southern side of a vehicle track that runs through the area but small numbers of artefacts were recorded on the northern side where ground surface visibility was poorer. Mudstone flakes predominated, with silcrete flakes also common and several mudstone cores. Most artefacts were noted on old disused tracks, with no artefacts noted on the main track.

*Pink flags showing artefact density throughout area (see also cover photo).*

As the remnant site is located in an area surrounded by mining related disturbance, and considering that previous consents to salvage the site have been issued, it is recommended that the site be salvaged according to the provisions of the HVO South AHMP, a course of action with which the CHWG representatives present concurred. The vicinity is earmarked for several ground disturbing activities and is used for vehicular access and powerline maintenance. Due to the high level of ground cover over some portions of the site, it is recommended that the site salvage be conducted either outside of the growing season or the ground cover be sprayed with herbicide prior to salvage to maximise artefact recovery.

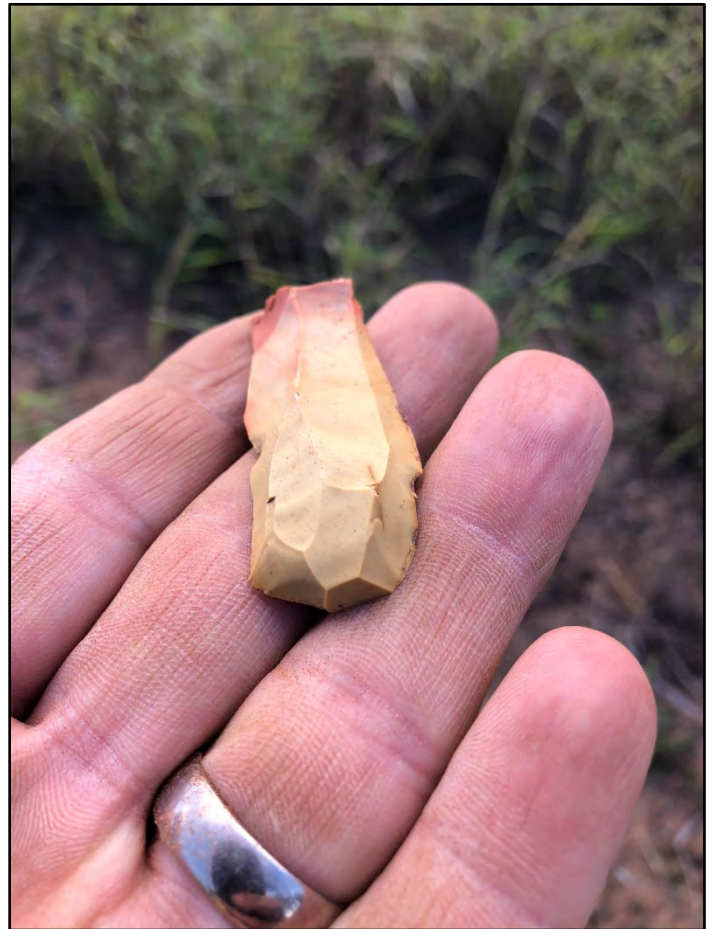
*Example of mudstone flake from area.*
