Hunter Valley Operations Aboriginal Heritage Management Plans October 2021 Compliance Audit Inspections

Report prepared for
Hunter Valley Operations

November 2021

ARROW
HERITAGE SOLUTIONS

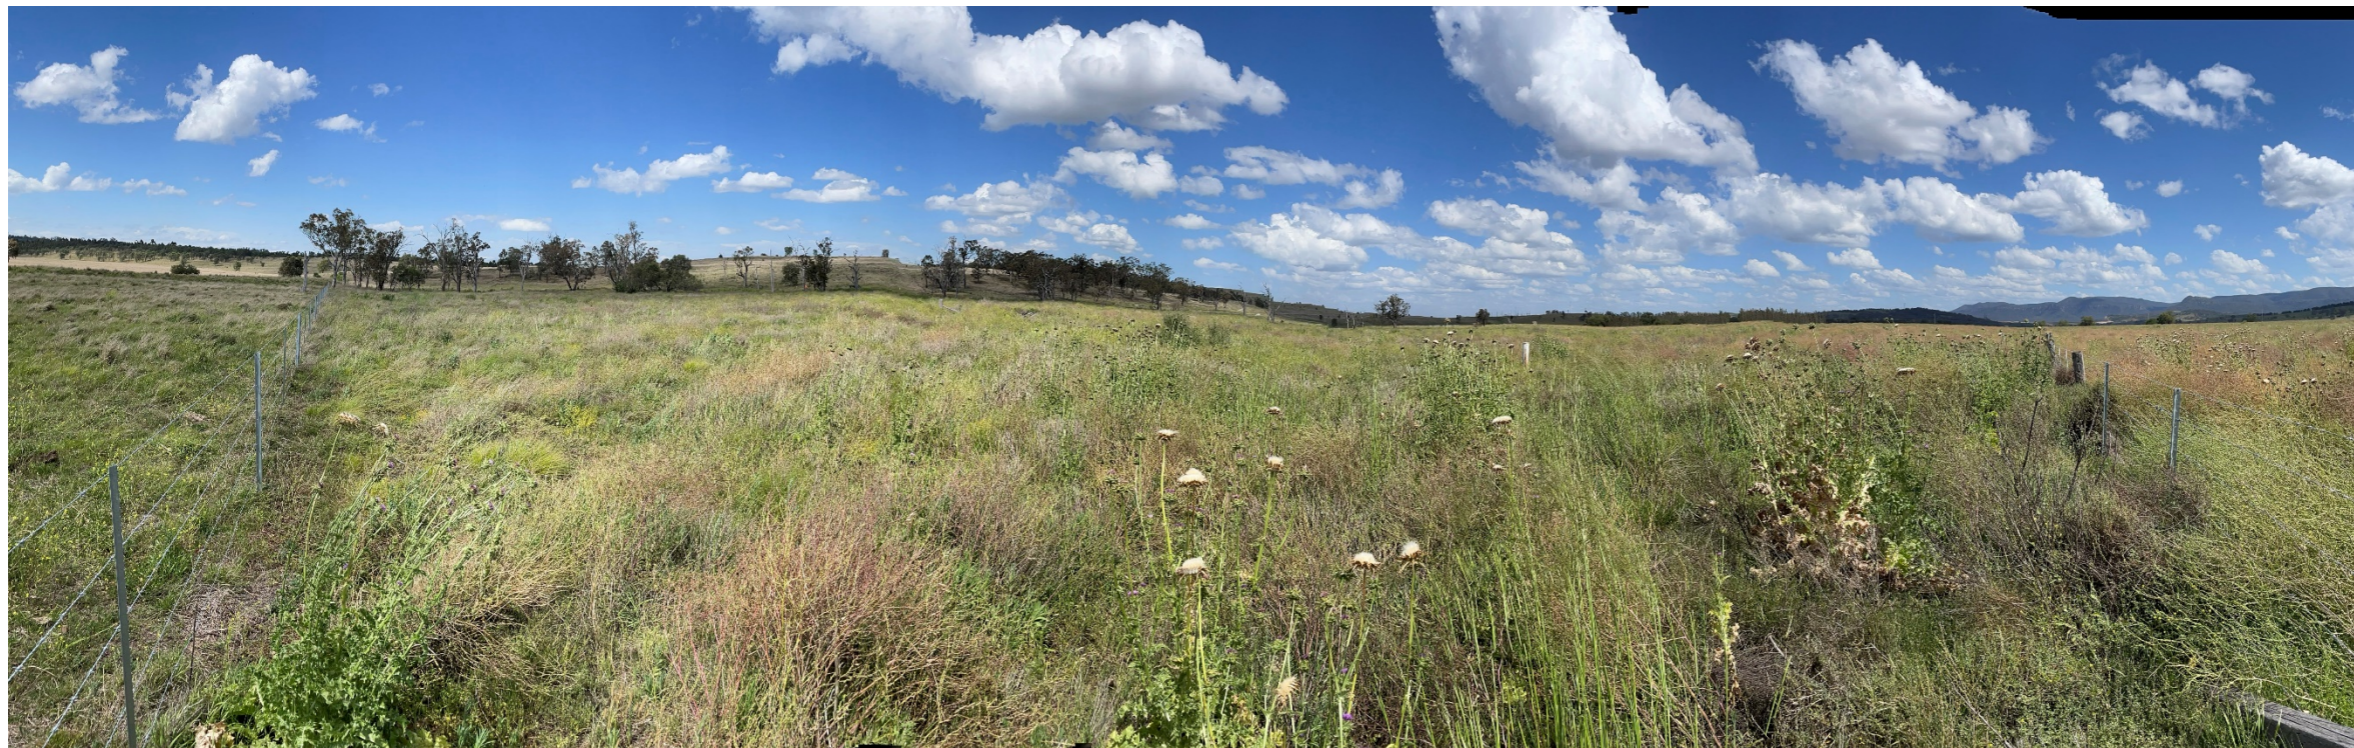
CM-CD1 Monitoring Point 1 Panorama – October 2021

However, it was noted that weed and vegetation growth throughout the CM-CD1 disturbance exclusion buffer area was very high. Also, feral pig activity was noted within the fenced area, but outside the disturbance exclusion zone buffer. Potential management measures were discussed with the field team and are presented as recommendations below.
