# **Newcrest Mining Limited**

## **CVO AEMR - Surface and Groundwater Assessment Report**

September 2020

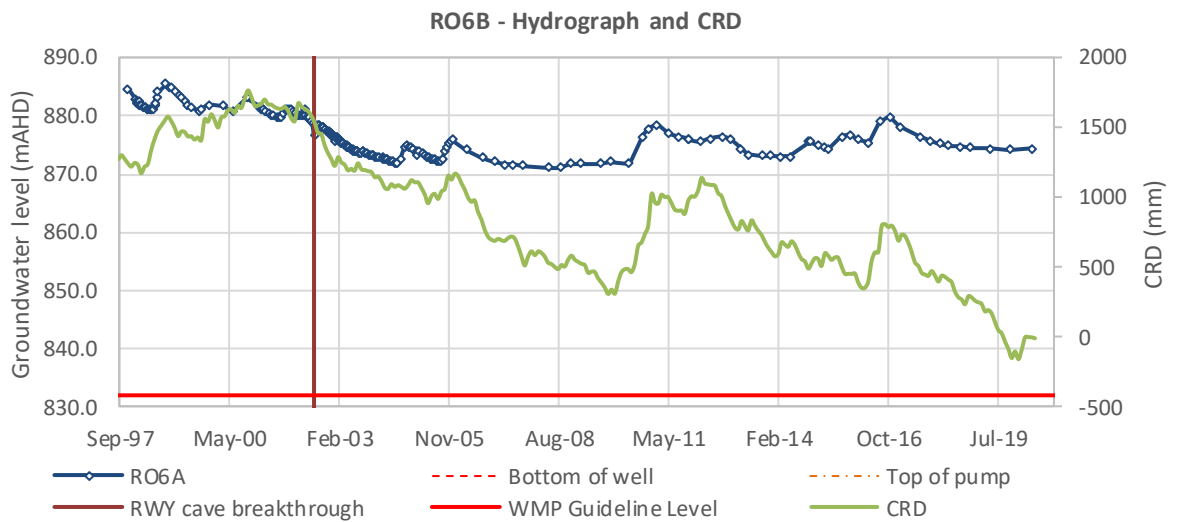
**Figure 3-2 RO6B groundwater level hydrograph**

The groundwater levels at RO6B and RO10B historically reflect trends in the CRD. This trend has continued during the reporting period with groundwater levels at RO6B and RO10B decreasing by 0.08 m and 0.63 m between May 2019 and November 2019 respectively in accordance with the decreasing CRD over this period. Groundwater levels at RO6B and RO10B increased by 0.21 m and 0.08 m between November 2019 and June 2020 in accordance with the increasing CRD over this period. Groundwater levels at RO6B and RO10B were above the guideline values during the reporting period. The groundwater level hydrograph for RO6B is plotted with the CRD in Figure 3-2.

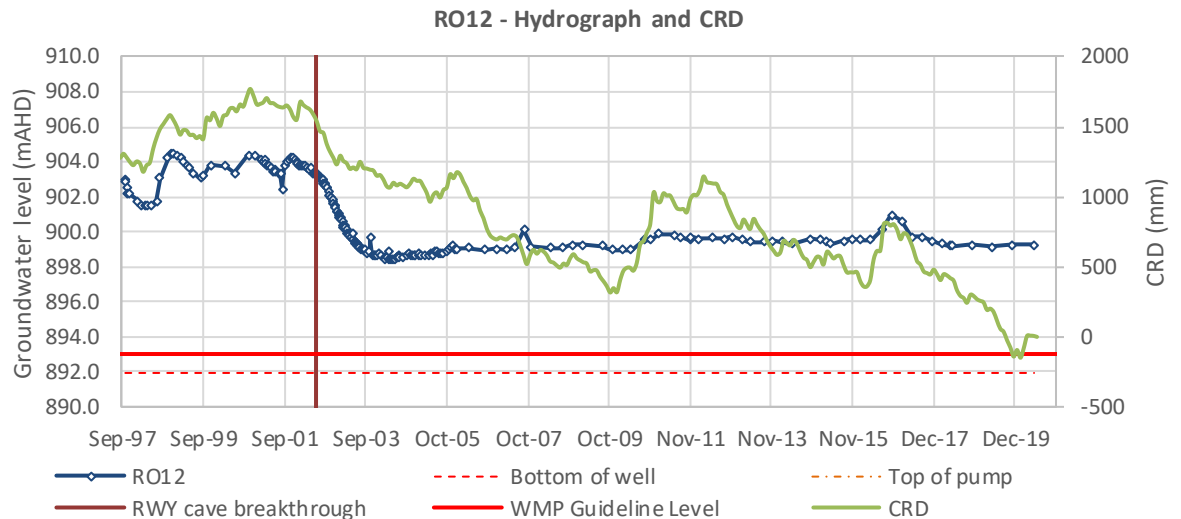
**Figure 3-3 RO12 groundwater level hydrograph**

Prior to 2006 the groundwater level at RO12 strongly reflected the trends in the CRD. However since 2006 the groundwater level has remained relatively stable and only shows recovery following extended periods of above average rainfall, for example after May 2010, and after July 2016. Groundwater levels at RO12 remained relatively stable throughout the monitoring period. The groundwater level at RO12 was above the guideline value for the reporting period (refer Figure 3-3).

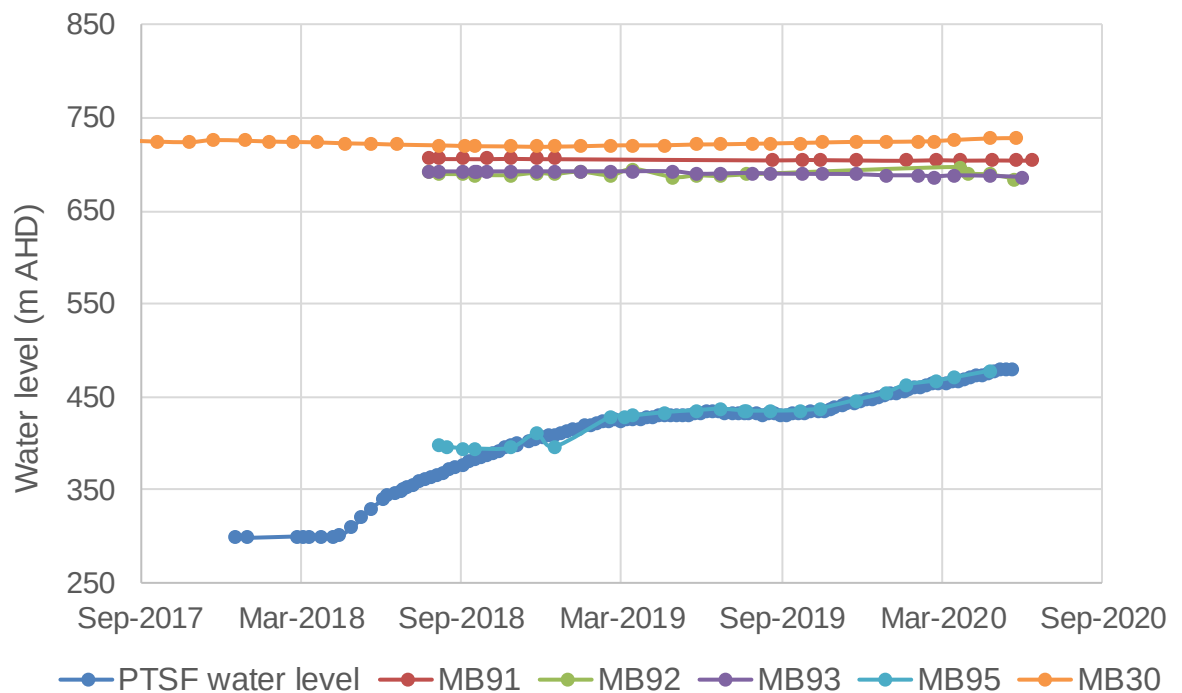
**Figure 3-7 Cadia Hill Pit groundwater level hydrographs and decant water level**

Decant water levels for the Cadia Hill Pit are plotted against groundwater levels for all monitoring bores in Figure 3-7. The figure shows that the groundwater levels in the majority of the bores are more than 100 m above the decant water level, and therefore unlikely to be affected by decant water. The groundwater level for MB95 is comparable to the decant water level, with levels at MB95 slightly above the decant level (by 3-4 m) for most of the reporting period. On occasions the decant level appears to be above the groundwater level at MB95, however this needs to be verified by more frequent monitoring at both sites. It should be noted that the screened elevation at MB95 is between 241 and 277 m AHD, which is well below the decant water level but above the base of the pit. As discussed below, there is also an increasing trend in groundwater level at MB30. Groundwater levels at MB30 are also shown in Figure 3-13. As discussed below, MB30 is screened over 200 m above the decant water level. MB30 is installed in the same fault as MB95 and there may be hydraulic connectivity between MB30 and MB95. Groundwater level trends and the likely hydraulic connection between the decant water and groundwater is discussed in the following sections.

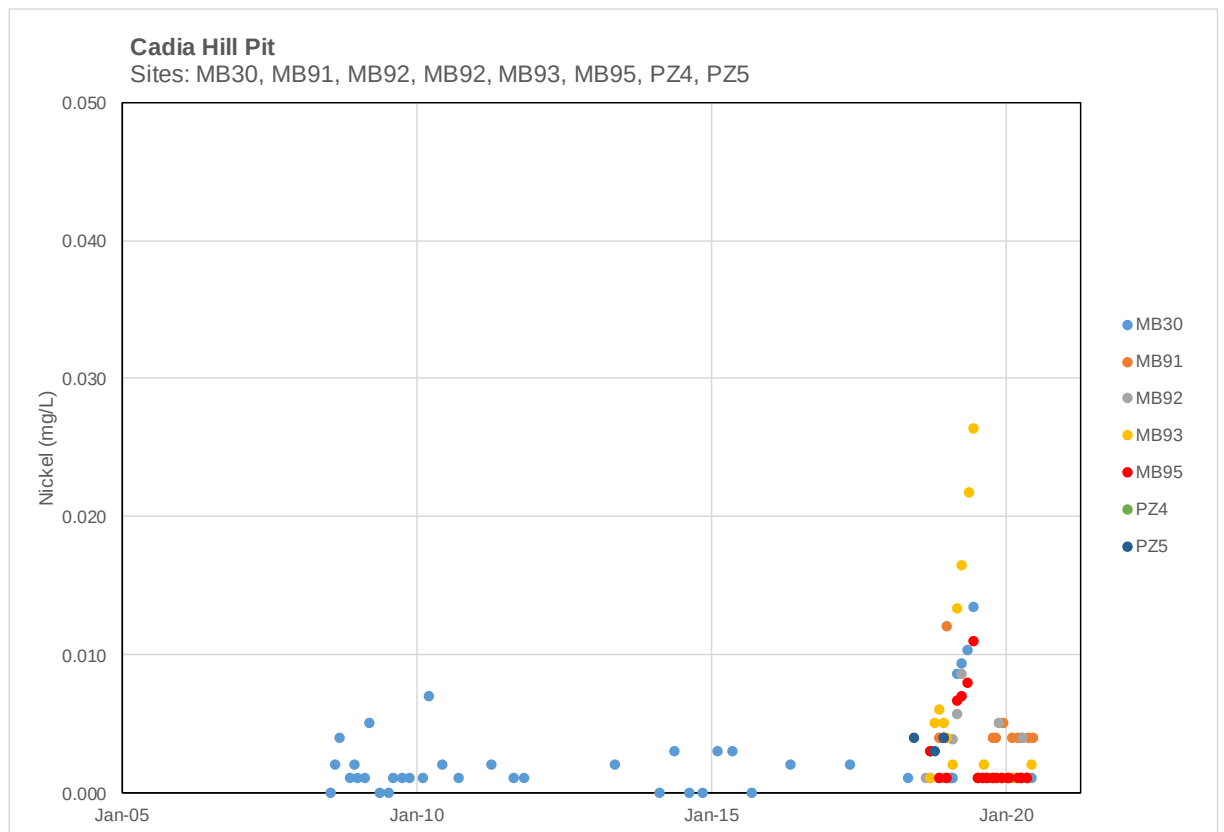
**Figure 3-8 Nickel concentrations in the Cadia Hill Pit area**

The groundwater level at MB92 has fluctuated by up to 7 m between successive readings. Further monitoring is required to determine a trend. Since January 2019 TDS concentrations at MB92 have reduced. Nickel concentrations at MB92 increased at the end of the previous reporting period, refer Figure 3-8. However, during the current reporting period, nickel concentrations at MB92 have generally been lower and did not exceed the guideline value of 0.02 mg/L, with the exception of some variability in April 2020. Manganese concentrations at MB92 exceeded the guideline value in April 2020. It is not possible for MB92 to be influenced by tailings decant water at this time since the screened interval of the bore is well over 100 m above the decant water level.

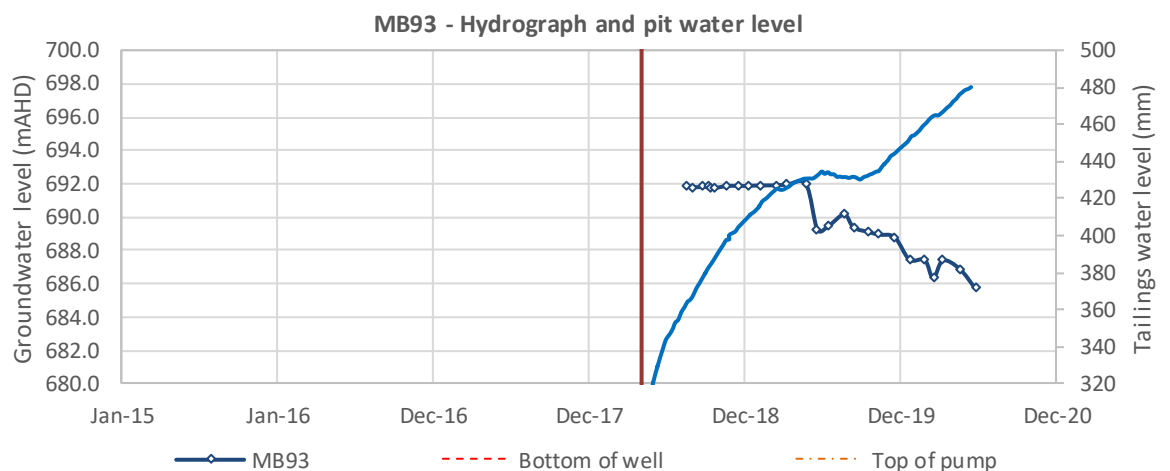
**Figure 3-9 MB93 groundwater level hydrograph**

The groundwater level at MB93 increased by approximately 0.9 m between June and August 2019. For the remainder of the monitoring period the groundwater level at MB93 was generally decreasing with levels dropping by approximately 4.4 m between August 2019 and June 2020. This may be associated with dewatering of the Cadia Extended Pit to the north. As with MB92, nickel at MB93 was elevated at the end of the previous reporting period and have been lower during the current reporting period.

The trigger value for manganese of 0.5 mg/L was exceeded at MB93 during the reporting period. CHPL's Level 1 investigations from the 2018-2019 reporting period concluded that there is no suggestion from the data that manganese represents a mine related impact. Over the previous and current monitoring periods there was an overall decreasing trend in pH at MB93, however pH increased slightly in May and June 2020. The guideline value for sulfate was exceeded at MB93 in August 2019 and February 2020. Sulfate concentrations at MB93 were generally lower than the previous reporting period. It is possible that groundwater chemistry has been influenced by the fall in groundwater levels at MB93. This will be verified as part of the next annual review as dewatering of the Cadia Extended Pit has ceased.

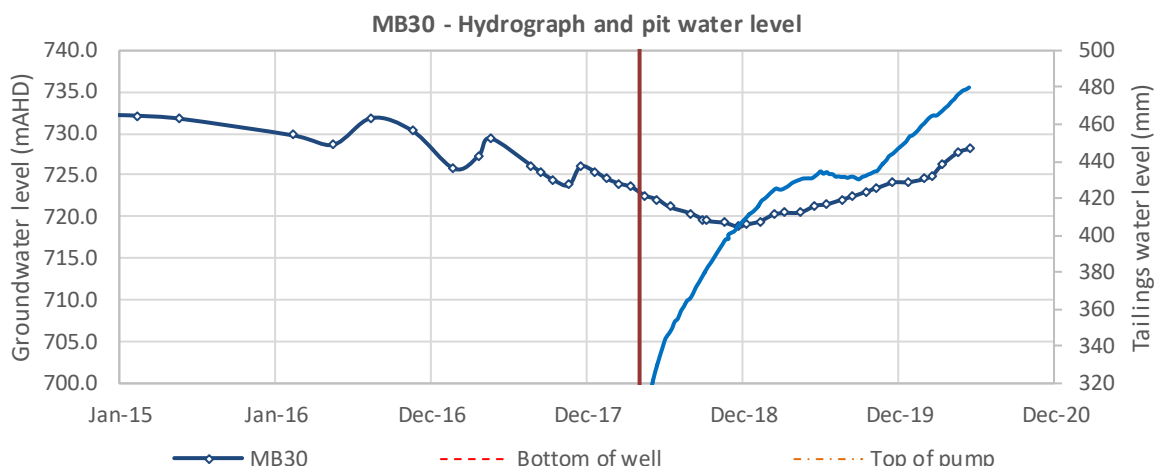
**Figure 3-13 MB30 groundwater level hydrograph**

Historically there has been a declining trend in the groundwater level at MB30 since mid-2010. This trend has been attributed to mining at Cadia Hill Pit and the overall negative trend in the CRD. Since December 2018 the groundwater level at MB30 has been increasing including an increase in groundwater level during the reporting period of 6.7 m as shown in Figure 3-13. This increasing trend does not correspond with CRD trends over the reporting period. The screened interval of bore MB30 is over 200 m above the decant level and therefore is unlikely to be influenced by decant water. MB30 was installed into the same fault zone as MB95, and there may be hydraulic connectivity between MB30 and MB95. Due to the uncertainty regarding the connection between MB30, MB95 and the pit decant, an additional bore, MB94, is being installed between MB30 and the decant pond in July 2020.

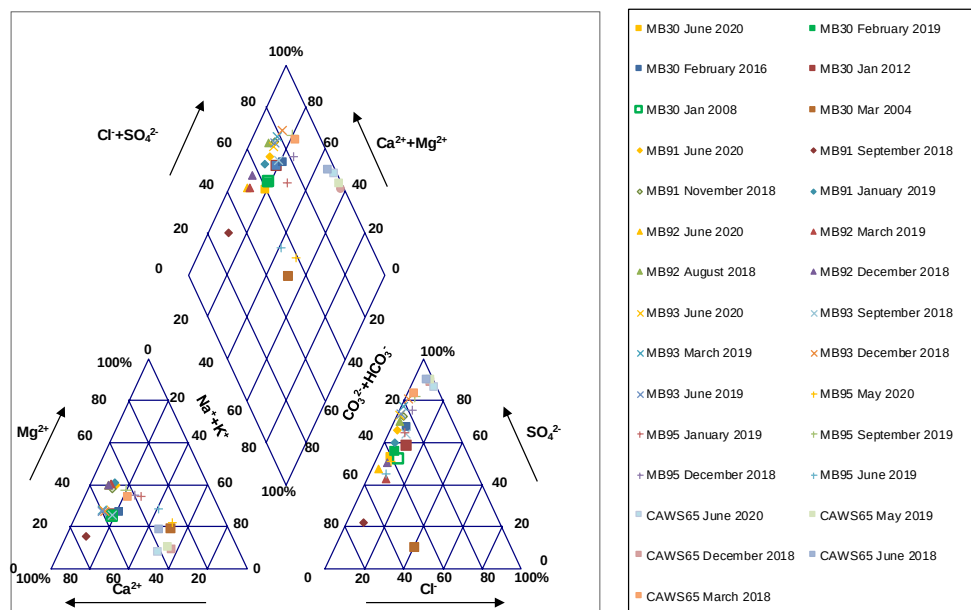
**Figure 3-14 Piper diagram for MB30, MB91, MB92, MB93 and MB95 and CAWS65**

A piper diagram of major cation and anion concentrations for MB30, MB91, MB92, MB93, MB95 and CAWS65 is shown in Figure 3-14. The plot shows a movement in water type for CAWS65 from calcium sulfate to sodium sulfate, with the sulfate dominance increasing over time. The plot also indicates some similarity in water type between MB95 and CAWS65, however the water chemistry at MB95 does not follow the same trend in cation and anion dominance as CAWS65 with variability in sulfate and bicarbonate dominance. Overall, there appears to be some localised influence of decant water at MB95, which may be the result of seepage during times when the decant water level is above the local groundwater level at MB95. However, the piper plot suggests there is mixing between decant water and background Ordovician groundwater at MB95 as the groundwater level equilibrates to the rising decant pond level. It is considered that there would be no migration of decant water beyond the localised seepage area in the immediate vicinity of the pit due to the strong hydraulic gradient towards the pit. There is minimal change in the major ion chemistry at the other groundwater sites and no indication of decant water influence at these sites.

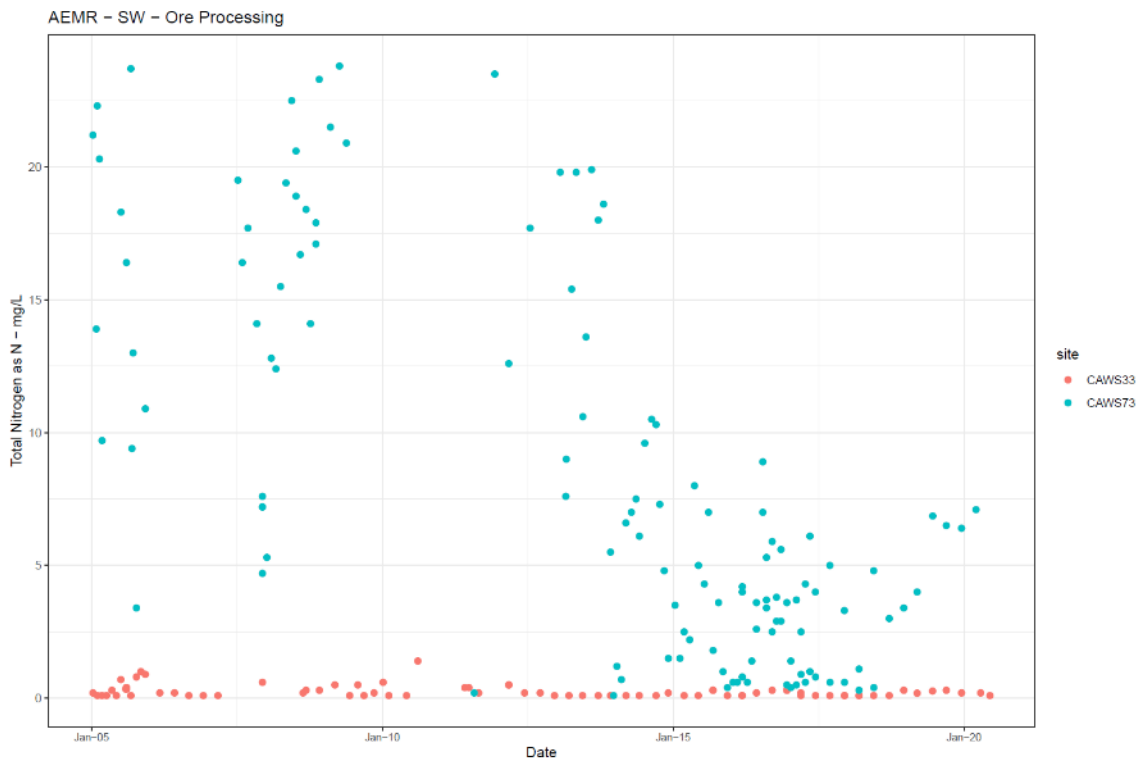
**Figure 3-17 Total Nitrogen concentrations in the Ore Processing Area**

Elevated nitrogen concentrations have been regularly observed at CAWS73, as shown in Figure 3-16 and Figure 3-17 below. These figures show that the majority of the nitrogen observed at CAWS73, mostly nitrogen oxides concentrations, had been generally decreasing from 2011 to late 2018. However, since this time nitrogen oxide concentrations have shown an increasing trend at CAWS73.

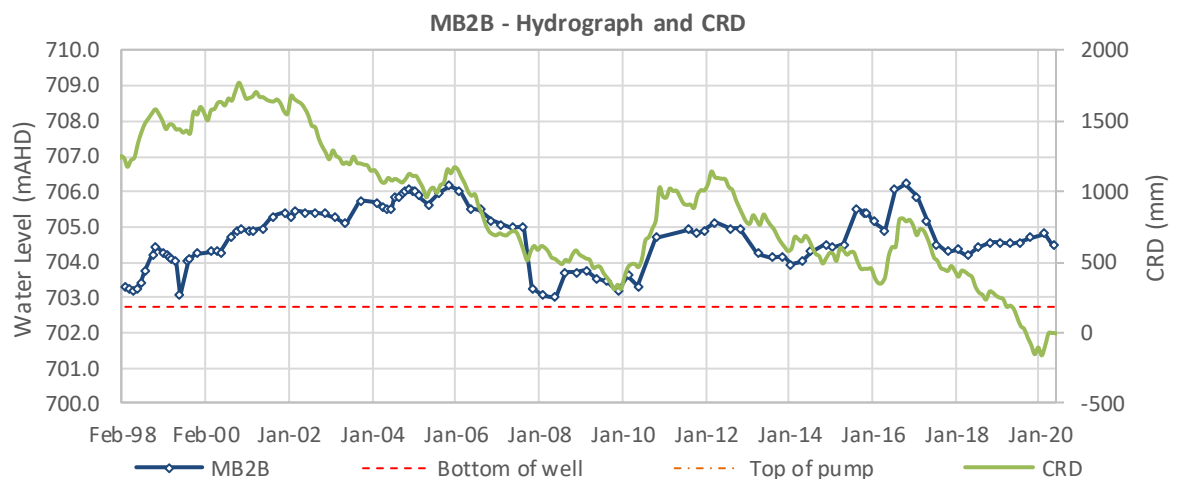
**Figure 3-19 MB2B groundwater level hydrograph**

The groundwater levels at MB2A and MB2B generally reflect the trends in the CRD for the majority of the monitoring period. For the previous reporting period the groundwater level increased approximately 1 m at MB2A and remained stable at MB2B despite a declining CRD trend. During the current reporting period groundwater levels at MB2A and MB2B were stable (refer Figure 3-19).

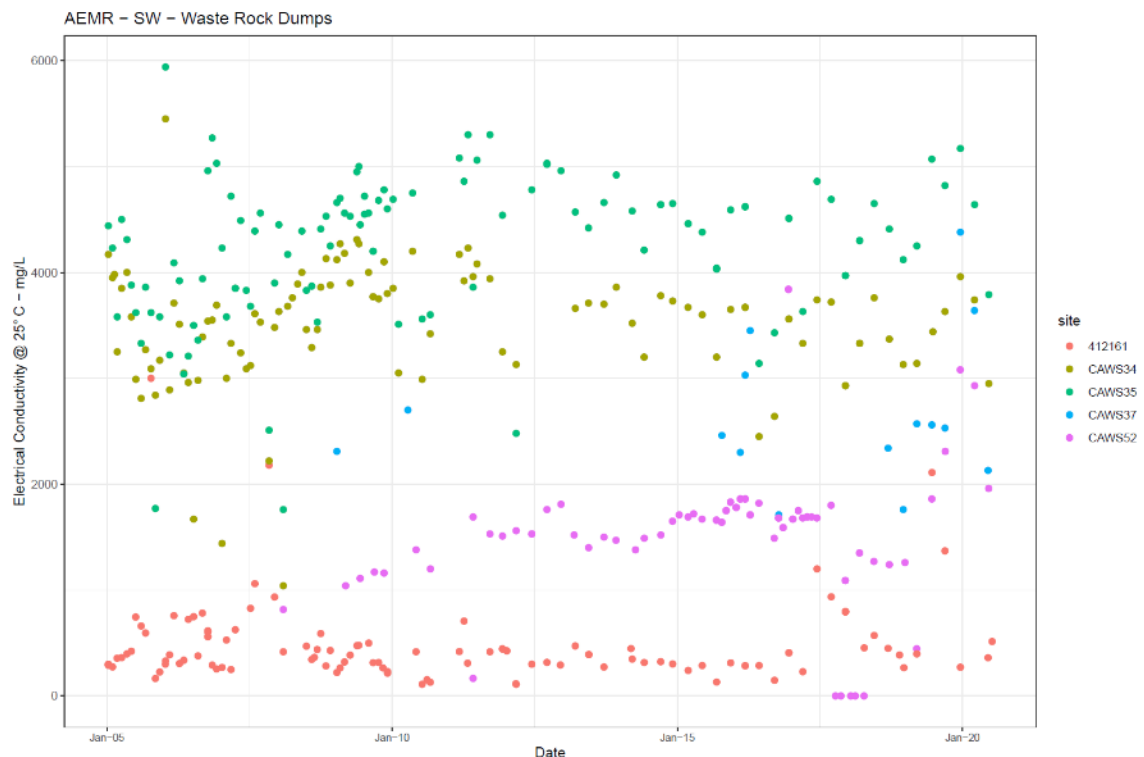
**Figure 3-25 Electrical conductivity in the waste rock dumps area**

The salinity of the waste rock dump leachate at CAWS34 and CAWS35 is in the brackish to slightly saline range, with EC values regularly exceeding 3000  $\mu\text{S}/\text{cm}$ . EC at CAWS52 has recently showed an increasing trend likely due to drought conditions (see Figure 3-25).

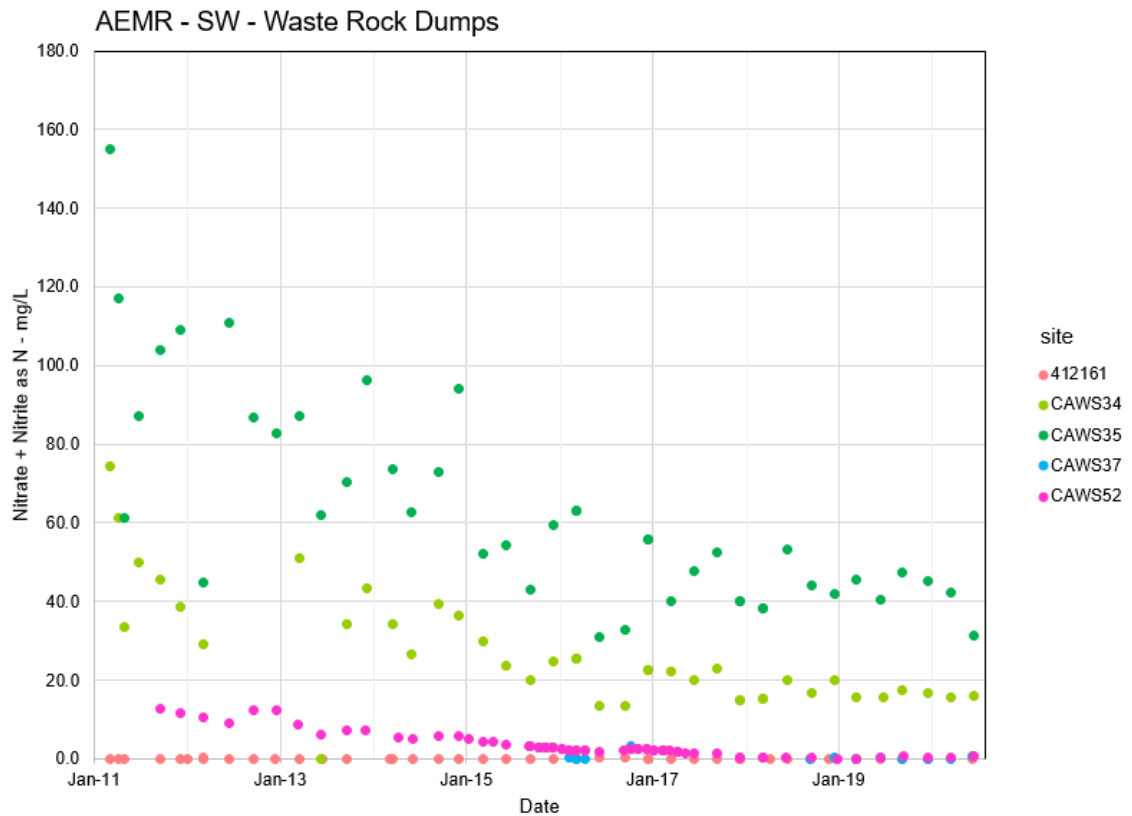
**Figure 3-26 Nitrogen oxide concentrations in the waste rock dumps area**

The waste rock dump leachate contains very high concentrations of nitrogen oxides, as shown Figure 3-26. These concentrations are associated with the WRDs, and have generally been higher at CAWS35 than at CAWS34. The nitrogen oxide concentrations have been decreasing gradually over time, and are now commonly below 50 mg/L in both leachate dams. Inspection of the available data indicates that nitrate is the dominant nitrogen species in the leachate.

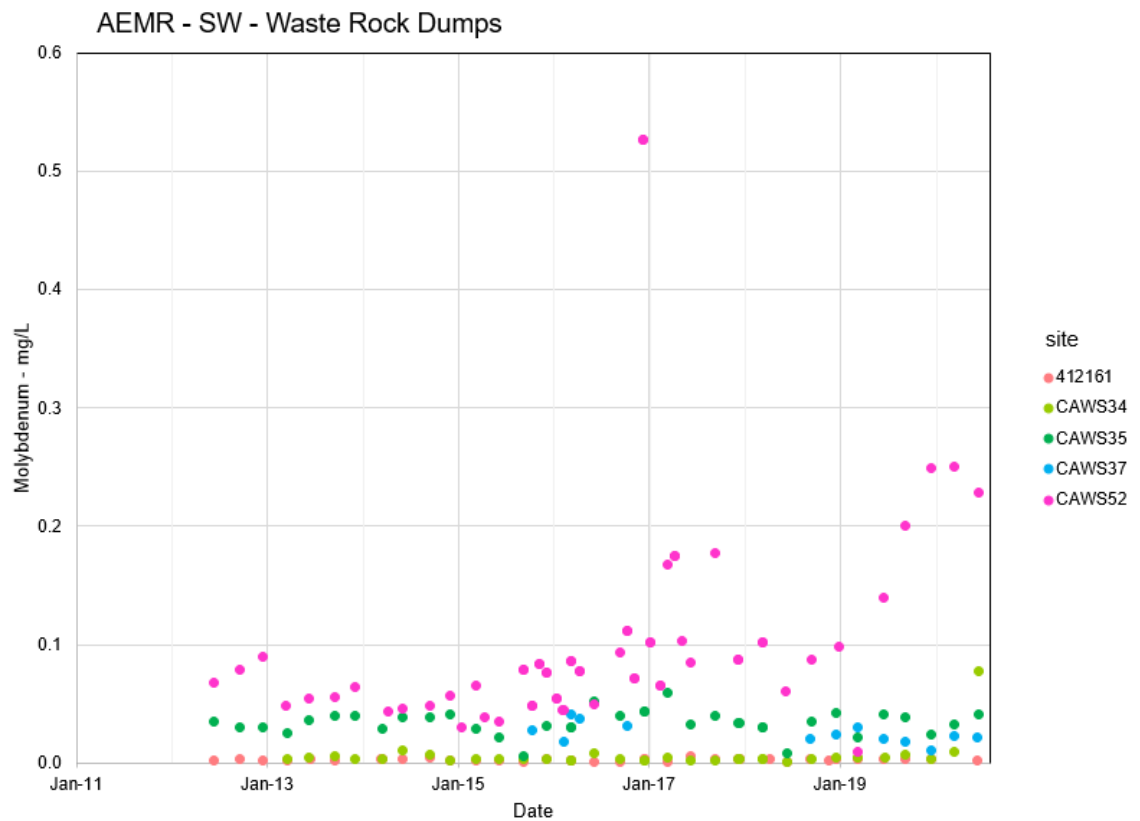
**Figure 3-27 Molybdenum concentrations in the waste rock dumps area**

Elevated concentrations of many metals have been observed at CAWS34 and CAWS35, which are attributable to the water having leached through waste rock. These metals are cadmium, cobalt, copper, manganese, nickel, selenium and zinc; concentrations of each have generally been higher at CAWS34. The concentrations of these metals have been generally decreasing over time. The exception to this trend is molybdenum (Figure 3-27), which has remained elevated at CAWS35, with no increase or decrease, however there is some sinuosity suggesting an annual cycle. Molybdenum concentrations have been higher at CAWS52 than at the leachate dams, which, considering that molybdenum is associated with the ore mined at Cadia, indicates the influences of process water as well as tailings decant water pumped to Rodds Creek Dam from the NTSF. The CAWS52 molybdenum results have shown an increasing trend since monitoring records began.

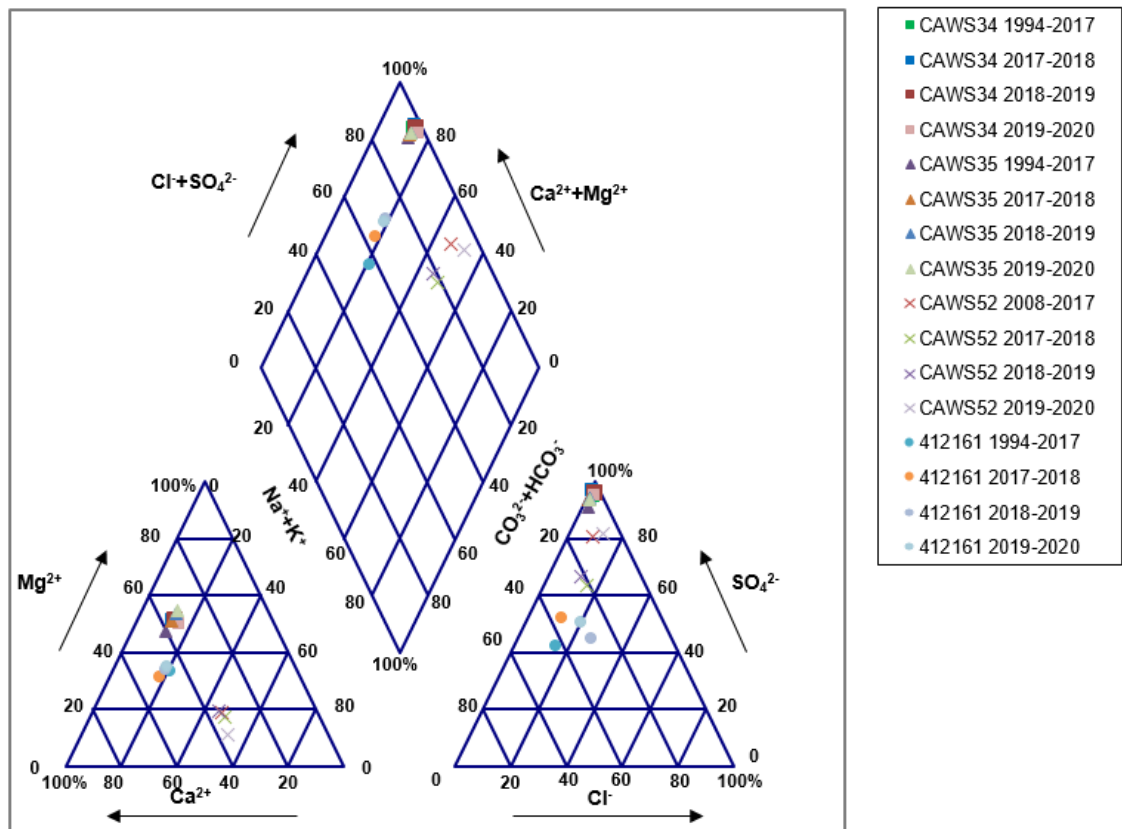
**Figure 3-28 Piper chart showing differences in major ion compositions at CAWS34, CAWS35, CAWS52 and 412161**

Average major ion (calcium, magnesium, sodium, potassium, chloride, bicarbonate and sulfate) concentrations at CAWS34, CAWS35, CAWS52 and 412161 for the 2017-2018, 2018-2019 and 2019-2020 reporting periods and all available previous data for each site were used to create the Piper chart presented as Figure 3-28. The Piper chart shows that the waste rock dump leachate is not ionically similar to the water in Cadiangullong Creek at 412161, which indicates that there has been no impact of the leachate in the creek between 1994 and 2020. The water at Rodds Creek Dam is also shown to be ionically dissimilar to that of the leachate at CAWS34 and CAWS35, with less dominance of calcium, magnesium and sulfate, though greater sulfate dominance than that observed at 412161, which is indicative of water pumped to the dam from the NSTF.

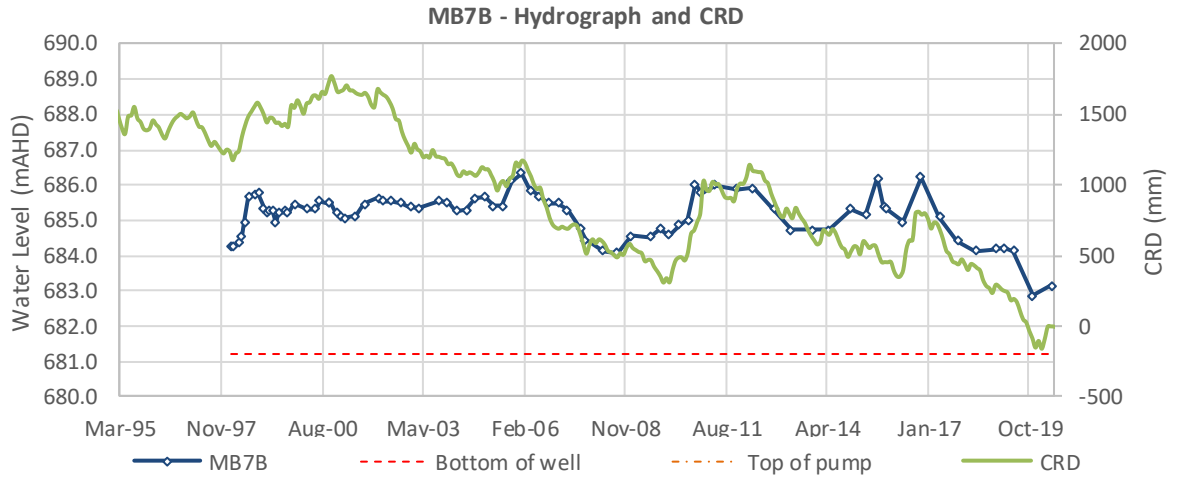
**Figure 3-29 MB7B groundwater level hydrograph**

During the previous monitoring period groundwater levels at MB7B responded to CRD; groundwater levels increased in response to the above average rainfall event in October/November 2018 and then continued to follow a declining trend in accordance with CRD. During the current reporting period groundwater levels at MB7B continued to decrease up to November 2019 in accordance with CRD then responded to a period of above average rainfall (refer Figure 3-29).

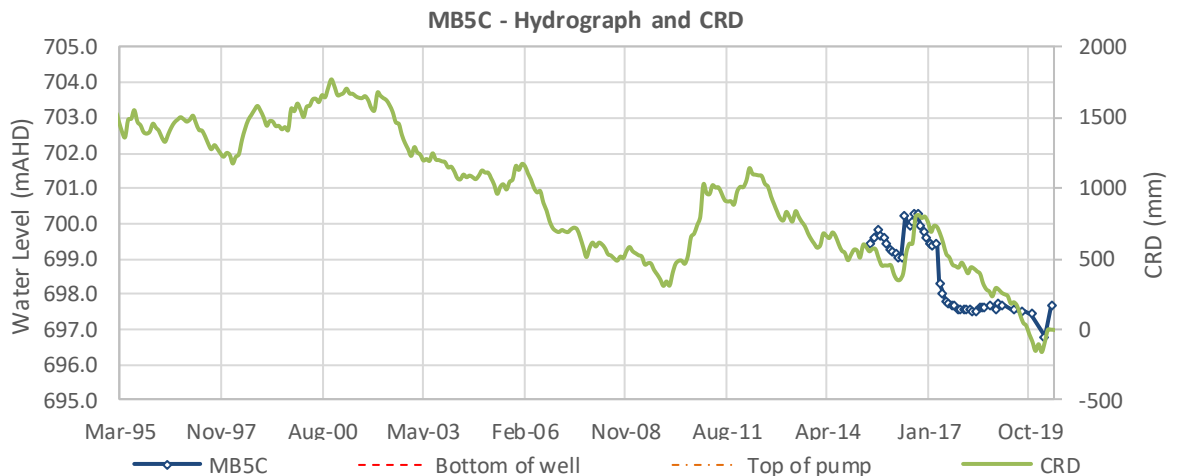
**Figure 3-30 MB5C groundwater level hydrograph**

The groundwater level at MB5C showed a rapid decline between April and July 2017. During the previous reporting period there was a delayed increase in the groundwater level following the above average rainfall event in October/November 2018. Following this the groundwater level showed a declining trend, consistent with the CRD. This decreasing trend continued throughout the current reporting period in accordance with CRD until groundwater levels increased in response to a period of above average rainfall in March and April 2020 (refer Figure 3-30).

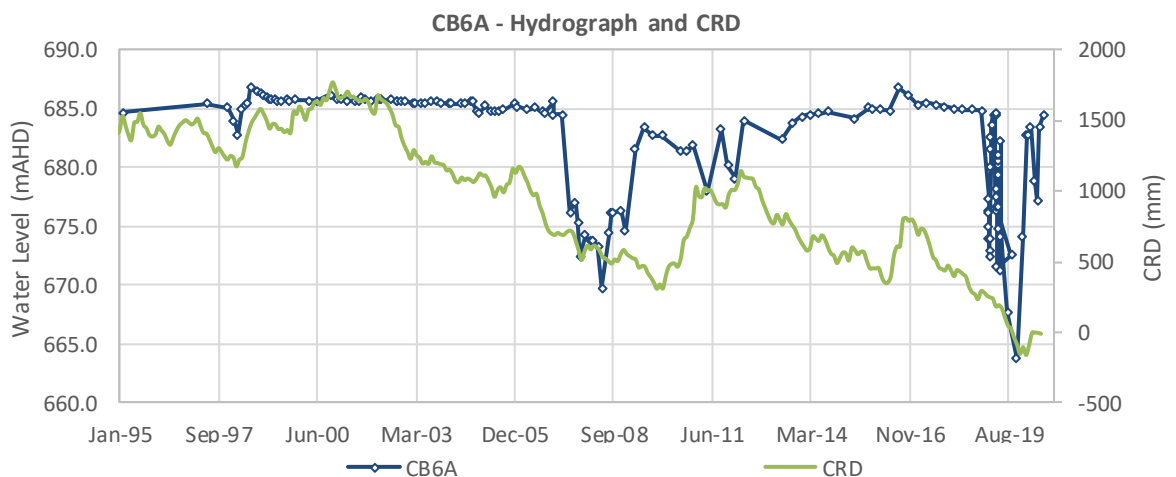
**Figure 3-31 CB6A groundwater level hydrograph**

CB6A is the monitoring bore for the CB6 production bore adjacent to the Southern Leachate Dam. Since November 2018 the groundwater levels show influence from pumping with rapid decline and recovery (refer Figure 3-31).

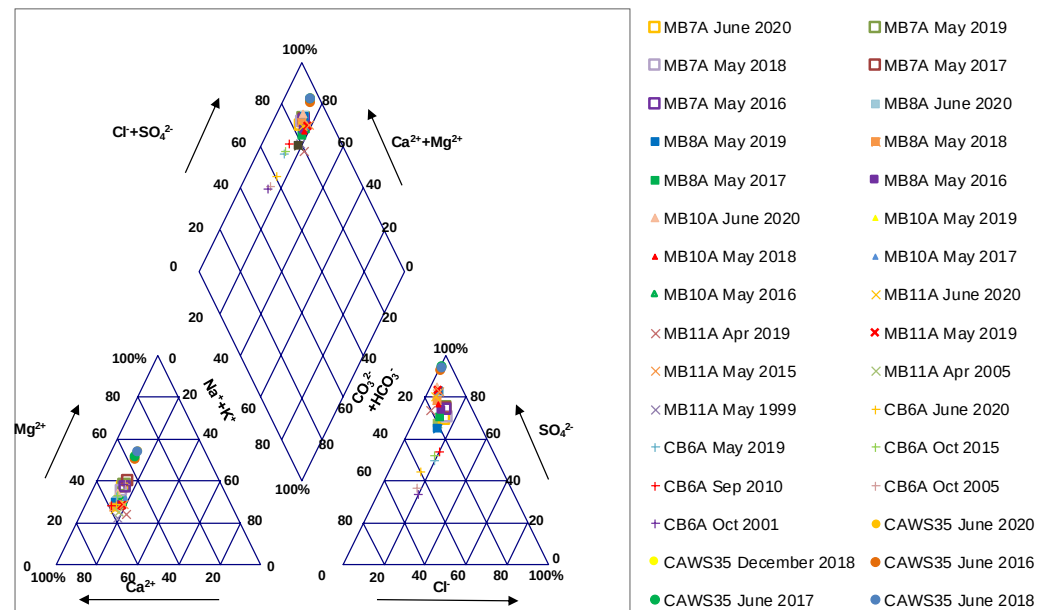
**Figure 3-34 Piper diagram for MB7A, MB8A, MB10A, MB11A, CB6A and CAWS35**

The Piper diagrams in Figure 3-33 and Figure 3-34 compare major ion chemistry of local groundwater to that of the northern leachate pond and southern leachate pond respectively. Waste rock dump leachate is calcium/magnesium sulfate dominant. Groundwater is generally calcium sulfate dominant. Prior to the current monitoring period, there appears to be some increase in sulfate dominance over time at MB5C, MB6A, MB8A and MB10A which indicates there may be some localised influence of SWRD leachate on groundwater. However, with the exception of manganese at MB6A, there are no trends in metals or nitrate that indicates influence of SWRD leachate at these bores.

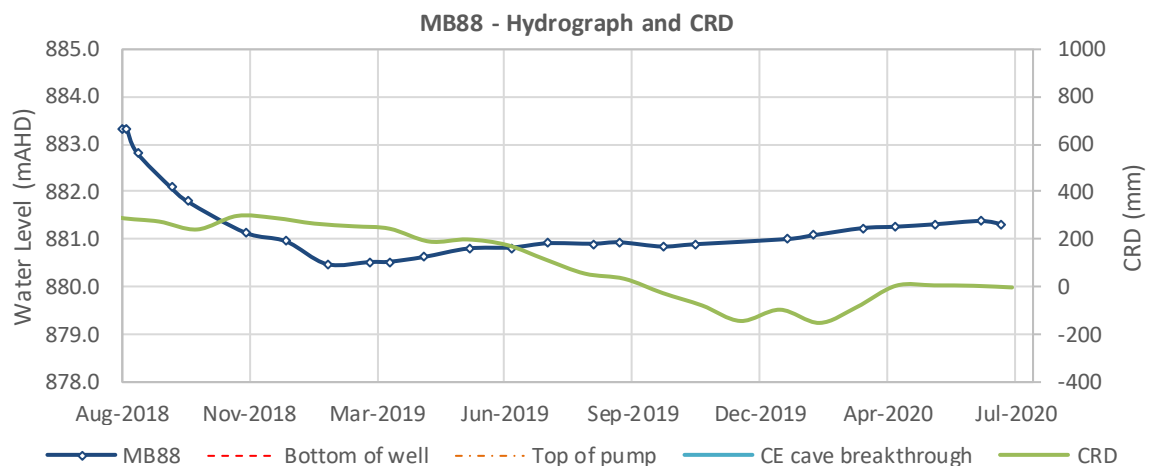
**Figure 3-36 MB88 groundwater level hydrograph**

A previous AEMR report (2017-2018) discussed the groundwater level at MB45, and attributed the decline to the lowering of pressure in the underlying bedrock or bore construction methodology. The groundwater level at MB45 continued to decline, until November 2018 when the bore was decommissioned. An additional bore, MB88, was installed nearby to determine whether groundwater levels were declining in the Tertiary Basalt or underlying Silurian/Ordovician bedrock. Monitoring of MB88 began in July 2017, and the groundwater level declined approximately 5 m by September 2018. This bore was redrilled in August 2018, and the groundwater level continued to decline by approximately 2.5 m until January 2019. Since January 2019 the groundwater level at MB88 has increased by approximately 0.9 m, despite generally decreasing CRD, refer Figure 3-36.

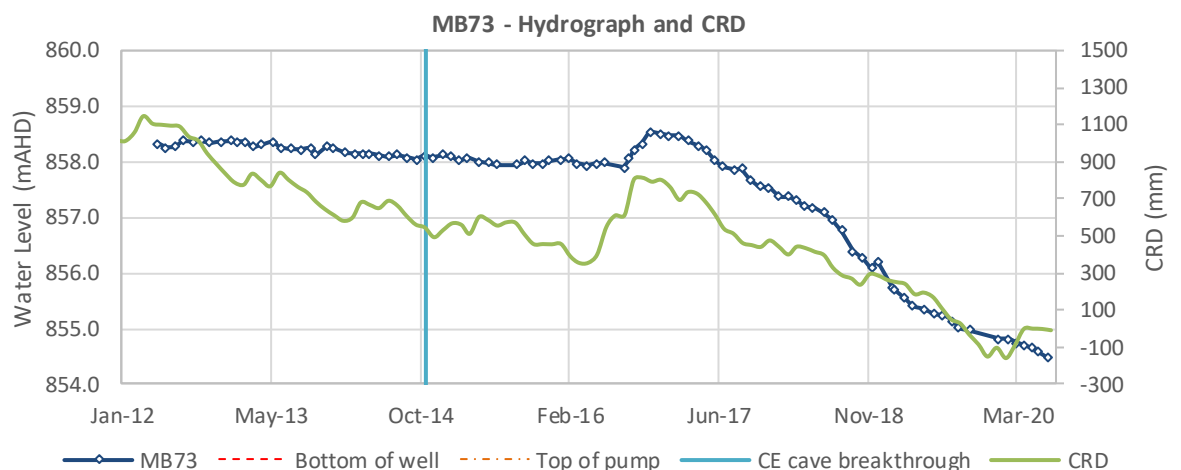
**Figure 3-38 MB73 groundwater level hydrographs**

Since October 2016, the groundwater levels at MB44B and MB73 (Silurian Sediments), refer Figure 3-38, have been declining. This trend continued during the previous and current reporting periods. The declining trend appears to reflect the CRD however the groundwater levels in these bores prior to October 2016 do not show significant drawdown response during periods of below average rainfall.

The groundwater level data for MB44B and MB73 was statistically assessed using the Hydrograph Analysis Rainfall and Time Trends (HARTT) statistical method. HARTT is a Microsoft Excel based regression model developed by the Western Australian Department of Agriculture and Food (Ferdowsian et al, 2000). HARTT involves establishing an underlying temporal trend in the groundwater level by separating the effect of above and below average rainfall. As such, the relationship between groundwater change and typical rainfall is established and it is possible to identify other factors that may influence the groundwater level.

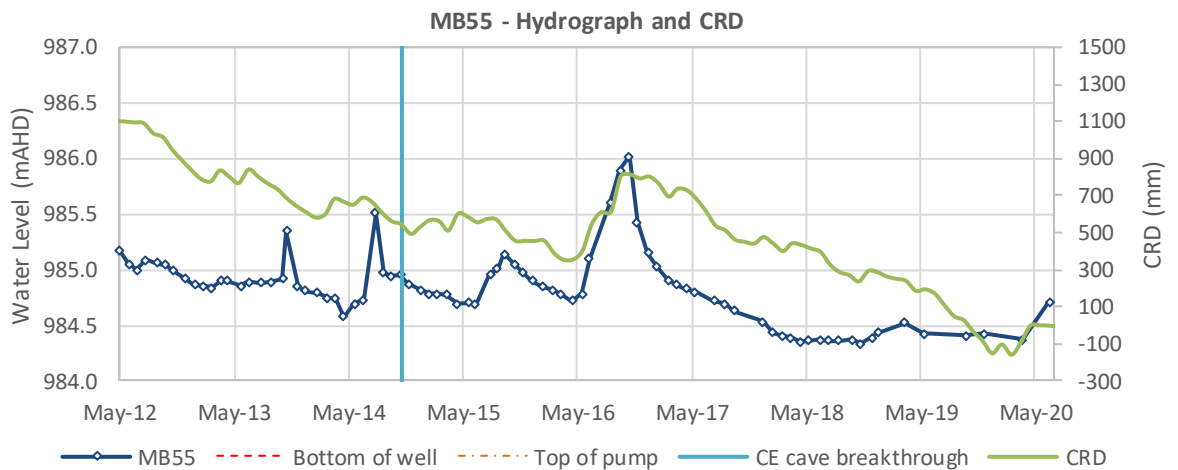
**Figure 3-39 MB55 groundwater level hydrograph**

Monitoring bores MB53, MB54, MB55 and MB56 are located towards the far north of the site. These bores historically reflect trends in the CRD. During the previous reporting period groundwater levels at MB53 and MB56 continued to respond to CRD trends; however MB54 and MB55 showed an increasing trend between November 2018 and May 2019 despite a period of decreasing CRD. During the current reporting period groundwater levels at MB53, MB54, MB55 (refer Figure 3-39), and MB56 were steady or were gradually increasing despite decreasing CRD for most of the reporting period. The increasing trends despite decreasing CRD may be due to bores recharging as a localised change in land use. The increase in groundwater levels between March 2020 and June 2020 at these bores is potentially due to increasing CRD over this period. The groundwater level guideline at MB55 was not exceeded during the reporting period.

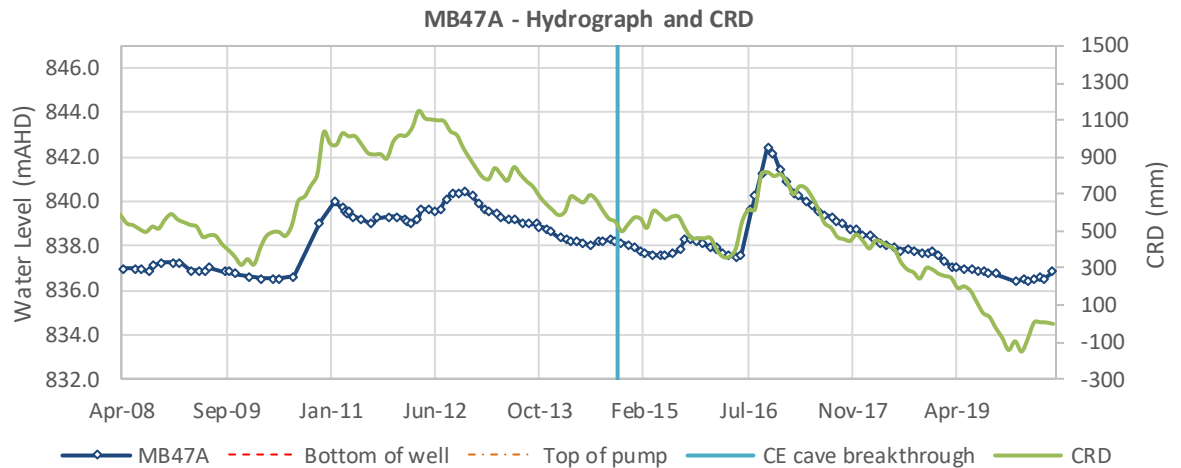
**Figure 3-44 MB47A groundwater level hydrograph**

MB47A and MB47B are located to the east of the mine and historically reflect trends in the CRD. During the previous reporting period groundwater levels showed a declining trend and this has continued into the current reporting period, until February 2020 where groundwater levels very slightly increased in response to a period of increasing CRD. These trends in groundwater level are consistent with CRD over this period. The groundwater level guideline for MB47A was not exceeded during the reporting period (refer Figure 3-44).

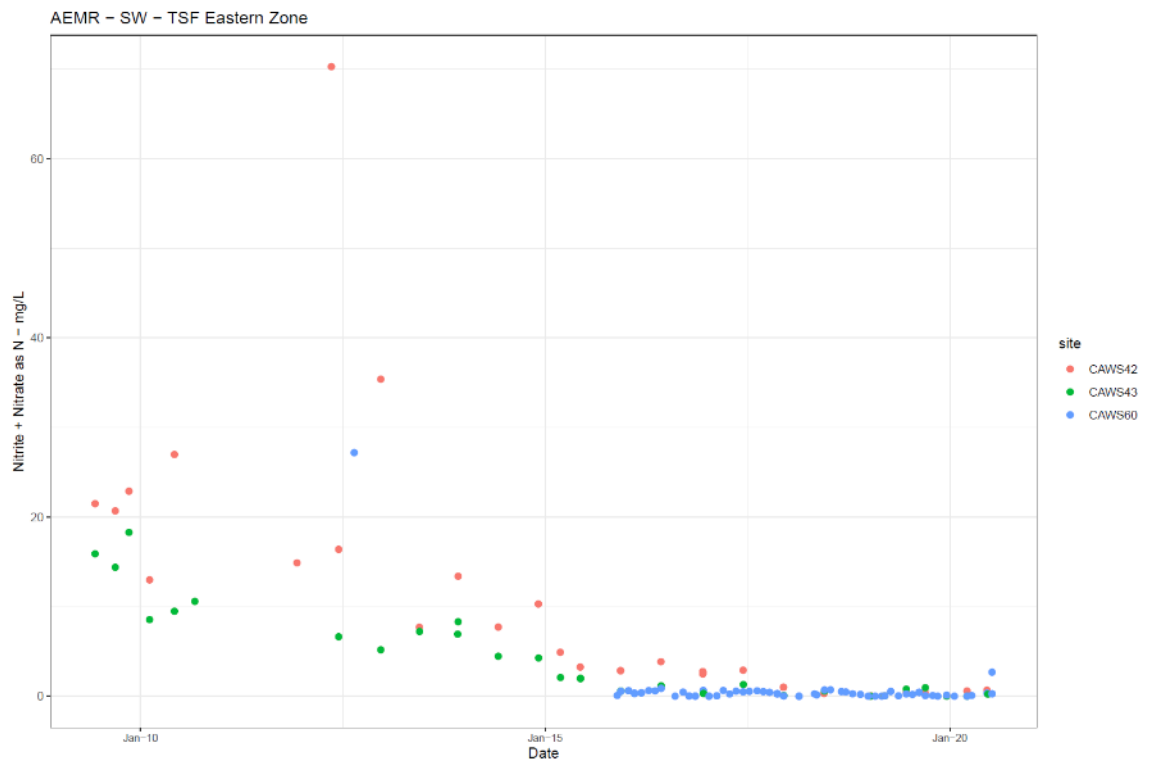
**Figure 3-46 Nitrogen oxides concentrations in the TSF eastern zone**

Nitrogen oxide concentrations in the decant pond water have generally decreased across the period of monitoring, and have remained below 5 mg/L since March 2015 (refer Figure 3-46). CAWS60 has been monitored since November 2015 and has generally had low nitrogen oxide concentrations which do not indicate the influence of tailings decant pond water.

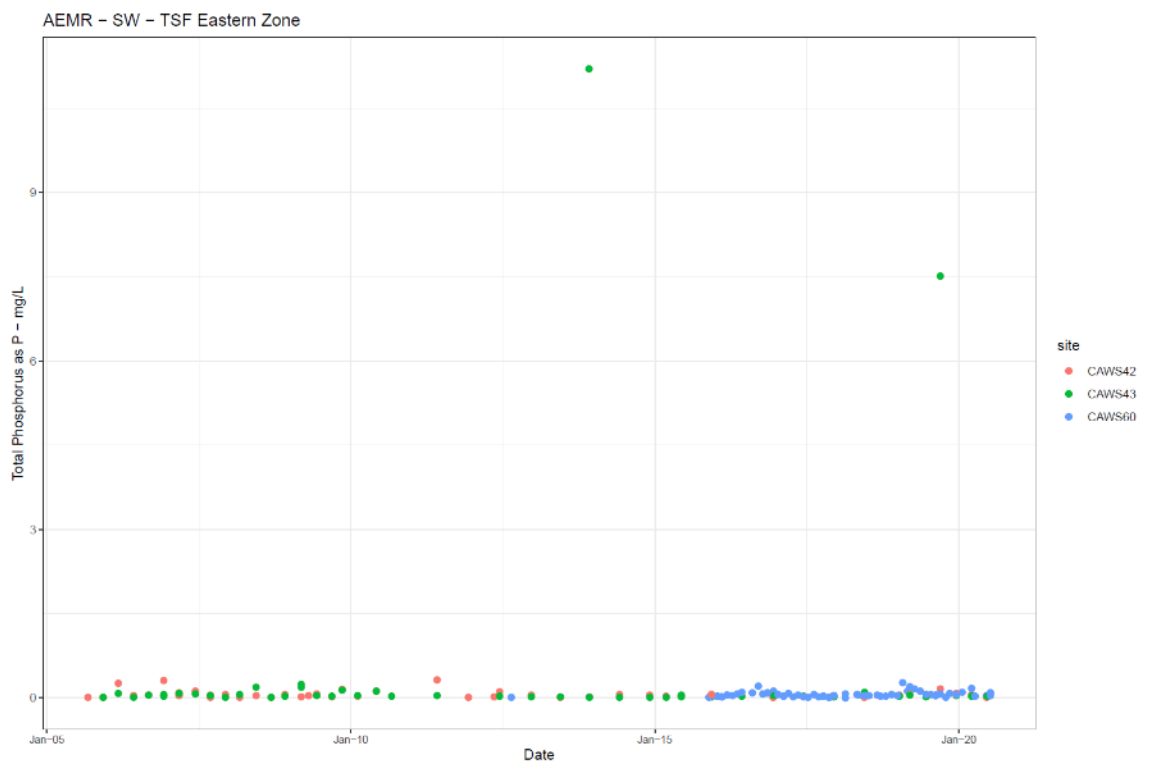
**Figure 3-47 Total phosphorous concentrations in the TSF eastern zone**

Total phosphorous concentrations have been more variable, and CAWS60 has had higher concentrations than CAWS42 and CAWS43 during the period of monitoring for the dyke pond (refer Figure 3-47). This likely reflects the influence of surrounding land use, such as agriculture runoff to the dyke pond.

A spike in total phosphorus and total nitrogen was observed at CAWS43 on 12 September 2019 with respective concentrations of 7.51 mg/L and 8 mg/L. There was no source indicator upstream at CAWS42 for this spike in nutrient and there was no impact downstream observed at CAWS31.

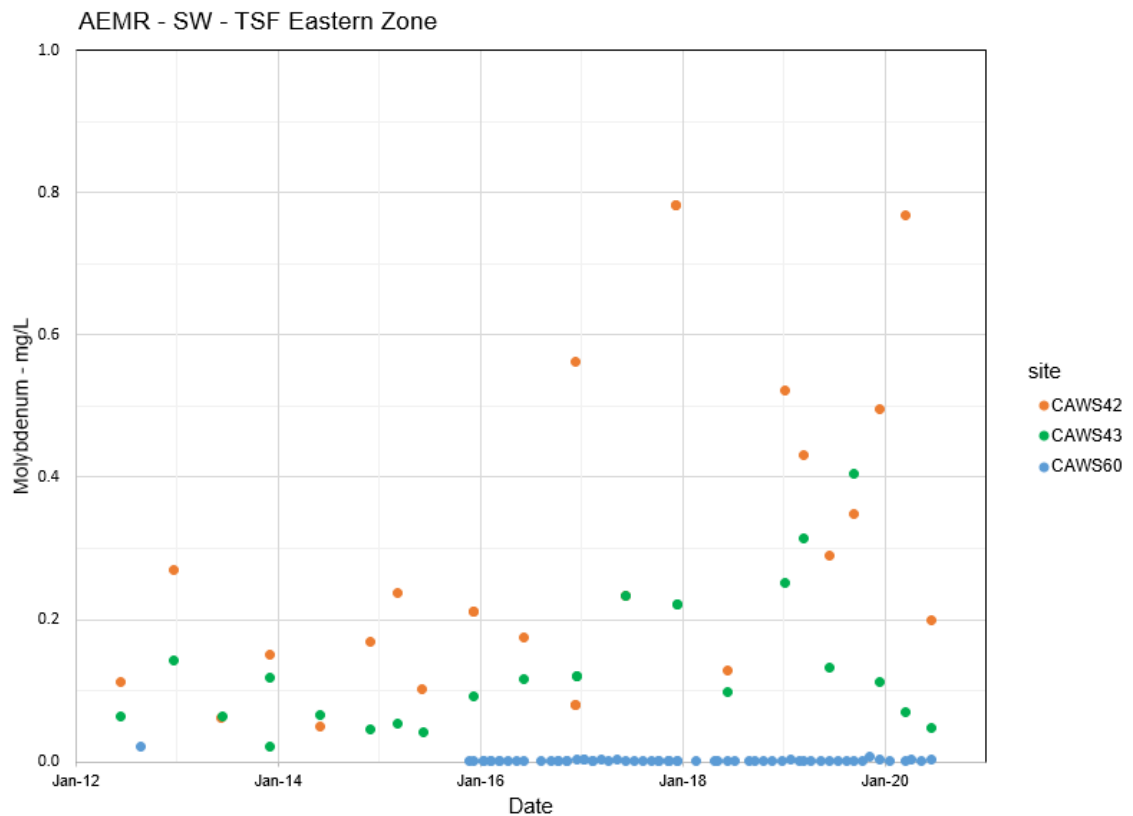
**Figure 3-48 Molybdenum concentrations in the TSF eastern zone**

Elevated molybdenum concentrations have been recorded at CAWS42 which is typical of tailings associated with the ore mined at Cadia (refer to Figure 3-48). Downstream at CAWS31, molybdenum concentrations are slightly higher than surrounding surface water monitoring points, but at concentrations of <0.034 mg/L, being the ANZG 2018 default toxicant guideline for freshwaters, these are not of concern. A decreasing trend has been seen at CAWS31 in recent times.

Molybdenum concentrations are highest in the tailings decant water at CAWS42 and CAWS43 (refer to section 3.9.1, Figure 3-48). As has been observed in previous reporting periods, influence of seepage from the tailings is evident based on the molybdenum concentrations observed at contained systems CAWS31 and CAWS41, though no influence on sites farther downstream is evident (Figure 3-67).
