# **Newcrest Mining Limited**

## **CVO AEMR - Surface and Groundwater Assessment Report**

September 2020

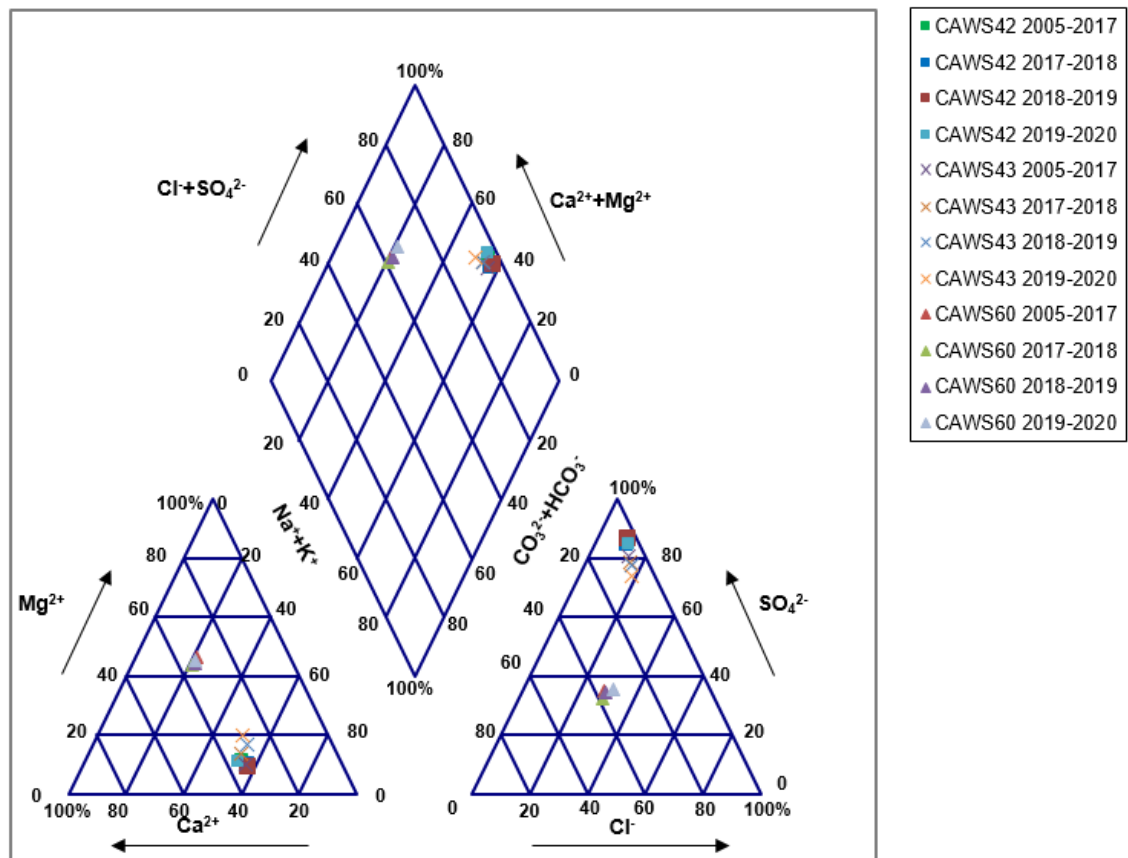
**Figure 3-49 Piper chart showing differences in major ion composition in the TSF eastern zone in the reporting period**

Average major ion (calcium, magnesium, sodium, potassium, chloride, bicarbonate and sulfate) concentrations at CAWS42, CAWS43 and CAWS60 for the 2017-2018, 2018-2019 and 2019-2020 reporting periods and the previous history of monitoring were used to create the Piper chart presented as Figure 3-49. The Piper chart shows that tailings decant pond water is ionically dissimilar from the dyke pond, and that there has been no substantial change in ionic chemistry at any of these sites over the period of monitoring. TSF decant water is sodium sulfate dominant.

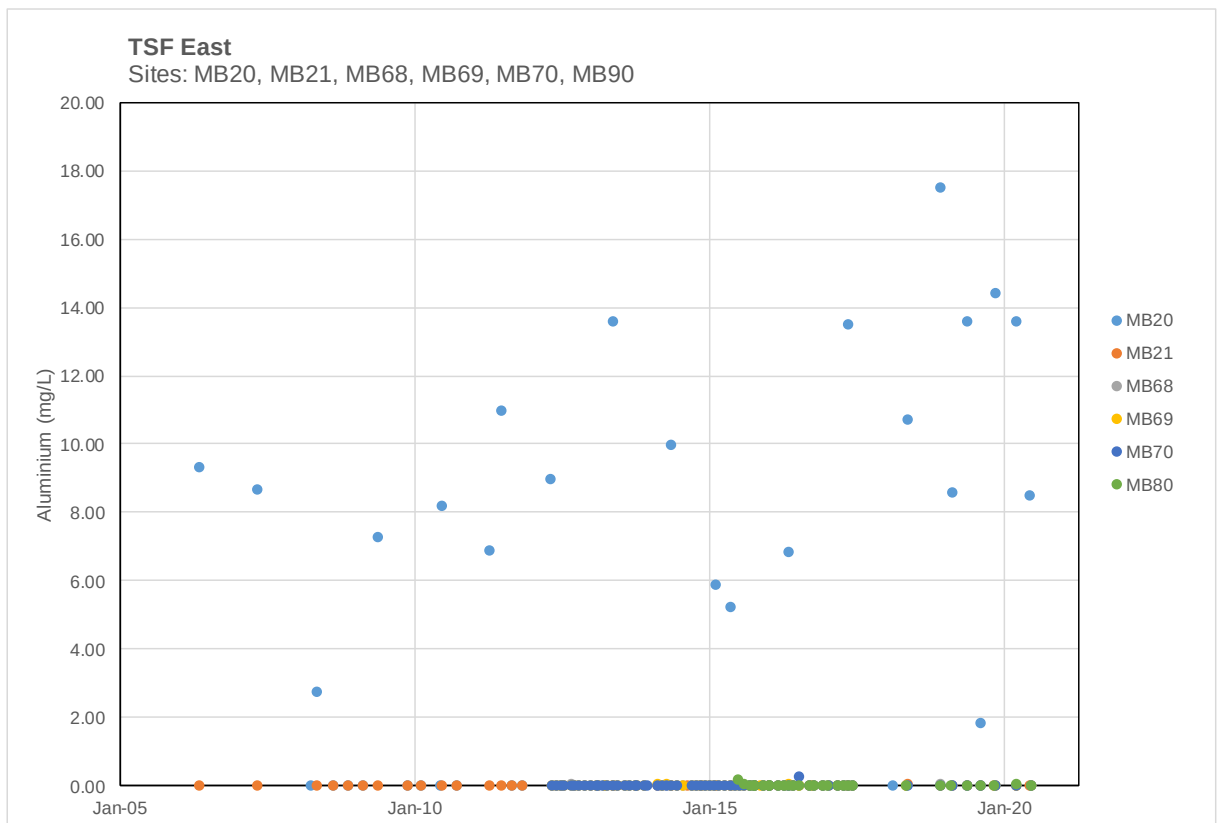
**Figure 3-50 Aluminium concentrations for bores to the east of the TSF**

The historical groundwater quality data shows elevated concentrations of aluminium, cadmium, cobalt, copper, zinc, mercury, chloride, magnesium, manganese, sulfate, potassium, sodium, calcium and TDS at MB20 compared to the other monitoring bores in the area. Many of these parameters have been elevated prior to the construction of the TSFs and therefore represent background groundwater quality. During the reporting period the trigger value for sulfate was exceeded at MB20 in November 2019 (3390 mg/L), March 2020 (3120 mg/L) and June 2020 (3100 mg/L). Aluminium and pH triggers were also exceeded at MB20 during the monitoring period. Sulfate and aluminium concentrations and pH values likely reflect natural variation in background groundwater quality and reported concentrations in the current period are within the range of historical values. Aluminium and sulfate concentrations for bores east of the TSF are shown in Figure 3-50 and Figure 3-51 respectively.

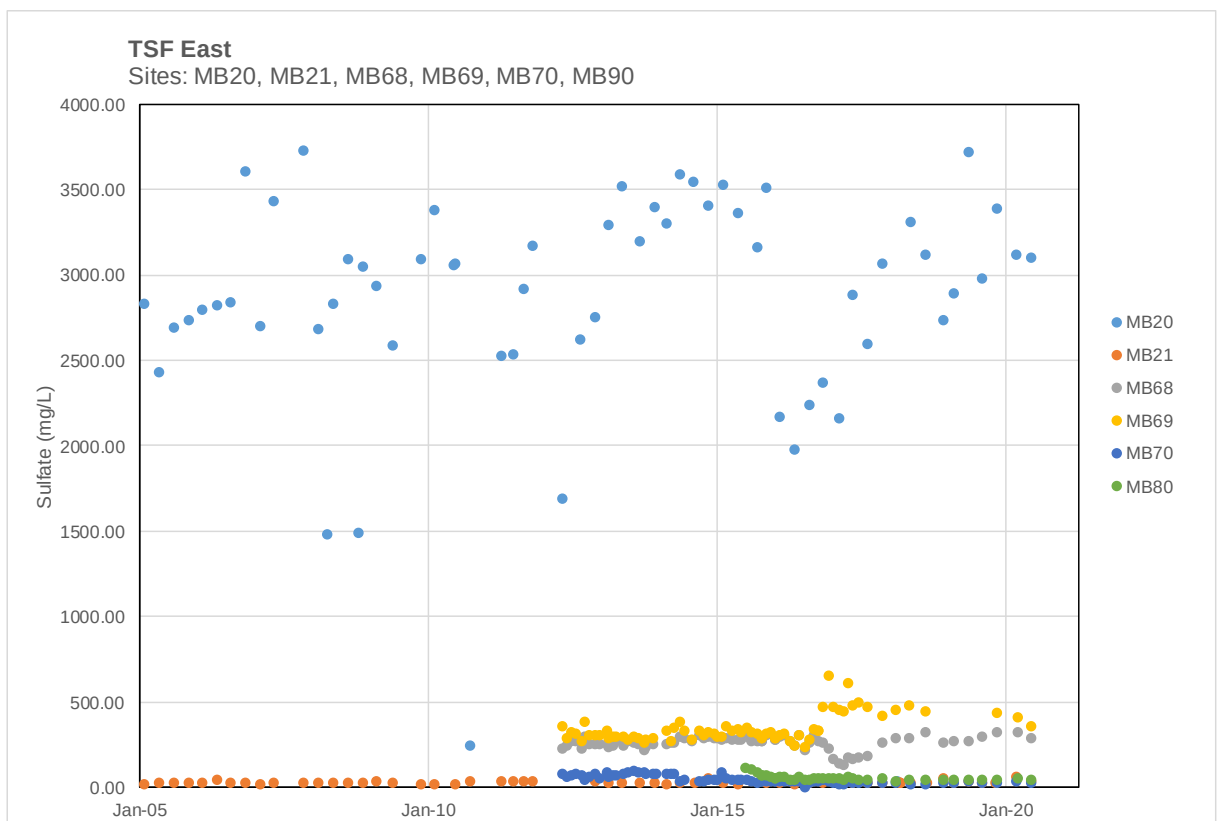
**Figure 3-51 Sulfate concentrations for bores to the east of the TSF**

There was a very slight spike in sulfate at MB21 in March 2020 (64 mg/L). While this concentration was above the historical range of results, it was significantly lower than surrounding monitoring locations (refer Figure 3-51) and below the trigger of 1000 mg/L. Sulfate concentration at MB21 returned to within the typical range of values in June 2020.

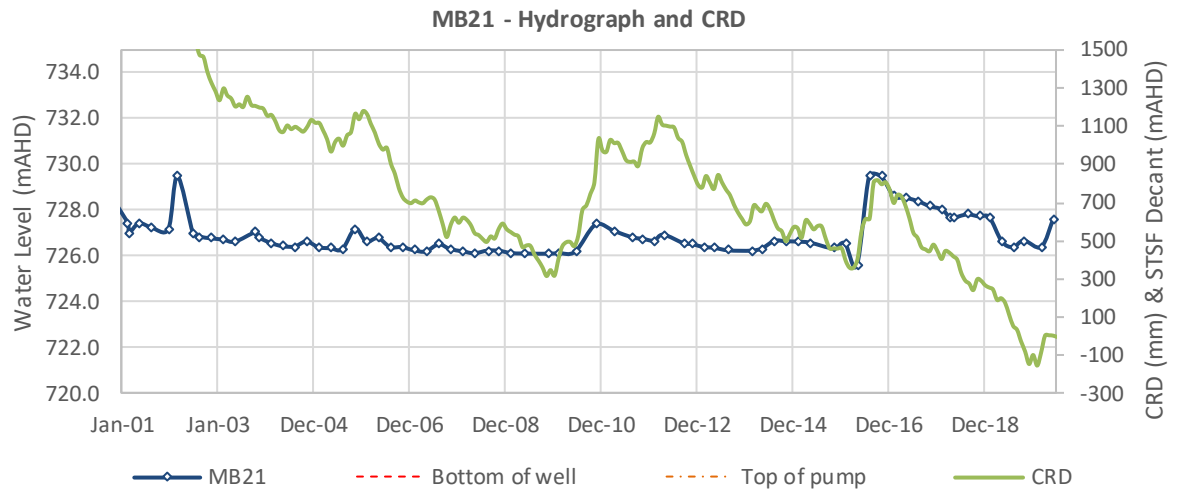
**Figure 3-53 MB21 groundwater level hydrograph**

The groundwater level at MB21 has historically reflected the trends in the CRD. The groundwater level increased rapidly between May 2016 and November 2016 following a period of above average rainfall during a similar period. Since November 2016 the groundwater level has shown an overall declining trend, consistent with CRD. Groundwater levels at MB21 increased by 1.2 m between March and June 2020 in response to a period of increasing CRD (refer Figure 3-53).

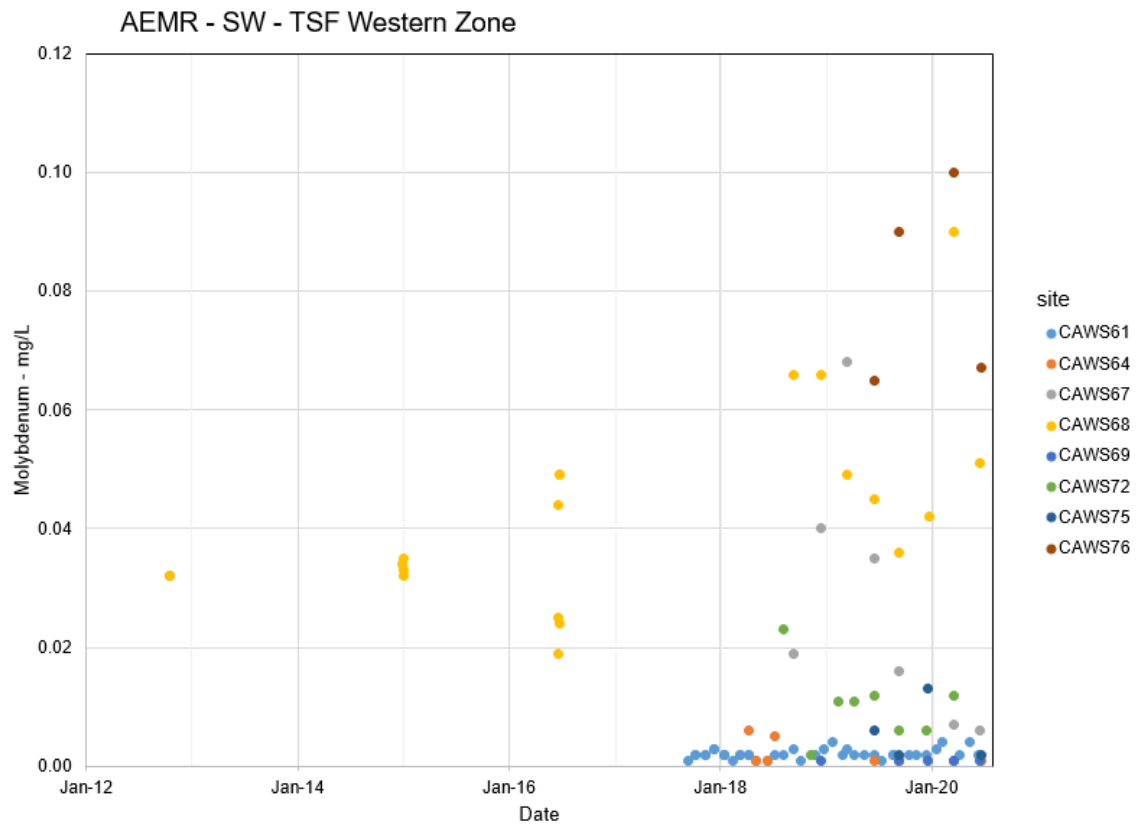
**Figure 3-56 Dissolved molybdenum concentrations at TSF western zone sites**

Molybdenum concentrations at sites CAWS67, CAWS68, CAWS69 and CAWS76 have been elevated compared to other sites within the TSF western zone (Figure 3-56), which, considering the consistently elevated molybdenum concentrations in TSF decant water and WRD leachate, indicates possible seepage from the TSFs and/or drainage/runoff from the TSF embankments, which are made from waste rock. No trend in these concentrations during the reporting period was evident however, indicating that the degree of the TSF influence has not increased during the reporting period. Furthermore, molybdenum concentrations remain low at CAWS61 with results < 0.005 mg/L, below the ANZG 2018 default toxicant guideline for freshwaters of 0.034 mg/L. CAWS61 being the downstream indicator for any seepages from CAWS67, CAWS68, CAWS69 and CAWS76 impacting on Cadiangullong Creek. Therefore there is no inferred surface water contamination impact from the TSF western zone on the receiving watercourse.

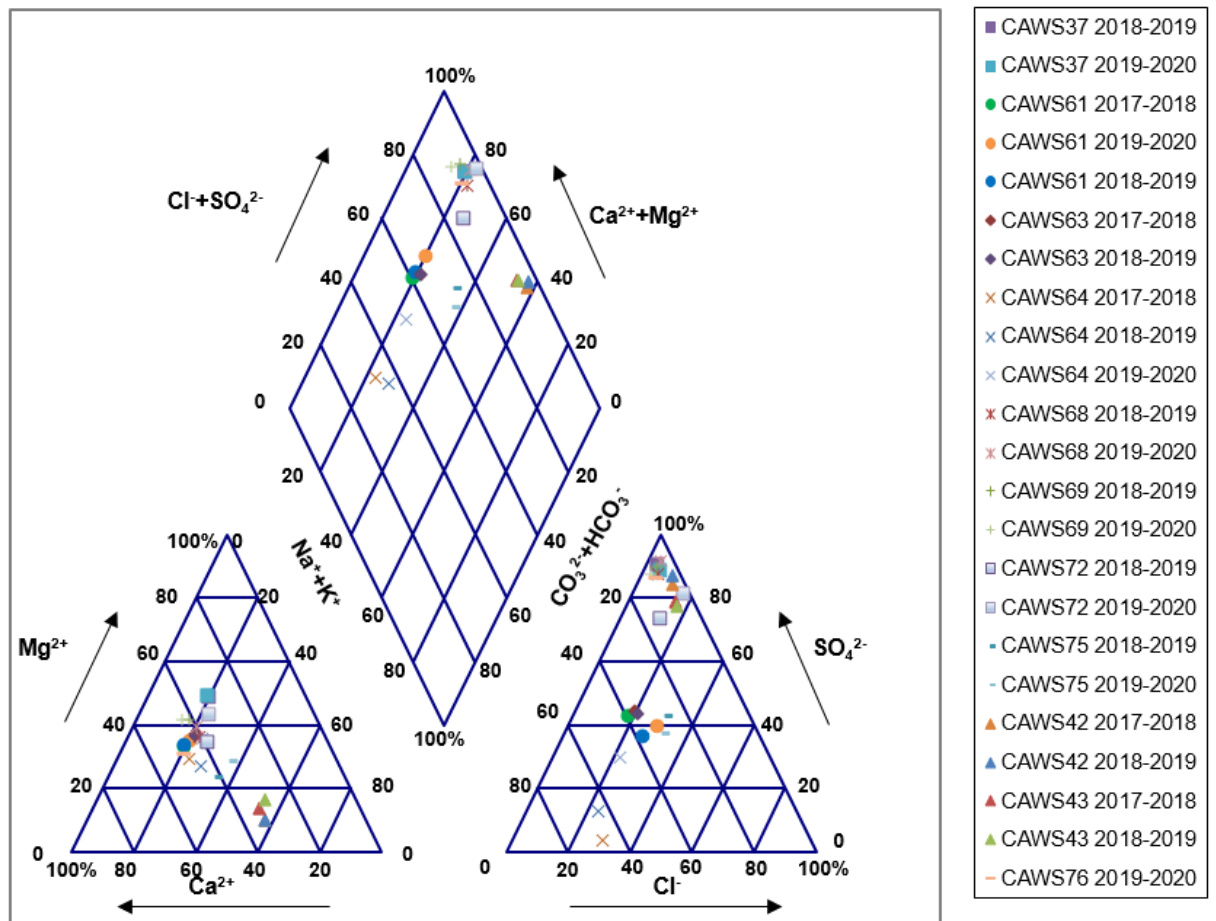
**Figure 3-57 Piper chart showing differences in major ion composition in the TSF western zone in the reporting period**

Average major ion concentrations at each of the TSF western zone sites for the reporting period were used to create the Piper chart presented as Figure 3-57. The Piper chart indicates some possible influence from the TSF decant water or drainage from the waste rock embankments on the sediment dams and seepages at CAWS68, CAWS69 and CAWS72 due to elevated sulfate concentrations. However it is noted that the groundwater in the area is naturally elevated in sulfate and there is dissimilarity between the major cation chemistry of the surface water seepages and decant.

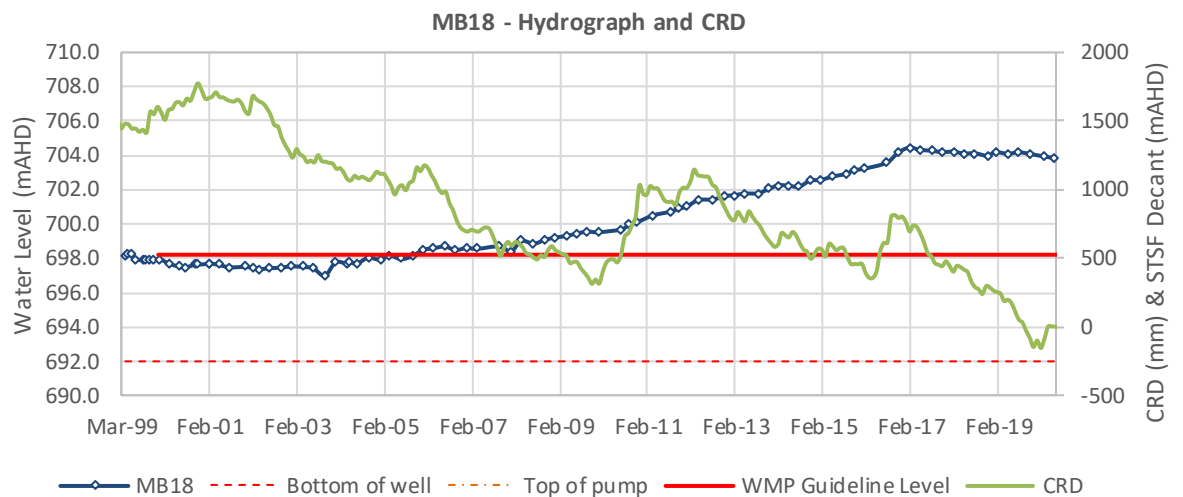
**Figure 3-58 MB18 groundwater level hydrograph**

The groundwater levels at MB18, located to the north-west of the NTSF, have shown an increasing trend for the majority of the monitoring period. However, since February 2017 the groundwater level has shown an overall declining trend (refer Figure 3-58). The groundwater level is still below the guideline level.

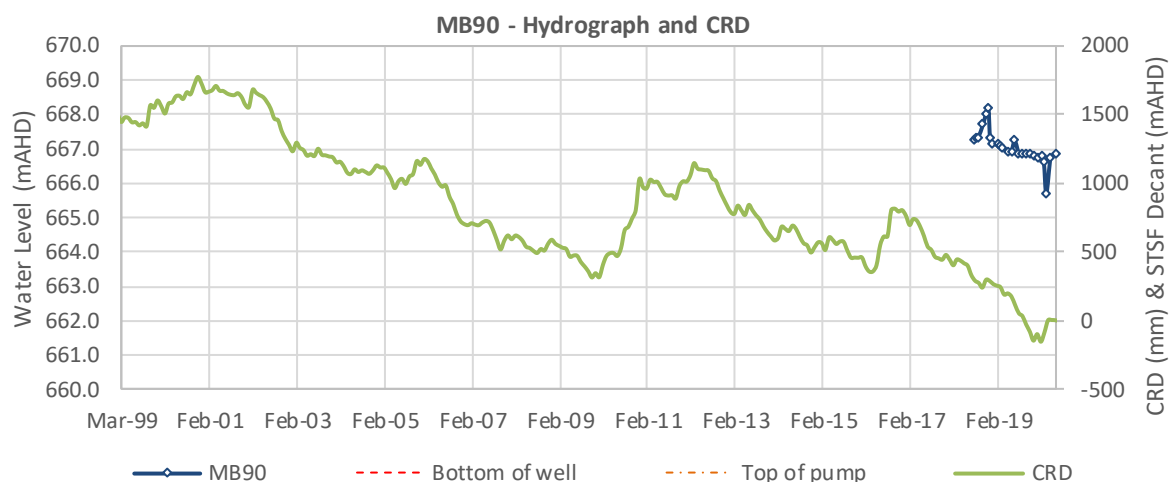
**Figure 3-59 MB90 groundwater level hydrograph**

The groundwater level at MB90 within the Tertiary Basalt (replacement for MB19A) previously increased between August 2018 and December 2018 potentially in response to a period of above average rainfall in October/November 2018. Since December 2018 groundwater levels at MB90 have generally been declining, potentially due to generally declining CRD over this period. Groundwater levels at MB90 increased in May and June 2020 following a period of above average rainfall in April and May 2020, refer Figure 3-59.

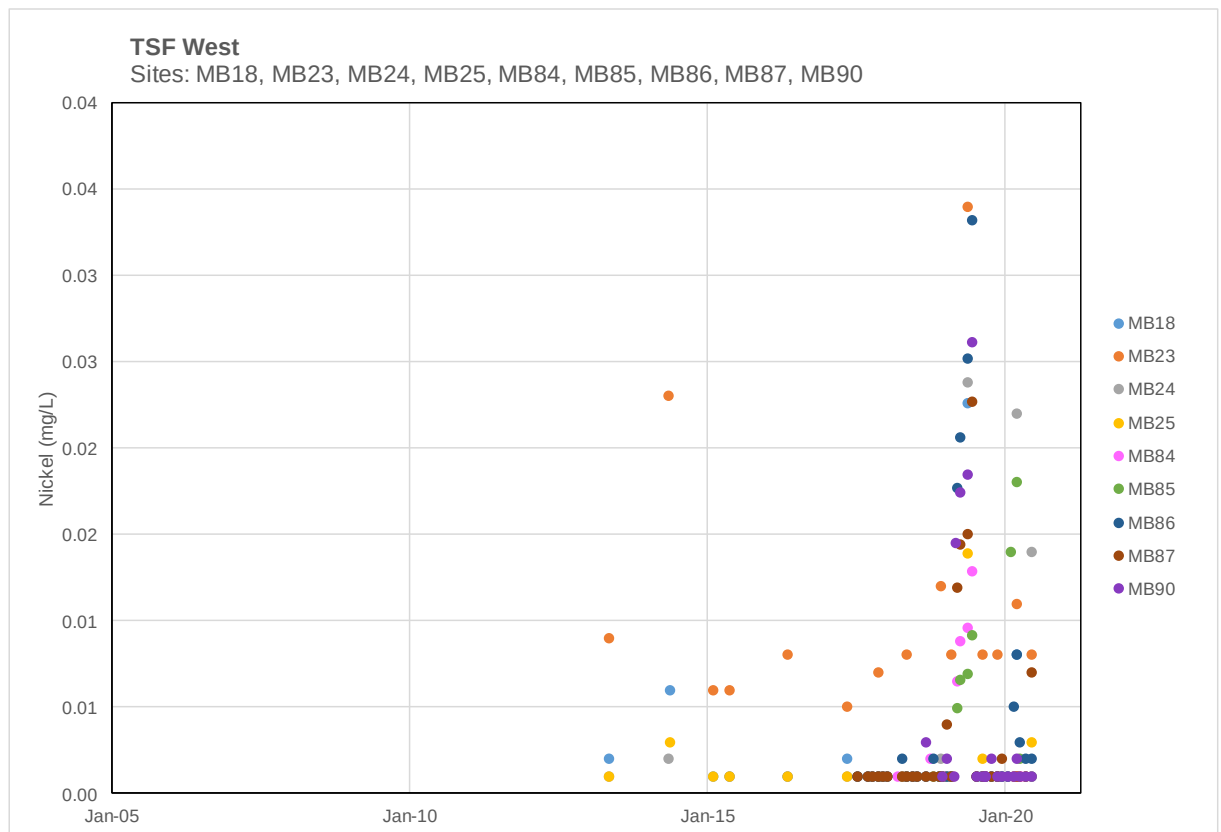
**Figure 3-60 Nickel concentrations in bores to the west of the TSFs**

During the previous reporting period there was an increasing trend in nickel concentrations at all bores, although no exceedances of the trigger value evident. This increasing trend in nickel was likely attributable to field or laboratory contamination or interference. However during the current reporting period nickel concentrations were lower at all bores (refer Figure 3-60). There was still some variability in nickel at MB24, MB85, MB86 and MB87 during the current reporting period.

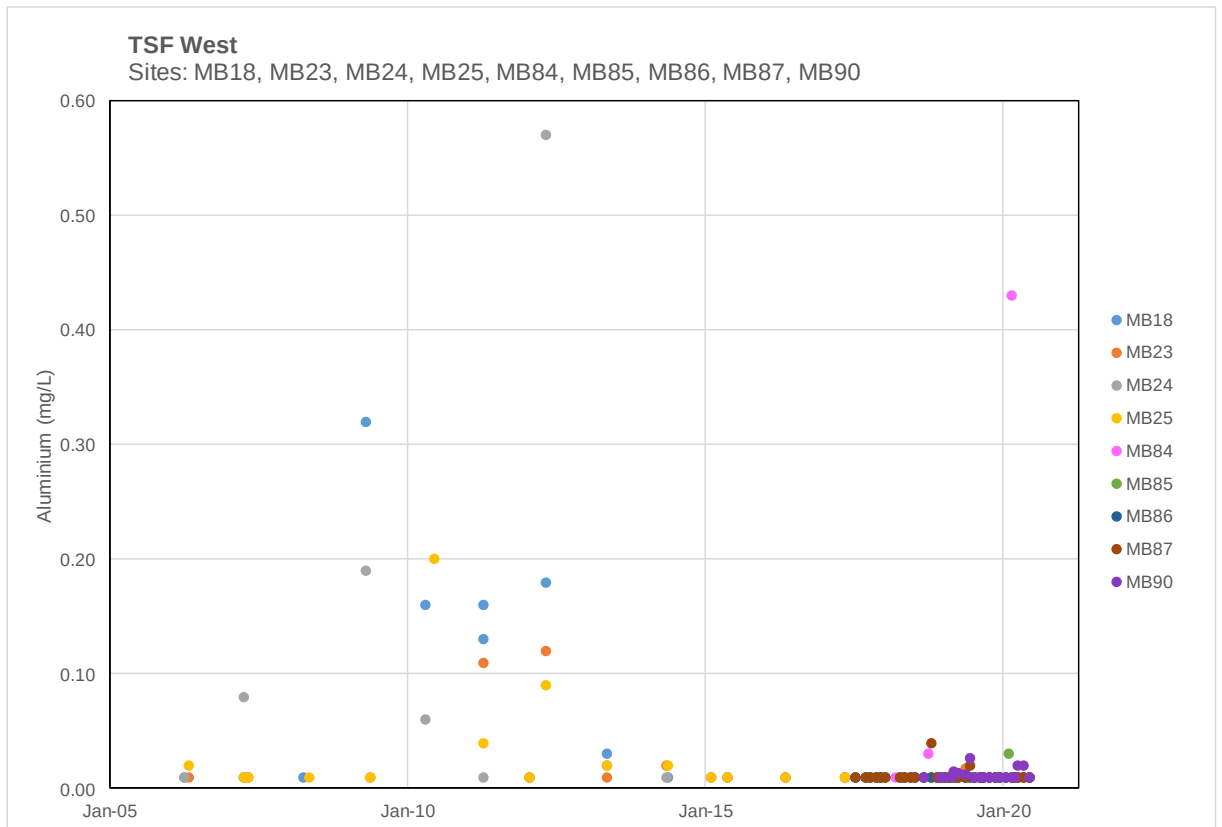
**Figure 3-61 Aluminium concentrations in bores to the west of the TSF**

During the previous reporting period aluminium concentrations increased at MB90. However during the current reporting period aluminium concentrations returned to typical values at MB90, with the exception of April and May 2020 where aluminium concentrations increased to 0.02 mg/L. Aluminium concentration at MB90 returned to typical values in June 2020. Aluminium concentrations are plotted in Figure 3-61.

There was a slight spike in aluminium at MB84 (0.43 mg/L) and MB85 (0.03 mg/L) in February 2020 (refer Figure 3-61). The aluminium concentration at MB84 in February 2020 was above the trigger value of 0.2 mg/L. CHPL's Level 1 investigations indicates the result was an outlier due to return to normal conditions. The aluminium concentration was not considered a persistent mine related water quality issue.

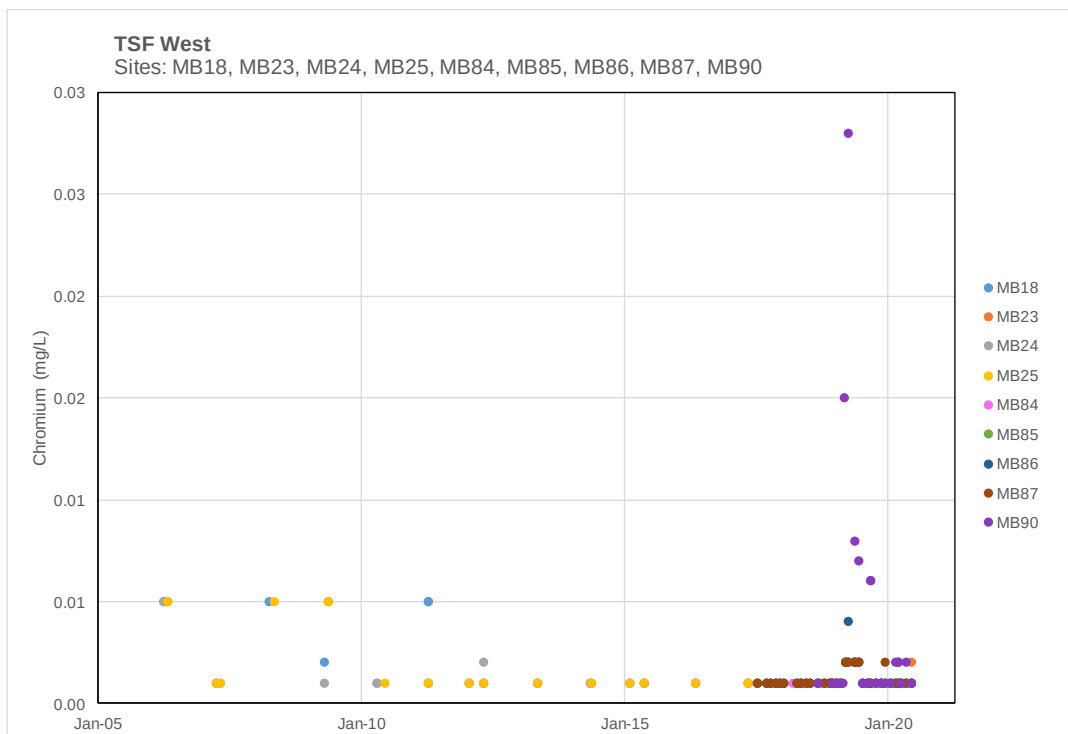
**Figure 3-62 Chromium concentrations in bores to the west of the TSFs**

Cadmium concentrations showed an increasing trend at MB23 between 2016 and late 2018. Since this time cadmium concentrations at MB23 have been relatively constant. Chromium concentrations were elevated (up to 0.03 mg/L) at MB90 during the previous reporting period. During the current reporting period, chromium concentrations returned to within the historical range of concentrations for bores to the west of the TSF (refer Figure 3-62).

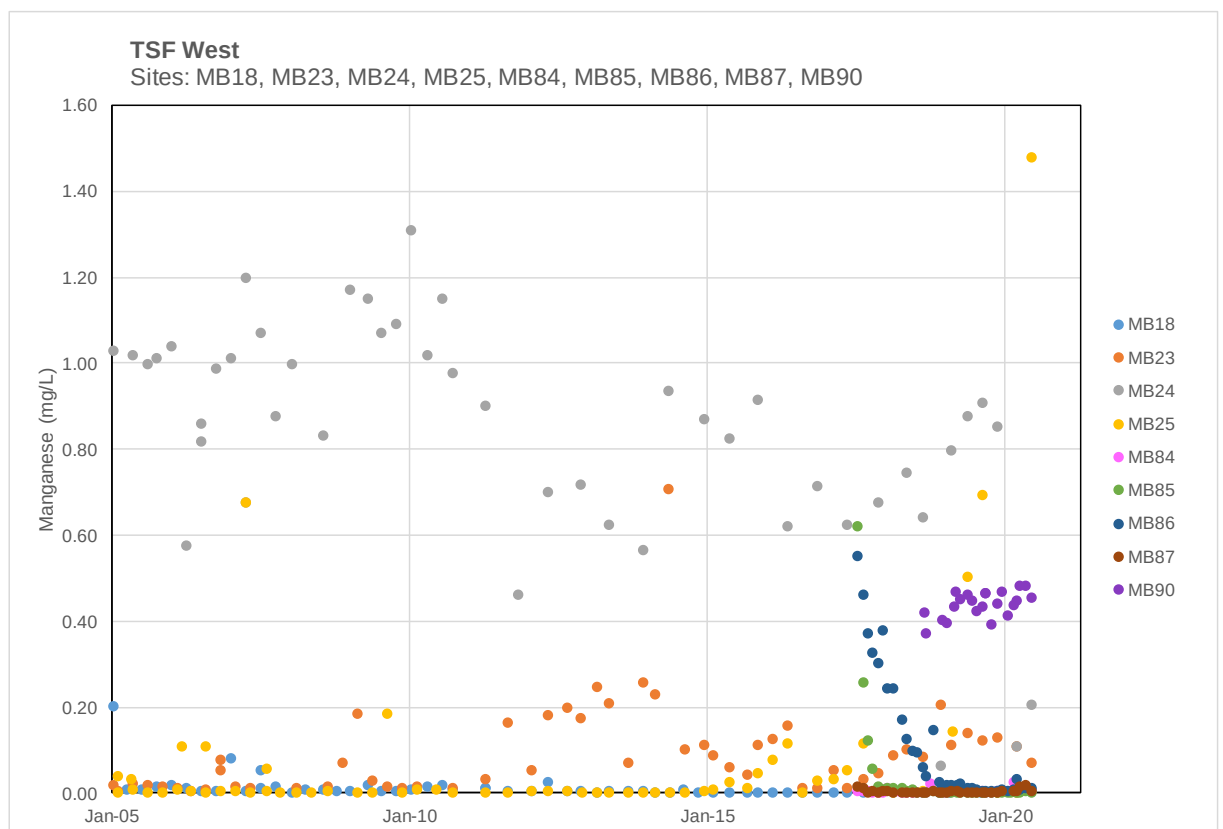
**Figure 3-63 Manganese concentrations at bores to the west of the TSFs**

During the current reporting period manganese concentrations were generally increasing at MB18, MB85, MB87 and MB90. Manganese concentrations at MB25 increased in June 2020 to 1.48 mg/L. Continued monitoring of manganese concentrations is recommended to confirm the trend at MB25. Manganese concentrations showed an increasing trend at MB24 during the previous reporting period, however were decreasing during the current reporting period. A historical decreasing trend in manganese has been observed at MB86, with manganese concentrations relatively constant during the current reporting period. Manganese concentrations are plotted in Figure 3-63.

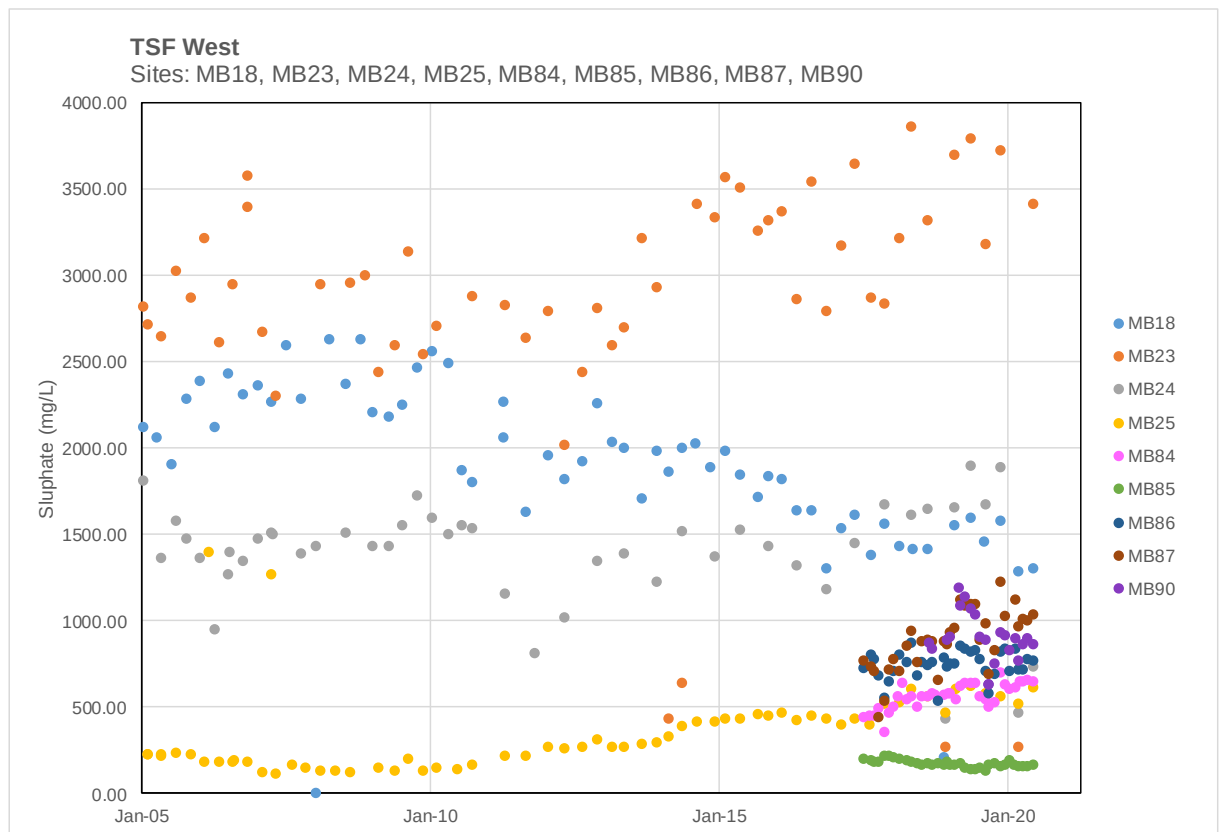
**Figure 3-64 Sulfate concentrations at bores to the west of the TSFs**

During the reporting period sulfate concentrations exceeded the trigger value at MB84, MB86 and MB87 (refer Figure 3-64). Review of groundwater quality by CHPL indicated that sulfate is naturally elevated at these locations. Exceedances of the trigger values are due to sulfate being naturally elevated at these locations. The exceedances of these trigger values are not attributable to impacts of mining. Review of these trigger values is recommended as part of the next review of the WMP.

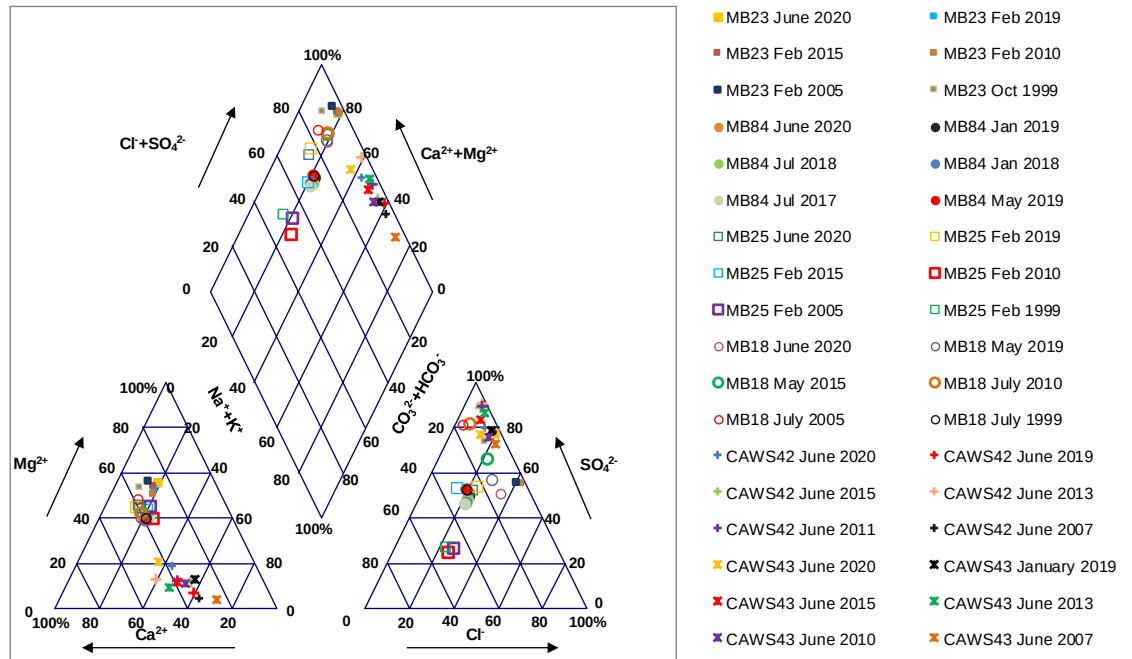
**Figure 3-65 Piper diagram for MB18, MB23, MB25, MB84, CAWS42 and CAWS43**

The Piper diagram in Figure 3-65 indicates minimal influence of decant water on local groundwater. Although the local groundwater has naturally elevated sulfate concentrations, the major cation chemistry is dissimilar to the decant water.

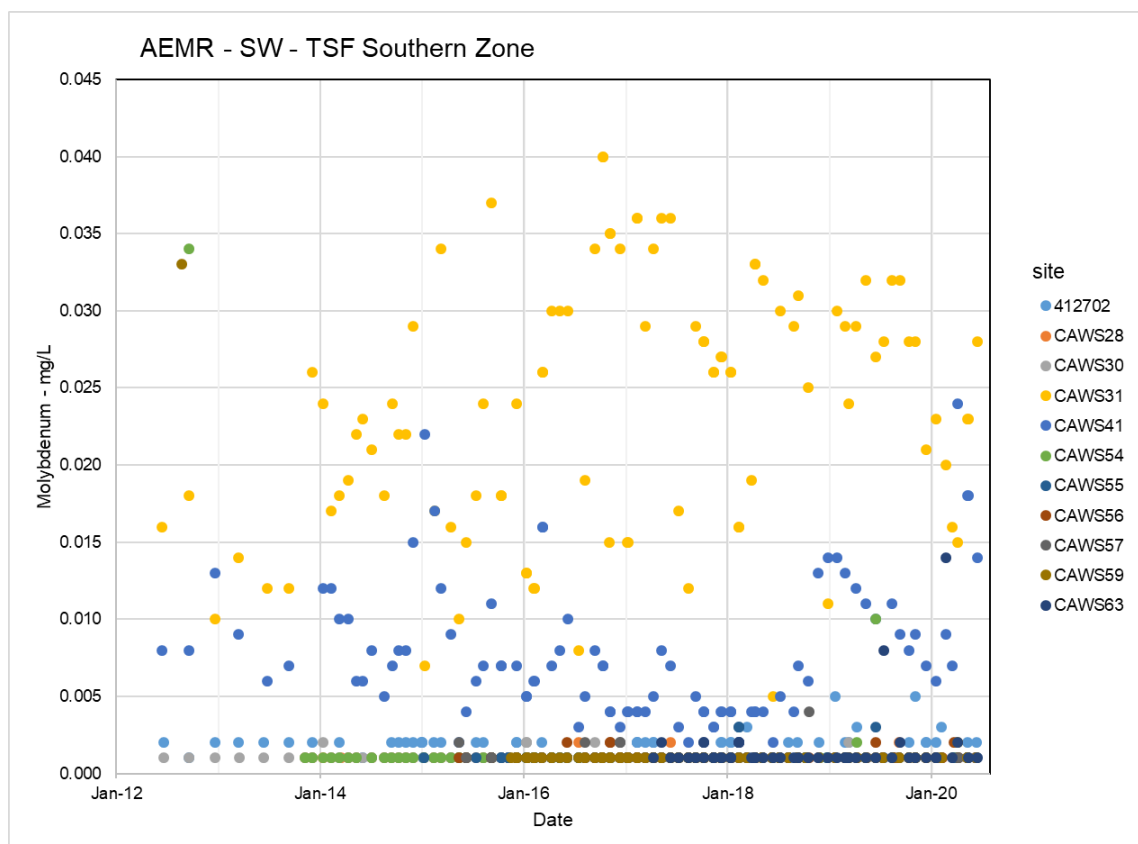
**Figure 3-67 Molybdenum concentrations in the TSF southern zone.**

Molybdenum concentrations are highest in the tailings decant water at CAWS42 and CAWS43 (refer to section 3.9.1, Figure 3-48). As has been observed in previous reporting periods, influence of seepage from the tailings is evident based on the molybdenum concentrations observed at contained systems CAWS31 and CAWS41, though no influence on sites farther downstream is evident (Figure 3-67).

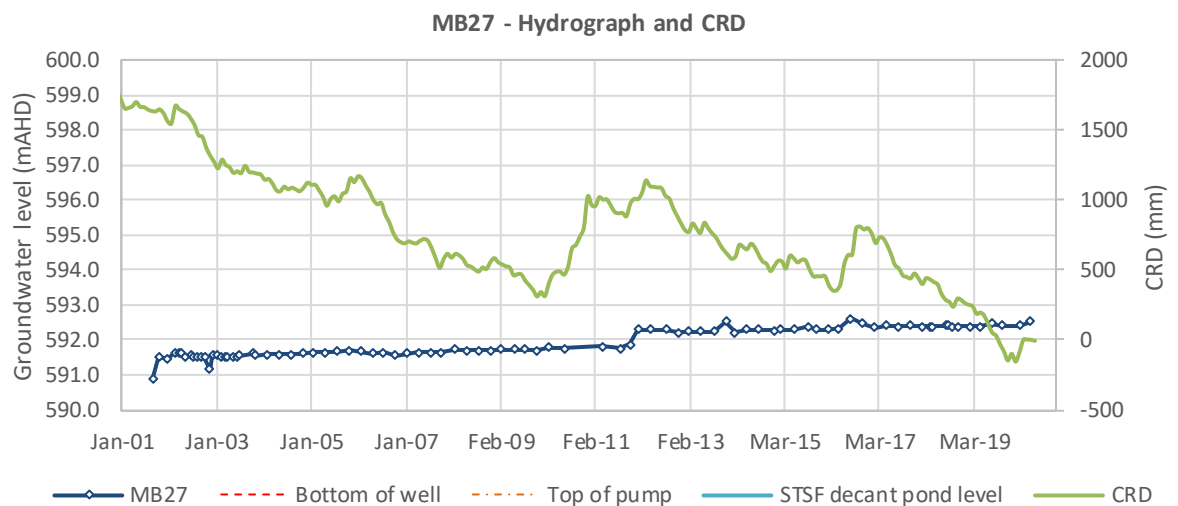
**Figure 3-68 MB27 groundwater level hydrograph**

The groundwater level at MB27 remained relatively stable between May 2019 and March 2020 despite generally decreasing CRD over this period, refer Figure 3-68. This indicates ongoing influence from TSF seepage at MB27. Groundwater levels at MB27 increased in June 2020 in response to above average rainfall in March and April 2020. The groundwater level at MB27 is below the guideline value.

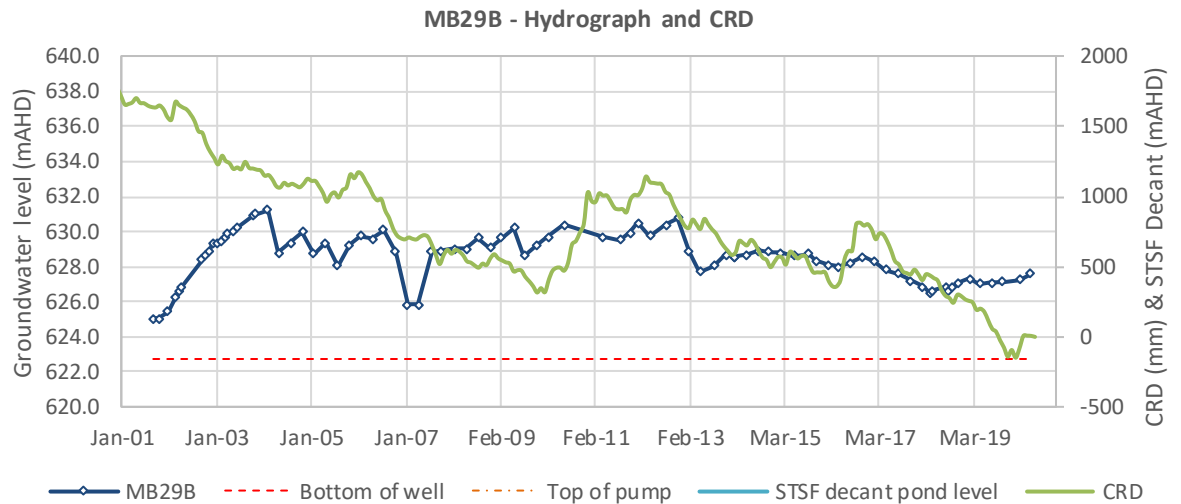
**Figure 3-69 MB29B groundwater level hydrographs**

MB29B has generally reflected trends in the CRD since 2008, and has showed an overall declining trend between December 2016 and April 2018. However groundwater levels at MB29B have displayed an overall increasing trend since April 2018 (refer Figure 3-69). This increasing trend occurred despite generally decreasing CRD over this period. The groundwater level for MB29B has remained below the guideline value.

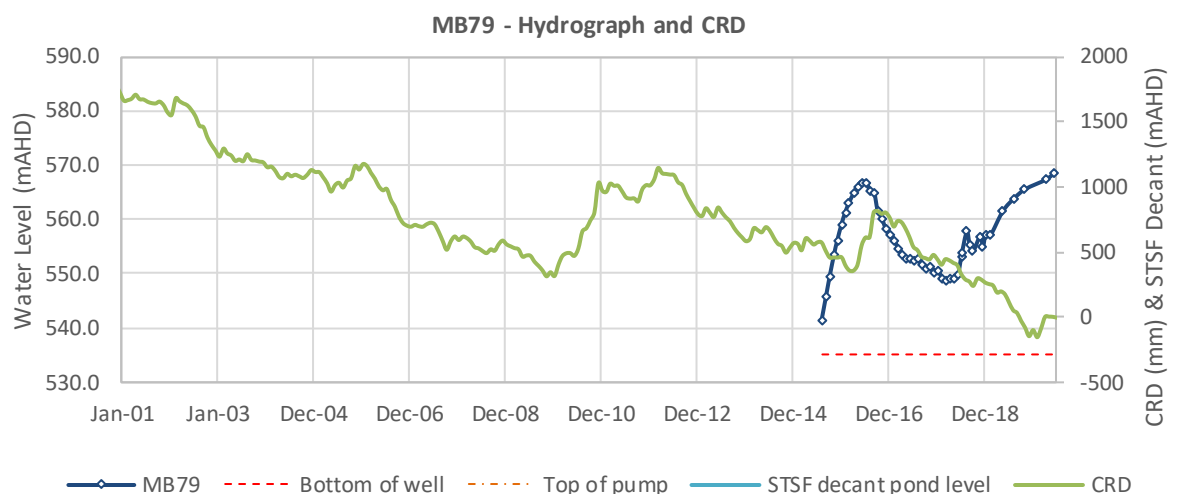
**Figure 3-70 MB79 groundwater level hydrograph**

The groundwater level at MB79 showed a historically increasing trend until June 2016. Between June 2016 and May 2018 the groundwater level showed a declining trend and an increasing trend since May 2018 (refer Figure 3-70).

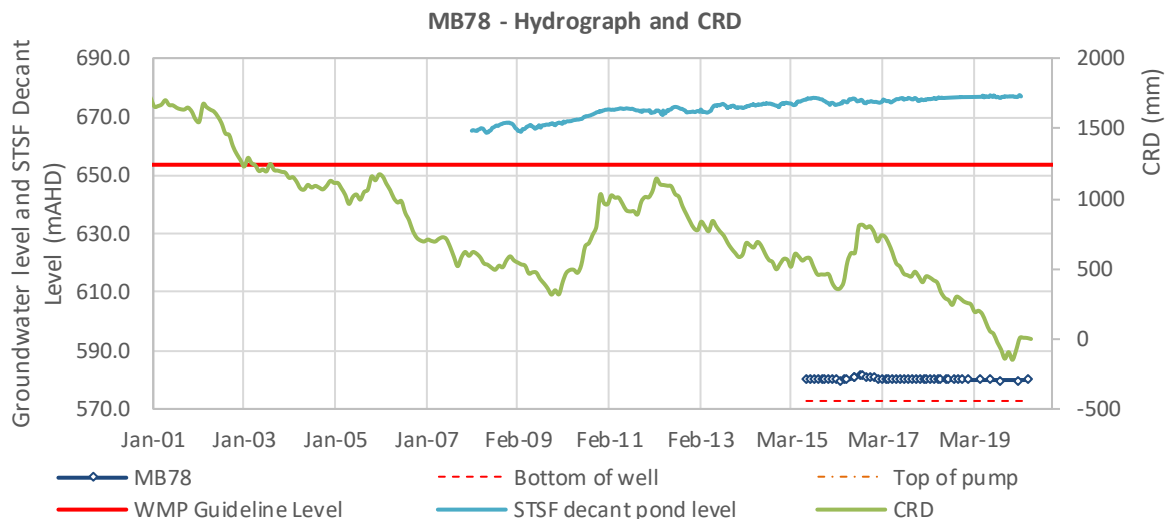
**Figure 3-71 MB78 groundwater level hydrograph**

The groundwater level at MB78 has historically reflected trends in the CRD. Since October 2017, groundwater levels at MB78 have been relatively stable. Groundwater levels decreased slightly (by approximately 0.2 m) in November 2019 and increased by a similar amount in June 2020, likely due to periods of below average and above average rainfall (refer Figure 3-71). The groundwater level at MB78 has remained below the guideline value.

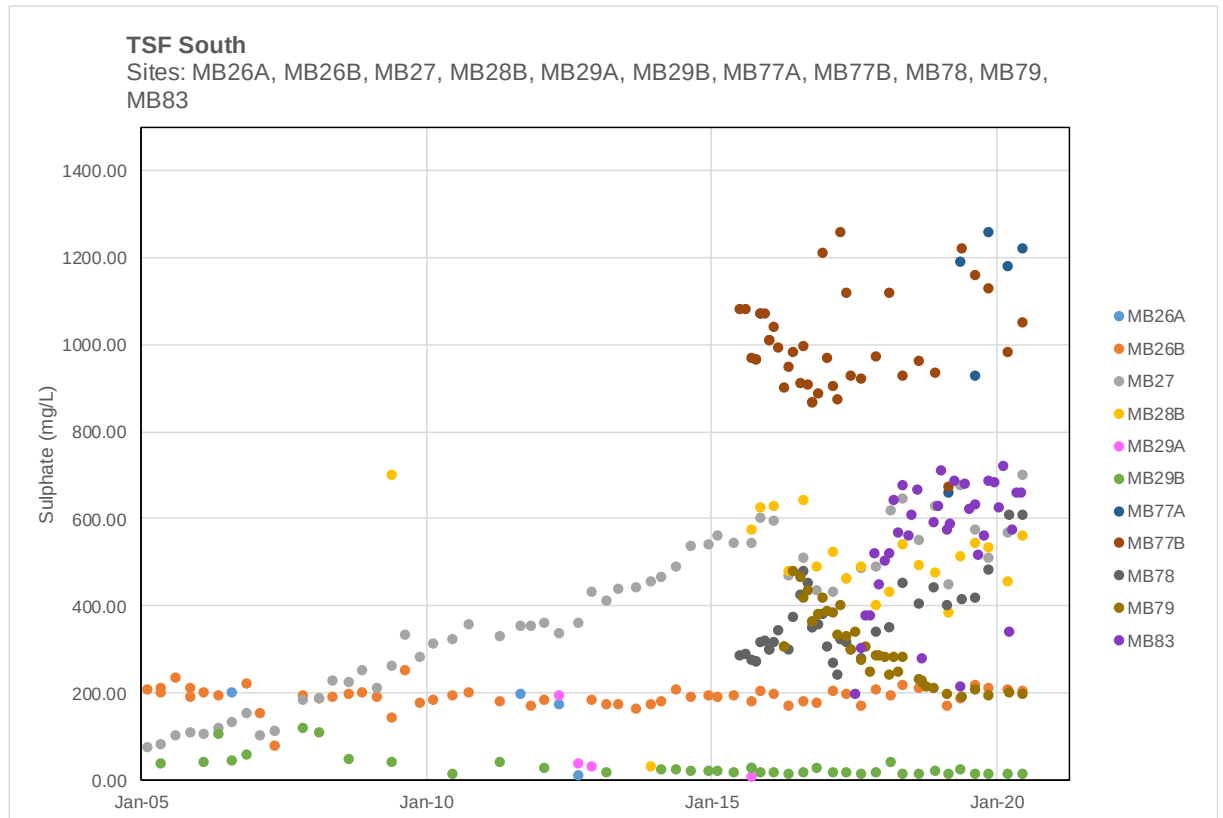
**Figure 3-72 Sulfate concentrations at bores to the south of the STSF**

Generally increasing trends have been observed in sulfate concentrations at MB27, MB78 and MB83, however sulfate concentrations at these locations were relatively constant during the monitoring period (refer Figure 3-72). Overall elevated sulfate concentrations are representative of background groundwater, although an increasing trend in sulfate over time may indicate decant influence. Sulfate concentrations were constant during the reporting period at MB79, the most down gradient site.

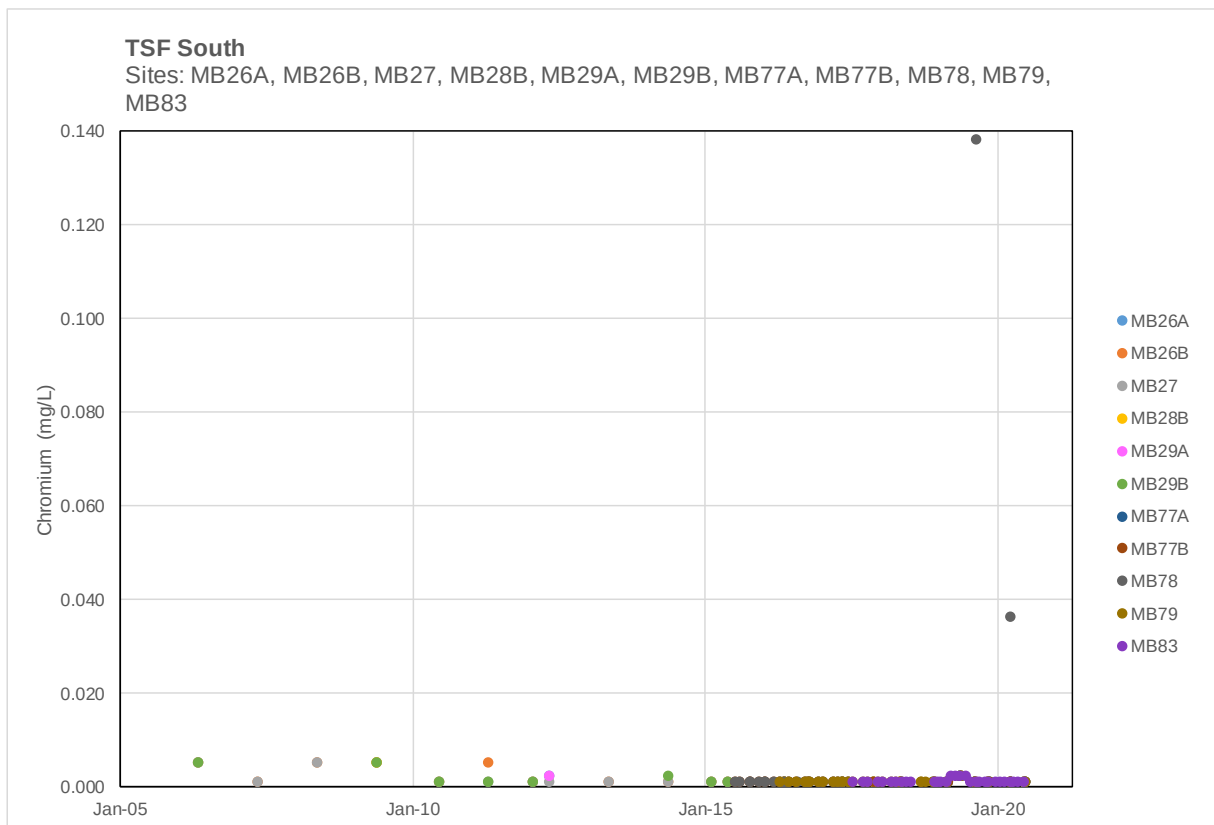
**Figure 3-73 Chromium concentrations at bores to the south of the STSF**

Chromium concentrations at MB78 were elevated in August 2019 and March 2020 (0.138 mg/L and 0.036 mg/L). Chromium concentrations at MB78 were lower and within the typical range of values in the remaining monitoring rounds in the reporting period. Chromium concentrations are plotted in Figure 3-73.

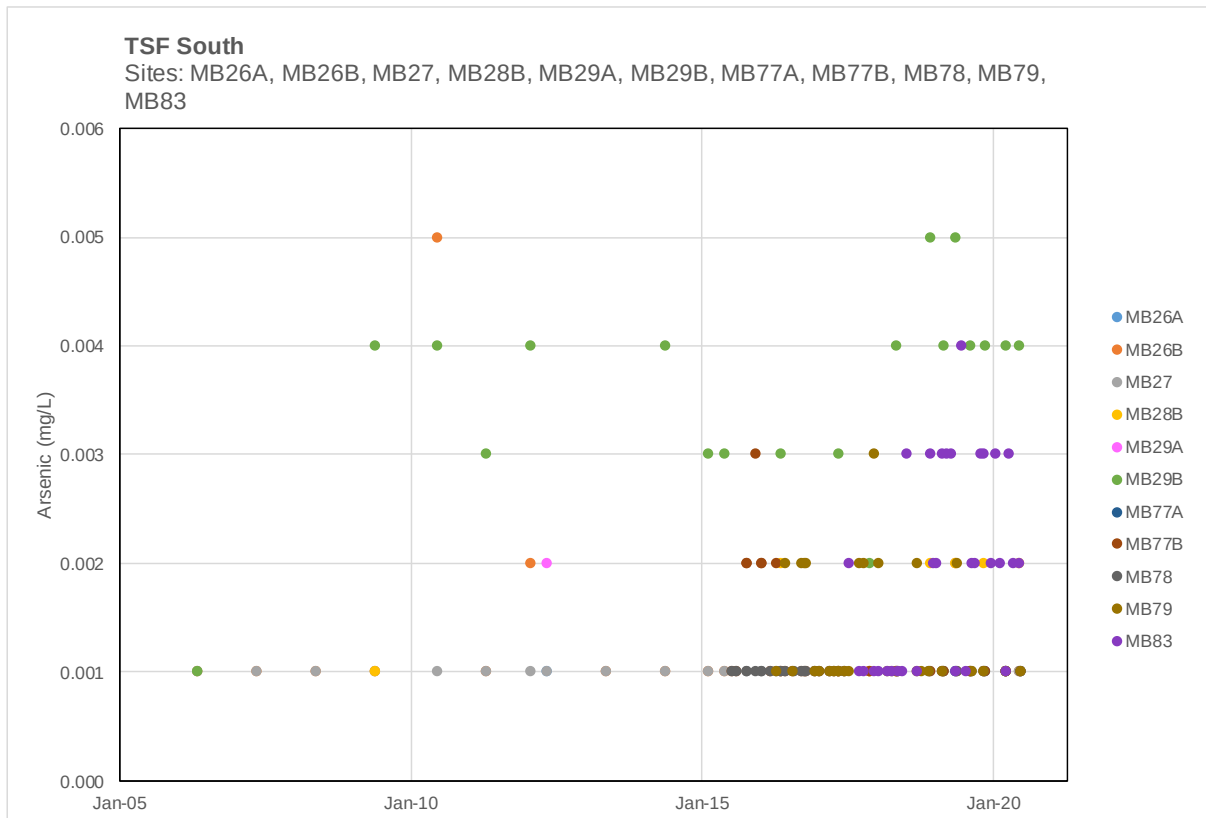
**Figure 3-74 Arsenic concentrations at bores to the south of the STSF**

Arsenic concentrations increased at MB29B and MB83 during the last two reporting periods. Arsenic concentrations were generally constant at MB29B and MB83 during the reporting period. Arsenic concentrations are plotted in Figure 3-74.
