# D.F.Dickson & Associates Pty Limited

The Project Manager  
Murlan Consulting Pty Ltd  
Jones Bay Wharf  
Sydney  
2 October 2009  
Attn: Mr. Ben MacGibbon

## **RE: 35 WATER ST – WAHROONGA, FURTHER SUPPLEMENTARY HYDROGEOLOGY AND INFILTRATION REPORT.**

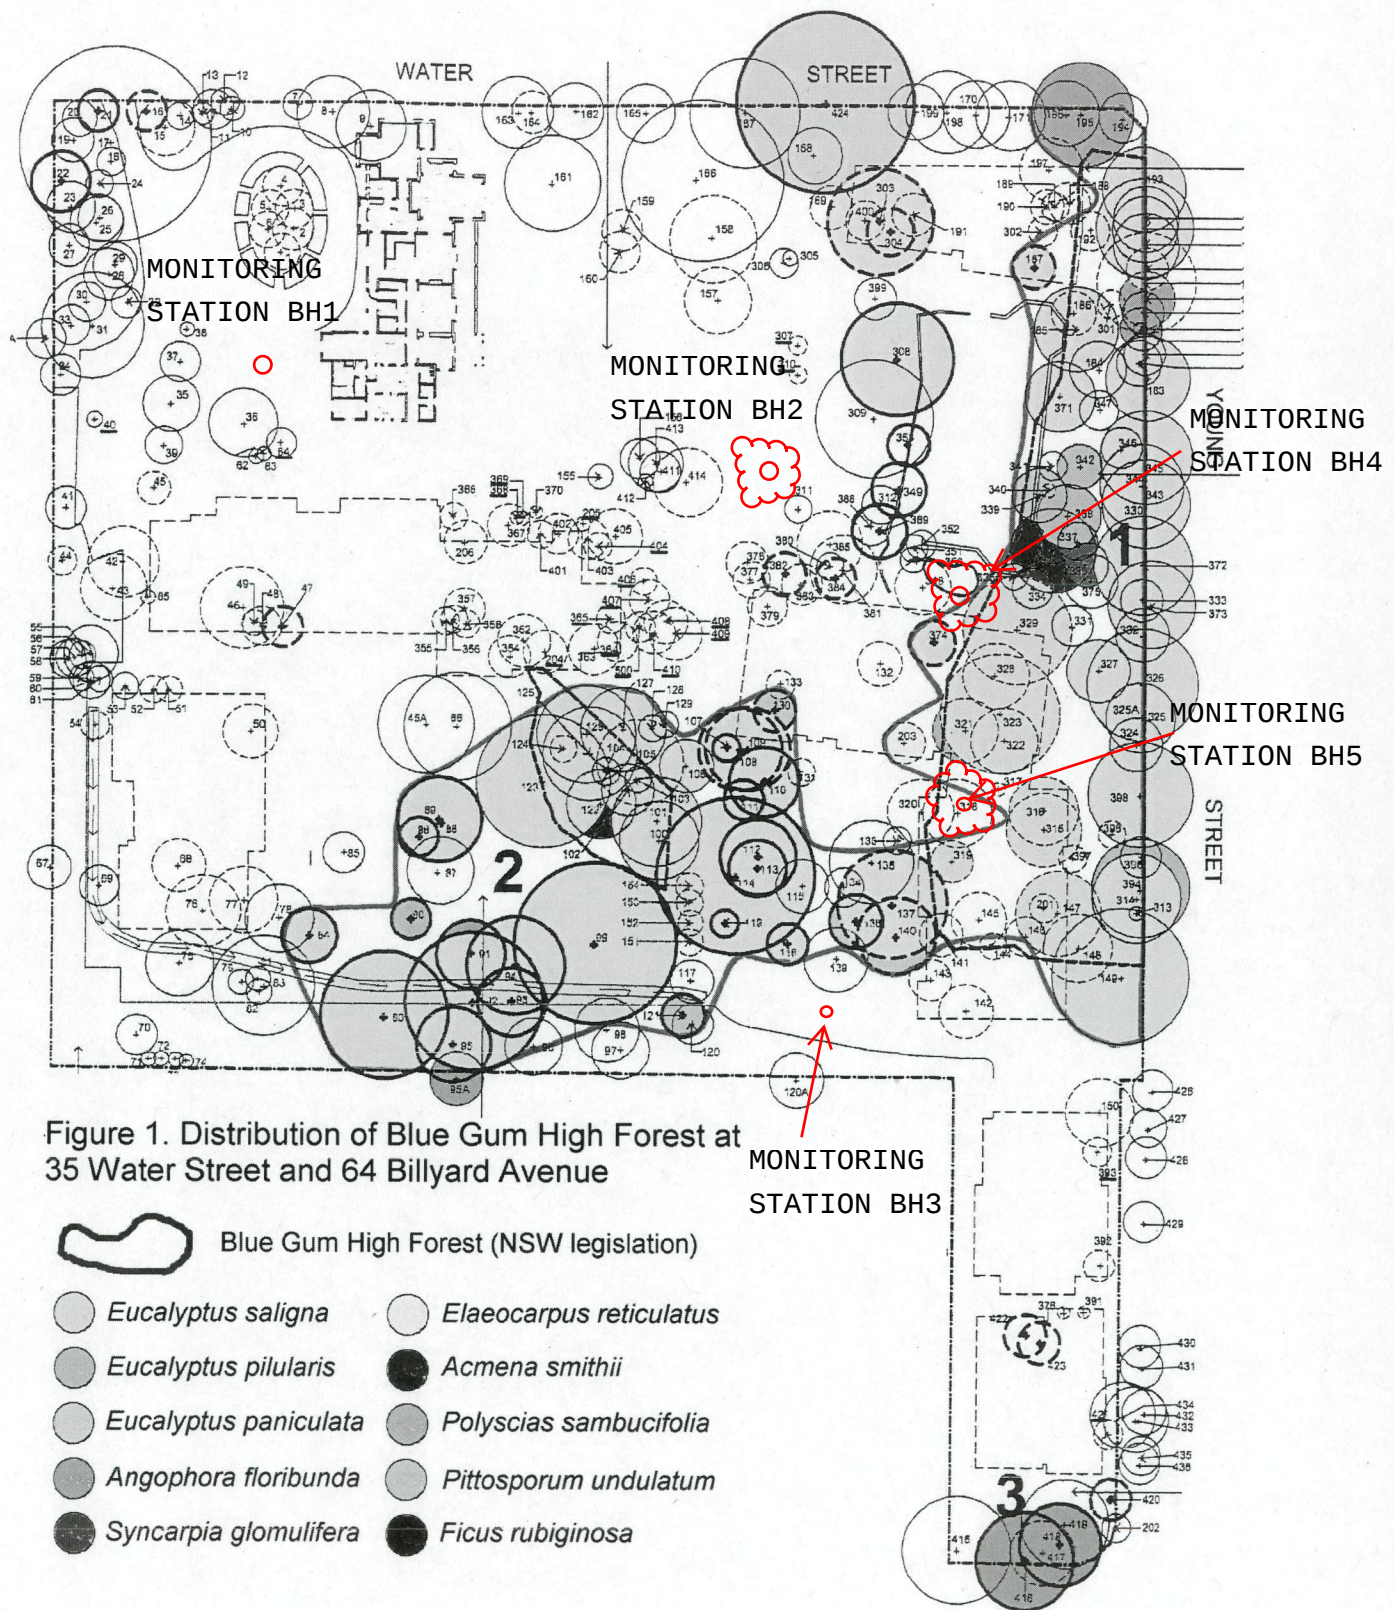
# LOCATION OF MONITORING STATIONS- PIESOMETER + SOIL MOISTURE STATIONS

PERMEAMETER AND FALLING HEAD TESTS AT MONITORING STATIONS 4 and 5.

Figure 1. Distribution of Blue Gum High Forest at 35 Water Street and 64 Billyard Avenue (Figure 1 of Smith 2007a)
