APPENDIX A – UCFL4

Site UCFL4 Site 1 (Removed from 2020 monitoring by UC MPL)

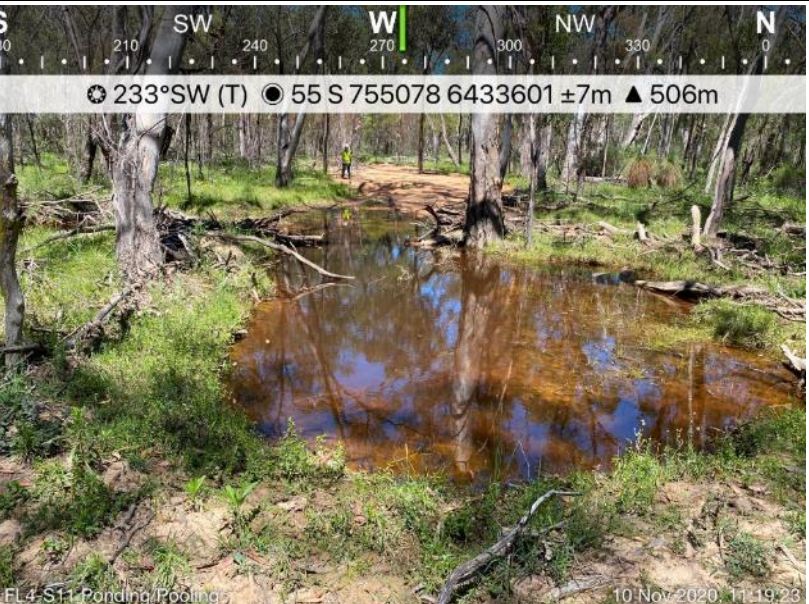
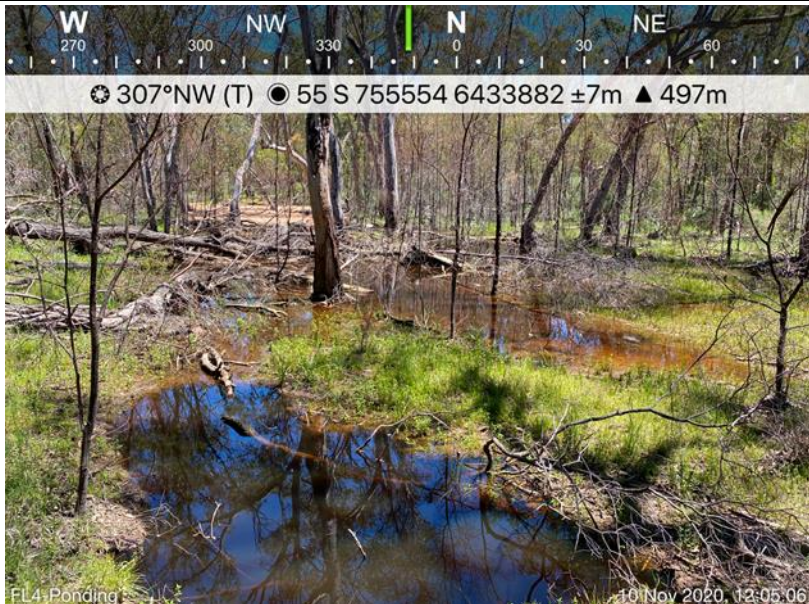
Ponding sites identified in 2020

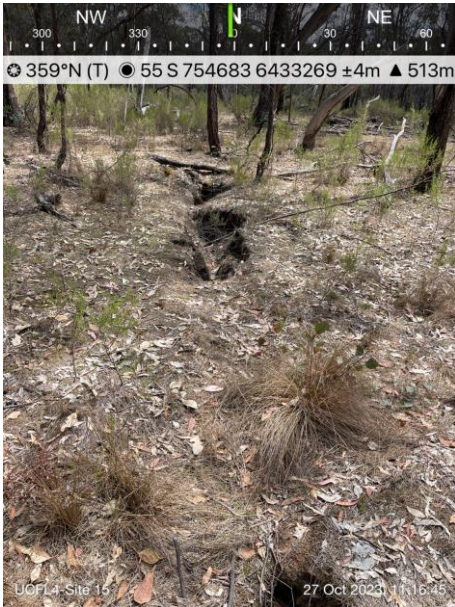
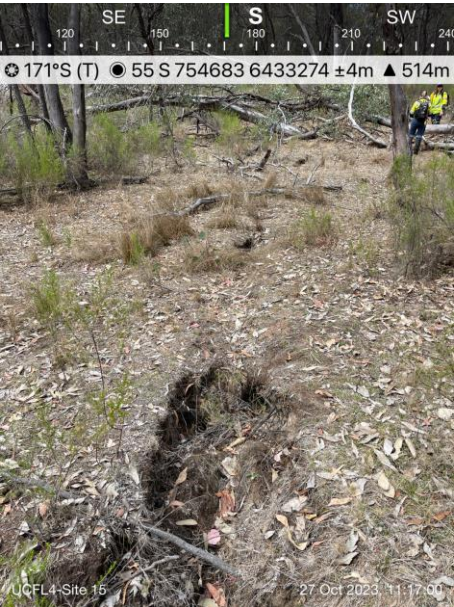
Year	October 2021	October 2022	October 2023		
Result	Pre-Mining	No Perceptible impacts	No Perceptible impacts*		
Comments / Interpretation					
<ul style="list-style-type: none"> - UCFL4 Site 15 is located above LW6 towards the eastern edge and was added to the monitoring program in 2021. - At the time of the October 2021 inspection, LW6 had 2968m of longwall retreat remaining (approximately 1.9km to the north of Site 15A). - The pre mining inspection noted the flow line was defined and the bed was partially vegetated with signs of instabilities. A scour was noted in the flow line with instabilities. Surrounding the flow line was well vegetated. - During the 2022 inspection the instabilities noted in 2021 appeared comparable with previous monitoring. - Water was flowing at the time of the inspection in 2022. - During the 2023 inspection the instabilities noted in 2021 appeared comparable with previous monitoring. - No water was observed flowing or pooling in 2023. There was decreasing groundcover. - * To the east of Site 15 extensive cracking across the creek line was identified in 2023 (see below)

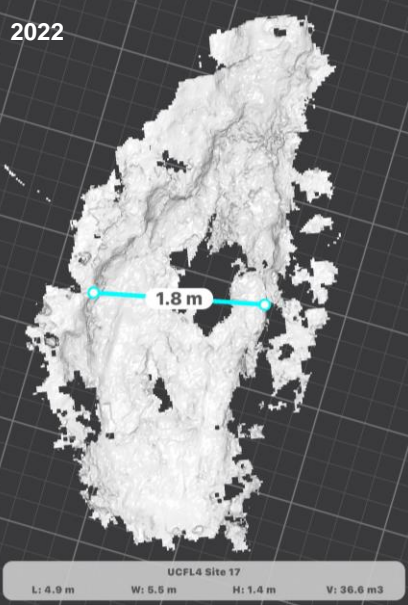
<p>2022 UCFL4 Site 17 L: 4.9 m W: 5.5 m H: 1.4 m V: 36.6 m3</p>

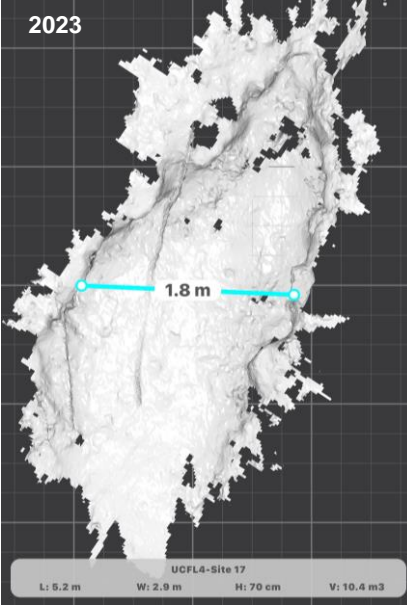
<p>2023 UCFL4-Site 17 L: 5.2 m W: 2.9 m H: 70 cm V: 10.4 m3</p>

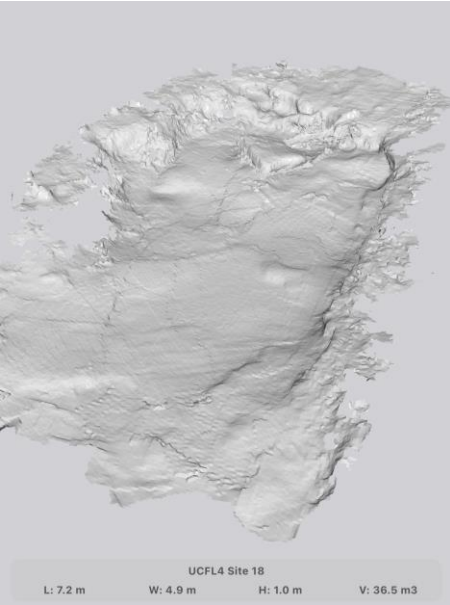
<p>UCFL4 Site 18 L: 7.2 m W: 4.9 m H: 1.0 m V: 36.5 m3</p>

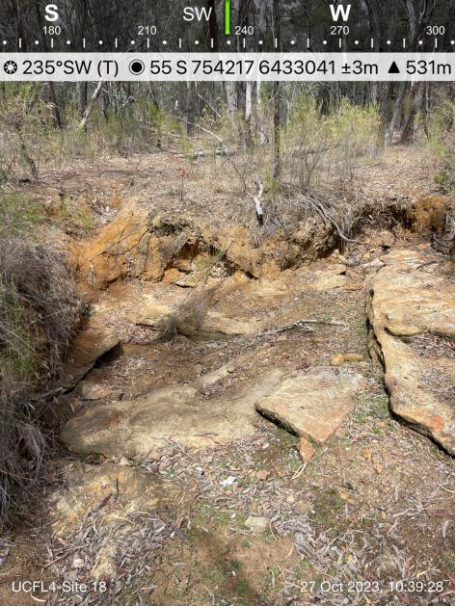
<p>UCFL4 - Site 18 27 Oct 2023, 10:39:28</p>

<p>UCFL4 - Site 18 L: 8.9 m W: 7.5 m H: 1.8 m V: 121.6 m3 UCFL4 - Site 18 L: 7.4 m W: 9.7 m H: 2.1 m V: 151.4 m3</p>

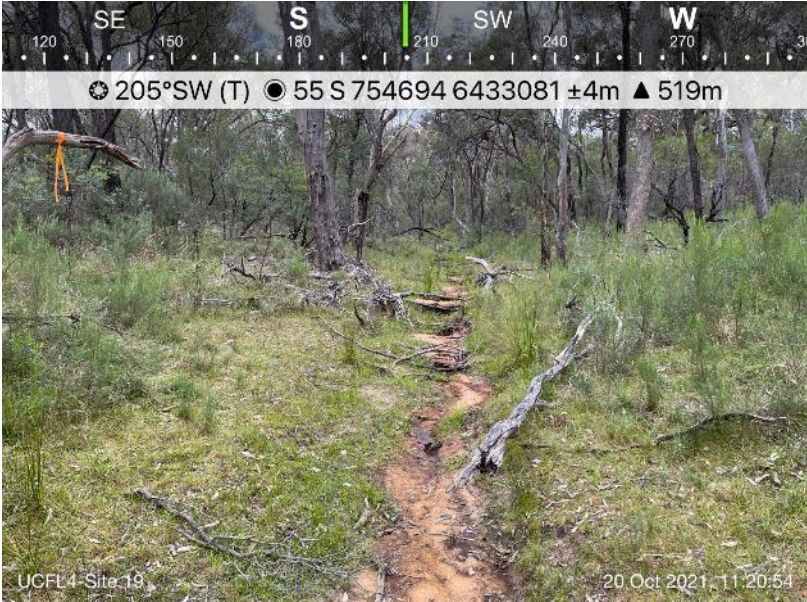
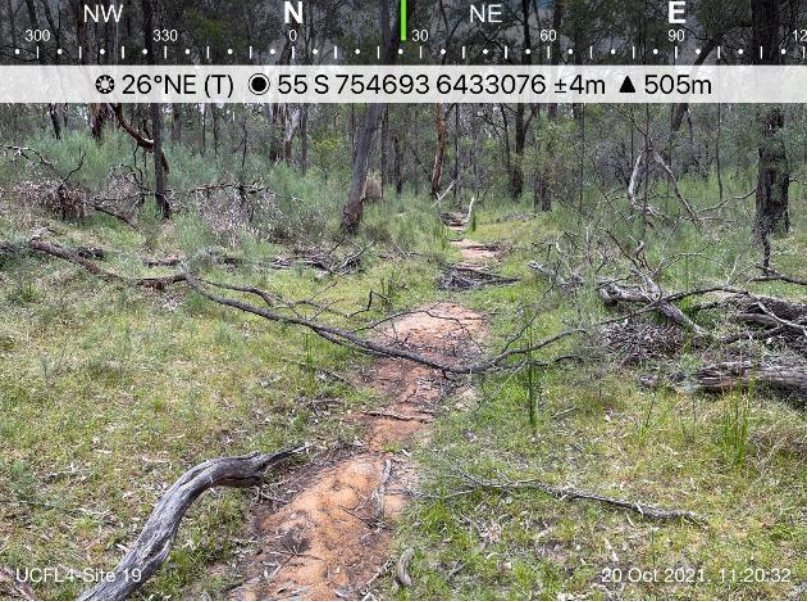
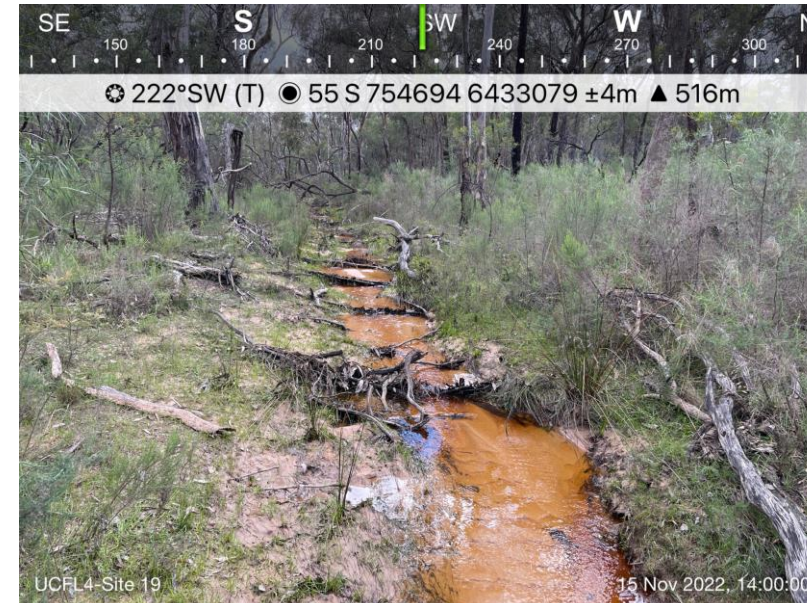
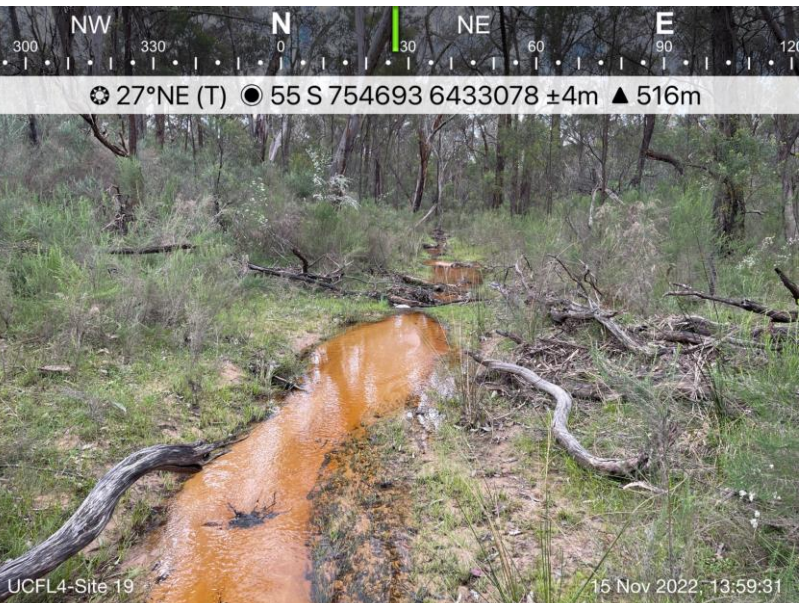
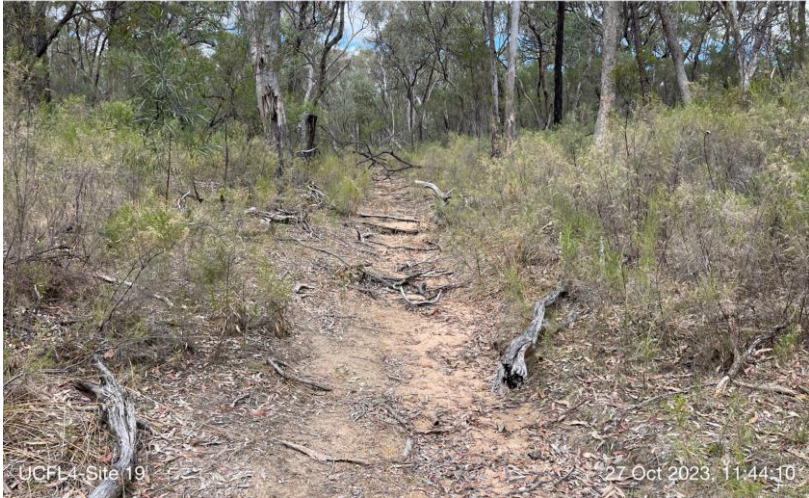
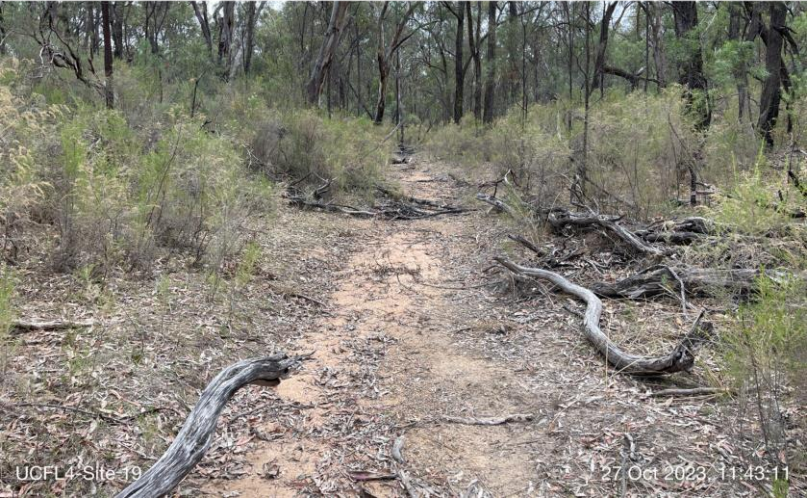
Year	October 2021	November 2022	October 2023		
Result	Pre-Mining	No Perceptible impacts	No Perceptible impacts		
Comments / Interpretation					
<ul style="list-style-type: none"> - UCFL4 Site 19 is located above LW6 towards the eastern edge and was added to the monitoring program in 2021. - At the time of the October 2021 inspection, LW6 had 2968m of longwall retreat remaining (approximately 1.9km to the north of Site 15A). - The pre mining inspection noted the flow line was well defined within a sand bed, well vegetated banks and surrounds and generally stable. - During the 2022 inspection the instabilities noted in 2021 appeared comparable with previous monitoring. - Water was observed flowing in 2022. - During the 2023 inspection the instabilities noted in 2021 appeared comparable with previous monitoring. - No water was observed flowing or pooling in 2023. There was decreasing groundcover.

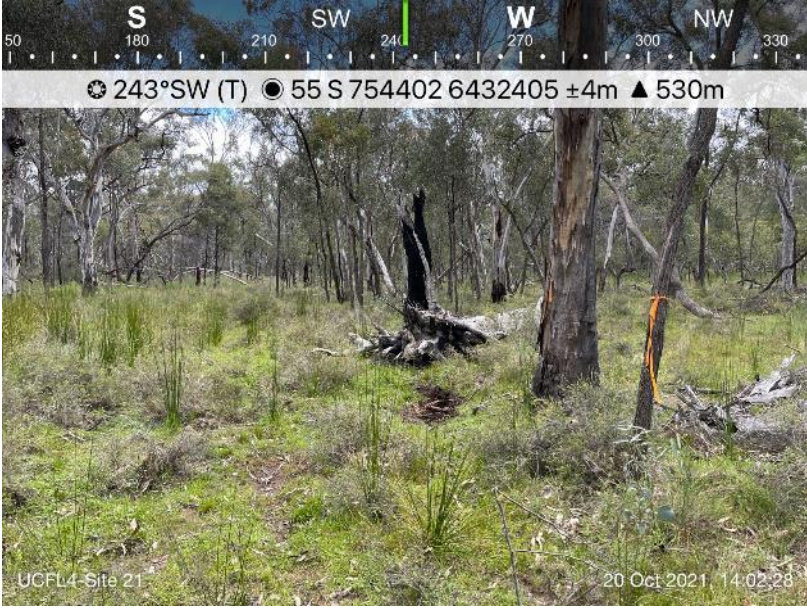
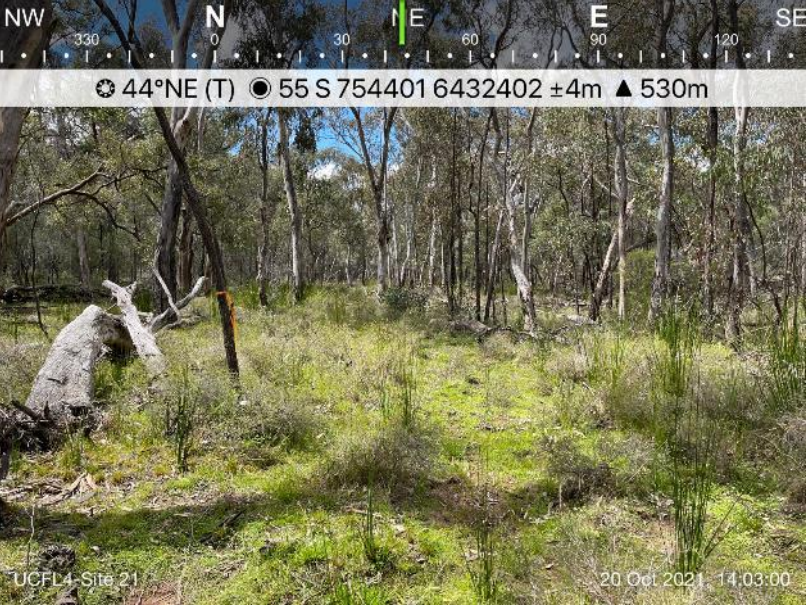
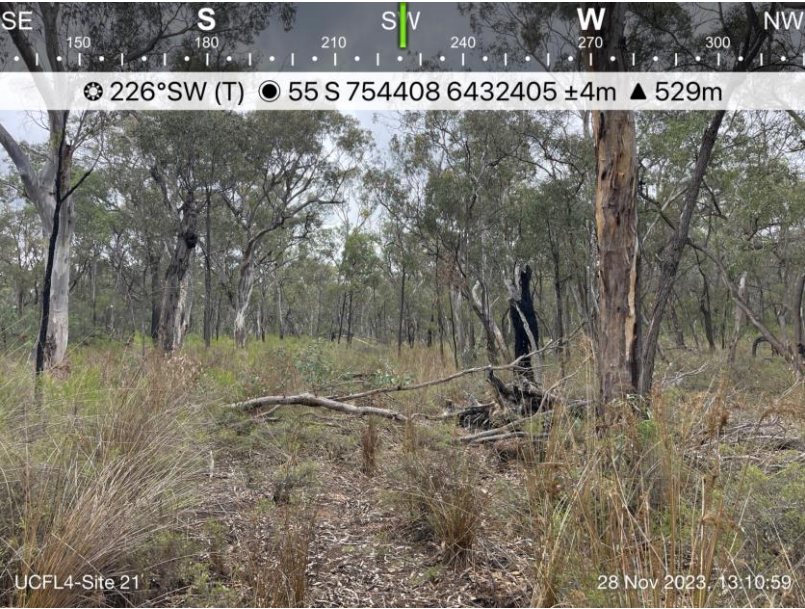
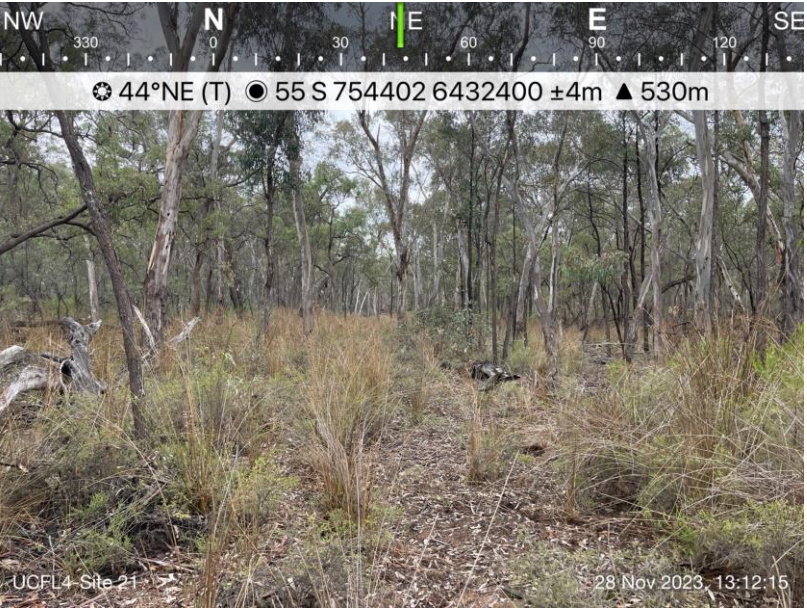
Site Attributes					
Date Sampled		28 November 2023			
Approximate Easting		754401			
Approximate Northing		6432402			
Monitoring Requirement		Monitoring to distinguish between natural erosion and erosion from mine subsidence instability, surface cracking, surface ponding and out of channel flows. Monitoring before longwall retreats and annually for a period of two years. Notes: Longwall (LW6) at Ulan West (Pre-Mining – 20 Oct 2021)			
2023 Monitoring Photo					
Year	October 2021	November 2022	November 2023		
Result	Pre-Mining	No Perceptible impacts	No Perceptible impacts		
Comments / Interpretation					
<ul style="list-style-type: none"> - UCFL4 Site 21 is located above LW6 near the end of panel towards the western edge and was added to the monitoring program in 2021. - At the time of the October 2021 inspection, LW6 had 2968m of longwall retreat remaining (approximately 1.9km to the north of Site 15A). - The pre mining inspection noted the flow line was not well defined, within a flood plain and was very well vegetated and stable. At the time of the inspection the ground was very saturated. A small scour was the only obvious instability noted. - During the 2022 inspection the instabilities noted in 2021 appeared comparable with previous monitoring. - Water was observed flowing in 2022. The ground was saturated with thick ground cover. - During the 2023 inspection the site appeared comparable with previous monitoring and the flow line was dry with decreasing groundcover.

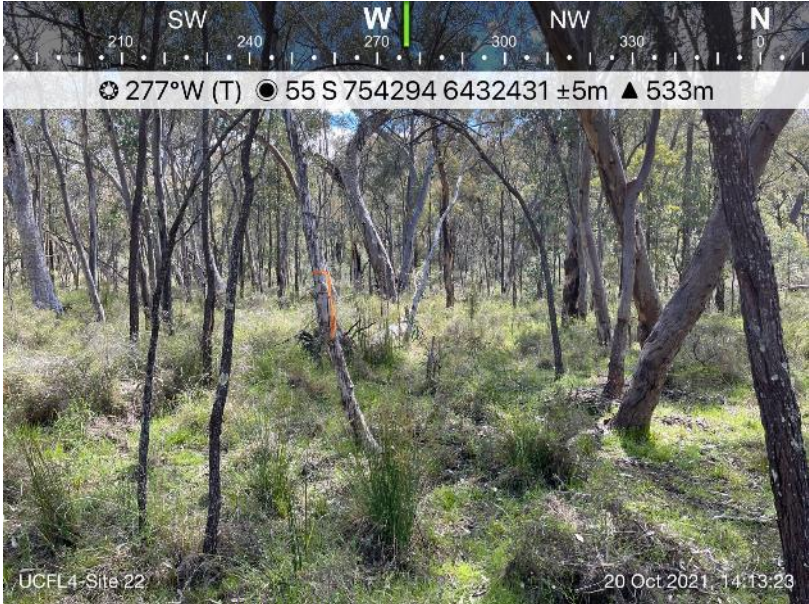
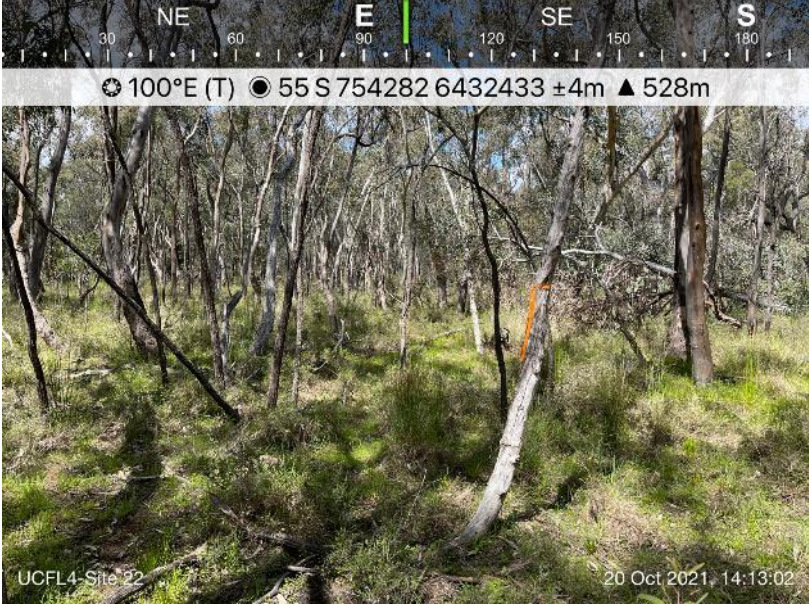
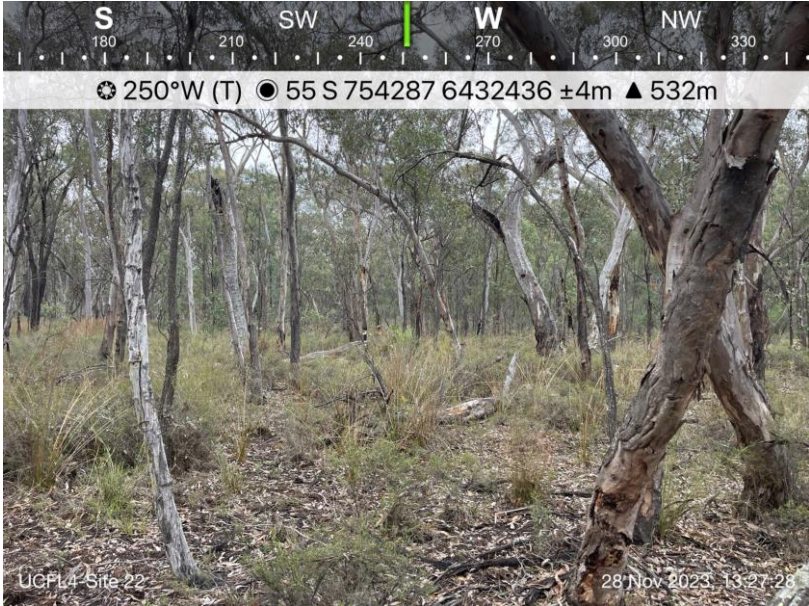
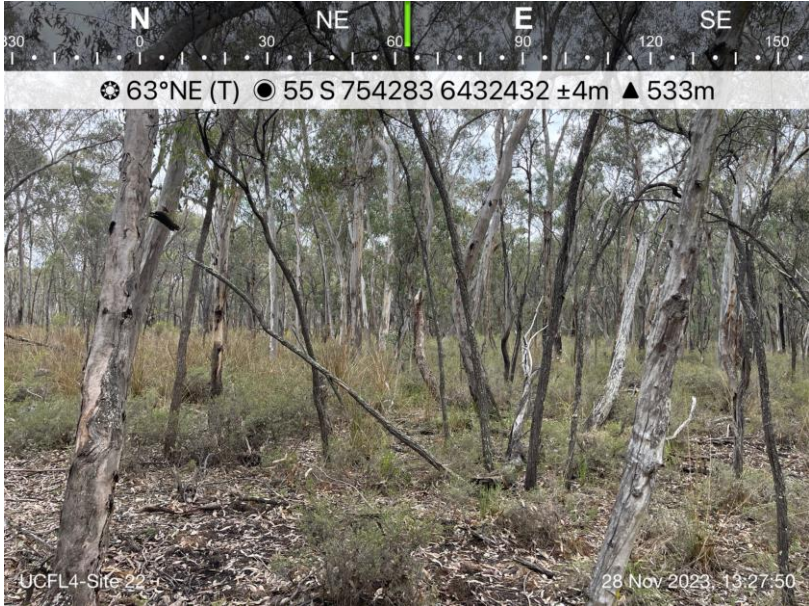
Year	October 2021	October 2022	November 2023		
Result	Pre-Mining	No Perceptible Impacts	No Perceptible Impacts		
Comments / Interpretation					
<ul style="list-style-type: none"> - UCFL4 Site 22 is located above LW6 near the end of panel on the western edge and was added to the monitoring program in 2021. - At the time of the October 2021 inspection, LW6 had 2968m of longwall retreat remaining (approximately 1.9km to the north of Site 15A). - The pre mining inspection noted the flow line was not well defined, within a flood plain and was very well vegetated and stable. At the time of the inspection the ground was very saturated. - During the 2022 inspection the instabilities noted in 2021 appeared comparable with previous monitoring. - Water was observed flowing in 2022. - During the 2023 inspection the site appeared comparable with previous monitoring and the flow line was dry with decreasing groundcover.
