**APPENDIX B – UCFL2**

**Site UCFL2 Site 1** (Removed from 2021 monitoring by UCML)

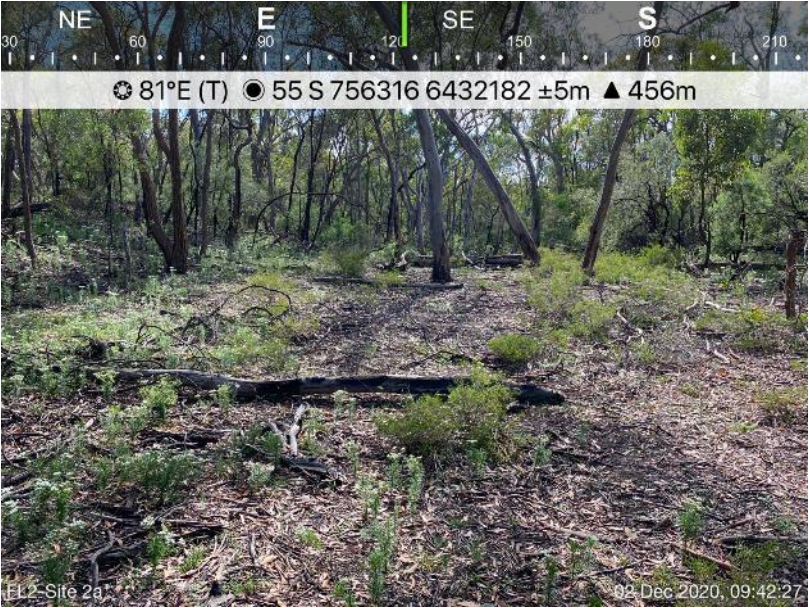
Year	Upstream	Downstream
2020

<b>Year</b>	<b>October 2017</b>	<b>February 2019</b>	<b>December 2020</b>	<b>October 2021</b>
<b>Result</b>	Perceptible impacts	Perceptible impacts (no change)	Perceptible impacts (no change)	Perceptible impacts (no change)
<b>Comments / Interpretation</b>				
<ul style="list-style-type: none"> <li>- UCFL2 Site 2A (near site 1A) is above LW2 and was identified during the 2017 monitoring program. Perceptible impacts in the form of a potential ponding site and minor surface cracking were observed.</li> <li>- During the 2020 inspection no perceptible change to historical cracking, partial infilling of cracking, an increase in ground vegetation, additional flood debris within and along the banks of the flow line were observed.</li> <li>- Continue to monitor infilling of crack with the channel bed noted 2020.</li> <li>- Partial infilling of cracks noted in 2021 – had not deteriorated since 2020.</li> <li>- Remove from monitoring</li> </ul>

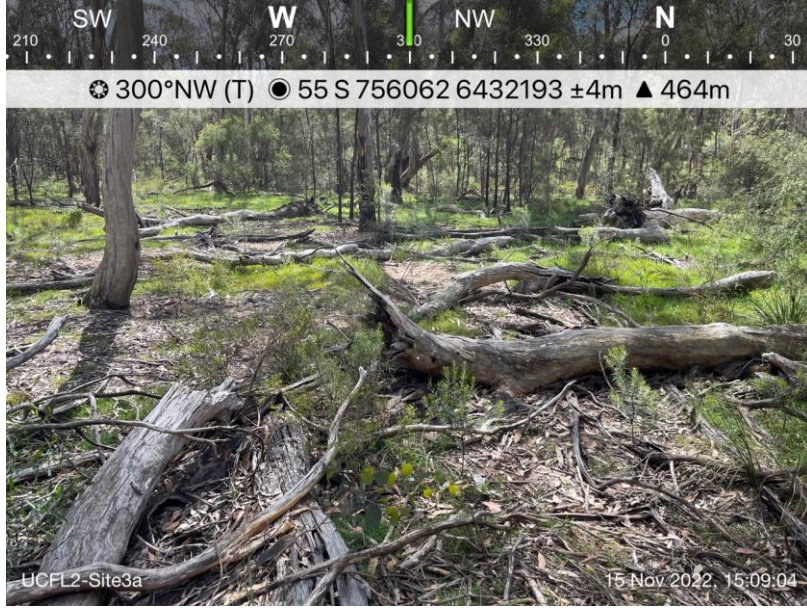
Year	Upstream	Downstream
	  <p>99°E (T) ● 55 S 756058 6432196 ±4m ▲ 464m</p> <p>UCFL2-Site3a 15 Nov 2022, 15:09:25</p>

<b>Year</b>	<b>October 2017</b>	<b>February 2019</b>	<b>December 2020</b>	<b>October 2021</b>	<b>November 2022</b>
<b>Result</b>	Perceptible impacts	Perceptible impacts	Perceptible impacts	Perceptible impacts (no change)*	Perceptible impacts (no change)*
<b>Comments / Interpretation</b>					
<ul style="list-style-type: none"> <li>- UCFL2 Site 3A is above LW2 towards the western edge of the longwall panel and was identified during the 2017 monitoring program. Perceptible impacts in the form of channel cracking were observed.</li> <li>- During the 2019 inspection there were signs of potential tunnel erosion noted.</li> <li>- During the 2020 inspection there were signs of increased tunnel erosion, although partial infilling was also observed.</li> <li>- Partial infilling of cracks noted in 2021 – had not deteriorated since 2020.</li> <li>- In 2022 the exact location of the erosion site was difficult to relocate due to increased ground vegetation and timber. The site in general appeared stable and past evidence of subsidence related impacts were not perceptible on the day of the inspection.</li> </ul>

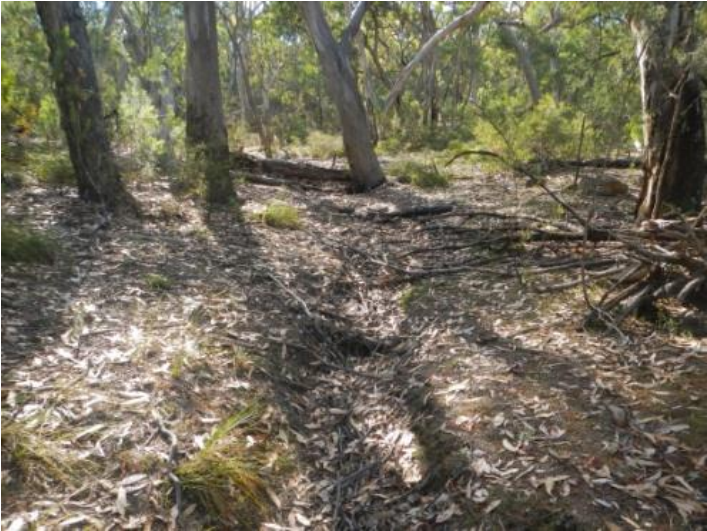
Year	Upstream	Downstream
2015

<ul style="list-style-type: none"> <li>- UCFL2 Site 4 is approximately located towards the western edge of LW3. To date no perceptible change has been identified as a result of longwall mining at this monitoring site.</li> <li>- During the 2020 inspection there was no evidence of subsidence related impacts identified. There was an increase in ground vegetation, additional flood debris within and along the banks of the flow line observed.</li> <li>- This site could be considered for removal from the post mining monitoring program of Ulan Creek tributaries due to no perceptible change since the completion of LW3 in October 2017.</li> <li>- During the 2021 there was no perceptible change to previous monitoring.</li> <li>- Remove from monitoring</li> </ul>						
<b>Recommendations</b>						
<ul style="list-style-type: none"> <li>- If unchanged and past two year recommend remove from annual monitoring program (<b>yes/no</b>)</li> <li>- Recommend recording cross sections at locations identified with channel and/or channel bank cracking as a result of subsidence, to monitor for erosion and/or changes to the channel width (<b>yes/no</b>)</li> </ul>

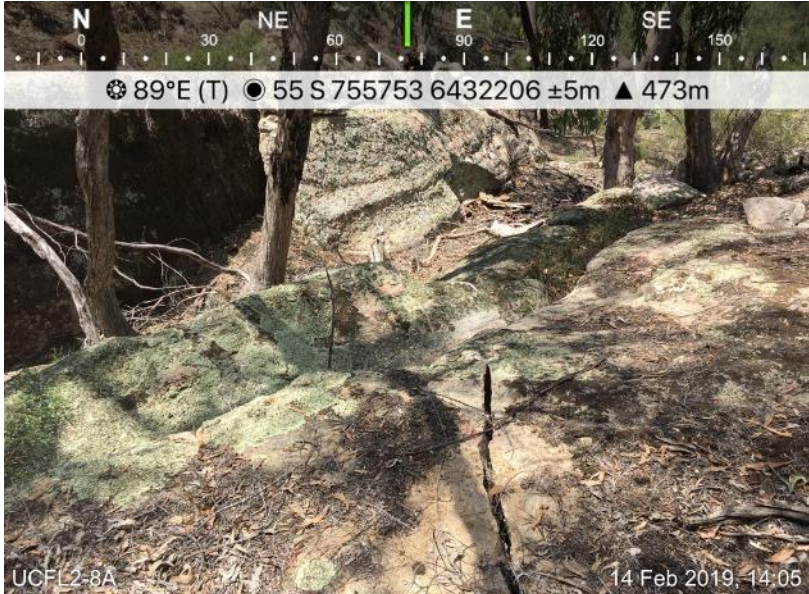
<p data-bbox="280 1350 1086 1382">UCFL2-8A 14 Feb 2019 14:05</p>

Year		
2017	  <p data-bbox="264 738 719 770">Ulan CK - Flow Line 2 - Crack 27 Oct 2017 11:50</p>	
2019
