## APPENDIX B: Ulan Creek

## 2025 Channel Stability Monitoring - Site Inspection Details

**Creek Name:** Ulan Creek

**Date:** 18 September 2025

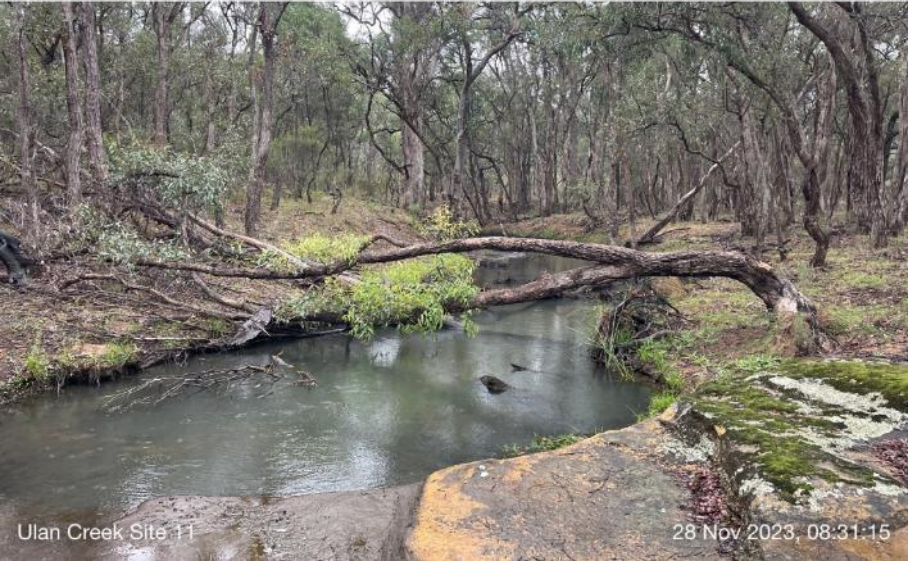
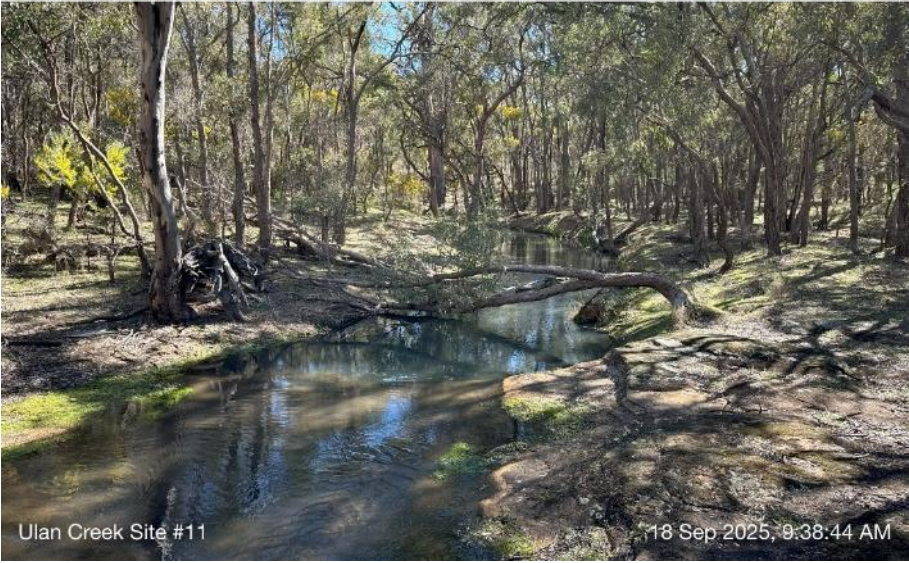
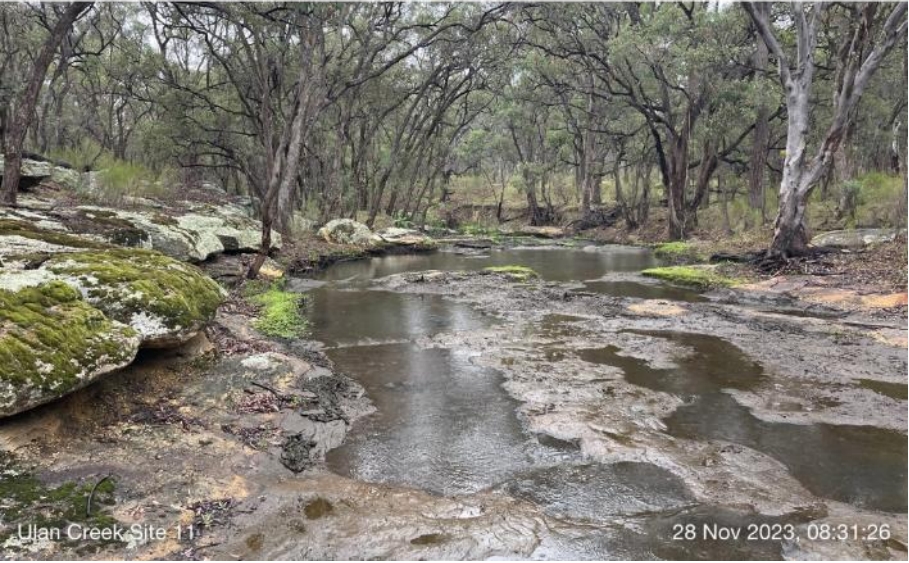
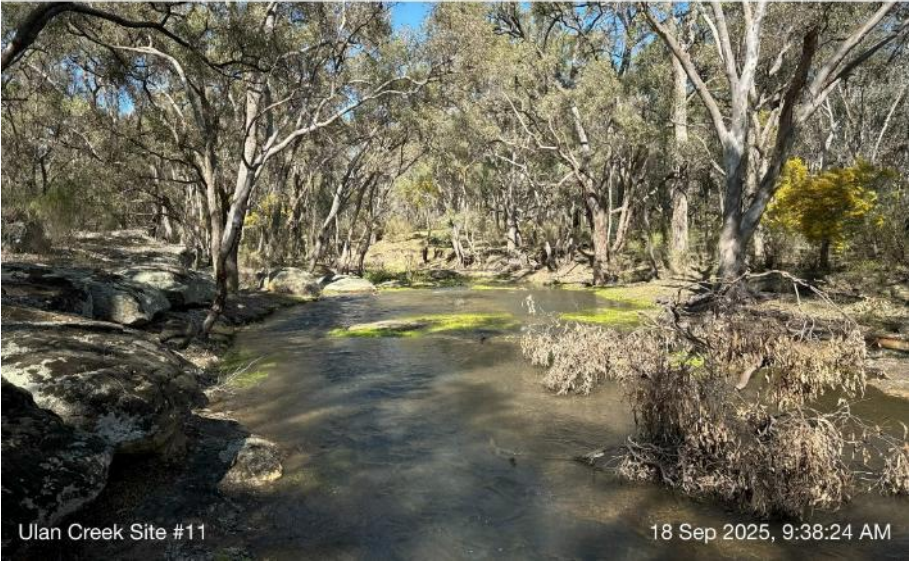
**Notes:** In 2025 observations were limited to the LHB and water flowing. This site appeared stable above the water line upstream of the bedrock.

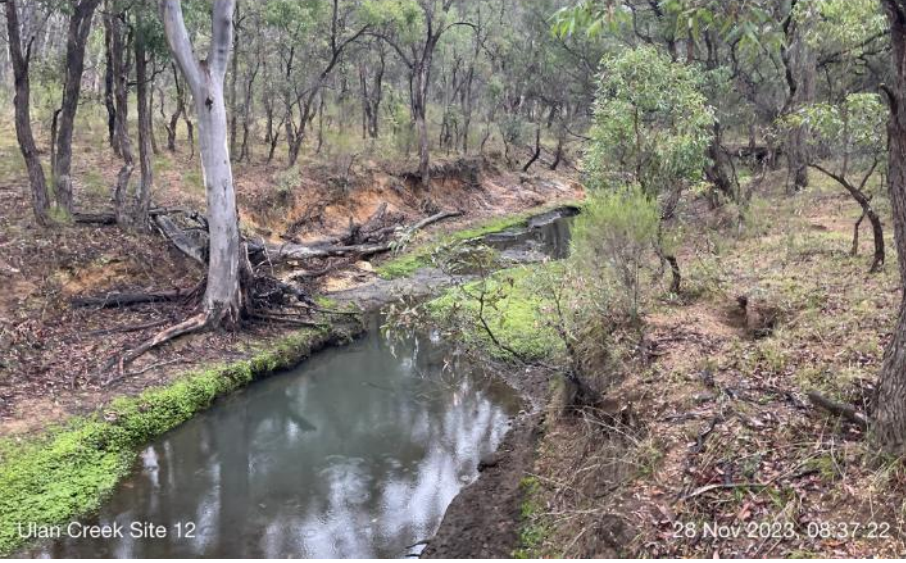
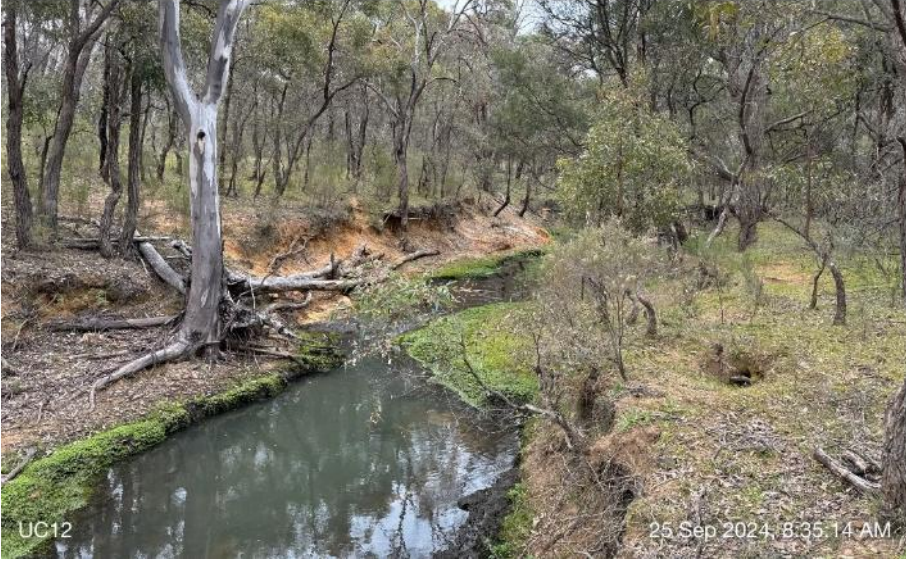
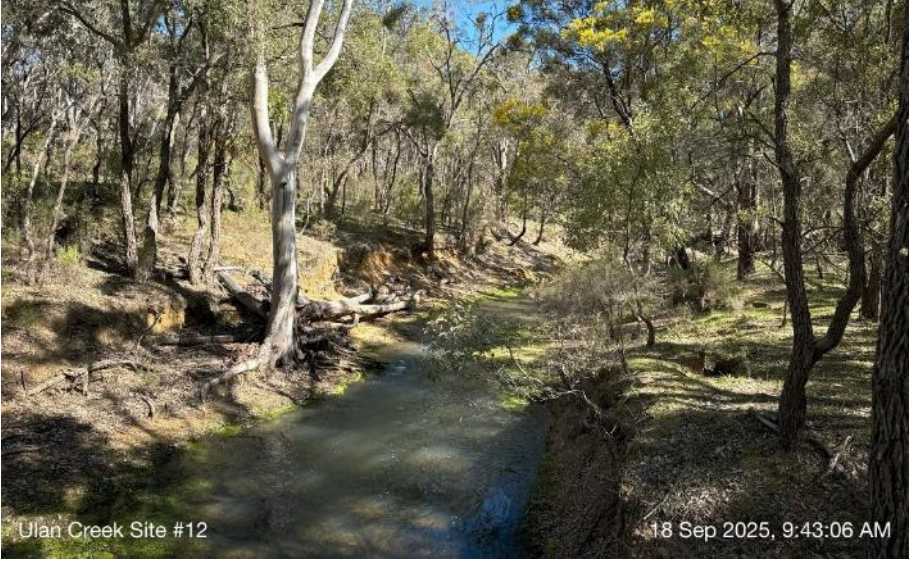
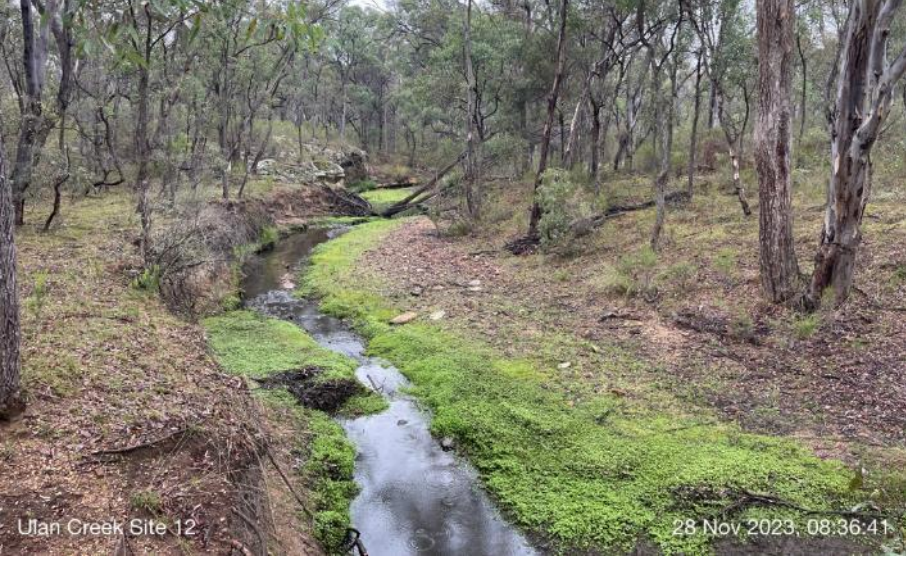
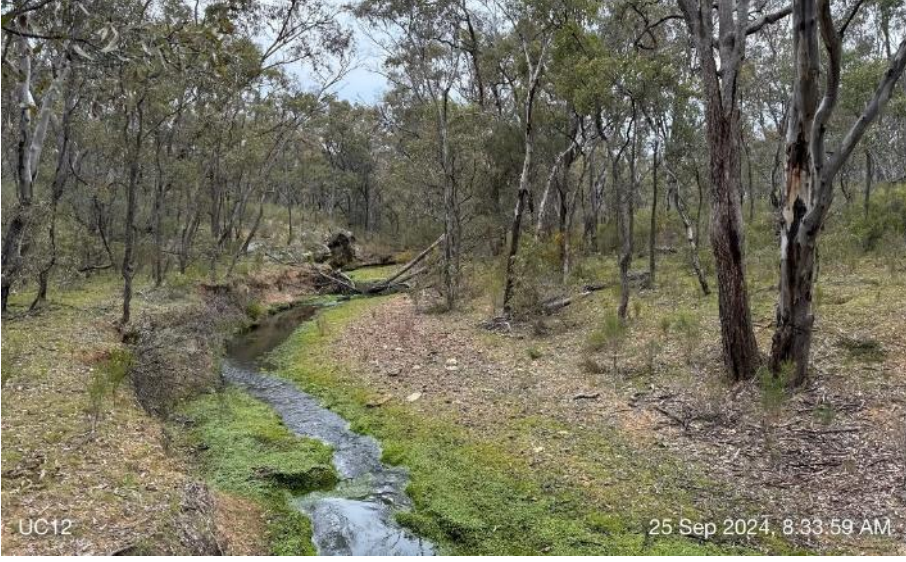
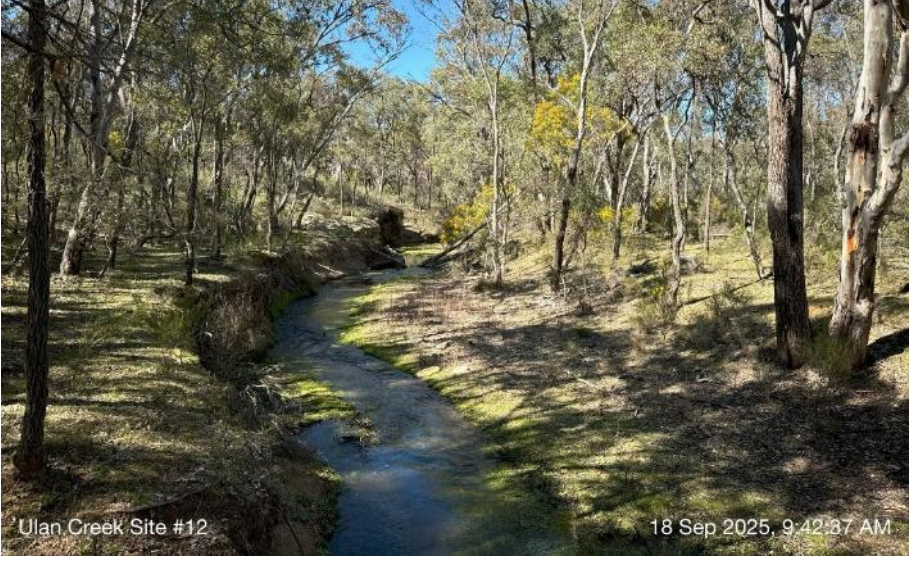
**General Observations:** Ulan Creek had water flowing at this location in 2025. The channel bed is characterised by gravel size and some larger rock, with signs of increasing vegetation along the low flow channel. Flood debris was located above the LHB in 2020. Increased erosion along the LHB was noted again in 2022. A tree had fallen into the creek from the LHB as noted back in 2020. The LHB wall is near vertical, almost entirely bare, with exposed tree roots, signs of very recent erosion and some minor undercutting. The RHB is a gentler slope, mostly with bare areas and sparse vegetation. Comparable groundcover above the LHB and RHB as previous year. Both sides of the creek are tree lined. An infestation of Tree of Heaven was noted between sites UC11 and UC12. Observations in 2025 are comparable to previous monitoring. The CSIRO *Ephemeral Stream Assessment* classification at this location as 'active'.

**Notes:** In 2025 observations were limited to the LHB and water flowing.

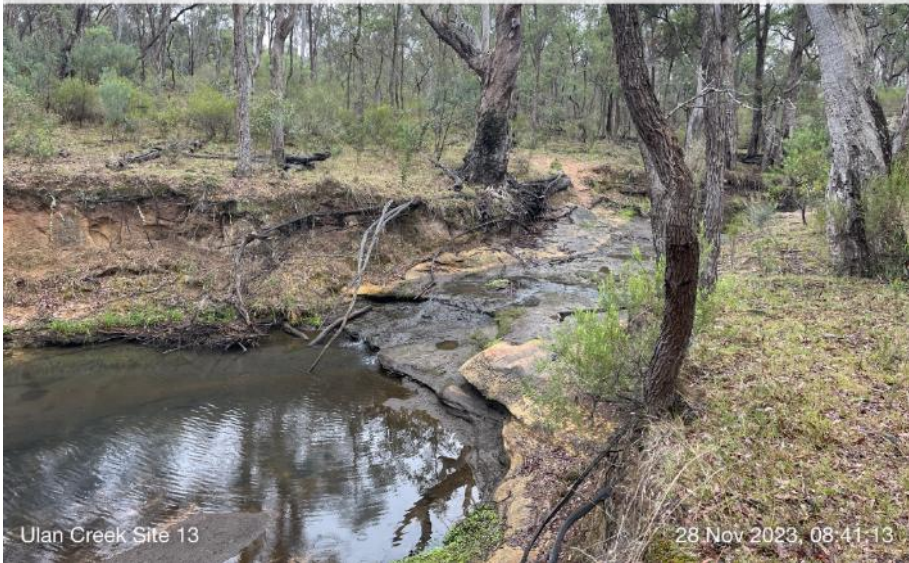
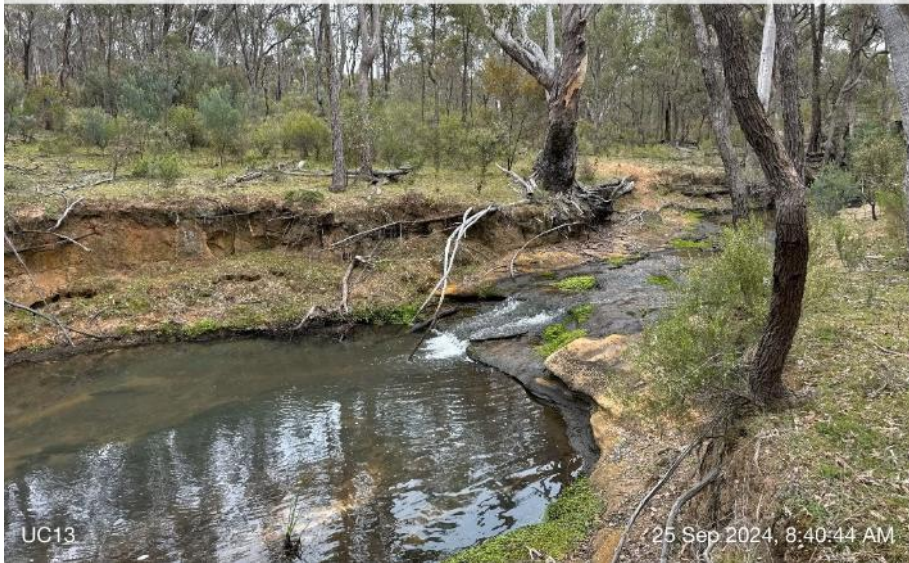
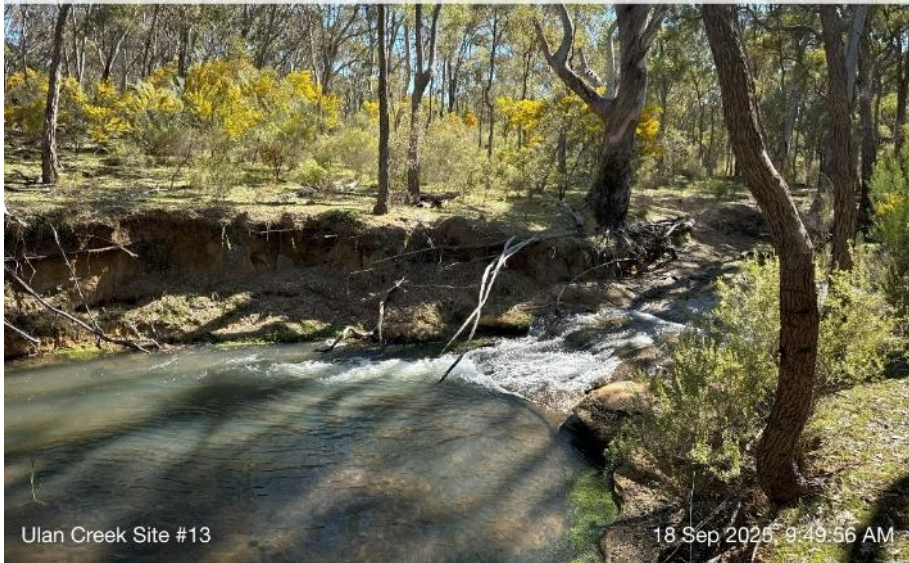
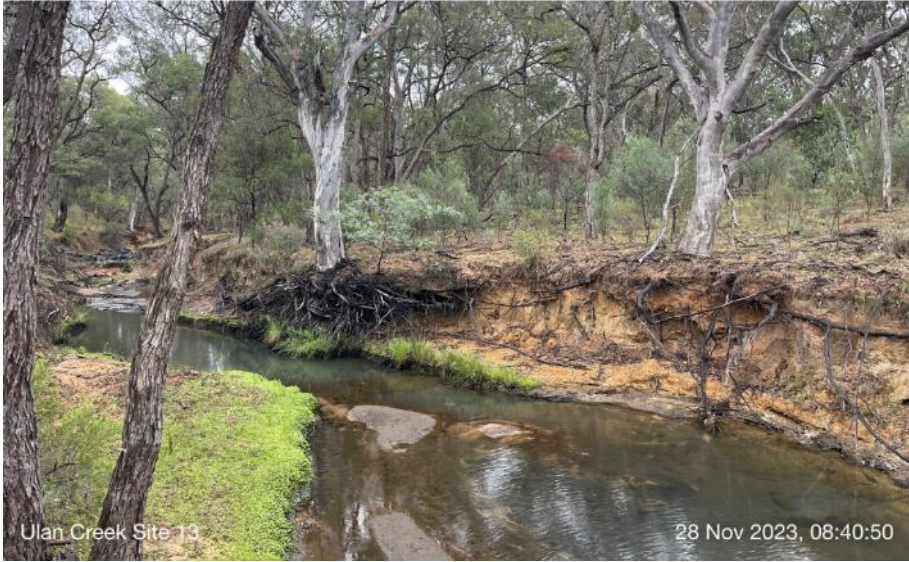
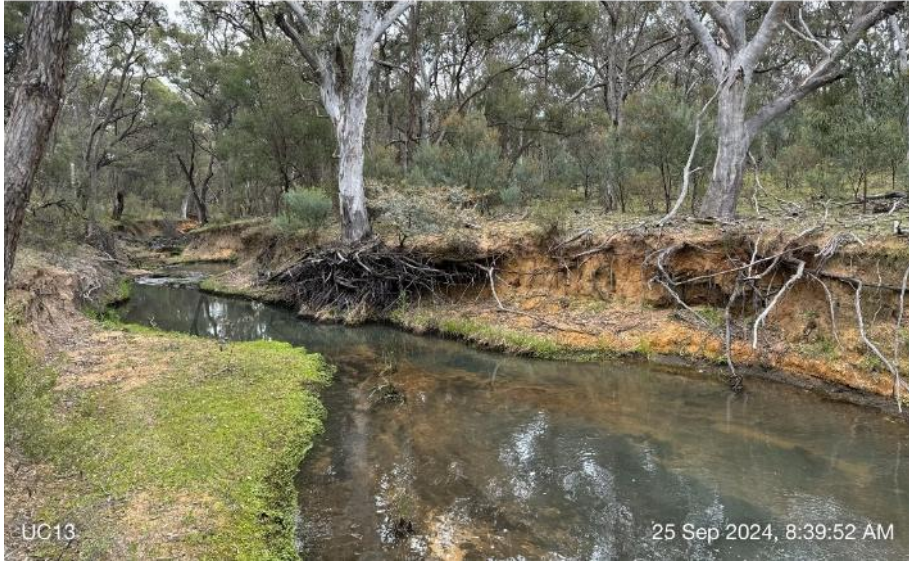
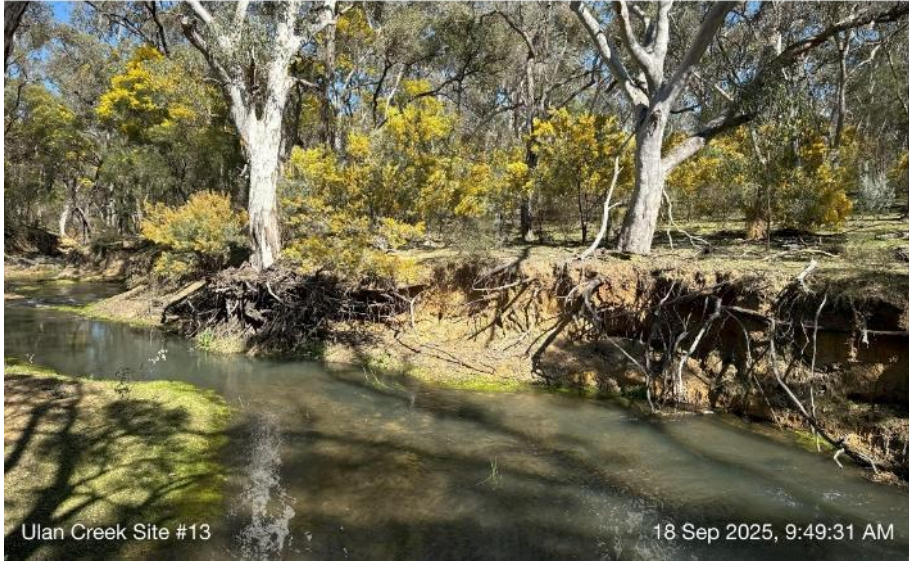
**General Observations:** Ulan Creek had water flowing at this location in 2025. From previous monitoring, the channel bed is a mix of silt, sand and gravel. In 2022 additional sand and sediments had deposited along the creek bed with little vegetation. Flood debris was located above the LHB in 2020. Active erosion along both banks was again observed in 2022. The LHB and RHB walls are near vertical, bare with exposed tree roots, signs of erosion and undercutting. Both sides of the creek are tree lined. Comparable groundcover above the LHB and RHB as in previous year. Observations in 2025 are comparable to previous monitoring. The CSIRO *Ephemeral Stream Assessment* classification at this location as 'active'.

**Notes:** In 2025 observations were limited to the LHB and water flowing. The creek bed could not be assessed.

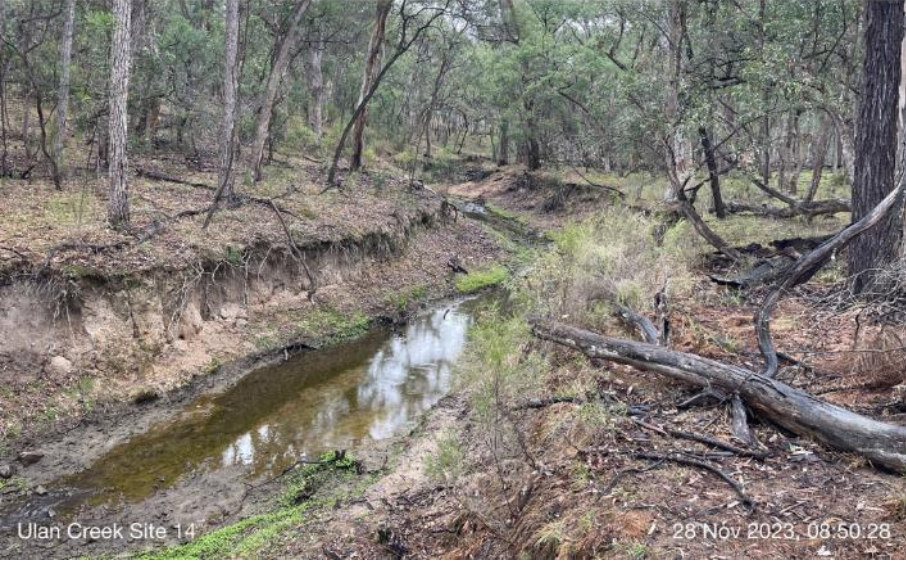
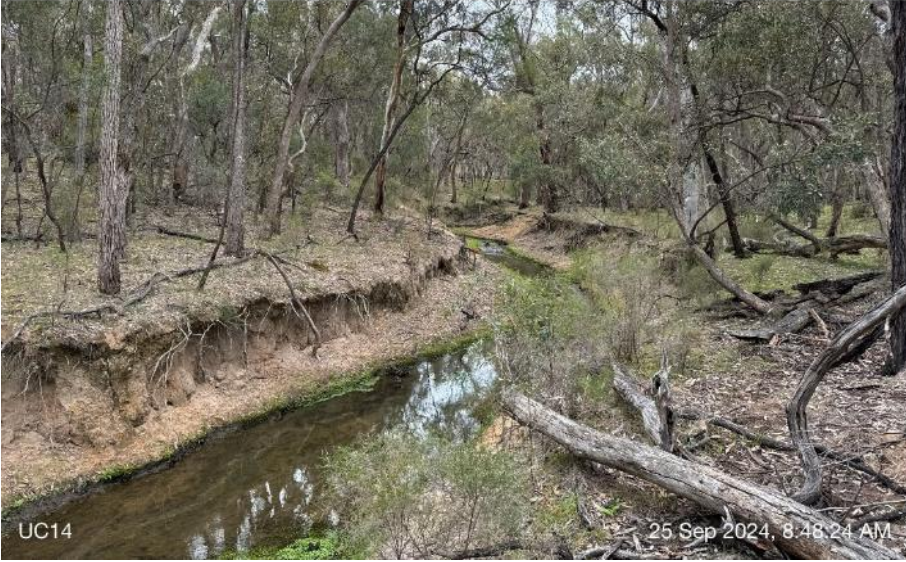
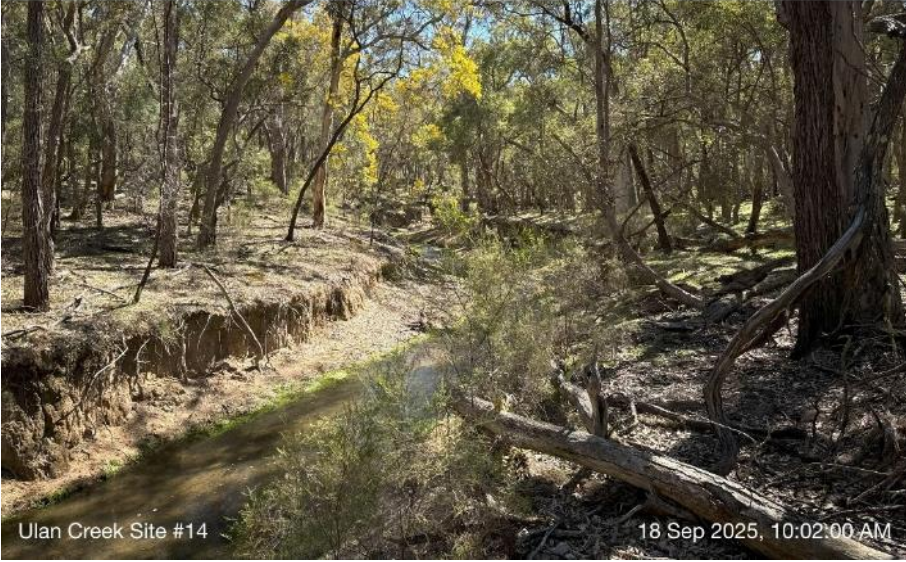
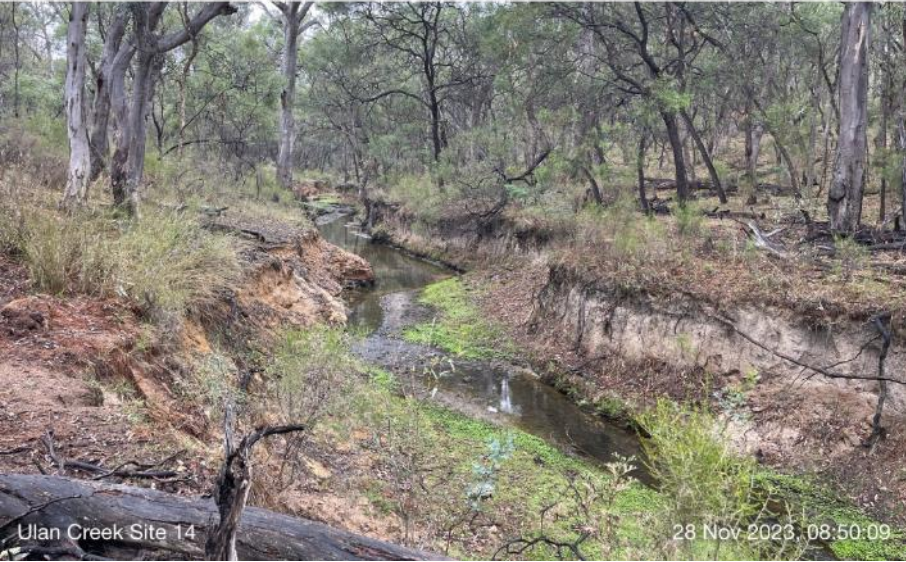
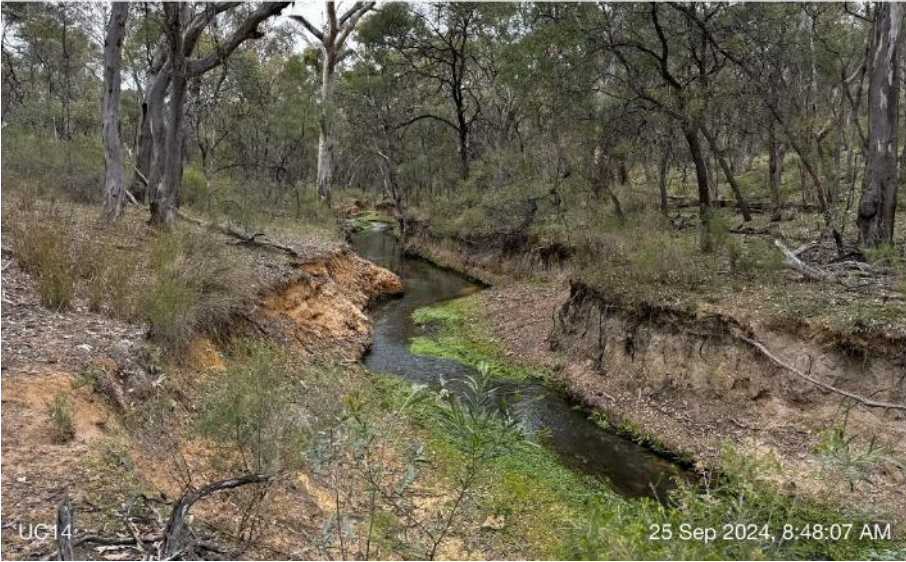
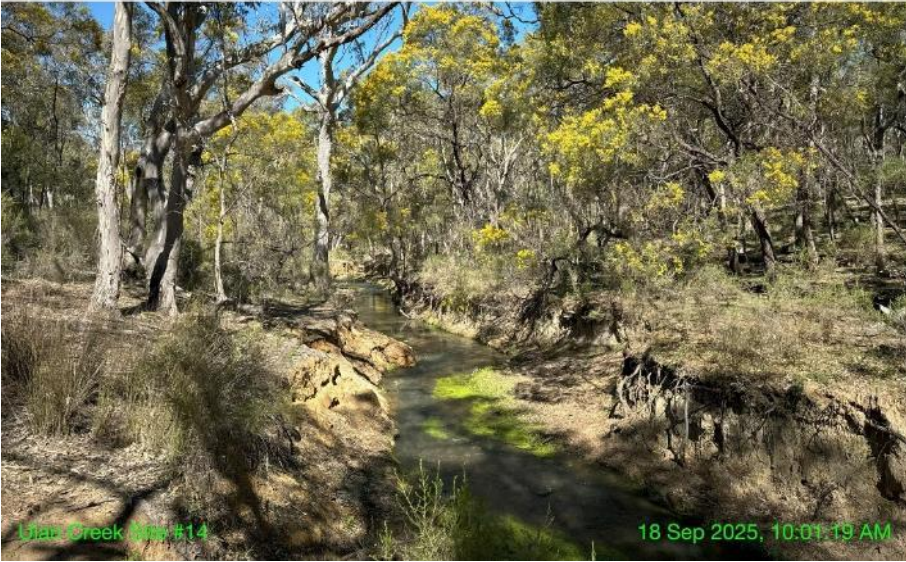
**General Observations:** Ulan Creek was flowing at this location in 2025. Active erosion along both banks was observed in 2022. From previous monitoring, the channel bed is a mix of silt, sand and smaller gravel. In 2022 additional build up of sand, silt and small gravel deposits were noted. Flood debris was located above the LHB in 2020. Increased erosion along both the LHB and RHB with undercutting more notable under the top edge of the banks in 2022. The LHB and RHB have near vertical walls from the top of the bank, bare with exposed tree roots and with signs of erosion. Comparable groundcover above the LHB and RHB as previous year. Both sides of the creek are tree lined. Observations in 2025 are comparable to previous monitoring. The CSIRO *Ephemeral Stream Assessment* classification at this location as 'active'

**Notes:** In 2025 observations were limited to the LHB and water flowing.

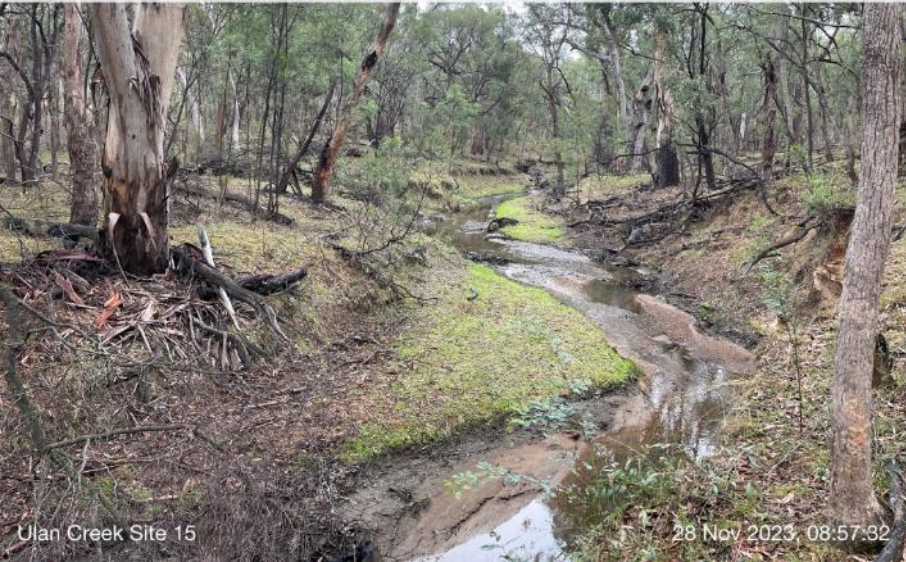
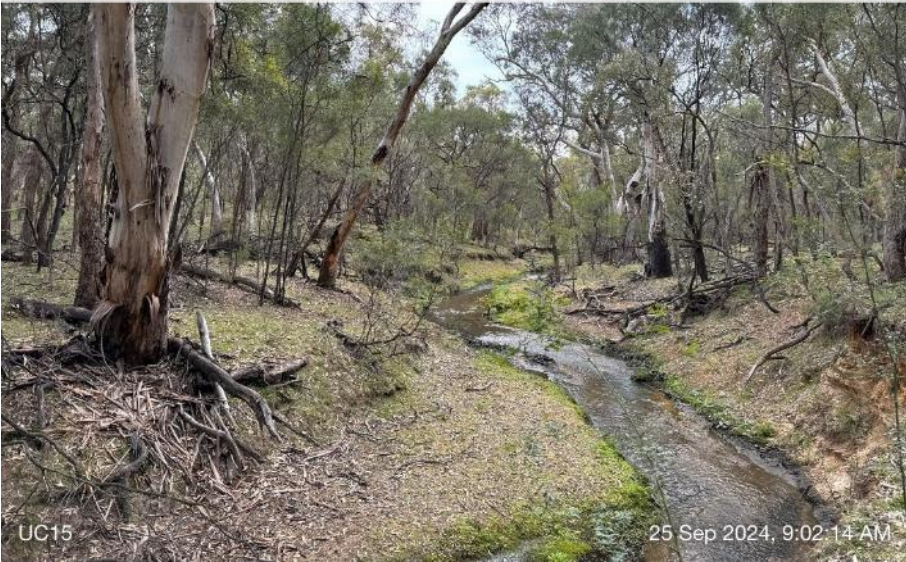
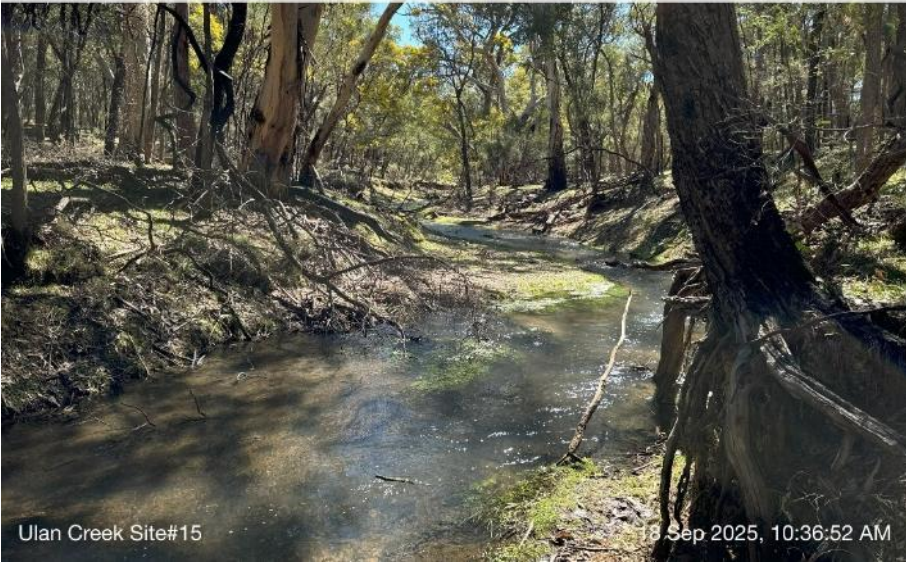
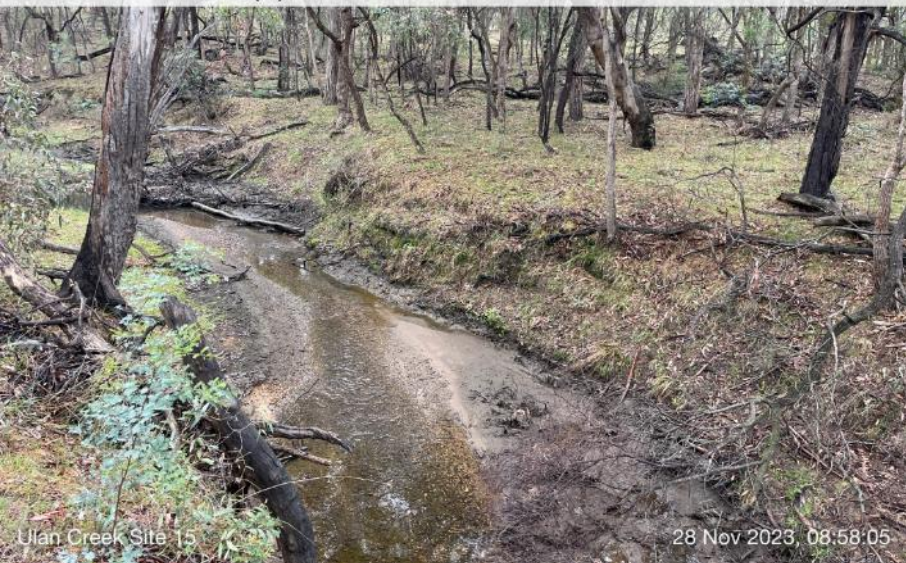
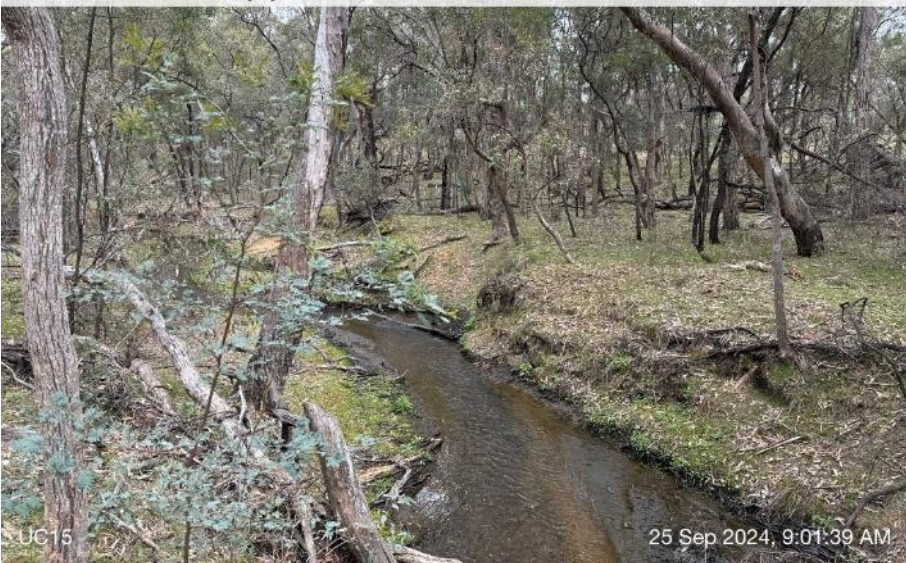
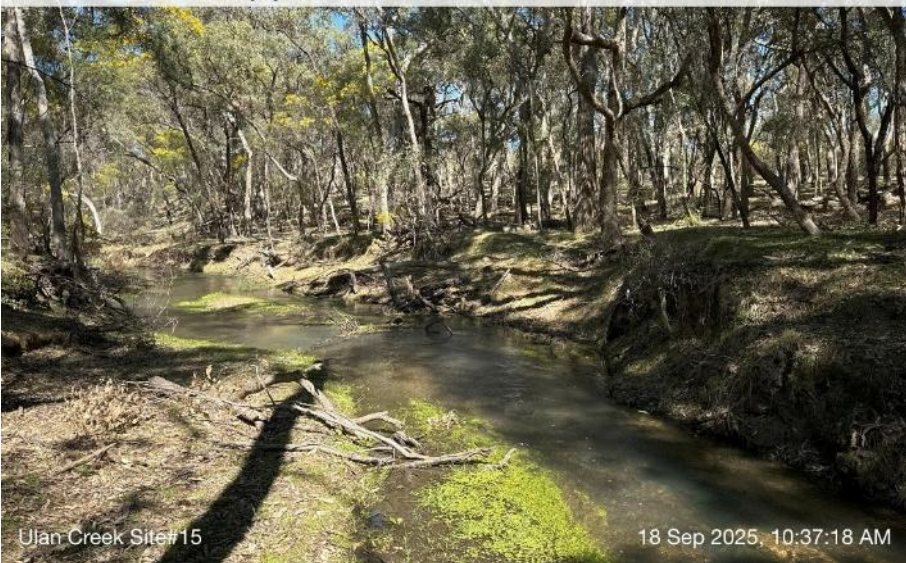
**General Observations:** Ulan Creek was flowing at this location in 2025. Active erosion along both banks was observed in 2022. From previous monitoring, the channel bed is a mix of silt, sand and gravel. In 2022 additional build-up of sand, silt and small gravel deposits were noted. The LHB and RHB have near vertical walls from the top of the bank, bare with exposed tree roots, with signs of erosion and bank undercutting. Comparable groundcover above the LHB and RHB as previous year. Both sides of the creek are tree lined. Observations in 2025 are comparable to previous monitoring. The CSIRO *Ephemeral Stream Assessment* classification at this location as 'active'.

**Notes:** In 2025 observations were limited to the LHB and water flowing.

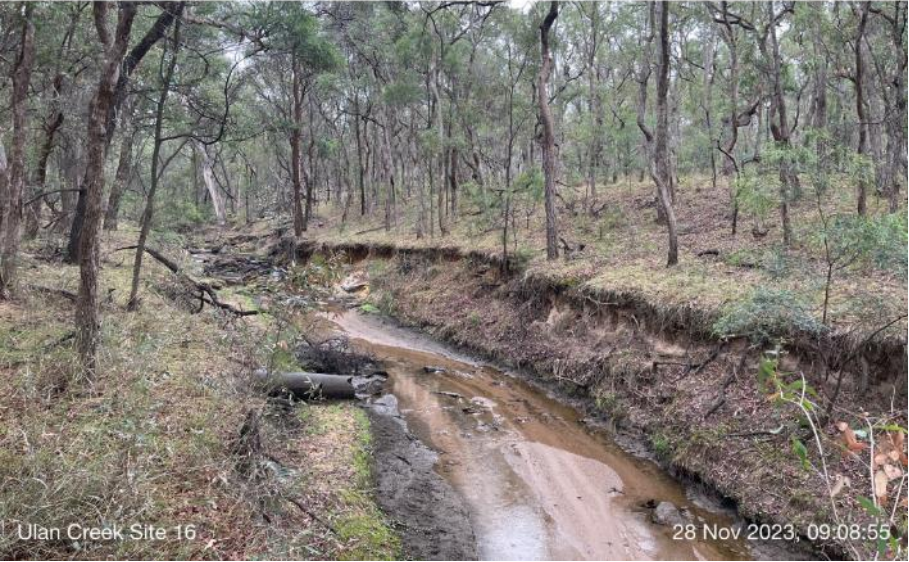
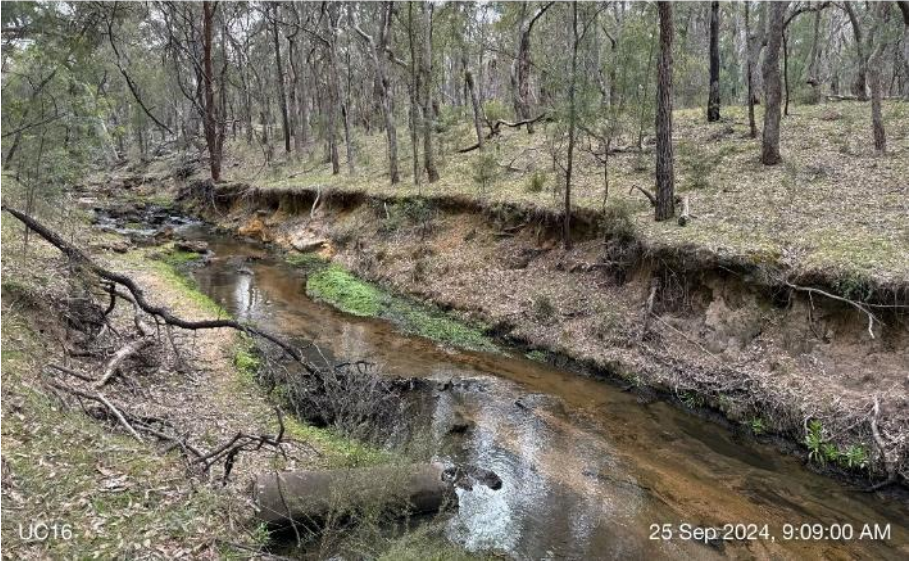
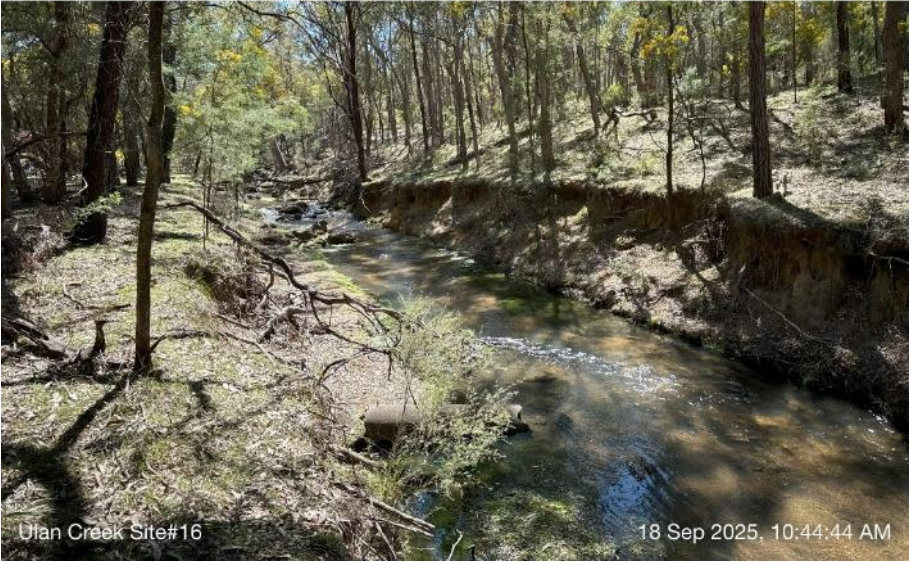
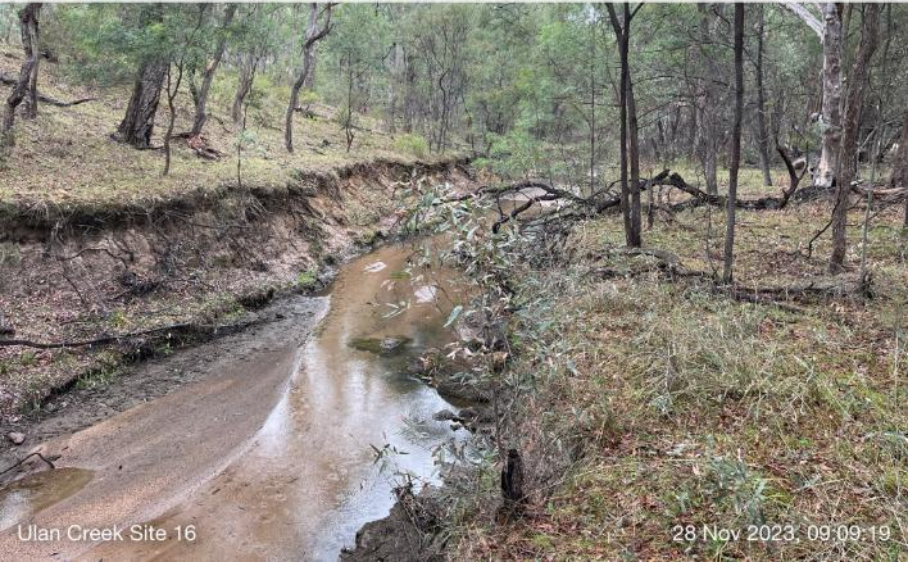
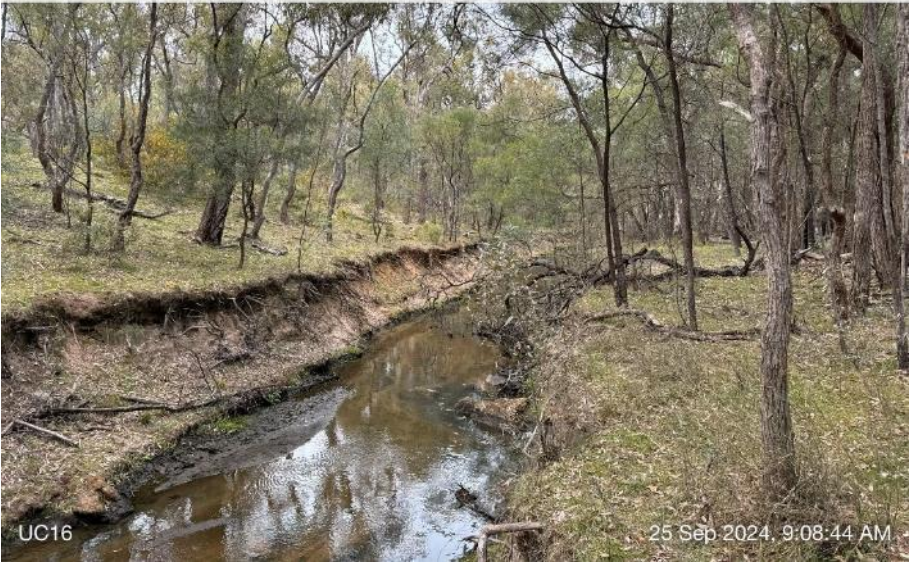
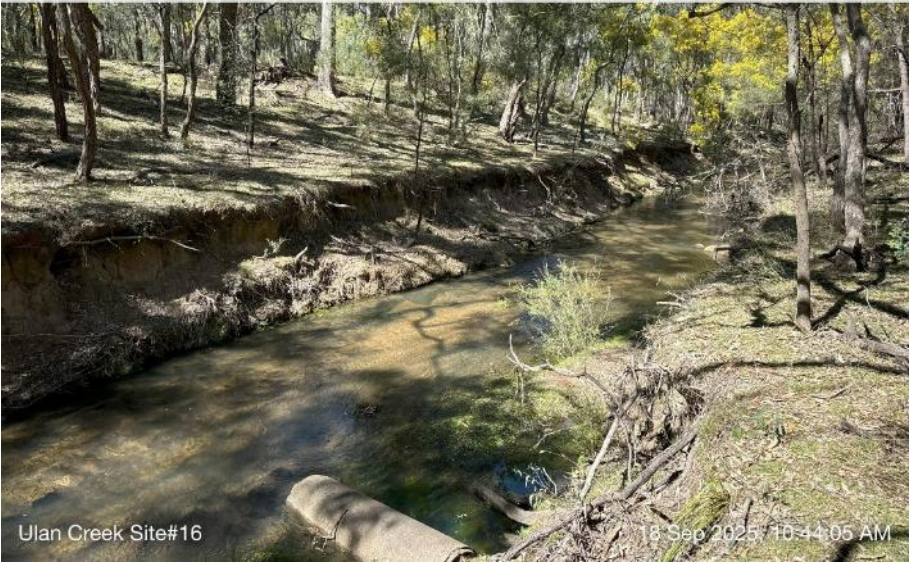
**General Observations:** Ulan Creek had water flowing at this location in 2025. Active erosion along both banks was observed again in 2022. A tree had also fallen into the creek sometime after the 2019 inspection. In 2022 additional gravel, silt and sand deposits had accumulated but less obvious than in previous years. The LHB and RHB have near vertical walls from the top of the bank, mostly bare with exposed tree roots and signs of erosion. An old concrete pipe culvert remains upstream from the site. Comparable groundcover above the LHB and RHB as previous year. Both sides of the creek are tree lined. Observations in 2025 are comparable to previous monitoring. The CSIRO *Ephemeral Stream Assessment* classification at this location as 'active'.

**Notes:** In 2025 observations were limited to the RHB and water flowing.

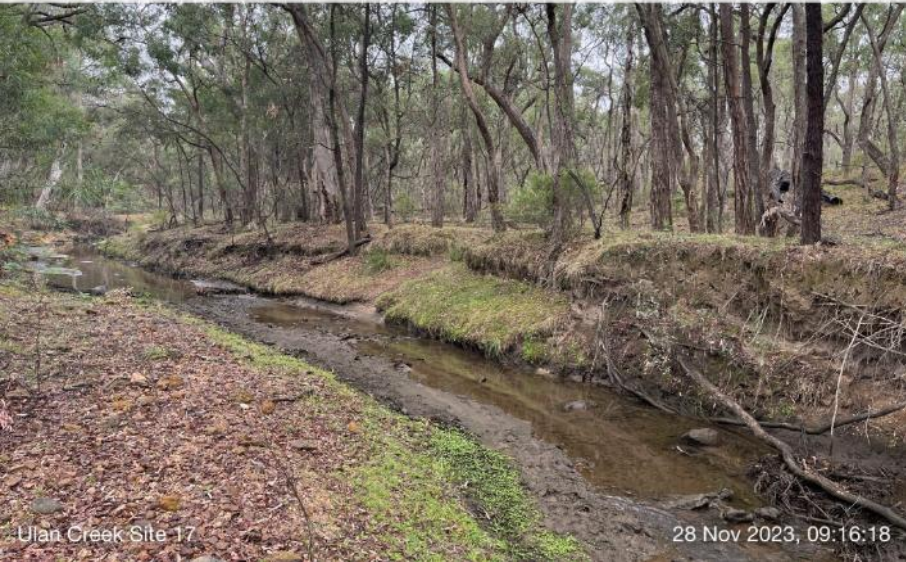
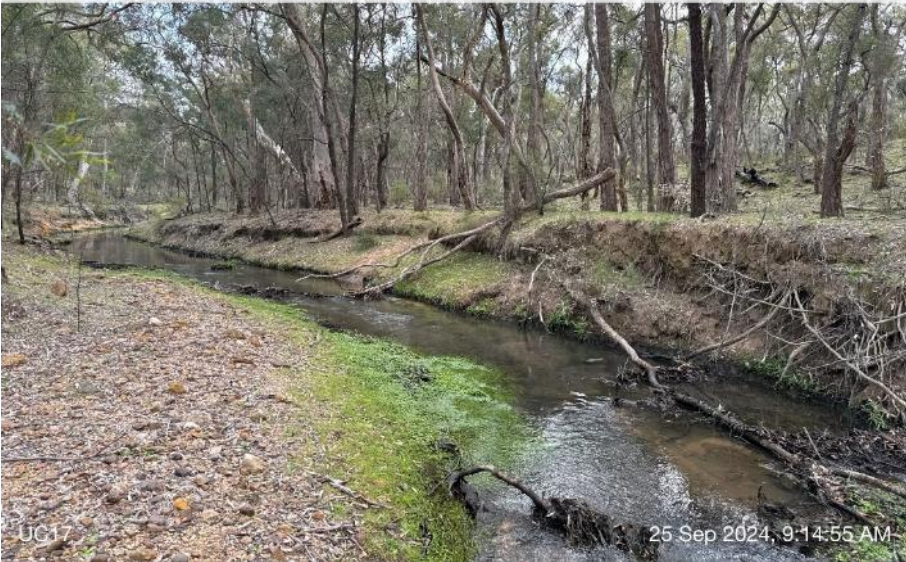
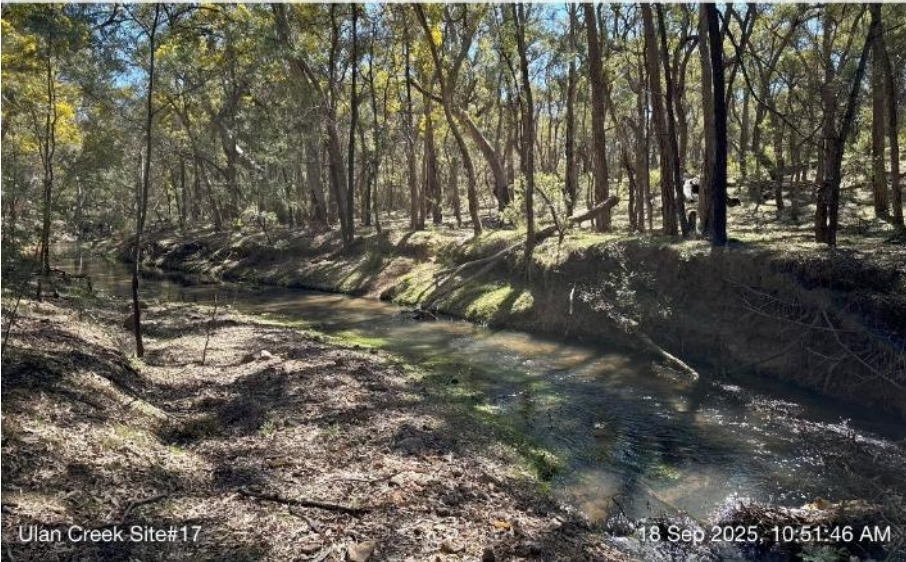
**General Observations:** Ulan Creek had water flowing at this location in 2025. Water was seeping into the creek along the LHB from an entering drainage line in 2021. The low flow channel bed had no vegetation and was a mix of silt, sand, gravel and larger rock material noted. In 2022 additional build up of sand, silt and small gravel deposits were noted. The LHB wall is near vertical, bare with exposed tree roots and signs of active slumping. Undercutting also observed along the LHB in 2022. The RHB is a gentler slope, mostly with bare areas and no vegetation. Comparable groundcover above the LHB and RHB as previous year. Both sides of the creek are tree lined. Observations in 2025 are comparable to previous monitoring. The CSIRO *Ephemeral Stream Assessment* classification at this location as 'active'.

**Notes:** In 2025 observations were limited to the RHB and water flowing.
