## APPENDIX B: Ulan Creek

## 2025 Channel Stability Monitoring - Site Inspection Details

**Creek Name:** Ulan Creek

**Date:** 18 September 2025

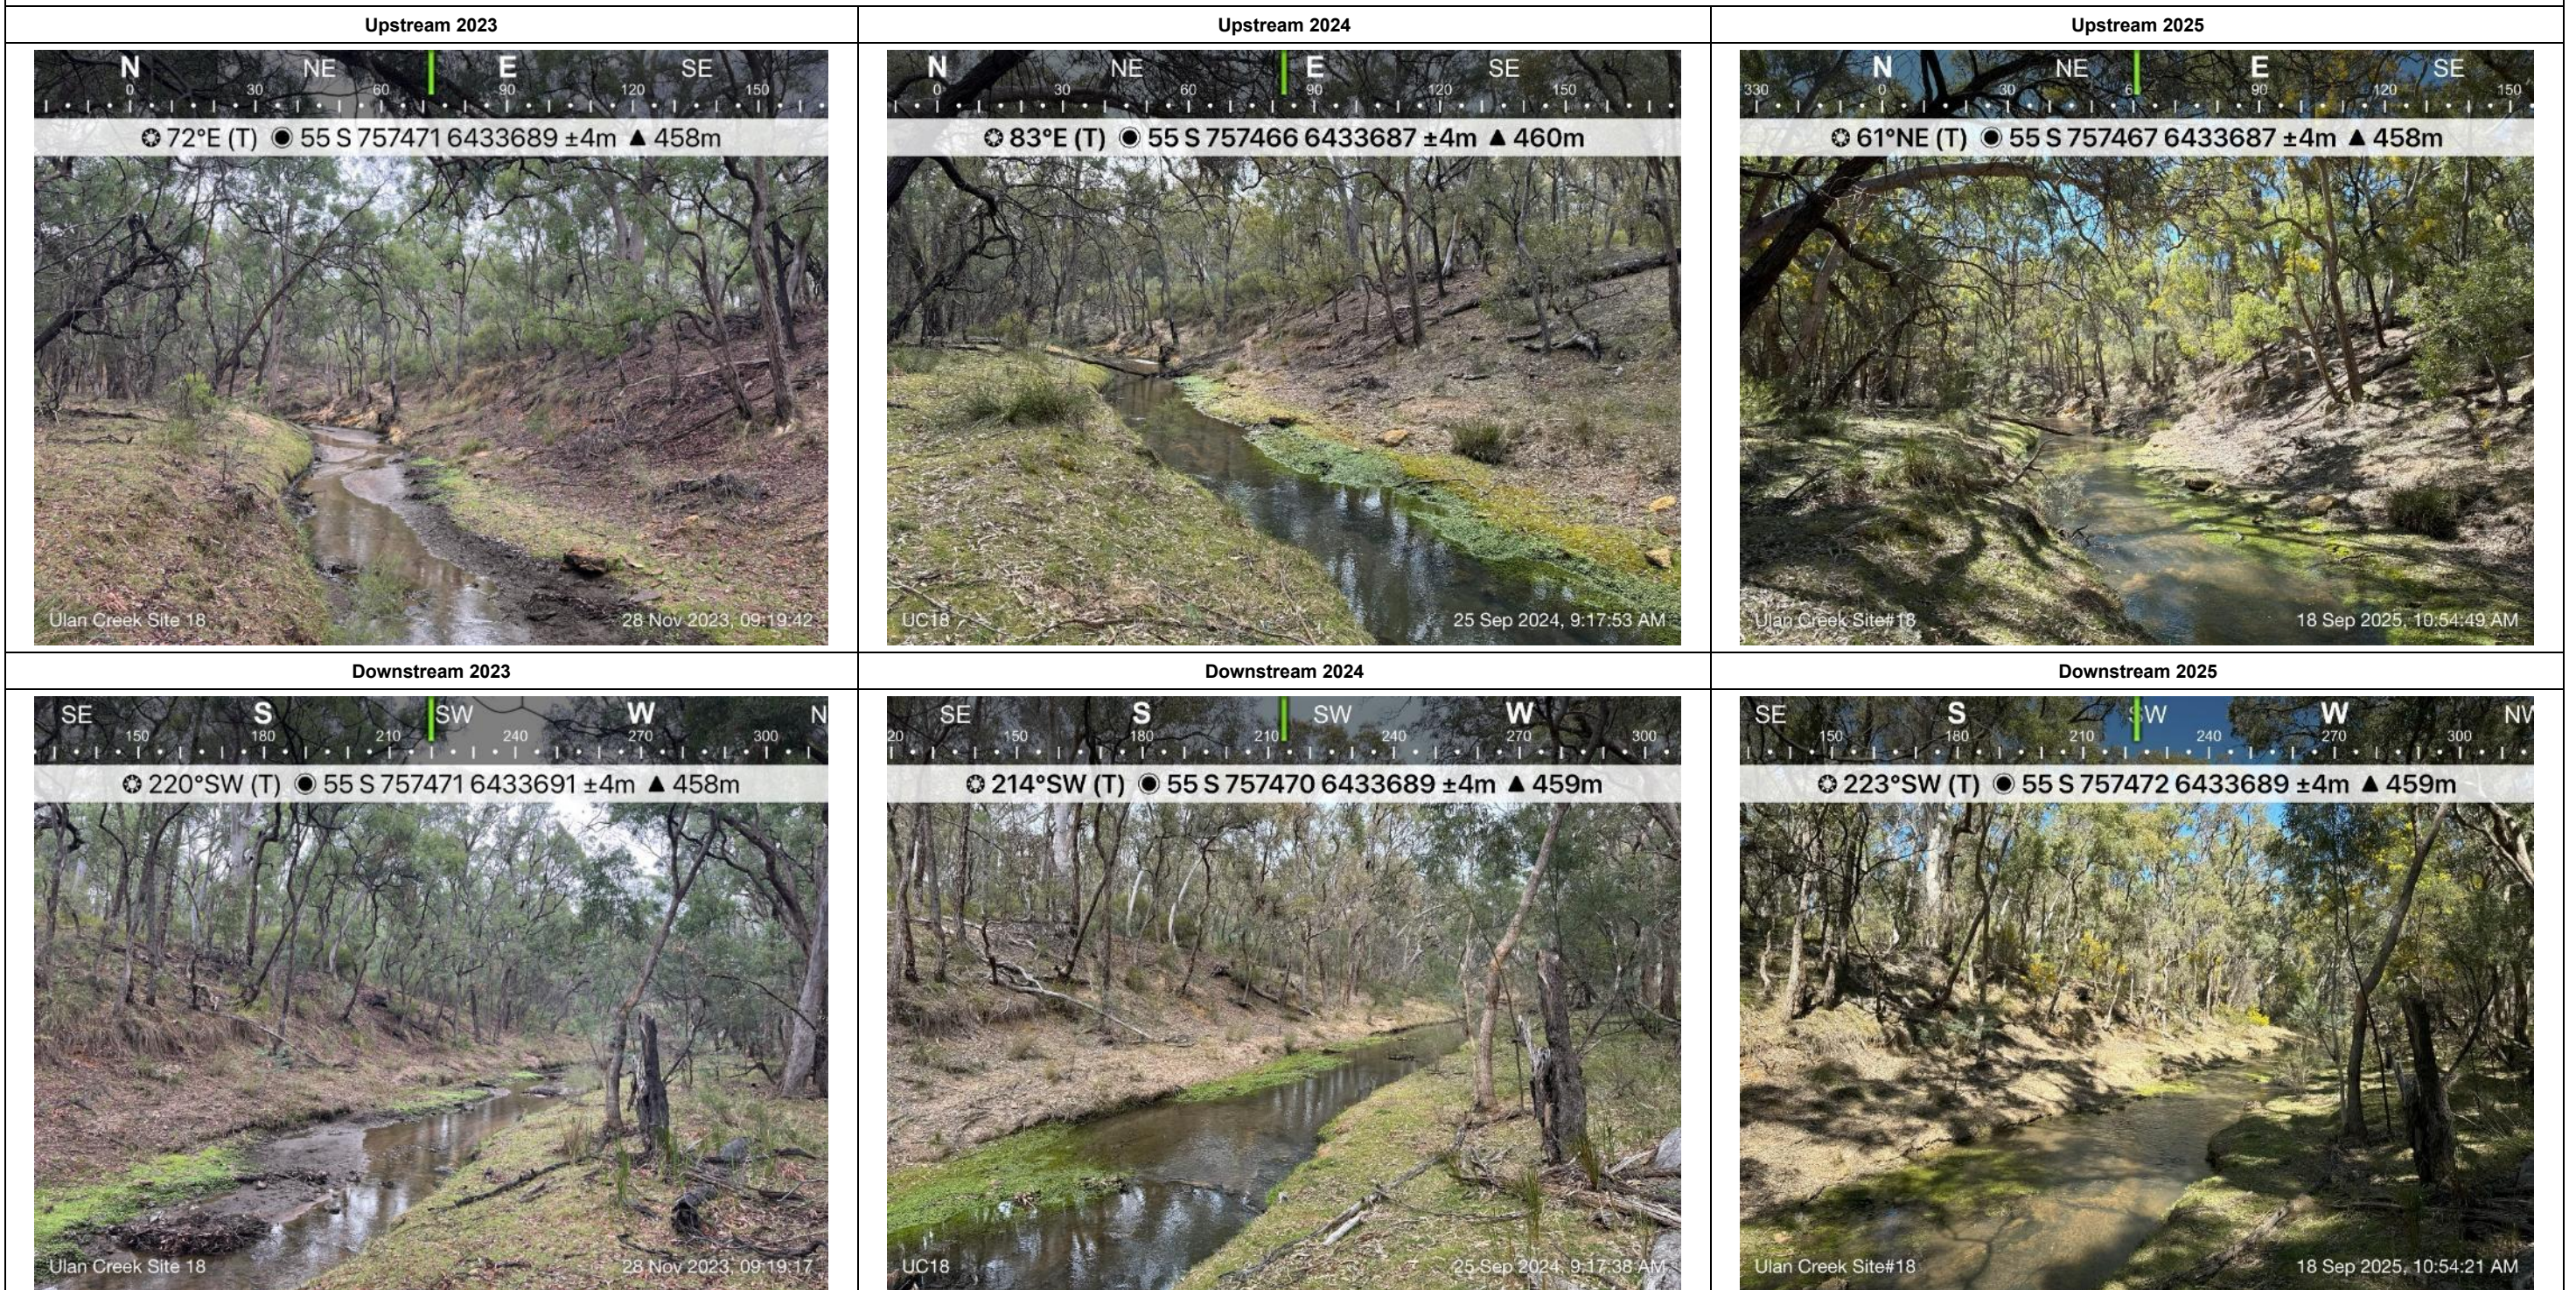
**General Observations:** Ulan Creek had water flowing at this location in 2025. Inflows into the creek were noted at this location in 2020. Continued undercutting (albeit minor) along the RHB was observed in 2021 and 2022. Silt, sand, small gravel and larger rocks noted in the channel bed. An increasing layer of silt sediments deposited within the low flow channel bed was noted in 2019. Flood debris and sand deposits were identified above the RHB in 2020. The RHB has a low slope with decreasing ground cover vegetation in 2025. The LHB wall is a steeper slope and partially vegetated in 2024. Comparable groundcover above the LHB and RHB as previous year. Both sides of the creek are tree lined. Observations in 2024 are comparable to previous monitoring. The CSIRO *Ephemeral Stream Assessment* classification at this location as 'potentially stabilising'.

**Notes:** In 2025 observations were limited to the RHB and water flowing

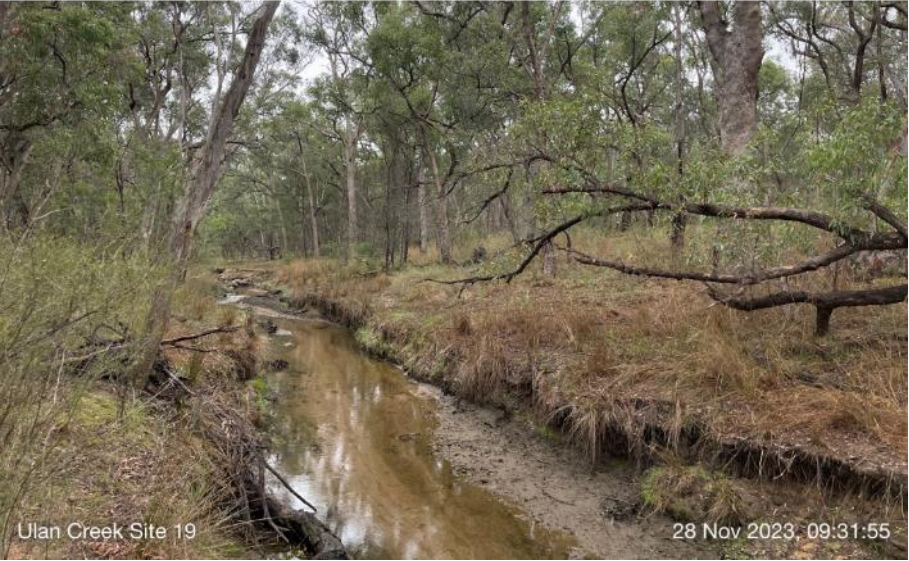
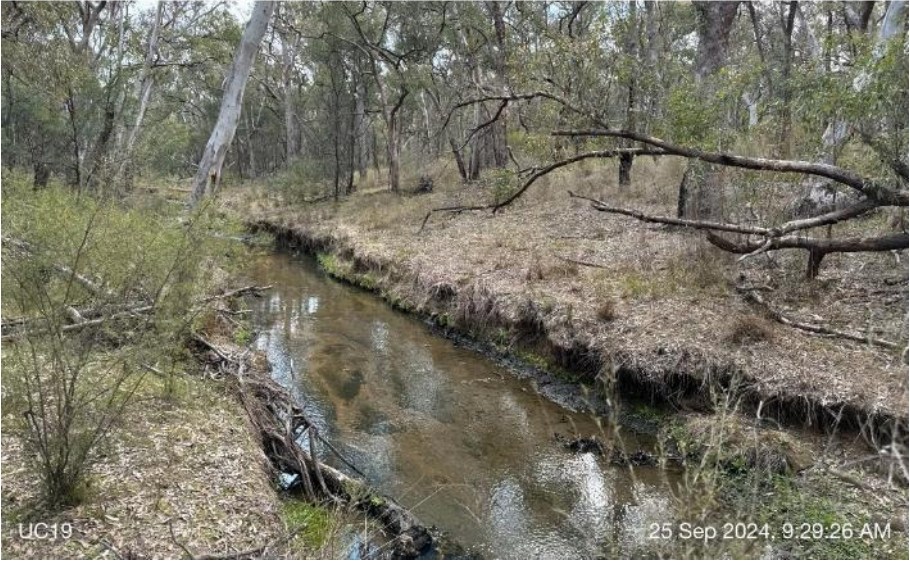
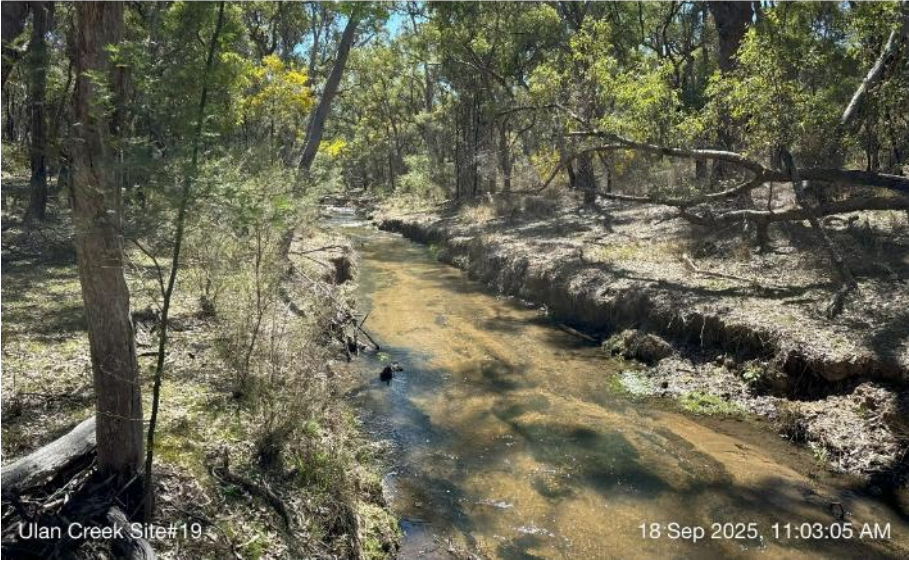
**General Observations:** Ulan Creek was flowing at this location in 2025. The channel bed had little to no vegetation and is a mix of silt, sand, small gravel and rock material. In 2022 additional build up of sand, silt and small gravel deposits was noted. Sand deposits were noted above the RHB in 2020. The small fallen tree observed in the channel bed in 2022 has been transported further downstream in 2023 to Site 20a. The establishment of a Common Rush (*Juncus* spp) since 2019 on the RHB with increasing density in 2021 and 2022 but appears to be going through a 'dieback' phase. Both the LHB and RHB have a moderate to steep slope and remain generally well vegetated. The LHB downstream displays recent signs of undercutting. A small section of the RHB had slumped into the flow channel in 2022. Comparable groundcover above the LHB and RHB as previous year. Both sides of the creek are tree lined. Observations in 2025 are comparable to previous monitoring. The CSIRO *Ephemeral Stream Assessment* classification at this location as 'active'.

**Notes:** In 2025 observations were limited to the RHB and water flowing.

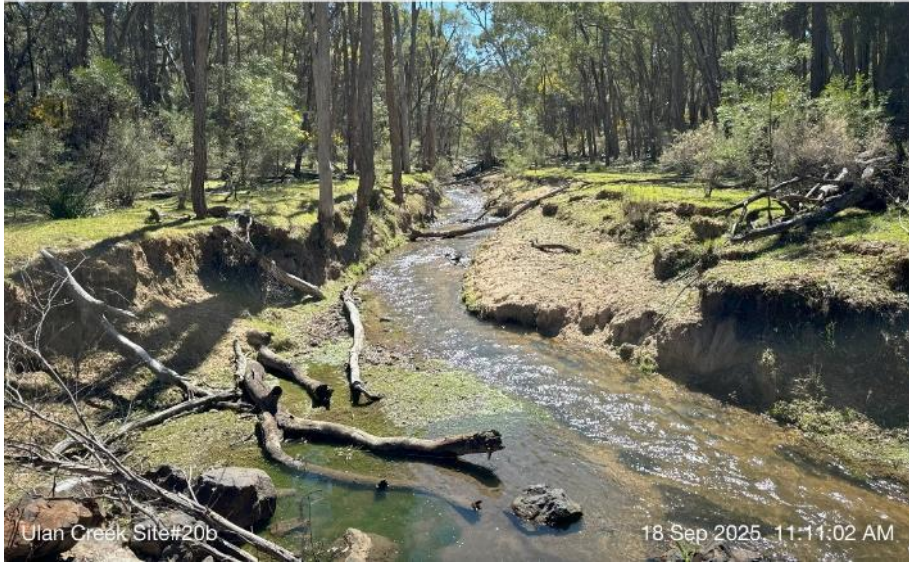
**General Observations:** Ulan Creek had flowing at this location in 2025. Active erosion along both banks was again observed. The flow channel bed had little to no vegetation. Silt, sand and small gravel size rock material was noted in the channel bed. Significant loss of a bank material and widening of the flow channel observed in 2020. Sand deposits above the flow line along the RHB noted in 2020. In 2022 additional build up of sand, silt and small gravel deposits were noted. The channel bed contains much larger foreign rock placed in the creek at some point, to possibly stabilise the creek (a portion of the RHB displays stability due to the rock armouring), however it appears to be having a more destabilising impact. Both the LHB and RHB have a moderate slope above the bank. The banks walls are sparsely vegetated, display recent signs of slumping, bank undercutting and causing a widening of the creek (particularly along the LHB). Comparable groundcover above the LHB and RHB as previous year. Both sides are tree lined. Observations in 2025 noted a similar deteriorating trend when compared to previous monitoring\*. The CSIRO *Ephemeral Stream Assessment* classification at this location as 'very active'.

**Notes:** In 2025 observations were limited to the LHB and water flowing. \*The increased erosion on the LHB exposing >1m of wall height decreased the 2022 score.Loss of bed/bank material since 2022 monitoring.

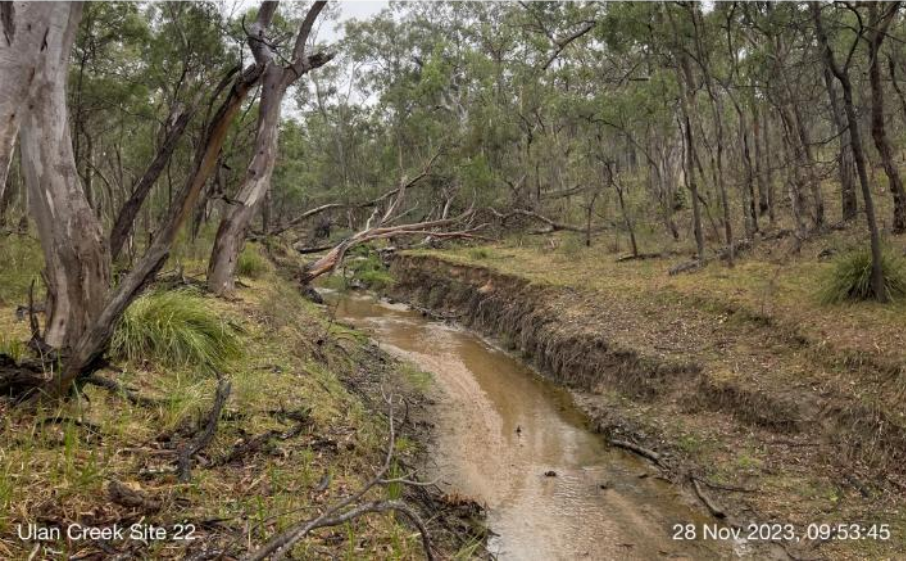
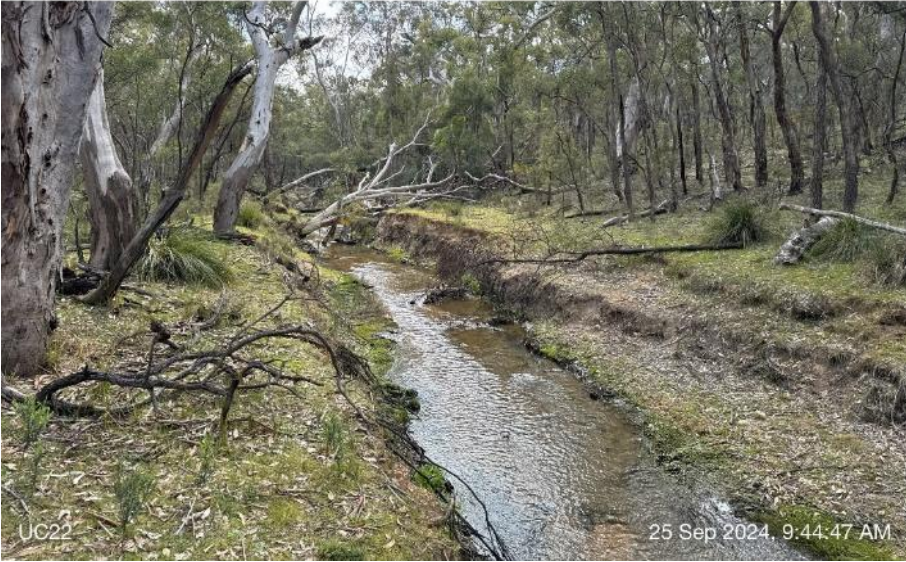
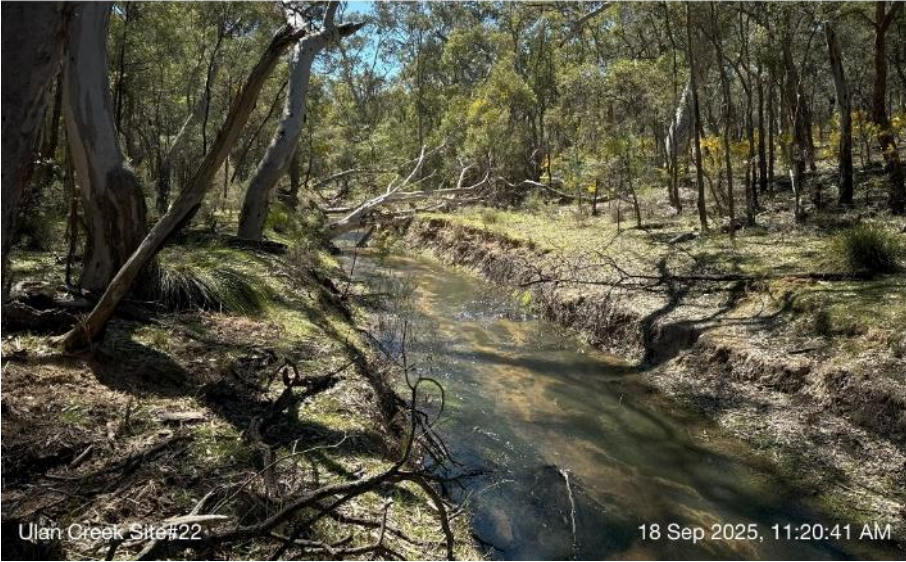
**General Observations:** Ulan Creek had water flowing at this location in 2025. Active erosion along both banks was again observed in 2022. The flow channel bed had little to no vegetation and is a mix of silt, sand, small size gravel and rock material. In 2022 additional build up of sand, silt and small gravel deposits was noted. Decrease of vegetation above the banks. A small scour in the channel bed forming in 2019 was infilled in 2020. Both the LHB and RHB have a moderate slope above the bank. Both bank walls are exposed and display recent signs of erosion. The RHB has a near vertical lower section with ongoing bank undercutting. The LHB also displays signs of bank undercutting. Comparable groundcover above the LHB and RHB as previous year. Both sides of the creek are tree lined. Observations in 2025 are comparable to previous monitoring. The CSIRO *Ephemeral Stream Assessment* classification at this location as 'active'.

**Notes:** In 2025 observations were limited to the RHB and water flowing.

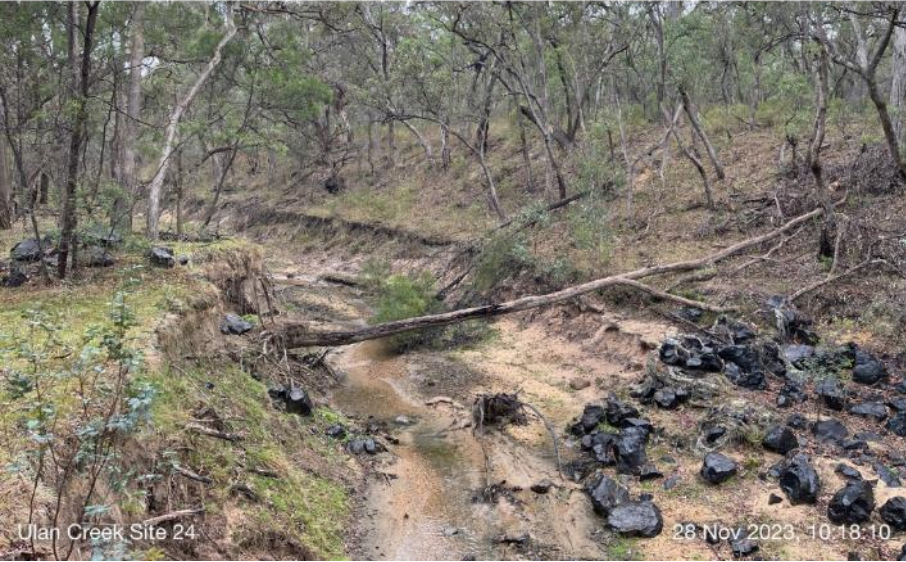
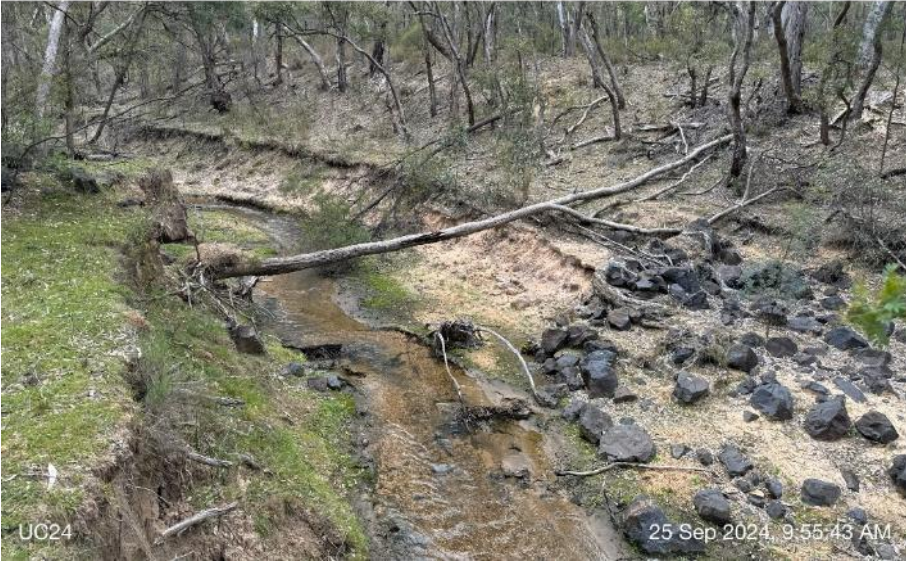
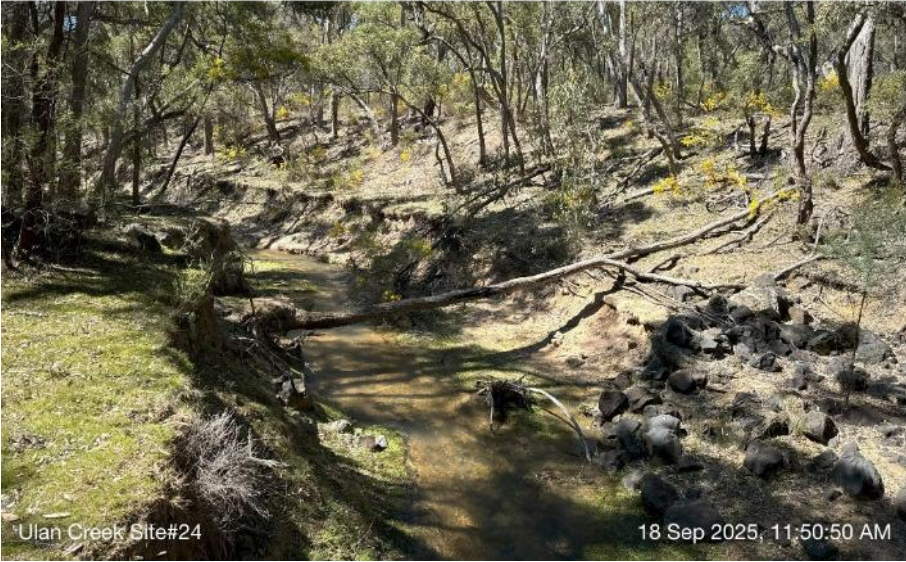
**General Observations:** Ulan Creek had water flowing at this location in 2025. Active erosion along both banks was again observed. The low flow channel bed had little to no vegetation and is a mix of silt, sand, small size gravel and rock material. In 2022 additional build up of sand, silt and small gravel deposits were noted. The channel bed contains much larger foreign rock and geofabric material to possibly stabilise the creek, however it appears to be having a more destabilising impact. The RHB has a gentle to moderate slope above the bank, the bank wall is bare and exposed, near vertical and displays recent signs of erosion and bank undercutting. The LHB has a steeper slope above the bank and is partially stabilised by the imported rock. Comparable groundcover above the LHB and RHB as previous year. Both sides of the creek are tree lined. Observations in 2025 noted a similar deteriorating trend when compared to previous monitoring. The CSIRO *Ephemeral Stream Assessment* classification at this location as ‘very active’.

**Notes:** In 2025 observations were limited to the RHB and water flowing.

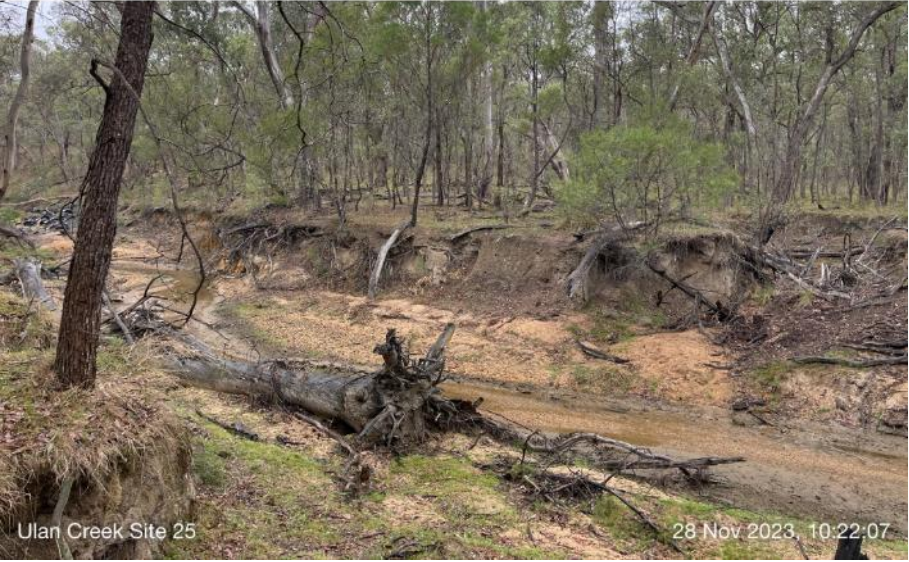
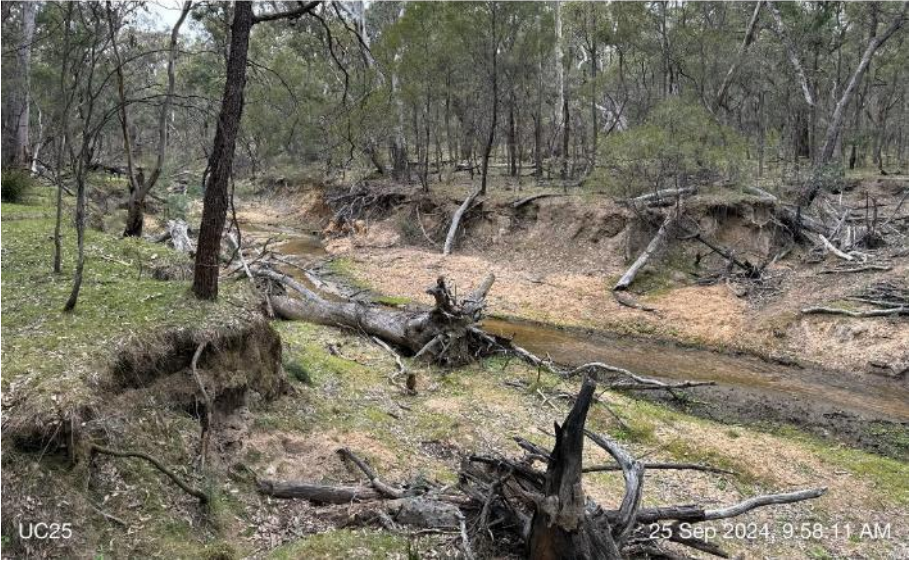
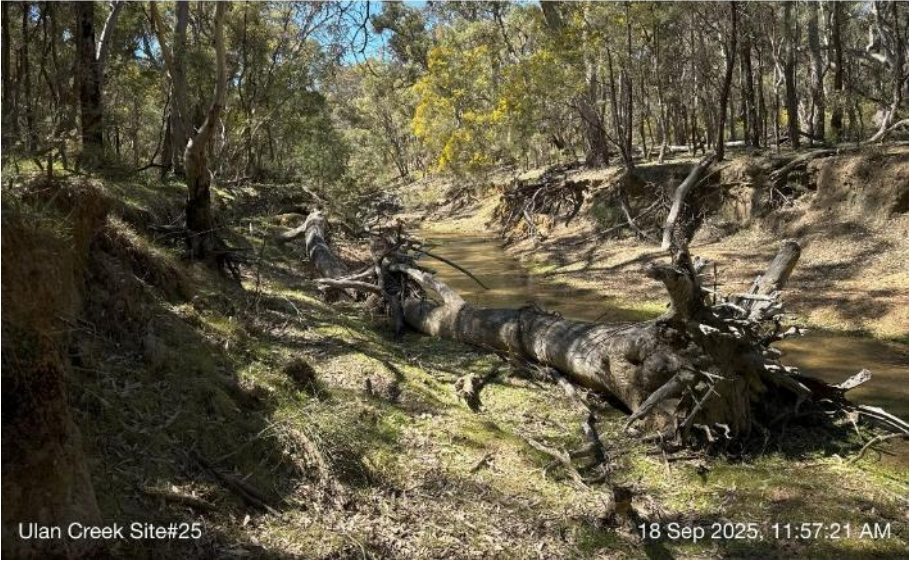
**General Observations:** Ulan Creek had flowing at this location in 2025. The low flow channel bed had little vegetation and was a mix of silt, sand, small size gravel and rock material. In 2022 additional build up of sand, silt and small gravel deposits were noted. Active erosion was again noted along both banks in 2022. Both the LHB and RHB have a gentle slope above the bank. The LHB wall is near vertical, bare and exposed, with bank undercutting further downstream exposing tree roots. The RHB wall also has sparse vegetation with exposed tree roots, near vertical sections from the top of the bank. Comparable groundcover above the LHB and RHB as previous year. Both sides of the creek are tree lined. Observations in 2025 noted a similar deteriorating trend when compared to previous monitoring. The CSIRO *Ephemeral Stream Assessment* classification at this location as 'active'.

**Notes:** In 2025 observations were limited to the RHB and water flowing.

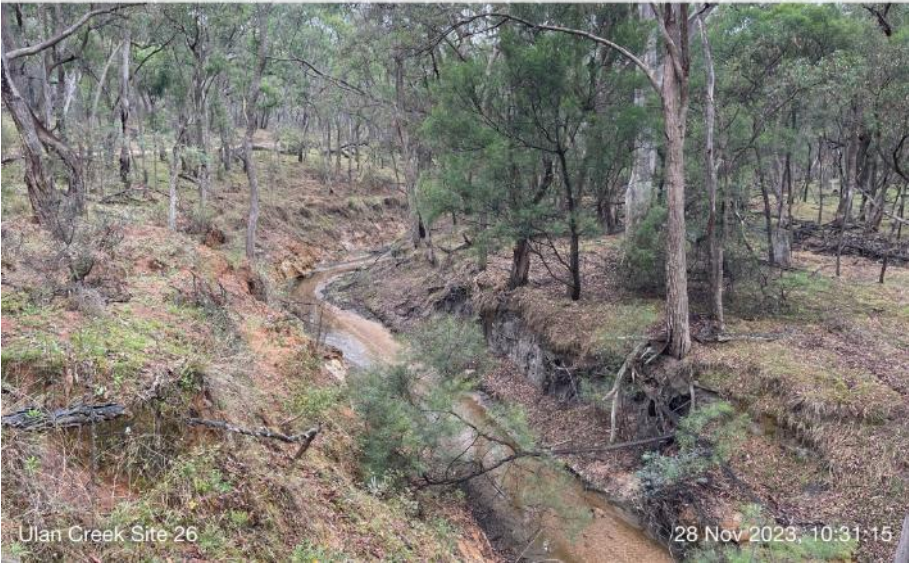
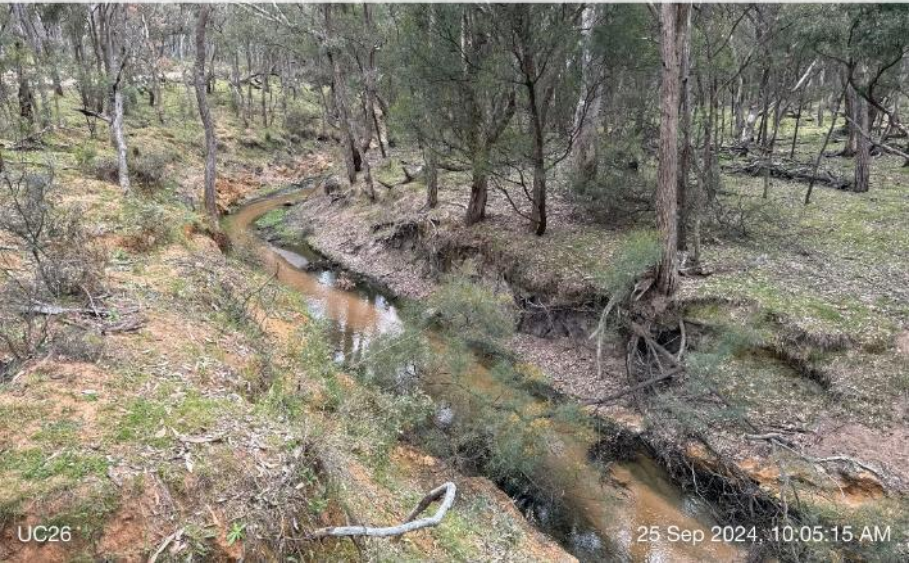
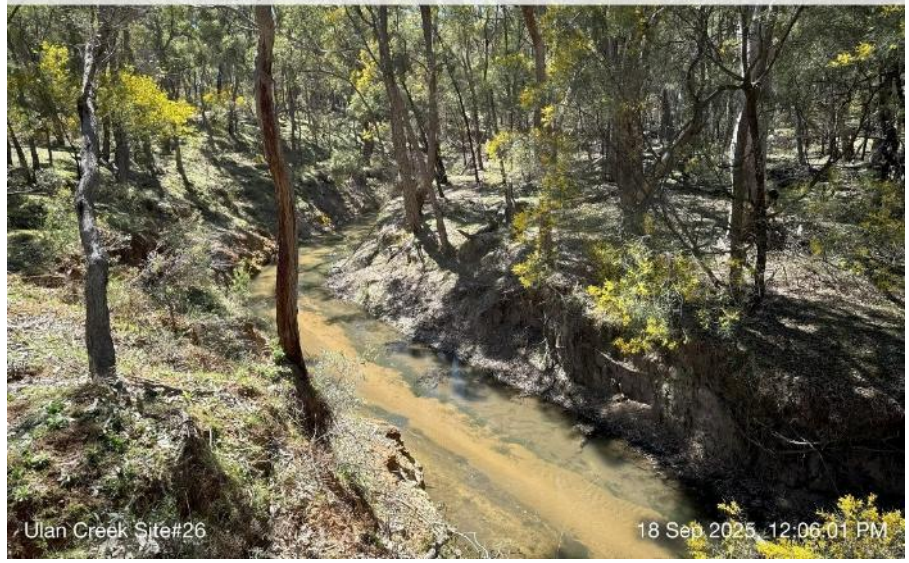
**General Observations:** Ulan Creek had water flowing at this location in 2025. The channel bed had little to no vegetation and is a mix of sand, silt and small size gravel. Active erosion was again noted along both banks in 2022. Both the LHB and RHB have a gentle slope above the banks. The RHB wall is near vertical, bare and exposed with signs of erosion back to bedrock. The LHB wall also has near vertical sections from the top of the bank, with bank undercutting further downstream exposing tree roots along the LHB. Comparable groundcover above the LHB and RHB as previous year. Both sides of the creek are tree lined. A large tree had fallen across the channel downstream since 2021. Observations in 2025 noted a similar deteriorating trend when compared to previous monitoring. The CSIRO *Ephemeral Stream Assessment* classification at this location as 'active'.

**Notes:** In 2025 observations were limited to the RHB and water flowing.

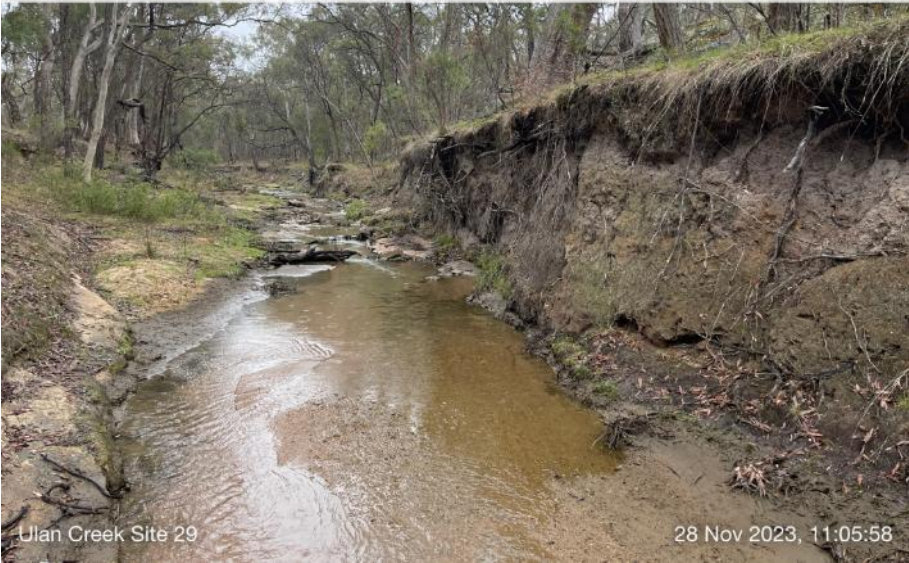
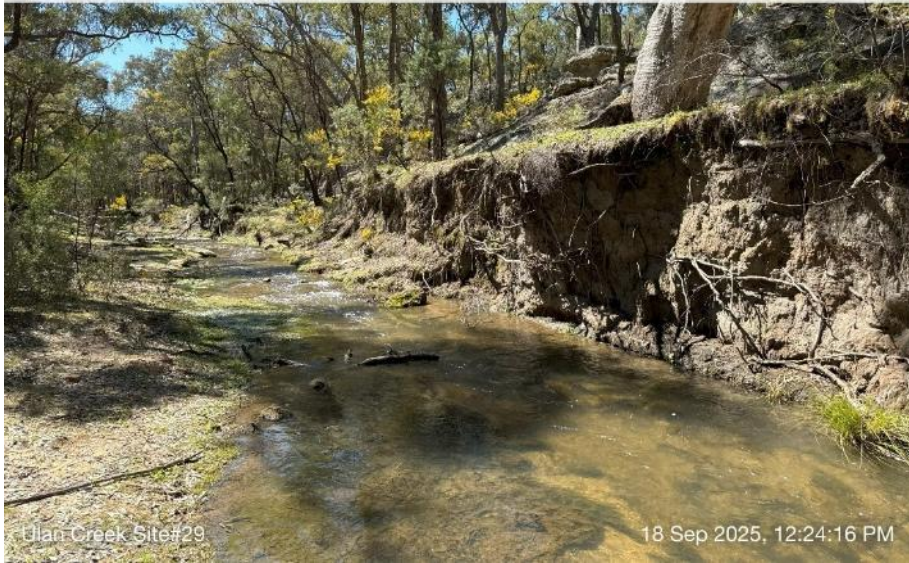
**General Observations:** Ulan Creek had water flowing at this location in 2025. The low flow channel bed had little to no vegetation and was a mix of sand and small to medium gravel size rock material. Deposited sediment was noted in the channel bed in 2020. Both the LHB and RHB have a steep rock/boulder slope above the bank. The RHB is near vertical formed from bedrock and is stable. The LHB wall has near vertical mid sections, sparsely vegetated with signs of active erosion in 2022. Comparable groundcover above the LHB and RHB as previous year. Both sides of the creek are tree lined. A piece of jute mesh that was most likely from Site UC25 was caught up on the RHB. Observations in 2024 are comparable to previous monitoring. The CSIRO *Ephemeral Stream Assessment* classification at this location as 'active'.

**Notes:** In 2025 observations were limited to the LHB and water flowing. Jute mesh material from RHB transported downstream since 2022 monitoring.

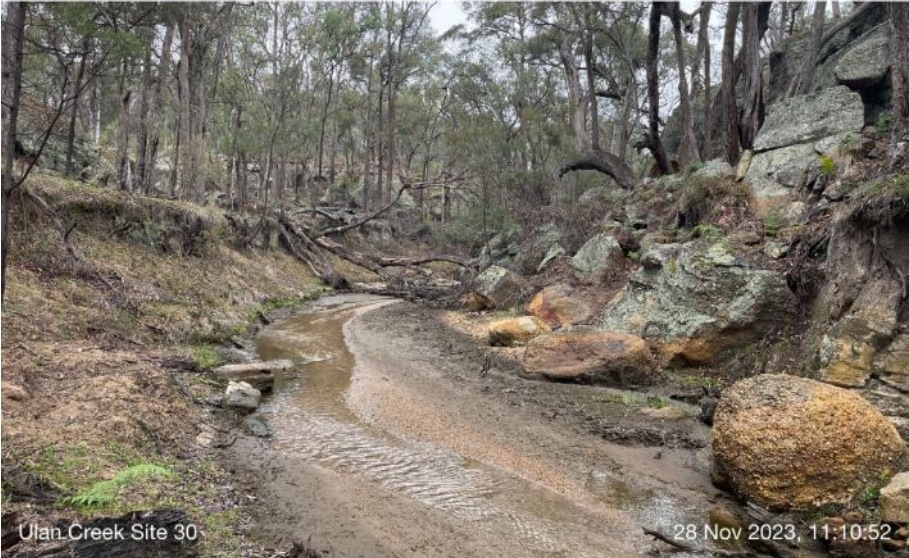
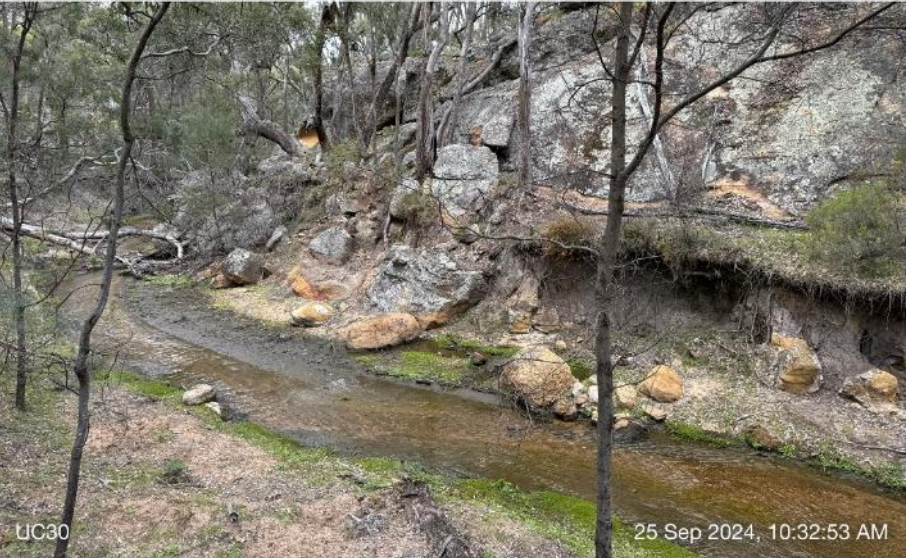
| Upstream 2023 | Upstream 2024 | Upstream 2025 |
|---|---|---|
| <div><div>E90SE120S150180SW210240</div><div>☼ 155°SE (T) ● 55 S 756850 6432313 ±4m ▲ 445m</div><div><div>Ulan Creek Site 3028 Nov 2023, 11:10:52</div></div></div> | <div><div>SE120S150180SW210240W270</div><div>☼ 191°S (T) ● 55 S 756854 6432321 ±4m ▲ 453m</div><div><div>UC3025 Sep 2024, 10:32:53 AM</div></div></div> | <div>Not inspected in 2025 due to access constraints from creek flows</div> |

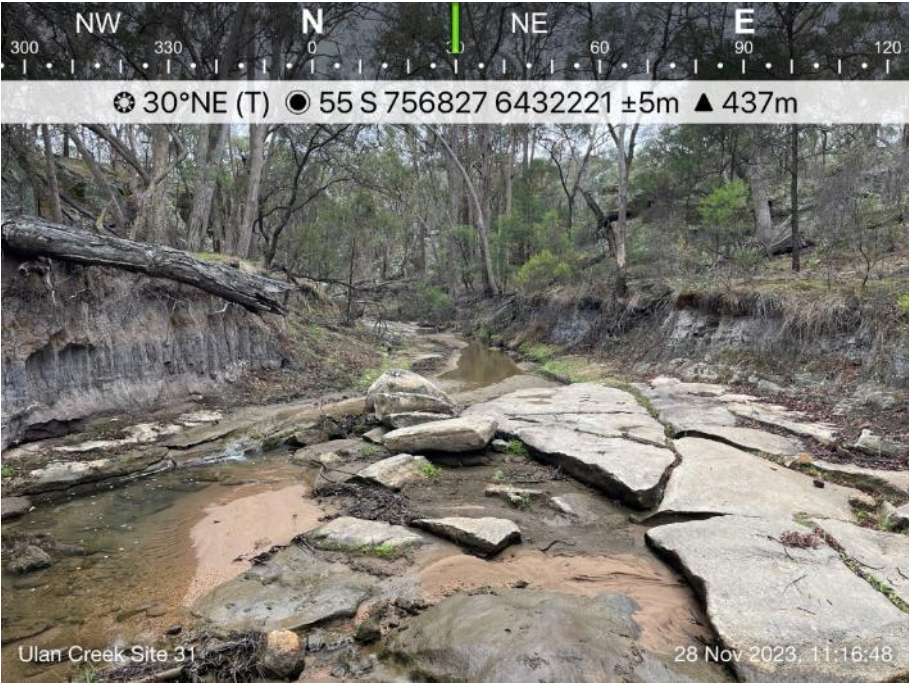
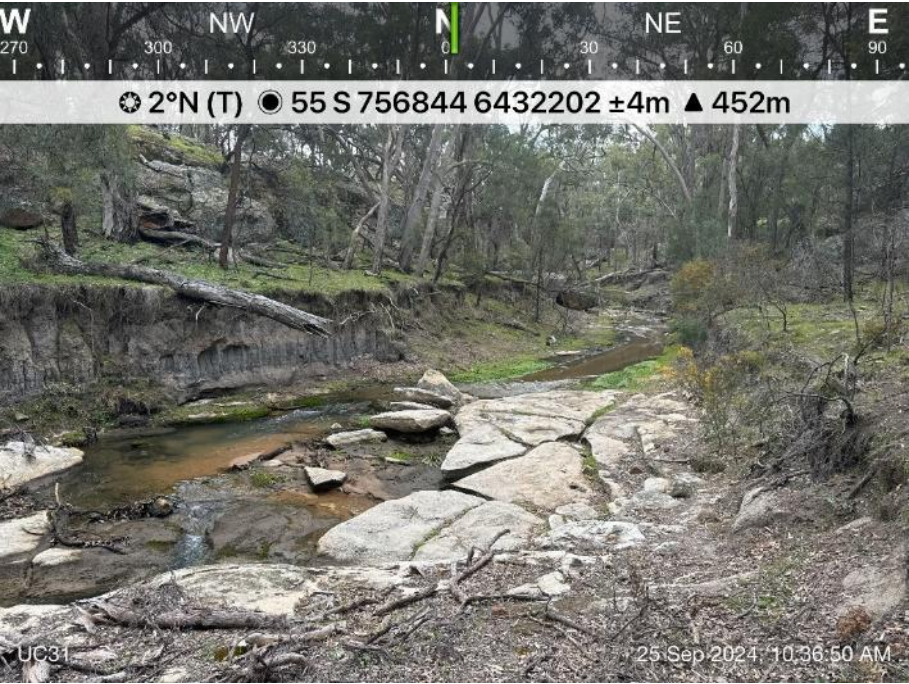
| 2025 Channel Stability Monitoring - Site Inspection Details | | |
|---|---|---|
| <p><b>Creek Name:</b> Ulan Creek</p> <p><b>Date:</b> Not inspected in 2025 due to access constraints from creek flows</p> <p><b>Monitoring Site:</b> UC31 (Not visited in 2020 this site was inaccessible)</p> <p><b>Coordinates (MGA/Zone 55):</b> 756840(E) 6432211(N)</p> <p><b>CISRO Ephemeral Stream Assessment:</b> Active</p> <p><b>General Observations:</b> Ulan Creek had water flowing at this location in 2024. The channel bed had little to no vegetation and formed from bedrock with deposited sediments and sand. Large pieces of bedrock type material were noted in the channel bed. In 2022 additional build up of sand and silt deposits were noted. The RHB has a steep rock slope above the bank. The RHB wall is near vertical, bare and exposed, displays undercutting erosion with exposed tree roots. The LHB wall has near vertical lower sections, a steep rock/boulder slope above the bank. The LHB is partially vegetated with signs of erosion. Both sides of the creek are tree lined. Observations in 2024 are comparable to previous monitoring. The CSIRO <i>Ephemeral Stream Assessment</i> classification at this location as 'active'.</p> <p><b>Notes:</b> In 2024 observations were limited to the LHB and by water flowing. A tree had fallen from the RHB across the creek since 2022 monitoring.</p> | | |

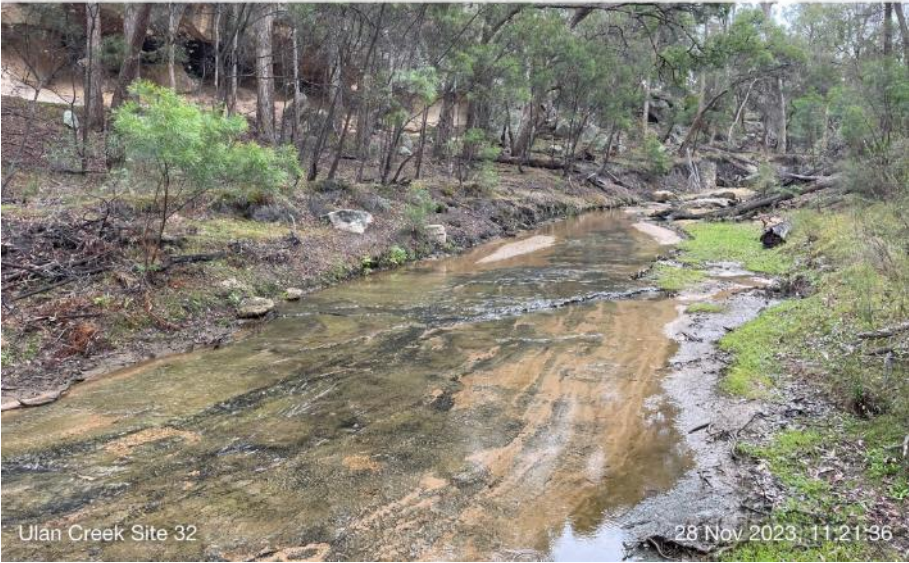
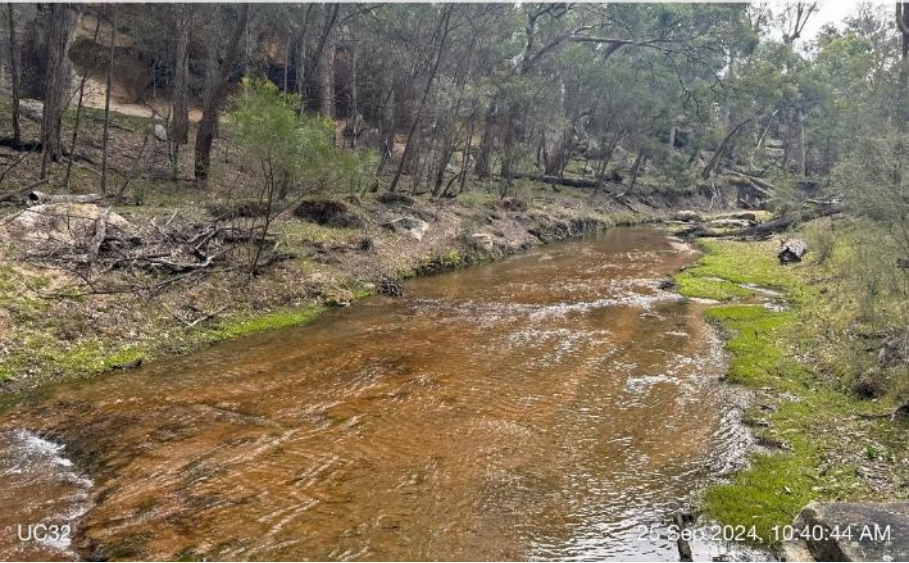
**General Observations:** Ulan Creek had water flowing at this location in 2024. The low flow channel bed has no vegetation and is formed from bedrock with sediment deposits. In 2022 additional build up of sand, silt and small gravel deposits were noted. There is a steep rock (almost cliff line in appearance) slope above the RHB bank. The RHB wall is a moderate slope and is partially vegetated with rock boulders and appears stable. The LHB is similar to the RHB. Both sides of the creek are tree lined. Observations in 2024 are comparable to previous monitoring. The CSIRO *Ephemeral Stream Assessment* classification at this location as 'potentially stabilising'.

**Notes:** In 2024 observations were limited to the LHB by water flowing.

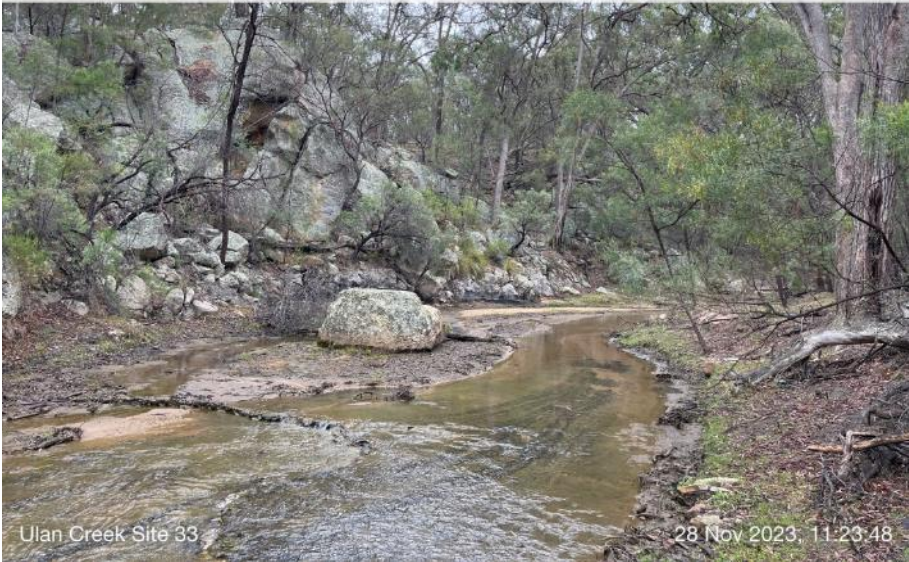
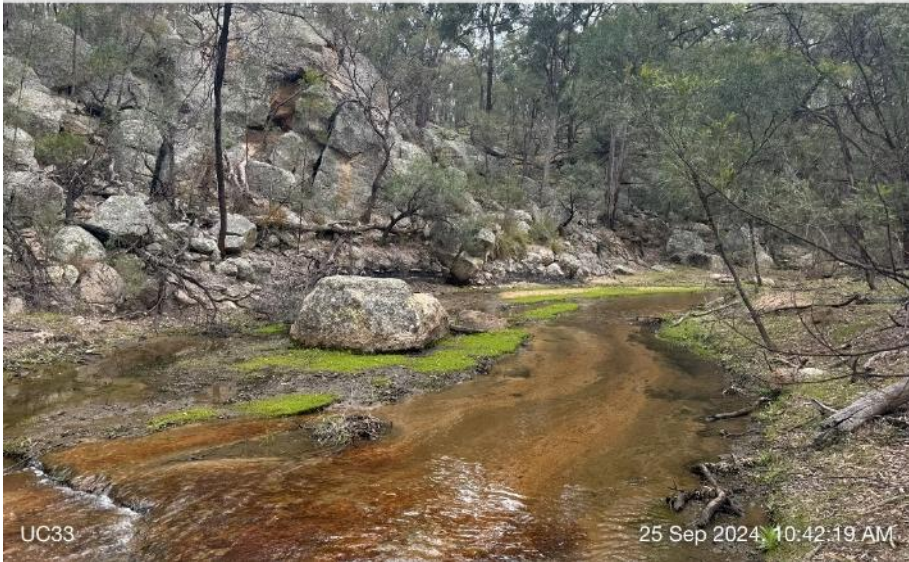
| 2025 Channel Stability Monitoring - Site Inspection Details | | |
|---|---|---|
| <div><div>Creek Name: Ulan Creek</div><div>Date: Not inspected in 2025 due to access constraints from creek flows</div><div>Monitoring Site: UC33 (Not visited in 2020 this site was inaccessible)</div><div>Coordinates (MGA/Zone 55): 756812 (E) 6432094 (N)</div><div>CISRO Ephemeral Stream Assessment: Potentially Stabilising</div><div>General Observations: Ulan Creek had water flowing at this location in 2024. The low flow channel bed had little to no vegetation, on bedrock covered with sediment deposits. In 2022 additional build up of sand, silt and small gravel deposits were noted. The RHB has a steep slope above the bank. The RHB wall is near vertical, bare and exposed and formed from bedrock and loose rocks and boulders, with signs of erosion. Carbonaceous bedrock material is also exposed along the RHB. The LHB has a moderate, partially vegetated slope, with a moderate to slope with rock boulders above the bank. Both sides of the creek are tree lined. Observations in 2024 are comparable to previous monitoring. The CSIRO <i>Ephemeral Stream Assessment</i> classification at this location as 'potentially stabilising'.</div><div>Notes: In 2024 observations were limited to the LHB by water flowing.</div></div> | | |

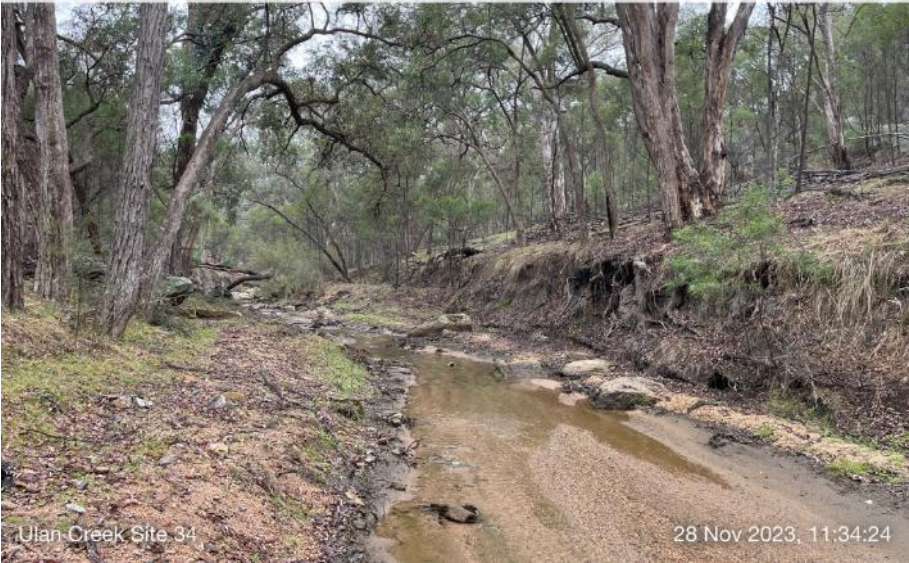
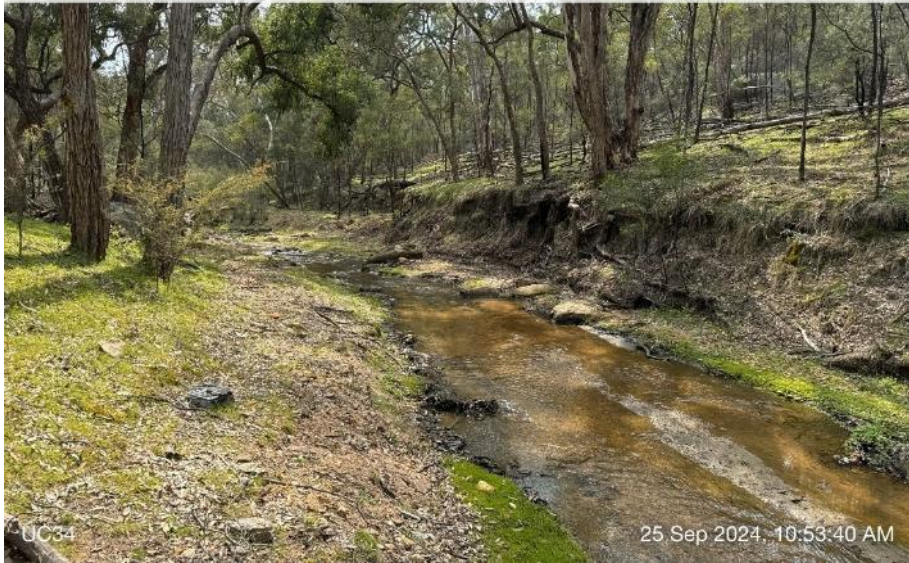
**General Observations:** Ulan Creek had water flowing at this location in 2025. Small to medium size rock material and deposited sediments noted in the channel bed. In 2022 additional build up of sand, silt and small gravel deposits were noted. The RHB is a moderate slope with increasing vegetation up slope, with little to no vegetation along the lower section. The LHB wall has near vertical sections from the top of the bank, mostly bare and exposed, with a moderate to steep slope above the bank. Signs of erosion was noted along both the LHB and RHB in 2022. Comparable groundcover above the LHB and RHB as previous year. Both sides of the creek are tree lined. Observations in 2025 are comparable to previous monitoring. The CSIRO *Ephemeral Stream Assessment* classification at this location as 'active'.

**Notes:** In 2025 observations were limited by water flowing.
