## APPENDIX B: Ulan Creek

## 2025 Channel Stability Monitoring - Site Inspection Details

**Creek Name:** Ulan Creek

**Date:** 18 September 2025

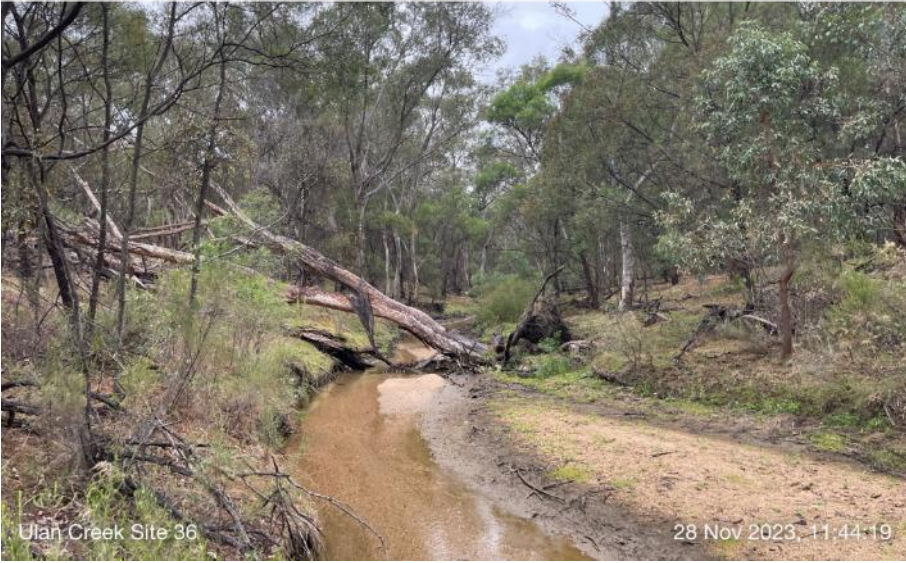
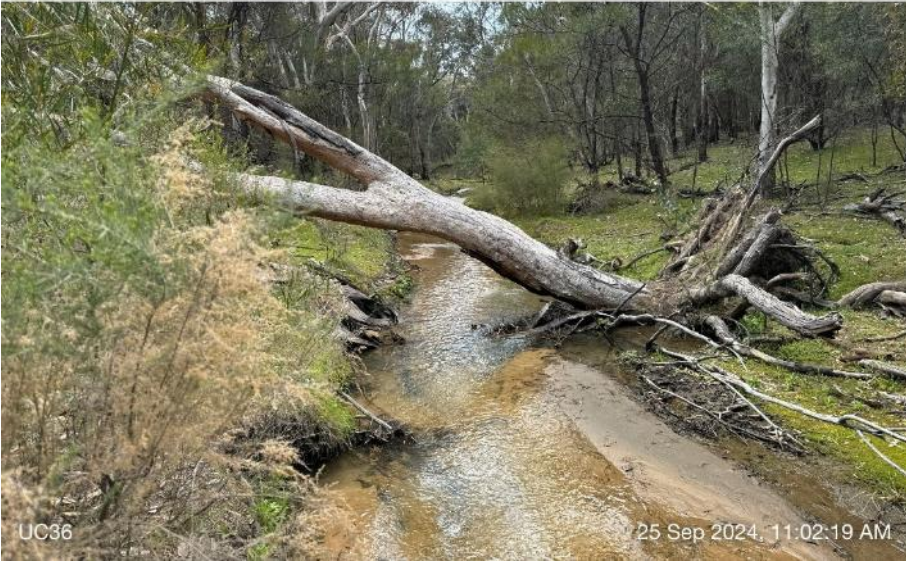
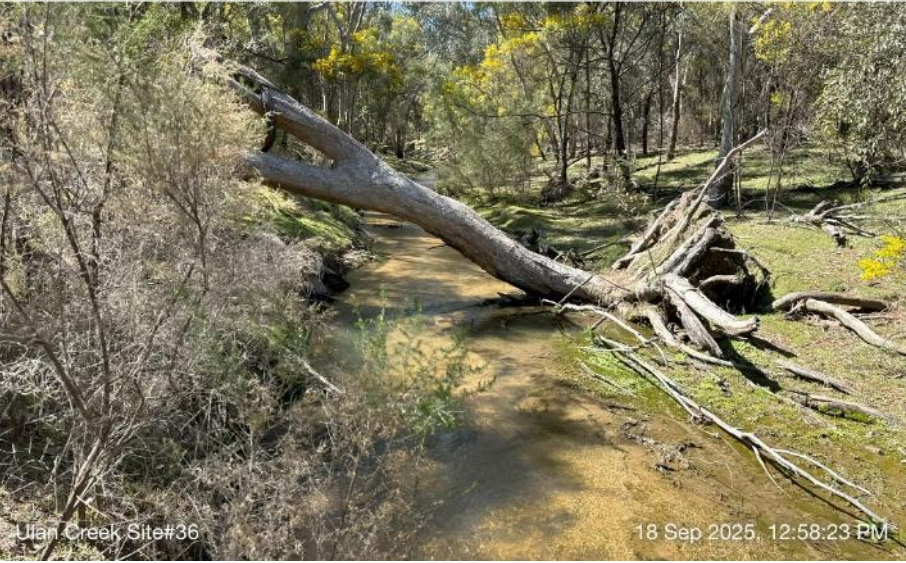
**General Observations:** Ulan Creek had water flowing at this location in 2025. The channel bed had little to no vegetation and is a mix of silt, sand and small to medium size gravel. In 2022 additional build up of sand, silt and small gravel deposits were noted. The LHB has a moderate slope above and was vegetated. The LHB wall displayed signs of undercutting. The RHB has a steeper slope above well vegetated. Comparable groundcover above the LHB and RHB as previous year. Both sides of the creek have some bare and exposed areas with evidence of past erosion although the amount. Both sides of the creek are tree lined. Observations in 2024 are comparable to previous monitoring. The CSIRO *Ephemeral Stream Assessment* classification at this location as 'potentially stabilising'.

**Notes:** In 2025 observations were limited to the RHB by water flowing.

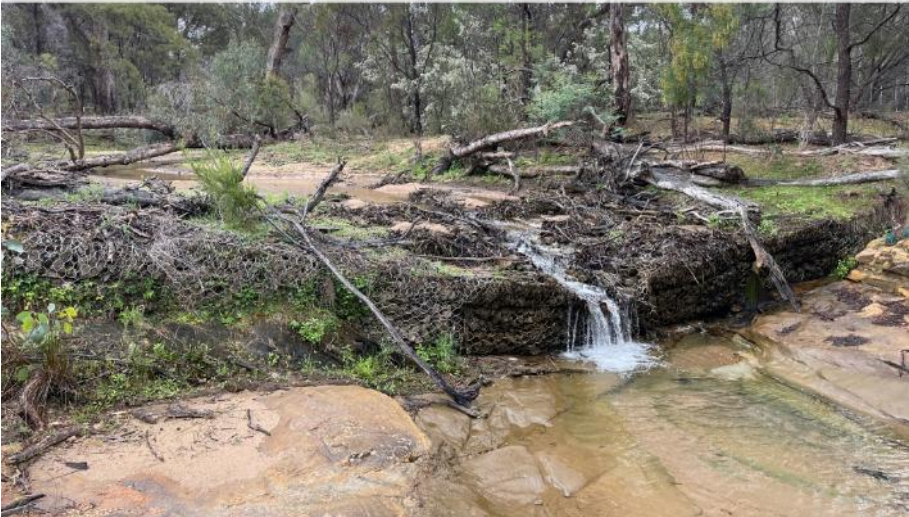
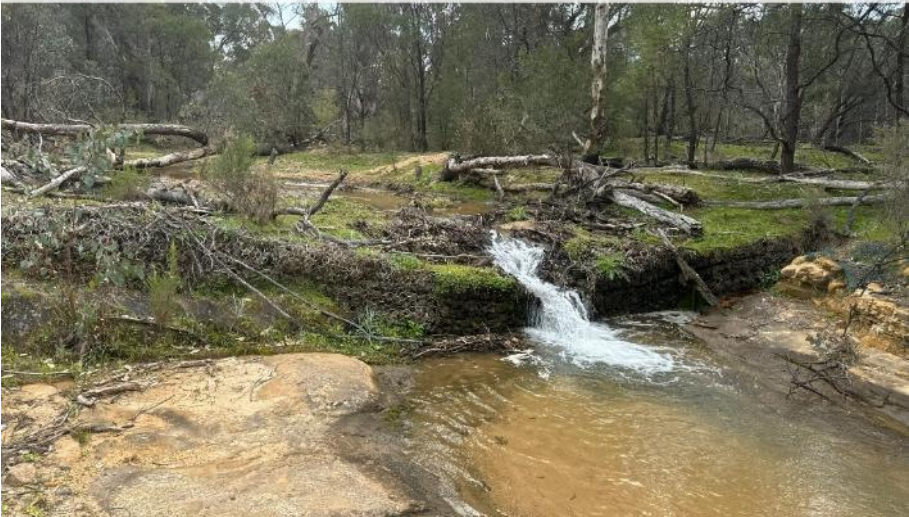
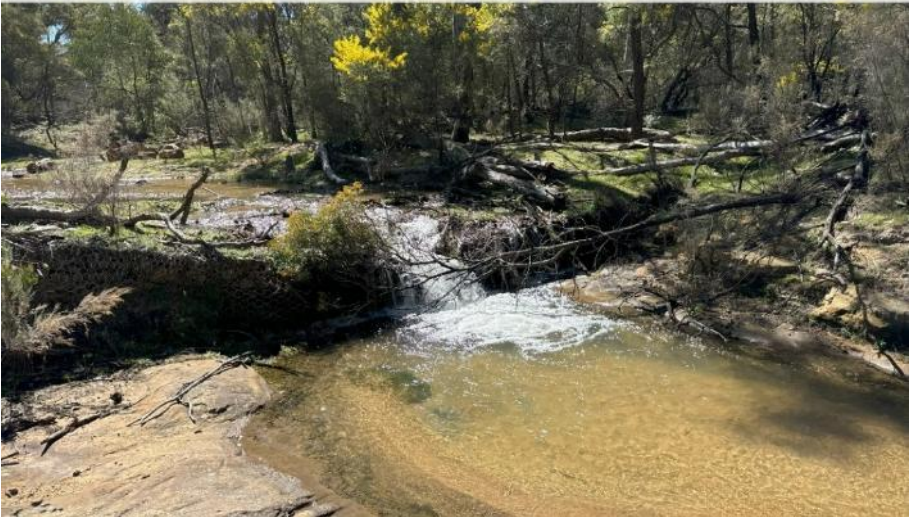
**General Observations:** Ulan Creek had water flowing at this location in 2025. The flow channel bed had little to no vegetation. Larger size rock material was noted in the channel bed. The site is located at a failed gabion structure installed to gain access across the creek which has accumulated flood debris. Previous scour holes in the creek bed downstream from the gabion structure have been infilled. The RHB has a moderate to steep slope. The LHB is a more moderate slope. Comparable groundcover above the LHB and RHB as previous year. Both sides of the creek have some bare and exposed areas with evidence of past erosion and flood debris. The coverage of ground cover noted along the banks appeared to be slightly increasing. Both sides of the creek have few trees lining the banks. Observations in 2025 are comparable to previous monitoring. The CSIRO *Ephemeral Stream Assessment* classification at this location as 'active'.

**Notes:** In 2025 observations were limited by water flowing.
