Annual Review 2020

Number: ULNCX-1862890609-23

Name of operation	Ulan Coal Mine
Name of operator	Ulan Coal Mines Propriety Limited
Development consent / project approval #	PA 08_0184
Name of holder of development consent / project approval	Ulan Coal Mines Propriety Limited
Mining lease #	CCL 741, MPL 315, ML 1341, ML1365, ML 1366, ML 1467, ML 1468, ML 1511, ML 1554, ML 1656, ML1754, ML1796, EL 5573, EL 7542, & EL 8687
Name of holder of mining lease	Ulan Coal Mines Propriety Limited
Water licence #	WAL41492, WAL19047, WAL37192, WAL37192, WAL41906, WAL42900 & WAL34921 (only allocation Licences listed).
Name of holder of water licence	Ulan Coal Mines Propriety Limited
MOP/RMP start date	01/12/2017
MOP/RMP end date	01/12/2024
Annual Review start date	01/01/2020
Annual Review end date	31/12/2020
<p>I, Robyn Stoney, certify that this audit report is a true and accurate record of the compliance status of Ulan Coal Mines Limited for the period 2020 and that I am authorised to make this statement on behalf of Ulan Coal Mines Pty Limited.</p> <p>Note.</p> <p>a) The Annual Review is an 'environmental audit' for the purposes of section 122B (2) of the Environmental Planning and Assessment Ac

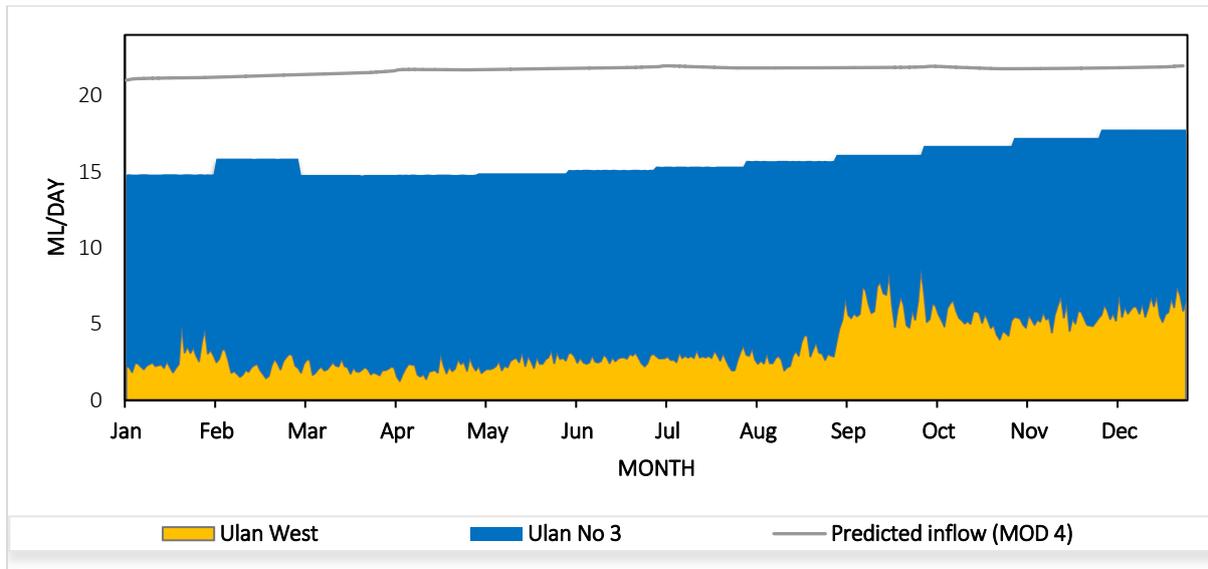
Figure 7-14 Comparison of Modelled and Calculated Groundwater Inflows to the Underground

Extracted water from pit inflows ranged between 14.8 ML/day and 17.8 ML/day in 2020 with a combined average of 15.78 ML/day. Abstracted volumes from each operation comprised Ulan West (23%) and Ulan No. 3 (77%) during 2020. **Figure 7-14** shows the modelled inflow combined for the two mine areas and indicates that actual inflows are less than the modelled inflows throughout the year.

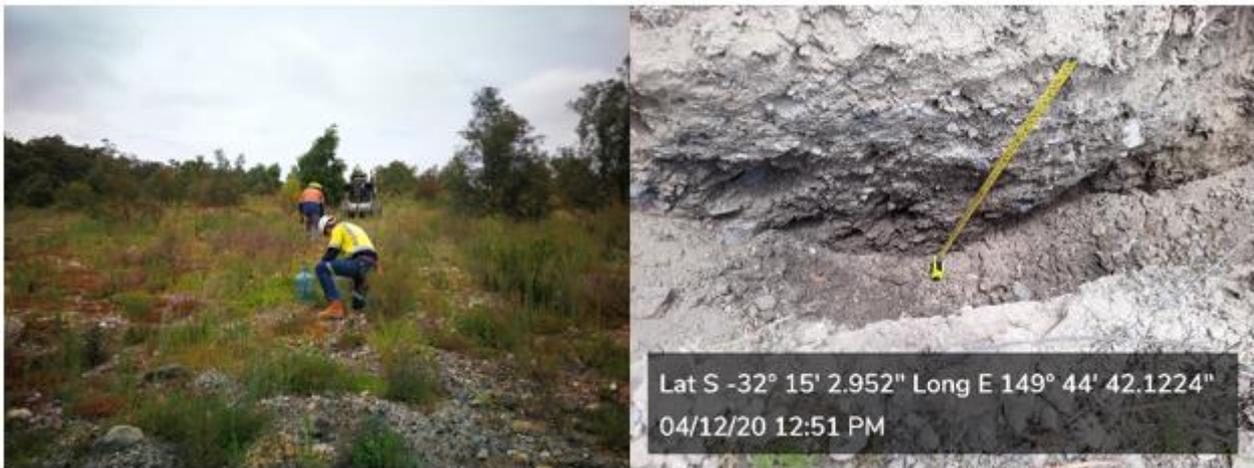
Figure 8-4 Rehabilitation Repairs/maintenance activities

Rehabilitation maintenance identified in the annual walk over inspection consisted of:

- Planting and seeding of failed rehabilitation areas;
- Soil sampling
- Removal of rubbish; and
- Weed spraying conducted early in 2020.
