# The University of Sydney: University Ovals 1 & 2

prepared by

The Tree School  
in association with

TREE MANAGEMENT PLAN

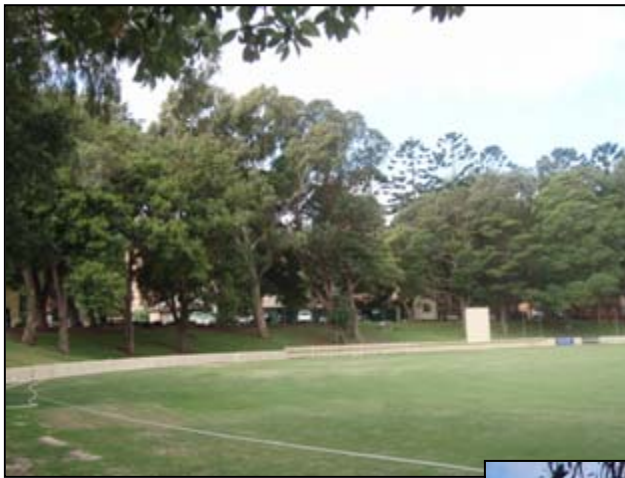
FIGURE 2: Oval 1

The trees around the Ovals provide good canopy cover and a shady pleasant environment. However, it appears that the species selection and planting locations have not been guided by a formal design concept or tree planting plan. A wide variety of types and styles of trees have been planted in an irregular fashion resulting in an ambiguous landscape character.
