BAAL BONE UNDERGROUND

Annual Review 2019

Name of Operation	Baal Bone Colliery
Name of Operator	Baal Bone Colliery
Project Approval Number	09_0178
Name of Holder of Project Approval	The Wallerawang Collieries Ltd
Mining Lease Number/s	CCL749, MPL261, CL391, ML1302, ML1389, ML1607
Name of Holder of Mining Lease/s	The Wallerawang Collieries Ltd
Water Licence Number/s	10BL601816, 10BL601817, 10BL601877, 10BL601970, 80BL236132, 80BL236134, WAL27887, WAL34952.
Name of Holder of Water Licence/s	The Wallerawang Collieries Ltd
MOP Start Date	20 th December 2019
MOP End Date	31 st December 2025
Annual Review Start Date	1 st January 2019
Annual Review End Date	31 st December 2019

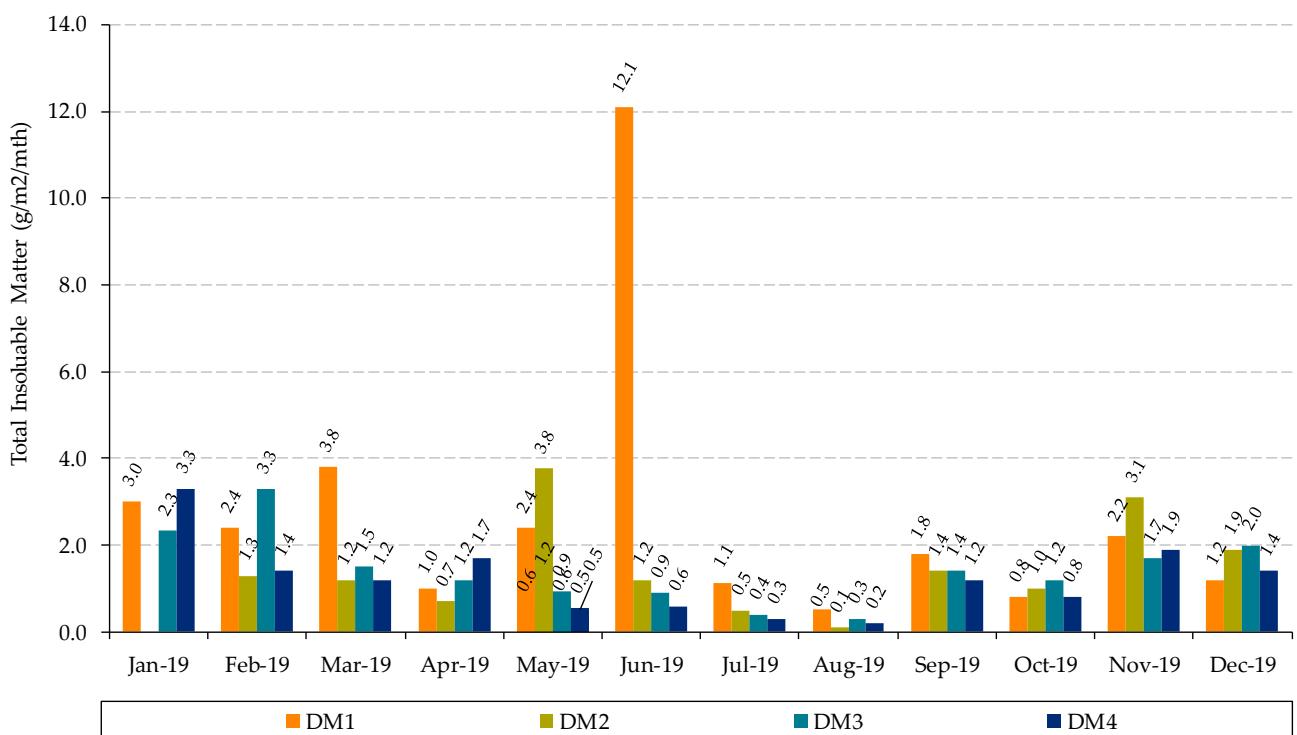
**Figure 5.2:** 2019 Deposited Dust Monthly Monitoring Results

(Note: while DM1 in June 2019 returned a result above the monthly maximum total deposited dust level of 4 g/m²/month, when the annual average is applied all results are well within Project Approval limits –refer to **Figure 5.3**).

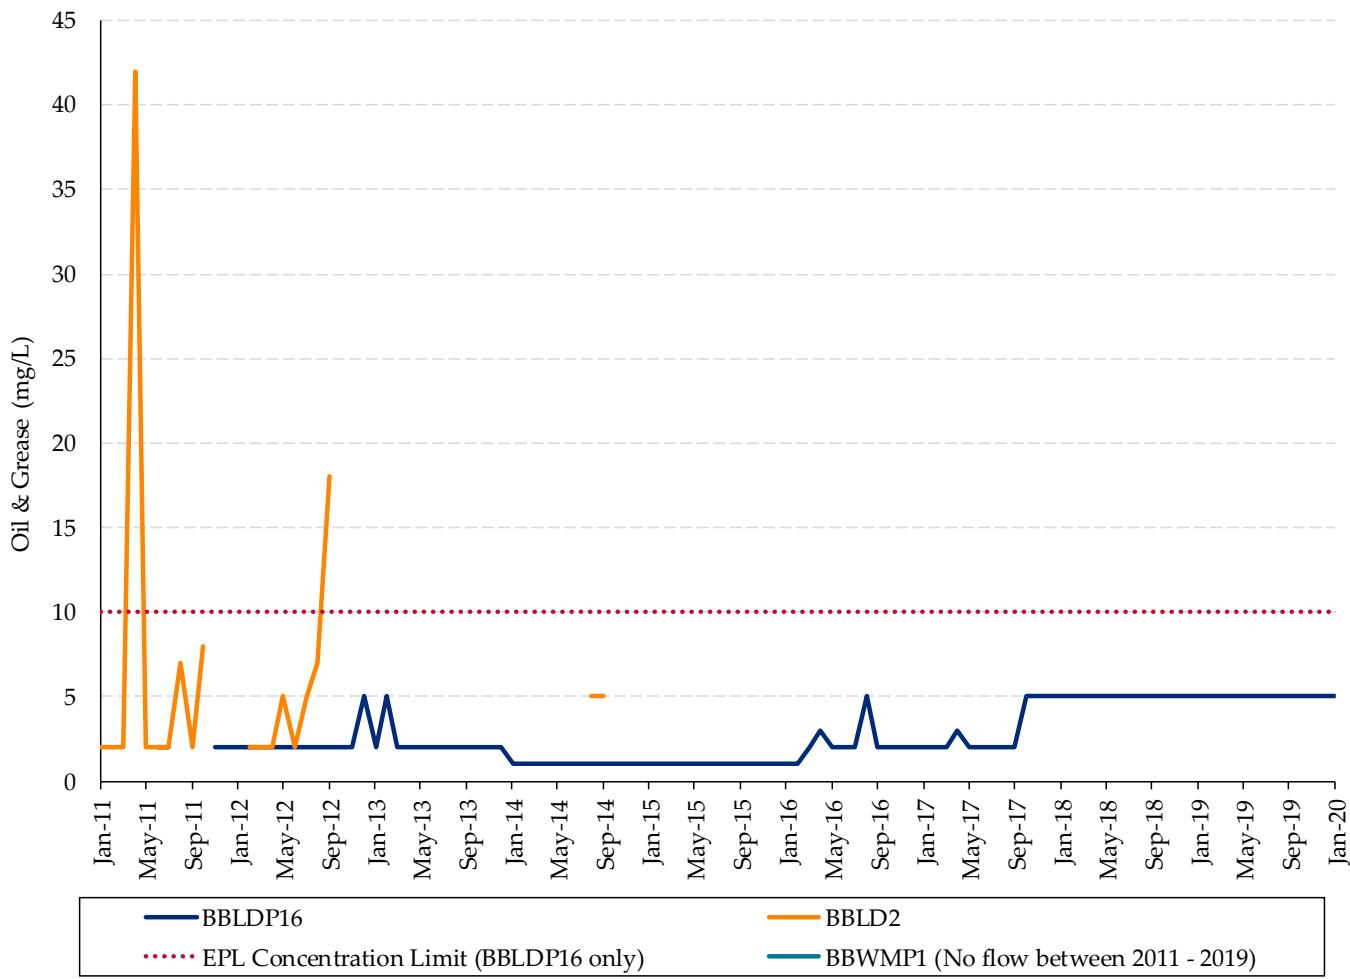
Figure 6.6 shows oil and grease levels from 2011 to 2019 at BBLD2 and BBLDP16. All oil and grease levels at BBLDP16 during 2011 - 2019 have remained well below the EPL limit of 10 mg/L.

Prior to January 2014, the limit of reporting for oil and grease was < 2 mg/L. From January 2014, limit of reporting value became < 1 mg/L before increasing back to <2 mg/L in March 2016. From October 2017 the limit of reporting increased to <5 mg/L due to changing to ALS Group Environmental Division Lithgow to undertake the monthly monitoring and analysis.

These changes in the limit of reporting account for the step change in reported oil and grease levels.

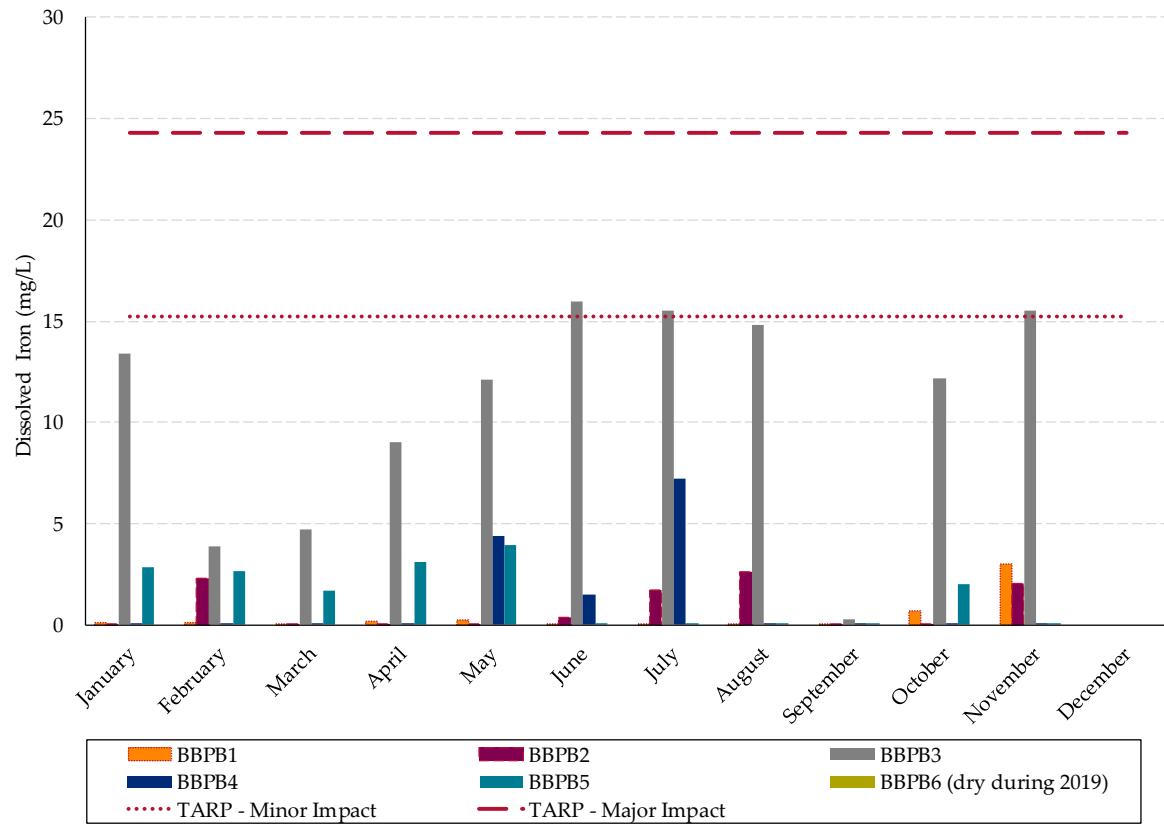
Figure 6.14: 2019 Groundwater Iron (dissolved) levels.

As shown above in **Figure 6.14**, 2019 iron levels were below the minor and major impact trigger levels for all bores except BBPB3. Dissolved iron levels at BBPB3 marginally exceeded the minor impact trigger level in June, July and November 2019. Due to the short duration of these exceedances of the minor impact level, no further action was undertaken.

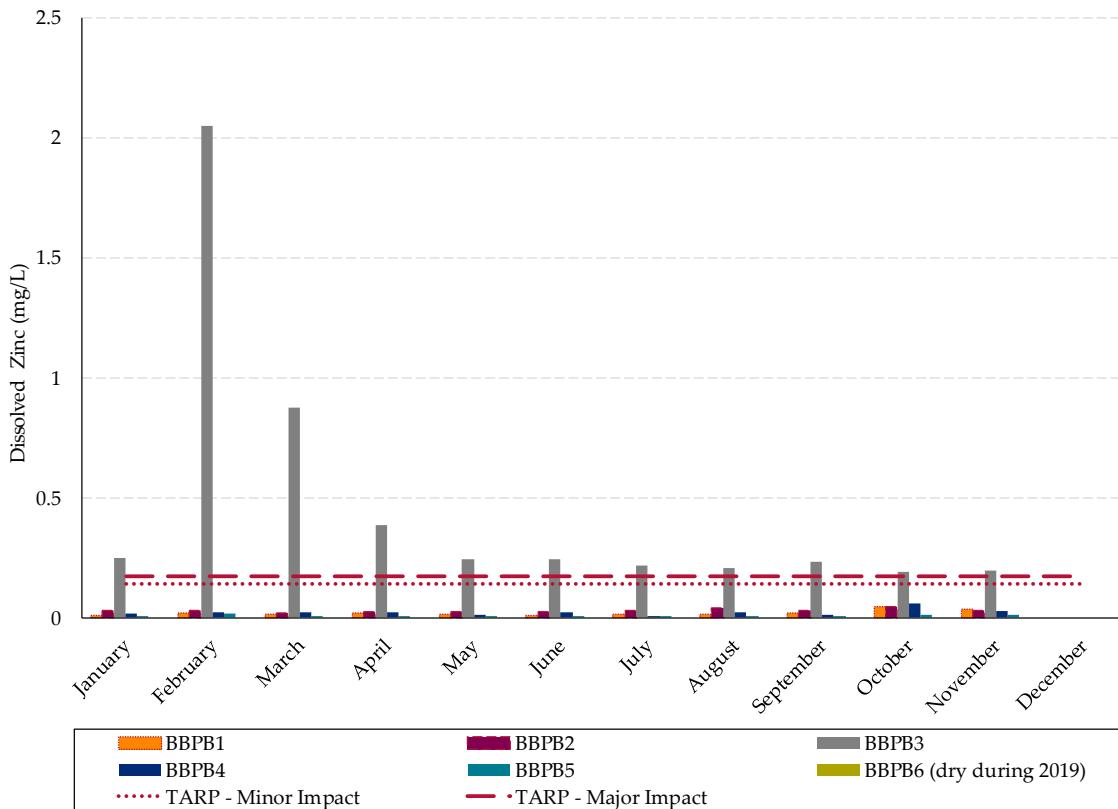
Figure 6.15: 2019 Groundwater Zinc Levels.

PA 09-0178	Schedule 3, Condition 21	Groundwater Monitoring Plan	Low	Ongoing exceedance of Water Quality Trigger Level for dissolved zinc (0.175mg/L) at BBPB3.	Section 6.2.2 and Section 9
EPL 765	P1.3	Monitoring Points	Administrative non-compliance	2019 IEA found that: "Although current monitoring plan appears consistent with the current EPL text, "2008 Licenced Monitoring Sites – Drawing 2" dated 10/01/2008 does not show EPL monitoring sites."	Section 9 and Section 10
EPL 765	M2.2	Air Monitoring Requirements	Low	In January 2019, a depositional dust gauge bottle was broken. Therefore no results were available. In May 2019 and September 2019, Baal Bone's four depositional dust gauges were exposed outside the standard of 30 ± 2 days (exposed for 27 days and 34 days respectively).	Section 5.1.3 and Section 9
CCL749	Condition 34	Consultation with District Soil Conservationist	Low	Consultation with the District Soil Conservationist Lithgow has not occurred at a minimum of six-monthly intervals.	Section 9 and Section 10

As shown above in **Figure 6.15**, 2019 zinc levels were below the minor impact trigger level for all groundwater monitoring wells with the exception of BBPB3. BBPB3 exceeded the minor and major impact TARP trigger levels for zinc for all months when sampling occurred during 2019.
