# **REDEVELOPMENT OF THE SYDNEY FISH MARKET PYRMONT**

## **Revised Arboricultural Assessment**

August 2010

**GARRY CLUBLEY**

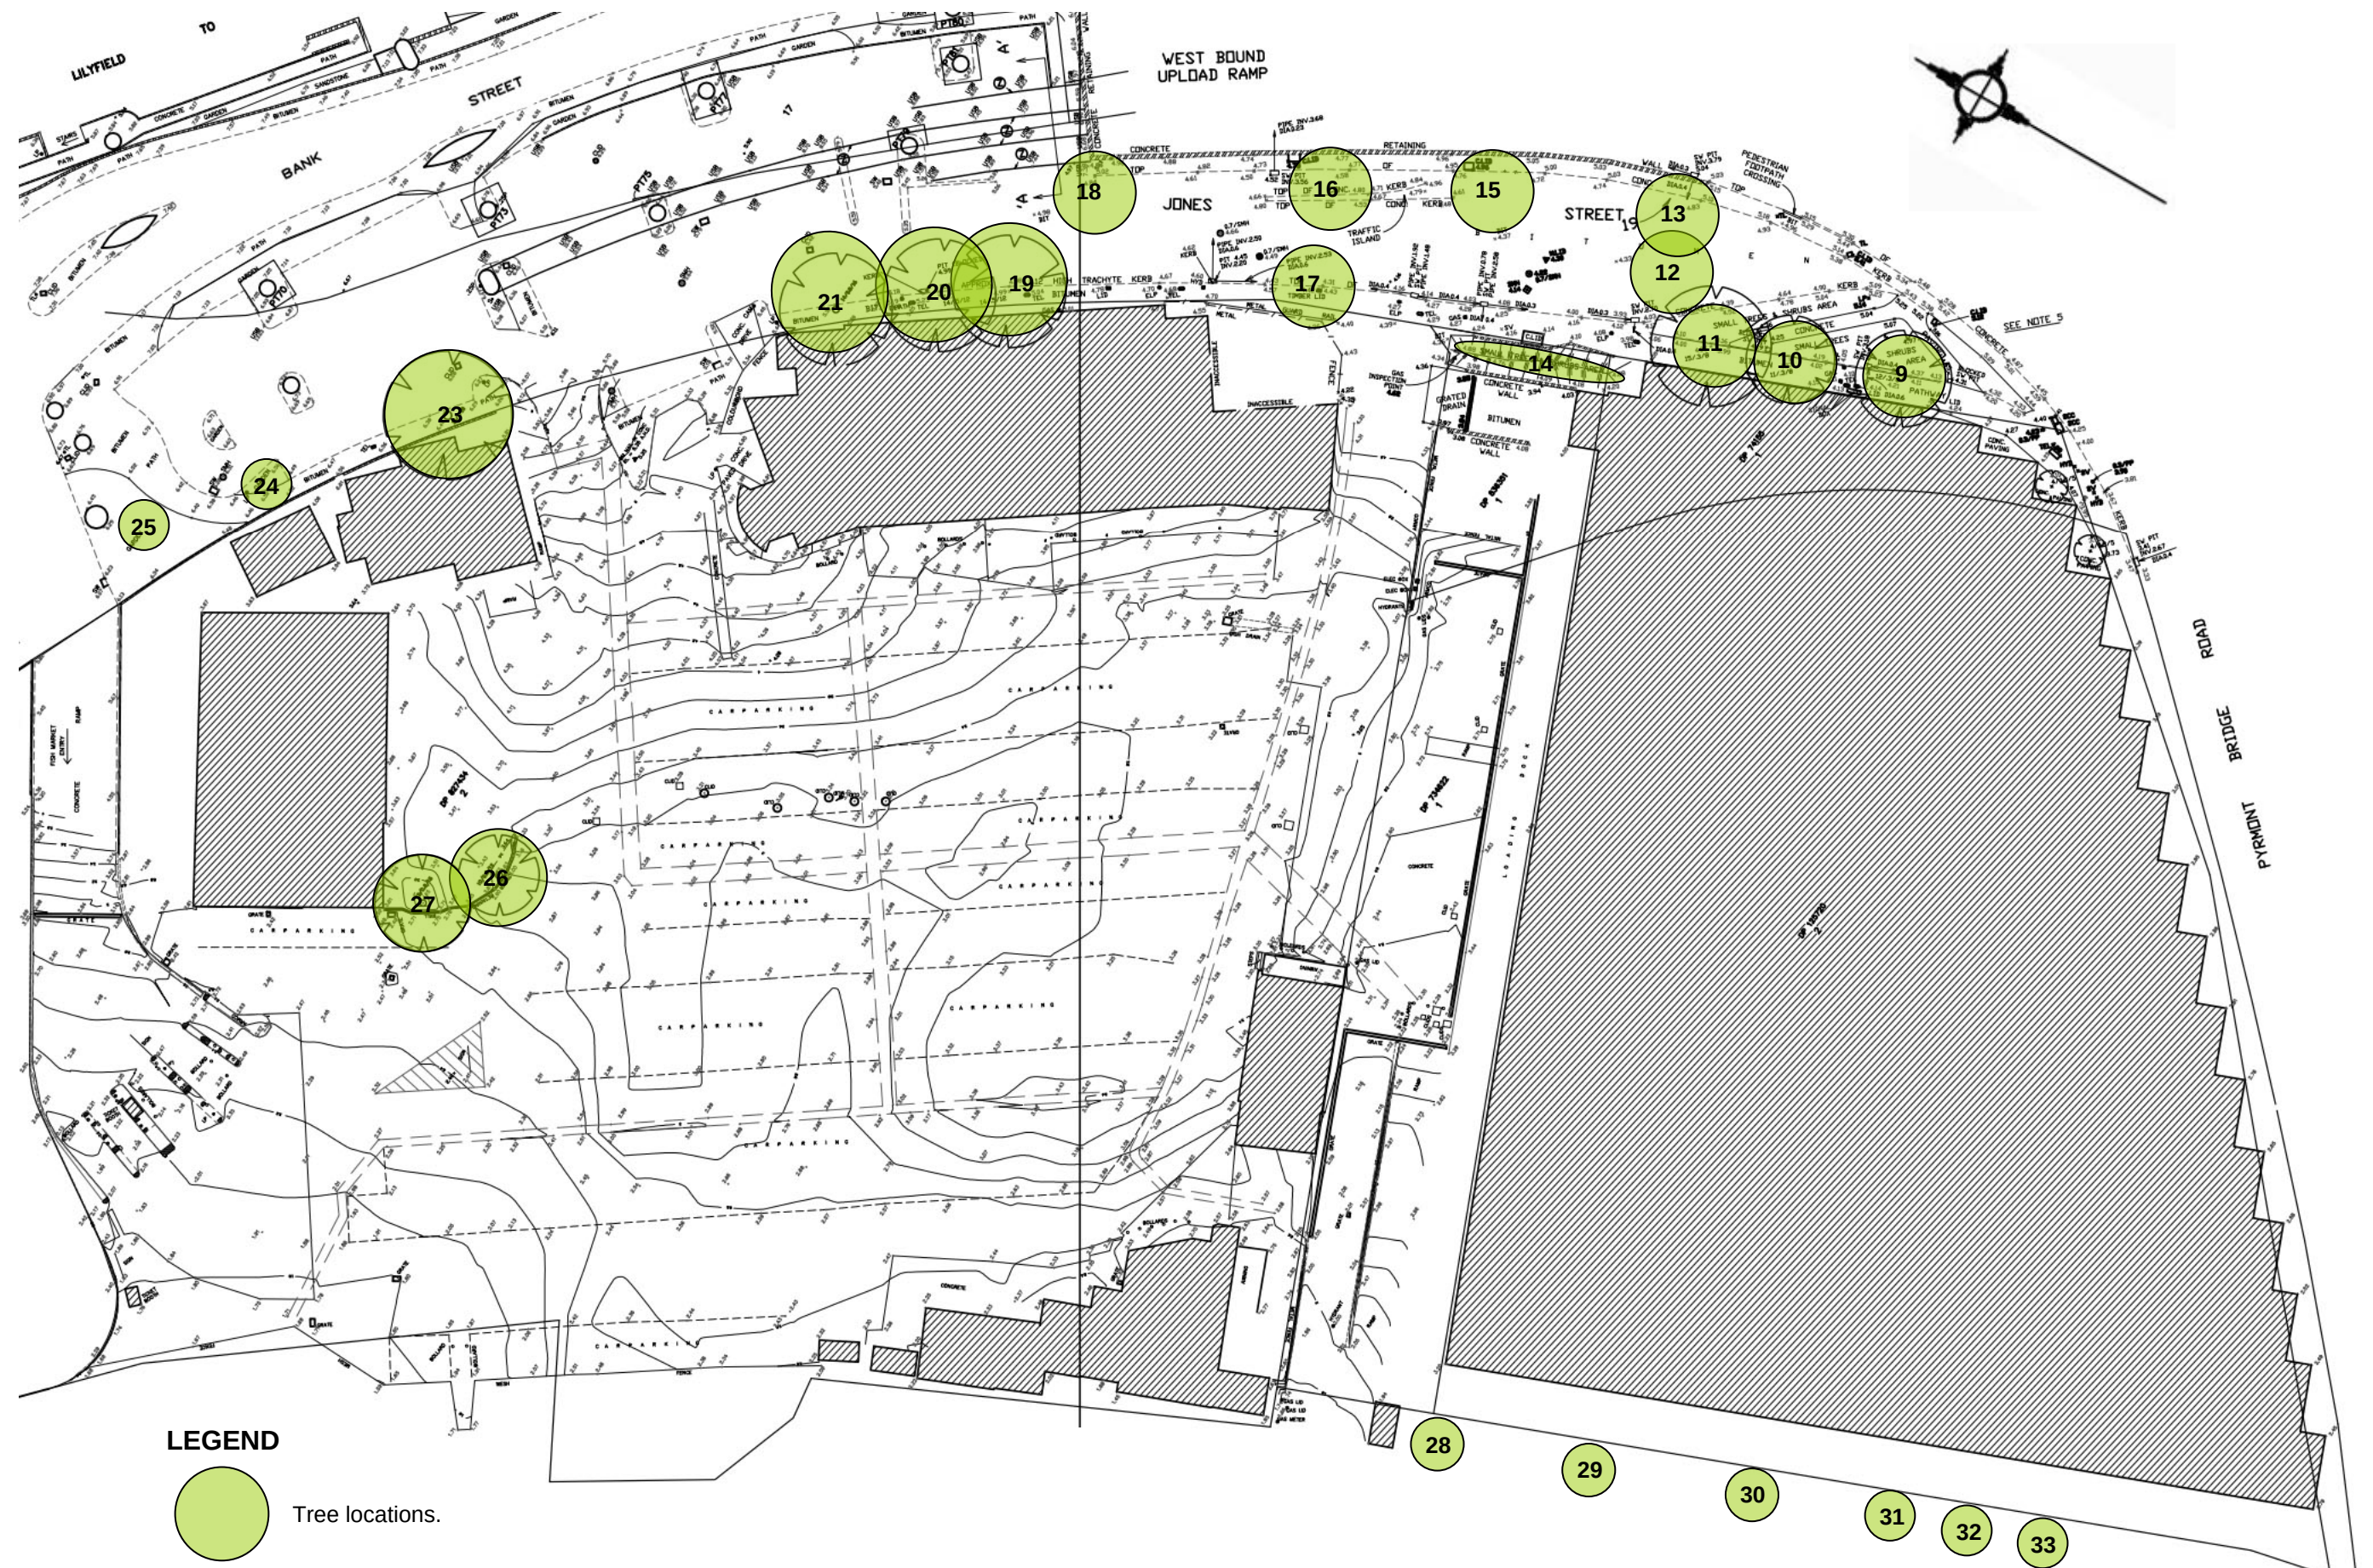
Figure 1 – Tree Location Plan

- 1.8** Refer to Figure 1 "Tree Location Plan" (Page 20 of this report) for the locations of trees identified in the Tree Inventory and Assessment Schedules.
