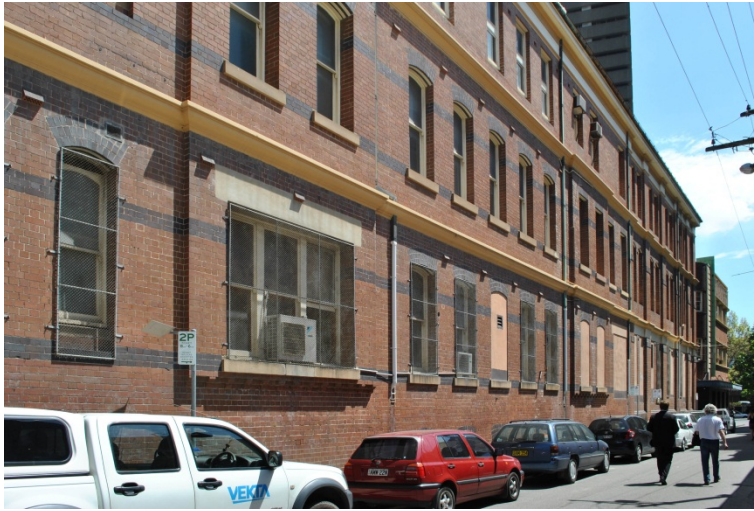
Figure 7.

The Administration Building forms an important edge to the northern end of Kensington Street due to its imposing scale and strong patterning created by the rhythms of the fenestration and projecting moulding which direct the eye along the street. The building is also notable for its lack of access from the public domain, reinforcing the prominence in the streetscape. Although the building reads as intact on casual inspection, closer interrogation reveals a wealth of layering and adaptation over the years.

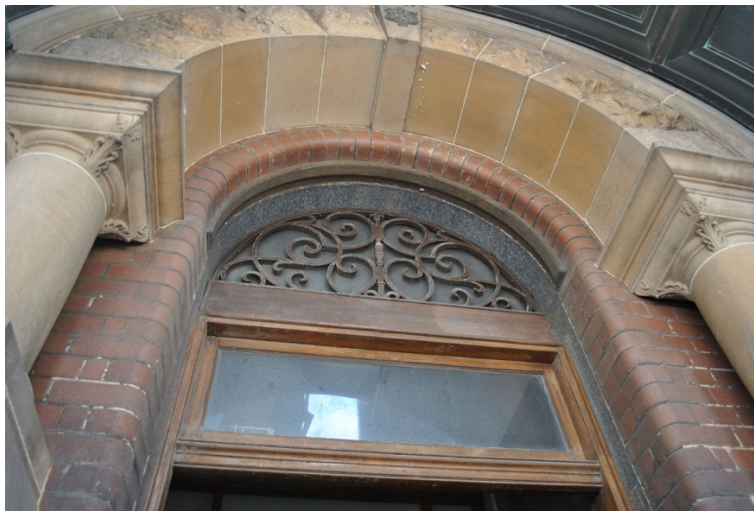
Figure 10.

The formal entrance to the building is positioned at the centre of the western facade of the building and opens into the internal road. Protected by a simple Romanesque style arch and copper-sheathed hood, its restrained design and quality construction allows it to play an important part in the composition of the building.

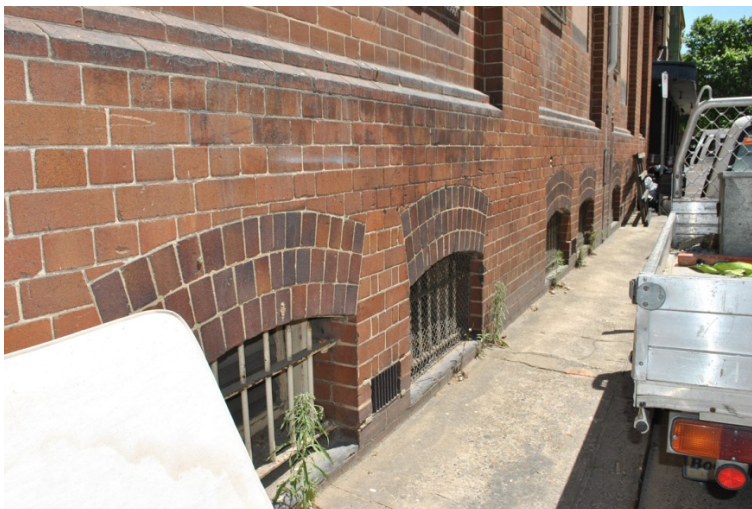
Figure 13.

The 1930s extension provided gridded windows to the basement on Kensington Street.

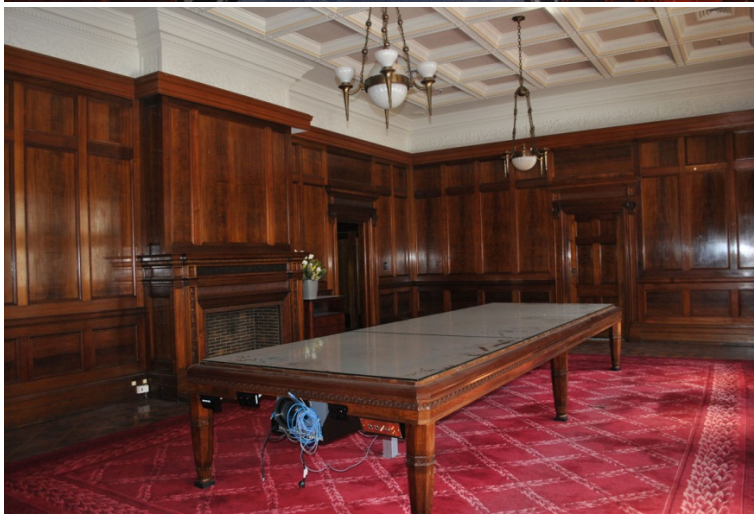
Figure 23.

The Boardroom is a visually impressive space. Although it was constructed as part of the 1930s alterations and additions, its stylistic approach is conservative and references earlier eras, consistent with the popular desire for companies to present themselves as solid, dependable bodies. The Boardroom (and its associated rooms) will be retained as a single luxury suite.

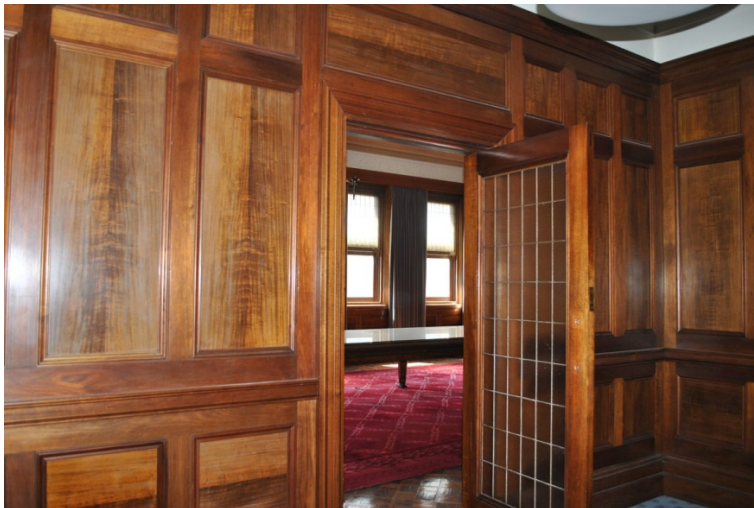
Figure 24.

Ante room to the Boardroom on Level 2. The ante-room will be retained in situ as part of the Boardroom Suite.

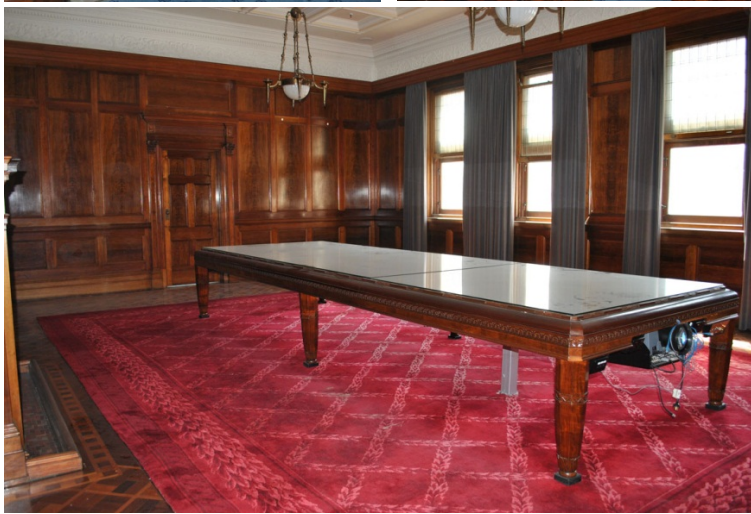
Figure 26.

Boardroom: looking to the windows on the eastern elevation. The table will be re-used elsewhere in the hotel as an interpretative element.

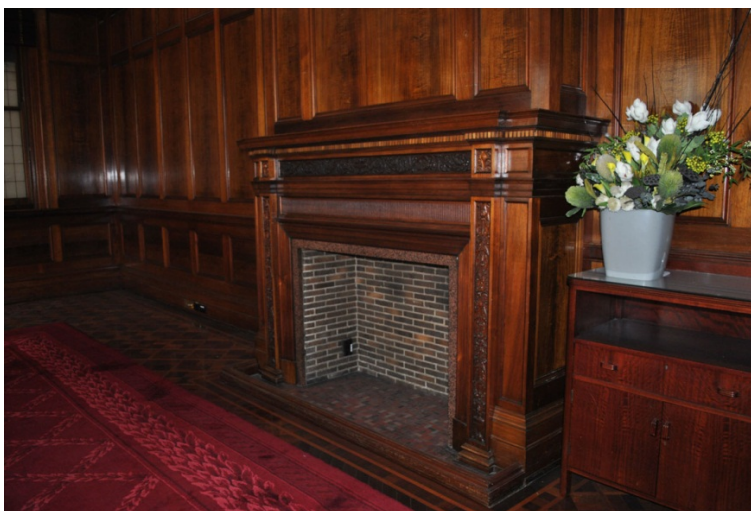
Figure 27.

The original fireplace with miniature brick lining and carved timber surround will be retained in situ.
