#### 4.4 FORMER GARAGE/RUM STORE AT 2-10 KENSINGTON STREET

## DESCRIPTION OF THE FABRIC OF 2-10 KENSINGTON STREET

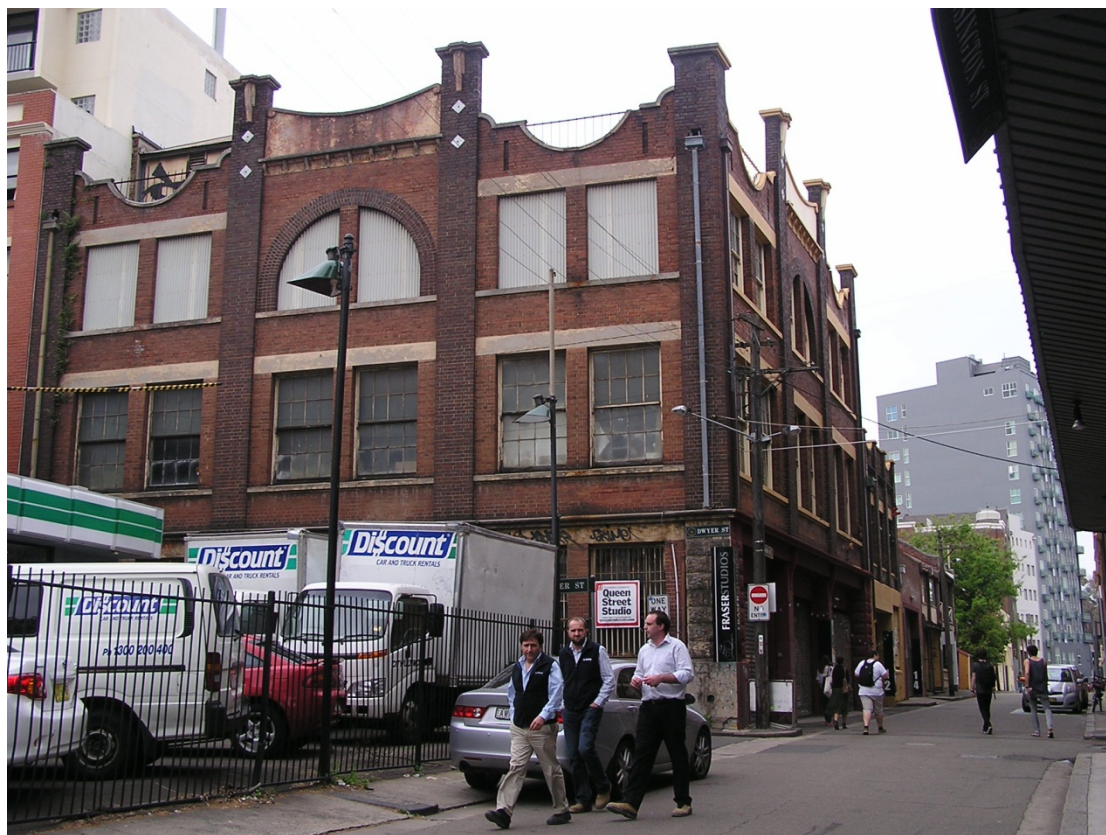
Figure 23. Former Motor Garage and Rum Cask Store at 2-10 Kensington Street viewed from the north (Broadway).

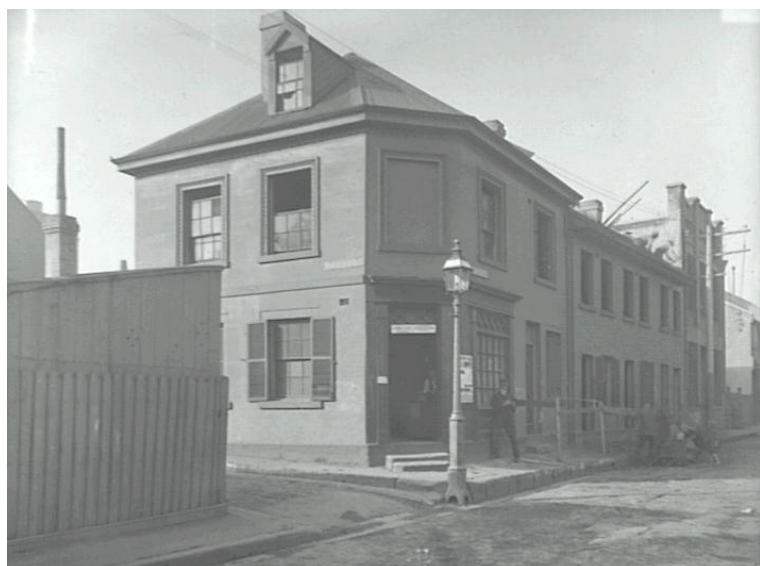
Figure 24. The corner of Dwyer and Kensington Streets c1908 prior to demolition for construction of the Motor Garage/Rum Bond Store on the corner in 1913. The newly built warehouse at number 12 is visible behind. (Sydney City Council Archives image Pix005-005108)

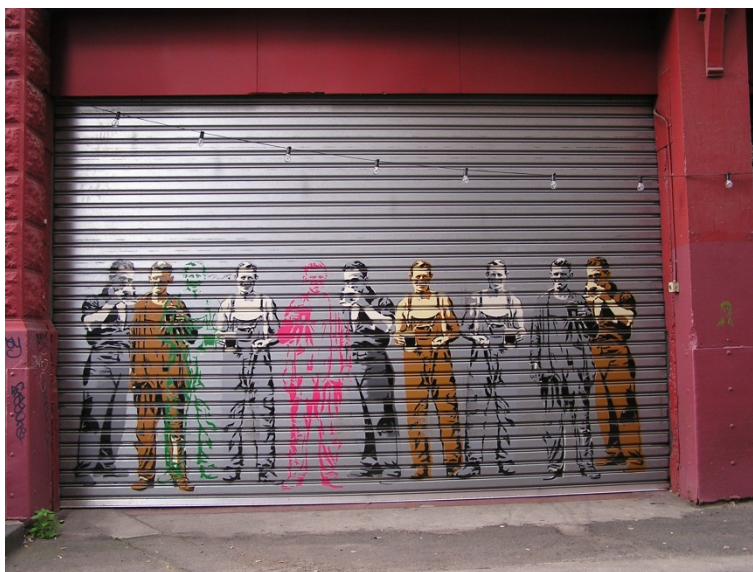
Figure 29. Street detailing — the building sits on the front property boundary. The narrow footpath area is ramped to street level to facilitate vehicular access to the wide door openings. The roller doors have been painted with images associated with the former brewery use and urban street art.

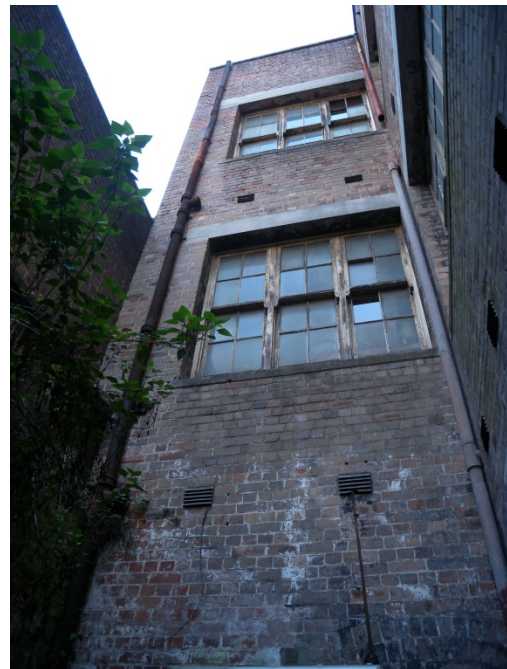
Figure 30 (above): The building is built to the eastern and southern boundaries with the exception of a small light well set at the south-eastern corner of the property. It is accessed only via a door at ground level. Large timber framed windows open to the well on each level.

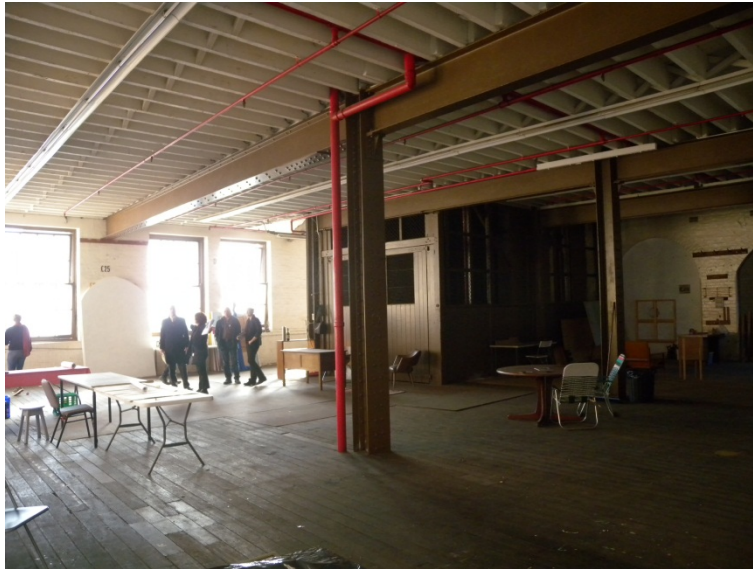
Figure 33. Interior – structural details. The structural capacity of the building was improved in the 1930s by the addition of Dorman and Long 'I' beams and columns in order to carry heavier loads as part of its use as a Bonded Store for alcohol. The main part of the internal structure is now supported by steel columns and beams framed by riveted girders, with the original lighter weight supports to the administration areas.

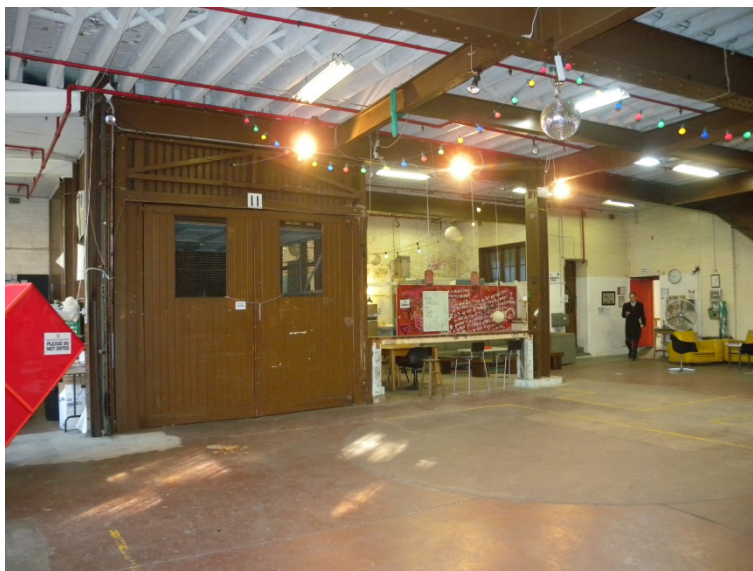
Figure 34. The lowest (ground) level of the building is an open, high ceilinged space. The central area has been reinforced with Dorman and Long 'I' beams and columns. The columns in centre of the ground floor level are set into concrete bases for additional stability. The main evidence of earlier use as a warehouse is the large vehicular lift structure set against the eastern wall. The door to adjacent occupancy on southern side (12 Kensington Street) has been cut into the original wall, as is shown by the changes in floor level, cut brickwork and lack of lintel or detailing. The opening to the light well is original. A simple office kitchen (recent) has been fitted to the eastern wall.
