## FABRIC OF THE TERRACES AT 16-16A KENSINGTON STREET

## MAJOR BUILDING MAINTENANCE AND REPAIR REQUIREMENTS FOR 16-16A KENSINGTON STREET

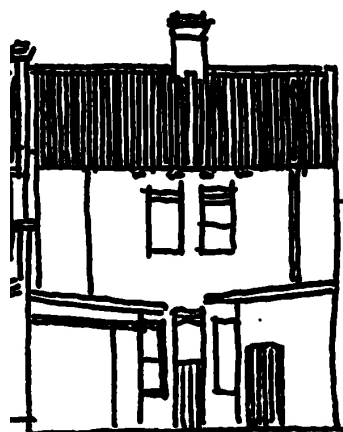
16-16A Kensington Street- rear (eastern) elevation

| Element or spatial quality | Heritage value represented | Contributory Value | Relevant fabric |
|---|---|---|---|
| Exterior façade to rear (east elevation) | Historic, aesthetic | High | Two storey with paired single storey wings. Notice that the wings have major damage. |

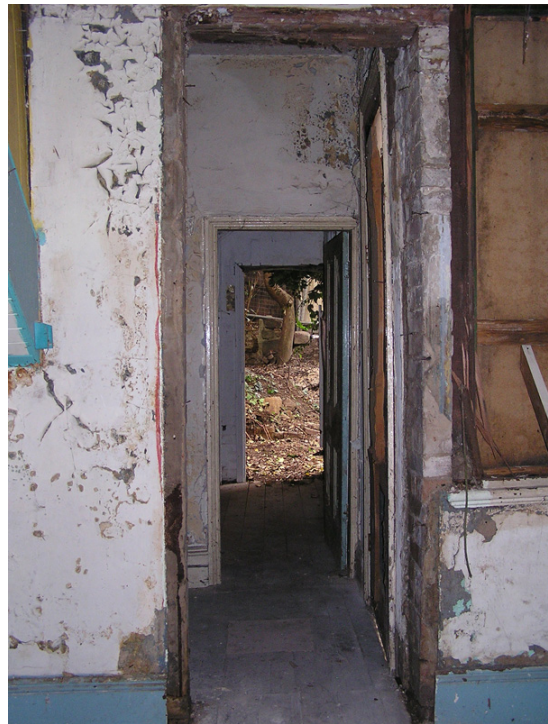
Figure 75. Looking to the rear of the terrace.
