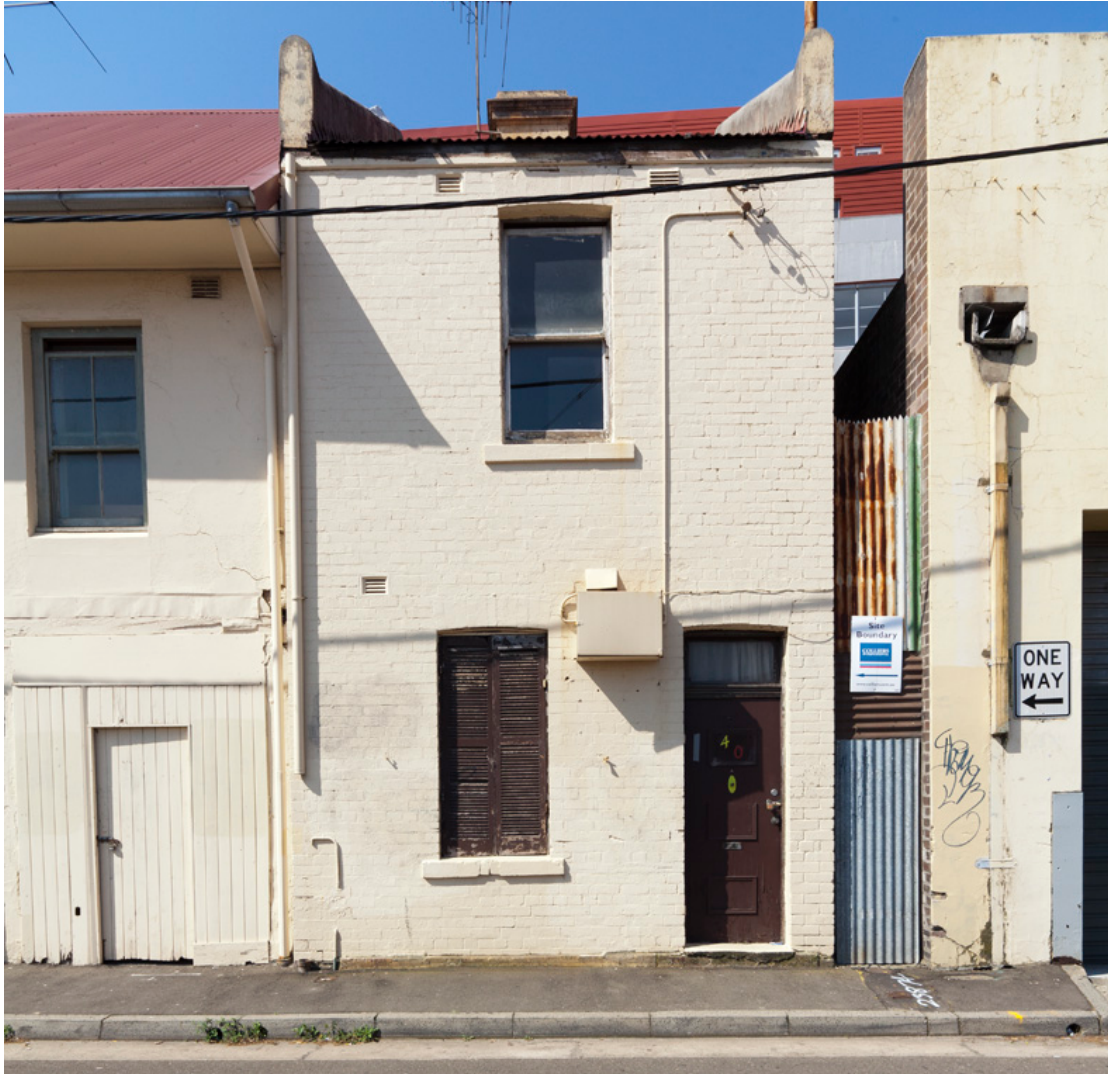
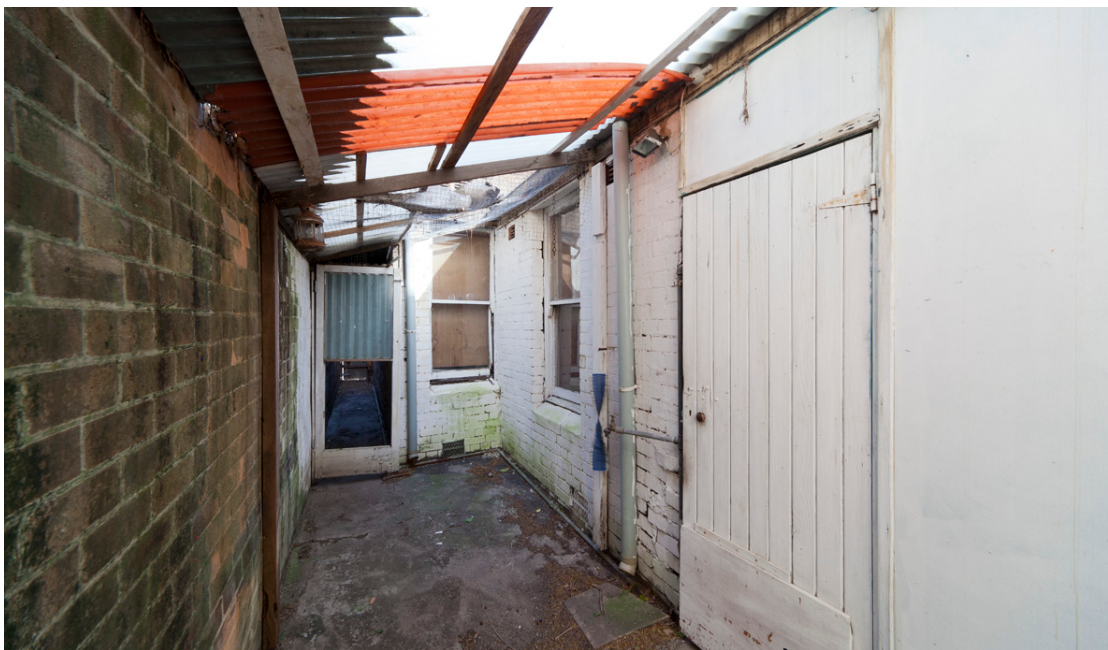
40 Kensington Street is a narrow, two storey brick terrace on a sandstone base with a single-storey wing to the rear under a skillion roof. It is built to the alignment of Kensington Street and abuts the terrace at 38 Kensington Street to the north. It is separated from the industrial building to the south by a narrow passageway, which was gated by a sheet of corrugated iron to allow access for the occupants of No.40 to the small courtyard at the rear. The chimney is placed close to the centre of the ridgeline.

The composition of the main elevation is simple and typical of a working-class terrace, with a door and single window at ground level and a centrally placed window to the upper level. The brickwork is laid in English garden wall bond and appears to be sound. The front door is not original.

Windows to both levels are double hung sash windows with a single pane of glass in each sash. The window at ground level has fine louvered timber shutters and steel mesh has been fixed to the interior of the window, presumably for security. The windows to the rear are the same as to the front elevation, suggesting that they were all inserted at the same time. Condition of the timber of these windows is poor due to lack of protection from weather and general lack of maintenance.

The rear walls are painted common brick. Some structural cracking is evident under the windows at ground level. The rear wing extension is partially clad in asbestos cement sheeting. The back door is a typical mid-late Victorian ledged and braced timber door.

There is evidence of water ingress at the south-eastern corner of the property which has damaged brickwork and interiors in this area.

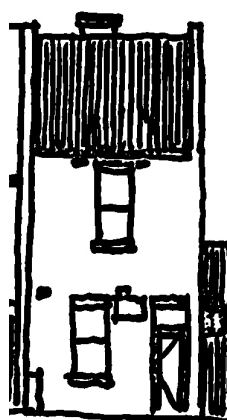
40 Kensington Street elevation

| Element | Comment |
|---|---|
| Walls | Exterior brickwork is largely intact, particularly to the street elevation and the main walls of the rear. More detailed inspection is required and if damage is found it should be repaired using matching materials and techniques. Painted brickwork may be re-painted if required. The wall should not be rendered. |

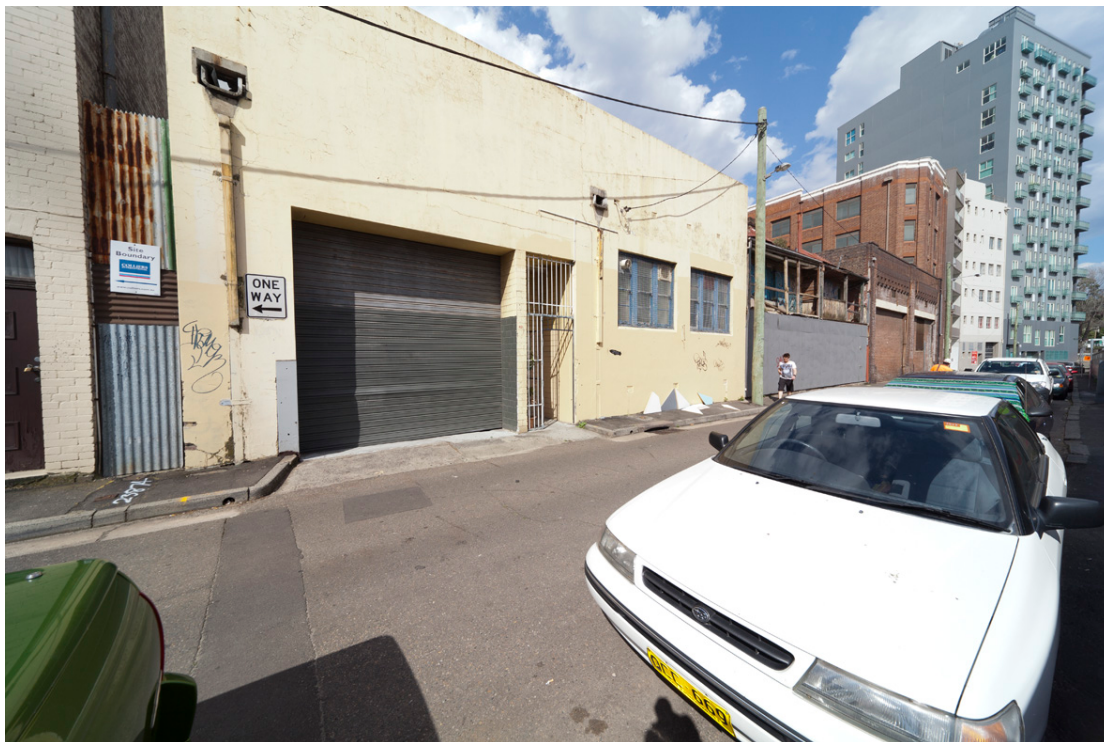
The warehouse at 42-44 Kensington Street was built as an infill building between the adjoining terrace houses and has been used for various industrial activities since this time. No detailed analysis of this building was undertaken in accordance with the requirements of the Brief for the CMP.

The building is a single storey building with a steel roller door, two large windows and a simple pedestrian door set in a simple, gable fronted brick building that has been painted white. The composition of the façade to Kensington Street is utilitarian, the pedestrian door being created from an earlier, wider vehicular opening. Two sets of windows are set to the southern part of the wall, each having three pairs of double-hung timber sash windows with horizontal glazing bars, all covered by wire mesh.

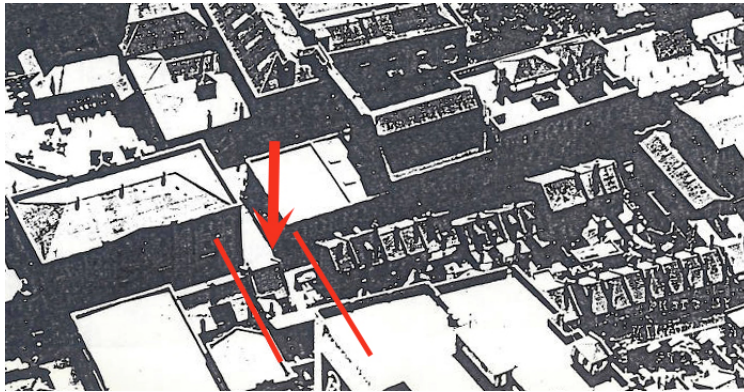
Figure 175. Aerial photograph taken in 1935 showing the buildings of the Kensington Street Precinct. A terrace house occupied the site with an open yard area to the north. (ANU BLA Z223/14 – sourced from Madden, 1989; *Identification of the Remaining Heritage Items on the Kent Brewery Site.*)
