# **Preliminary Site Investigation for Contamination**

**Proposed Marulan Quarry at No. 16501  
Hume Highway, Marulan, NSW**

Global Quarries Australia Pty Ltd

23 December 2025

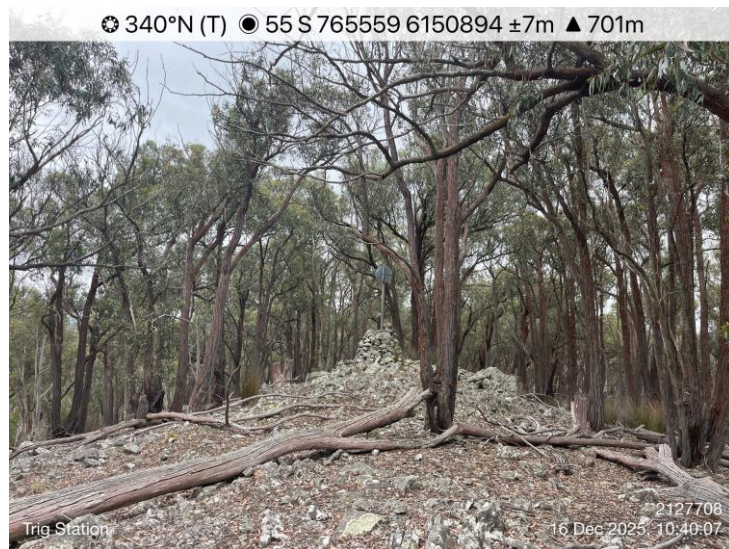
The site was observed to slope away from a central hill and high point on the site (Lot 3), located at the trigonometrical station (Shelly Trig Station) (Photo 5). The land falls steeply from this high point to the east, west and south. Narambulla Creek and its tributaries occur south of the site at the base of the slope (Photo 6 and Photo 7). A ridgeline runs north from the high point towards the Hume Highway, with gently to moderately steep slopes occurring east and west of the ridgeline.

Photo 5: View looking north at the trigonometrical station, which is also the highest point of the site (16/12/2025)

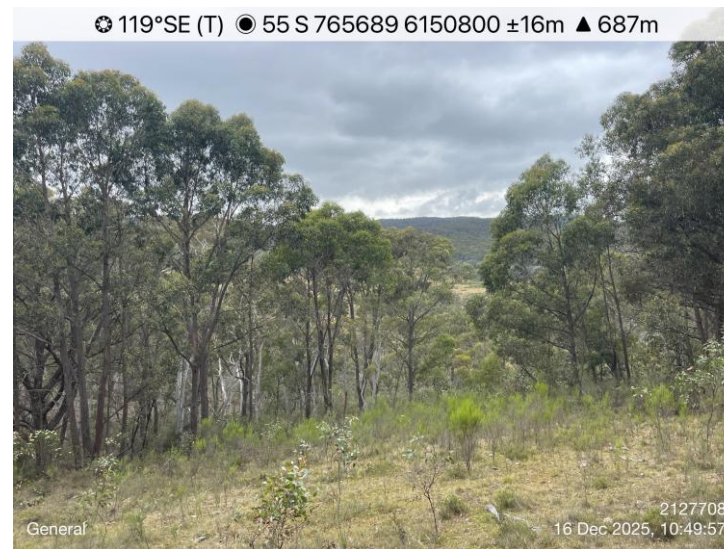
Photo 6: View looking south-east towards Naramburra Creek from the central hill at the site (16/12/2025)

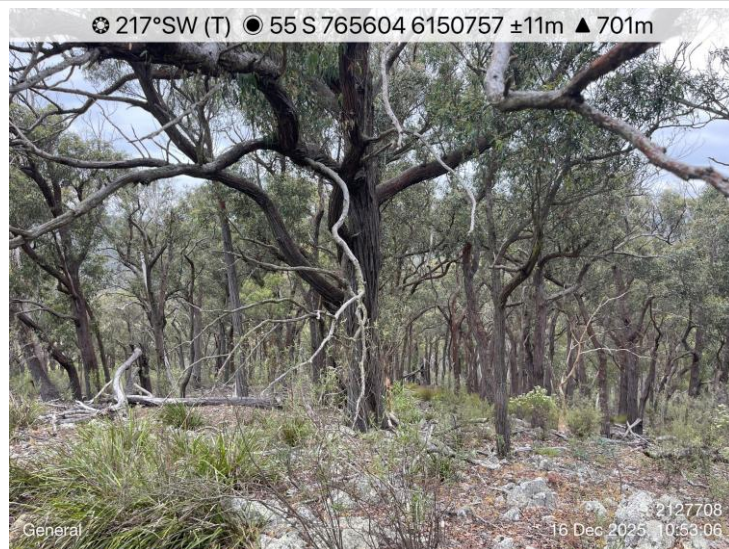
Photo 7: View looking south-west from the central hill at the site. Steep slopes evident (16/12/2025)

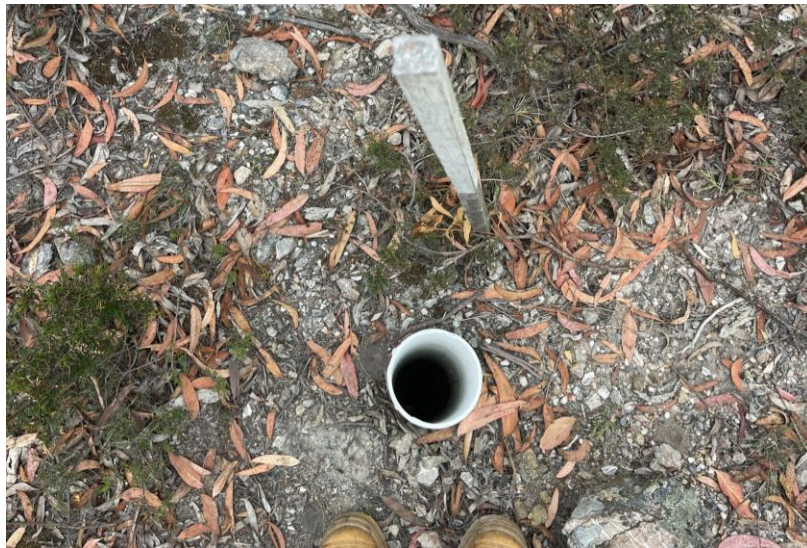
Photo 9: Cased hole near a green bulk bag location. Greater than 30 m deep (16/12/2025).

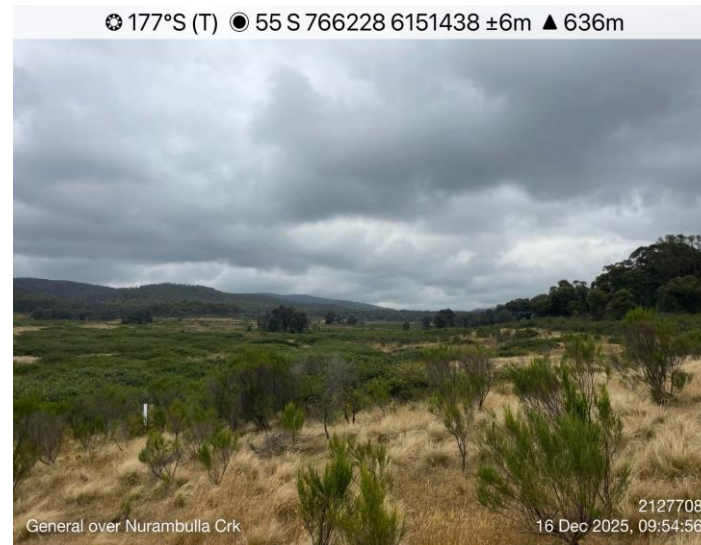
Creek flats were present around Narambulla Creek, largely occupied by grass, blackberry bushes and sparse trees (Photo 10). Narambulla Creek and its tributaries were not flowing at the time of the site visit. The water was ponded within discontinuous segments of the watercourse. Narambulla Creek appeared slightly cloudy with low turbidity and had an aqua blue tinge (Photo 11). Further upstream, the surface water was pale brown, more cloudy with moderate to high turbidity (Photo 12). No odours, sheen, iron precipitation or foam were noted in the watercourse. The creek was deeply incised into the surrounding land and highly eroded (Photo 13), with the banks approximately 2 m high in some areas.

Photo 10: View looking south over the eastern boundary of the site and Narambulla Creek (16/12/2025)

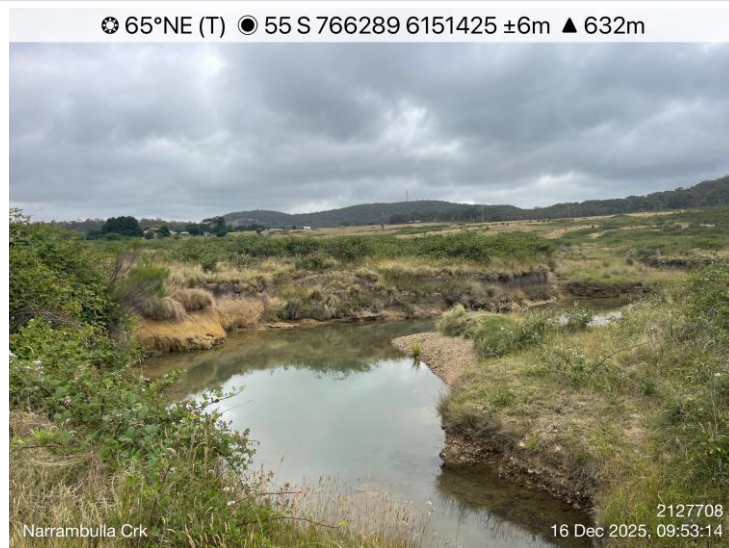
Photo 11: View looking north-east at Narambulla Creek located immediately off-site on the eastern side of the site (16/12/2025).

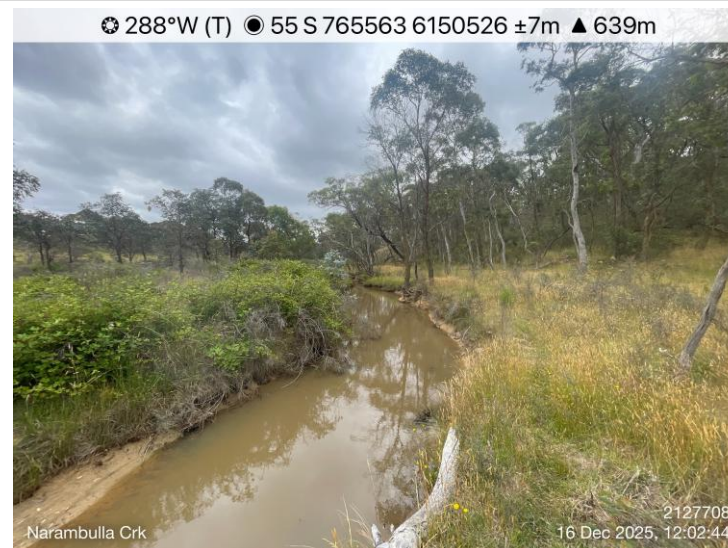
Photo 12: Narambulla Creek upstream of Photo 11, facing west (16/12/2025)

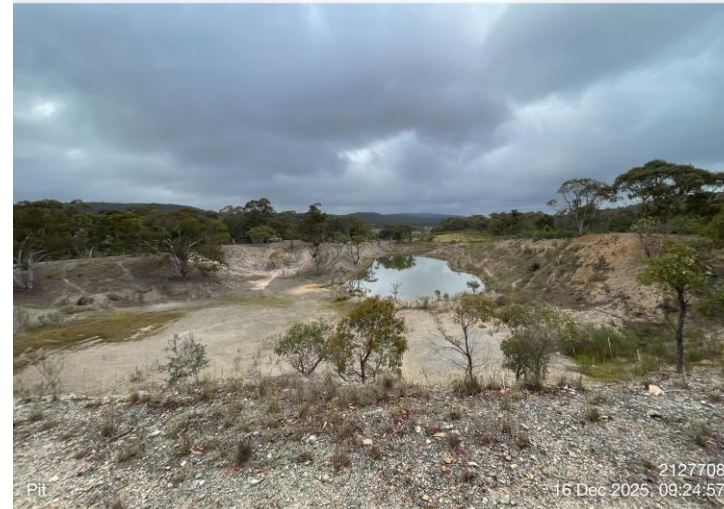
The borrow pit area was situated in the north-east of the site (Lot 4). The pit is approximately 150 m long and 50 m wide, the pit walls are approximately 5 to 10 m high (Photo 14). A dam has formed within what appears to be the base of the borrow pit and is estimated to be greater than 1.5 m deep. Several haul roads / access tracks down into the pit were present. The haul roads / access tracks appear to have been constructed with quarry material. Remnants of a car body were observed adjacent to one haul road near the borrow pit (Photo 15), no contamination was observed in the vicinity of the car body. No evidence of filling or importing material was observed in or around the borrow pit.

Photo 14: View looking south towards the borrow pit from the northern wall (16/12/2025)

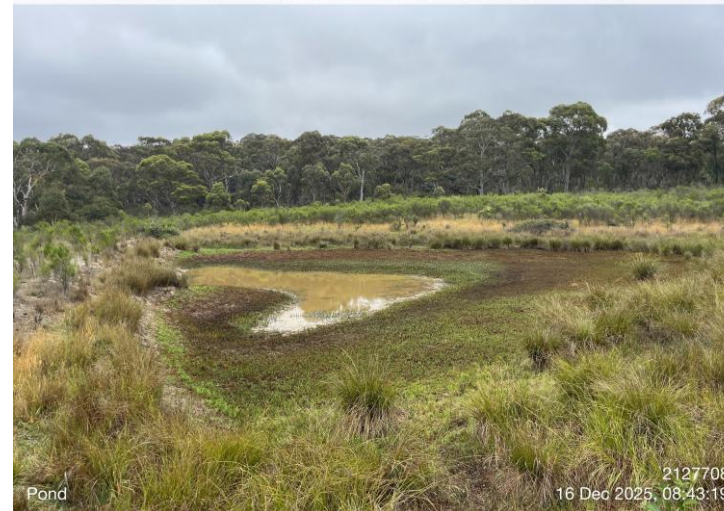
Two dams are located in the areas surrounding the borrow pit, one immediately to the east (Photo 16) and another located immediately south (Photo 17). Both dams had low water levels, with the water described as pale brown, moderately turbid, and no odours, sheen, foam or iron precipitation. A piezometer (Hole 3) was located immediately south of the borrow pit (Photo 18). The monument was in good condition, and the standpipe was measured to be 0.830 m above ground level. The water level was recorded at 1.980 m below top of casing using a water whistle, which is 1.150 m below ground level (bgl). The base depth of Hole 3 was greater than 30 m and could not be gauged with the length of measuring tape available on-site.

Photo 16: View looking west at the dam located just east of the borrow pit (16/12/2025)

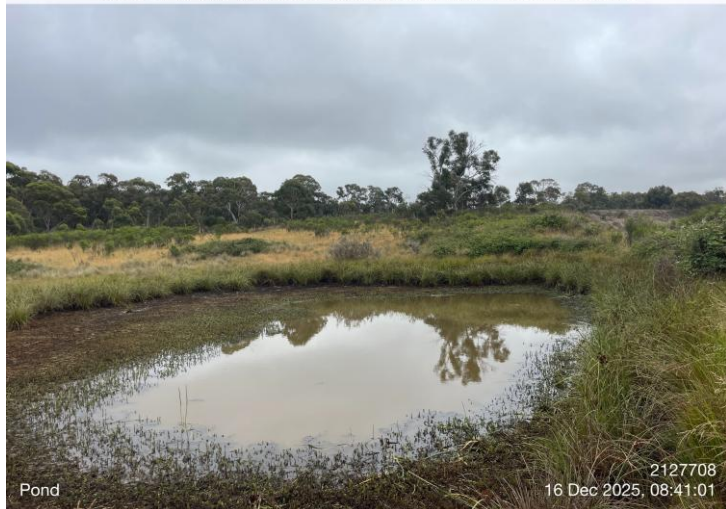
Photo 17: View looking north at the dam located immediately south of the borrow pit (Lot 4) (16/12/2025)

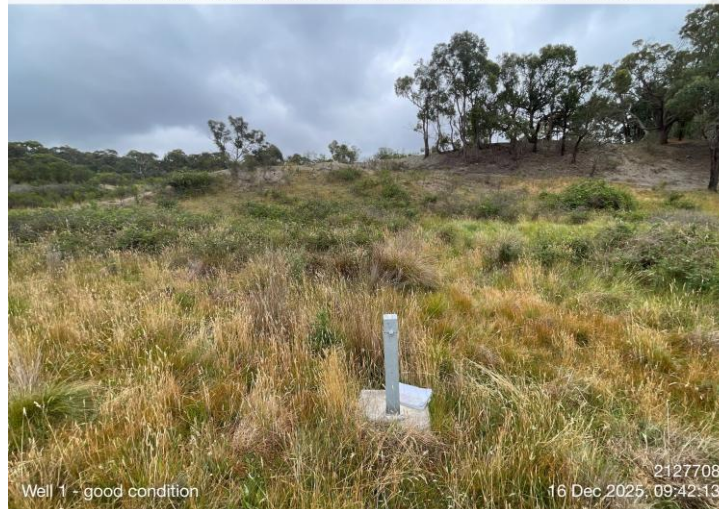
Well 1 - good condition

Photo 18: View looking north-west at piezometer Hole 3, situated immediately south of the borrow pit (Lot 4), looking north-west (16/12/2025).

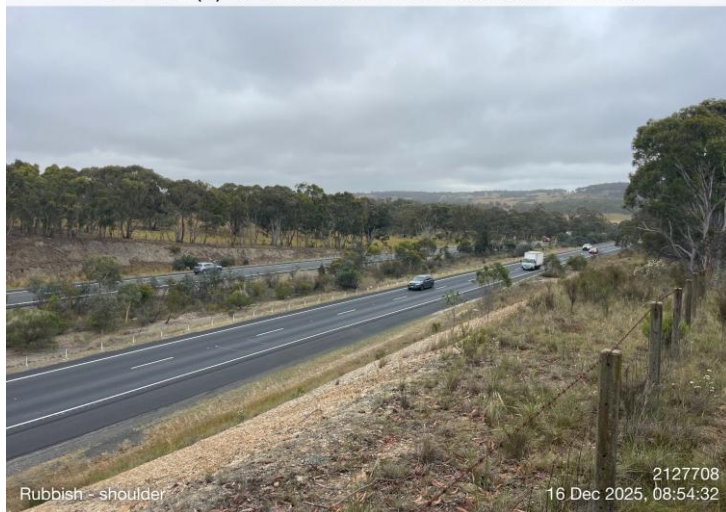
The northern site boundary occurs adjacent to the Hume Highway for approximately 2.2 km (Photo 19). Rubbish was frequently observed scattered along the road shoulder and median strip, and included fast food containers and wrappers, Styrofoam, soft and hard plastics and a tyre (Photo 20). A small pile of bitumen with tyre tread and plastics was dumped near the access gate to site on the northern boundary (Lot 4) (Photo 21). No other fly tipping was observed along the Hume Highway at the time of the site visit.

Photo 19: View of the Hume Highway, shoulder and median strip, facing north-east (16/12/2025)

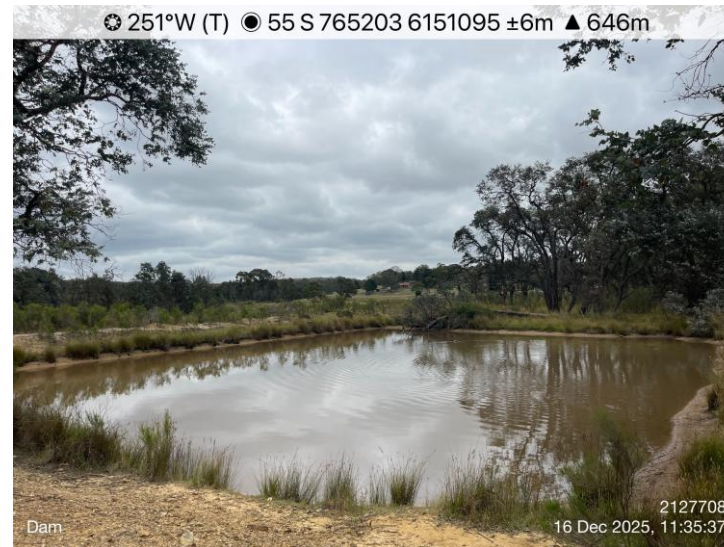
Photo 22: View looking west at the dam located in the south-west of the site (16/12/2025)

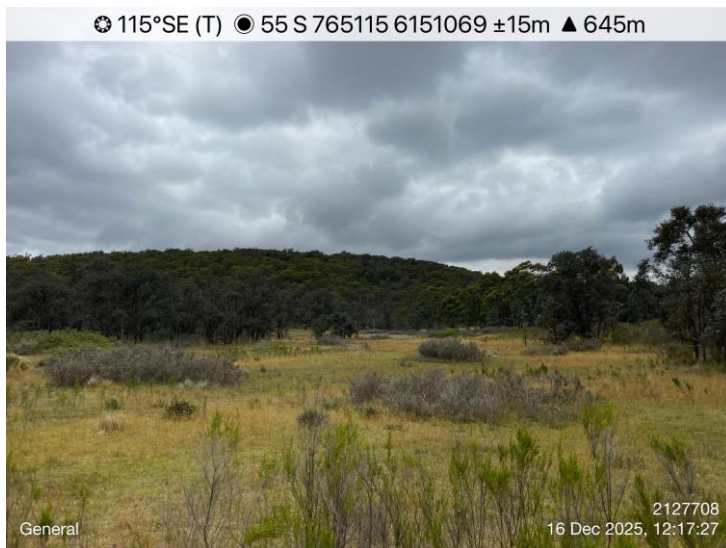
Photo 23: General view from the cleared land in the south-west of the site (Lot 3). Facing south-east towards the trigonometrical station and hill (16/12/2025)

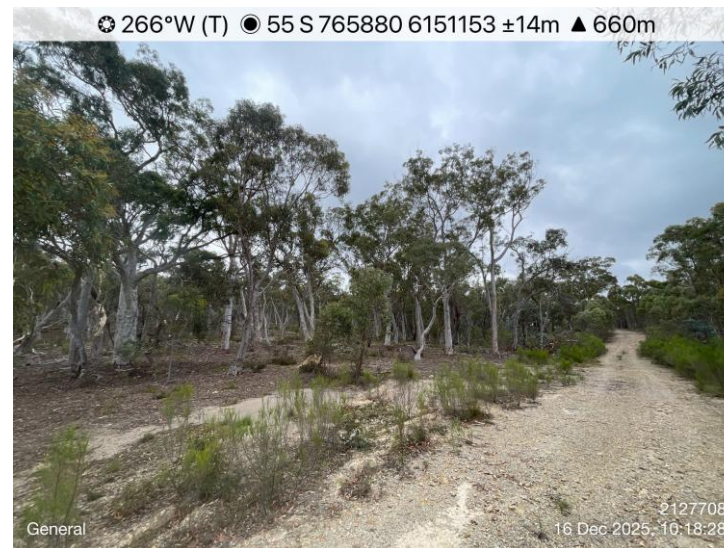
A gravel road passes through the centre of Lot 3, from Winfarthing Road to Lot 4 in the east. The road continues in a northerly direction connecting with the borrow pit area in the north-eastern portion of the site (Lot 4). The road appears to have been constructed from on-site material (Photo 24). Trees left over from the clearing of the road were sporadically stockpiled adjacent to the gravel road (Photo 25).

Photo 24: View looking west along the internal gravel access road that passes through the centre of Lot 3 (16/12/2025)

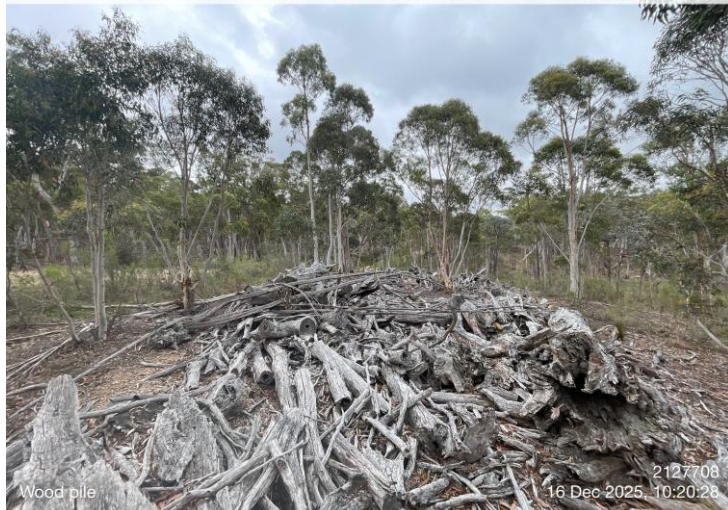
Photo 25: Example of wood stockpiles left over from the clearing for the internal gravel access road on Lot 3 (16/12/2025).

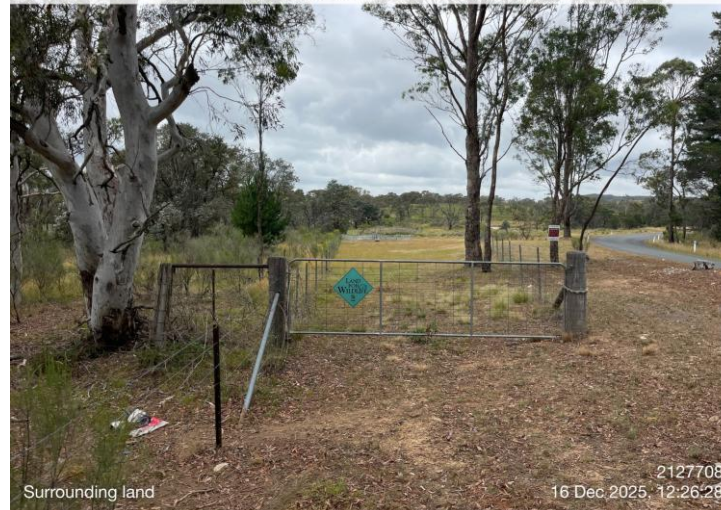
Winfarthing Road is adjacent to the western boundary of Lot 3 (Photo 26). Relatively small occurrences of rubbish were noted on either side of the road. Three instances of fly tipping were observed, one located immediately inside the northernmost access gate to the site (Lot 3) off Winfarthing Road (Fly tipping 1); the second instance was observed on the road shoulder approximately 150 m south of the southern access gate to Lot 3 off Winfarthing Road (Fly tipping 2) and the third was located approximately 75 m south of the Hume Highway on Lot 3 (Fly tipping 3). Fly tipping 1 comprised a degraded mattress, bottles and jars and ceramics (Photo 27), which appeared to have been dump some time ago. Fly tipping 2 comprised cardboard boxes and a toaster press and appeared to have been placed relatively recently (Photo 28). A pile of wire was also noted within the boundary fence near Fly tipping 2 (Photo 29). Fly tipping 3 comprised four pieces of rusted scrap metal, resembling corrugated iron sheeting and 44 gallon drum (Photo 30).

Photo 26: View looking south towards the access gate to Lot 3 located off Winfarthing Road and at the land adjacent to western boundary of site. Cattle yards visible in the background of the photo (16/12/2025)
